Historic building recording and test-pit evaluation at Duncan's Gate, Colchester, CO1 1UN

July 2016

CAT Report 1022
November 2016

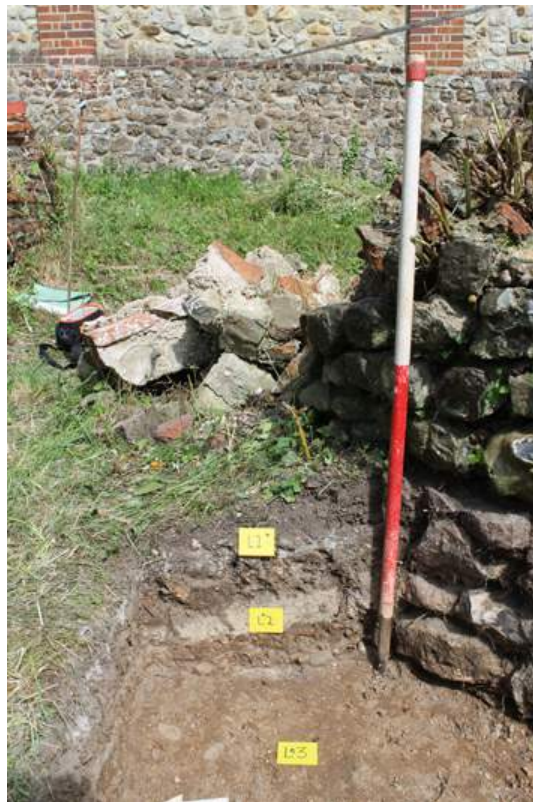
The layers described above butt up against the modern retaining wall to the north of the collapsed masonry (Photograph 5). Below these layers and at the base of the retaining wall is L3 (an orange/brown sandy silt), which has two features (described below) cut into it. The test-pit was stopped at this depth as it seemed that L3 was undisturbed subsoil.

Photograph 5 Section of test-pit, showing layers butting up against the retaining wall. Photograph taken facing west.

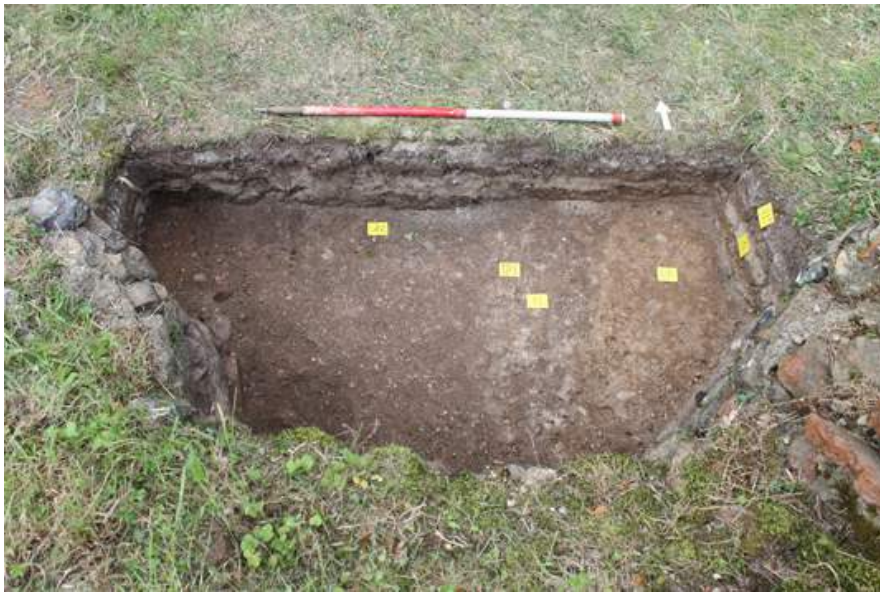
Two features were observed in the test-pit. F1 was the backfilled Roman drain that Duncan discovered in 1853 that services the town and is aligned through the gate to the north. It lined up exactly, both with the still visible grated-over drain to the south, and with the plans from Hull's excavation (Fig 3). The fill of F1 was a dark brown/grey sandy silt and was not excavated, although some Roman pottery and tile was recovered from its surface (see Finds below). Although we can be confident that this cut is for the original Roman drain, the fill of this feature is likely backfill from Duncan's or Hull's excavation.

Photograph 6 Overhead photo of test-pit. F1, F2 and L3 visible.

F2 was only observed at the very north end of the test-pit, and lies within the same cut as F1 (i.e. the Roman drain). The fill was very similar to that of F1, but was clearly darker. Again, this seems likely to be the backfill from one of the two previous archaeological excavations of this feature.

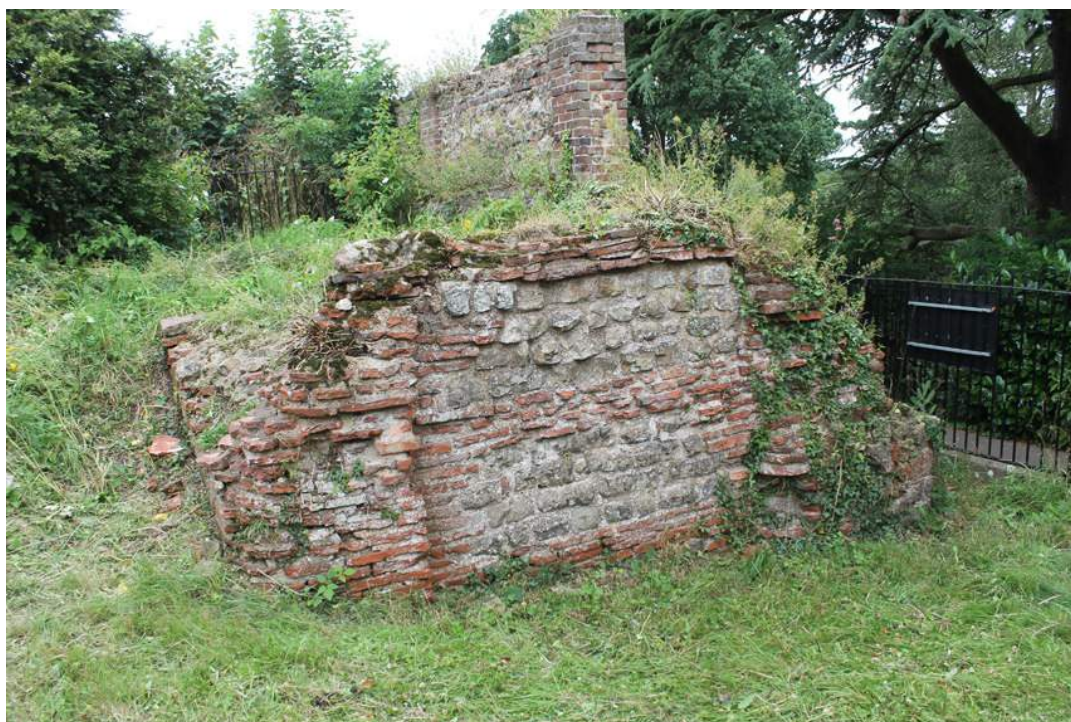
The two sides of the gate vary in preservation, with the western side being in better condition than the eastern – the western side stands 2.4m from the current ground level (Photograph 8), while the eastern side stands 1.7m (Photograph 9). As a result of this height discrepancy, the western side has more courses of brick and septaria remaining (Fig 4). As with the rest of the town wall, neither of the sides stand at their original height at the time of construction (the town wall is thought to have been at least 6m tall – Crummy 1997, 87).

Photograph 8 Western pier of Duncan's Gate Photograph taken facing north-west.

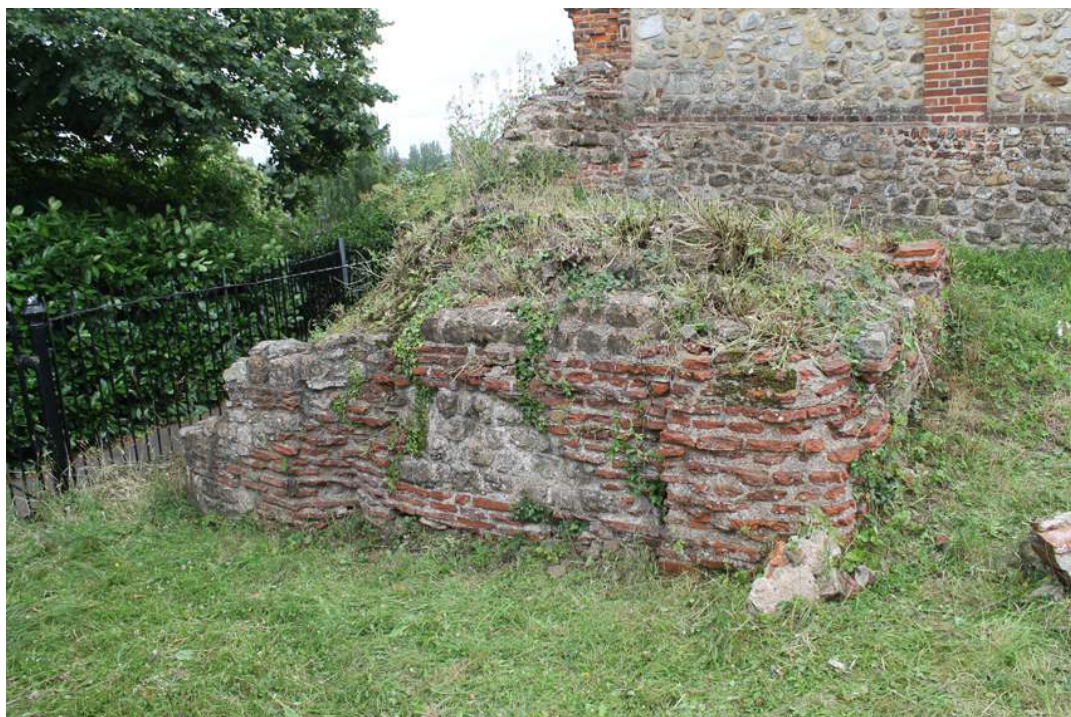
Photograph 9 Eastern pier of Duncan's Gate. Photograph taken facing north-east.

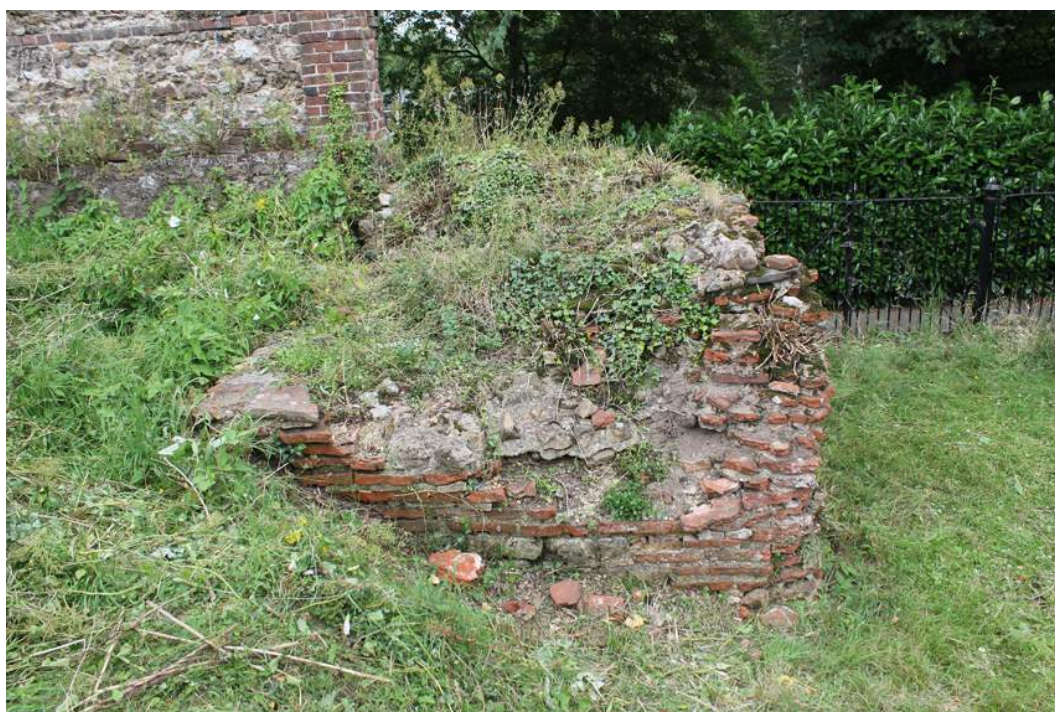
Both sides are extensively overgrown and have deteriorated significantly in the last century – banks of soil and plant debris have been deposited or built up on the east and west sides of the gate (mimicking the original Roman rampart). Photographs from 1920s (after Hull's excavation) show the sides of the gate free-standing with no vegetation around them (Photographs 1 and 4). During the course of this investigation, it was clear that the gate was in a rapid state of decay, with several lumps of masonry scattered around the site that had recently fallen off from the wall.

Photograph 10 Southern face of western pier. Visible is the decayed concrete used to consolidate the wall in the 1920s. Photograph taken facing north.

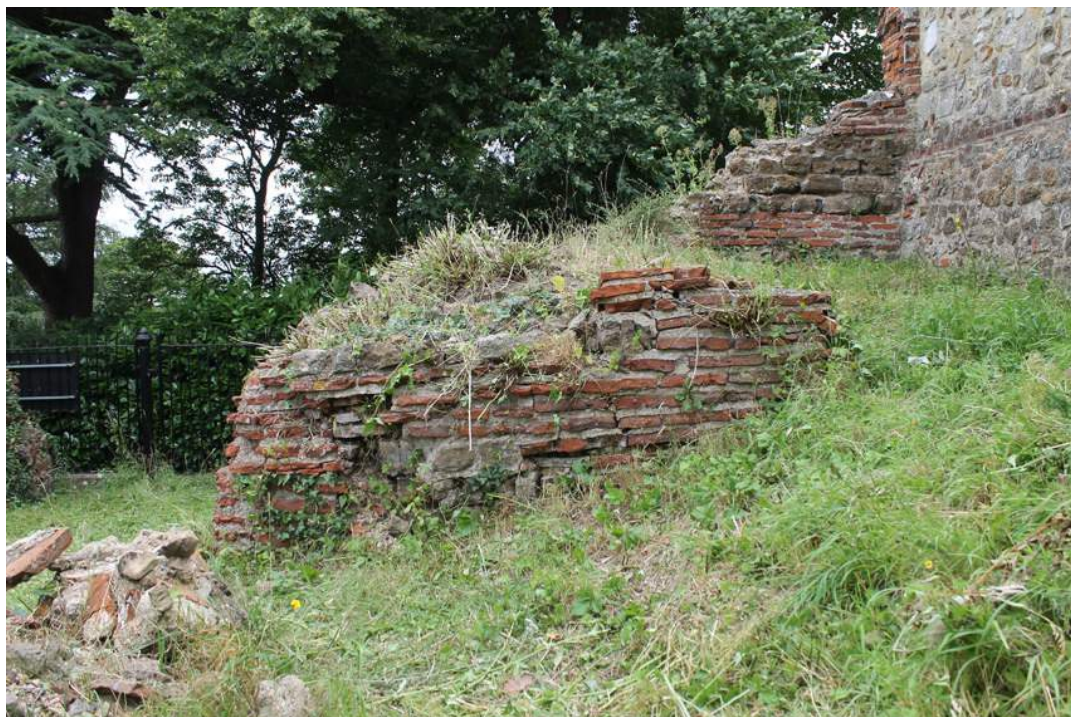
Photograph 11 Southern face of eastern pier. Visible is the decayed concrete used to consolidate the wall in the 1920s. Photograph taken facing north.

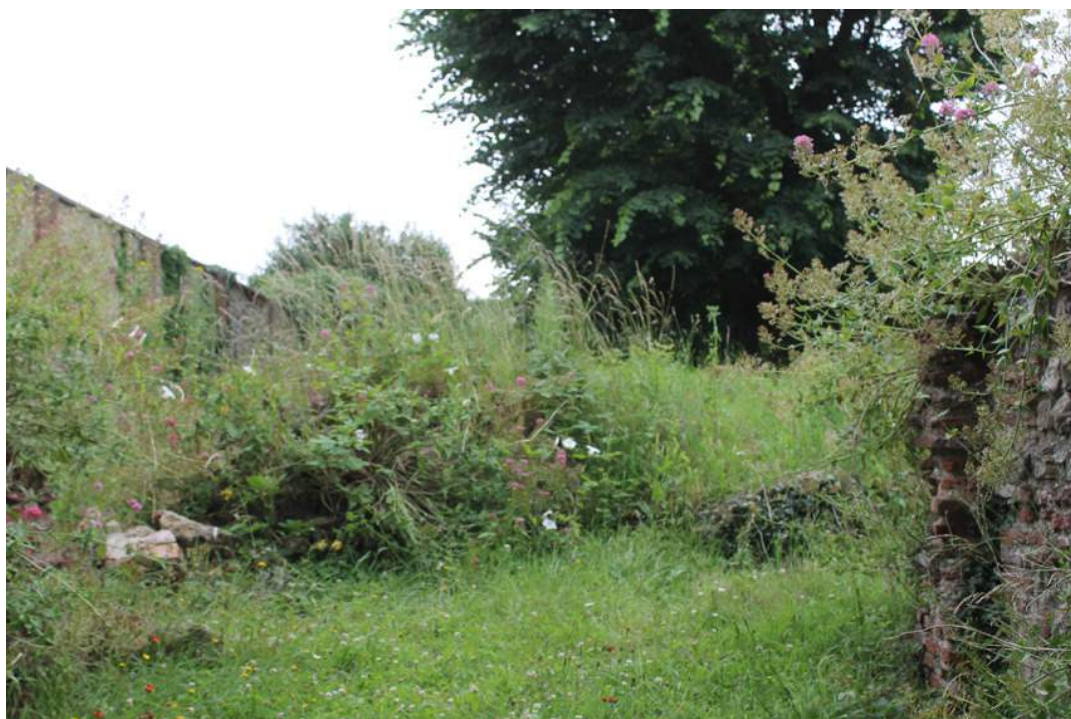
The collapsed masonry lies approximately 1m to the south of Duncan's Gate, and is heavily overgrown (Photograph 12). Even after removal of a substantial amount of overgrowth, the only section identifiable on the surface were the tile courses (with some occasional septaria fragments) defining the windows of the gate tower (Photographs 13, 14 and 19). The entire western half of the collapsed masonry is covered in grass, making any identification impossible. Although the limits of the collapse are difficult to define, the masonry appears to be about 10 square metres in area.

Photograph 12 Collapsed masonry prior to the removal of overgrowth. Photograph taken facing south.

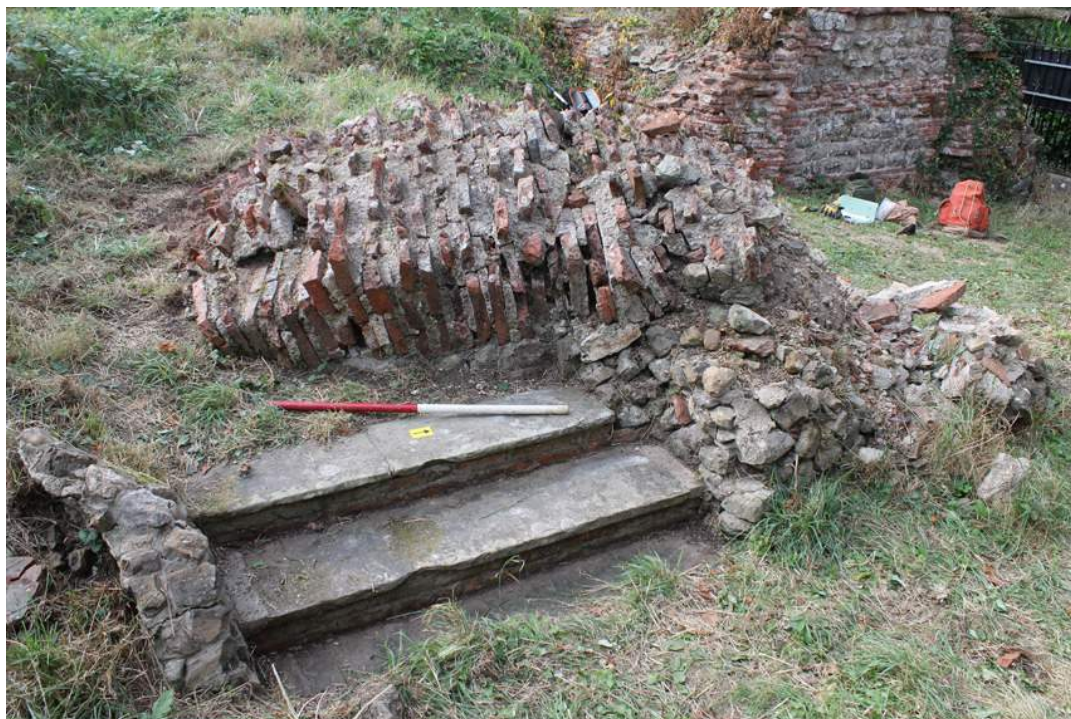
On the south-east side of the masonry, two concrete steps have been added leading up to the collapsed tile courses, probably in an attempt to convert the masonry into a garden feature in the early 20th-century (Photograph 15).

Photograph 15 Collapsed masonry, showing tile courses repaired with modern concrete. Also visible is the modern steps added to the collapse in the early 20th-century. Photograph taken facing north-west.

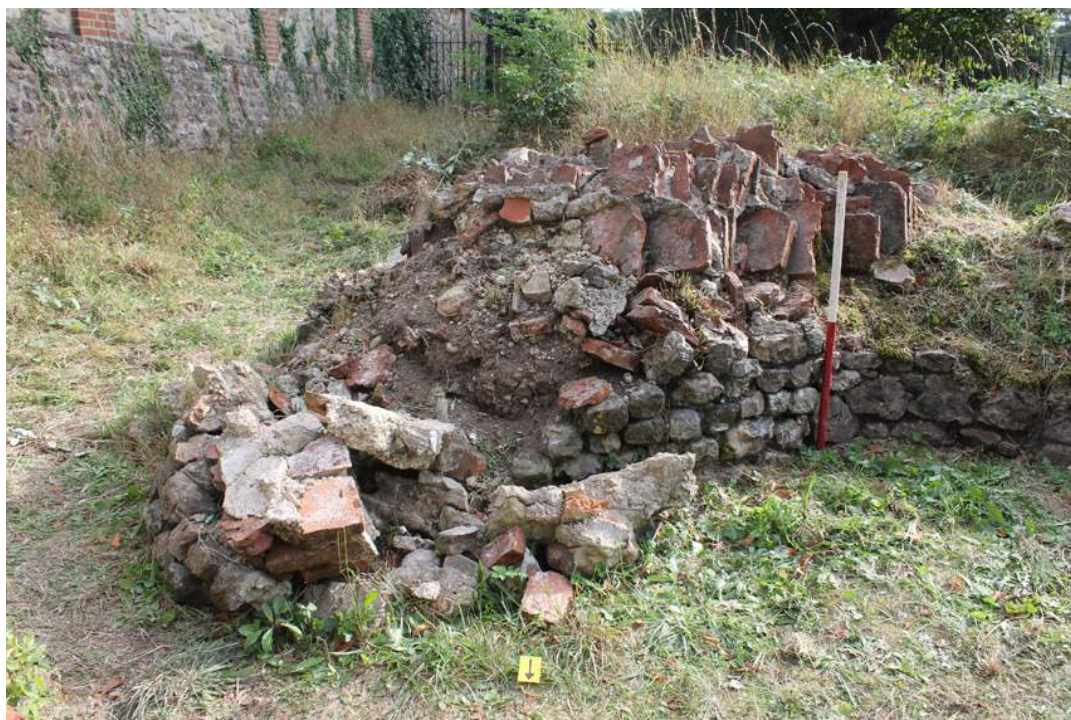
The north-east corner of the masonry has very recently suffered a significant collapse, with the modern concrete render, retaining wall and a course of tiles having fallen, exposing the original lime mortar beneath (Photograph 17).

Photograph 17 Recent collapse to east of masonry. Lime mortar exposed behind concrete render and retaining wall. Photograph taken facing south.

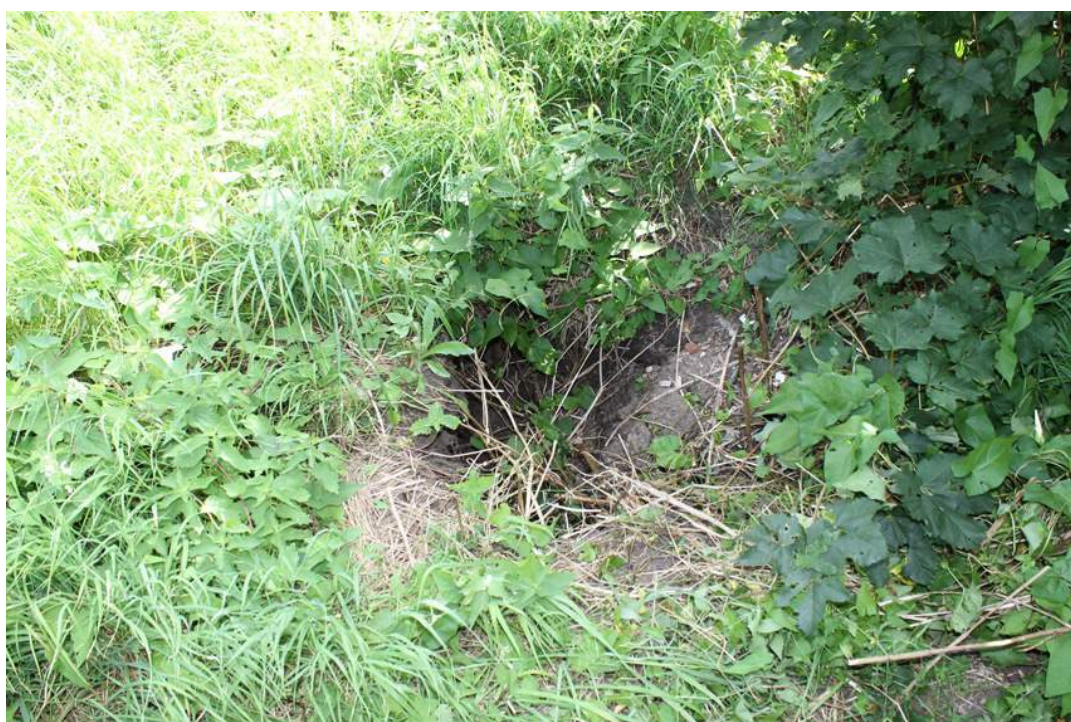
During the course of the work detailed in this report, a section of subsidence was observed to the west of the collapsed masonry (Fig 2). The ground in the area was extremely unstable and seemed to have subsided to a significant depth (Photograph 18). Upon observation down the hole Roman tile was visible. It seems possible that this collapse indicates a previously unknown section of the Roman drainage system – alternatively it may be the result of the Hull's 1920s excavations, as a north-east/south-west aligned trench running from Duncan's Gate is shown in his report (Fig 9). Either way it would be advisable for this area of collapse to be investigated and shored up to prevent further damage.

Photograph 18 Area of collapsed ground to south-west of Duncan's gate. Possibly evidence of a Roman drain run? Photograph taken facing south.

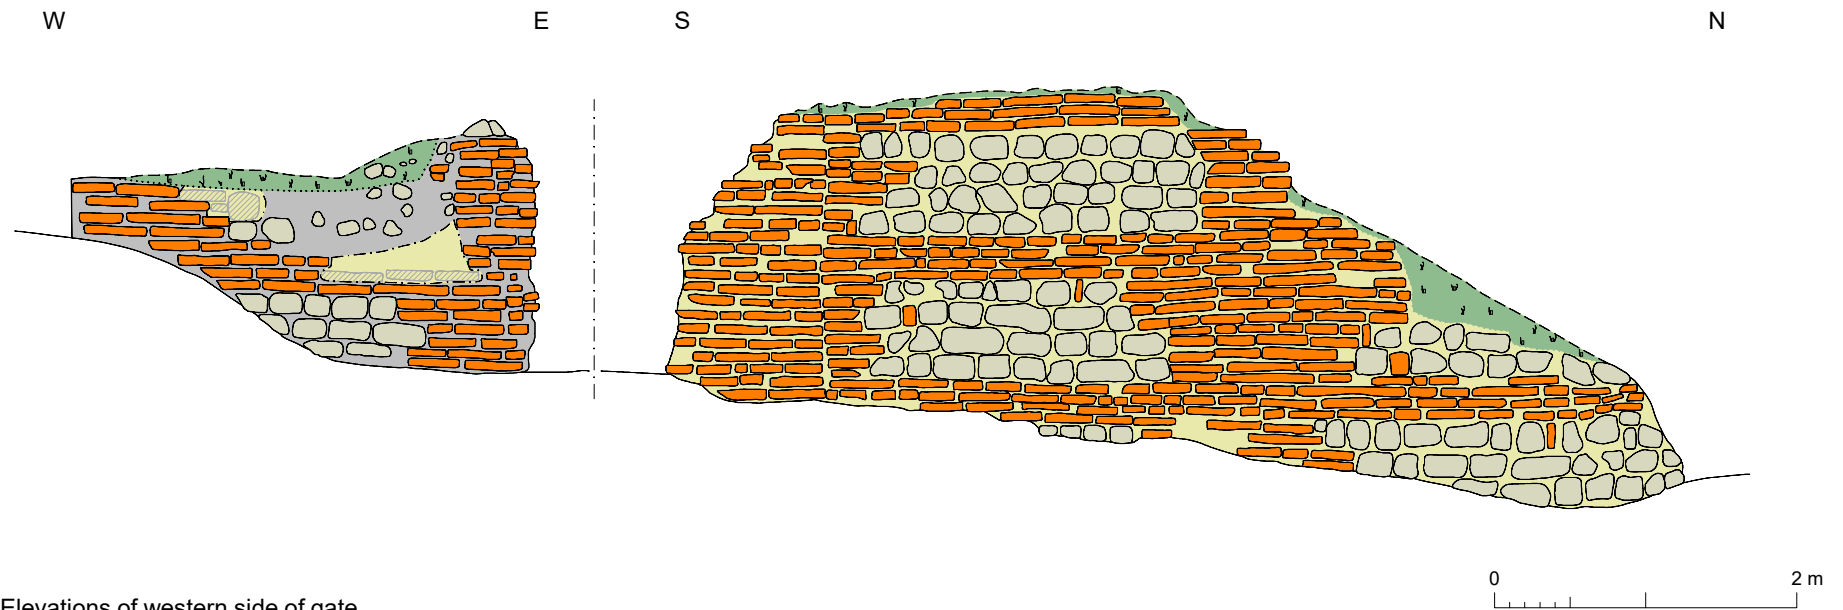
Fig 4 Elevations of western side of gate.

The conservation efforts conducted in the 1920s were mostly focused on the collapsed masonry (see below), but parts of each side of the gate were also conserved. Largely this

conservation was restricted to the south face of each side (where they are most damaged- Photographs 10 and 11), but part of the west facing elevation of the eastern side was also conserved (Fig 5).

The method of conservation consisted of some areas of the wall/masonry being re-bonded with concrete in an attempt to prevent further collapse. This concrete is very different in appearance from the original Roman lime mortar and so is quite jarring aesthetically (although in some areas the moss and overgrowth make it hard to distinguish between the two). Additionally the concrete itself seems to have decayed significantly since it was laid, in areas re-exposing the original Roman mortar.
