**Heathwell House,
Stone Lane,
Tiptree, Essex**

Historic Building Record

HER ECC4105

Heritage Asset Assessment

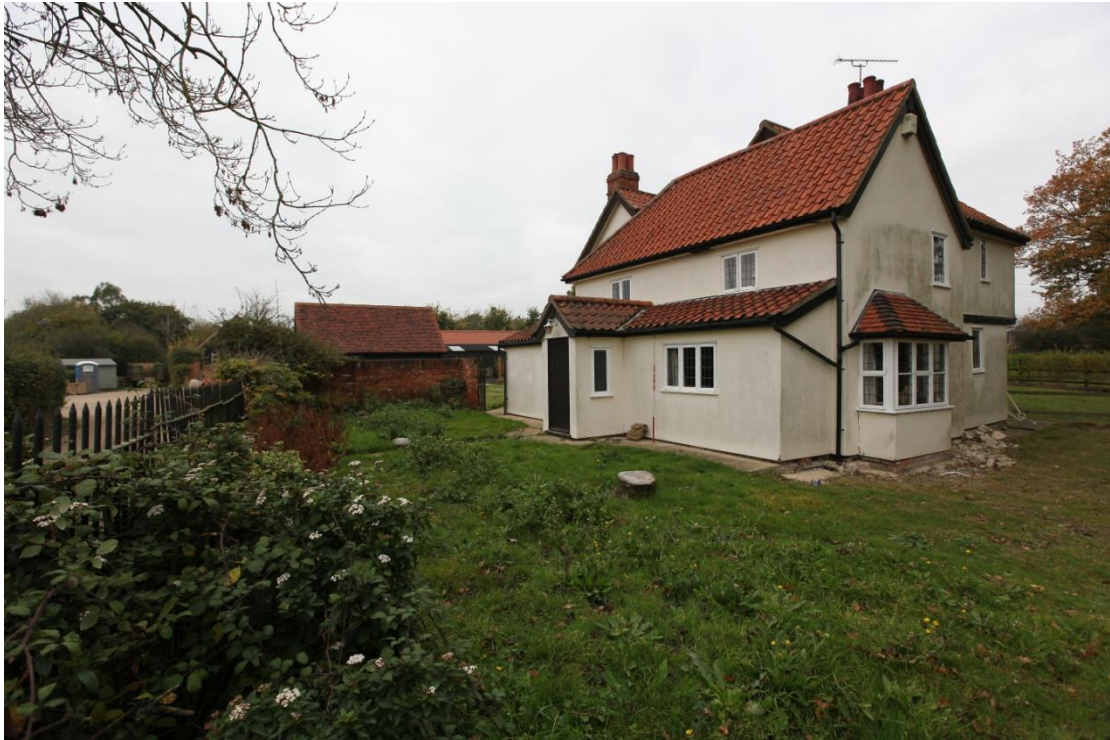
Illus. 1. Heathwell House from the south-east showing Stone Lane on the left. The building's uniform appearance is the product of an extensive late-20th century or early-21st century restoration which disguised its complex origins with new windows, pantiles and cement render.

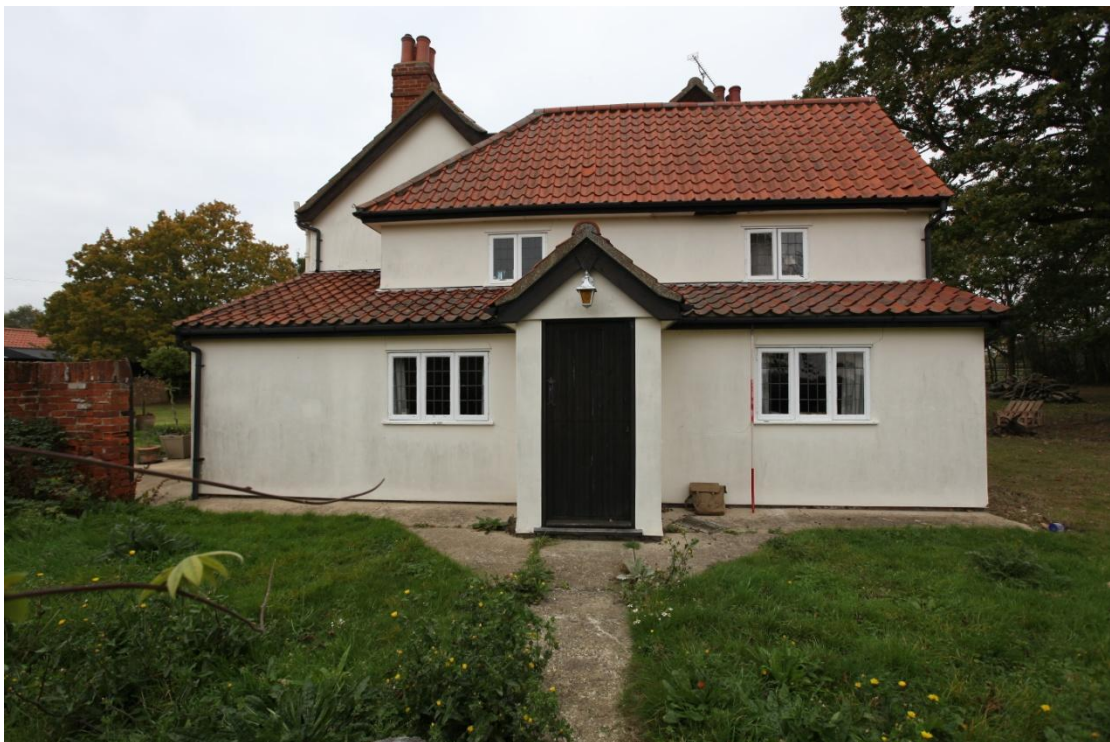
Illus. 2. The southern facade showing the hipped roof of the original 19th century structure (1) on the right behind its mid-20th century lean-to extension (4). The north-western rear extension (3) is visible on the left.

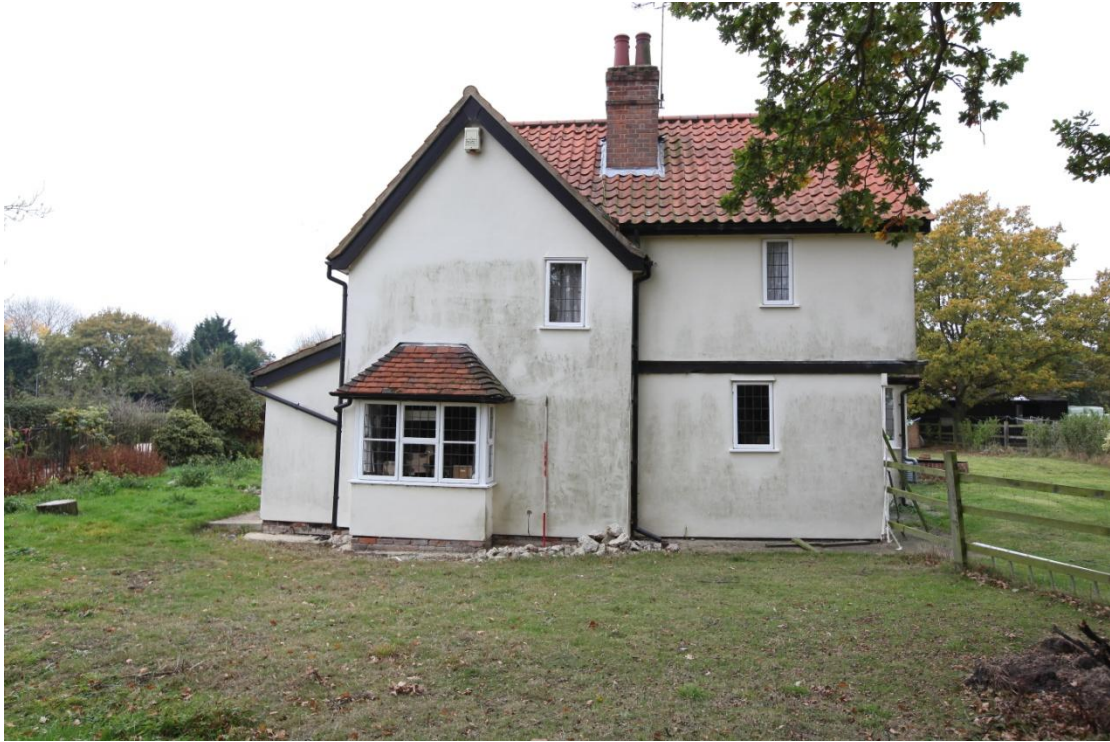
Illus. 3. The building from the east with the original 19th century gabled structure to the left (1) and the north-eastern rear extension (2) on the right.

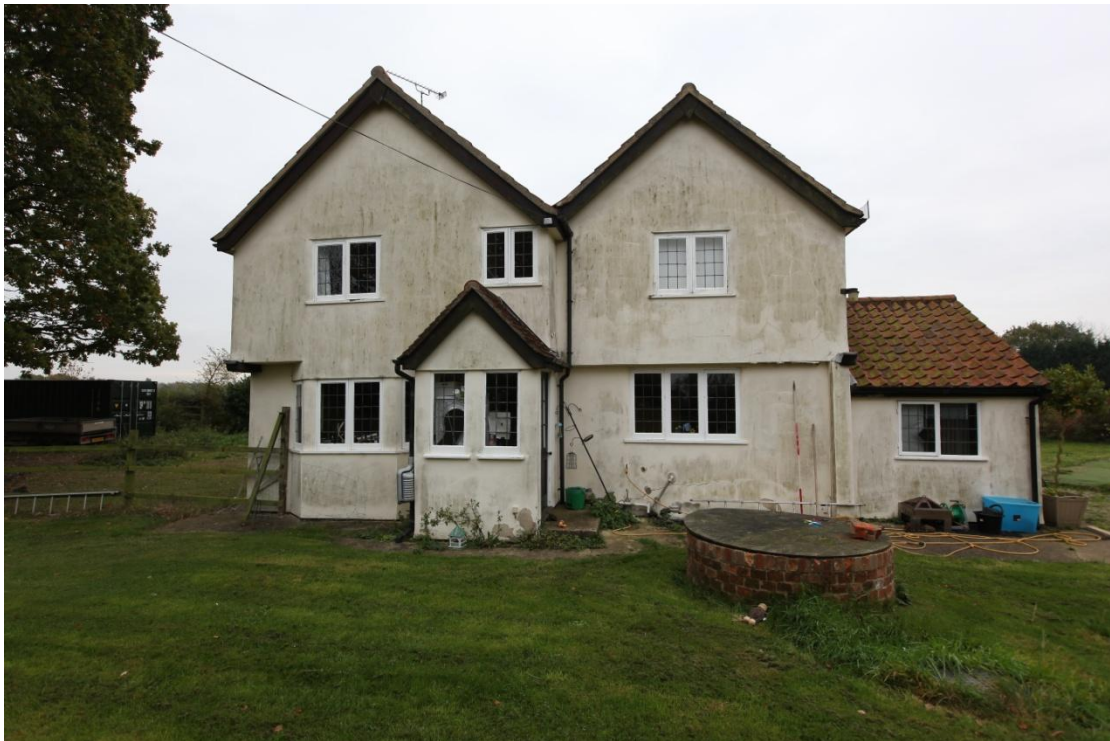
Illus. 4. The rear (northern) elevation showing the two gabled rear extensions (2 and 3) after the removal of the Mock Gothic false timbers shown in 1983 (figure 11). The central rear porch and the single-storied kitchen extension on the right (3a) were built after 1983.

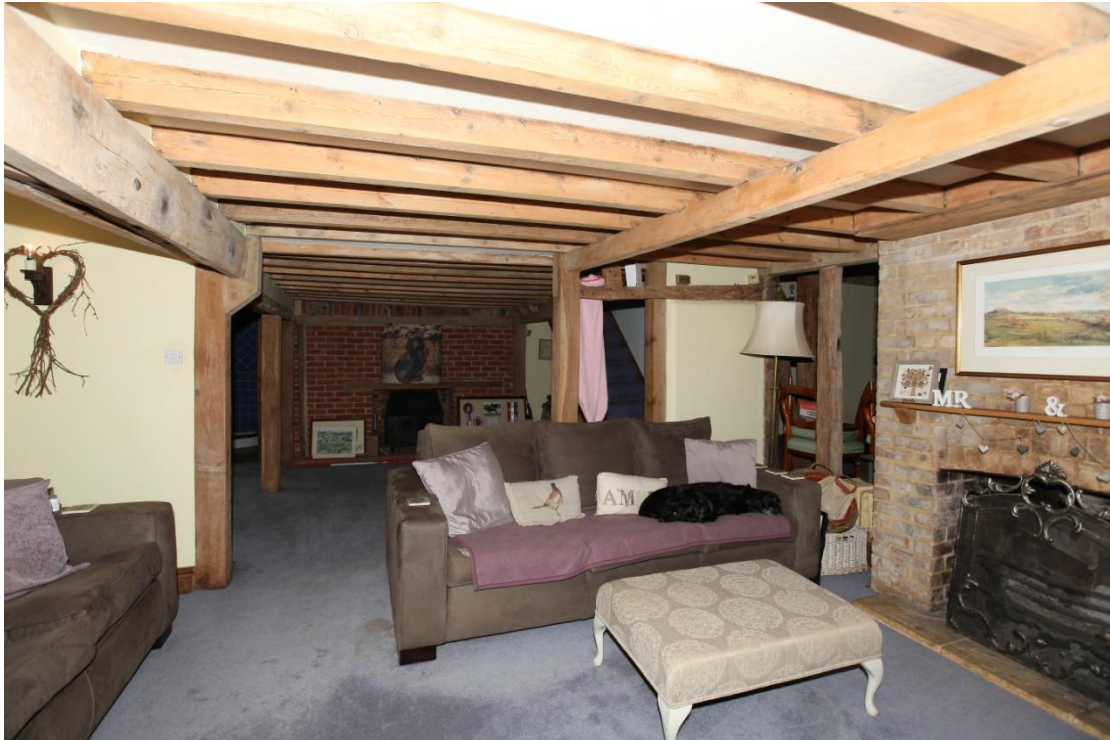
Illus. 5. The interior of the original two-bay building (1) looking west from its eastern gable. The ceiling and the chimney of the eastern bay on the right date only from the addition of the rear wing (2) after 1923. Some of the timbers at the foot of the staircase may survive from the original central partition but the southern wall to the left has been entirely removed where it adjoins the later lean-to extension (4).

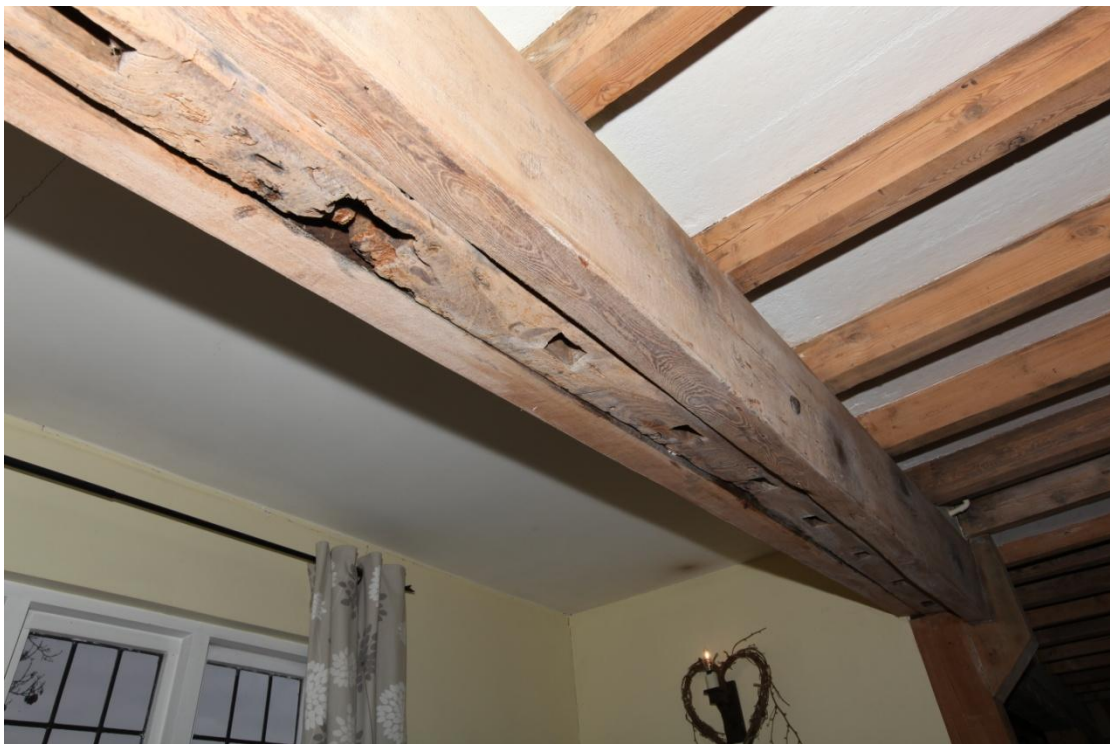
The roof-plates of phase 1 contain angled notches where studs were formerly nailed in addition to unpegged mortises, indicating that its walls have been rebuilt on at least two occasions. The downward slope of the original front mid-rail to the east suggests this may

have occurred due to the same process of subsidence that affects the property today. Whether the initial reconstruction occurred before the 1920s is unclear, but the building retained its original modest outline on the Ordnance Survey of 1923 and was still divided into a pair of cottages (figure 6). The two gabled rear extensions shown in illus. A2.4 had more than doubled its size by 1954, when it had become a single dwelling (figure 7), but they were probably added at different times given the differences in their scale and proportions. It would make neither economic nor aesthetic sense to build a single addition in so complex a manner. The larger north-eastern wing is likely to have appeared first (phase 2), with the smaller added soon after (phase 3), although the latter was extensively disguised during the most recent refurbishment which included the rebuilding of its roof and it may conceal earlier fabric. Both wings were artificially aged with waney planks imitating medieval timber framing in the fashion of the inter-war years, as shown in the sales particulars of 1983 (figure 10). This Mock Gothic exterior is consistent with the north-eastern wing's ceiling (A2. 10) which consists of tall-sectioned pine joists lodged on a square-sectioned axial joist in imitation of medieval ceilings. The pine was initially stained black in the same tradition but has been cleaned by abrading its surface. The gault-brick chimney contains back-to-back arched fireplaces heating both the new wing and the eastern bay of the original structure (1b), and the latter's ceiling was rebuilt to match that of the extension. The new ceiling was significantly higher than the old, which would have rested on the remaining southern mid rail little more than 1.5 m above the present internal floor. While the ground-floor fireplaces are arched and open in the Mock Gothic style, the first-floor tiled fireplaces are typical of the late-1920s and 30s, as is the ceiling of panelled fibreboard in the phase 2 bedroom (2f).

Illus. 6. A detail of the front wall of the eastern bay (1b) showing the empty, unpegged mortises of its original mid-rail from which the ground-floor studs have been removed. The timber is now supported by a pair of bolted clamps where it adjoins the lean-to extension (4c).

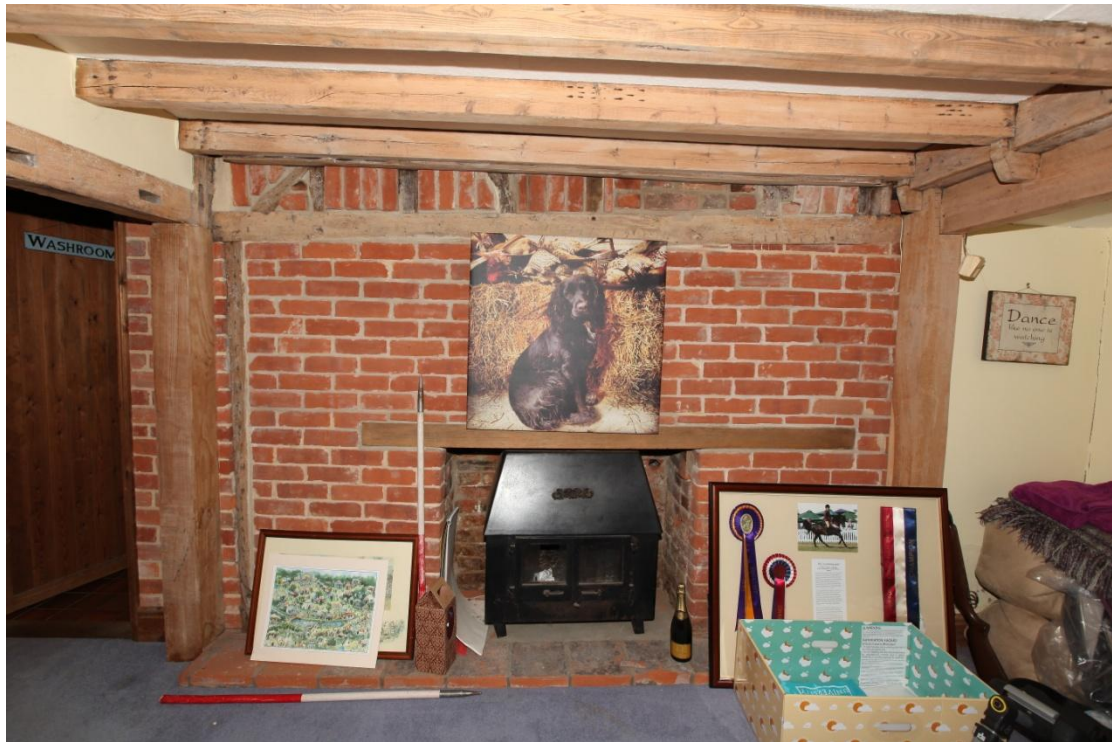
Illus. 7. The modern brick fireplace in the western gable of phase 1 showing the original mid-rail with a diagonal primary brace to the left. Some studs appear to be pegged to the rail, although the timber may have been re-used, but most are not. The posts to left and right relate to the mid-20th century restoration (phase 2), as does the re-used southern mid-rail on the left.

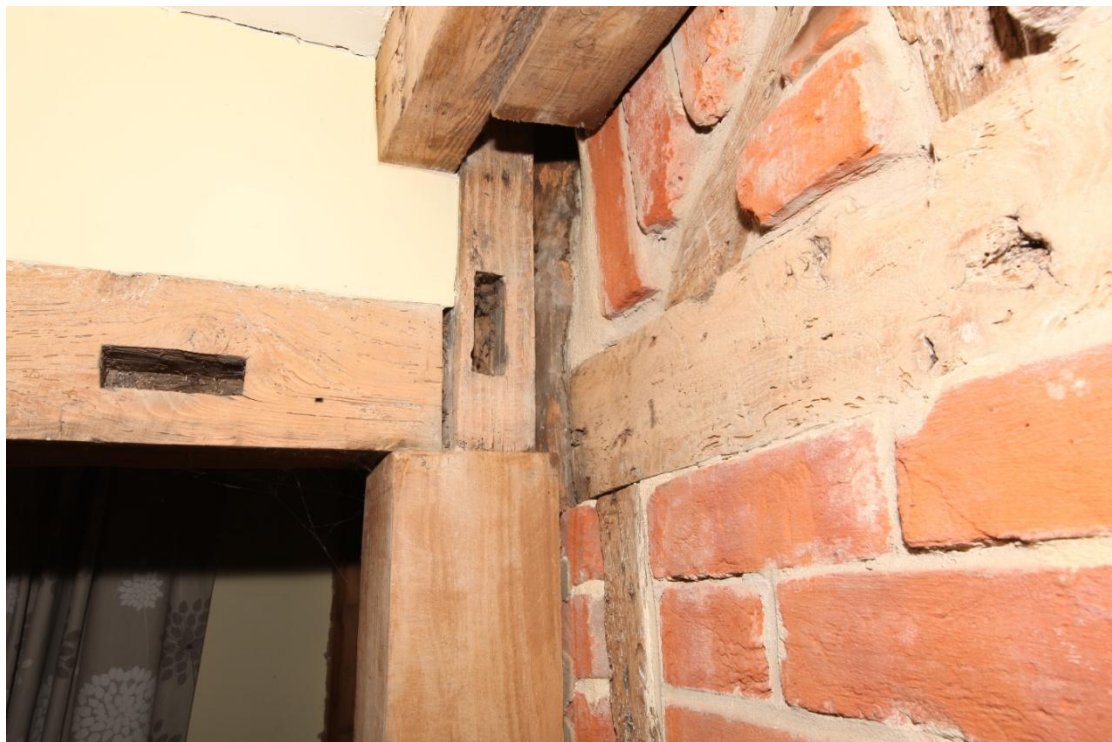
Illus. 8. A detail of the left-hand post in illus. 7 above, showing the original south-western corner post of phase 1 hidden behind it. The pegged joint between the post and the gable mid-rail is visible in the centre of this image, but the diagonal primary brace is nailed rather than pegged in the typical manner of the early- to mid-19th century.

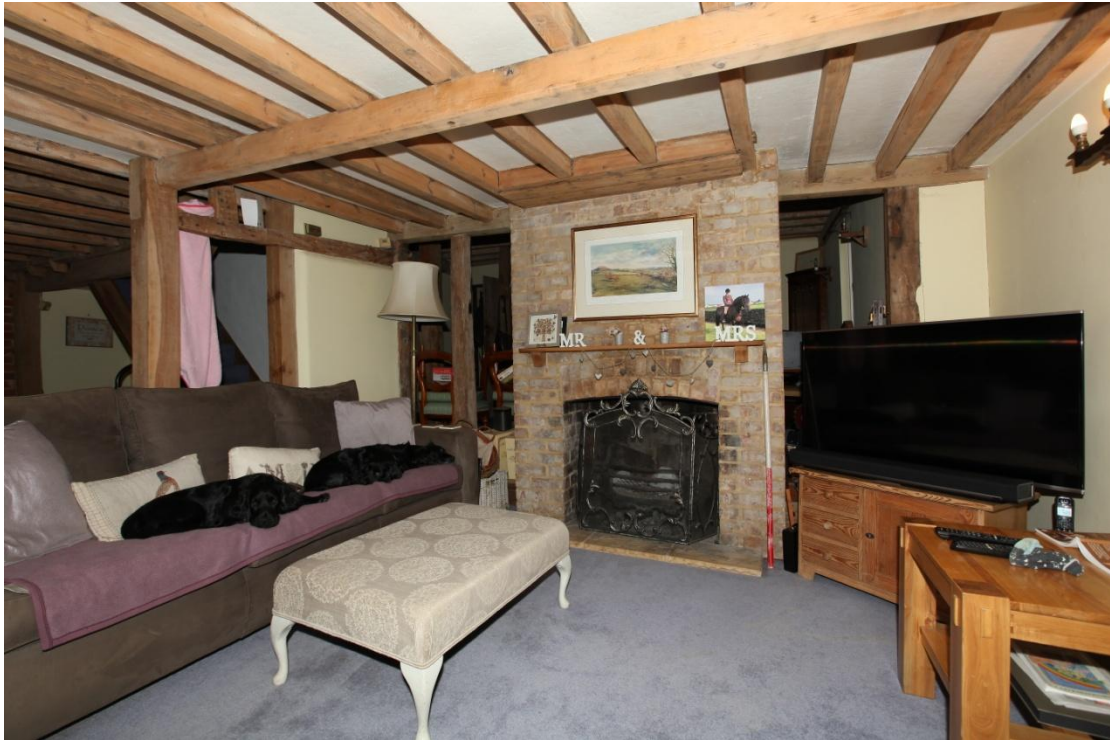
Illus. 9. The rear (northern) interior of phase 1's eastern bay (1b) showing the gault-brick arched fireplace and chimney of phase 2. The chimney is respected by the present ceiling, which replaced the original ceiling at the same time.

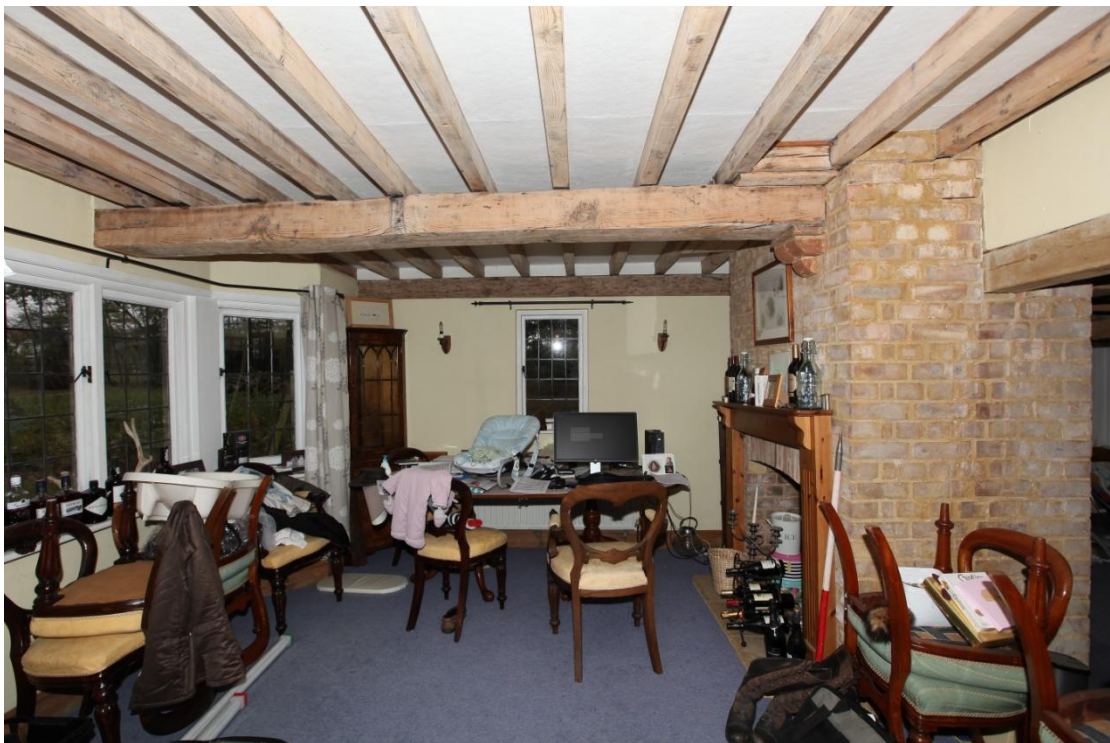
Illus. 10. The interior of the north-eastern extension (2) as seen from the west, with its original chimney containing identical back-to-back fireplaces adjoining bay 1b on the right. The tall-sectioned pine ceiling joists have been cleaned of their original Mock Tudor stain, and are lodged on an axial joist in the same crude manner as those of the contemporary ceiling in phase 1.

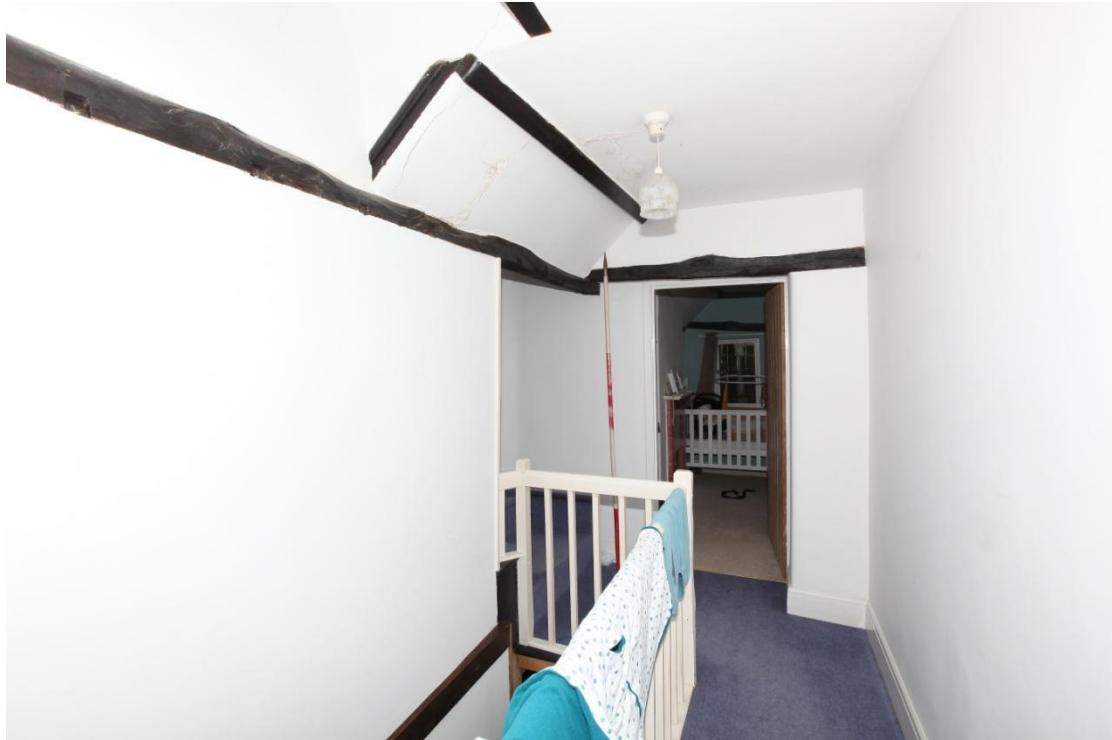
Illus. 11. The first-floor stair landing (1afl) from the west showing the black-painted original northern roof-plate and central tie-beam of phase 1, with the bedroom above its eastern bay (1bf) in the rear. Note the empty notches for studs in the roof-plate (top left), which suggest the wall fabric has been renewed twice.

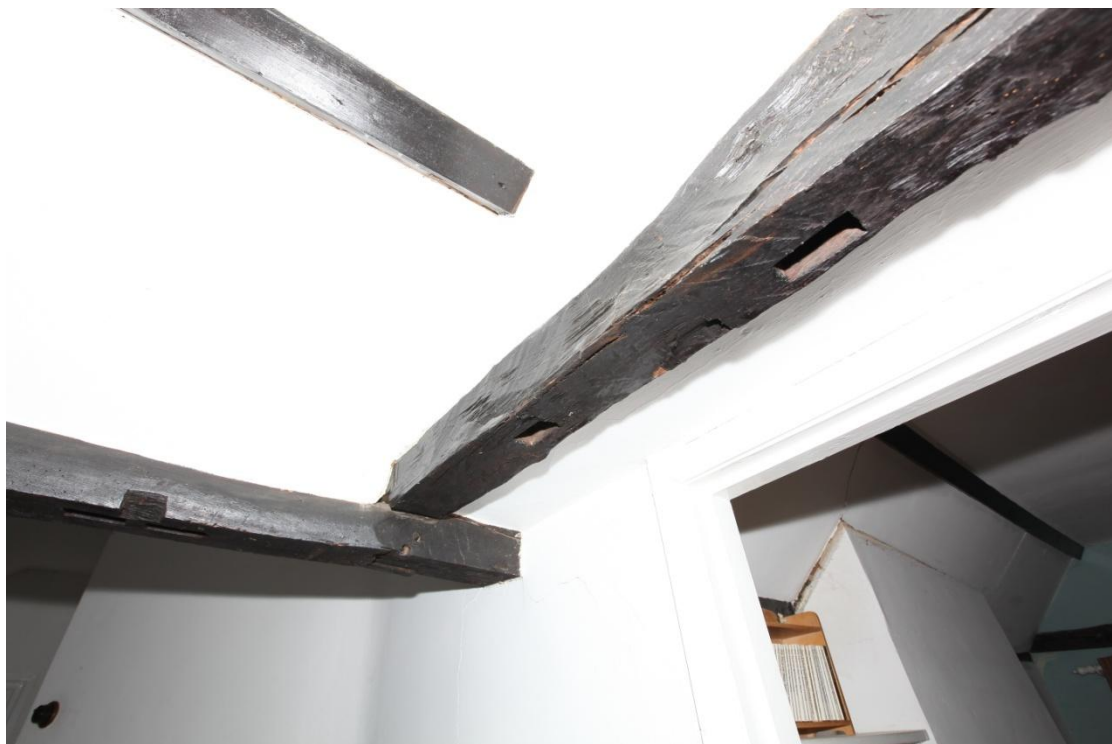
The two equal bays of the timber frame were divided by an internal partition as indicated by the stud mortises in the central first-floor tie-beam (A2.12), and its upper storey possessed a low ceiling at eaves level as shown by mortises for missing axial joists in the same tie and its gable counterparts. The timbers at the foot of the modern staircase may survive from the central partition but the ground-floor ceiling has been completely replaced and it is unlikely that any original wall fabric remains *in situ* on the lower storey. The building's precise layout is therefore impossible to establish, but the symmetrical framing strongly suggests it formed a small pair of identical one-up/one down tenements which probably possessed rear storage lean-tos from the outset. Such an interpretation is consistent with the tithe survey which describes the building as a house with two quarter-acre gardens in the same ownership. Only one tenant is named (Jacob Chignell) but this was usual on tithe surveys even where additional occupants are known to have existed: alternatively one of the two cottages may have been empty at the time. The building was certainly a pair of cottages by 1874 as shown in figure 4. Its owner in 1839 owner possessed at least one additional garden elsewhere, and two further houses with a quarter acre garden belonging to a local farm lay in close proximity on the other side of the road. These buildings and gardens almost certainly originated as part of the well-documented speculative programme of settlement on Tiptree Heath during the late-18th and early-19th century which saw the establishment of numerous market gardens. Their dwellings frequently took the form of very small semi-detached tenements built as cheaply as possible from weatherboarded studwork, and Heathwell House is likely to have resembled the local examples of similar scale shown in figure 9. The exact locations of its doors and windows are uncertain but the two cottages probably shared a central chimney with doors adjoining their gables as in the same photographs.

Illus. 12. A detail of the central tie-beam in illus. 11 showing the empty, unpegged stud mortises of the first-floor partition which divided the building's two original bays. Identical empty mortises are visible in the roof-plate (left) along with empty stud notches, indicating more than one significant phase of rebuilding.

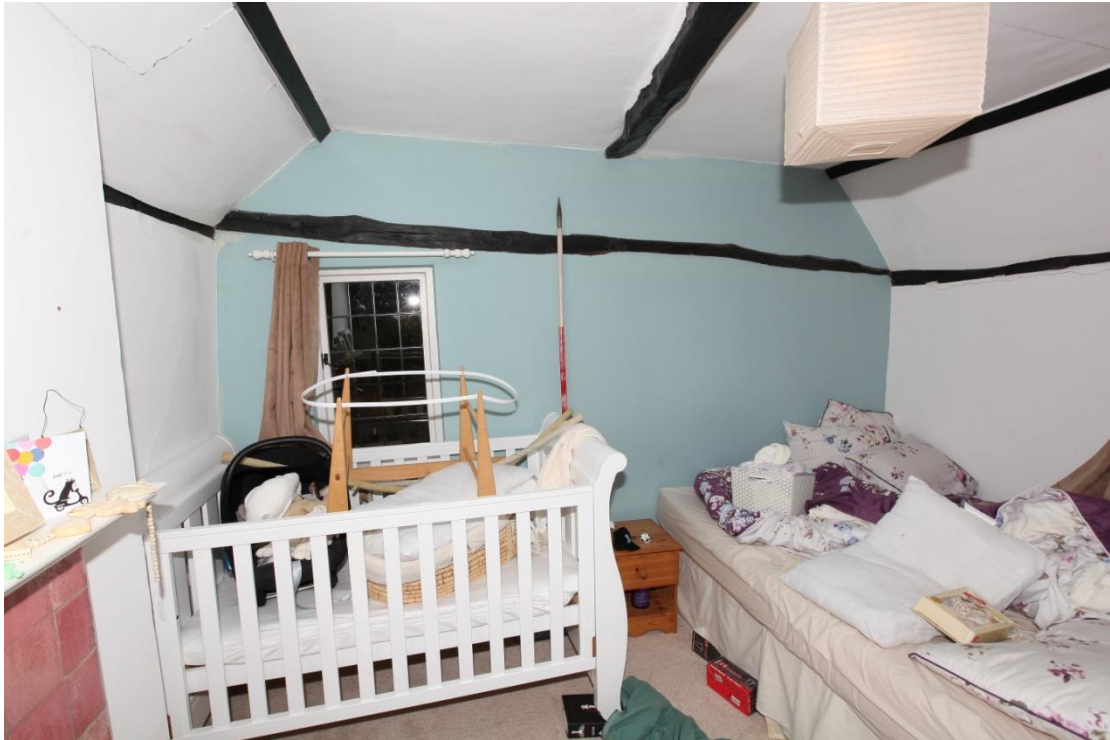
Illus. 13. The eastern internal first-floor gable of phase 1 (1bf) showing the original tie-beam with a central mortise for the axial joist of a missing original ceiling at eaves level. Identical mortises are visible in the centres of all the exposed tie-beams.

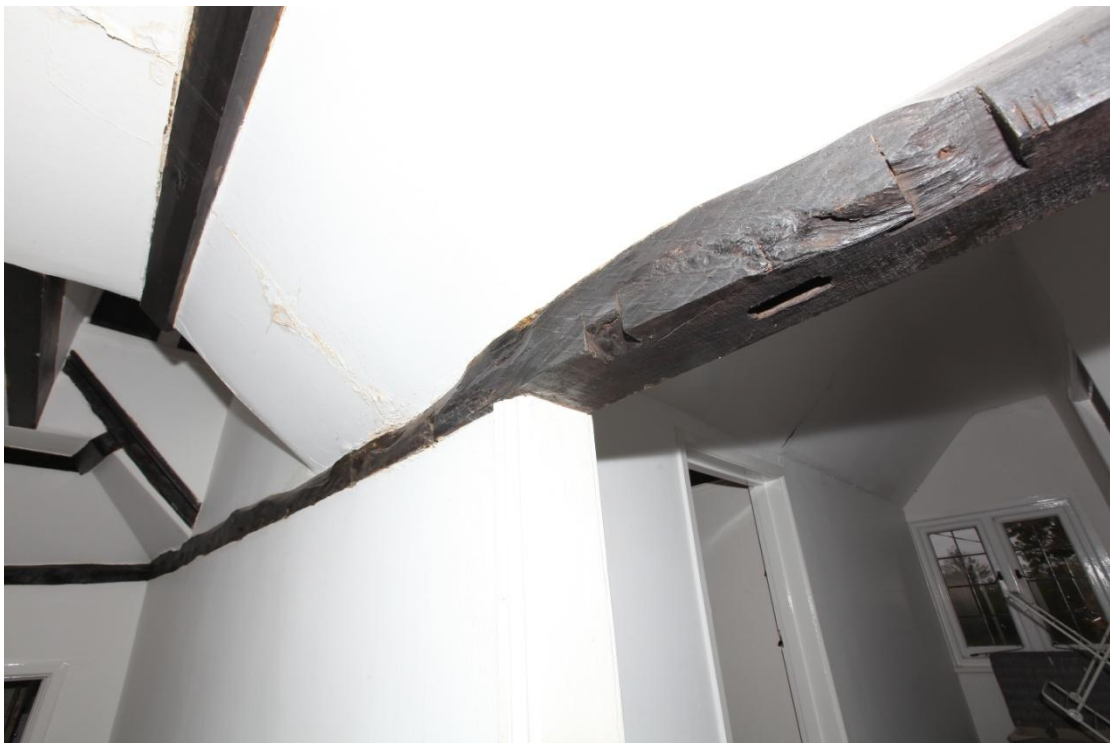
Illus. 14. The northern roof-plate of the original western bay (1afl) showing its combination of empty notches and unpegged mortises. The mortises are likely to relate to the original wall studs which were later replaced by a series of notched and nailed studs – most of which were renewed in turn during the 20th century restoration. Note that the western gable tie-beam in the rear to the left is at the same level as the roof plate, with an iron strap securing the two in a manner rarely found before the 1830s.

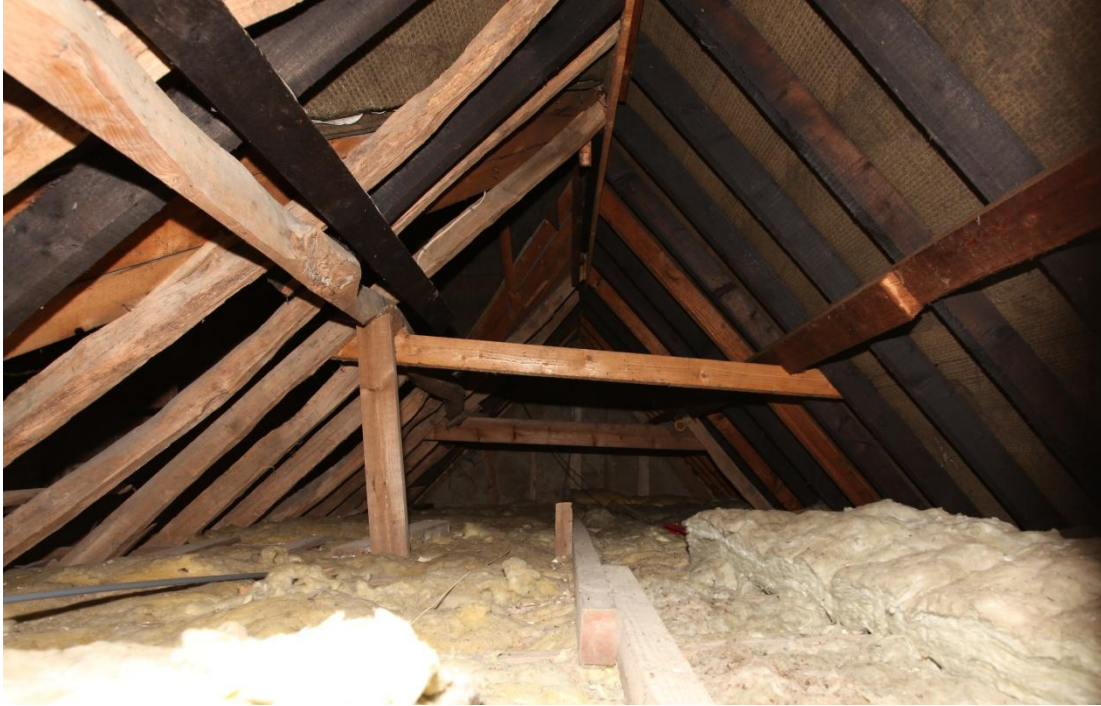
Illus. 15. The original roof structure of phase 1 seen from its western gable. The waney, unpainted rafters on the left (north) are original but the collars and the southern rafters are 20th century replacements in two phases – one set of new softwood timber has been stained black, presumably with preservative. The studs of the eastern gable appear to be original indicating the building was initially hipped at only one end.

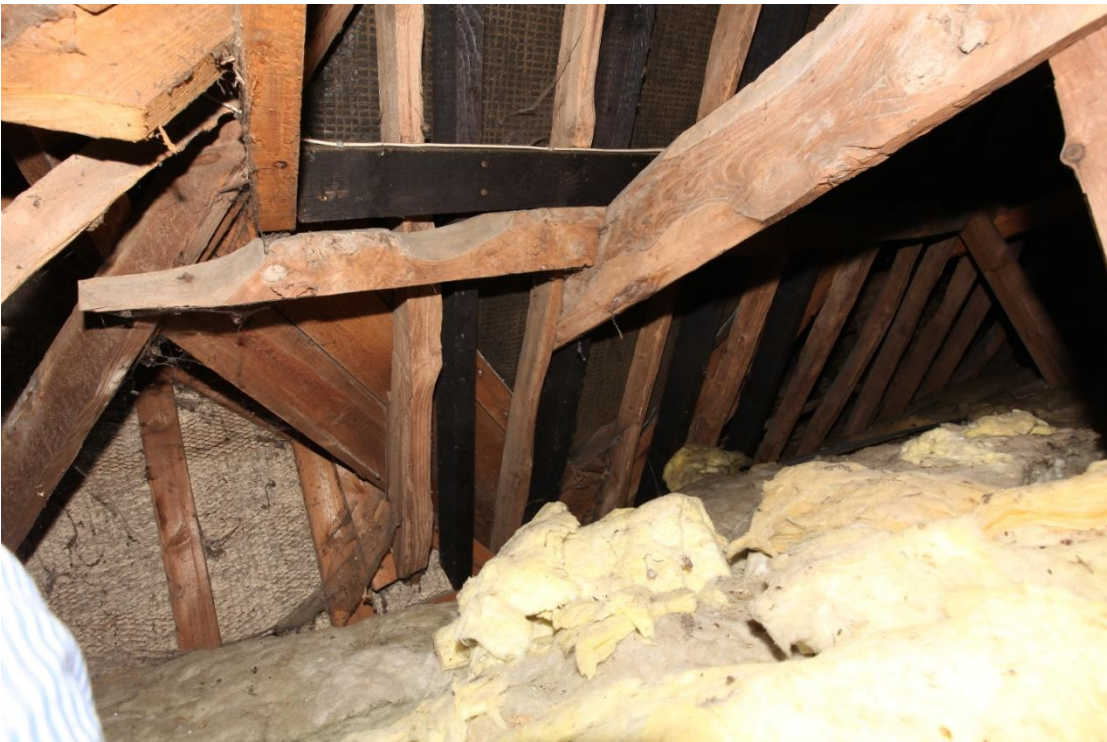
Illus. 16. The original clasped-purlin phase 1 roof structure with a nailed collar at its hipped western end, as seen from the south. The pine timbers, both stained and unstained, are modern additions. The 20th century softwood and cement render of the north-western extension (3) is visible at bottom left.
