FINGRINGHOE CHURCH

Historic Buildings and Conservation
Essex County Council

Report commissioned by the Parochial Church Council and prepared by
Karen Fielder with assistance from David Andrews, 2007

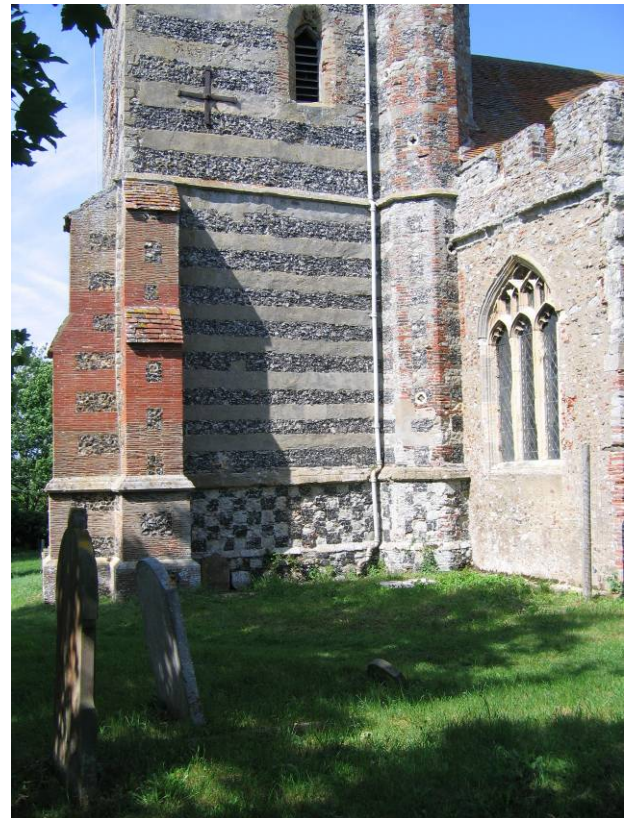
Fig. 2 The two buttresses built under the supervision on Wykeham Chancellor in 1920. They have since been repaired with modern tiles.

1920 brick buttresses faced in flint and tile were built at the south-west corner (*Fig. 2*).

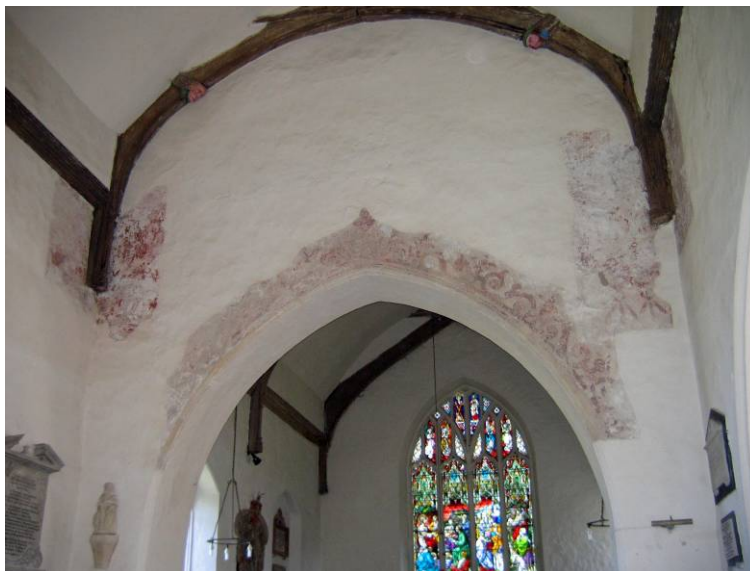
Fig. 3 The chancel arch with wall paintings uncovered following the 1884 earthquake and the unusual timber roof with carved portrait heads on the spur ends.

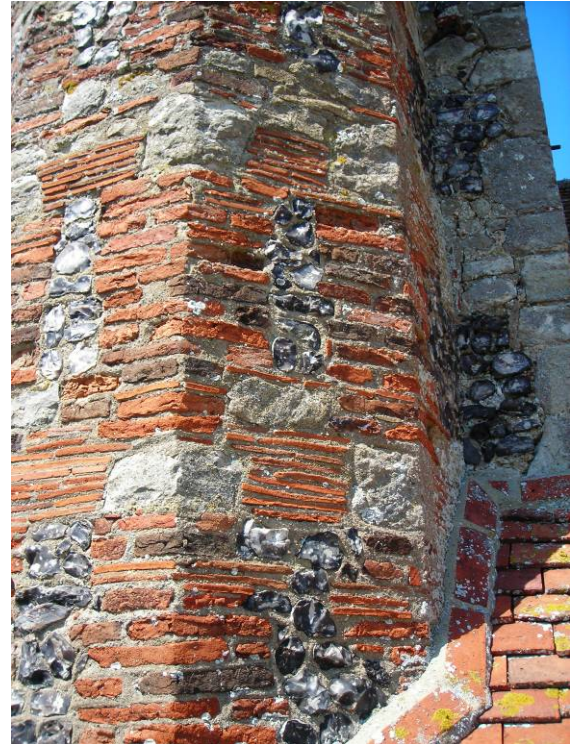
The RCHME report of 1922 states that the staircase turret was recently refaced, and the walls and newel repaired, the extent of the repairs increasing towards the top of the staircase (Fig. 4). As has already mentioned, Montagu Benton suggests works to the turret were carried out around 1890, and may have been a response to earthquake damage. The turret was in the view of Mr Powys 'rebuilt very well and in a most conservative spirit', with 'no deception', as the modern bricks were left exposed to view on the inside. The stair is remarkable for its exceptional narrowness.

Fig. 5 Detail of the staircase tower, rebuilt after the 1884 earthquake. Although modern brick has been left exposed in the interior, the exterior uses tile and narrow brick as seen elsewhere on the tower.

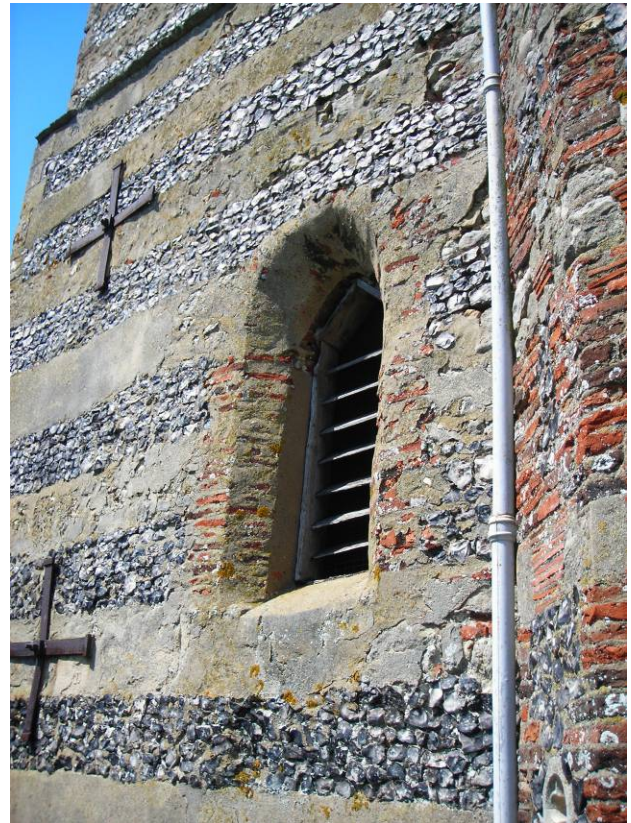
Of the tower windows, the Royal Commission survey recorded that the single lancet windows of the second stage had splayed external jambs of plastered Roman brick, with two centred rear arches and splays of plastered rubble and Roman brick, and that the windows had been restored in places. The estimated date of these was 13th century in the survey notes, but 14th century in the published report. This indecision is excusable given the rather crude construction of these windows, which were concealed by plaster. The brickwork in fact seems mostly to be locally made 14th century brick (*Fig. 4*).

Fig. 5 Second stage window formed of 14th century brick.

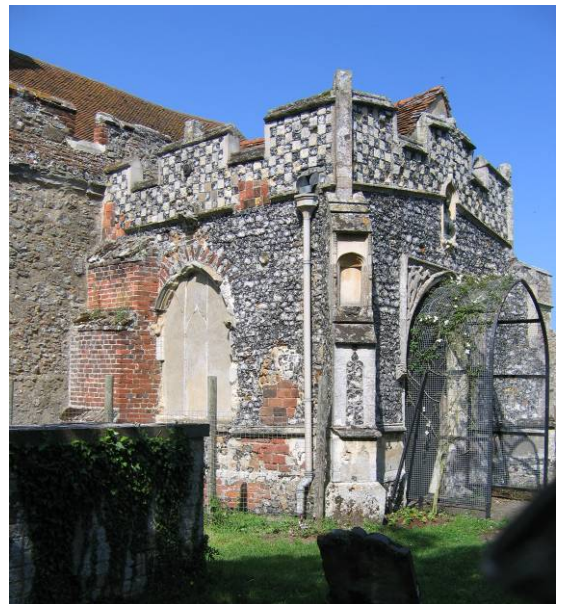
In the SPAB report of 1915 the flint panels on the lower level of the porch were described as mutilated and patched with tile and brick representing repairs generally pre-19th century in date. This flint chequerwork was noted as being fragmentary when Benton was writing in 1938.

The porch was designed to have an almost flat or camber beam roof, but this was replaced by one of steep pitch without tie beams, plastered below and covered with tiles. (Visual inspection of the roof timbers indicates that it is a clasped purlin roof with windbraces of substantial timbers, and datable to the late 16th or 17th centuries. It is not 18th century as suggested by the RCHME). The side walls have been patched with red brick and tile from time to time and a brick buttress added in the north-west angle (*Fig. 6*).

Fig. 6 The south porch, exhibiting evidence of periodic repairs.

In his report of 1915, Mr Powys advocated a minimum intervention approach to repairs to the porch, in accordance with SPAB principles. He placed emphasis on dealing with structural defects rather than renewal and reinstatement of features such as the lost pinnacles. He proposed retaining the pitched roof, rather than attempting to reinstate the original flat roof. He also recommended the retention of the brick and tile patching, rather than renewing the flint panels which would, in his view, 'produce just that neatness which we want to avoid'.

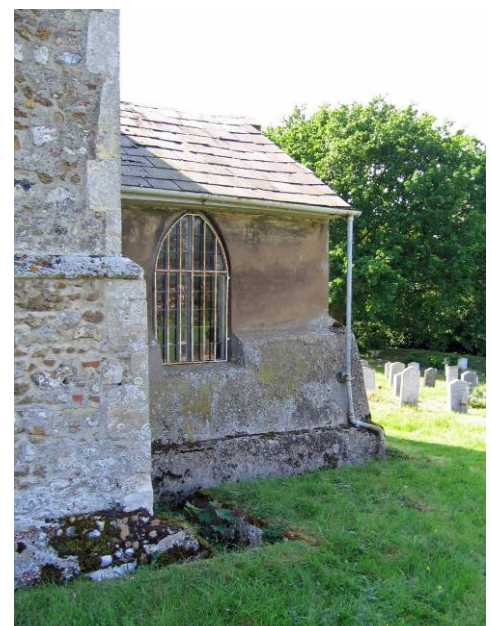
The brick north vestry was constructed around 1840, according to Montagu Benton, but was built on old foundations which rise a few feet above ground level (*Fig. 7*). Benton suggests that the original building was 15th century in date (on the basis of the doorway), and served as a sacristy. Alternatively it may have been used as a priest's lodging. At the time of the 1915 SPAB report the walls of the vestry were described as covered with Roman cement.

Fig. 7 The north vestry, an early 19th century structure built on older foundation walls.
