Barn at Wood Hall  
Main Road  
Wormingford

Building recording

Report by Richard Shackle

August 1998

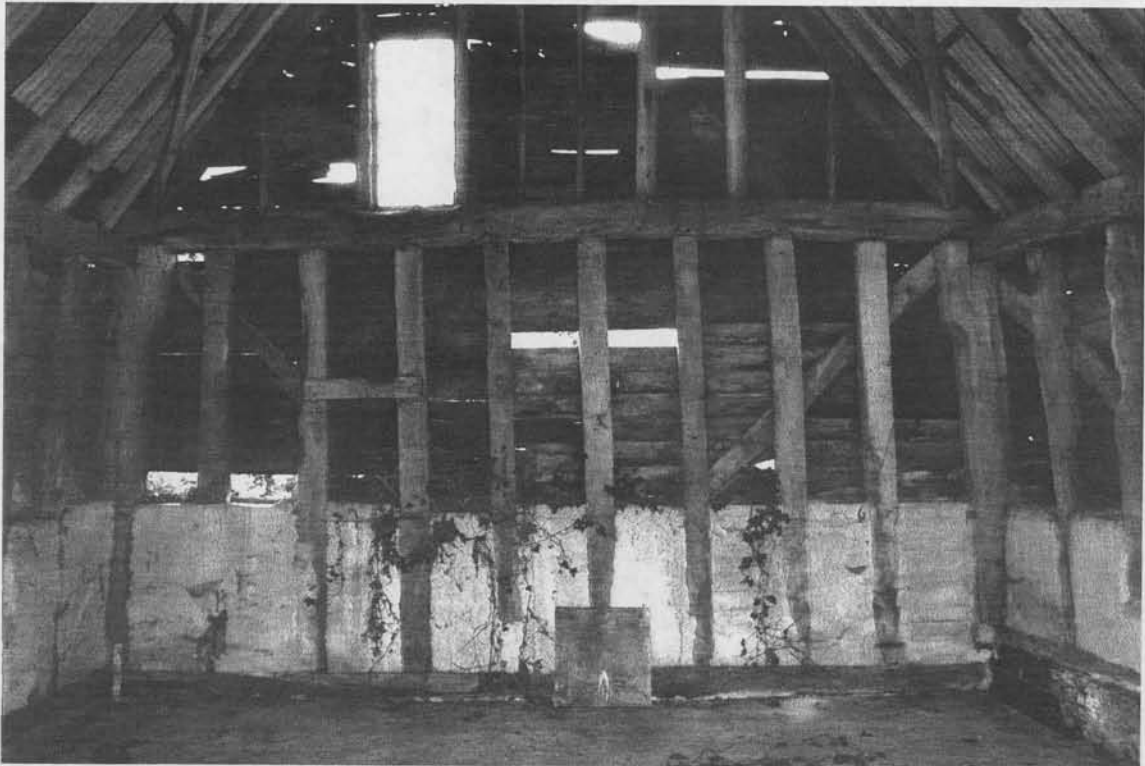
Truss (1) at the west end was a gable end. There are mortices on top of the tie beam to indicate this. The two corner posts had tension braces to the end wall and to the side walls. All four braces still exist but they no longer reach the studs into which they were originally pegged. The south west post has a door rebate for a door in the southern wall. There is no further evidence for this door in the adjoining studs so presumably this small access door existed only in the early phases of the barn.

Plate 8 Truss 1 (end truss)

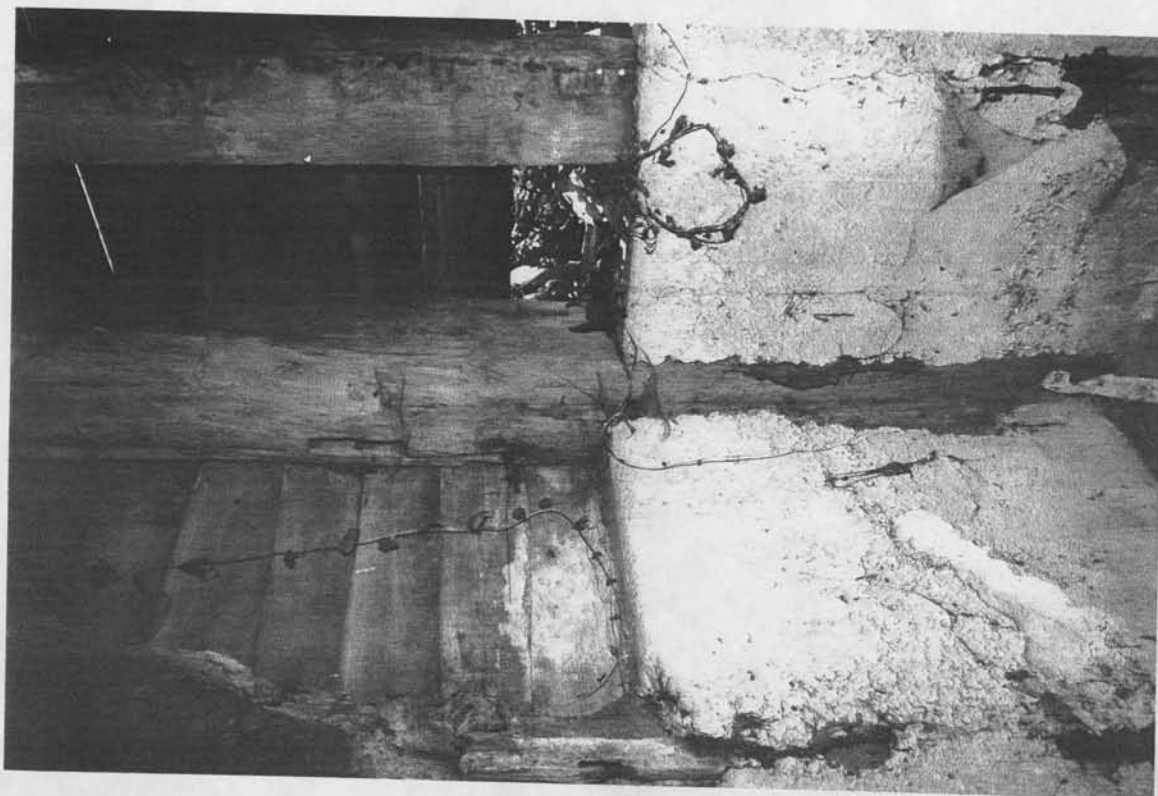
Plate 10 Truss 1: detail of door rebate in south post

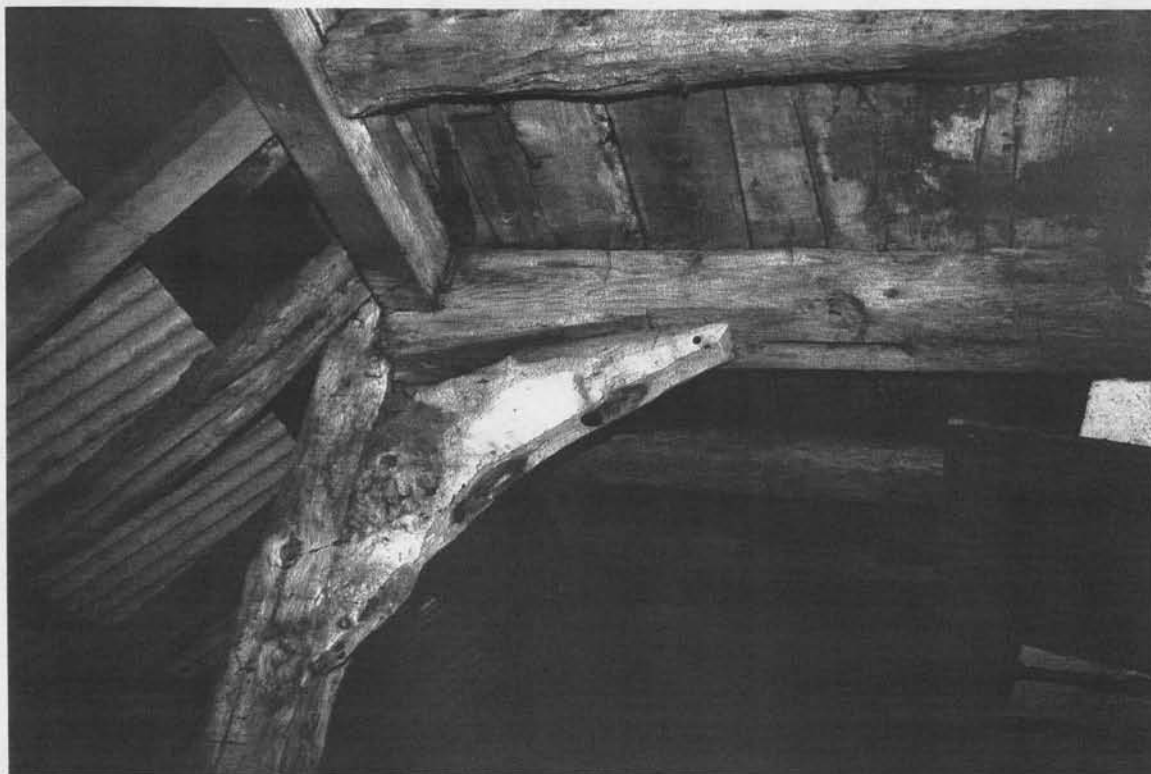
Truss (2) has jowled posts whereas all the other trusses except the end trusses have had their jowls cut away to allow the later knees to fit better. The posts and tie beam seem to be a set as the mortices for the former braces appear to correspond. The post on the south side has a carpenter's mark "1" on it.

Plate 11 Truss 2: detail of knee and jowl

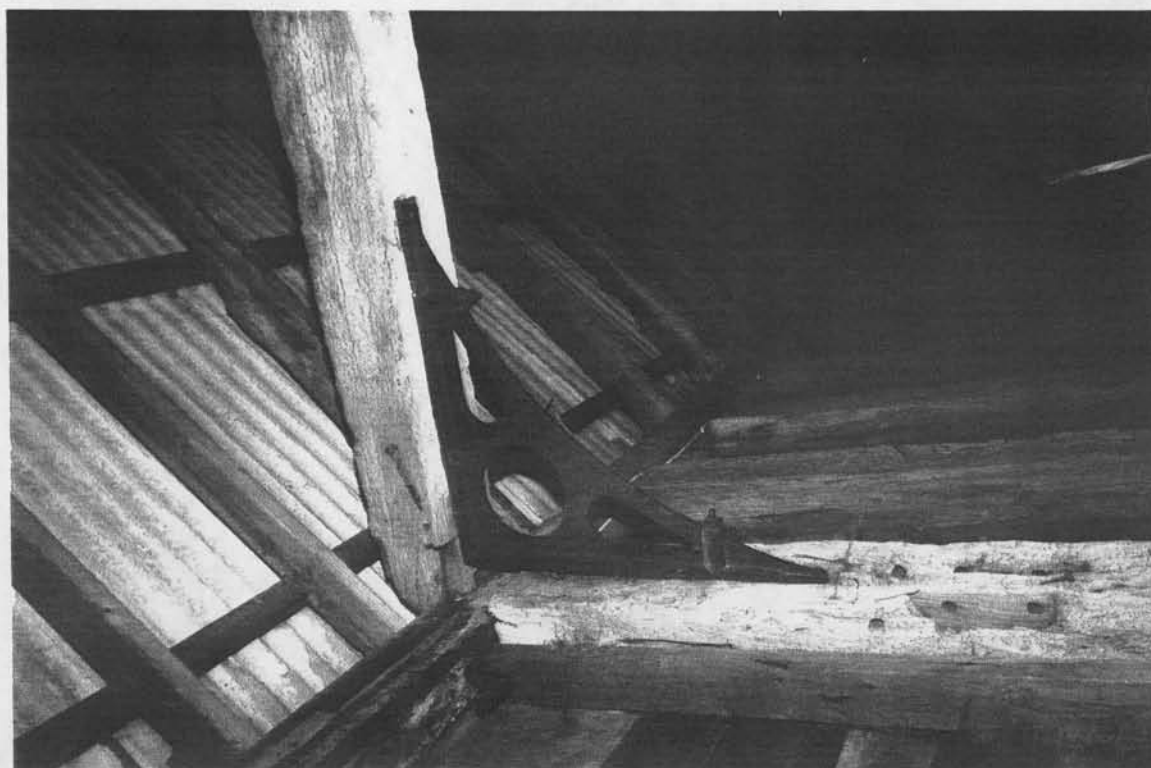
Truss (4) adjoins the midstrey but the southern post has been replaced with a large reused timber with pegged mortices in it. This truss has iron brackets like those on truss (3).

Plate 12 Truss 4: detail of iron bracket

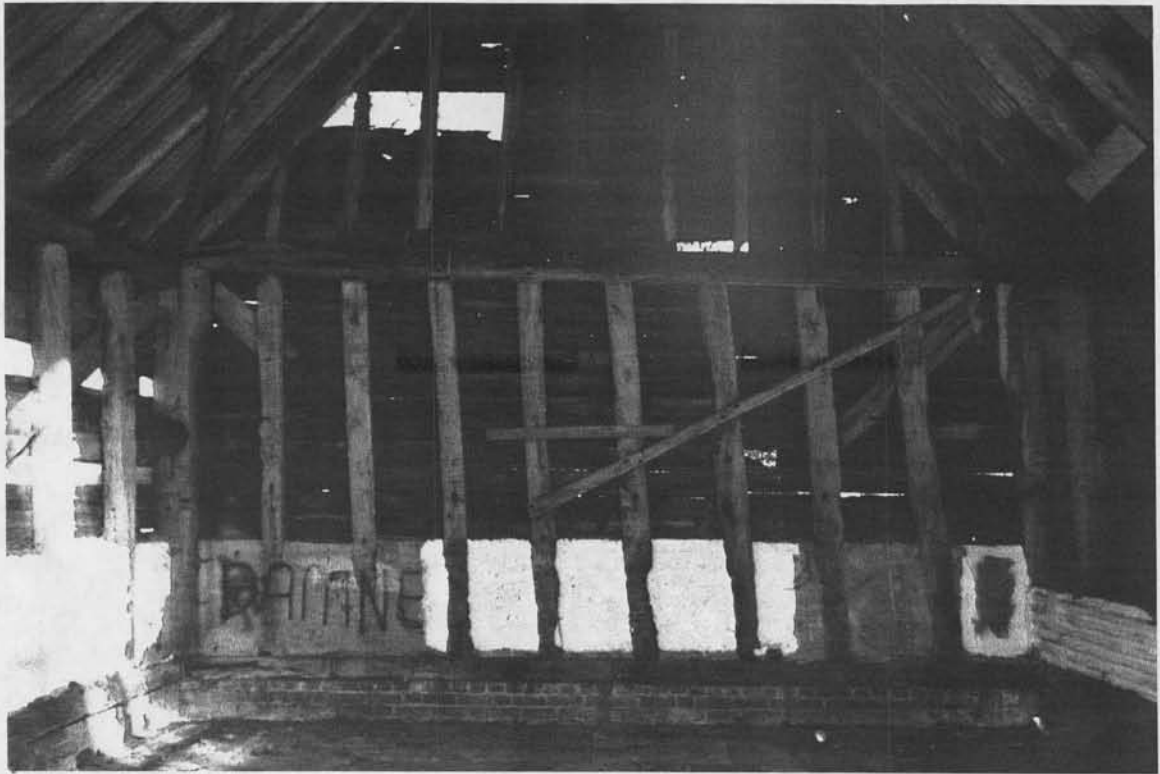
Truss (6) (east end): This end truss has tension bracing along the end and side walls. In the north-east corner there is evidence for another corner tie. The mortice in the end tie beam can clearly be seen but there is no matching joint on the adjacent wall plate, showing that this plate is a later replacement. In the south east post, part of the jowl and brace have broken away. The tie beam has housings for rafter feet on the top face, showing that originally the barn was hipped at this end.

Plate 13 Truss 6 (end truss)

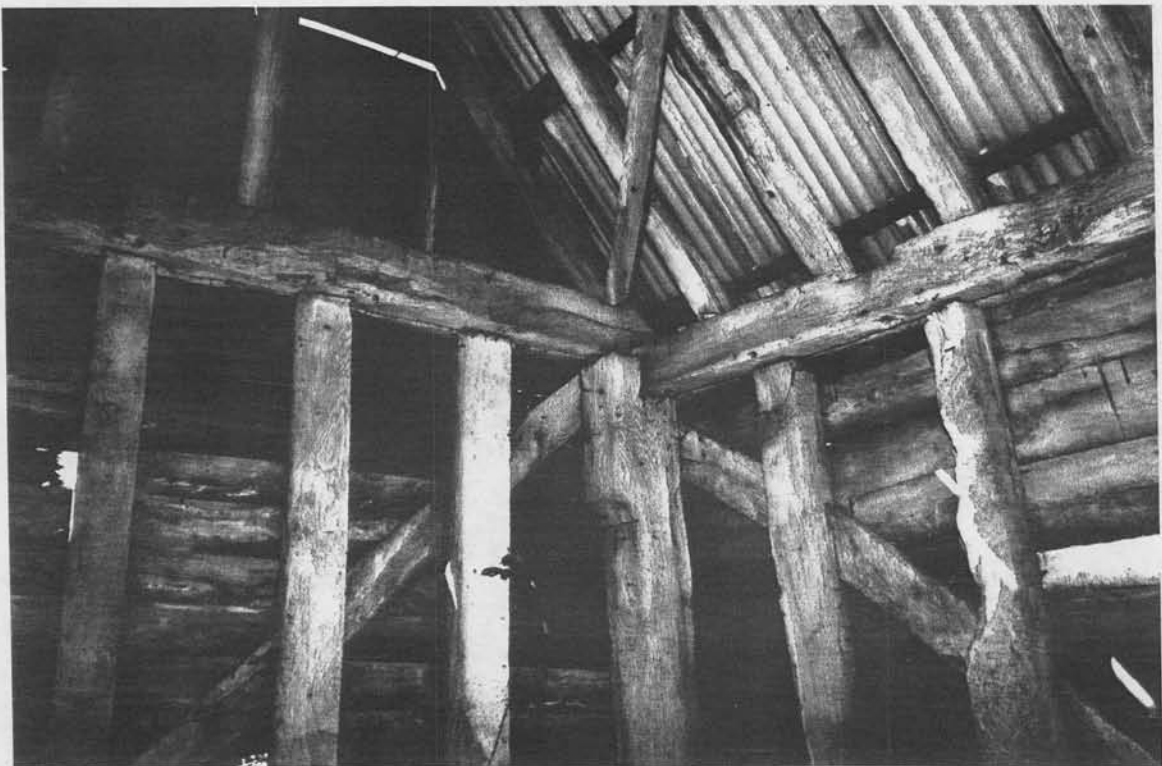
Plate 14 Truss 1: view showing joints for angle tie

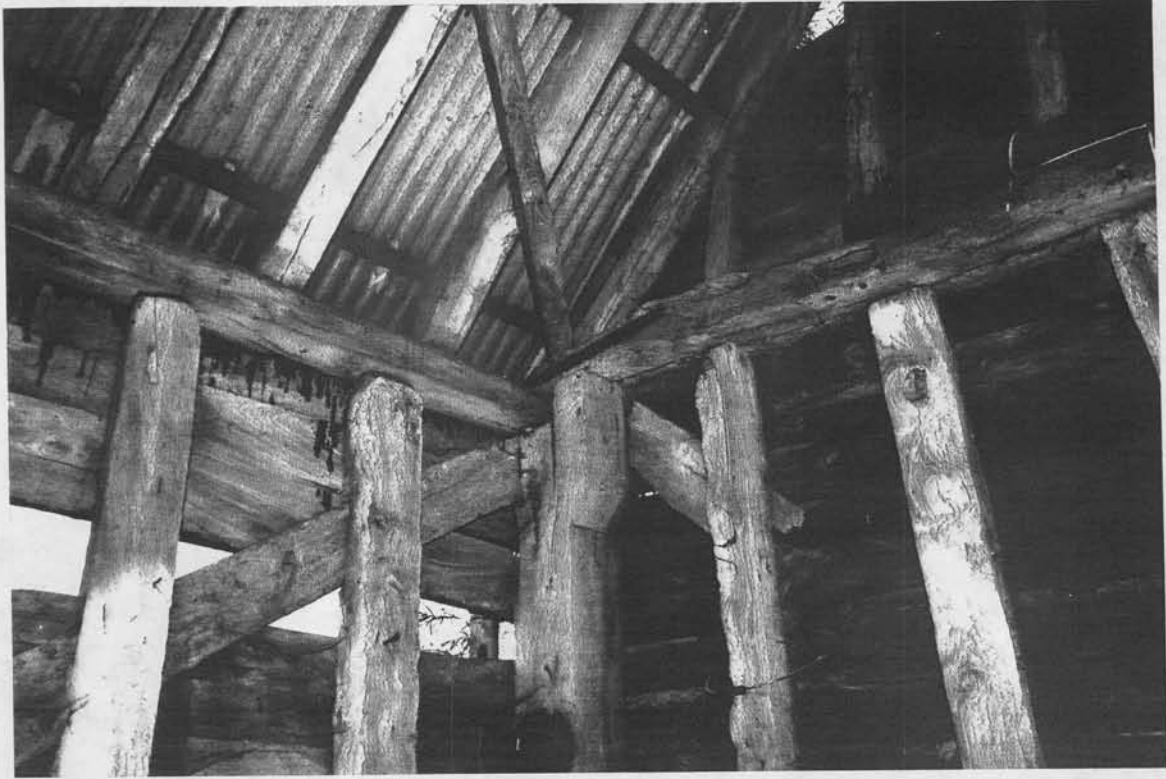
Plate 15 Truss 6: view showing mortice for angle tie on tie beam, also showing adjoining piece of top plate (replacement as there is no joint for angle tie on top face).

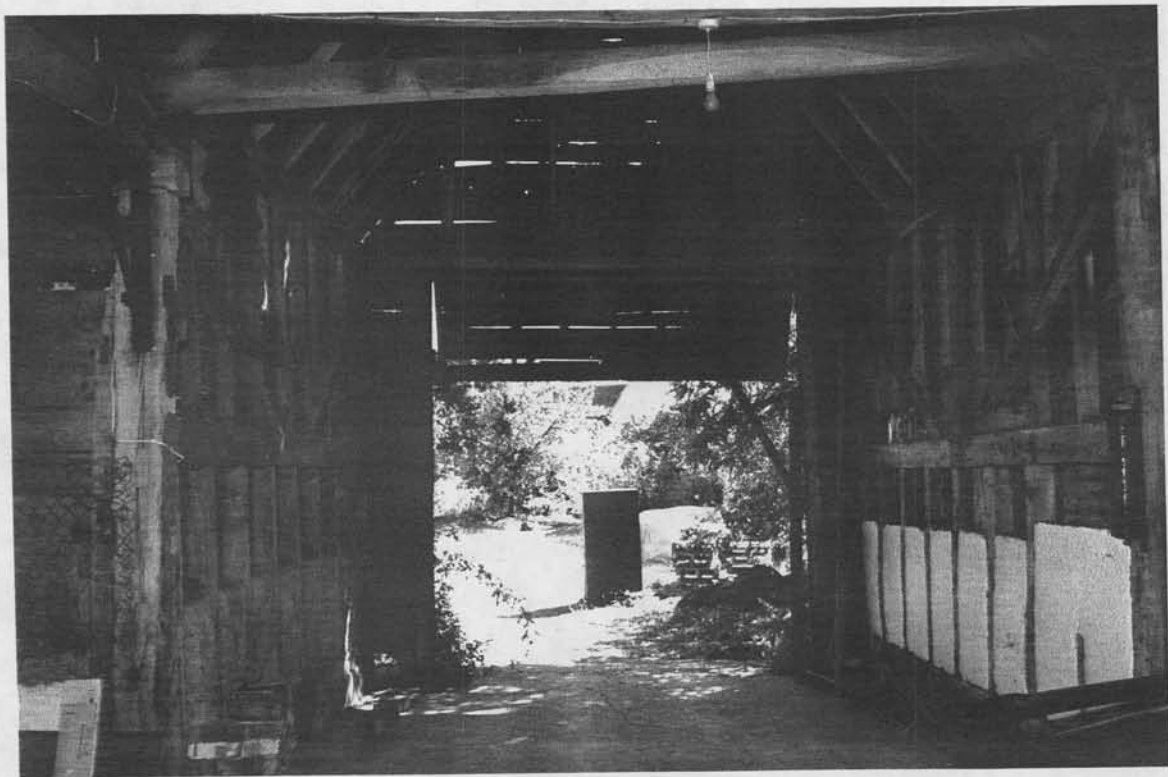
The original barn had a midstrey as can be seen by the mortice on the south face of post on truss 3. In the 18th or 19th century the present midstrey was put up. It is taller than the original midstrey to accommodate taller loaded waggons at harvest time. The top plate of the barn was cut through at this time to allow for the taller waggons. The tie beam at the north end of the midstrey has come adrift from its dovetail joint on the east side. To rectify this problem an extra tie beam has been put in place and the rafters of the barn now rest on this. At the south end of the midstrey was a tall barn doorway. The original doorposts have been replaced by modern timbers, but on the underside of the tie beam you can see where the posts were pegged in. The empty mortices on the inner faces of the cornerposts suggest that the doorposts were braced to the corner posts in some way. At harvest time it was usual for loaded waggons to enter a barn via the midstrey and leave via a lower doorway in the opposite wall after being unloaded. In the north wall of this barn opposite the midstrey is a small modern door and some light modern framing, suggesting to me that there could have been a low door here for waggons.

Plate 16 General view of midstrey

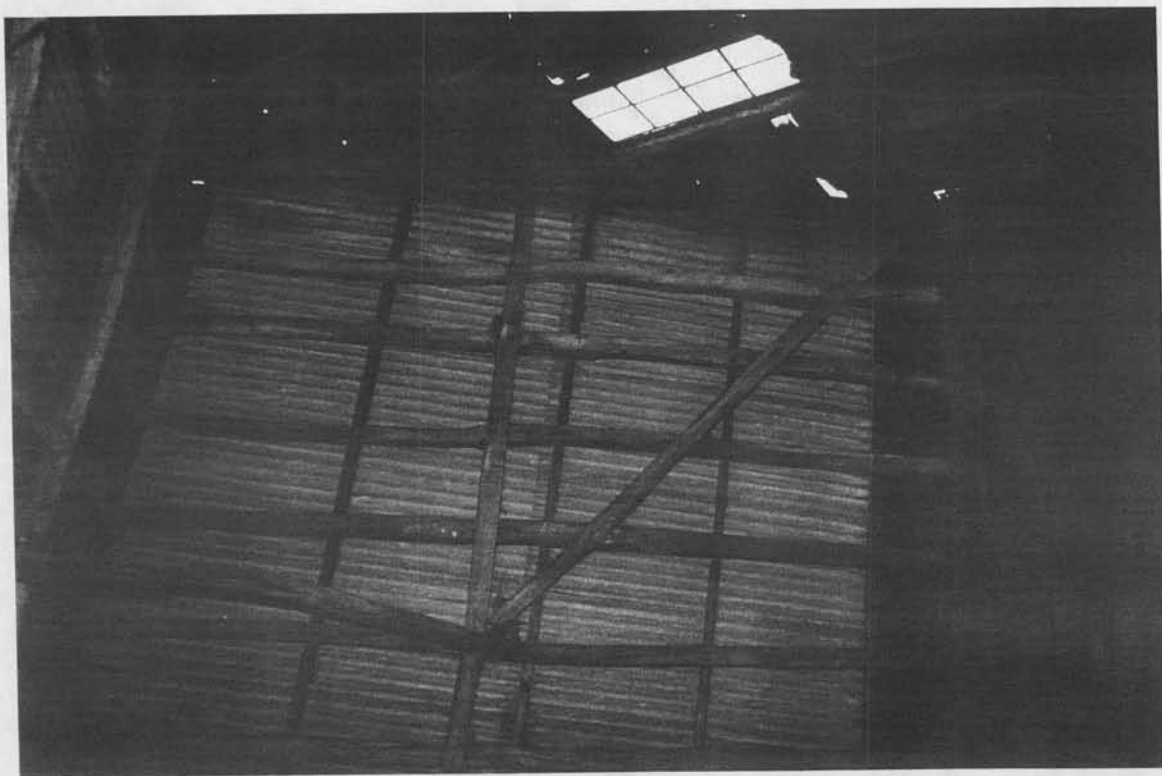
The present roof probably dates to the 18th or early 19th century. It is a side purlin roof with windbraces in the end bays and by the midstrey. The rafters are mostly oak but some appear to be elm. Many of these rafters are reused and have collar joints in them which are not required for the present roof. Most of the rafters are about 4½ inches square. Sometime this century some of the old rafters have been replaced by small 4x2 inch rafters, particularly in the midstrey area. The roof is covered by modern sheeting.

Plate 18 View of roof showing side purlin, collar and wind brace

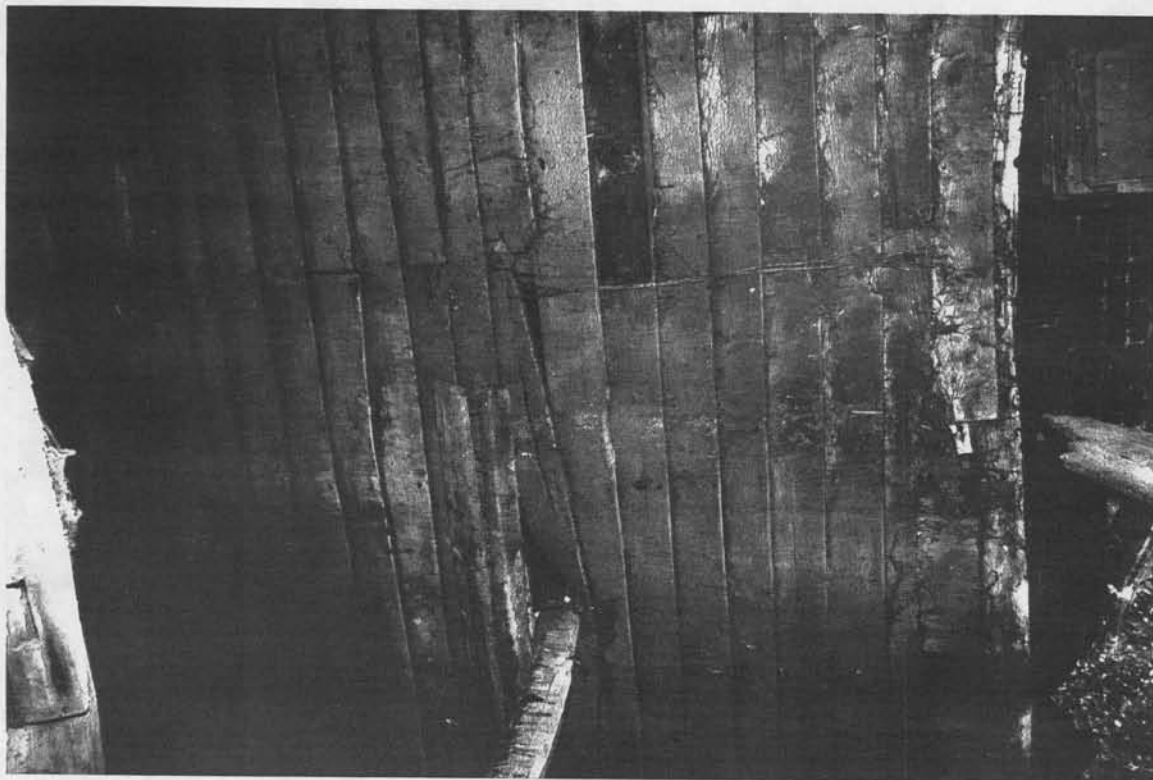
All the weatherboarding is modern except that on the south side where it is protected by the lean-to cow byre and pig sties. These lean-tos are 19th century but the weatherboarding could date back to the 18th century.

Plate 21 Weatherboarding of barn seen from inside cow byre

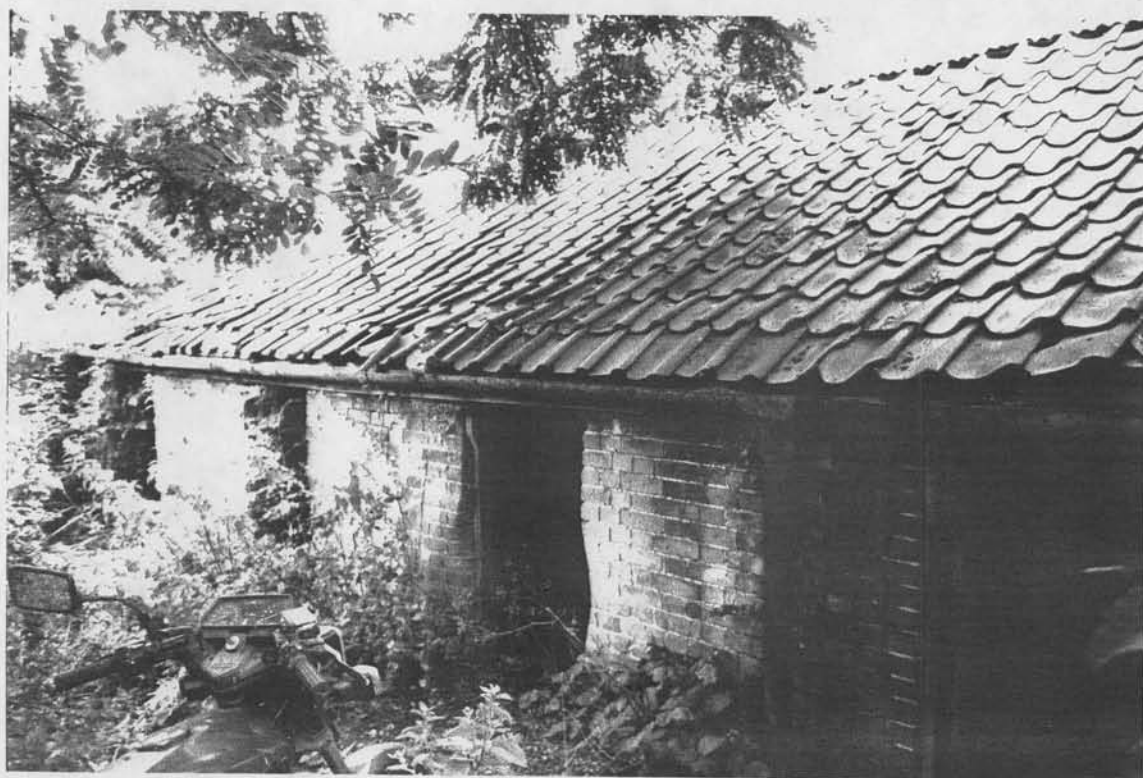
The range of four pig sties were probably built in the late 19th century. The south elevation is a 9 inch brick wall. The opening to each pig sty had a wooden frame but these have almost entirely rotted away. The partitions between the sties are made of small scantling timbers covered in boarding. The pig sty at the west end has a small window in end brick wall. The roof is supported by curved tie beams morticed into the studs of the barn. The rafters are rectangular small scantling timbers. The roof is of red pantiles.

Plate 22 Exterior of pig sties

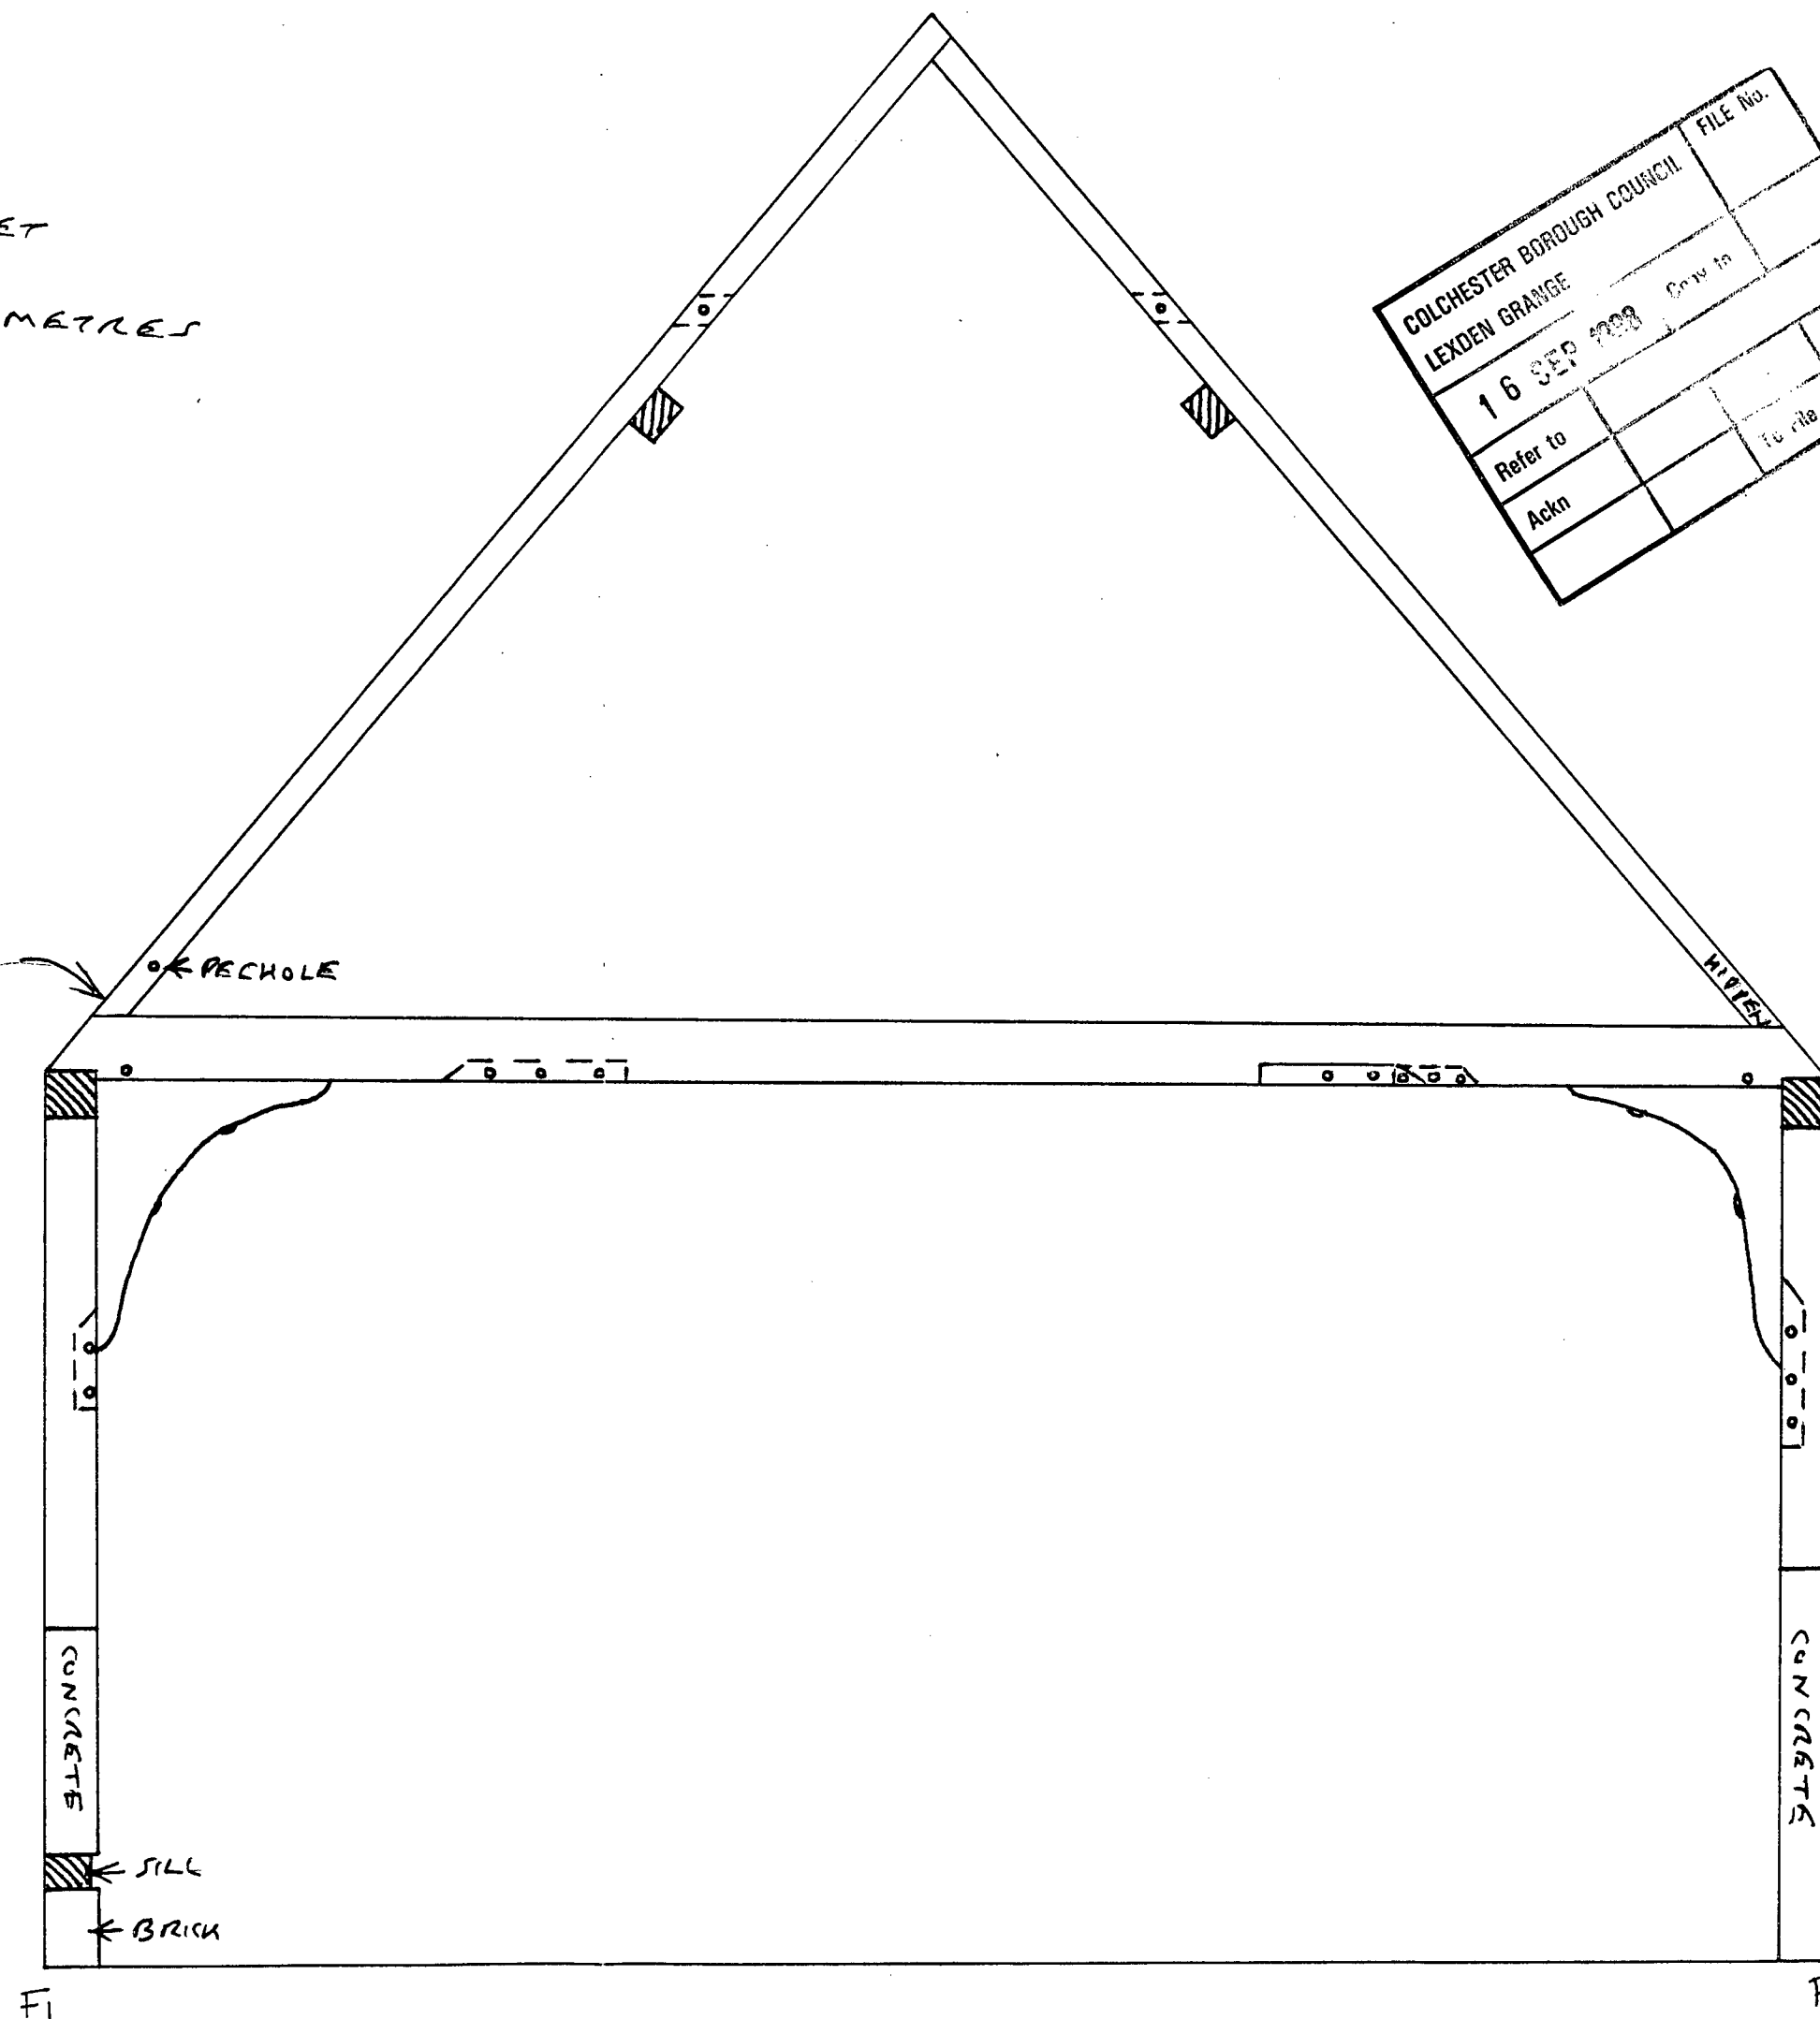
TRUSS ⑤  
FIGURE ⑧

Truss (5): As with the other trusses the braces have been cut out and replaced with knees. This truss is however different from the others in that it has a rafter couple sitting on top of it and pegged into it. This rafter couple have joints in them, high up, for an earlier collar.

RAFTER  
COUPLE  
SIT ON  
TOP OF  
TIE BEAM
