**Historic building recording at B Mess,
formerly the Officers' Quarters,
Le Cateau Barracks, Colchester,
Essex,
November 2013 and December 2019**

**report prepared by
Chris Lister and Mark Baister**

CAT Report 1512
February 2020

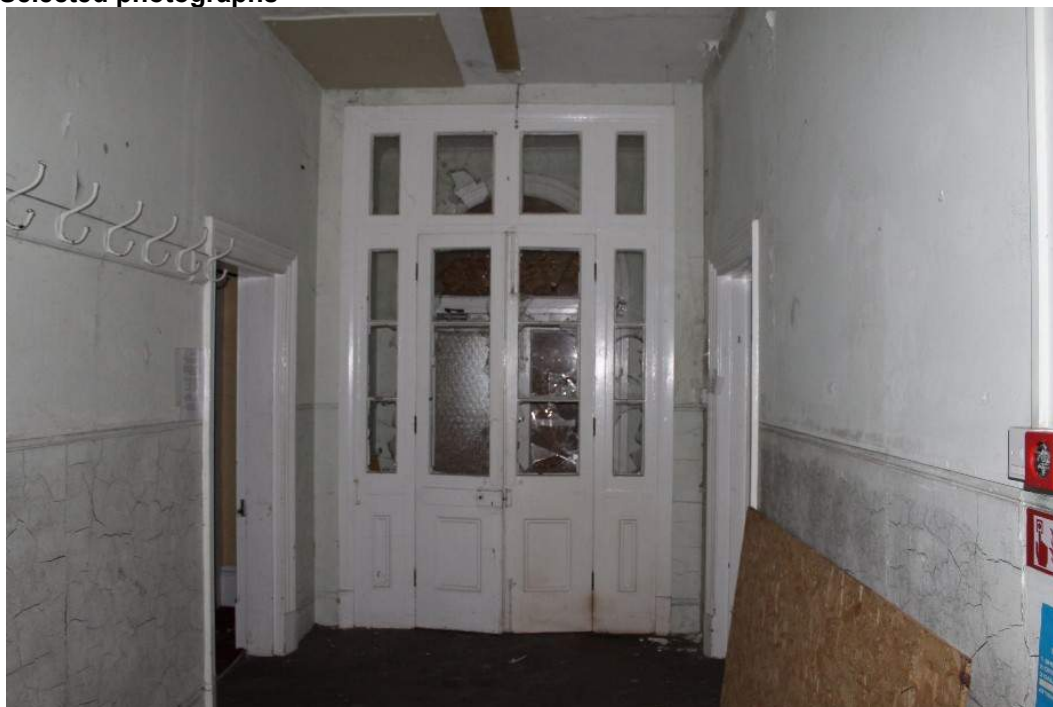
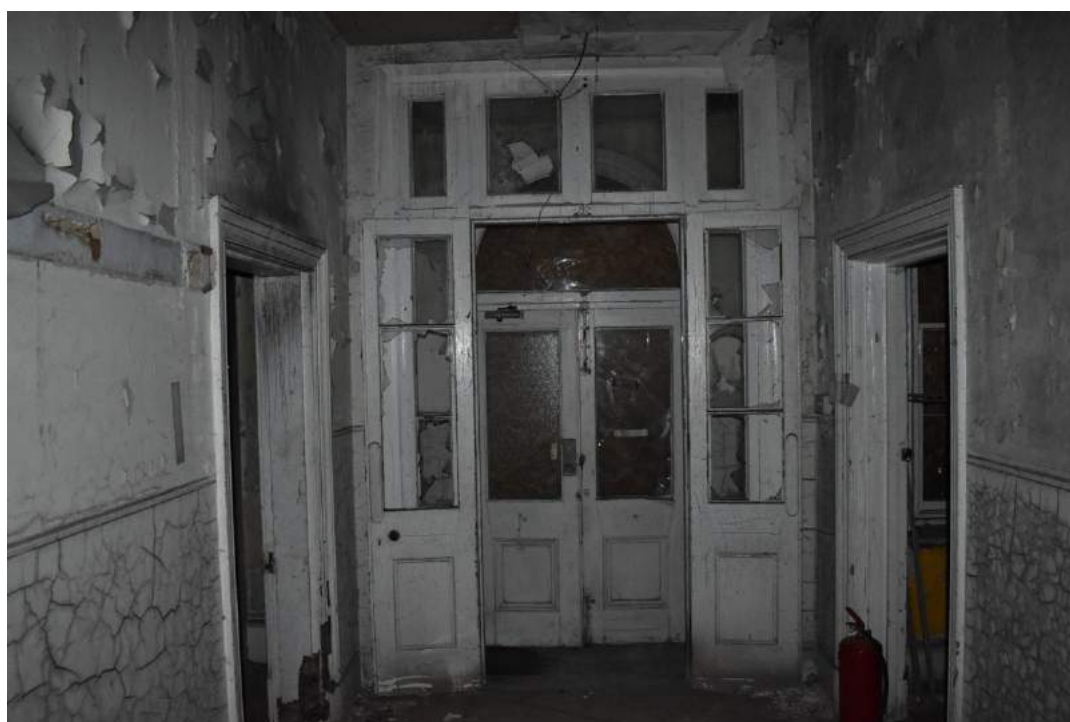
Plate 1 Entrance way ii, showing the original inner and outer doors of the porch and original coat hooks on the left wall - view south-east. Photo from November 2013 above, photo from December 2019 below.

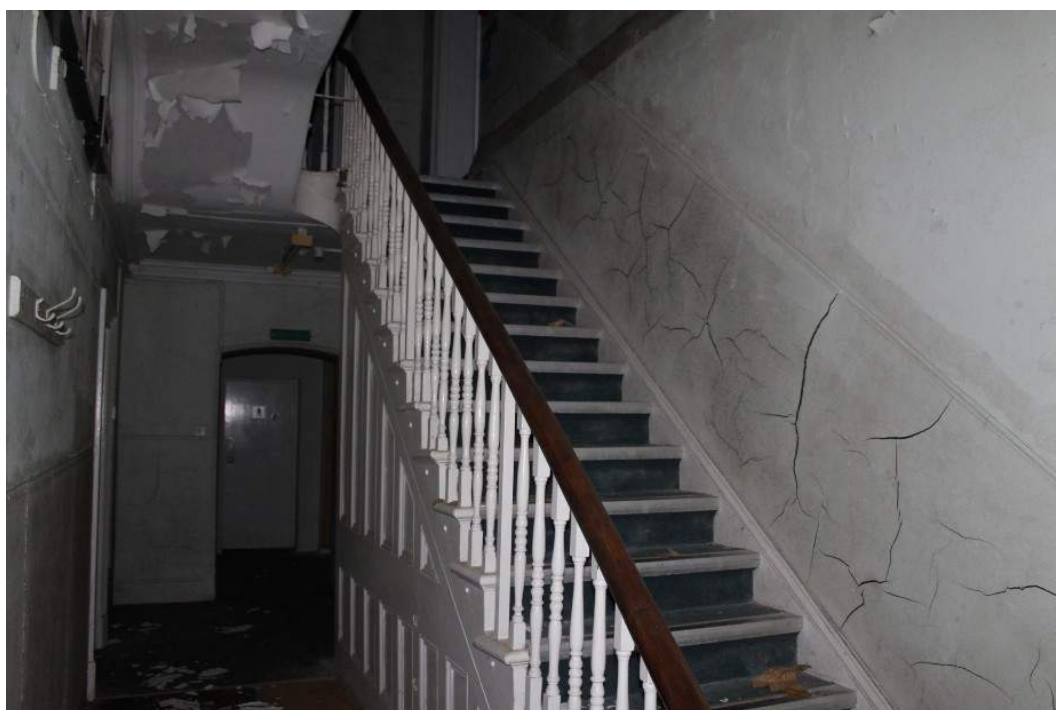
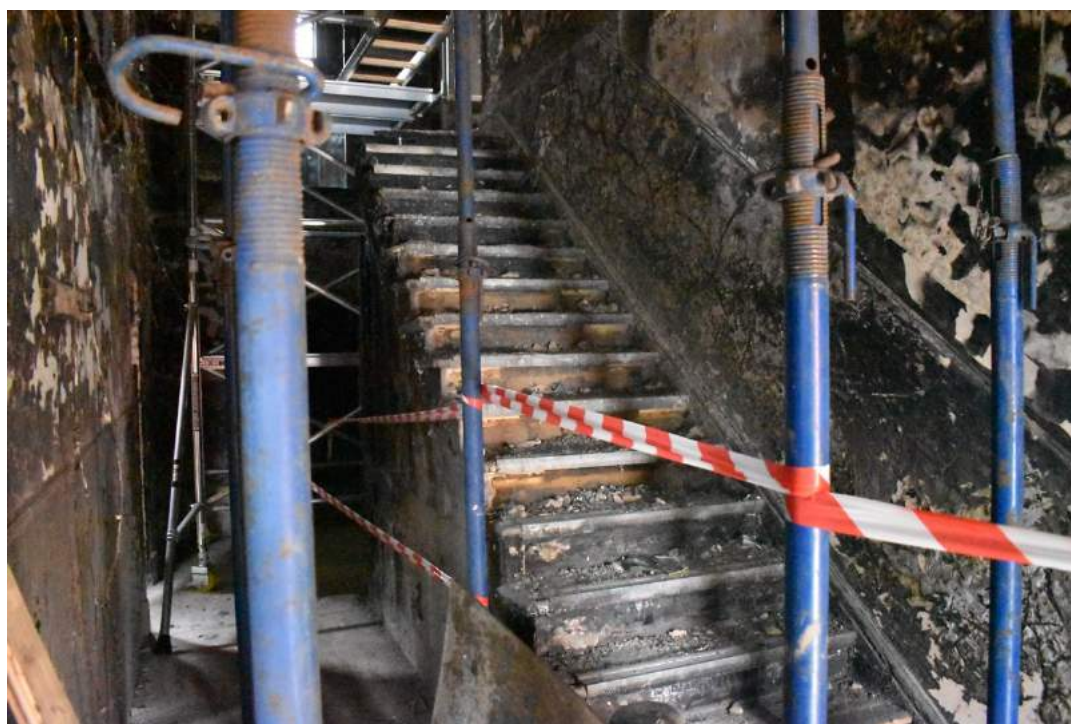
Plate 2 Stairwell iv, showing the original staircase, coat hooks and the entrance to the 1904 lavatory – view north-west. Photo from November 2013 above, photo from December 2019 below.

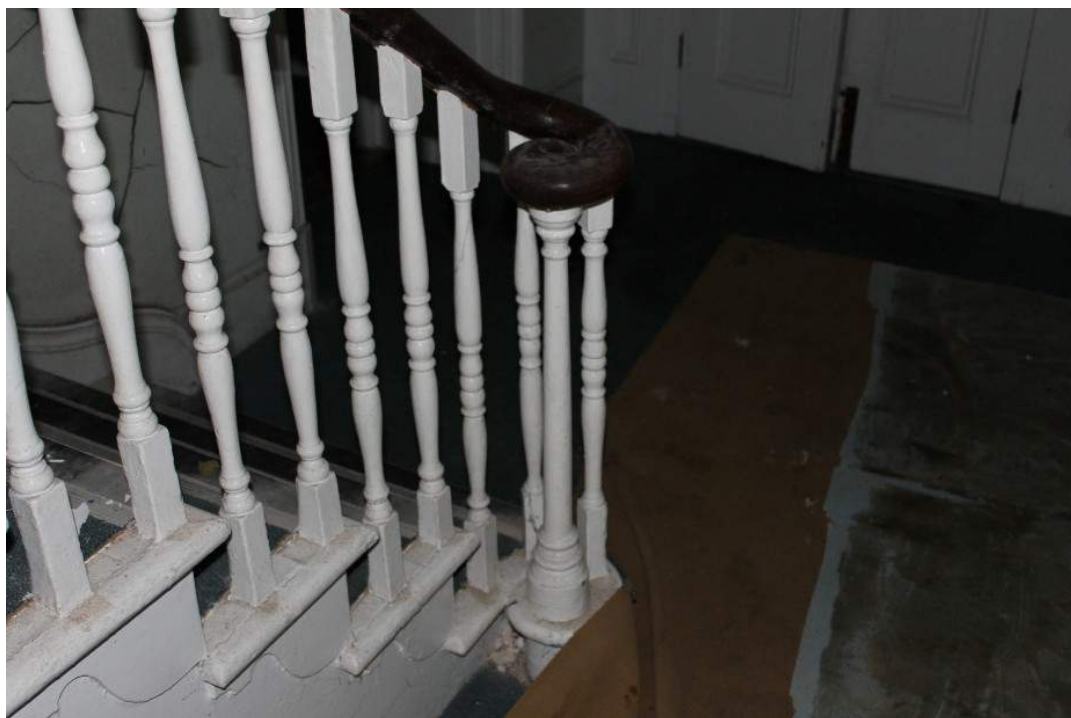
Plate 3 Stairwell iv, detail of the mahogany banister with spiral end and the turned balusters of the open string staircase. Photo from November 2013 above, photo from December 2019 below.

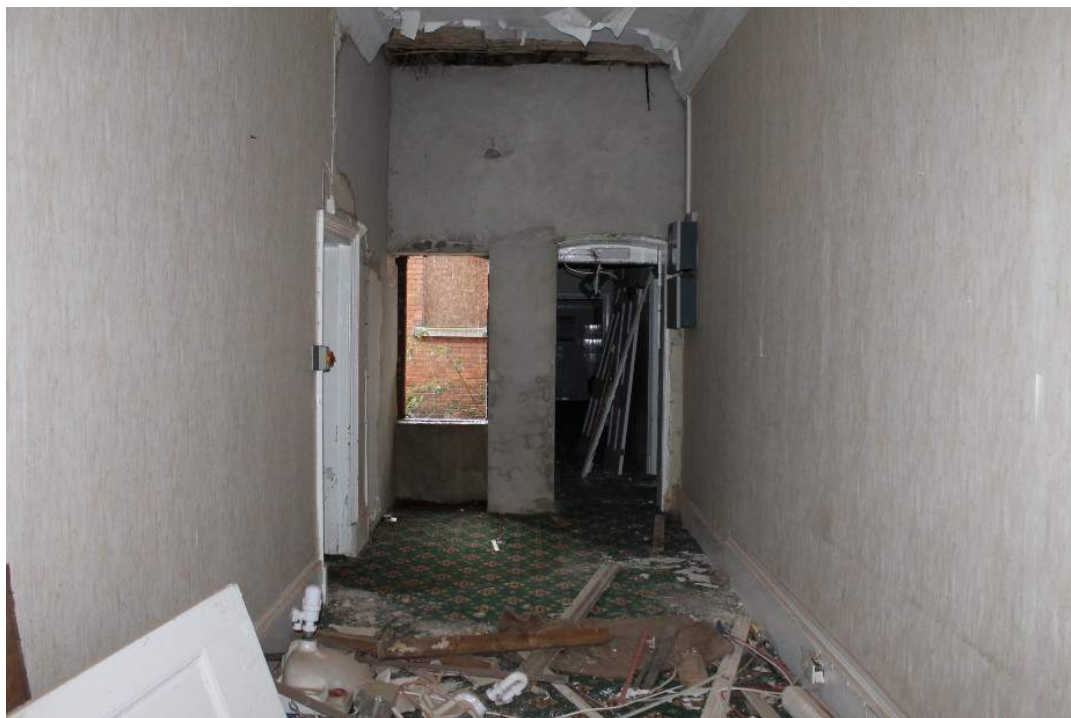
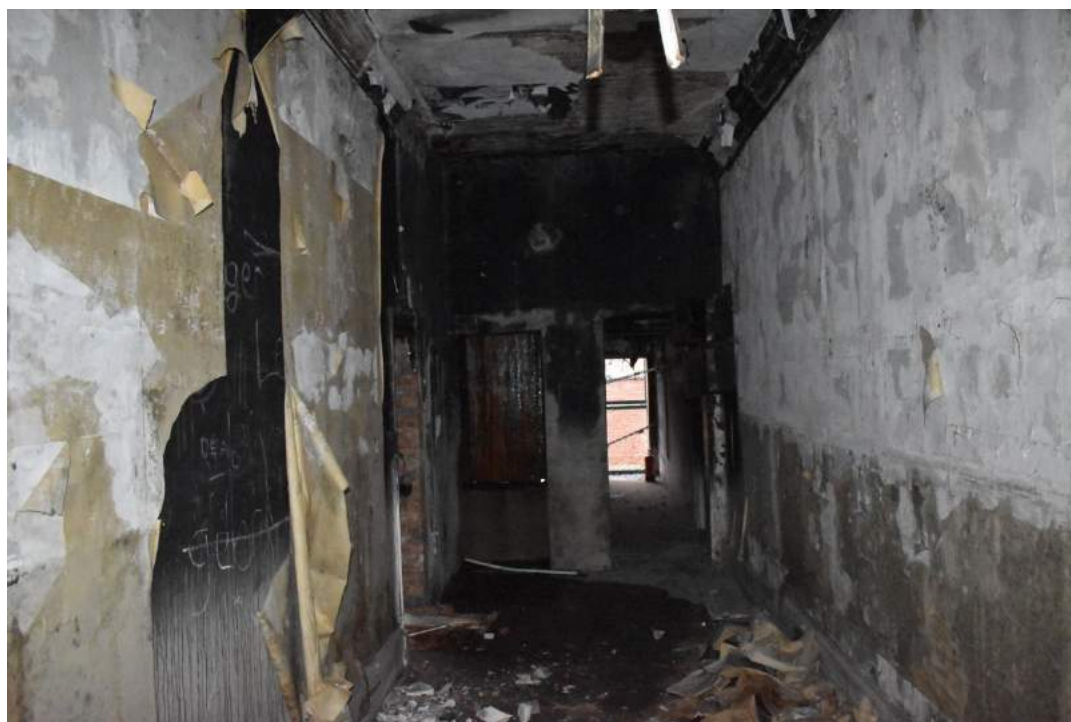
Plate 4 Entrance way *iii* with the removed staircase and the 1904 toilet block to the rear - view north-west. Photo from November 2013 above, photo from December 2019 below.

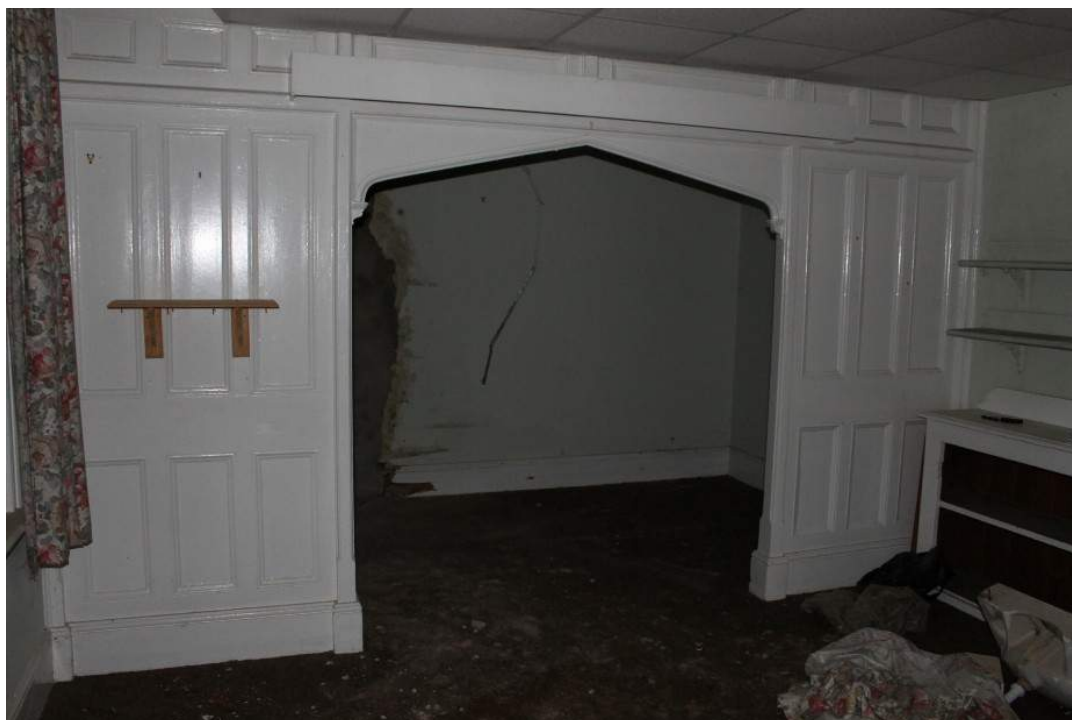
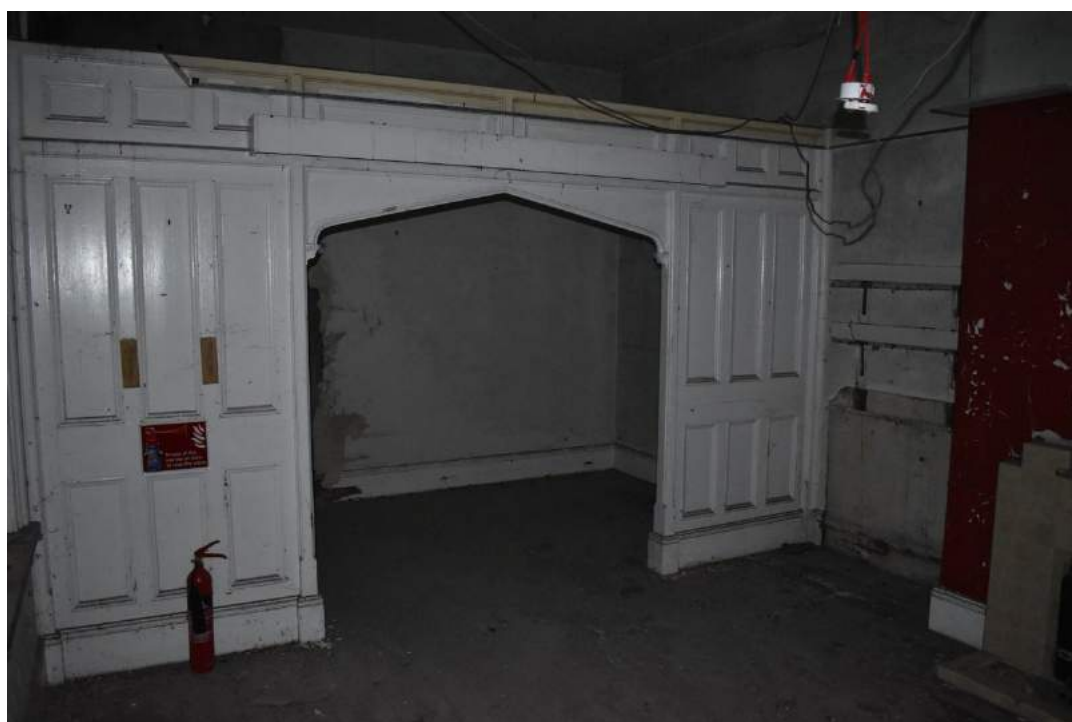
Plate 5 Original wooden partition in room 2 separating the sleeping area from the sitting room – view south-west. Photo from November 2013 above, photo from December 2019 below.

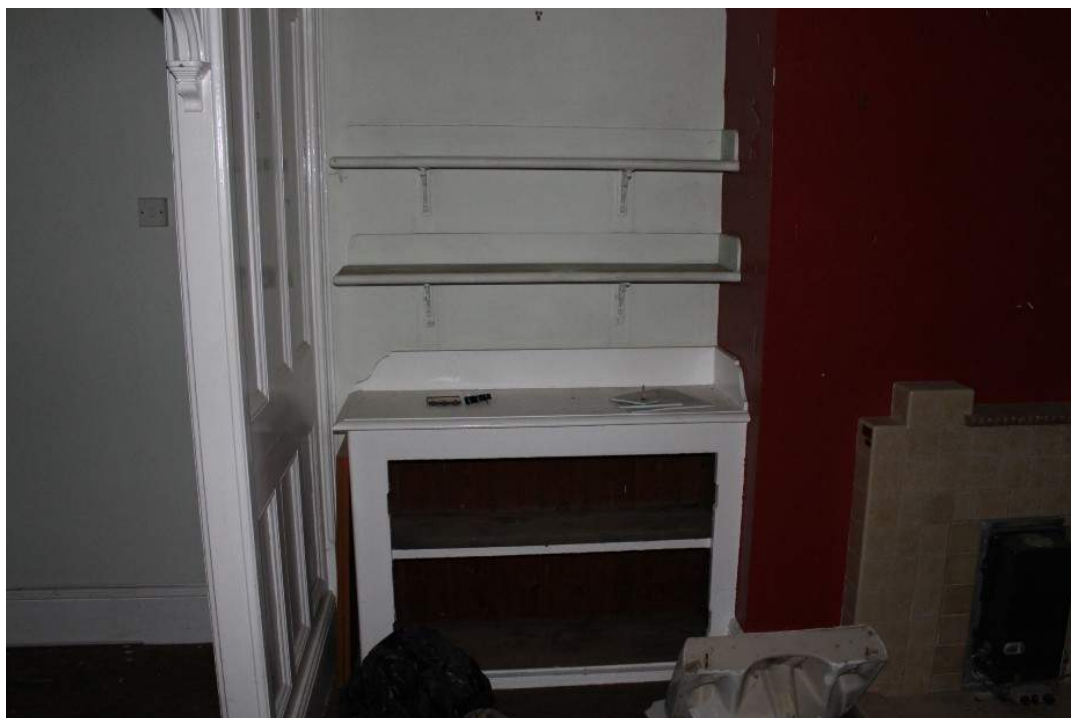
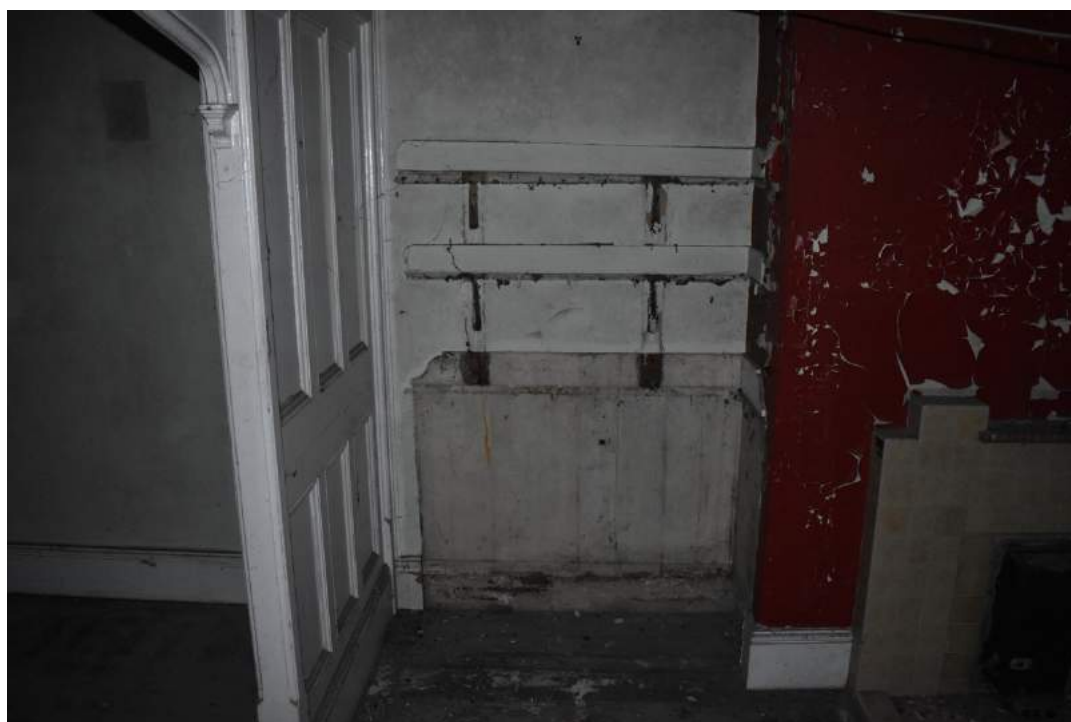
Plate 6 Dresser and shelving in room 2, either relocated from the 1876 rooms or faithfully reproduced – view north-west. Photo from November 2013 above, photo from December 2019 below.

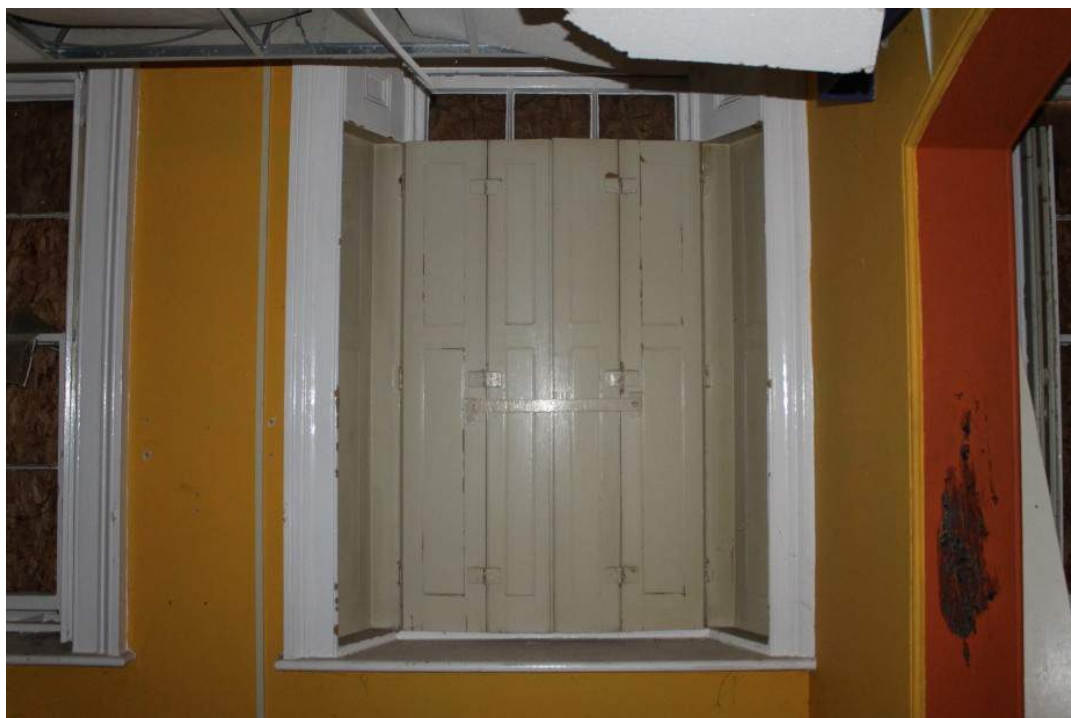
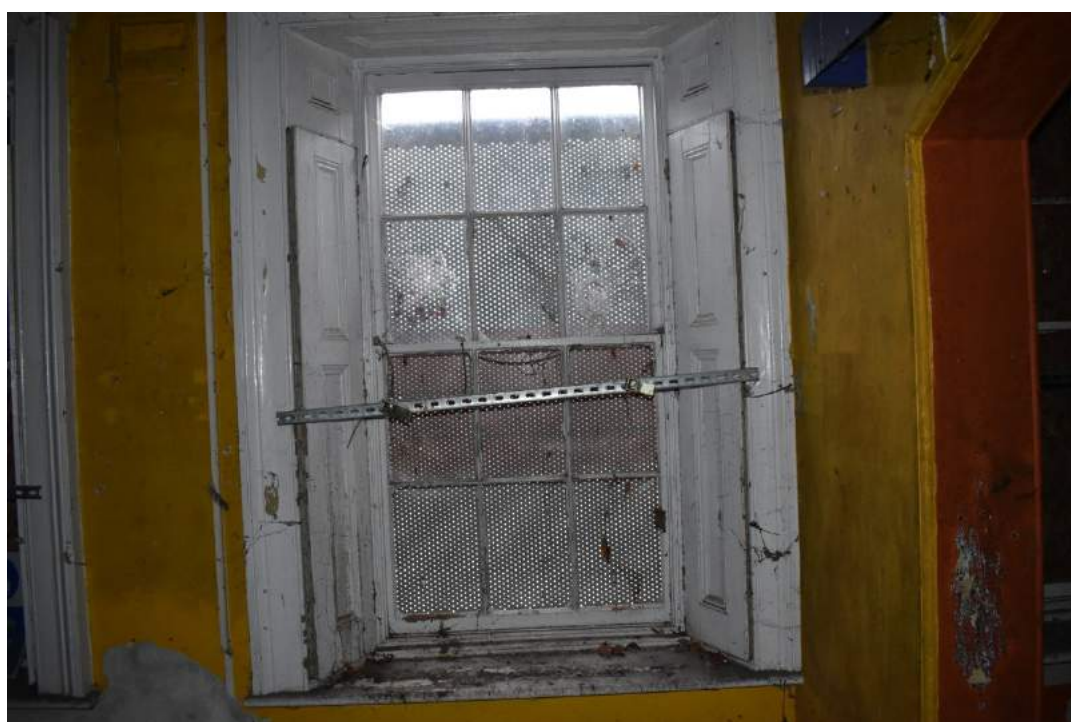
Plate 7 Example of the sash windows with recessed wooden shutters in the ground floor rooms of the 1874-5 building - view south-east. Photo from November 2013 above, photo from December 2019 below.

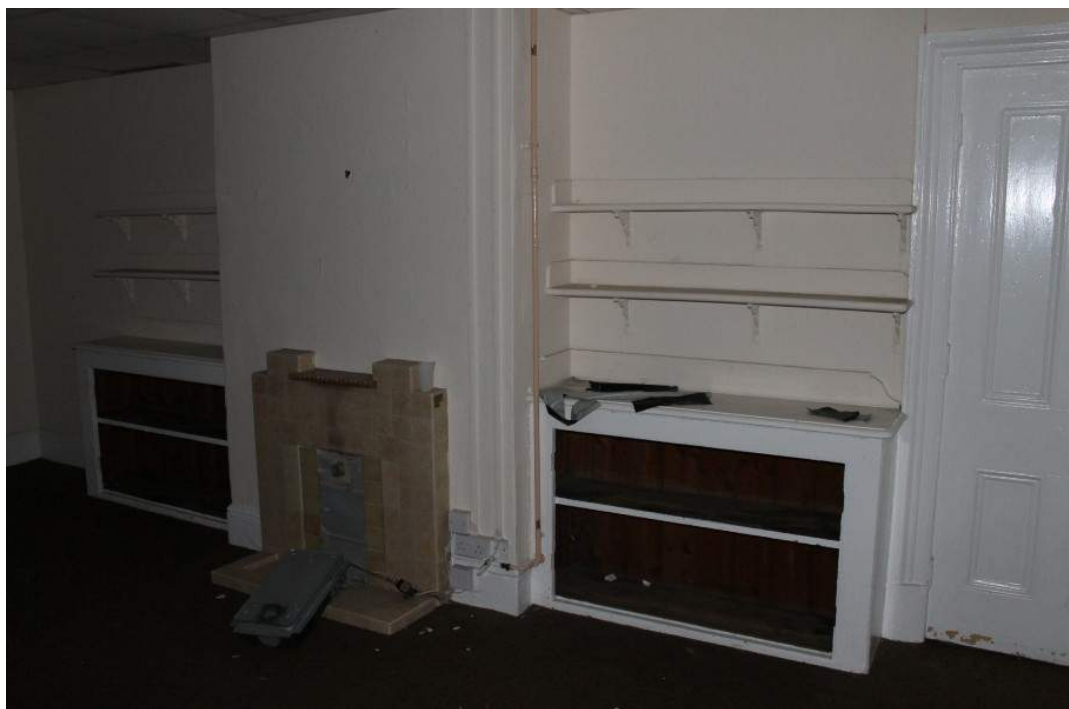
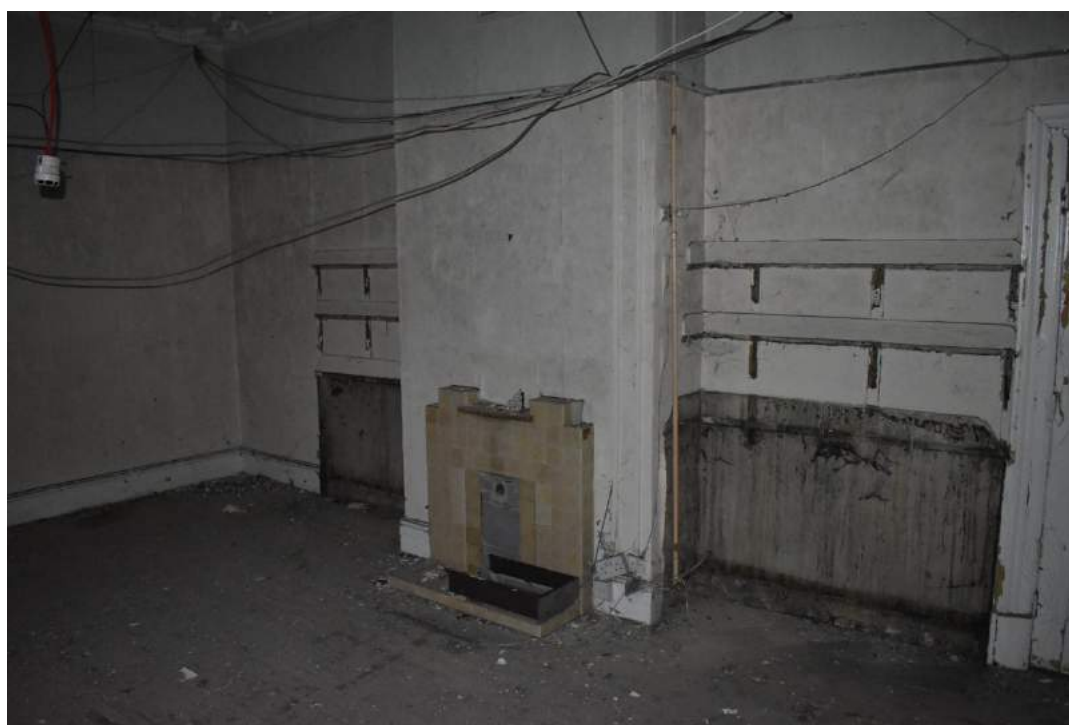
Plate 8 Room 4, formerly the sitting room of the second Field Officer, with the original four-panel door leading to the bedroom of said officer – view west. Photo from November 2013 above, photo from December 2019 below.

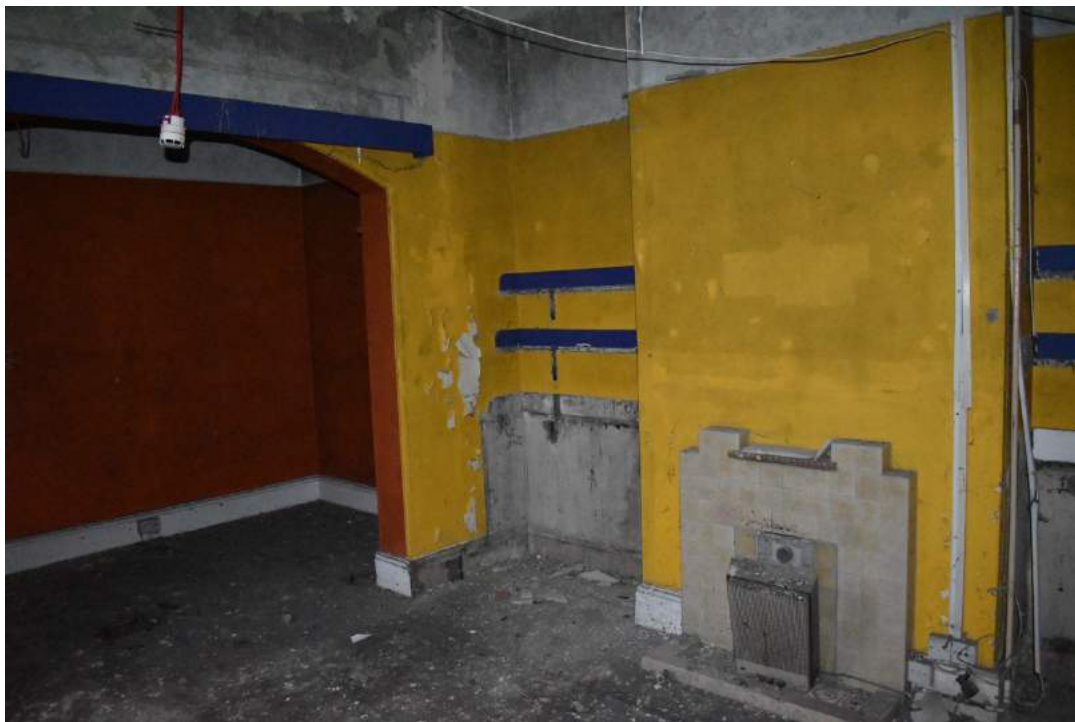
Plate 9 Room 7, formerly the quarters for Officer No.1, showing the brick arch separating the sleeping area from the sitting room, with the original dresser and shelving to the left of the chimney breast – view south. Photo from November 2013 above, photo from December 2019 below.

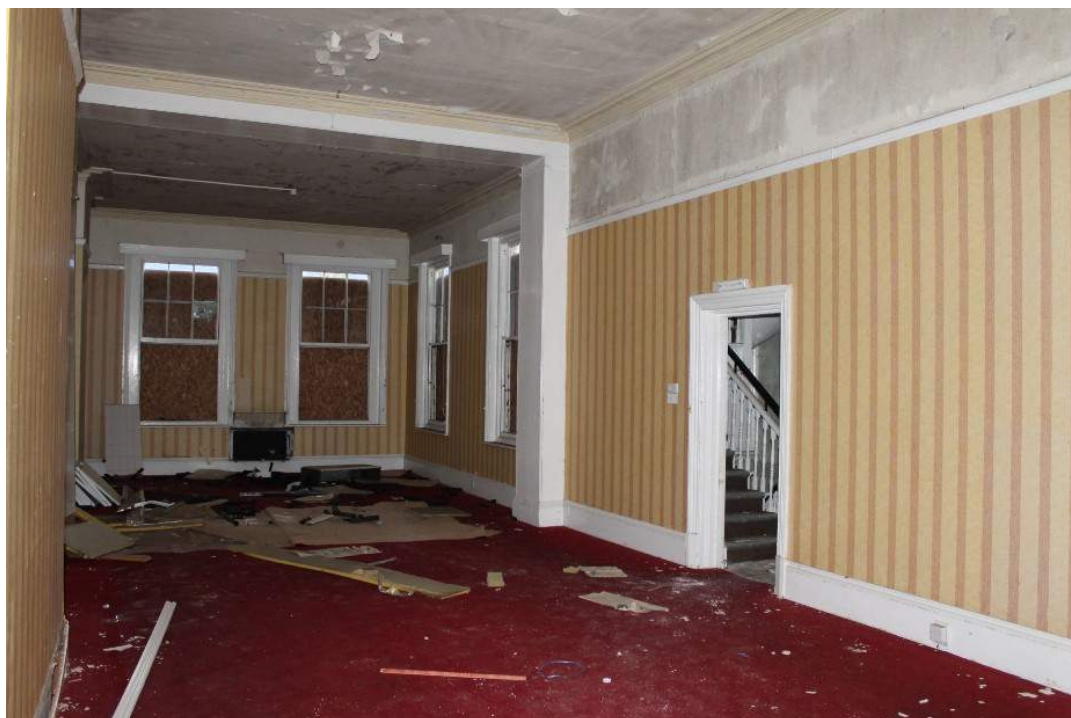
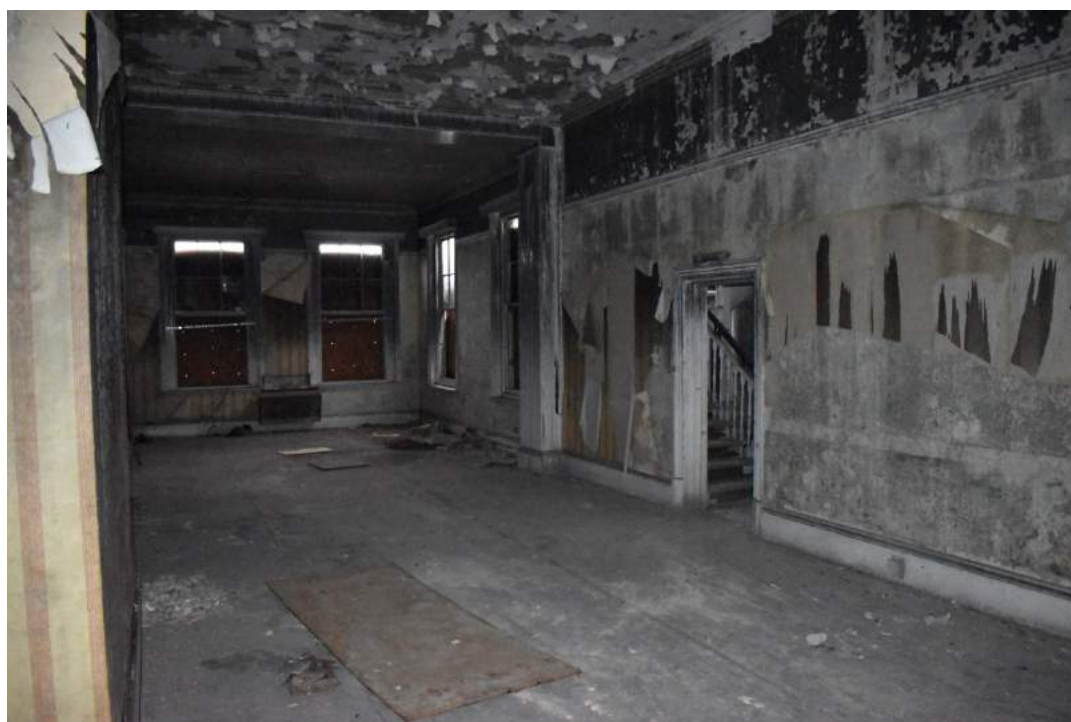
Plate 10 The mess room with the 1922-62 extension to the rear and the original doorway to the servant's stairs in the right-hand wall – view north. Photo from November 2013 above, photo from December 2019 below.

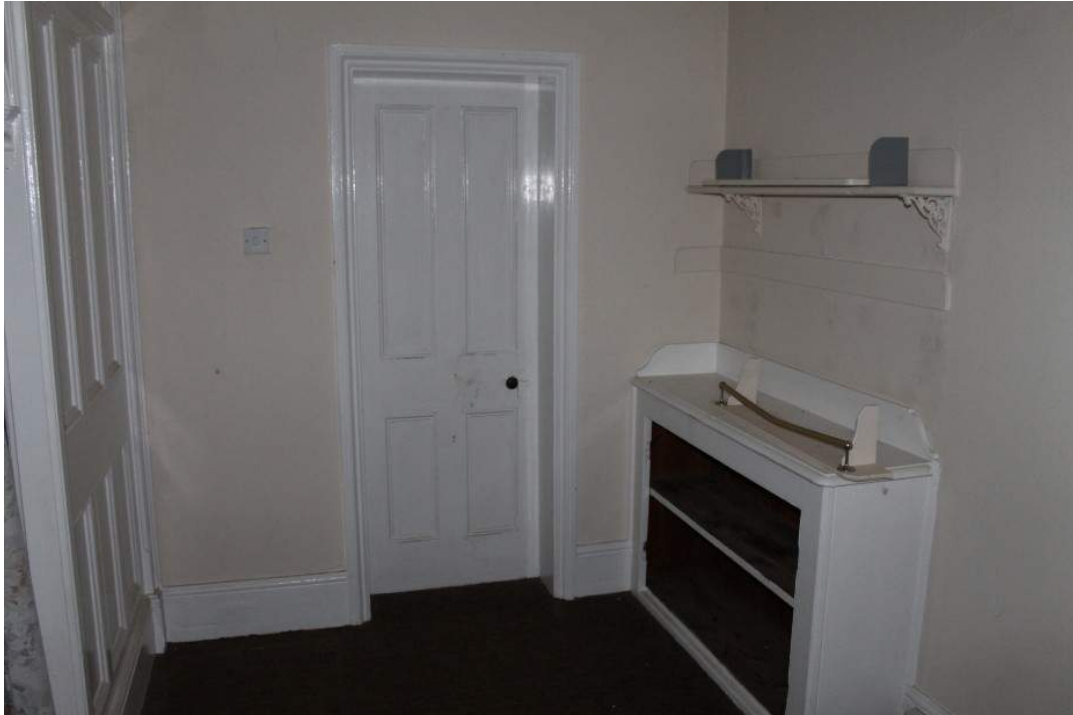
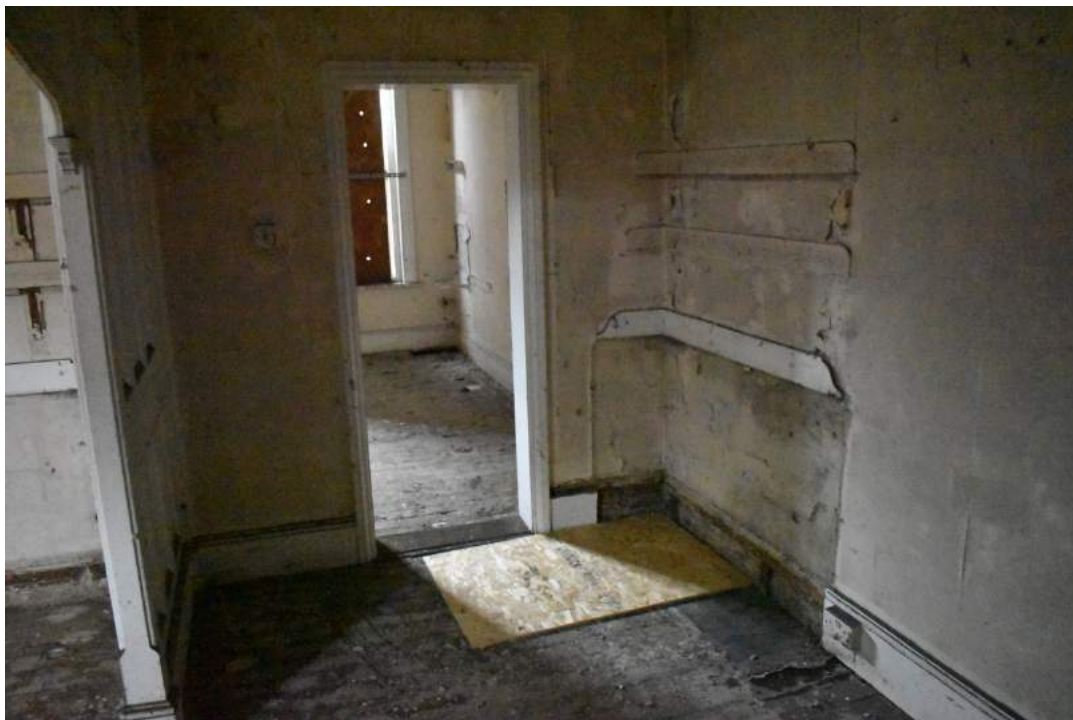
Plate 13 Room 11, showing the additional dresser and shelving in the sleeping area and the connecting doorway with the sleeping area of Room 12 – the panelled wooden partition separating the sleeping area from the sitting room can be seen on the left – view south-east. Photo from November 2013 above, photo from December 2019 below.

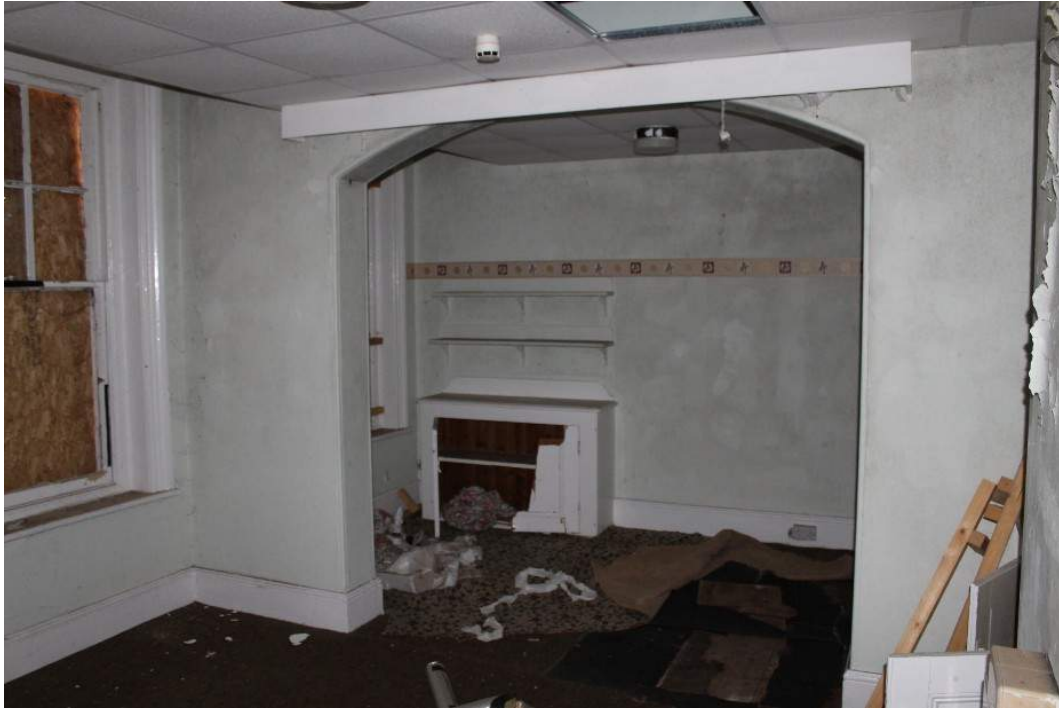
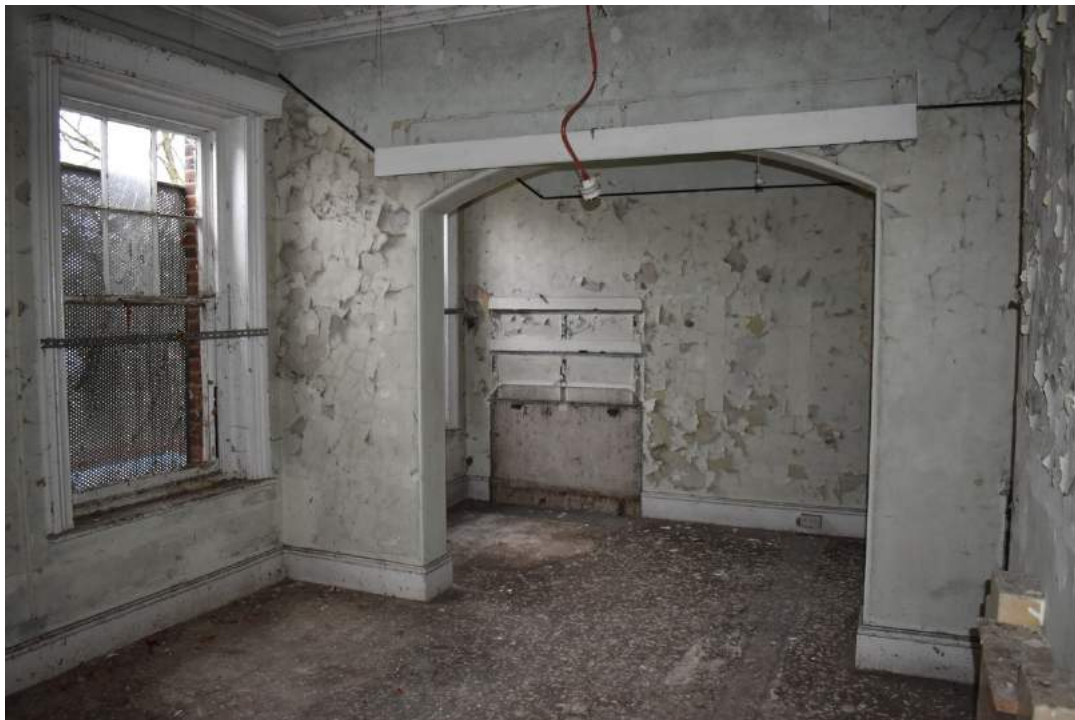
Plate 14 Room 17, the former quarters for Field Officer No.6, showing the repositioned dresser in the sleeping area and the windows without the recessed wooden shutters – view south. Photo from November 2013 above, photo from December 2019 below.

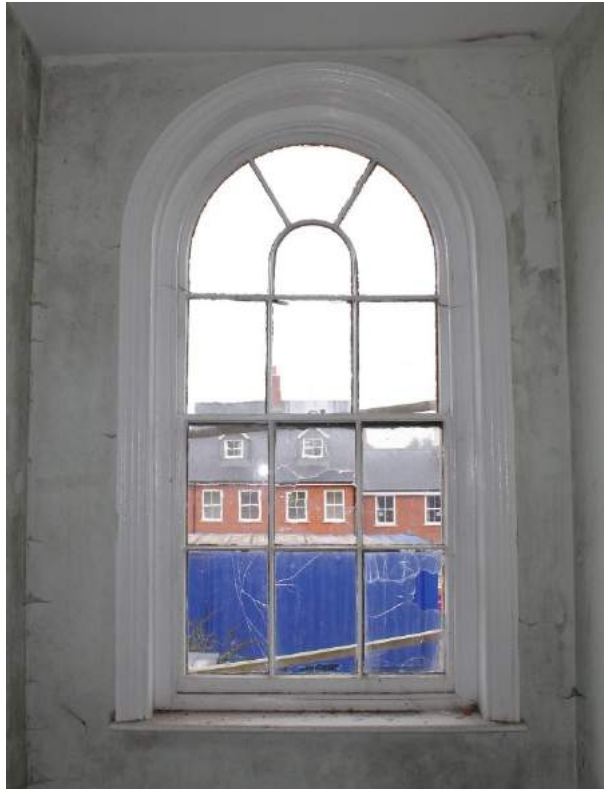
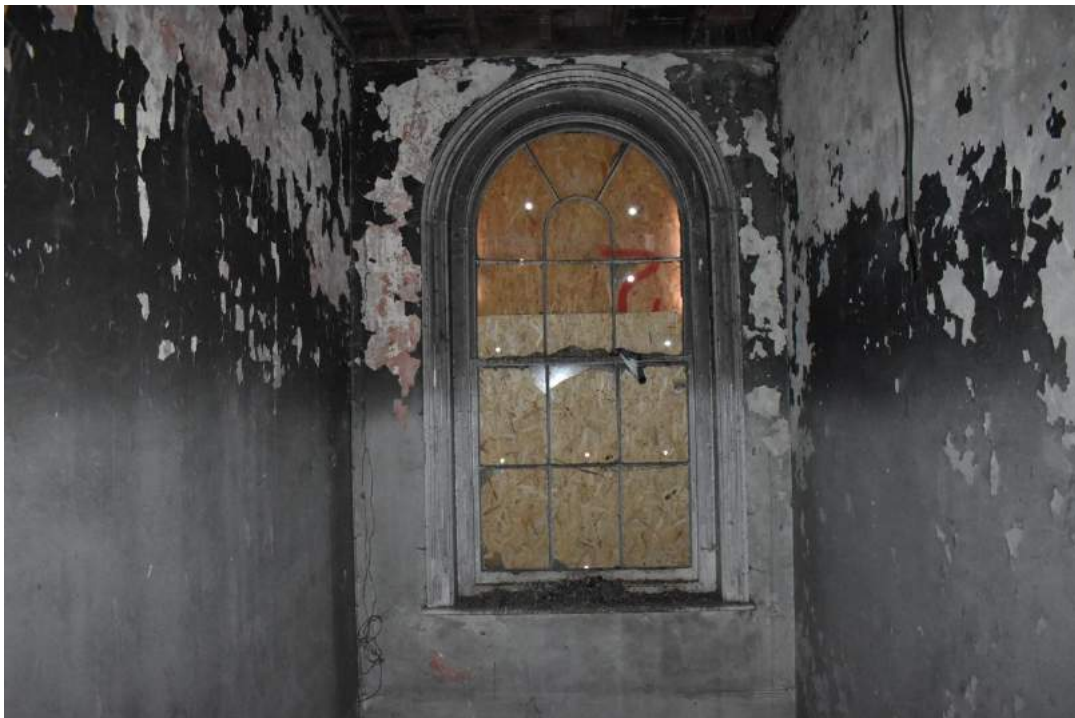
Plate 15 Example of the Italianate sash windows found in rooms 18-21. Photo from November 2013 above, photo from December 2019 below.

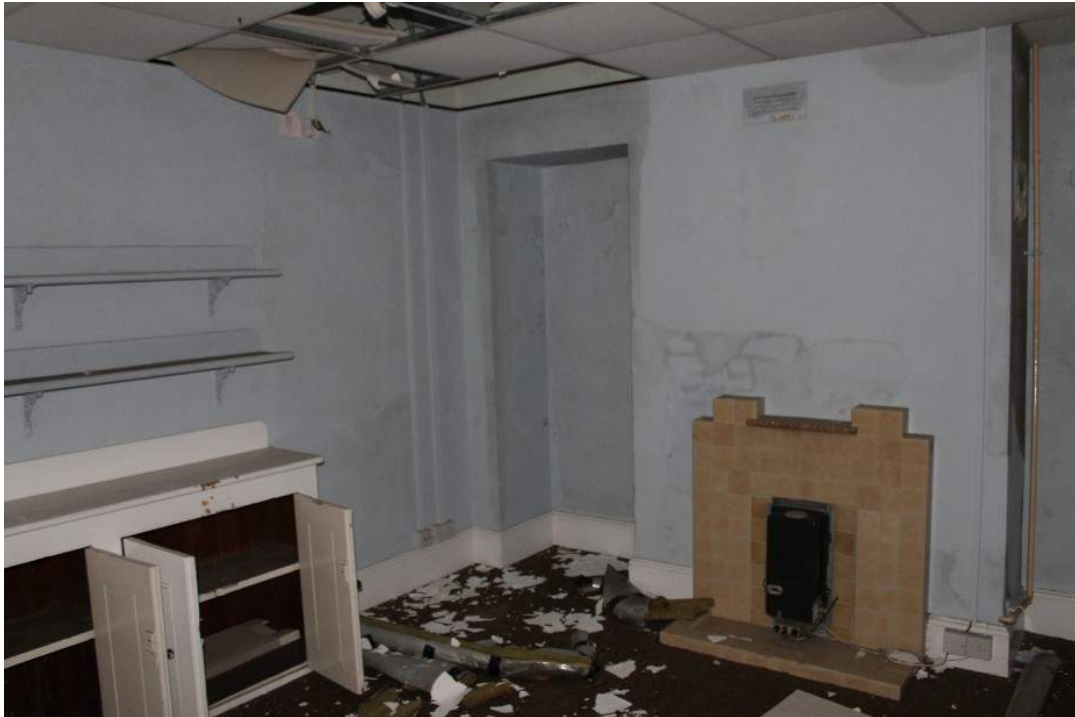
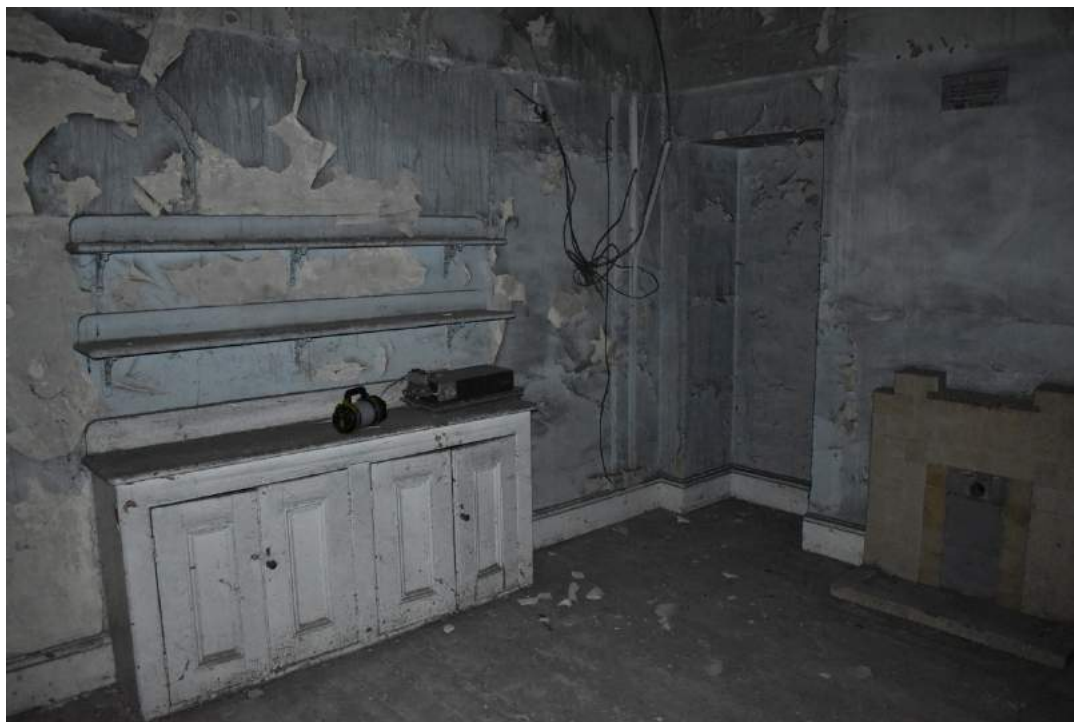
Plate 16 Room 18, formerly quarters for the servants of Officers Nos.1, 6 and 7, showing the bricked-in original doorway to the left of the chimney breast and the double-width dresser on the dividing wall – view south. Photo from November 2013 above, photo from December 2019 below.

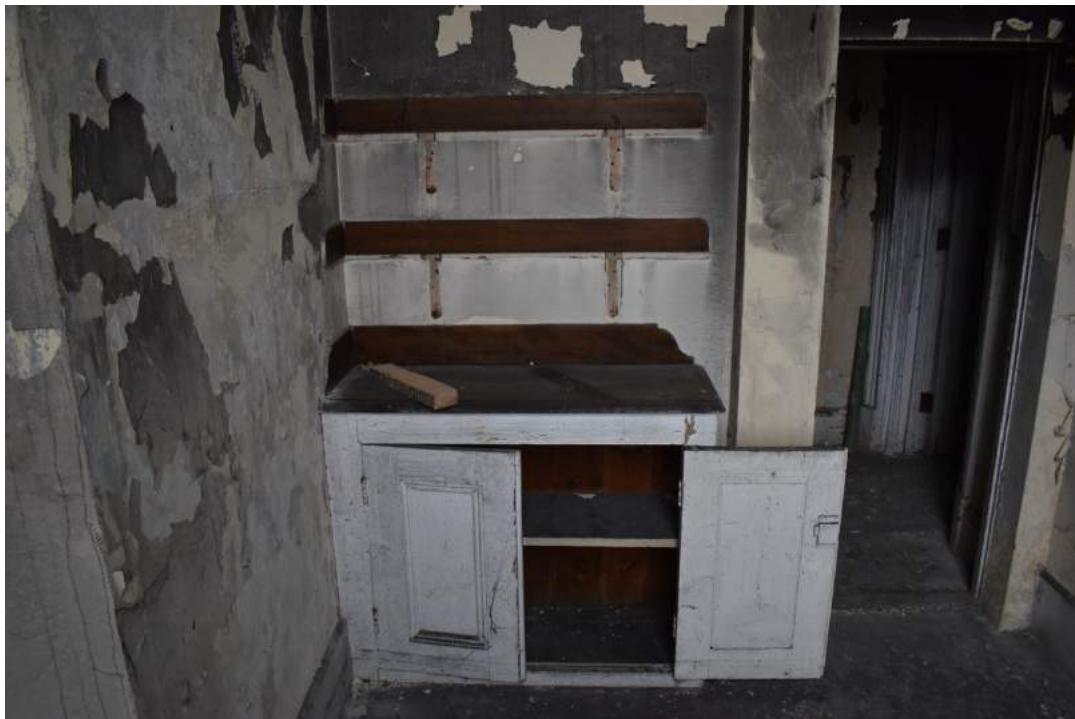
Plate 18 Detail of relocated dresser in room 20, showing the unpainted finish – view north-east. Photo from November 2013 above, photo from December 2019 below.

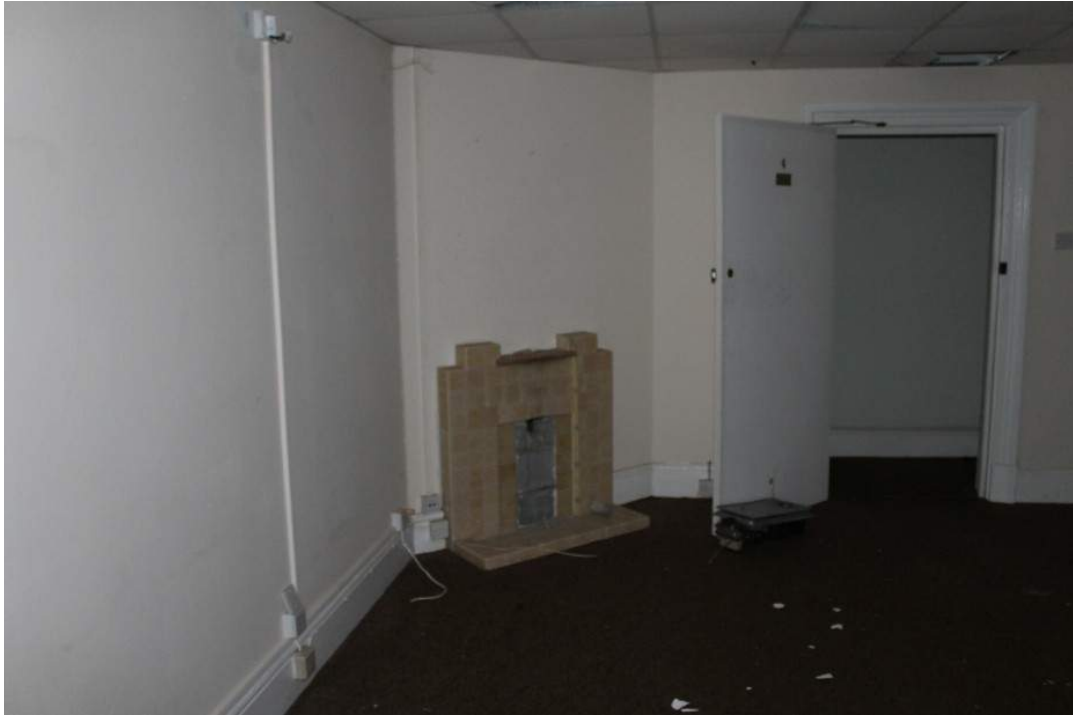
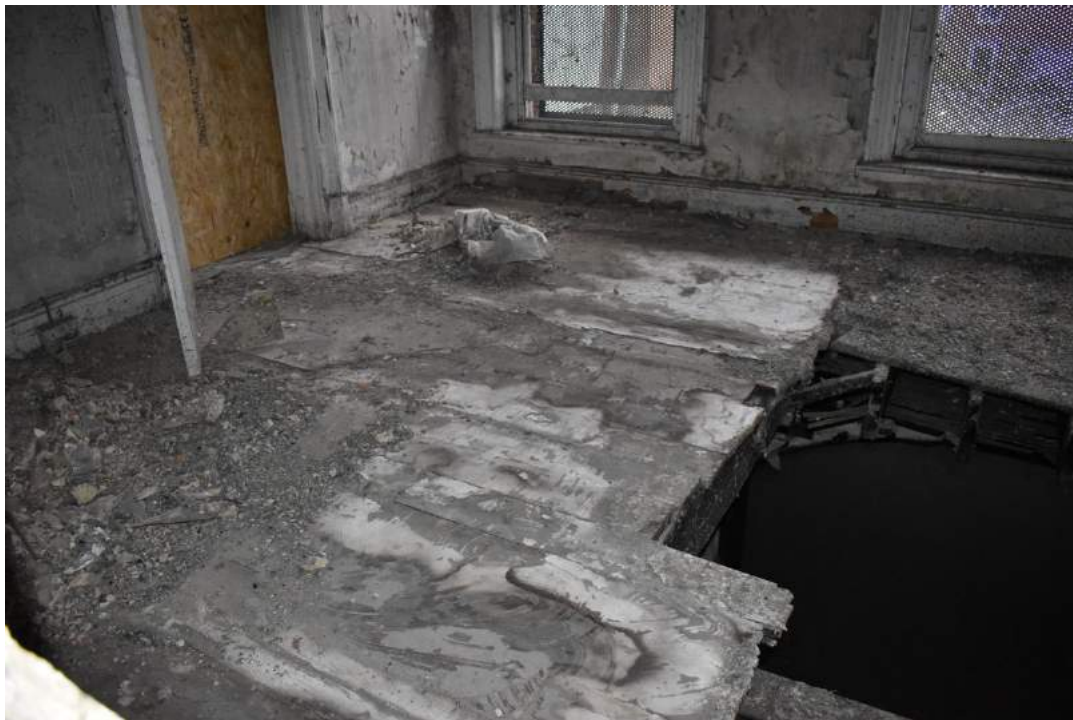
Plate 20 Room 22, formerly the quarters for Officer No.9, showing the relocated doorway and fireplace – view south-west. Photo from November 2013 above, photo from December 2019 below.
