**Historic building recording at B Mess,
formerly the Officers' Quarters,
Le Cateau Barracks, Colchester,
Essex,
November 2013 and December 2019**

**report prepared by
Chris Lister and Mark Baister**

CAT Report 1512
February 2020

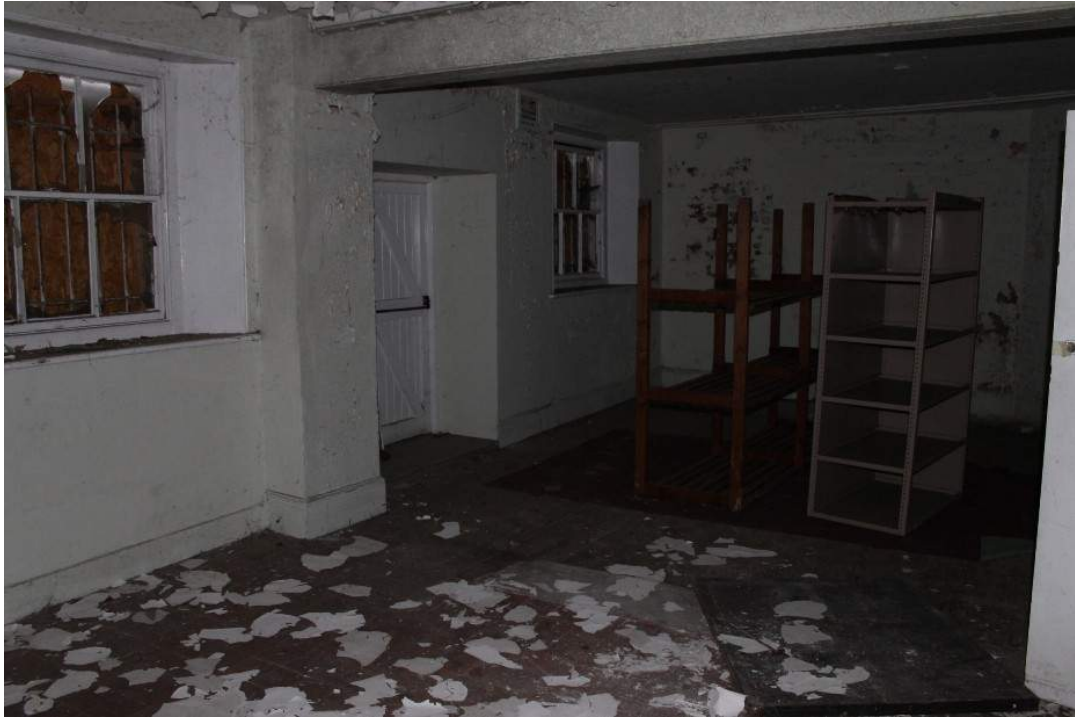
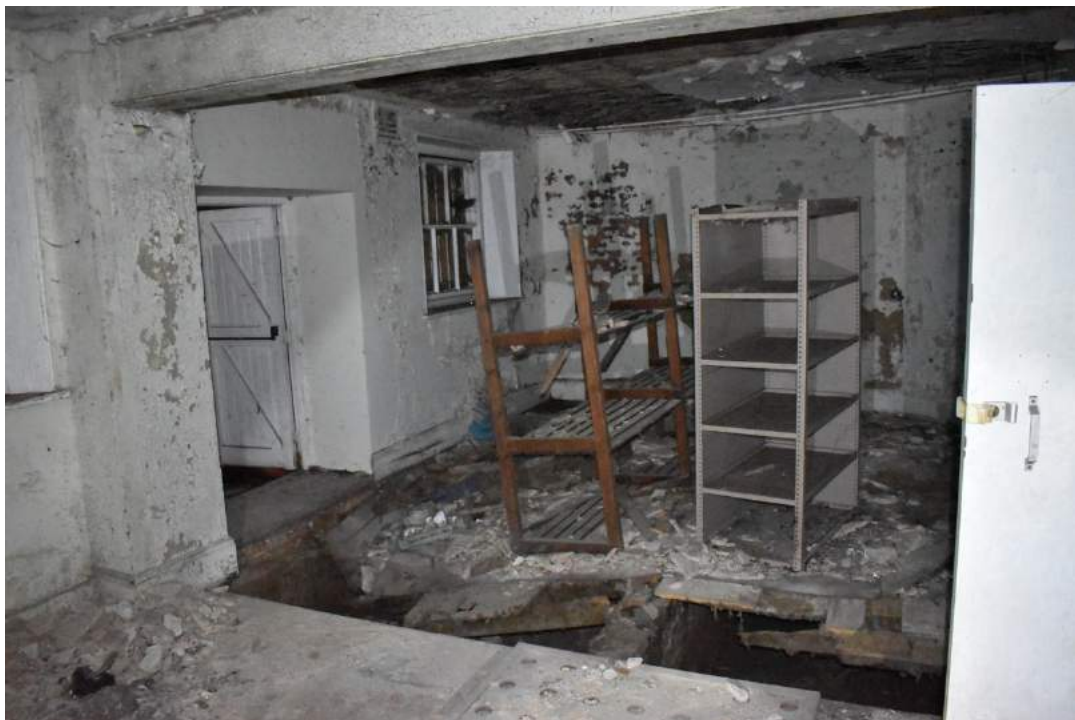
The basement was largely insulated from the effects of the fire, and so the only damage suffered is the floor of rooms 38 and 39.

Plate 22 Rooms 39 and 38, the former kitchen and mess manager's room, with the dividing wall removed and a doorway inserted through one of the windows of the mess manager's room – view south. Photo from November 2013 above, photo from December 2019 below.

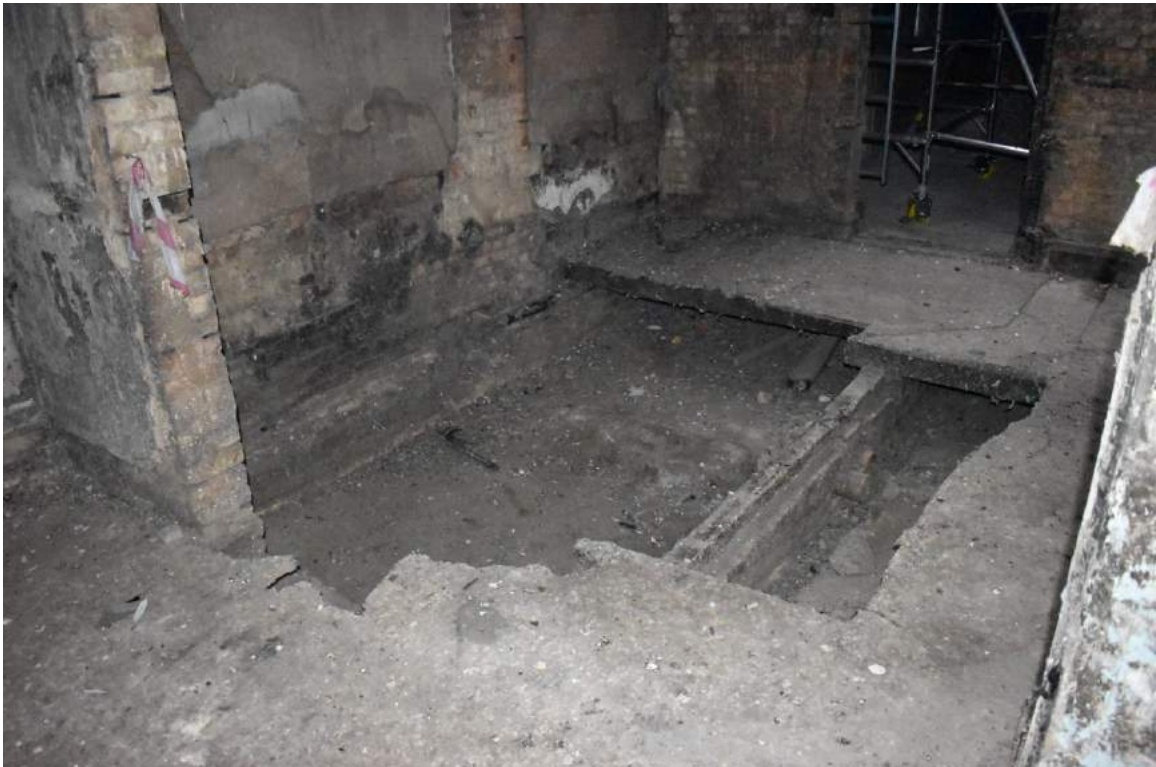
The fire the Officers' Quarters suffered in 2014 caused considerable damage to the building. It has completely destroyed rooms 24 and 25 on the first-floor, and the rooms below them on the ground-floor, leaving only the brick-built shell. Rooms immediately adjacent to the epicentre of the blaze, including the bar and entranceway iv, have also been heavily damaged. The fire is, however, not responsible for all of the damage the building has suffered in the last six years. A large number of the original features and fittings, including dressers, shelves and some doors, have been removed from the structure, most of them from the south-west end of the building in areas impacted very little by the fire. Ironically, the rooms left most inaccessible due to the blaze (rooms 26 and 27 on the first-floor) have all their features surviving (albeit in a damaged state).

Plate 24 Missing floor in ground-floor on building below room 24, with exposed brick plinths - view north.

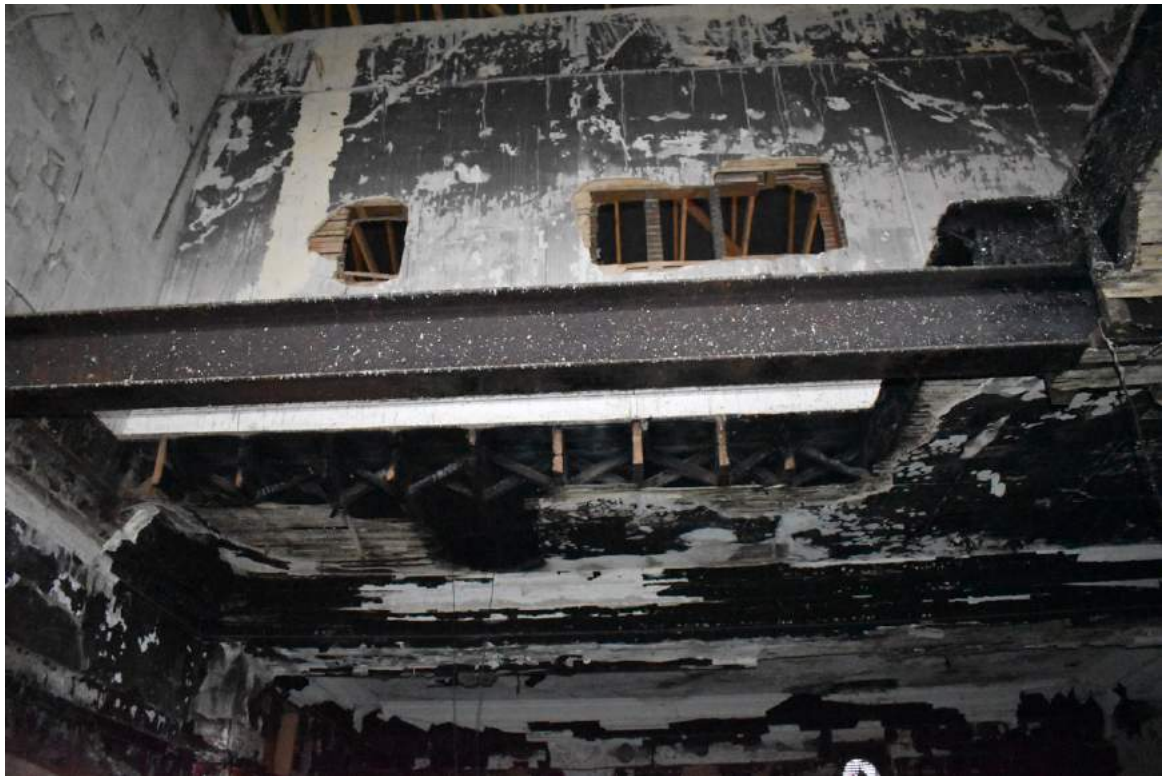
From the bar eastwards is the section of the Officers' Quarters most severely damaged by the 2014 fire, and many of the features described above no longer survive, or, if they do, are in a significantly dilapidated state. Most of the wallpaper has burnt away and the flooring is heavily damaged, with several holes exposing the brick plinths below (Plate 24). In addition, the first-floor above the eastern rooms only partially survives, with a large section of ceiling above the bar completely absent. This has exposed the bridging beams and shown them to be constructed of metal, rather than timber. Similarly, the beams supporting the inserted archways are also shown to be of metal construction (Plates 25 and 26).

Plate 25 Metal beam that would have supported the floor of room 22 prior to the fire. Herringbone strutting visible behind - view south-east.

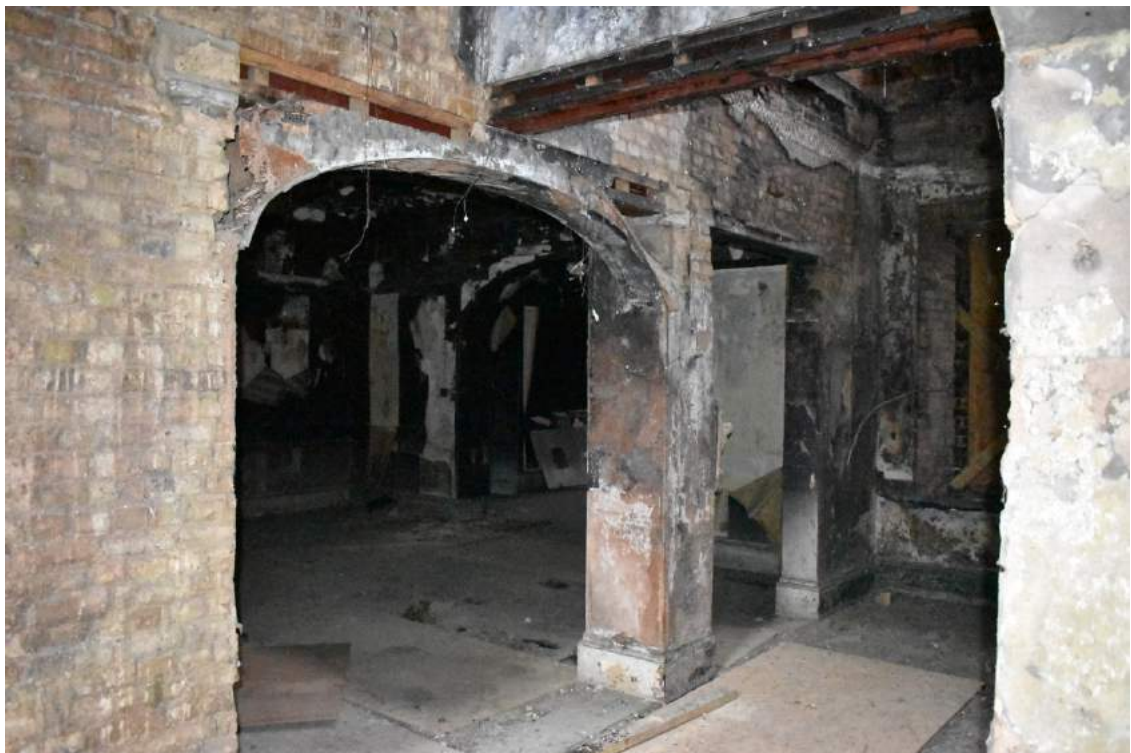
Plate 26 Inserted arch leading into bar with removed wall to right, both supported by metal beams - view west.

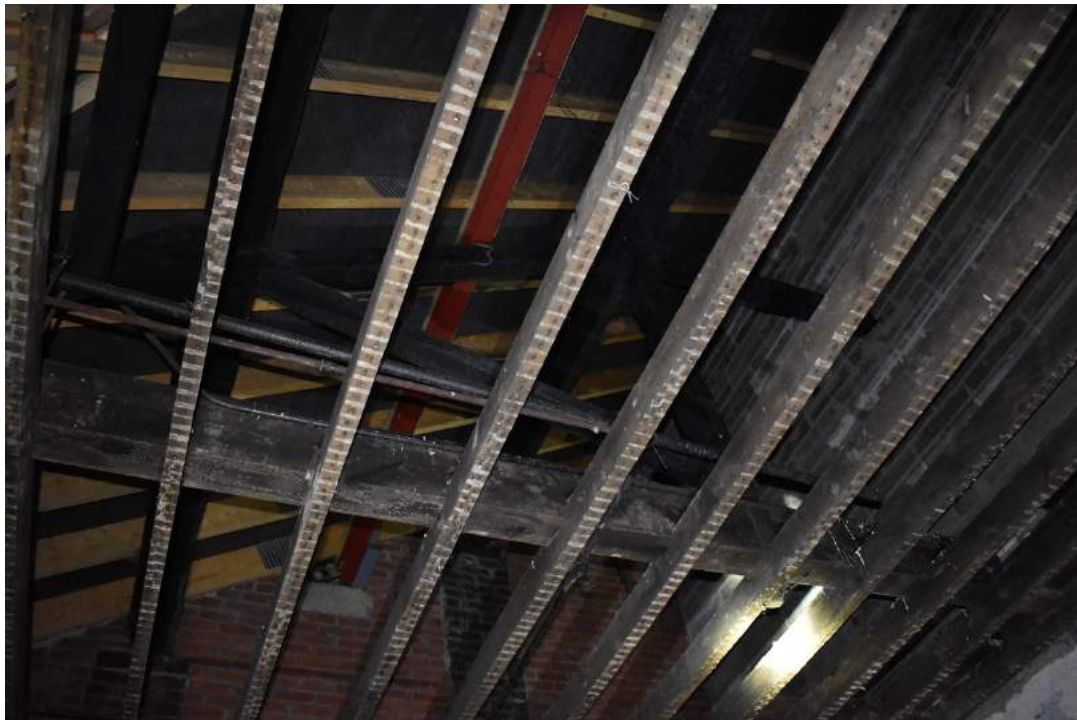
Plate 28 Detail of queen-post truss above room 19 on first-floor - view south-east.

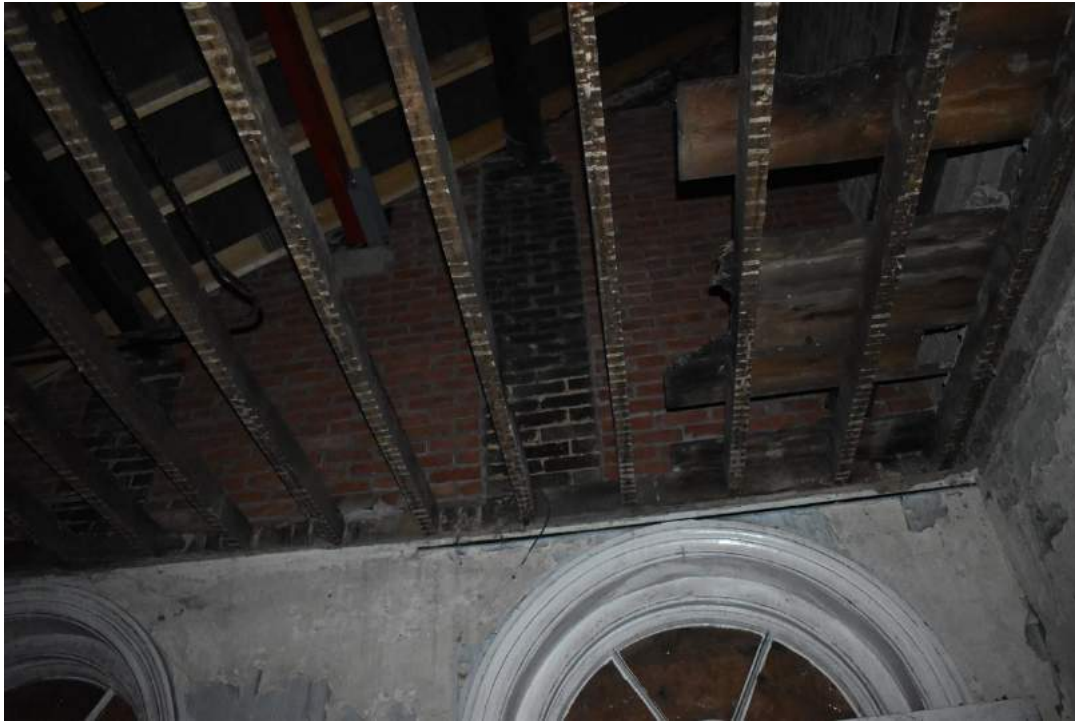
Plate 29 Engineering brick columns supporting purlins socketed into gable brickwork above room 19 - view south-east.

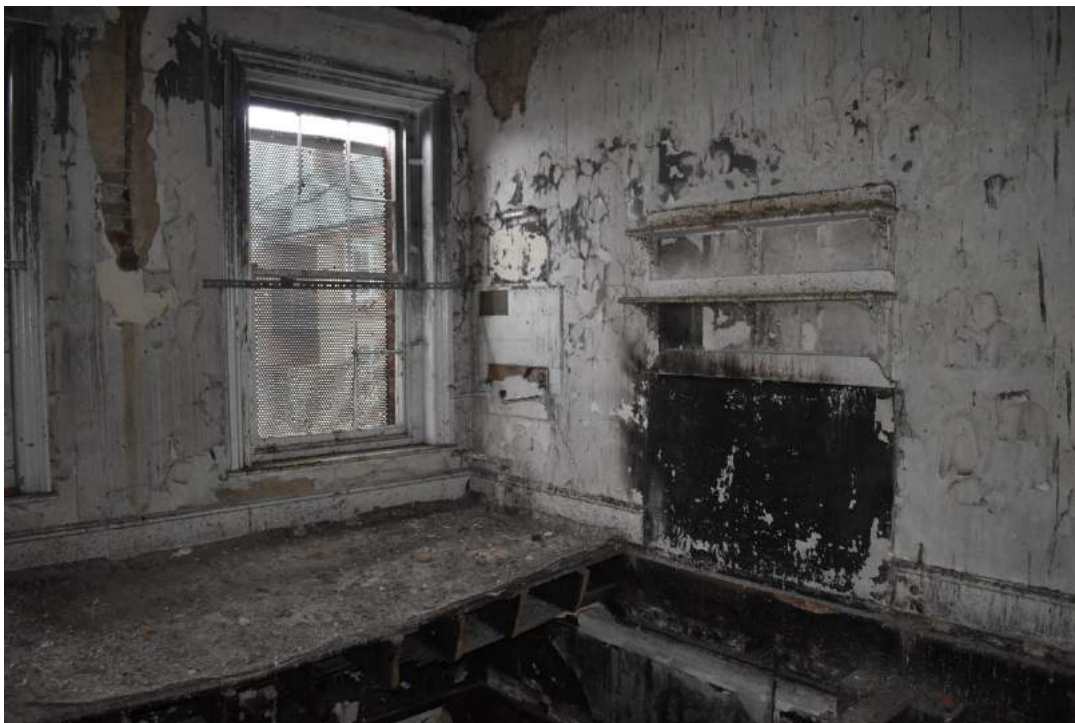
Plate 30 Room 22, showing the missing floor and dresser, but surviving shelves - view north.

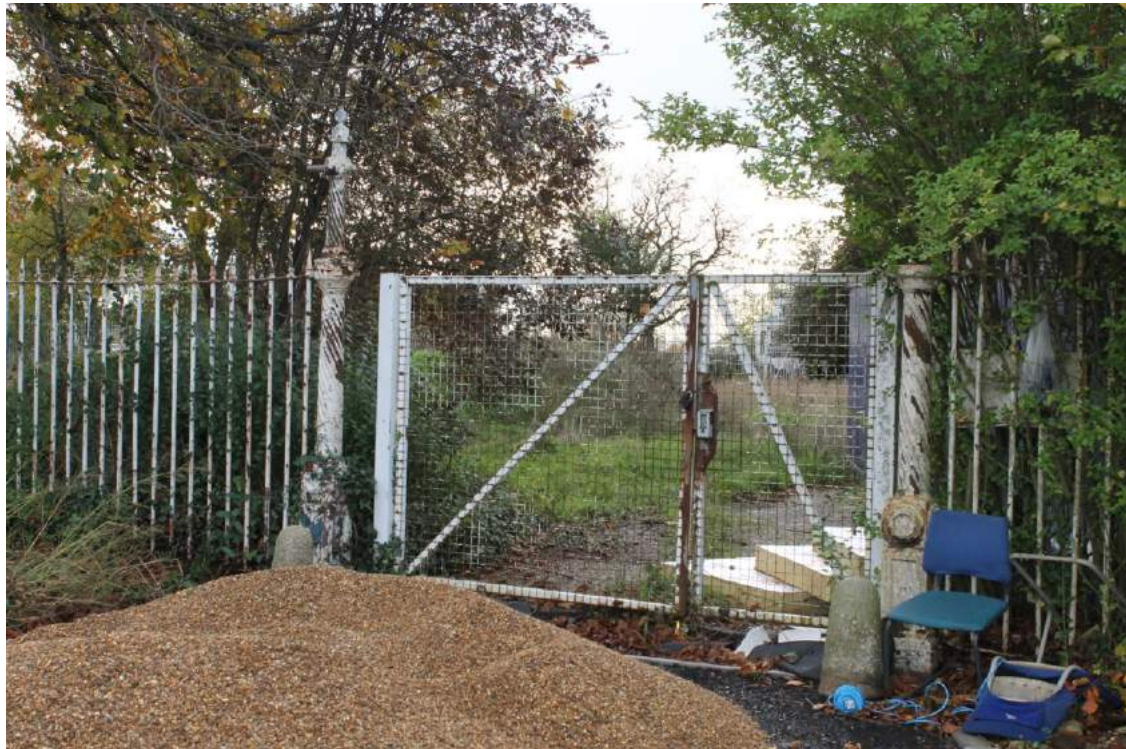
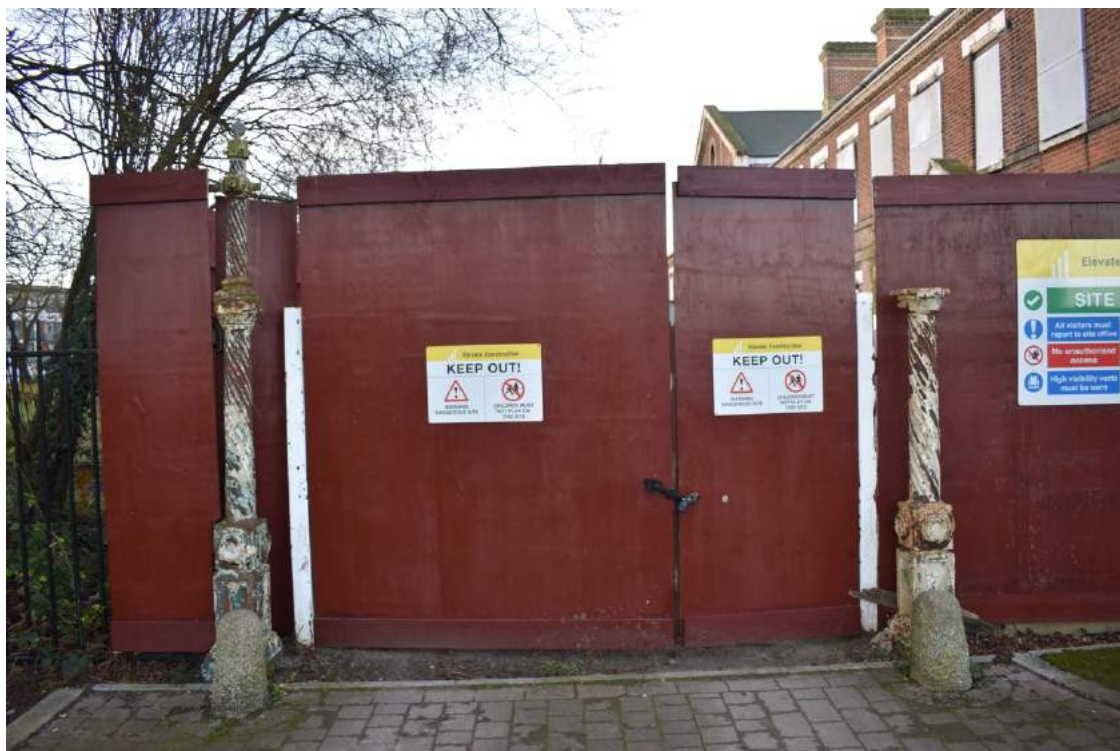
The perimeter fence of the Royal Artillery Barracks has long since been removed, with only the section surrounding the garden in front of the Officers' Quarters surviving. Probably at the same time as the 1904 alterations were carried out (or shortly after) the Officers' Quarters was enclosed in its own iron fence, joined to the earlier palisade and provided with gates formed by iron barley-twist posts incorporating gas lamps. Although the gates themselves have since been replaced, all four of the gate posts and short sections of the fence have survived. *Only three of the gate posts are now extant; the northern one on the western entrance is missing. The surviving posts, however, are in the same condition they were six years ago (Plates 33 and 34). The fence has since been entirely replaced.*

Plate 33 Surviving gate posts with gas lamps at eastern entrance to site. Note missing top of right post. Photo from November 2013 above, photo from December 2019 below.

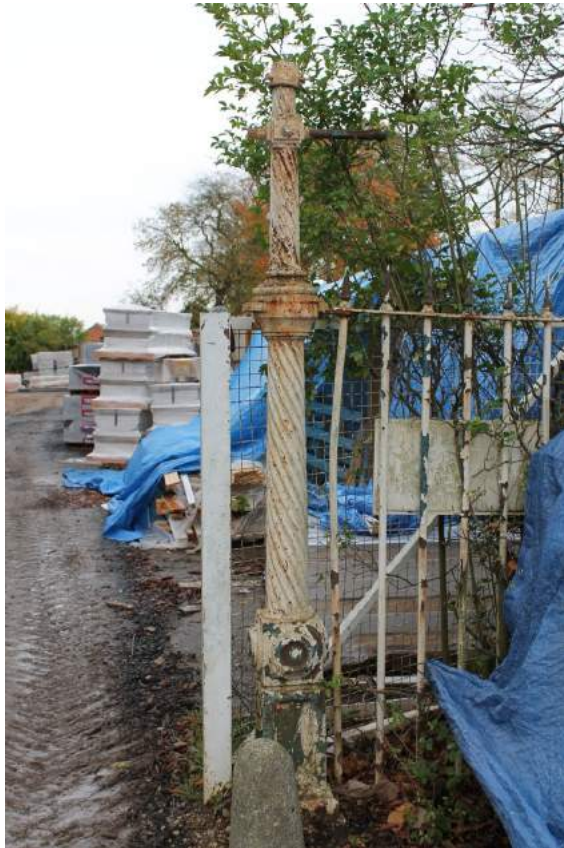
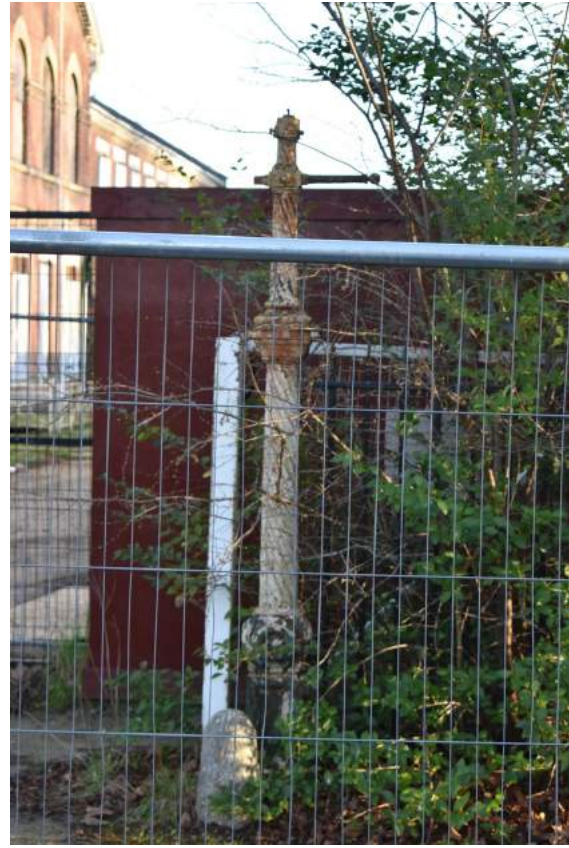
Plate 34 Surviving southern gate post and gas lamp at western entrance. Photo from November 2013 left, photo from December 2019 right.
