**St Chloe,
Layer de la Haye,
Essex**

Historic Building Record

HER Event Code ECC4374/OASIS ID leighals1-366678

September 2019

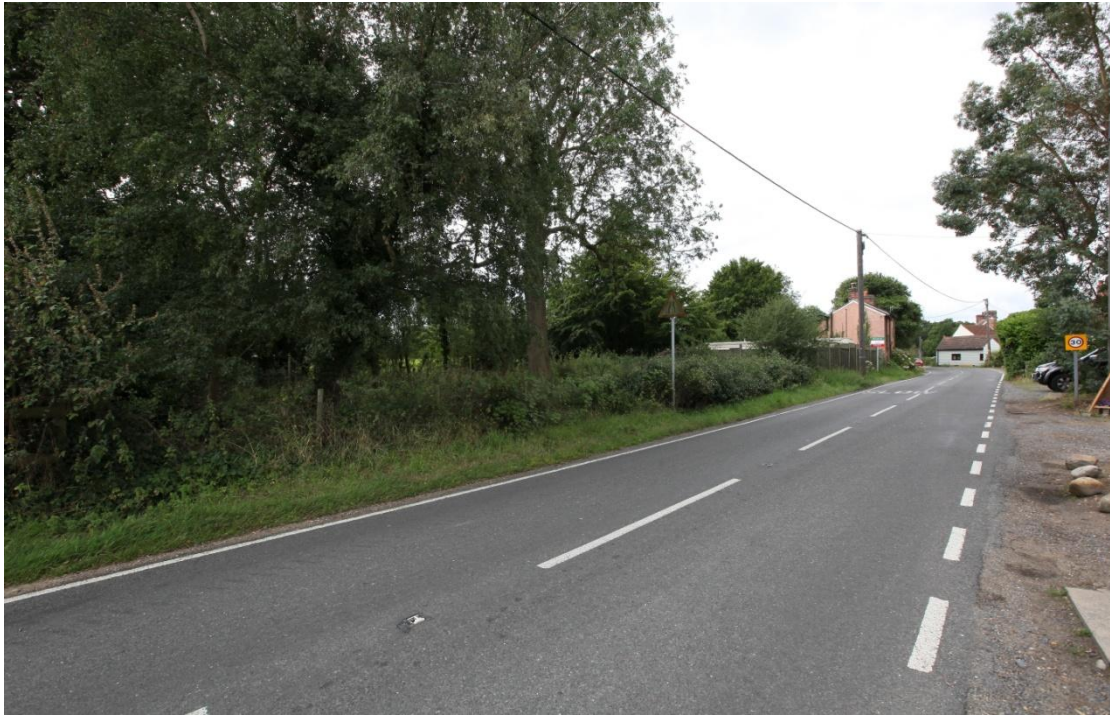
Illus. 1. A general view of the site from Abberton Road to the east showing the site of the six cottages and chapel to the left with St Chloe in the rear.

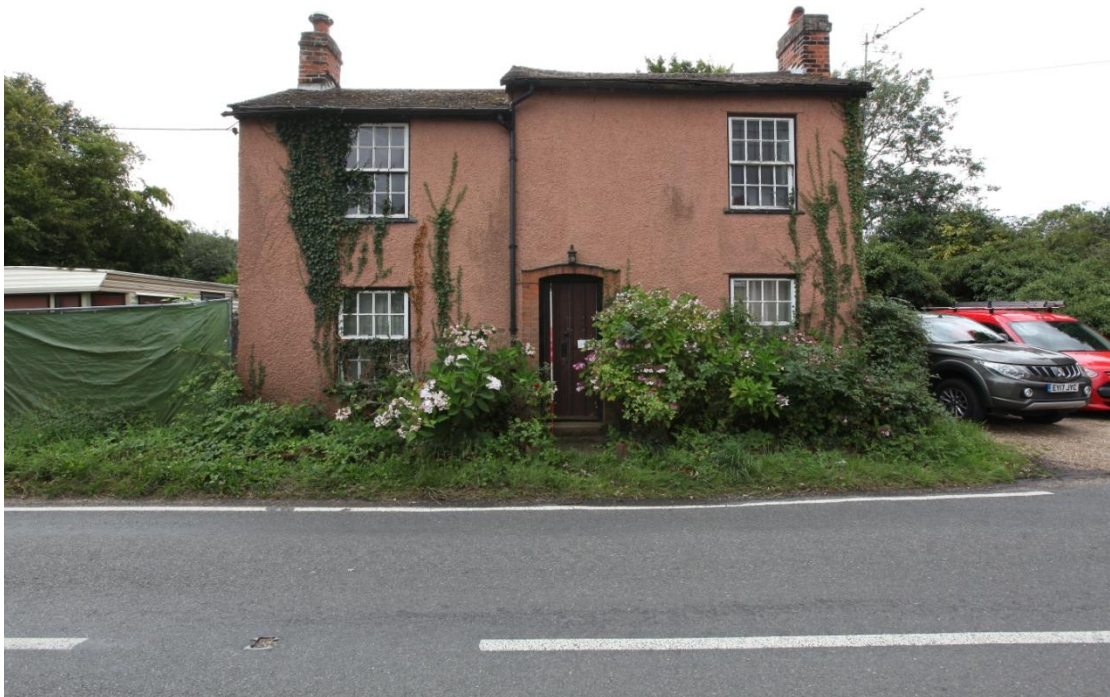
Illus. 2. The unusually asymmetrical northern facade with uniform mid-19th century sash windows without horns to their corners (as would be expected in the late-19th century). The brickwork is entirely concealed by 20th century cement render and it is unclear whether the lower section of the building on the left (1) represents a slightly later addition to the taller section on the right (2).

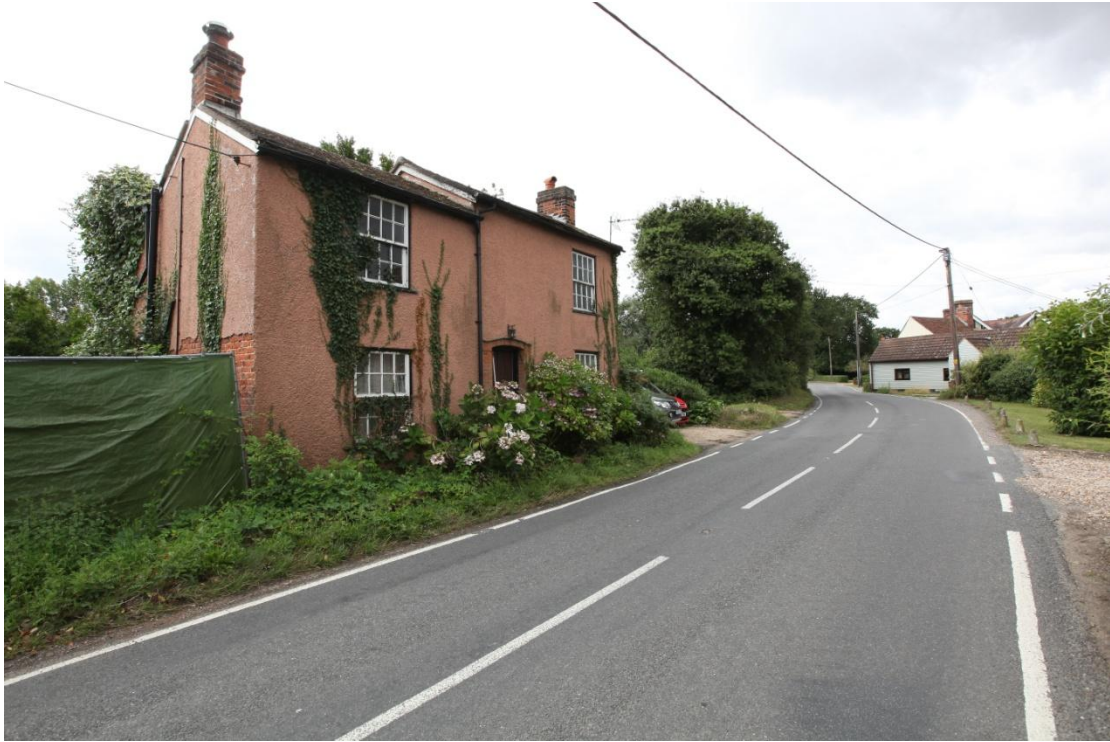
Illus. 3. The house from the north-east showing the uniform peg-tiled roofs of the building's two sections with shallow pitches more usually intended for slate. The gable chimney of the taller western section is wide enough for two flues but its counterpart on the east only one.

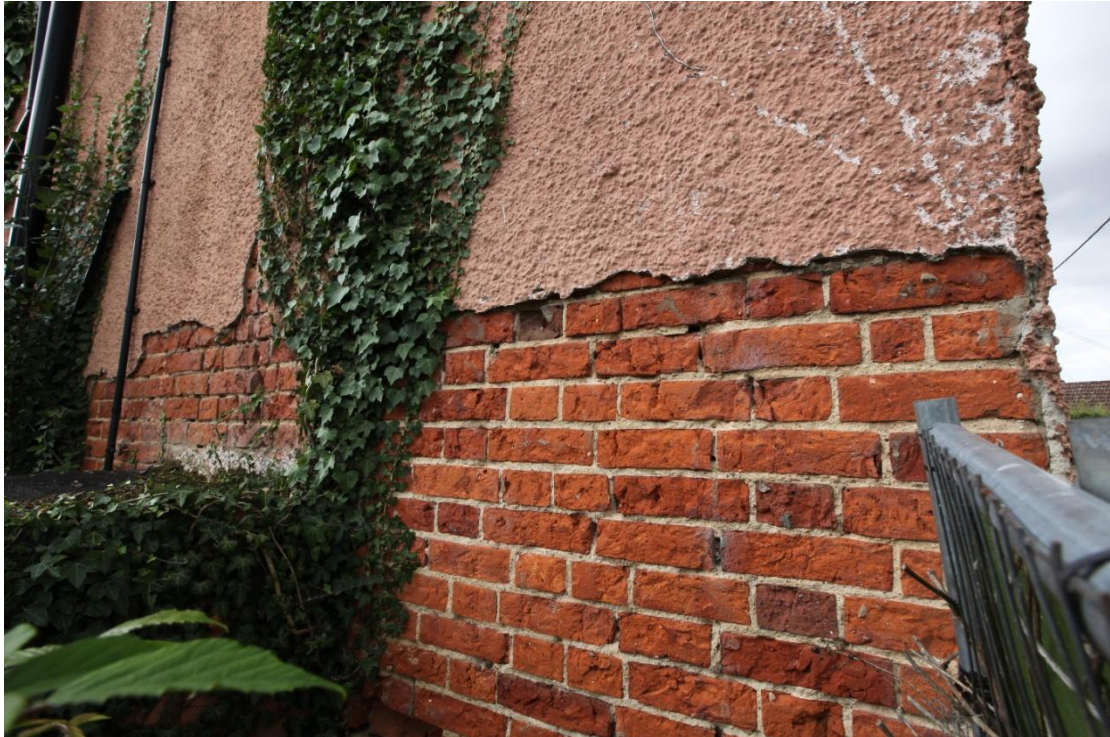
Illus. 4. A detail of the eastern external gable showing its high-quality red brickwork laid in what appears to be a form of Monk Bond beneath the modern cement render. The brickwork of the western gable exposed in the roof appears to consist of contrasting gault (white) brick (illus. A2. 15).

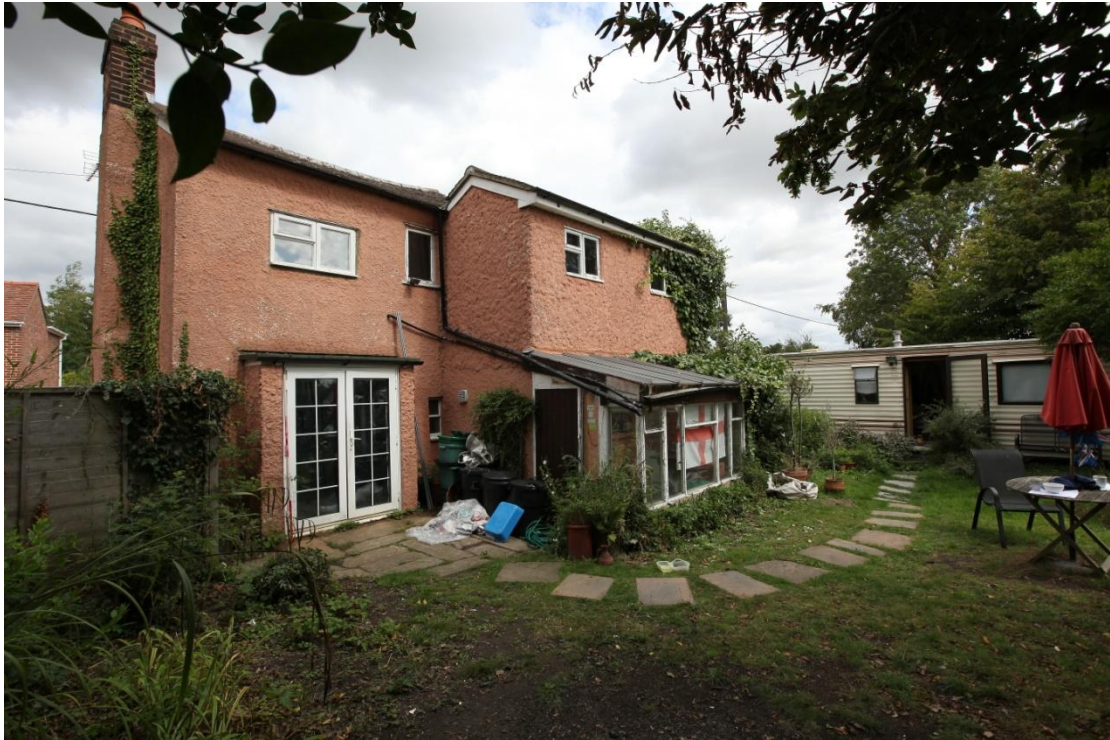
Illus. 5. The building from the south-west showing its late-20th century windows, French doors and conservatory with the narrow pitched roof of the mid-20th century rear extension (3) in the centre.

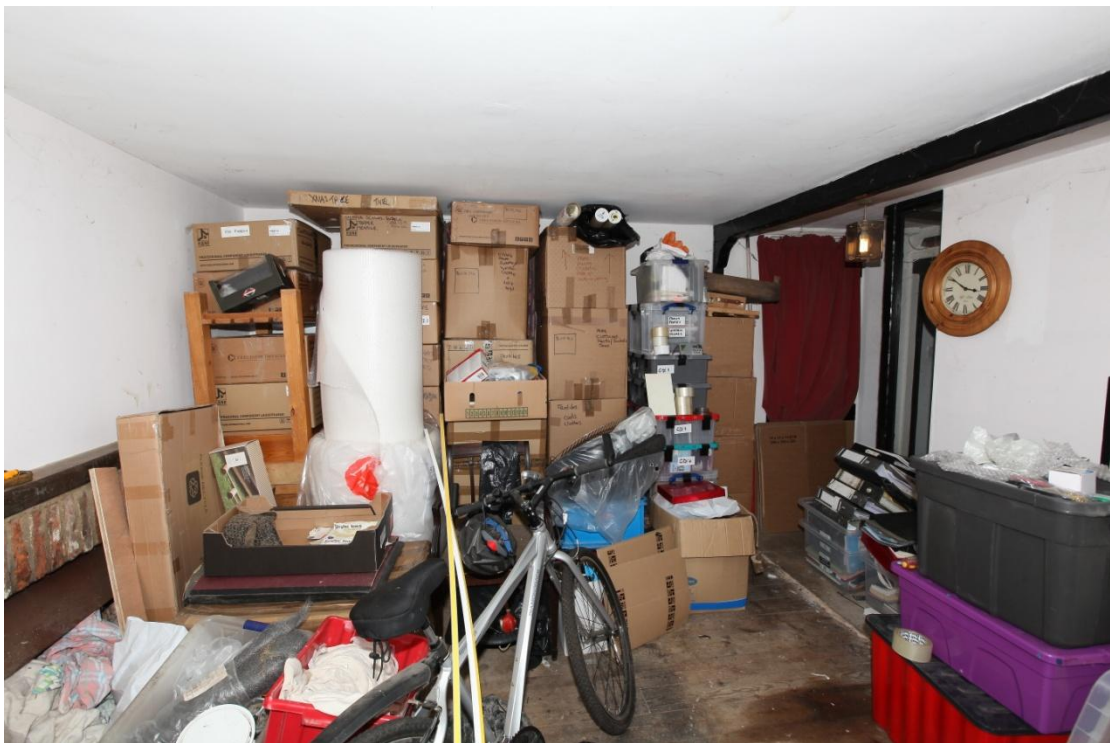
Illus. 6. The modern lounge (2), as labelled in figure 12, seen from the rear (south) with the entrance door and central staircase on the right. The late-20th century brick fireplace in the western gable is visible on the left. The ostensibly original narrow pine floorboards meet concrete at the 20th century black-painted ceiling timber adjoining the modern staircase on the right – suggesting this timber replaced the partition of a wider original stair and/or entrance passage.

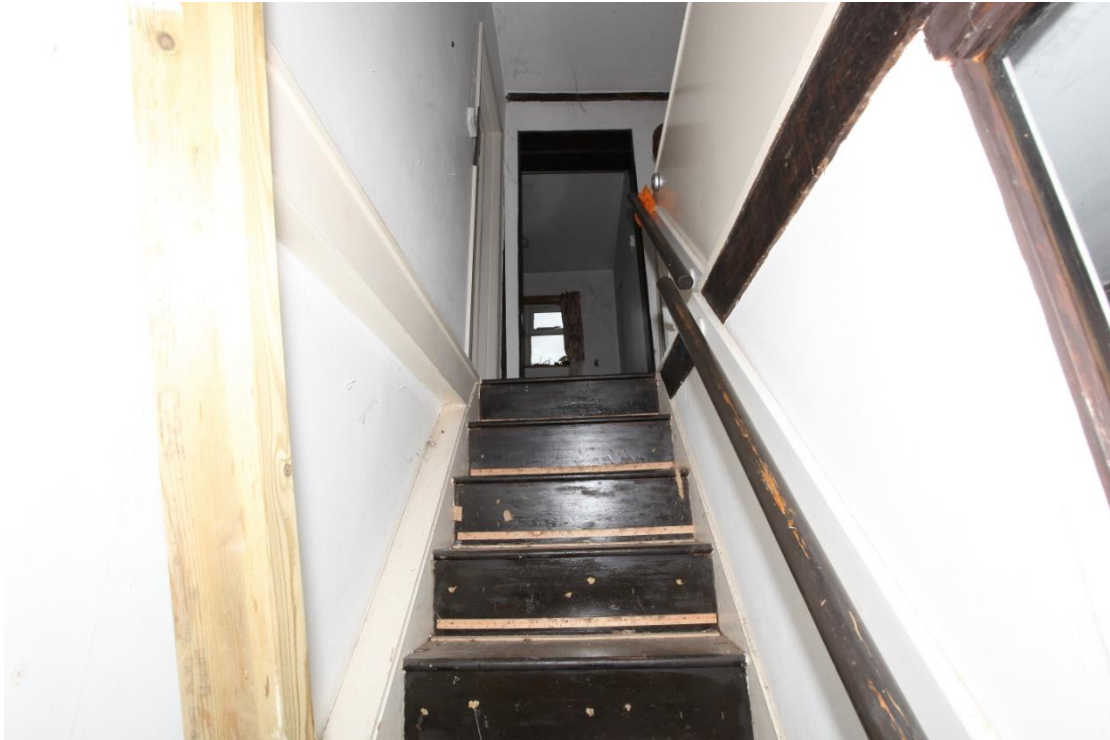
Illus. 7. The narrow late-20th century boarded central staircase viewed from the entrance lobby to the north and showing the door to the first-floor bathroom lobby in the extension (3f) immediately above.

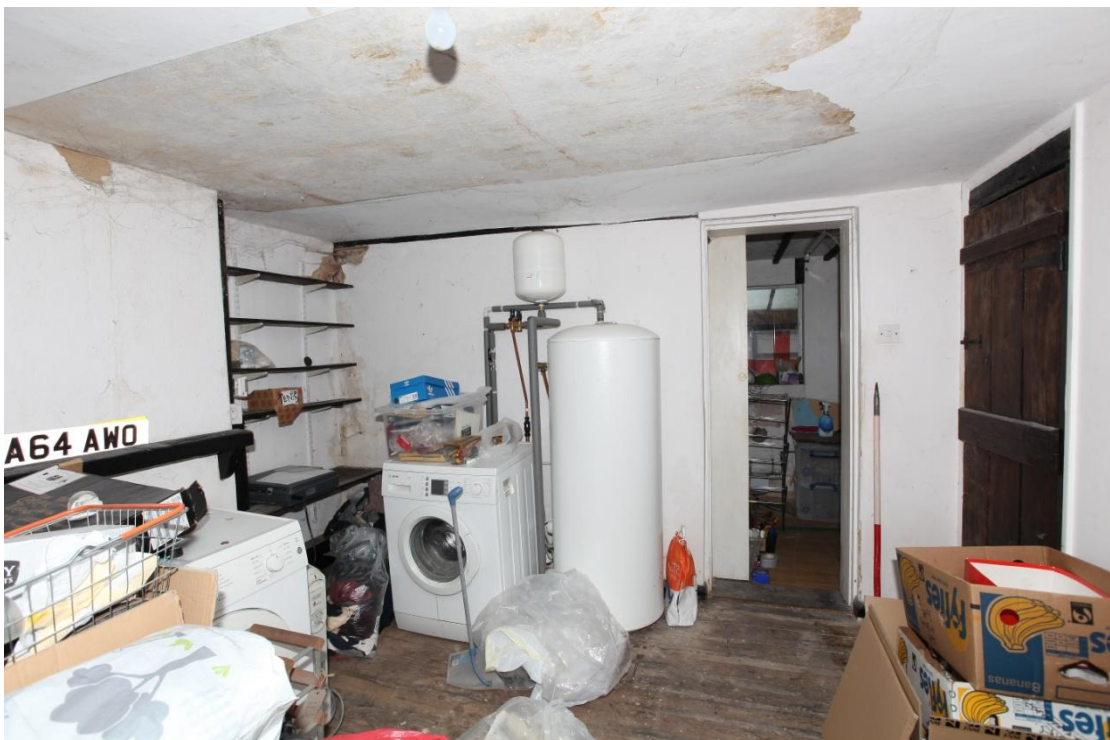
Illus. 8. The dining room (1) from the north showing the door to the kitchen (3) in the centre with an under-stair cupboard on the right and the gable fireplace on the left. The fireplace is blocked and lies beneath a 20th century Mock Gothic wooden shelf. The narrow pine floorboards are identical to those of the lounge (2) but the height of the dining room floor is 10 cm lower (4 ins).

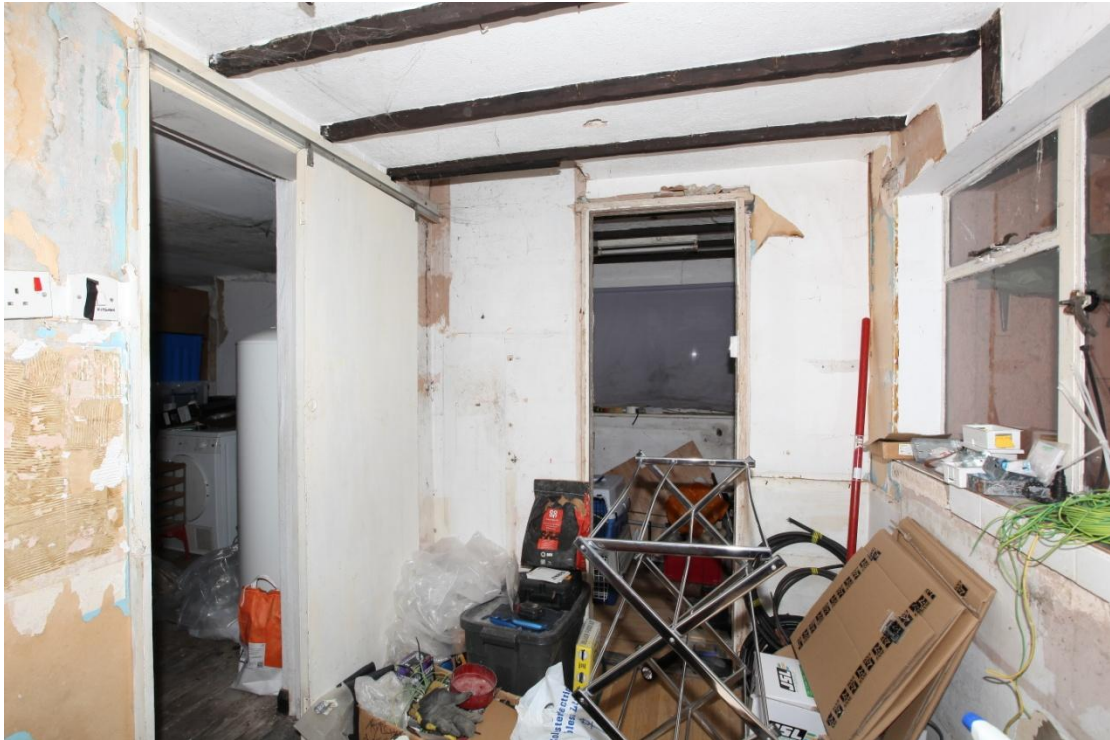
Illus. 9. The interior of the mid-20th century kitchen extension (3) from the east showing its southern Crittall window on the right with the door to the dining room (1) on the left. The ceiling joists appears to have been exposed from the outset to create a Mock Gothic appearance.

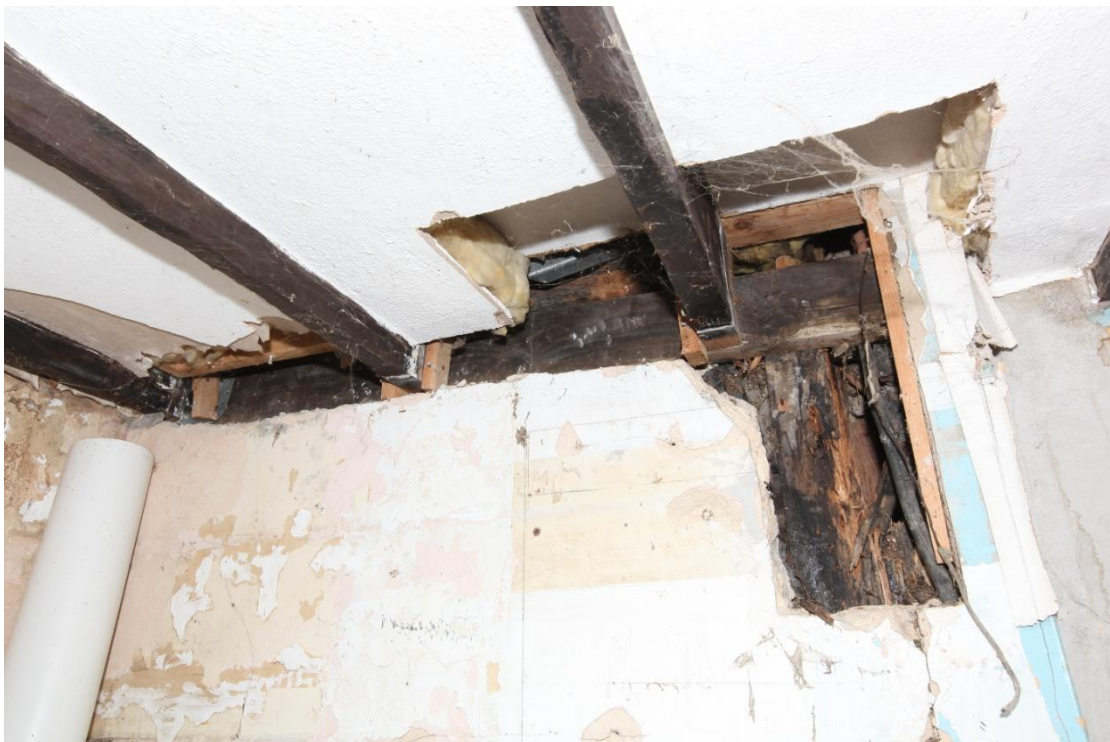
Illus. 10. A detail of the exposed softwood studwork of the original rear wall in the northern interior of the kitchen extension (1). It appears that the entire back wall consisted of rendered studwork in contrast to the more expensive brick of the northern facade and gables.

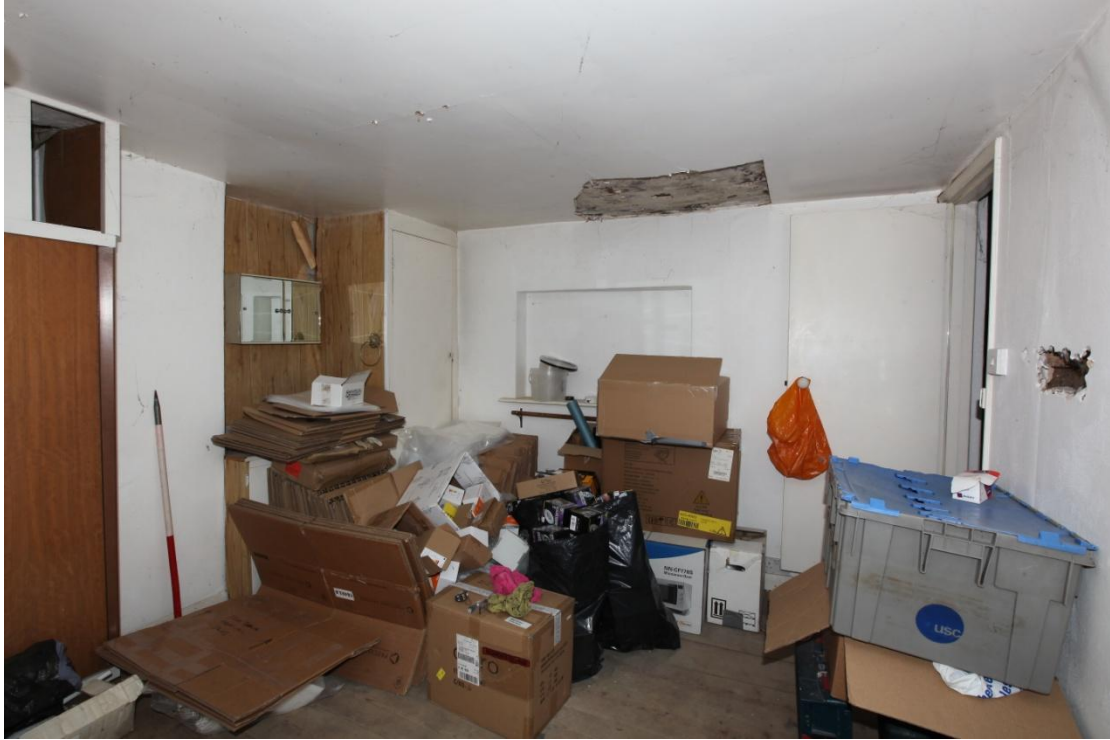
Illus. 11. The southern interior of the eastern bedroom (1) showing the recess of the original rear window blocked by the 20th century extension (3) with the door to the stair landing on the right. There is no evidence of a fireplace in the eastern gable to the left and the narrow chimney served only the ground floor.

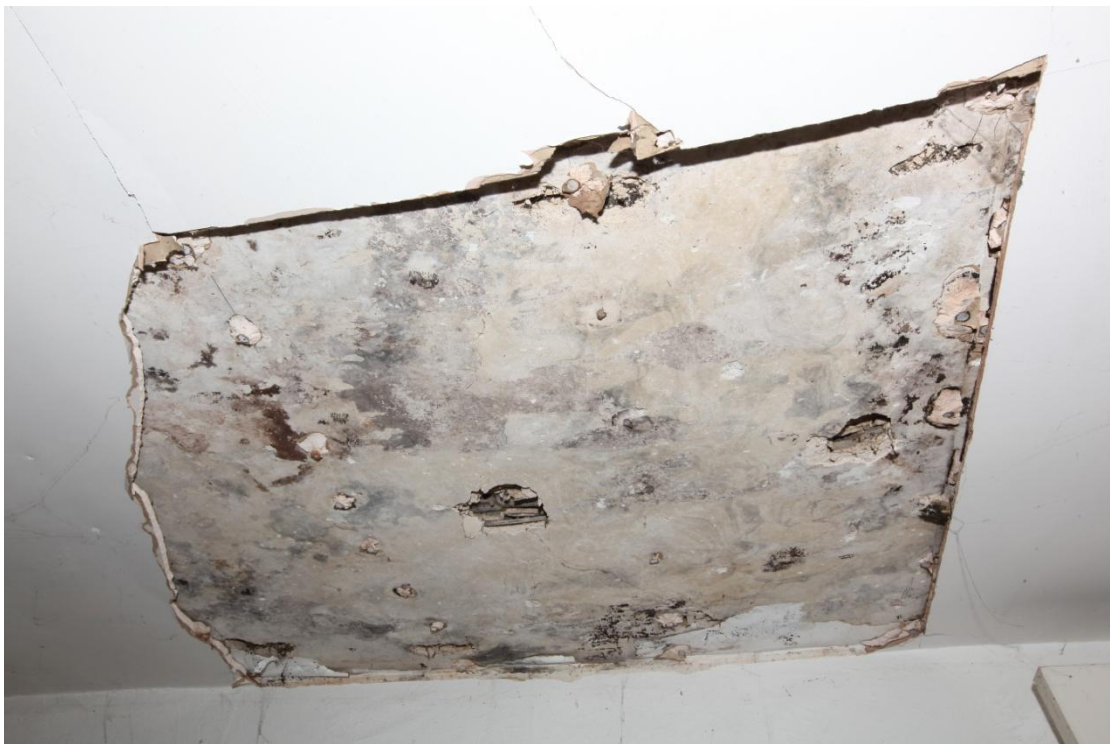
Illus. 12. A detail from the north of the original lath-and-plaster ceiling of the western bedroom (1f). The coarse lime plaster is typical of the 19th century, but was hidden by plasterboard during the late-20th century refurbishment.

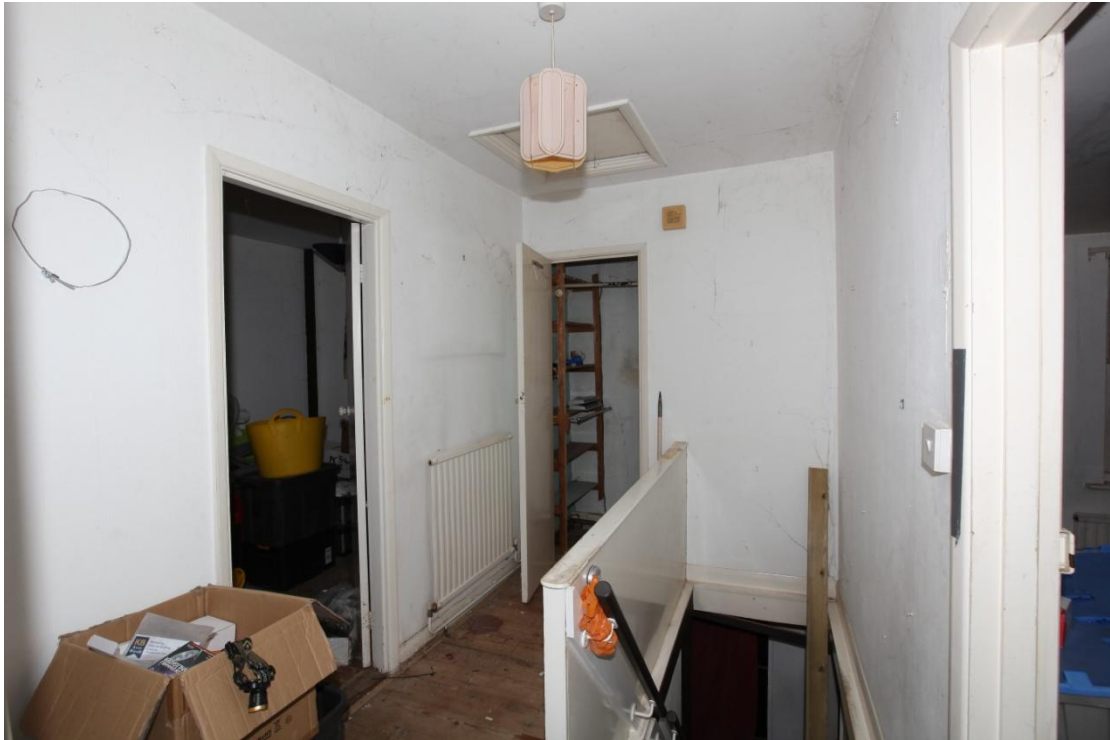
Illus. 13. The first-floor stair landing from the rear (south) showing its late-20th century plasterboard walls and architraves with the entrance to the western bedroom (2f) on the left.

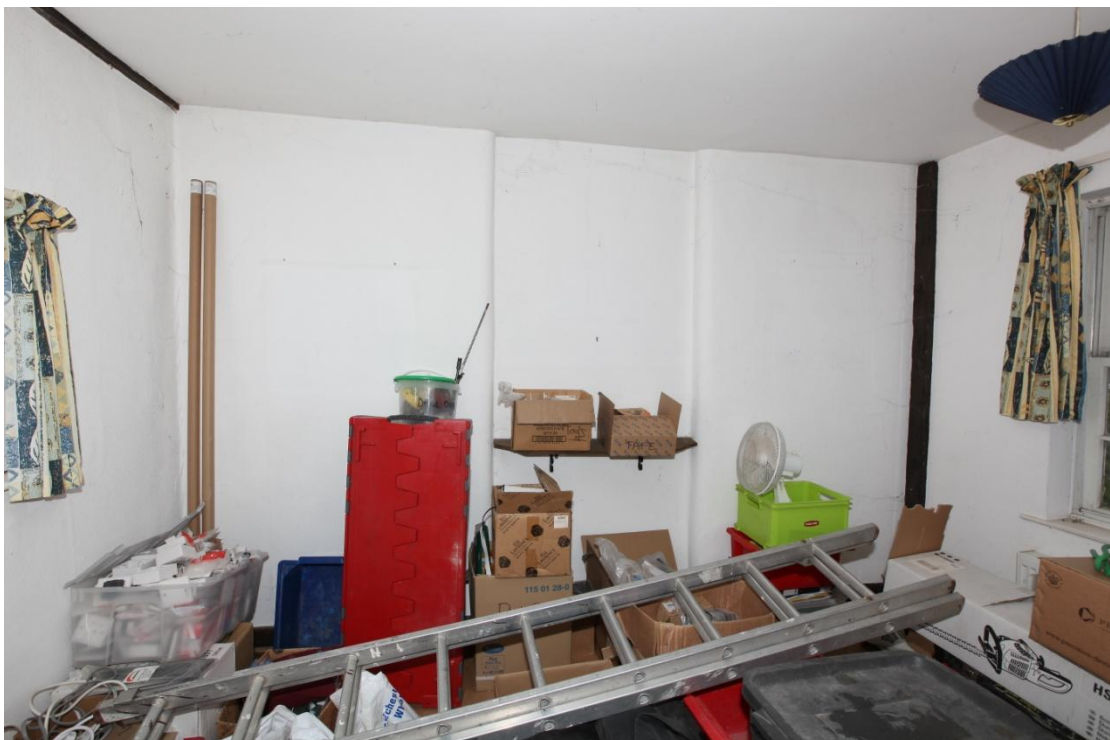
Illus. 14. The western internal gable of the western bedroom (2f) showing the unusual central recess indicating the position of the chimney. A fireplace may have been removed from this position. The timber to the right is a 20th century Mock Gothic insertion.

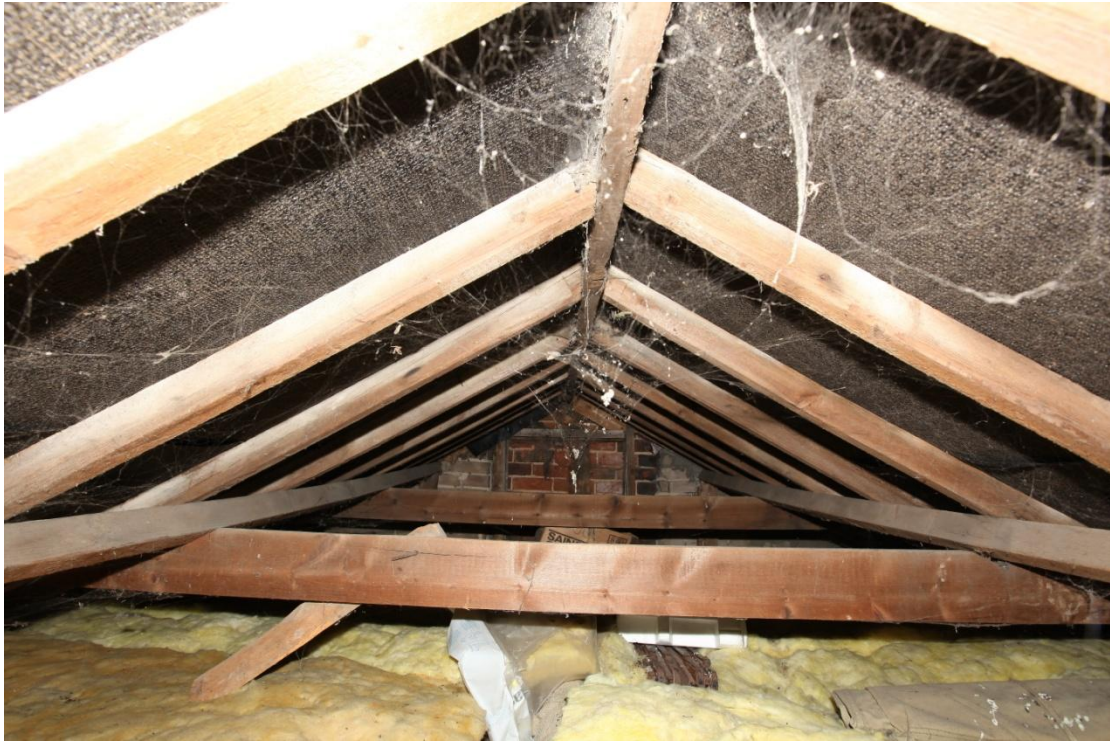
Illus. 15. The original softwood roof structure of the taller western section (2) looking towards the apparent gault-brick fabric of the western gable with the red-brick chimney in the centre. The edges of the gault brickwork appear to be broken suggesting the present chimney may be represent an alteration.

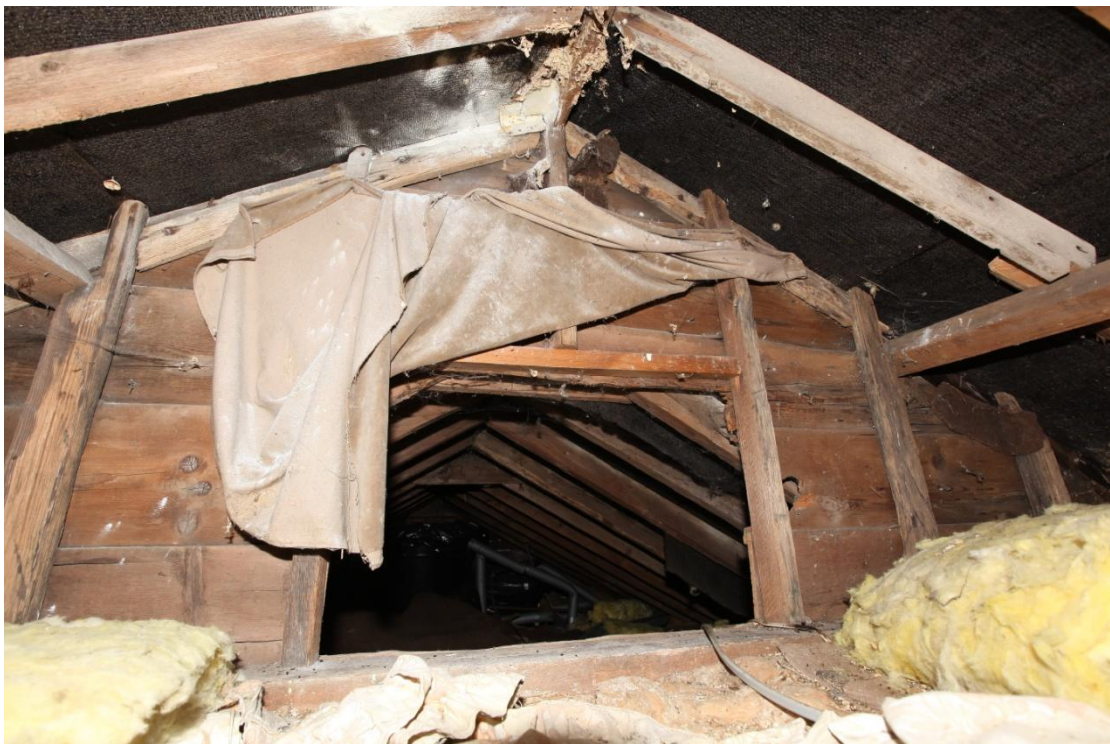
Illus. 16. The roof structure of the taller western section (2) showing the boarded studwork partition adjoining the lower section (1) to the east. The connecting aperture has been inserted by cutting the boarding. The softwood rafters of the eastern section are much the same but appear to lack purlins.
