# Jankes Barn

Jankes Green, Wakes Colne

Building Record (Planning Condition 7)

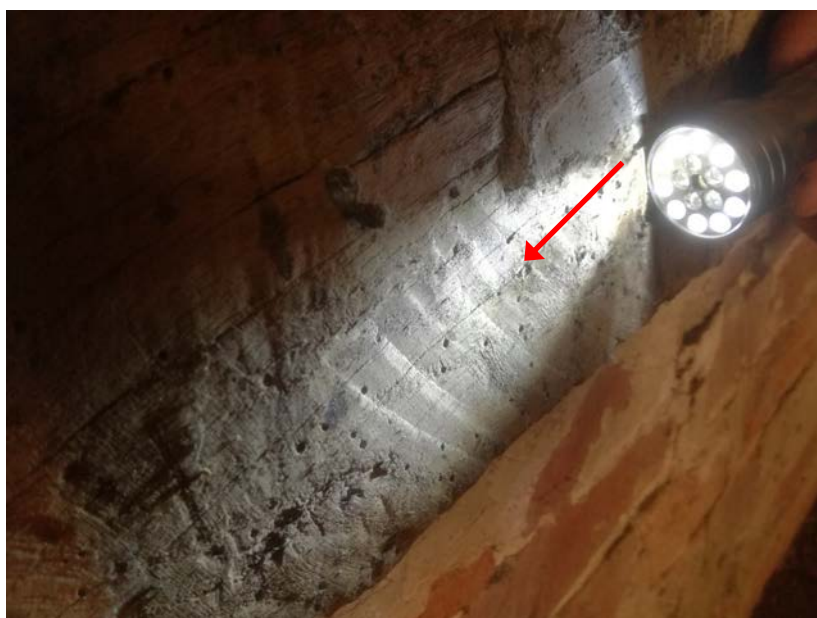
**Fig 8:**

Jankes barn; showing some horizontal marks on one of the timber studs. Very close together marks such as these are most commonly caused from use of a modern planer/thicknesser machine which shapes timber to the required section-size using a rotating cylindrical blade

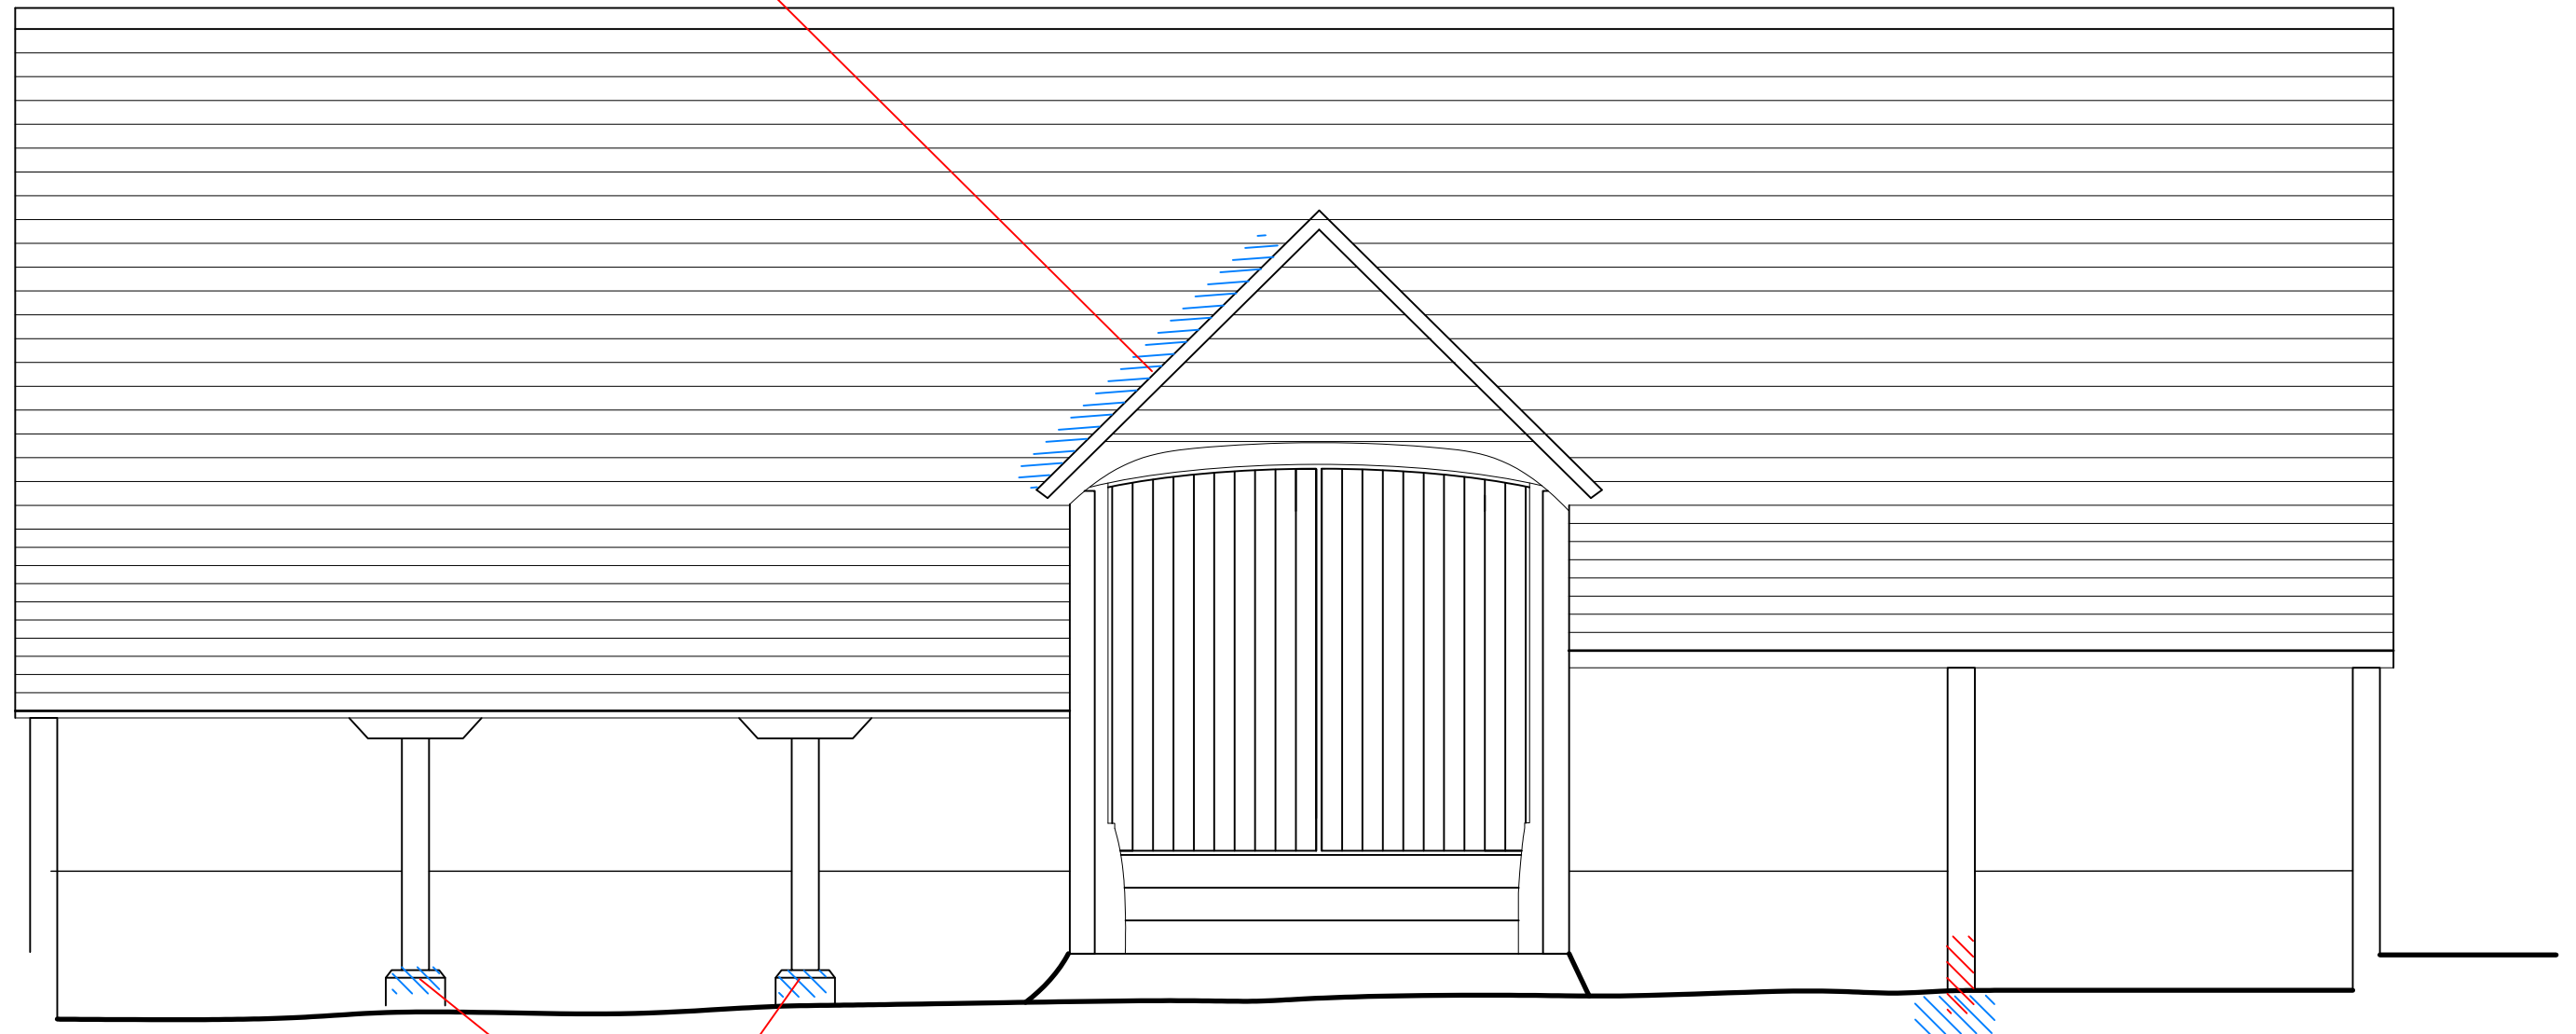
Post feet embedded in  
masonry plinths

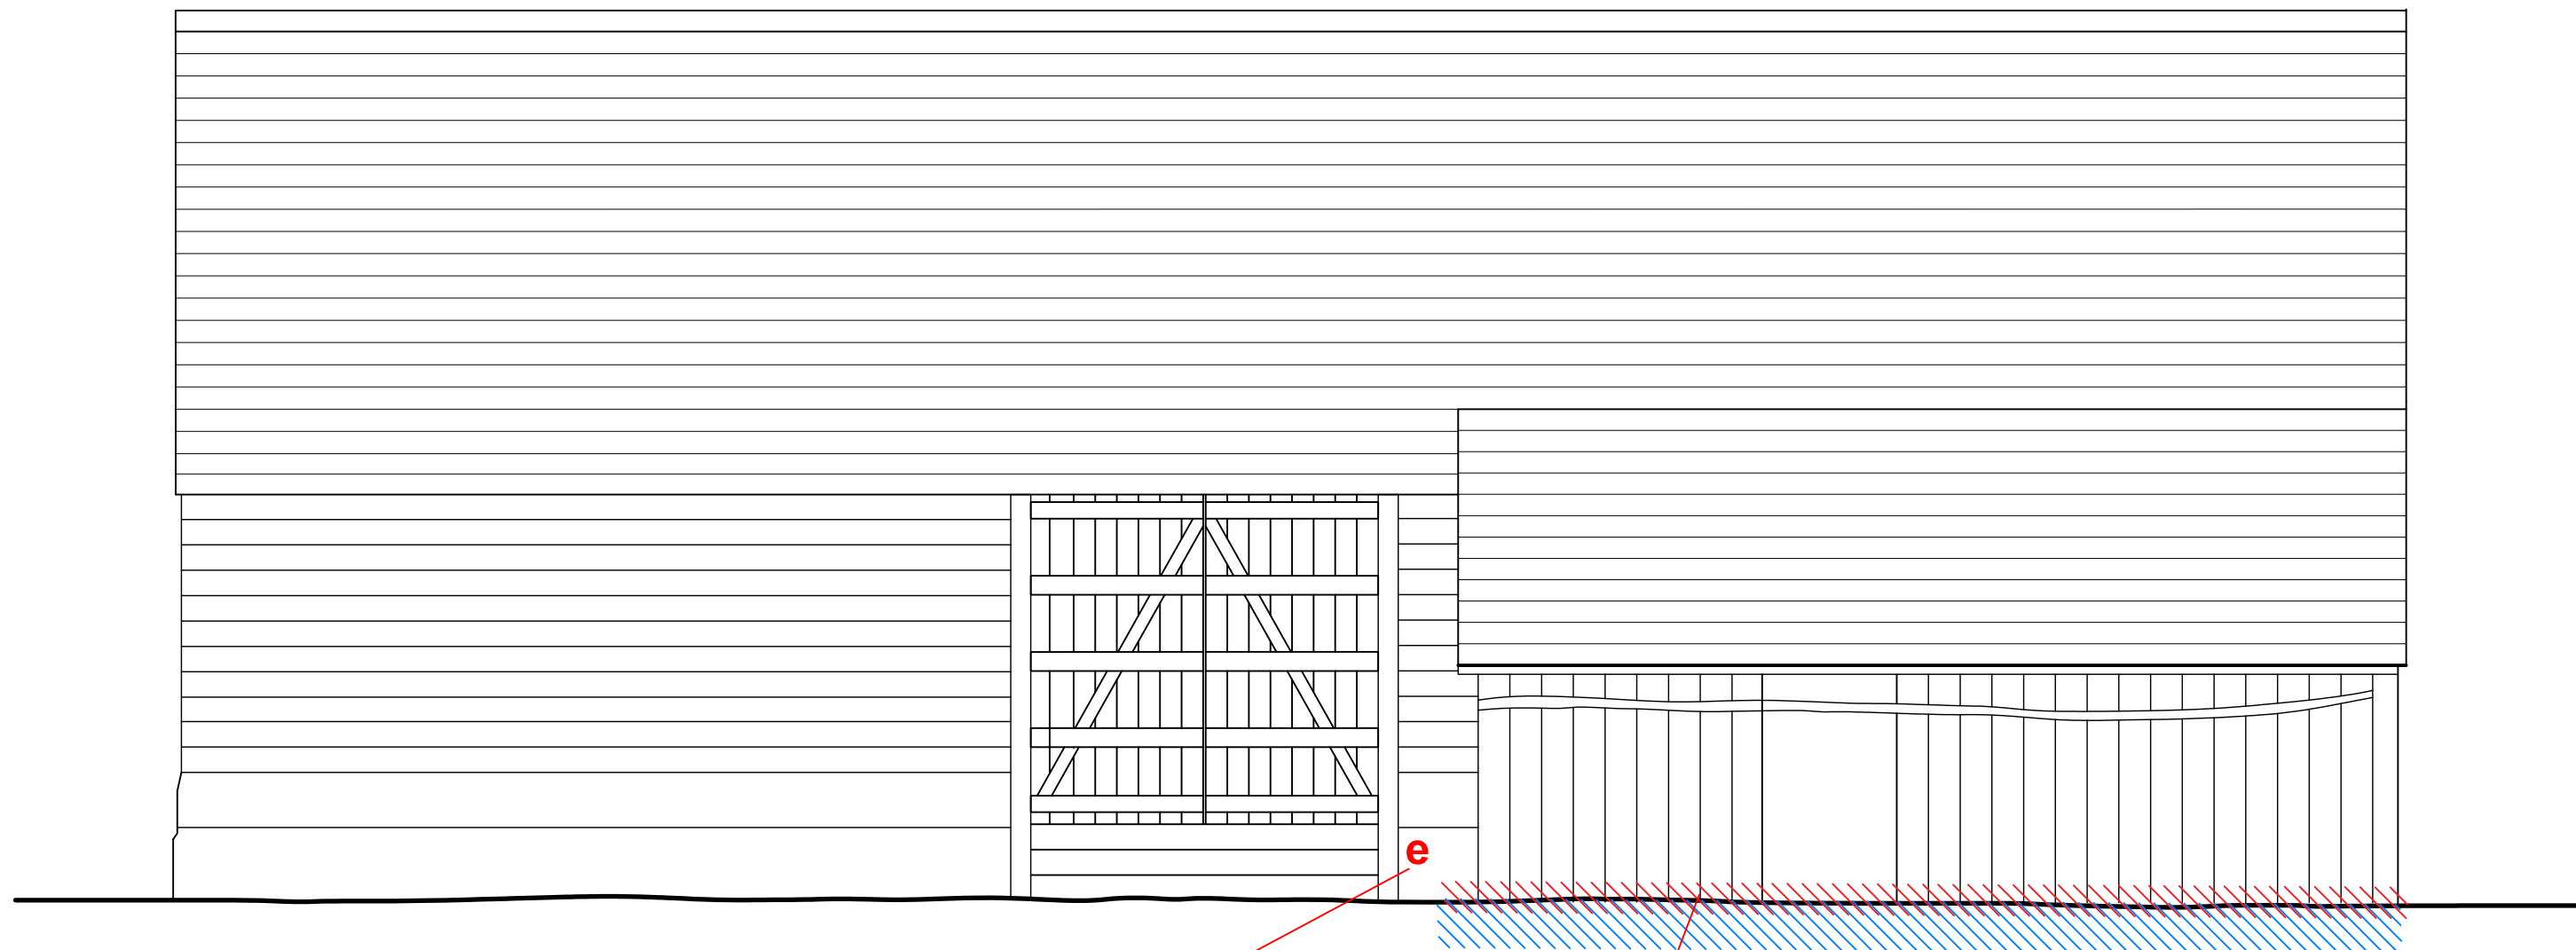
Masonry wall has settled substantially to the south. Structural Engineer to comment

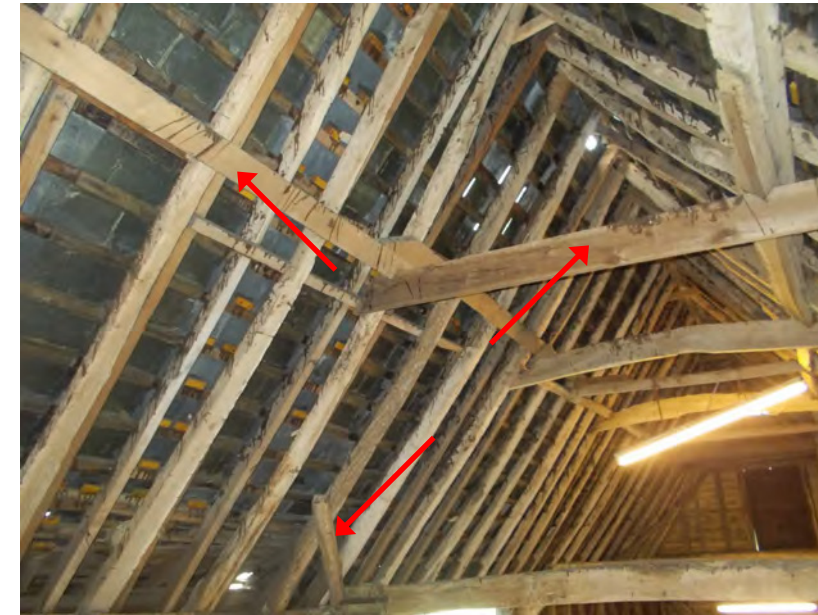
**Fig 7:**

Roof; looking west showing non-historic elm purlins along the south pitched roof supported by a non-historic softwood collar. Note also diagonal brace has broken away near its point of genesis

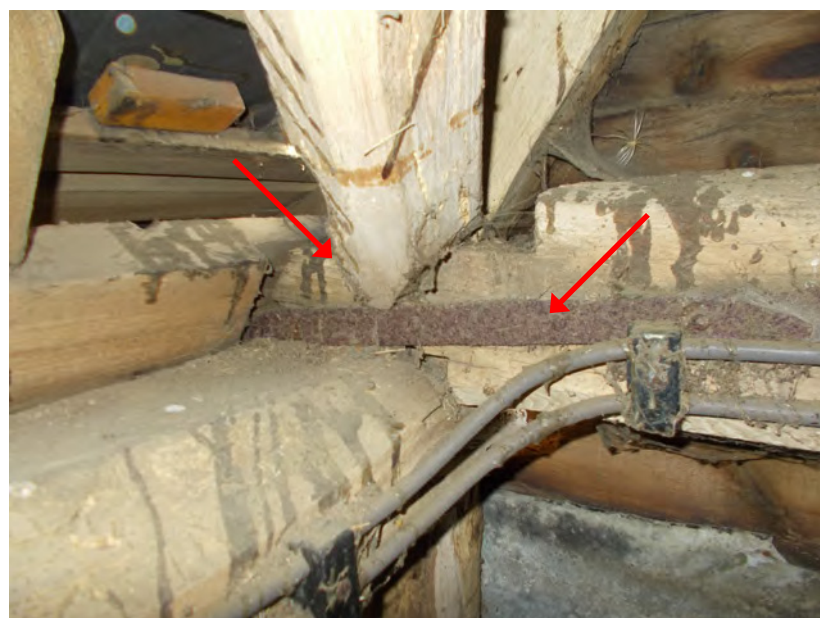
**Fig 10:**

Roof; showing north-east corner. Note how the diagonal wind brace meets the tie beam which in turn is supported by the rafter wall plate and main post. Also note the historic metal strapping. It is unclear whether this was original to the construction of the building or as a later remedial measure

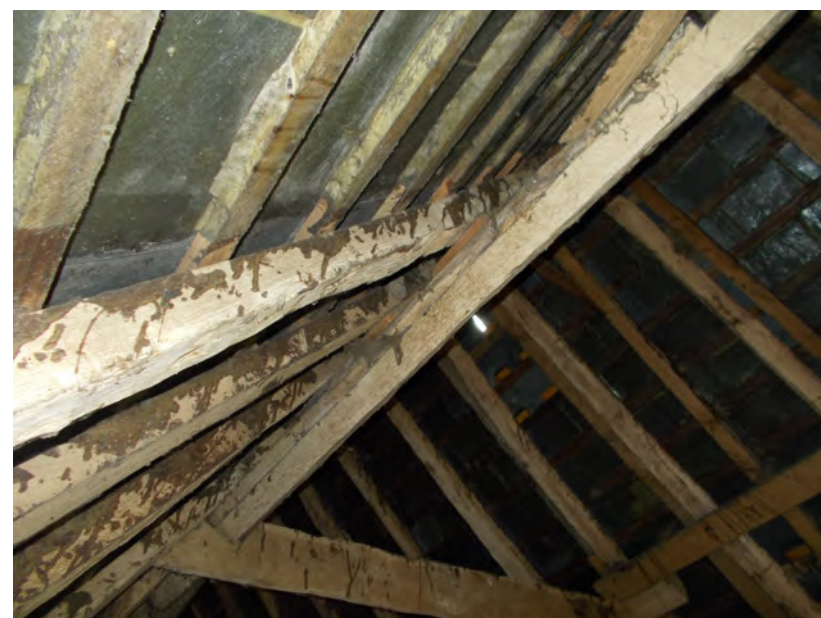
**Fig 14:**

Roof; showing roof elements that have been previously painted with what appears to be a chemical treatment. Hutton and Rostron do not advocate the use of remedial chemical treatments and care should be taken when working with timbers that have been treated, as it may be harmful to health

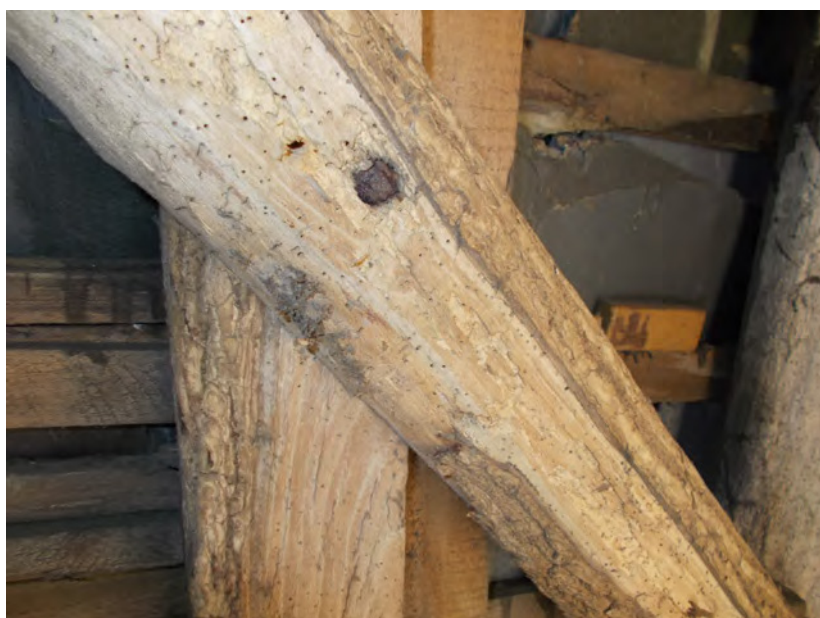
**Fig 18:**

Roof; showing broken wind brace in bay 2. Note the timber used is elm and has been extensively eaten by common furniture beetle. Activity was found to be active in this timber but not aggressively so, however still allow for this damaged timber element to be removed

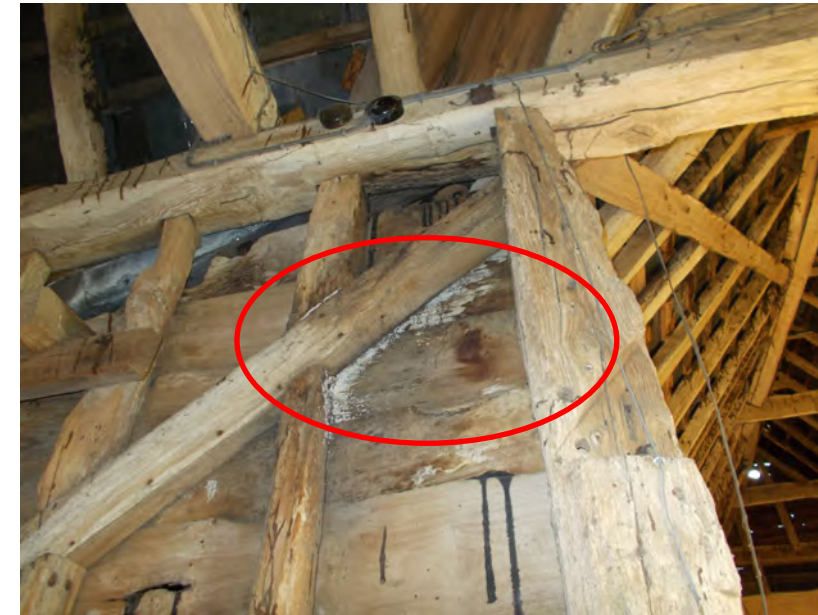
**Fig 31:**

Roof; showing south-east corner of midstrey. Note the active wet rot decay to the historic clapboards in this location as a result of defective flashing details

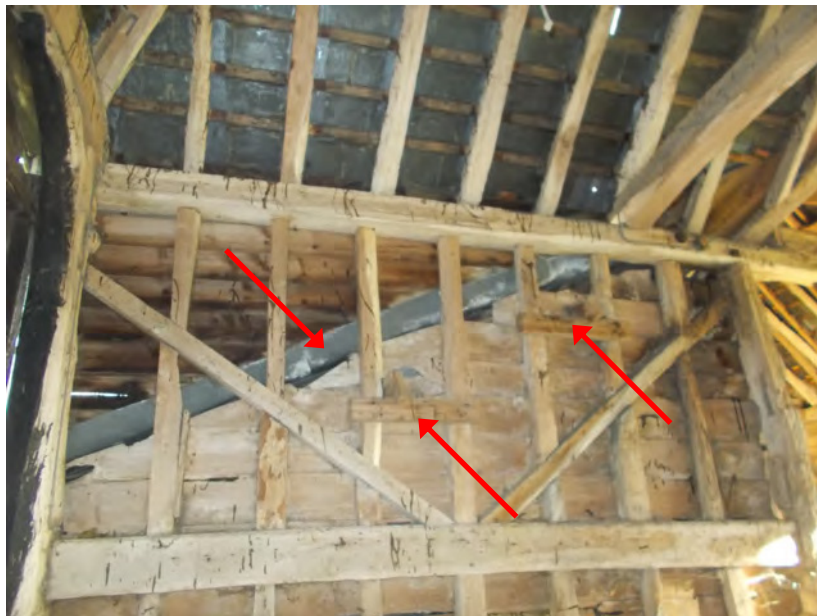
**Fig 30:**

Roof; showing east wall of midstrey. Note how the pitch and flashing of the cat slide are evident from this position. Also note how purlins project through into midstrey structure and are supported on short horizontal timbers

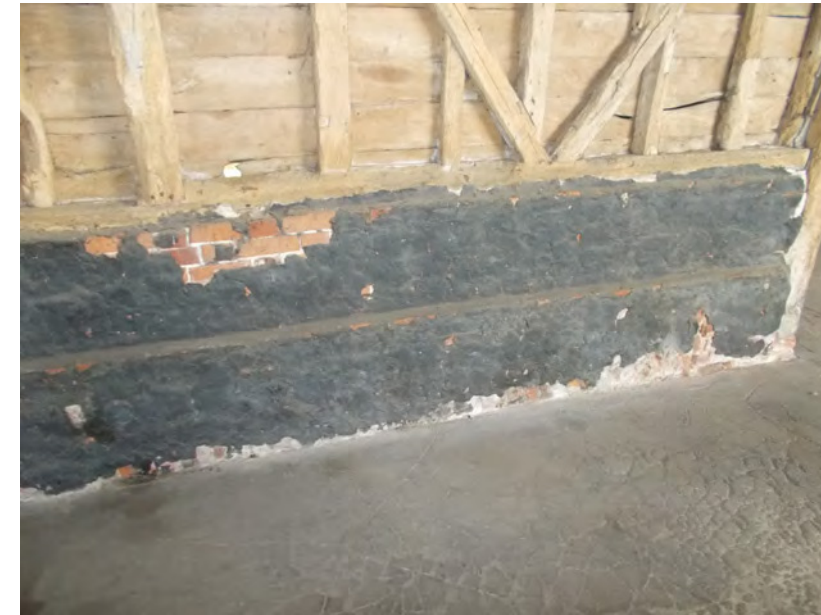
**Fig 35:**

Timber frame; showing brick plinth wall coated in what appeared to be a bituminous material. This may be trapping moisture against the brickwork and preventing the masonry structure from breathing leading to damp and decay issues to the brickwork

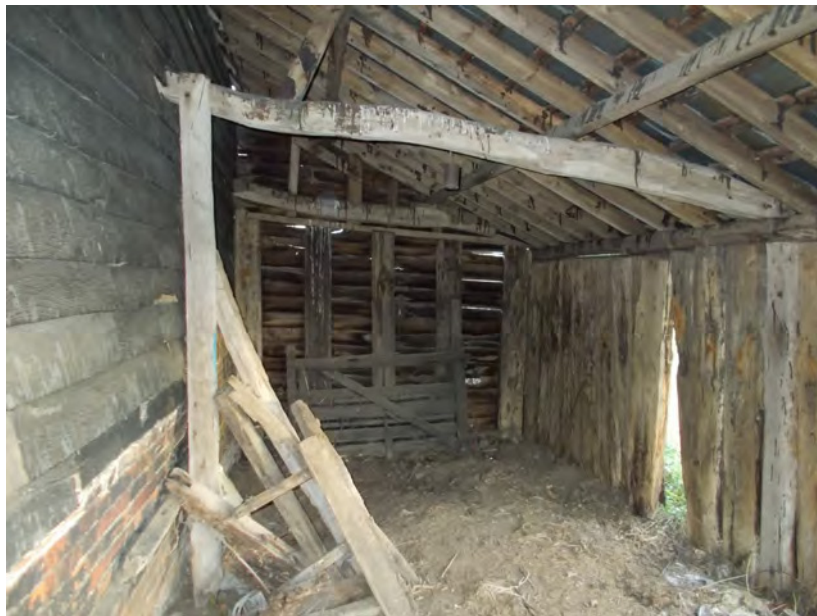
**Fig 34:**

Roof; showing catslide 3's roof structure. Note the half-tie has additional support from an upright member whereas the catslides to the north elevation do not. Also note the majority of the roof structure (apart from half-tie) is of softwood

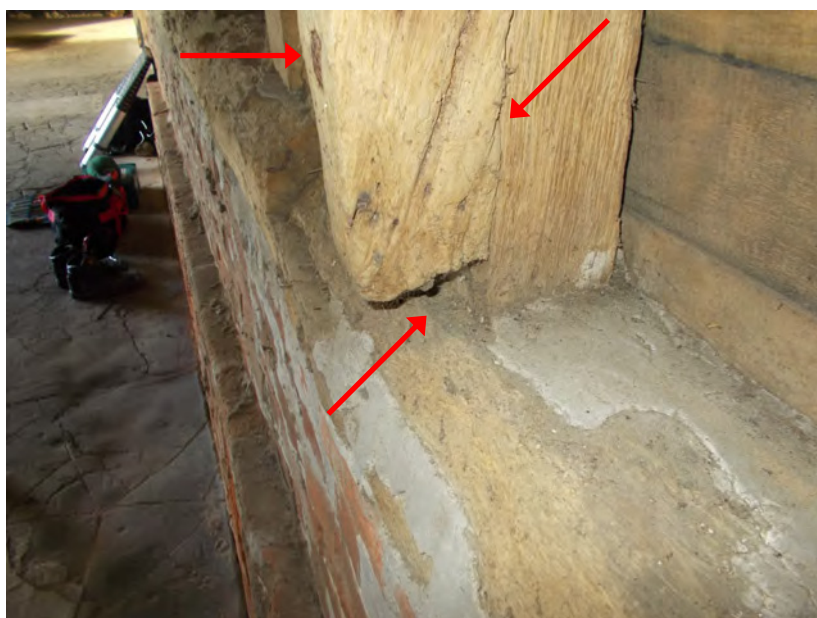
**Fig 38:**

Timber frame; showing north end of truss main post foot. Note how the main post foot has had a new element scarfed into it for 50 per cent of its section and bolted together. Also note how the newer scarfed-in section is now taking the entire bearing weight of the main post. Provisionally allow for a patch to be placed under the front historic post foot to share the weight with the rear patch. Structural engineer to comment

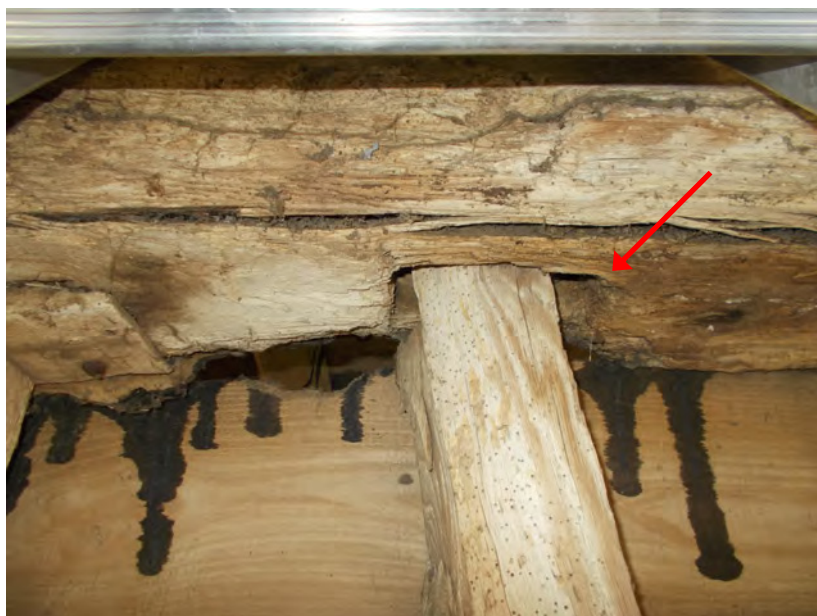
**Fig 42:**

Timber frame; showing underside of rafter plate with heart wood shakes in timber surface. These are of no structural concern. Also note stud mortice location is oversized for stud. The carpenter has also dispensed away with the usual practice of squaring off the corners (which are rounded from the hand auger) of the mortice suggesting it was always intended to be oversized and perhaps done pre-emptively
