Forge Cottage and The Forge, Church Road, Peldon, Essex CO5 7PS
Description and analysis of the House and former Forge. Recorded 16 02 2013.
Revisited 28 07 2015.

Scope of this Report.

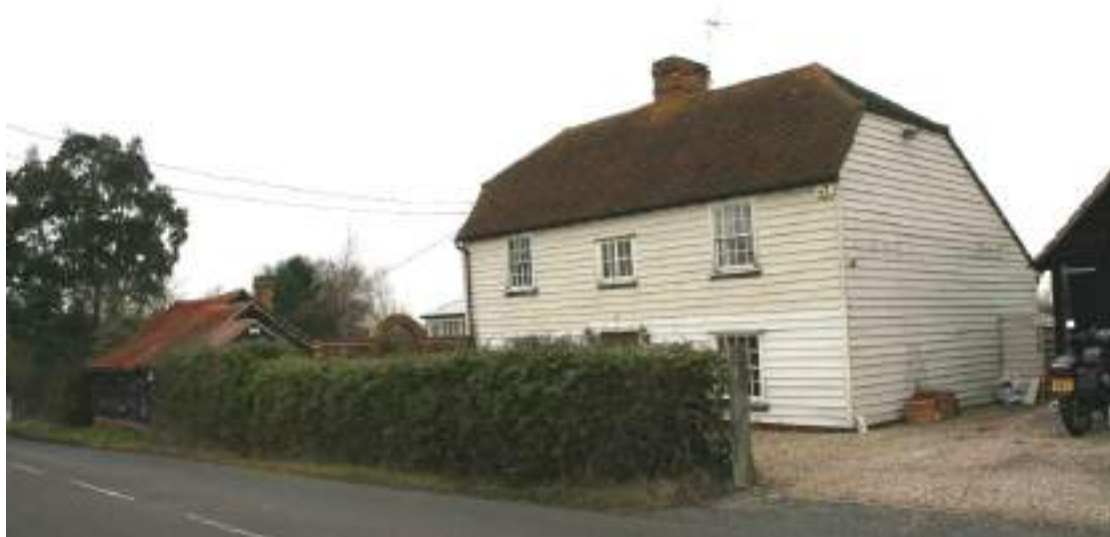
The house and cottage pictured in February 2013. Note the degraded paintwork.

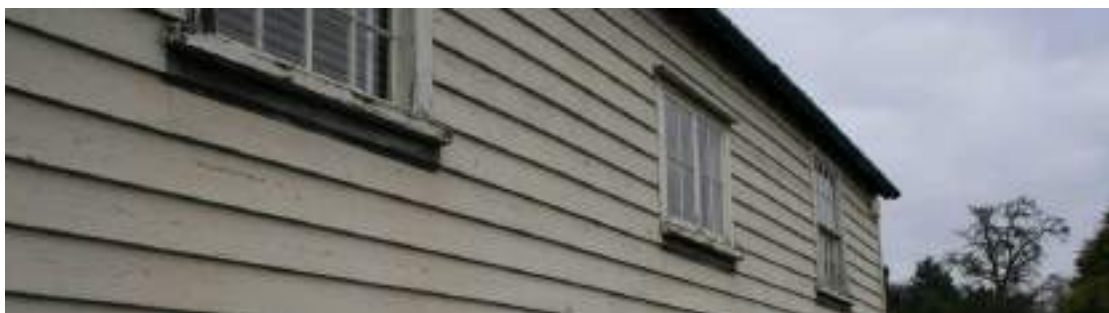
Detail of the upper range of windows. Note the rot in the cills.

The SE elevation, which is the main facade facing the road, has a complete set of replacement timber 8/8 sash windows and a modern oak front door set in a new frame. Above the front door is a pair of four light casements. The frames, especially the cills are in poor condition with visible signs of rot and must be softwood.

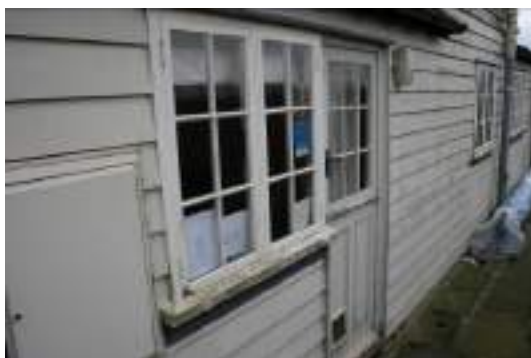
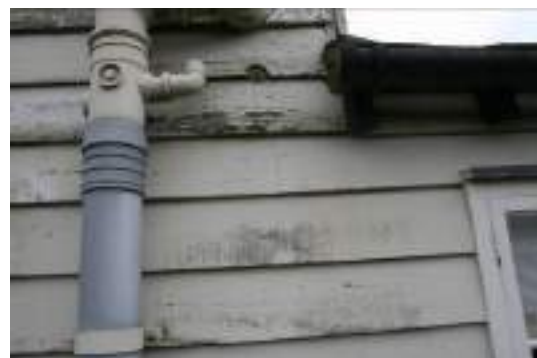
Detail of the rear windows and doors. Detail of the failing cladding.

The rear windows are timber 6 light casements and the doors is a LC20th timber door with a 9 light glazed upper section hinged independently. The walls are clad in thin section weatherboards applied in 1982 which are rotting quite significantly especially close to the grey and black plastic rainwater goods.

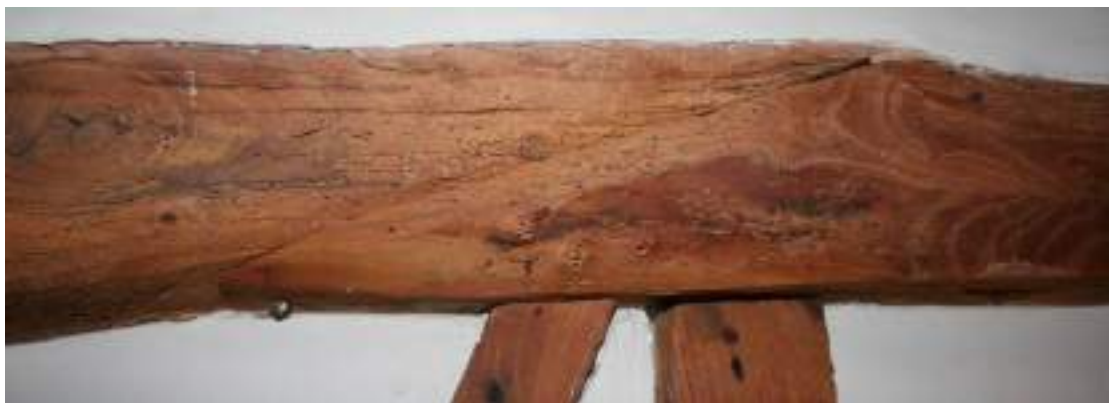
Clumsy scarf in the SW wall above the primary brace.

The work is poor quality and the studs are not pegged but clout nailed. Most of those in the Kitchen party wall are nailed into rebates. There are plain scarves in the mid-rail which must be nailed.

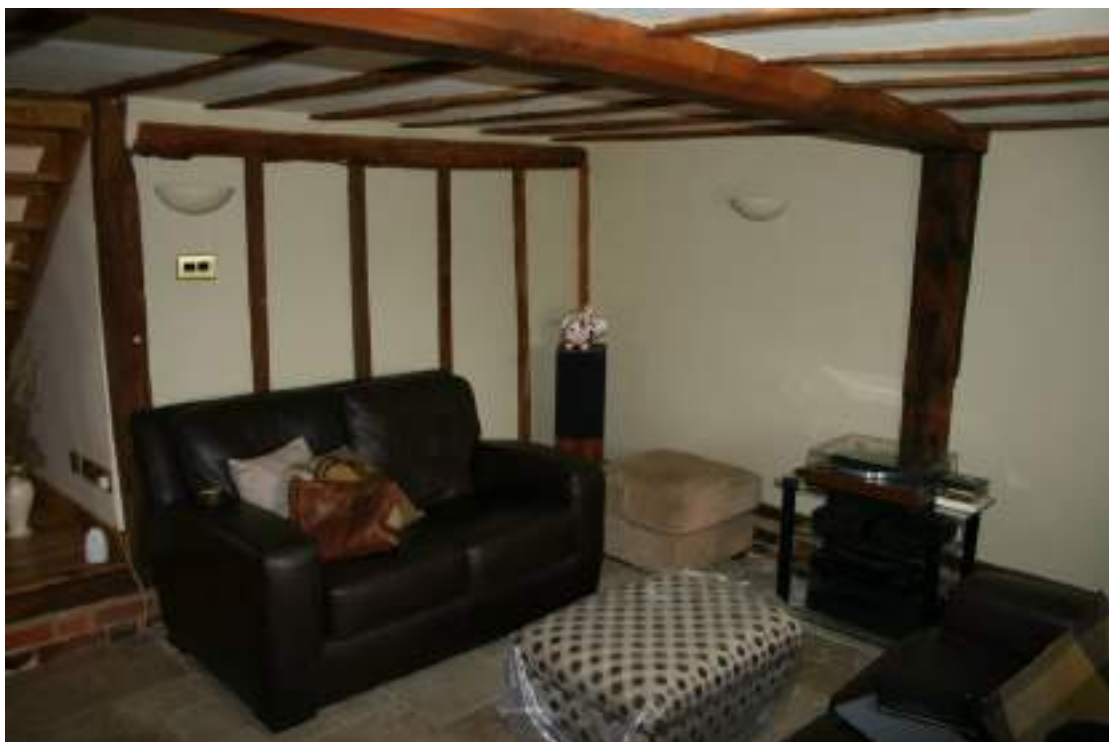
Looking N in the Dining Room. The principal post has iron reinforcing straps on both sides.

Of interest is the principal post in the NE wall. This is also visible in the bedroom above. It has very long (approx 6ft) wrought iron straps that are clout nailed using EC20th branded clouts and represents a major repair to the frame.

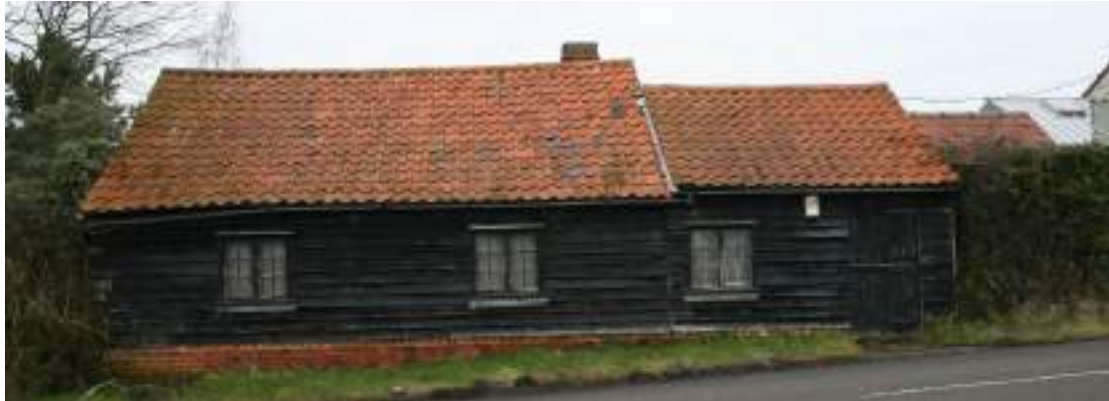
The SE elevation close to the road.

The Forge is split into two distinct builds. To the NE is small two bay single story timber-framed building clad with LC20th weather-boarding in poor condition, fastened with galvanised nails. Where it has failed it can be seen that the scantling frame has been first clad with plywood sheeting.

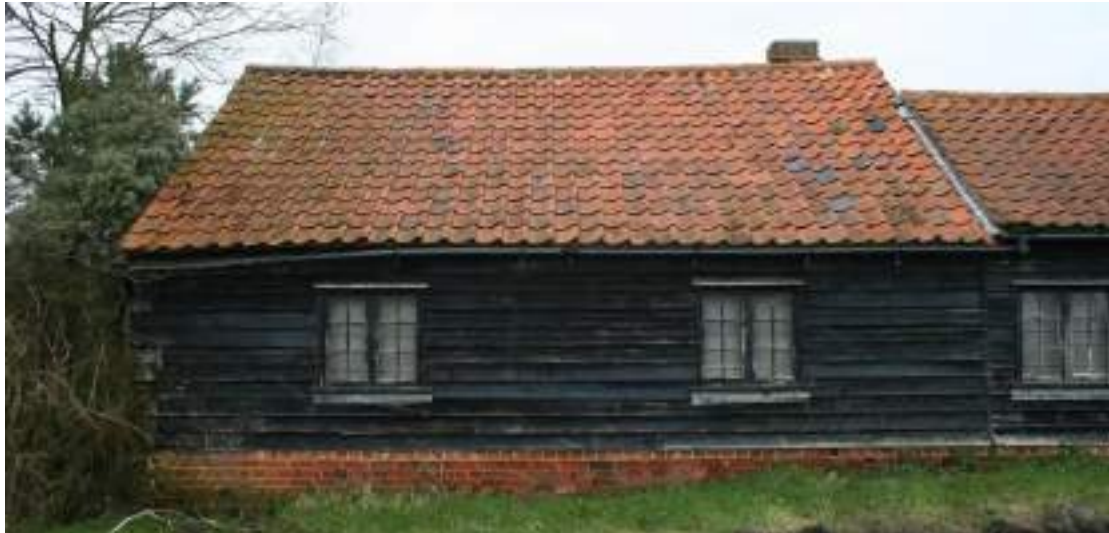
The larger unit is the later of the two builds.

The larger unit, known as the Wheelwright's Shop is of similar appearance to the Forge and has been reclad with 9mm plywood and poor quality LC20th weather-boards fixed with galvanised French nails. The plinth, although rebuilt retains some earlier 65x110x225mm red brick in lime mortar.

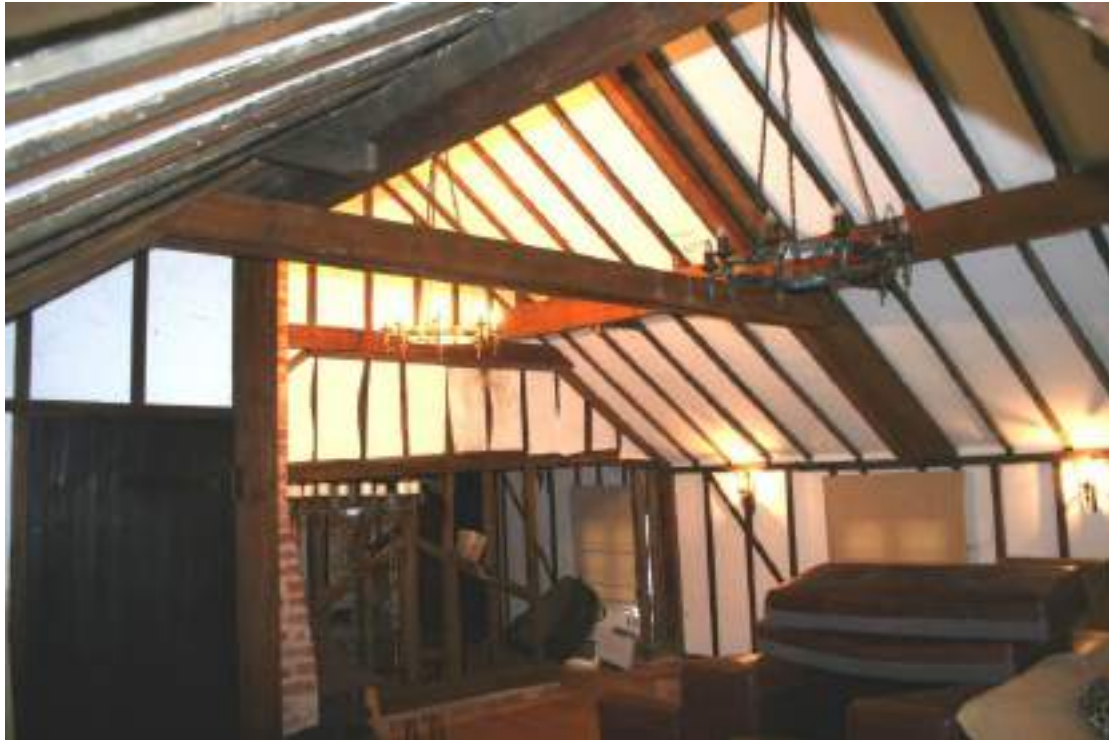
The roof has been completely remodelled.

The roof of the Wheelwright's Shop has been completely remodelled whilst retaining the original 2x4in machine softwood rafters. The original collars have been cut and new, longer collar pairs introduced with new principal rafters to clasp new side purlins whilst retaining the older members. Both the walls and the ceiling have been panelled with plaster boards and Rockwool insulation between the rafters which leads to a very cold room.

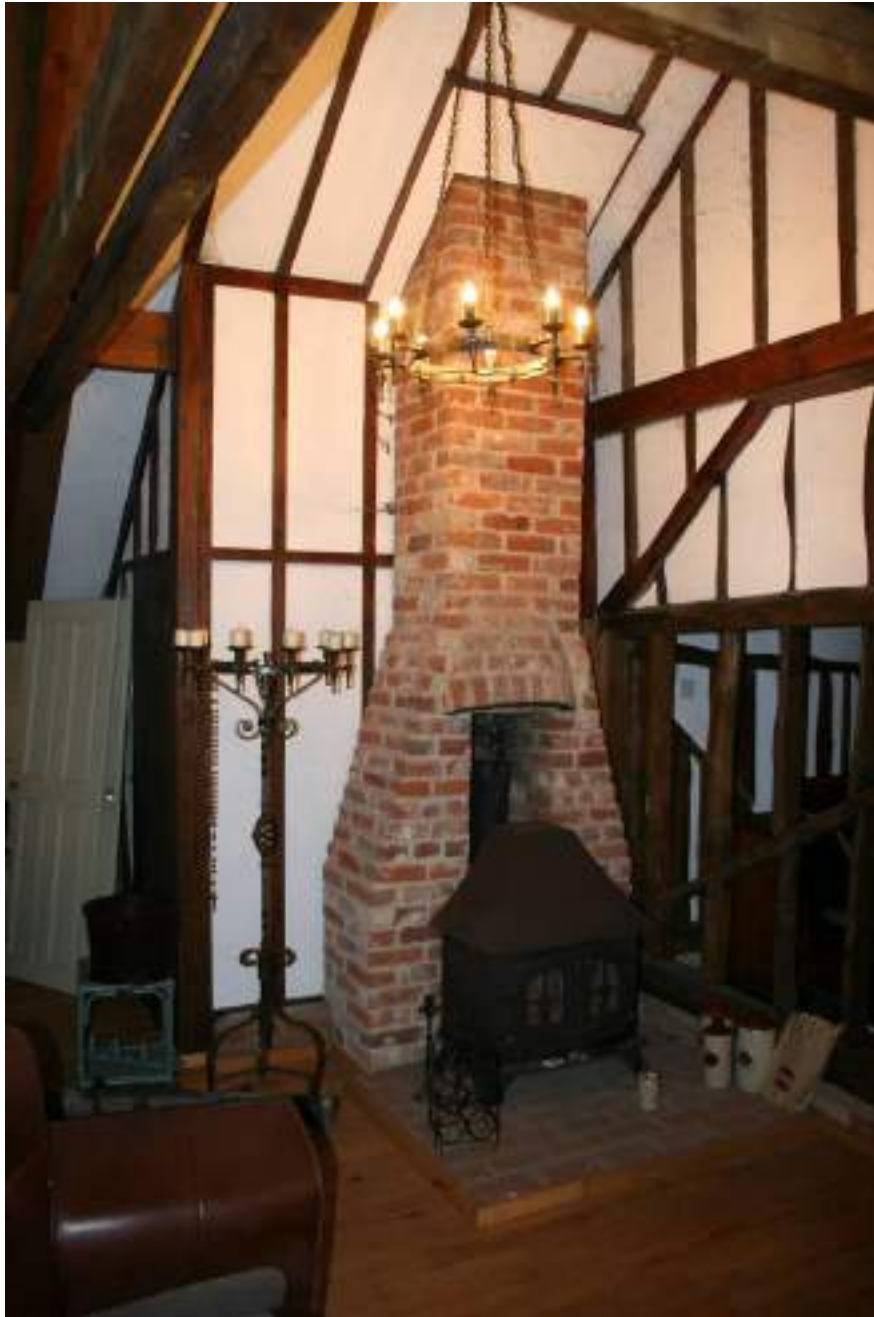
Looking N towards the Forge. The fireplace is a LC20th fake.

Installed in the Wheelwrights Shop is a tall brick firestack built in a style reminiscent of a hooded forge. Constructed of reused C19th bricks it is bonded with grey cement and lined with a steel flue for a modern multi-fuel burner. The chimney flue has a very long crack running up it probably due to excess heat from the burner. LC20th.

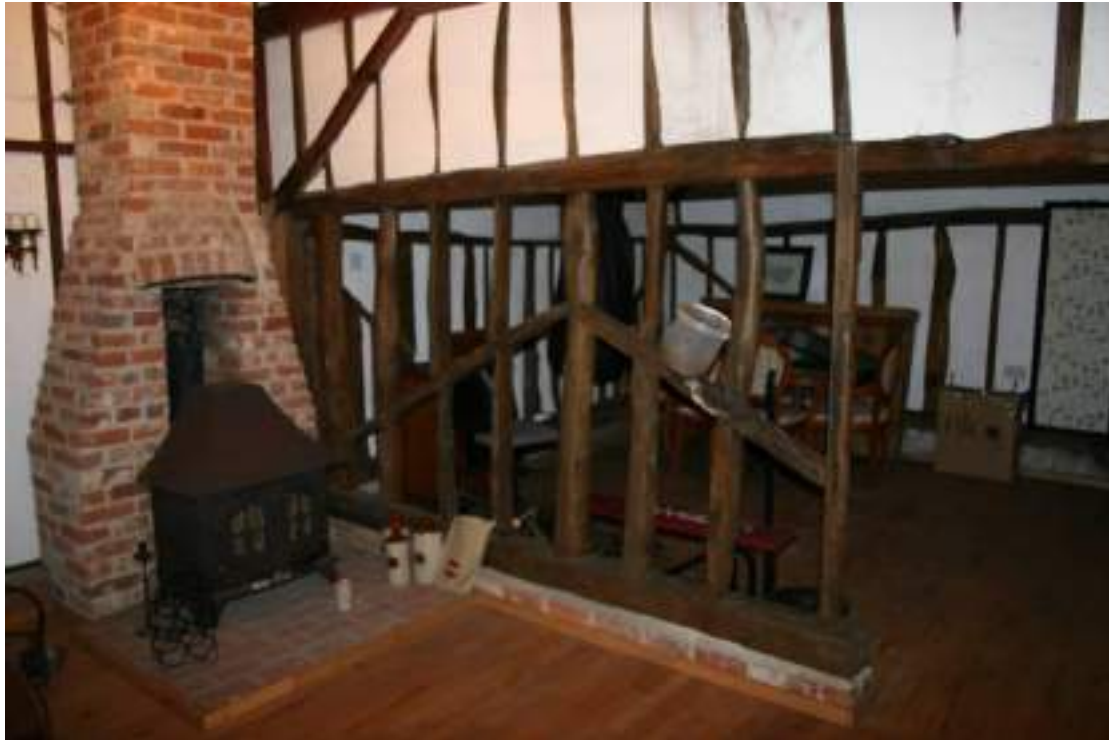
The timber-frame of the Forge. The studs have been truncated and raised on a plinth.

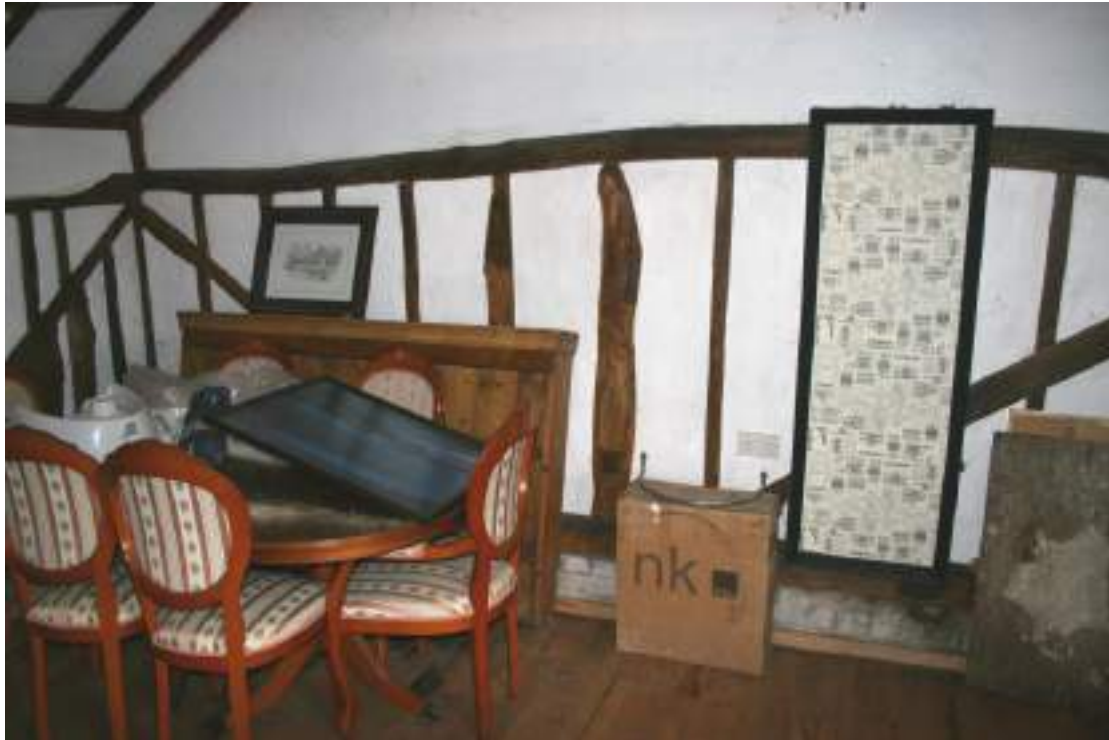
The NE wall. The section by the cabinet is a C20th rebuild.

The NE wall appears largely rebuilt with several machined 2x4in studs in place of the more 'rustic' studs whose form is exaggerated by the LC20th plastering. There is also a bandsawn diagonal brace and there may have been a doorway here.
