BRIDGEWICK HALL

PHOTOGRAPHS SUPPORTING PLANNING AND LISTED BUILDING  
APPLICATION

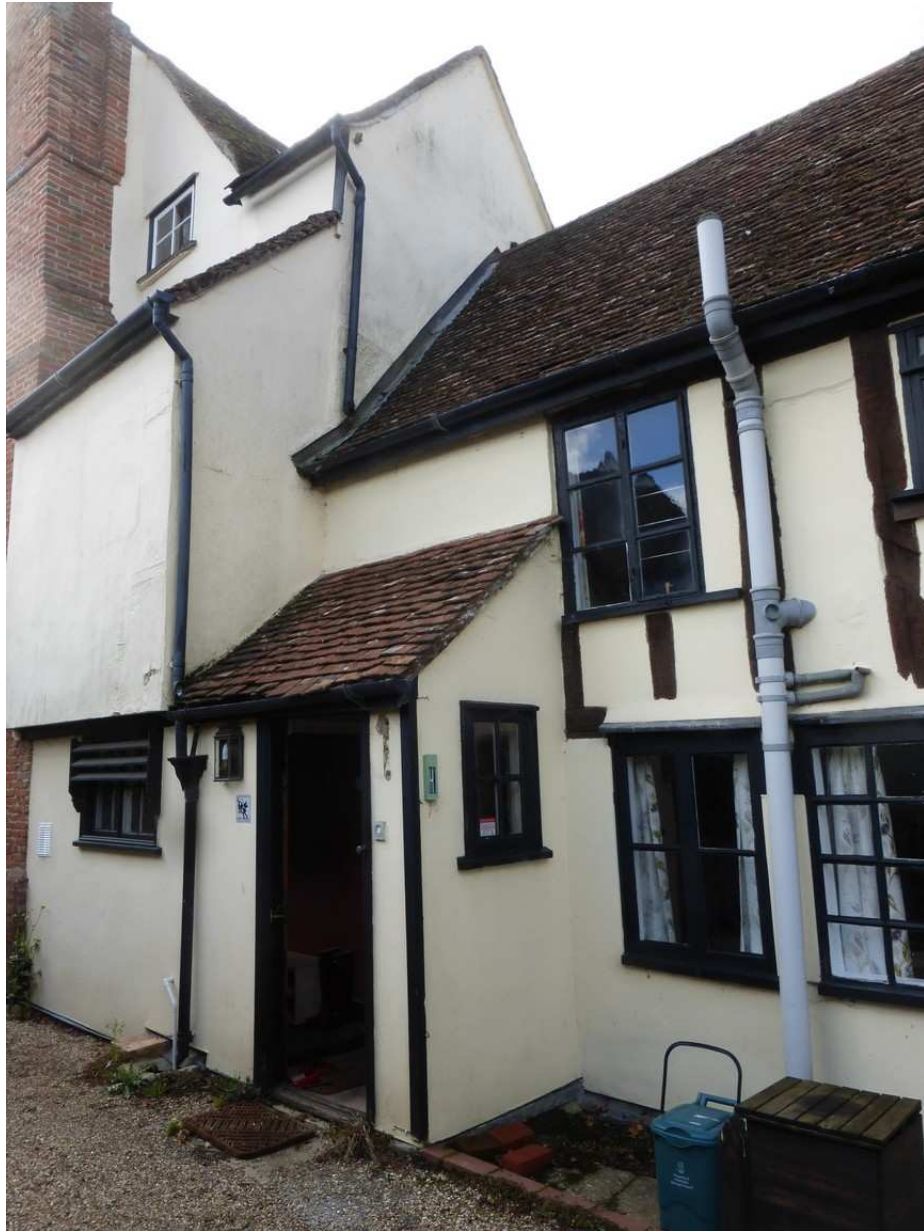
View of the side door arrangement.  
The soil and vent pipe and wastes are to be removed.

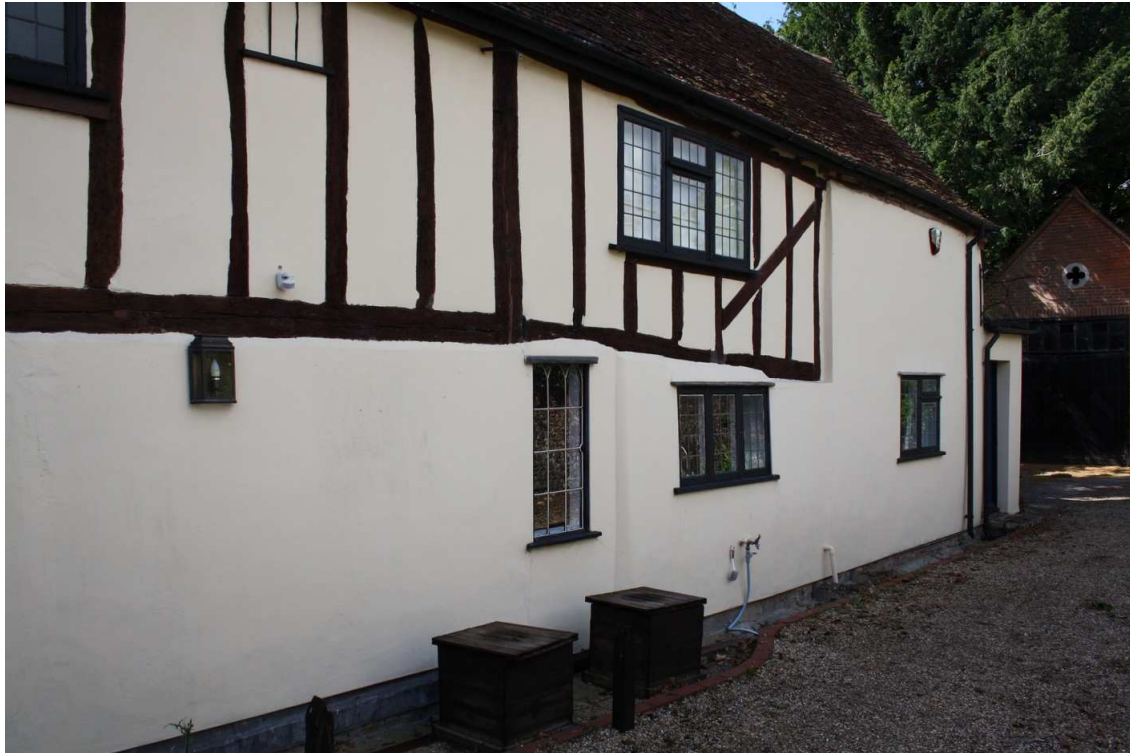
The east side showing windows for replacement.  
The gothic headed iron window is to remain.

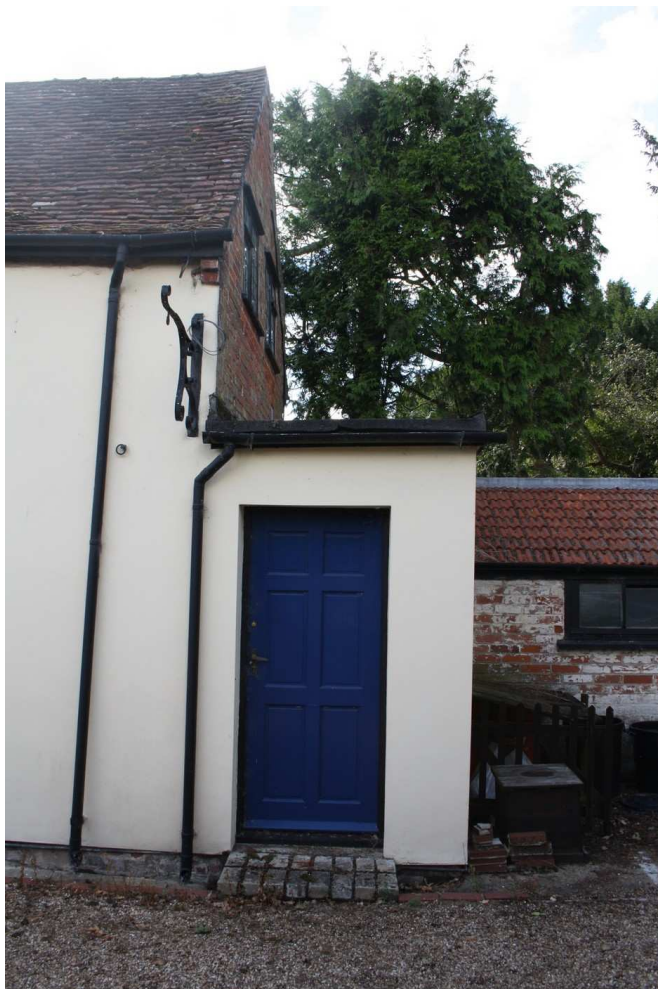
The internally blocked off  
external door to the new Boots is  
to become a window.

The flat roof is to be pitched with  
a slate finish.

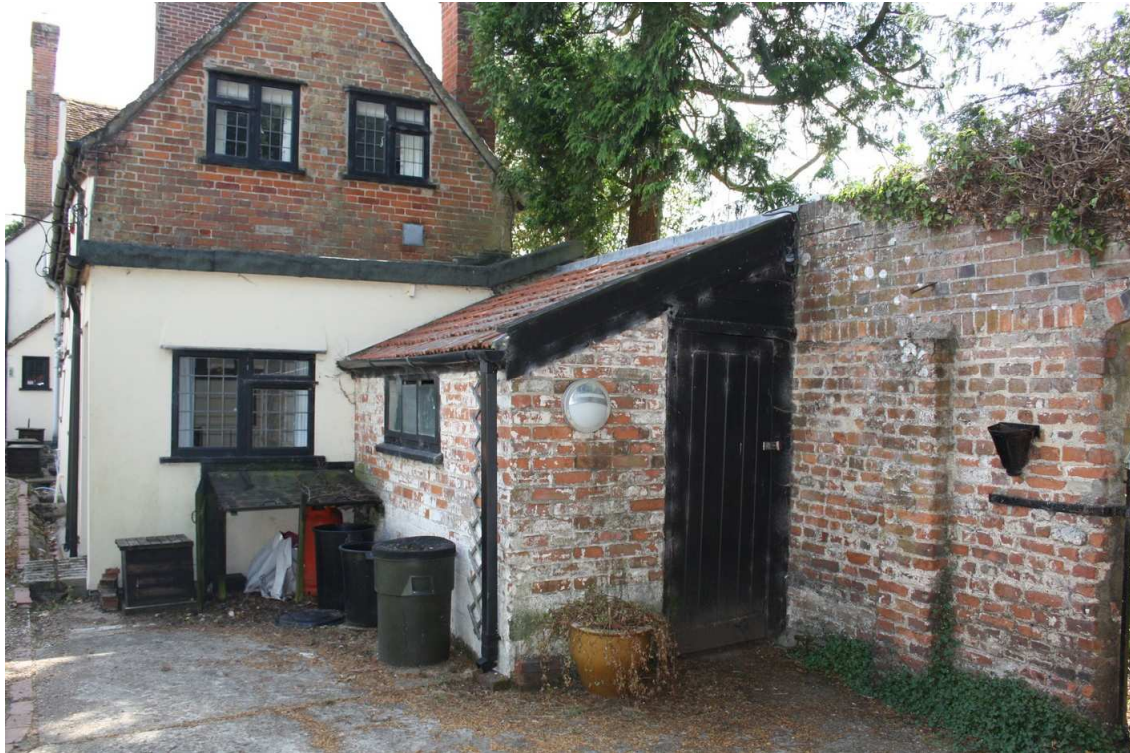
The north end. The ground floor window to be replaced with an external door, the First Floor windows are to be replaced. The shed is to be clad in vertical boards, the window replaced and the shed door is to become a window.

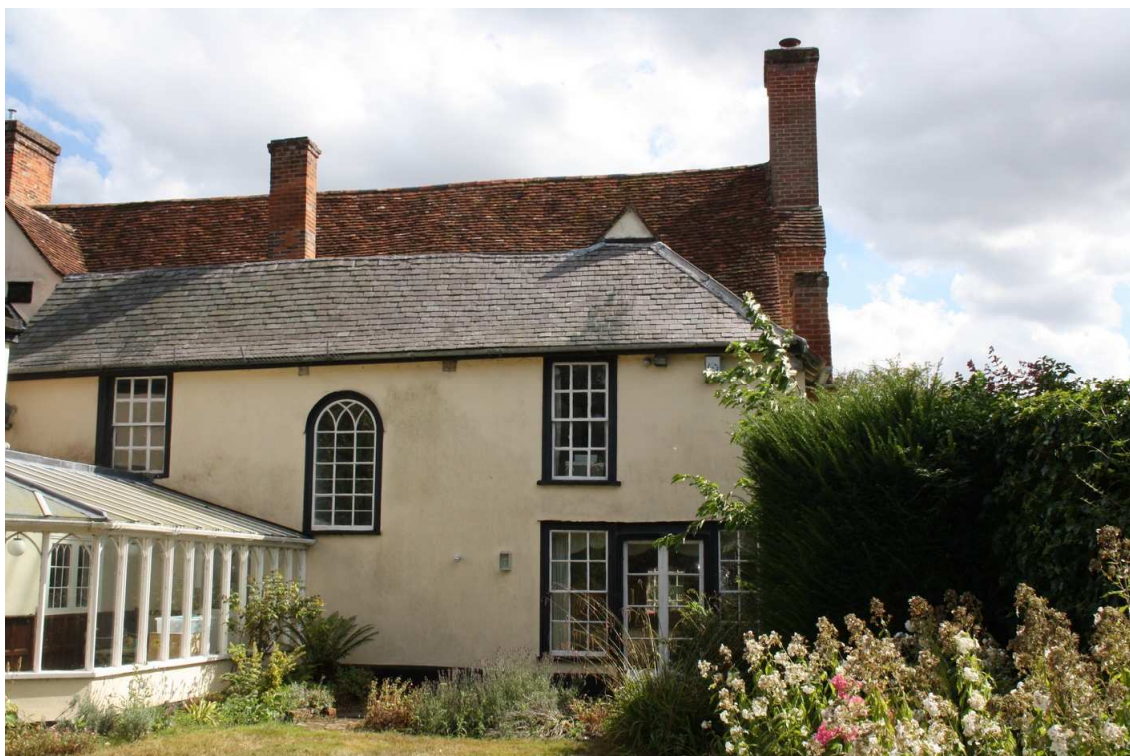
The main part of the house from the north looking south.  
The conservatory is to be demolished.

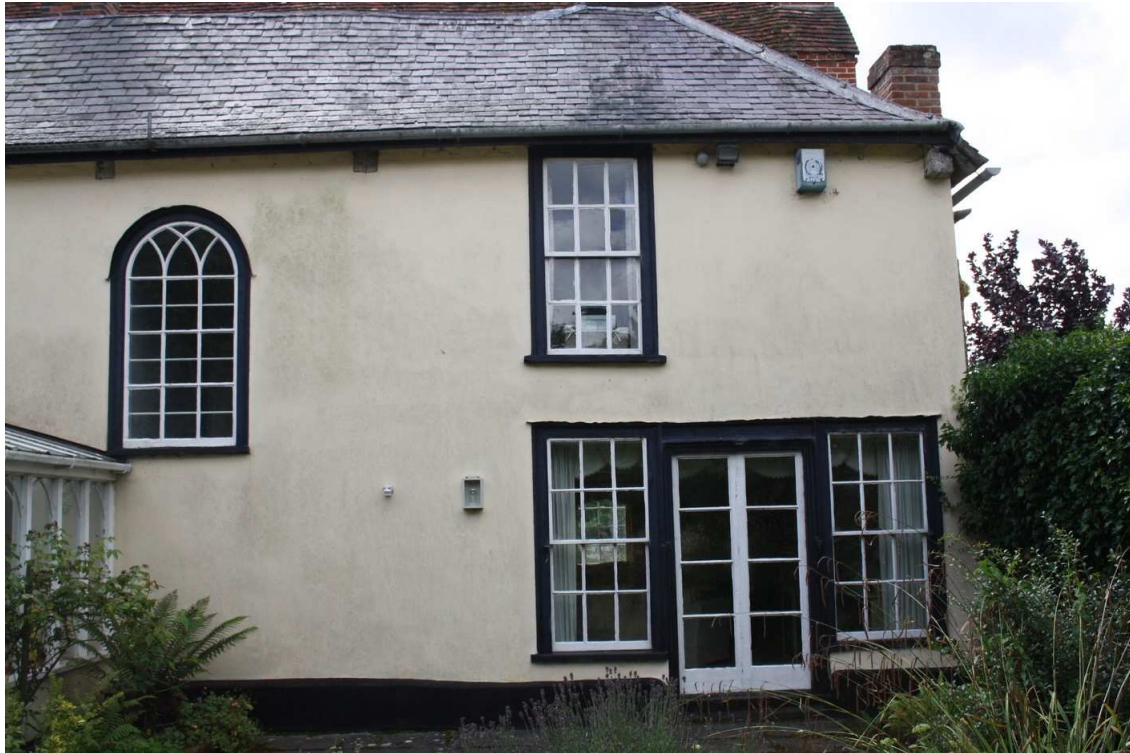
The Drawing Room French doors are to be replaced.

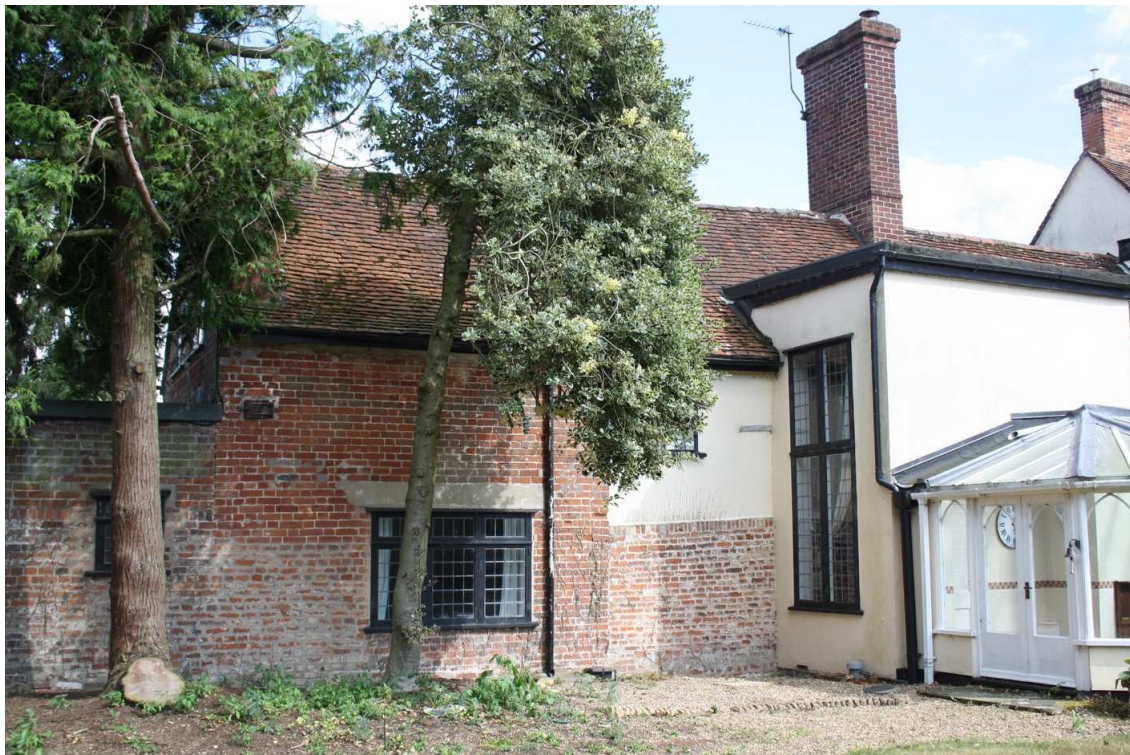
The stair tower is to be demolished

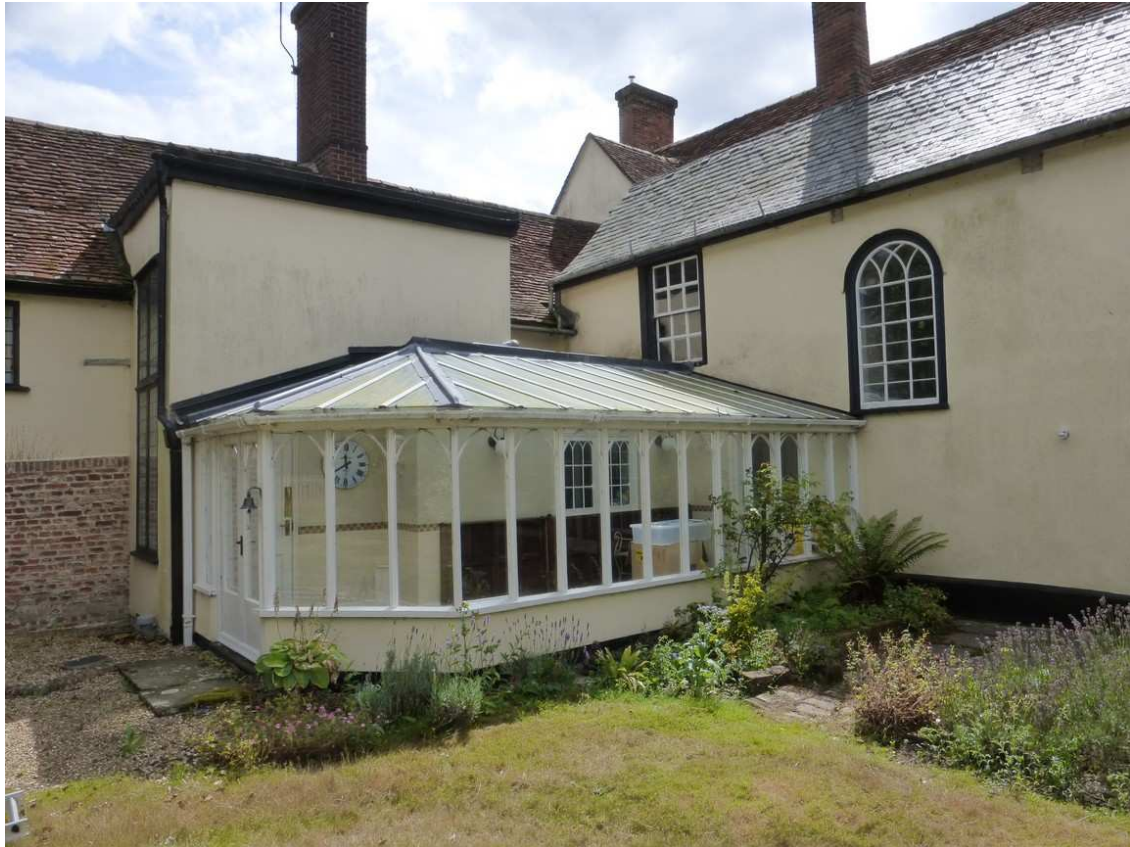
The stair tower and conservatory are to be demolished.

The two C18 windows are to be refurbished.

The Utility Room and WC, also to be demolished, are visible through the Conservatory.

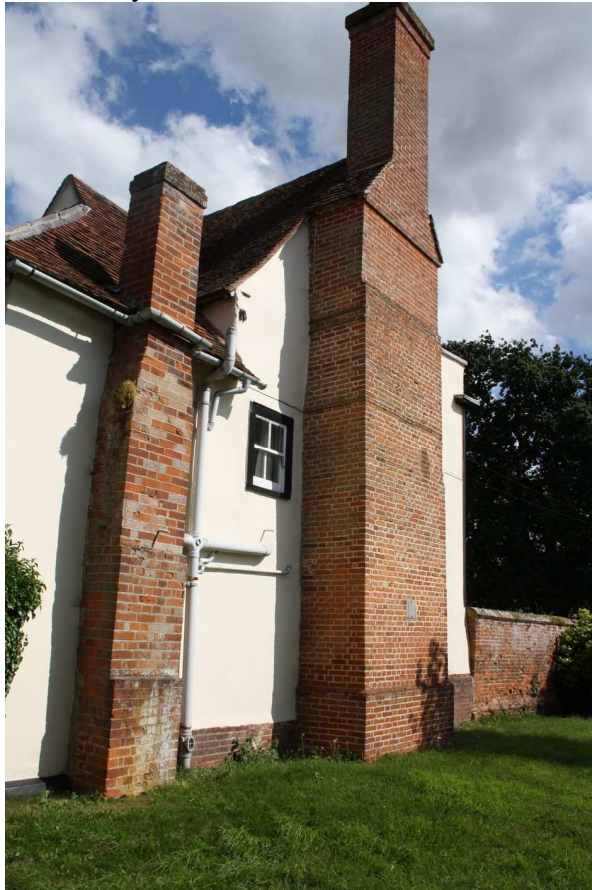
The west wall from the churchyard.

The unsightly plumbing is to be simplified.

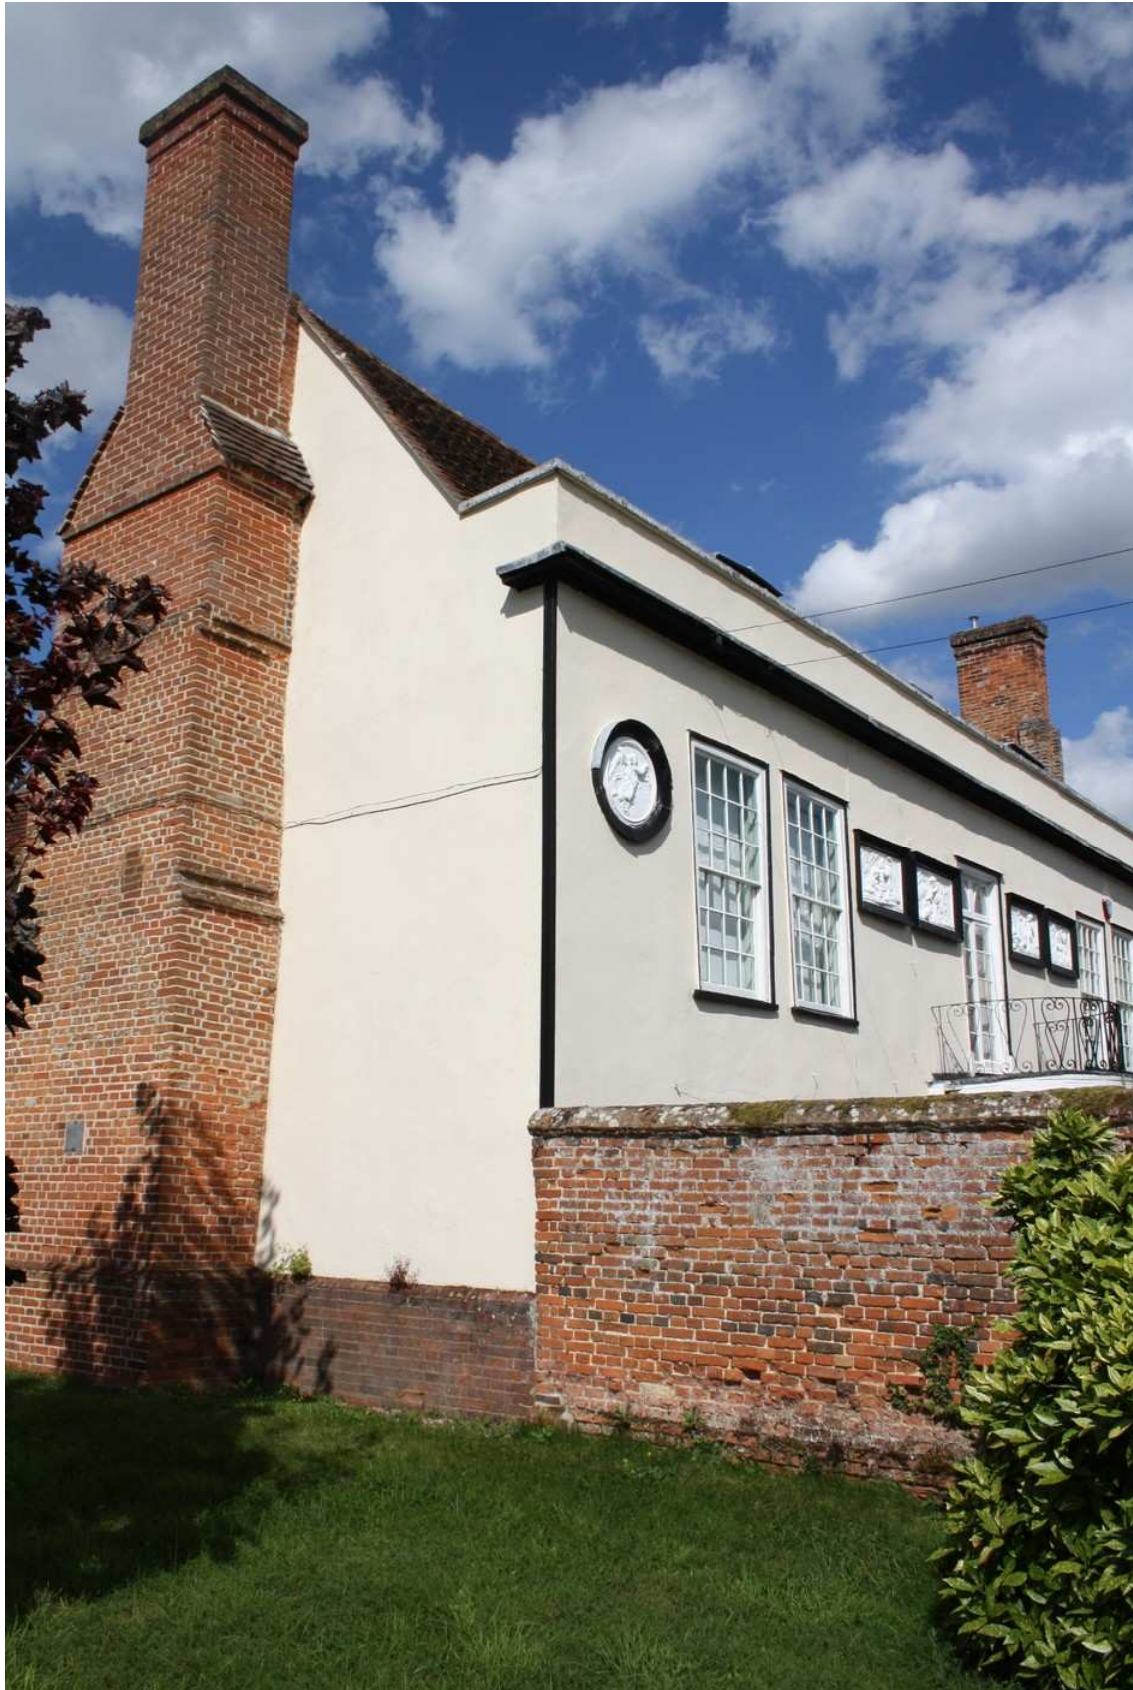
The west wall from the south west within the churchyard.  
A new rainwater pipe will take water from the parapet gutter  
and there will be a new window in the gable.

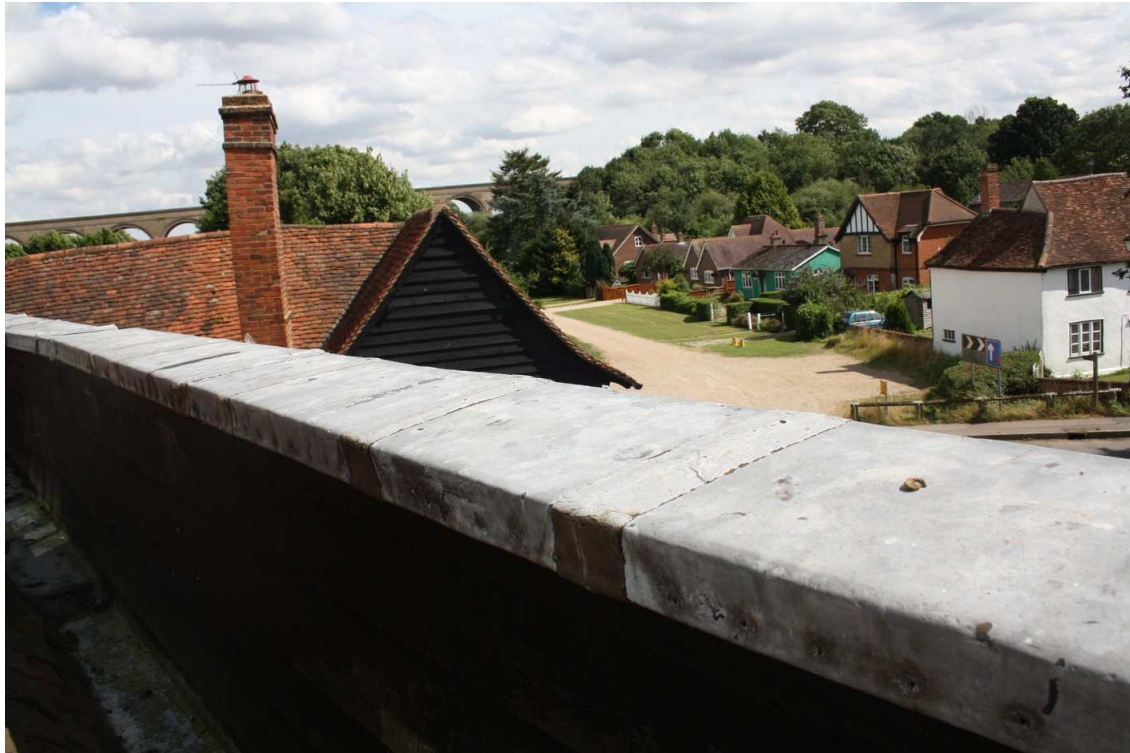
Replacement of the south parapet coping.  
The coping is heavily repaired with flashband.

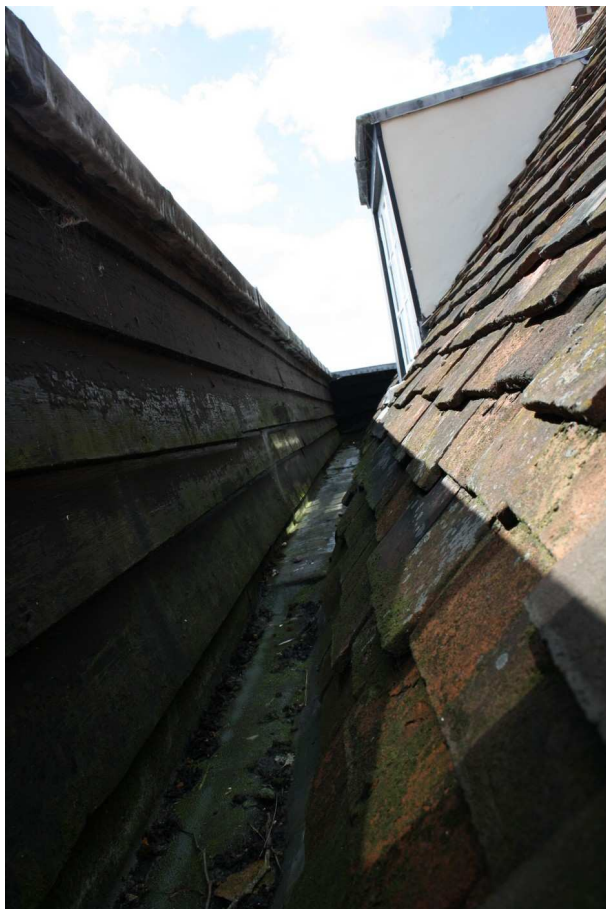
Replacement of the south frontage  
parapet gutter.

The lead panels are over-length  
with inadequately low steps.  
There are flashband repairs.

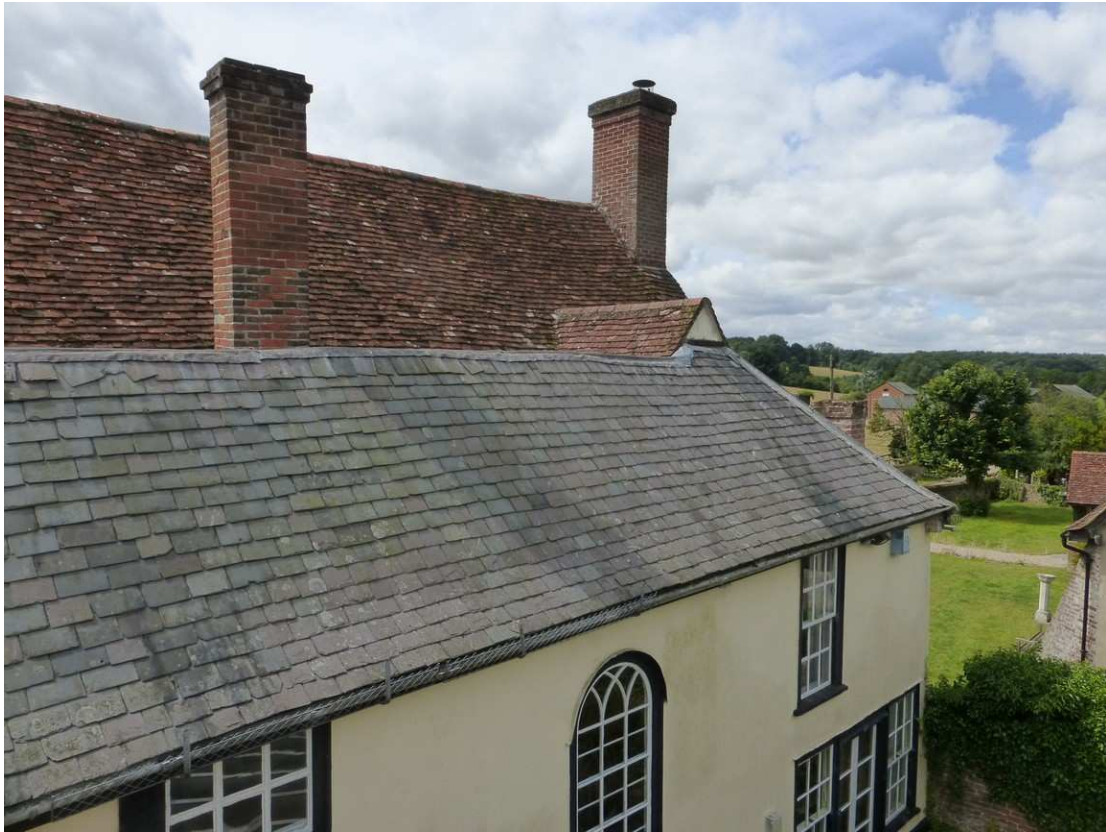
The slate roof and lead ridge are in a very poor condition at the north roof pitch

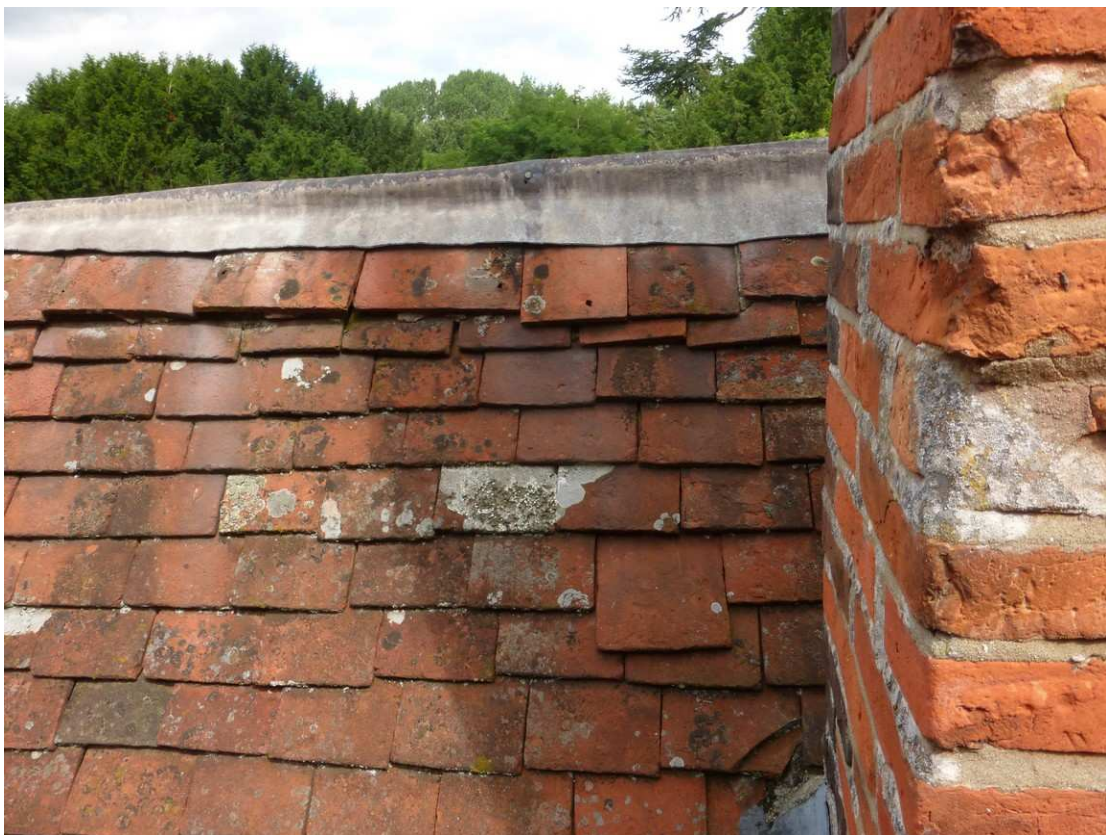
#### Re-roofing

Tiling and lead ridge at the south pitch of the north roof at the internal valley gutter.  
The pitch on the other side of the ridge is slated.

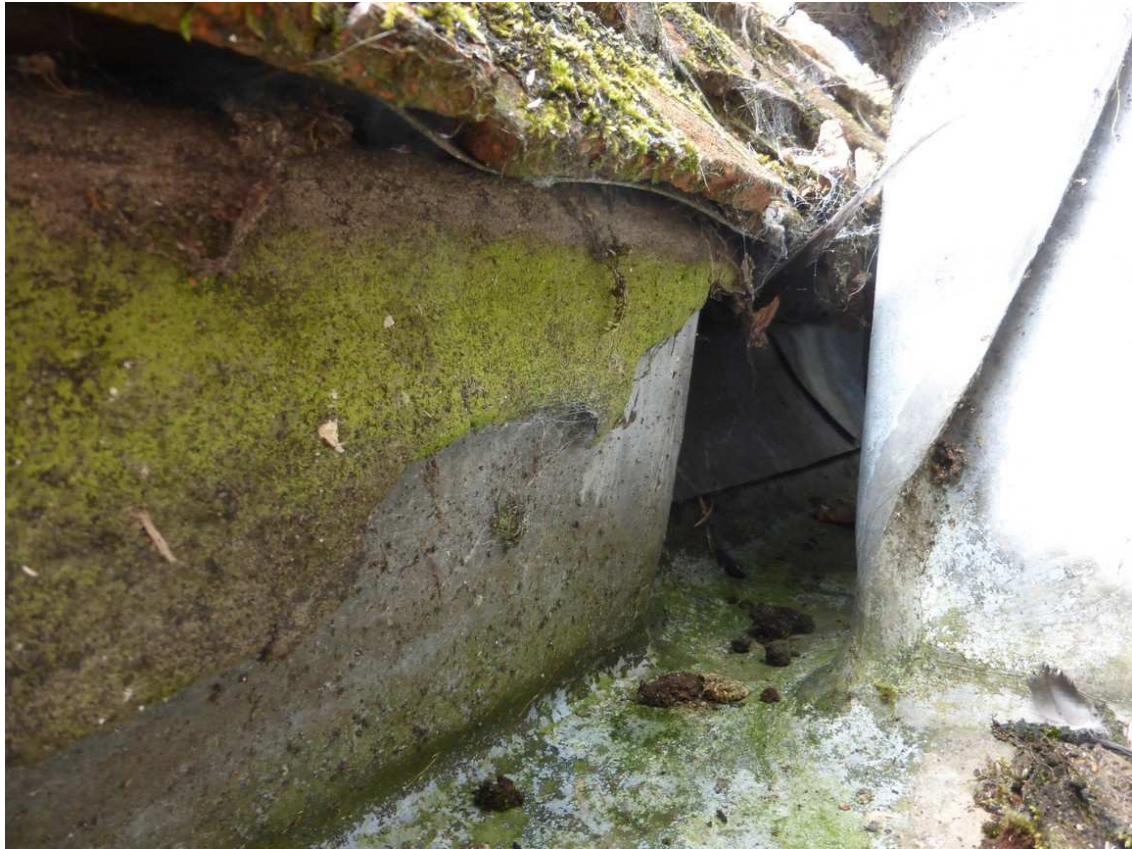
Detail of the outflow point of the rainwater chute into internal valley gutter,  
behind the chimney

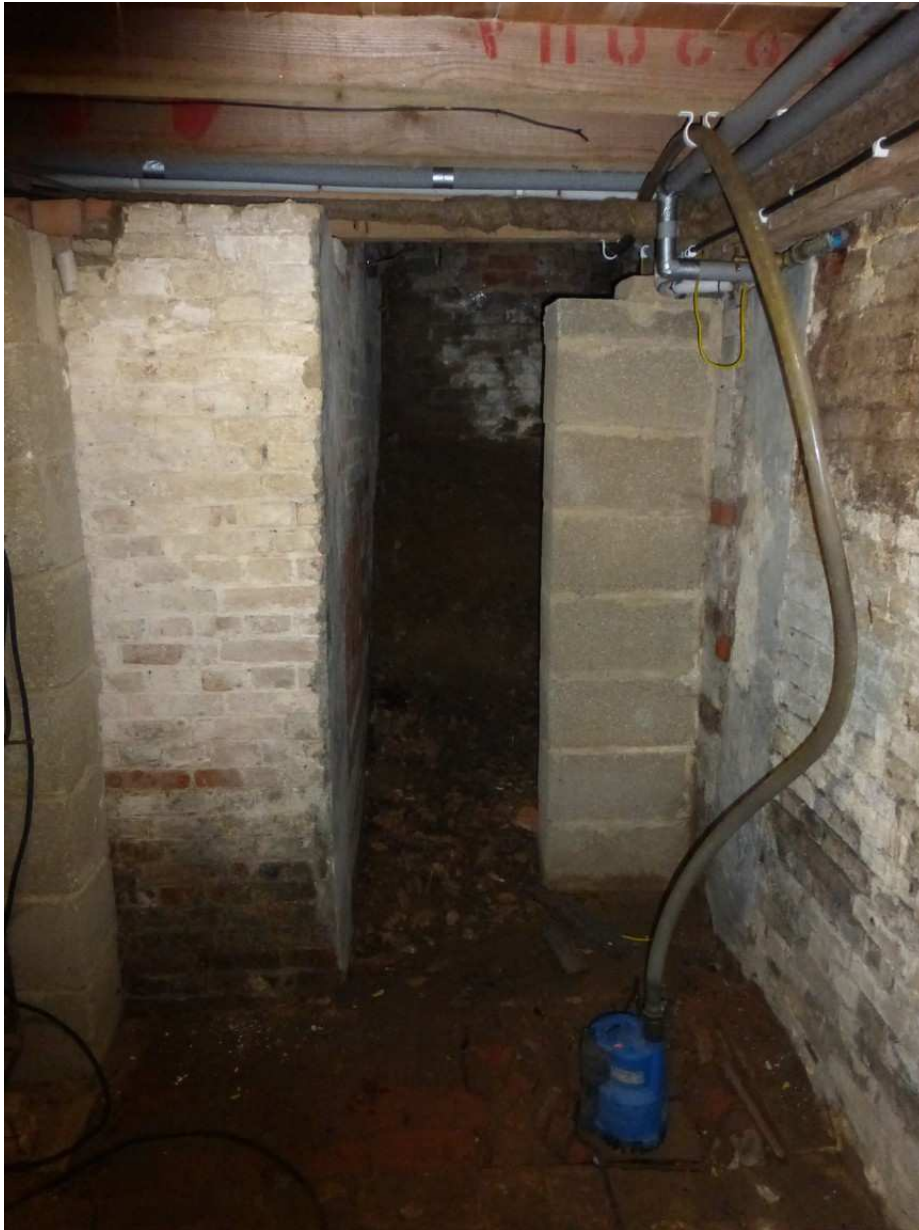
The cellar sump is to be rebuilt and the ceiling insulated and fireproofed.  
The coal hatch over the dark area in the distance is to be made secure.

Note that part of the cellar ceiling is recent. Other areas are original.

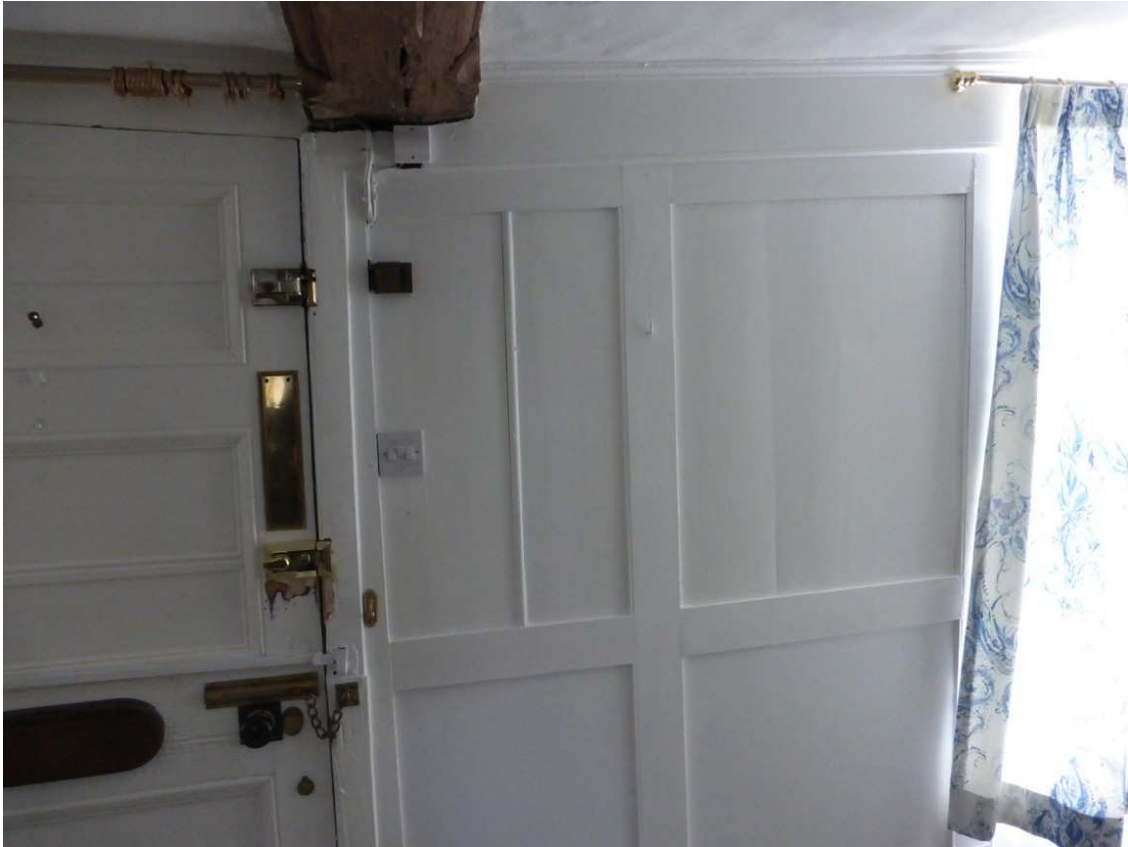
Main entrance external door.  
This door and the panelling is to be refurbished.

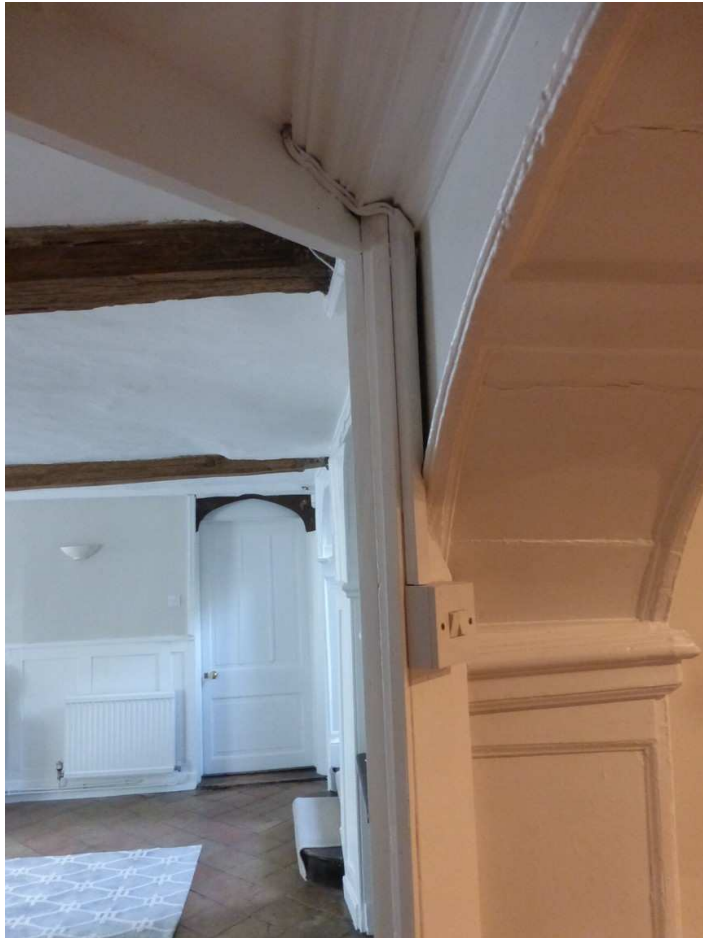
Removal of the door to  
Lobby 2 from the Entrance  
Hall.

This door and frame has  
been inserted without  
removing the existing  
mouldings, making its  
removal relatively simple.

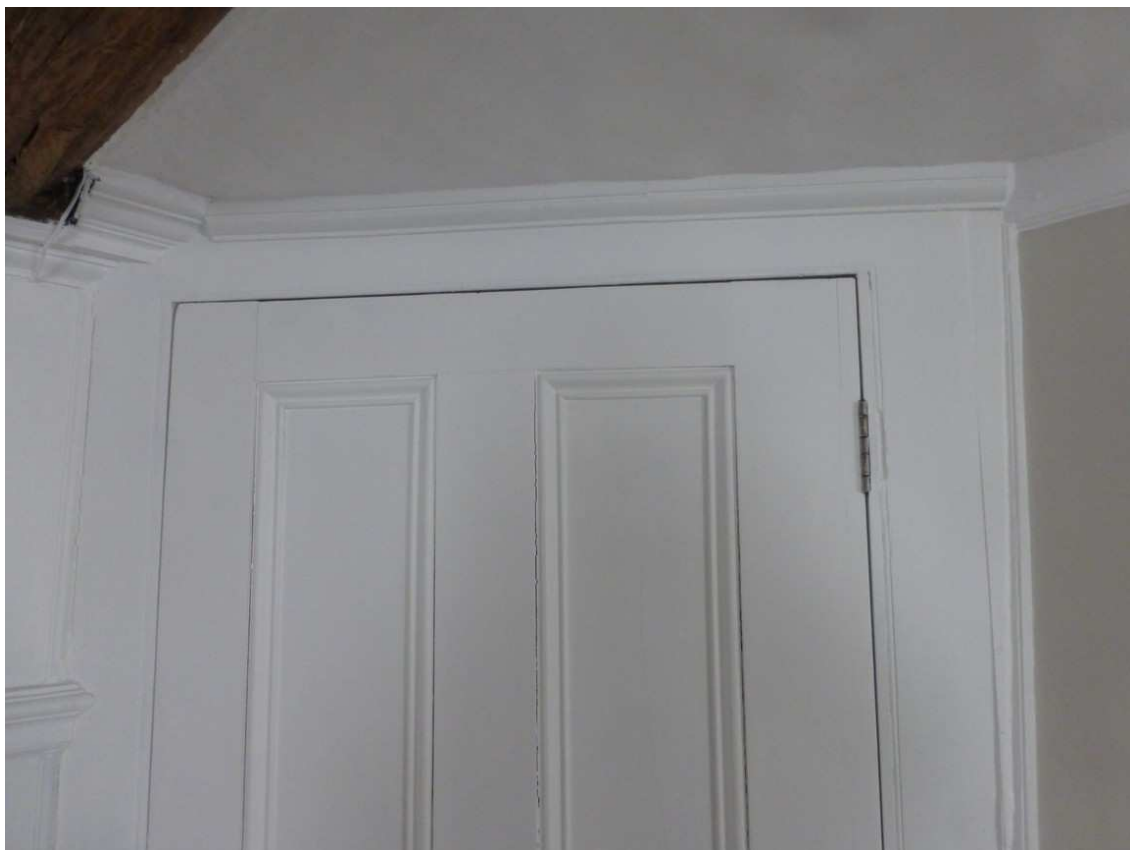
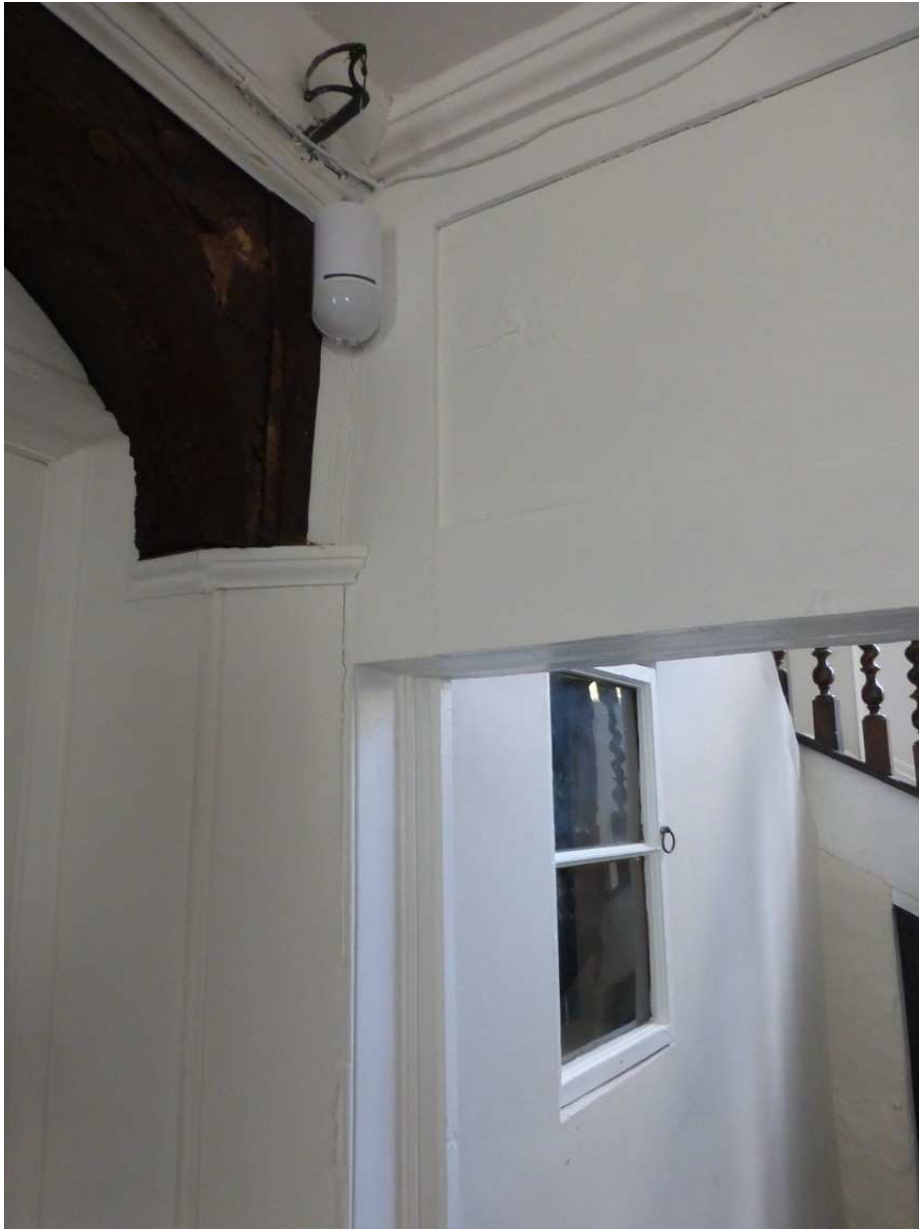
Improvement of mouldings in the Hall - the arch over the door to the Drawing Room.  
A variety of off-the-shelf mouldings have been used as make-shift repairs  
and it is intended to replace the worst offenders.

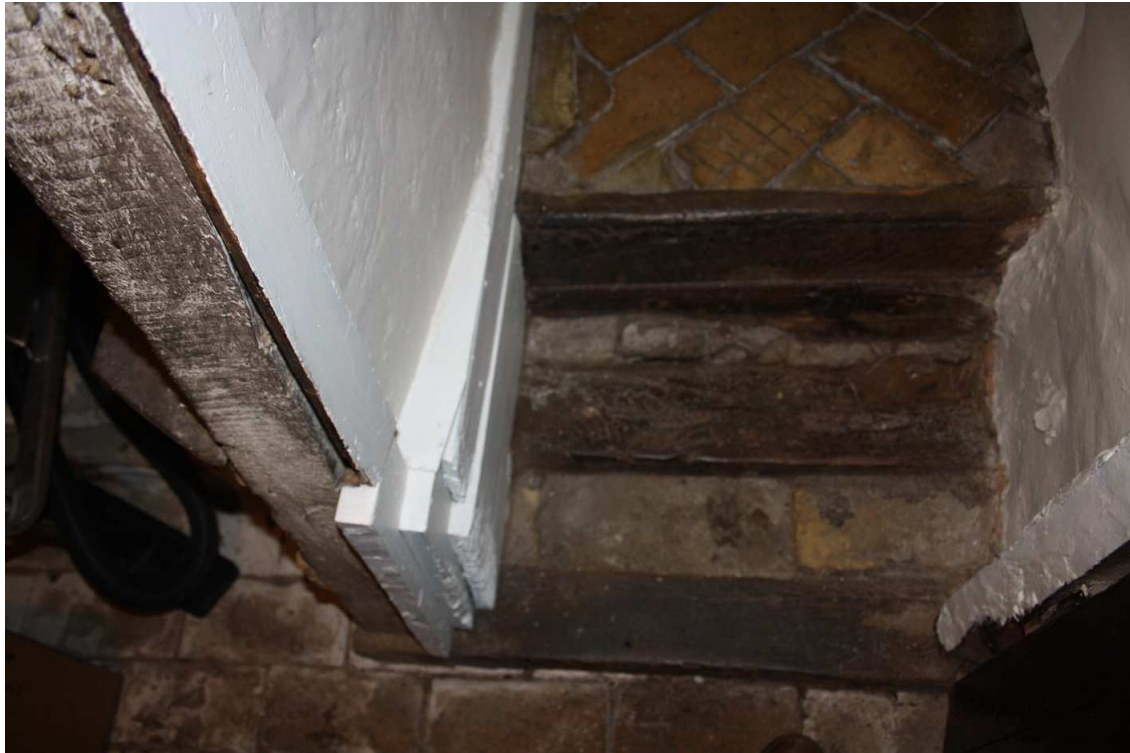
Entrance Hall/Understair Cupboard  
The dangerous steps are to be rebuilt.

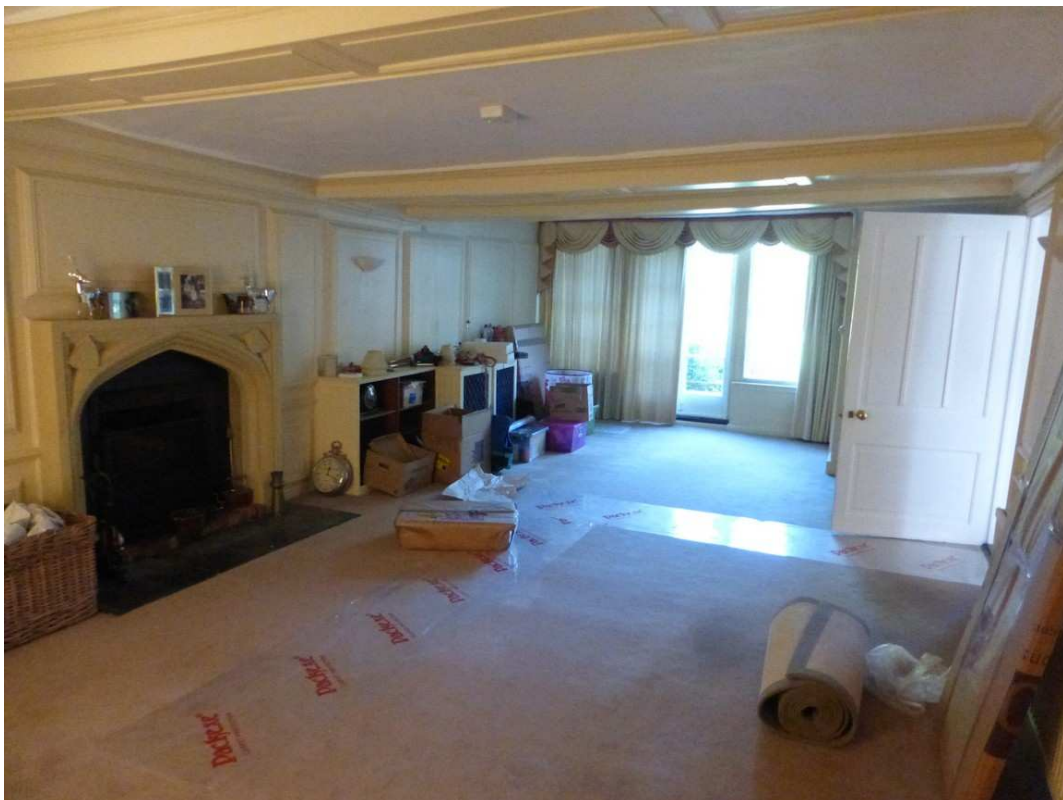
Drawing Room  
The existing fireplace is to be replaced and the built-in cabinet removed.

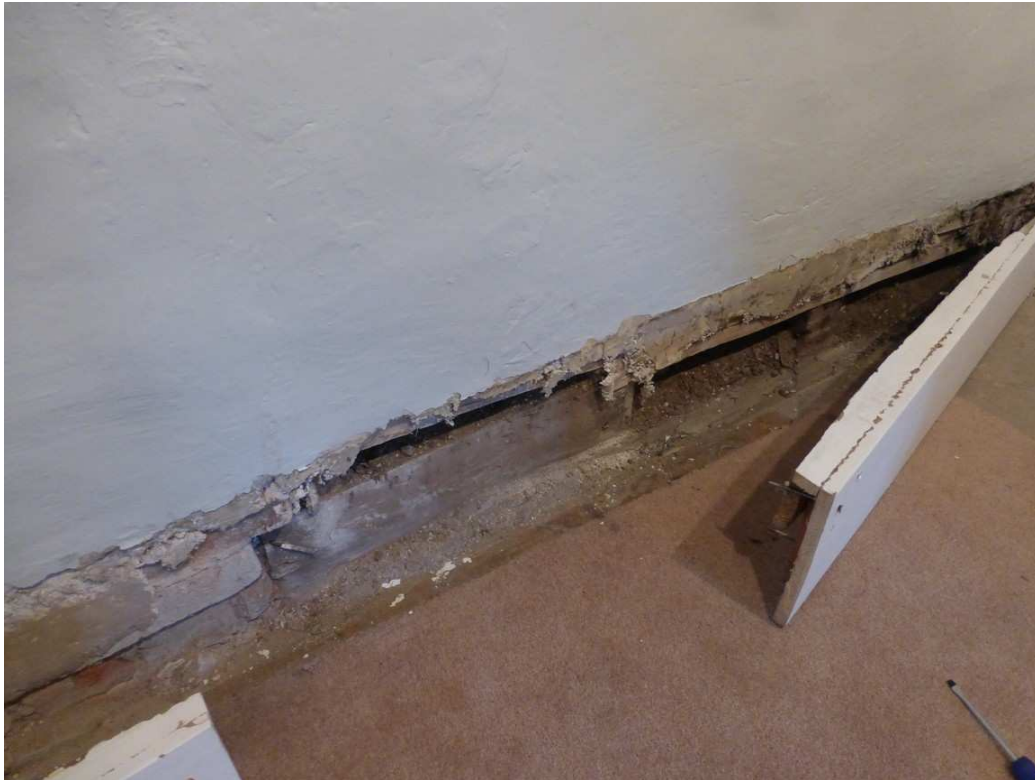
Forming a new opening to new WC1.

The new opening is planned to coincide with an existing opening since closed up. This view shows the break in the groundsill. The shadow of the former opening is visible in the plasterwork though difficult to appreciate in this view.

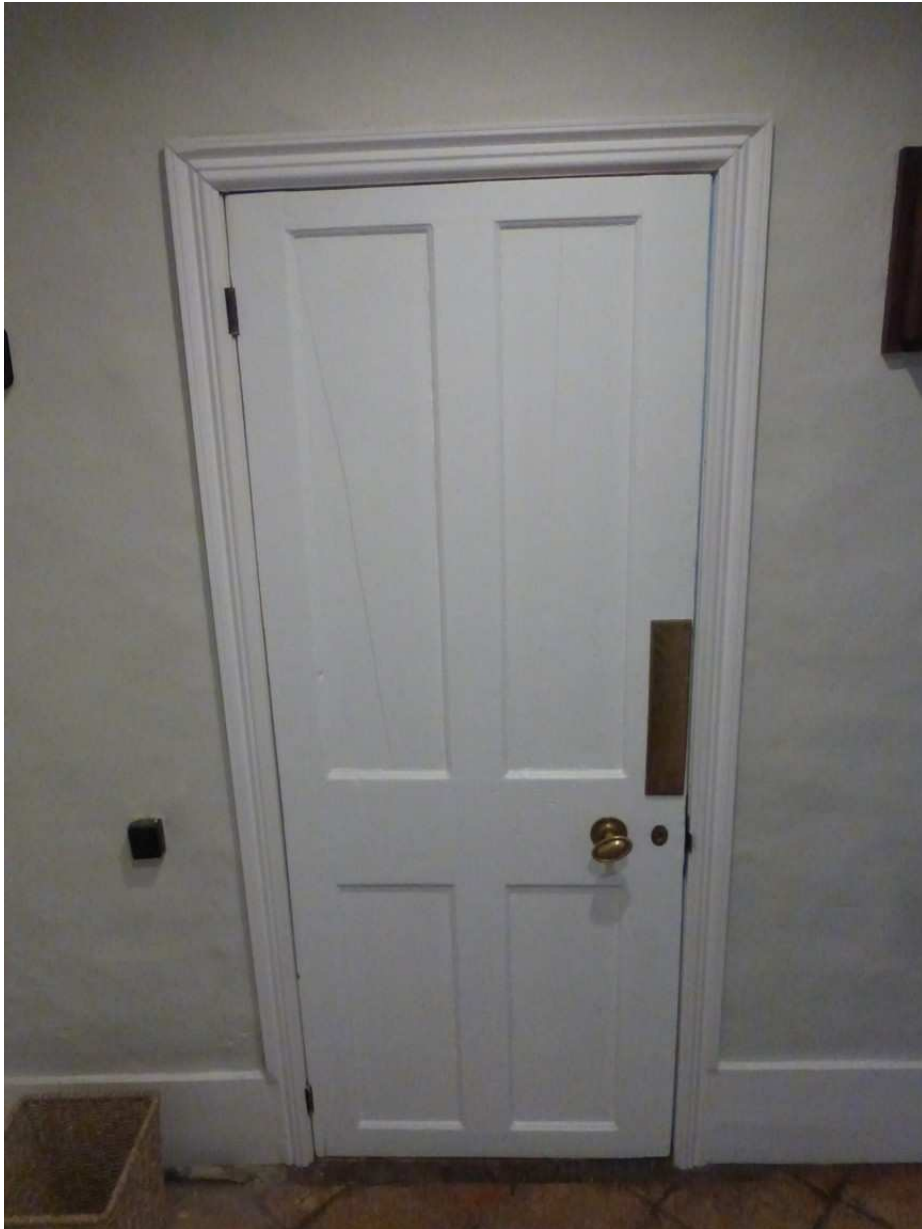
Door to be reswung in Lobby 2.
