BRIDGEWICK HALL

PHOTOGRAPHS SUPPORTING PLANNING AND LISTED BUILDING  
APPLICATION

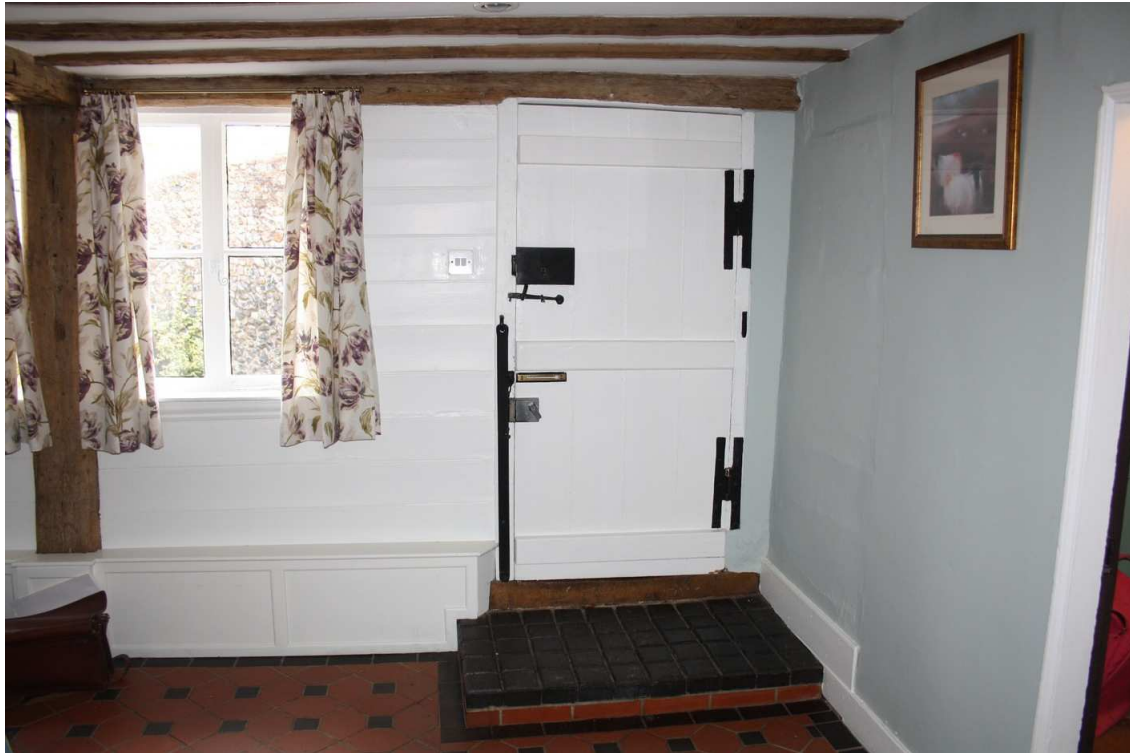
Rear Hall

The step is to be removed and the floor lowered.  
The plinth panelling will be removed/adapted/renewed accordingly.

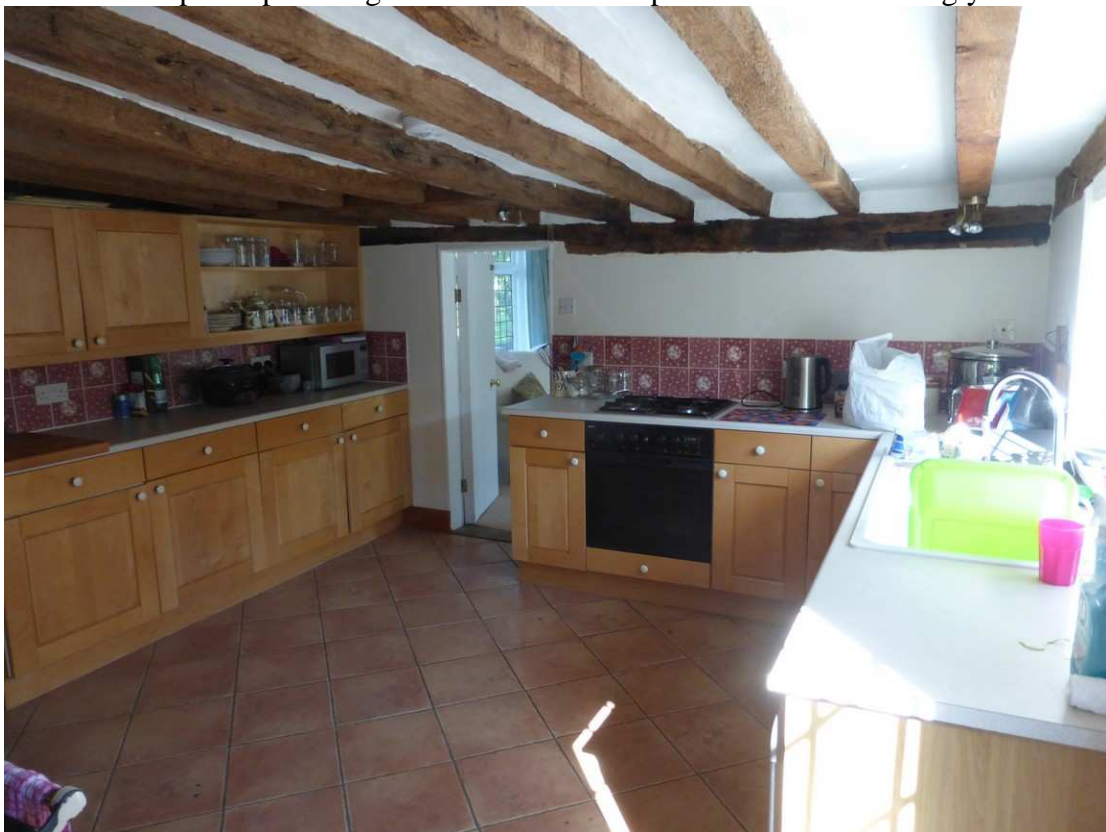
Kitchen (new Back Kitchen)

The fittings are to be replaced, the door moved to the right and the floor lowered.

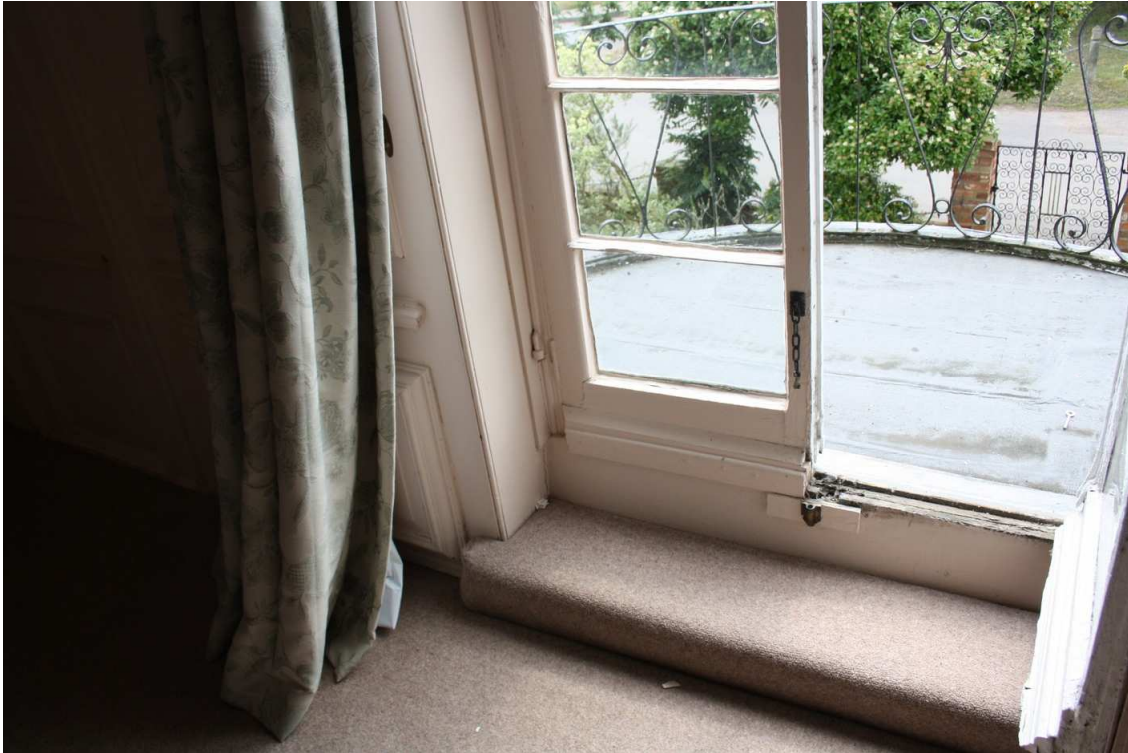
Bedroom 2 (new Master Bedroom)/Porch Roof  
The doors are to be refurbished, the porch re-roofed and the railing replaced.

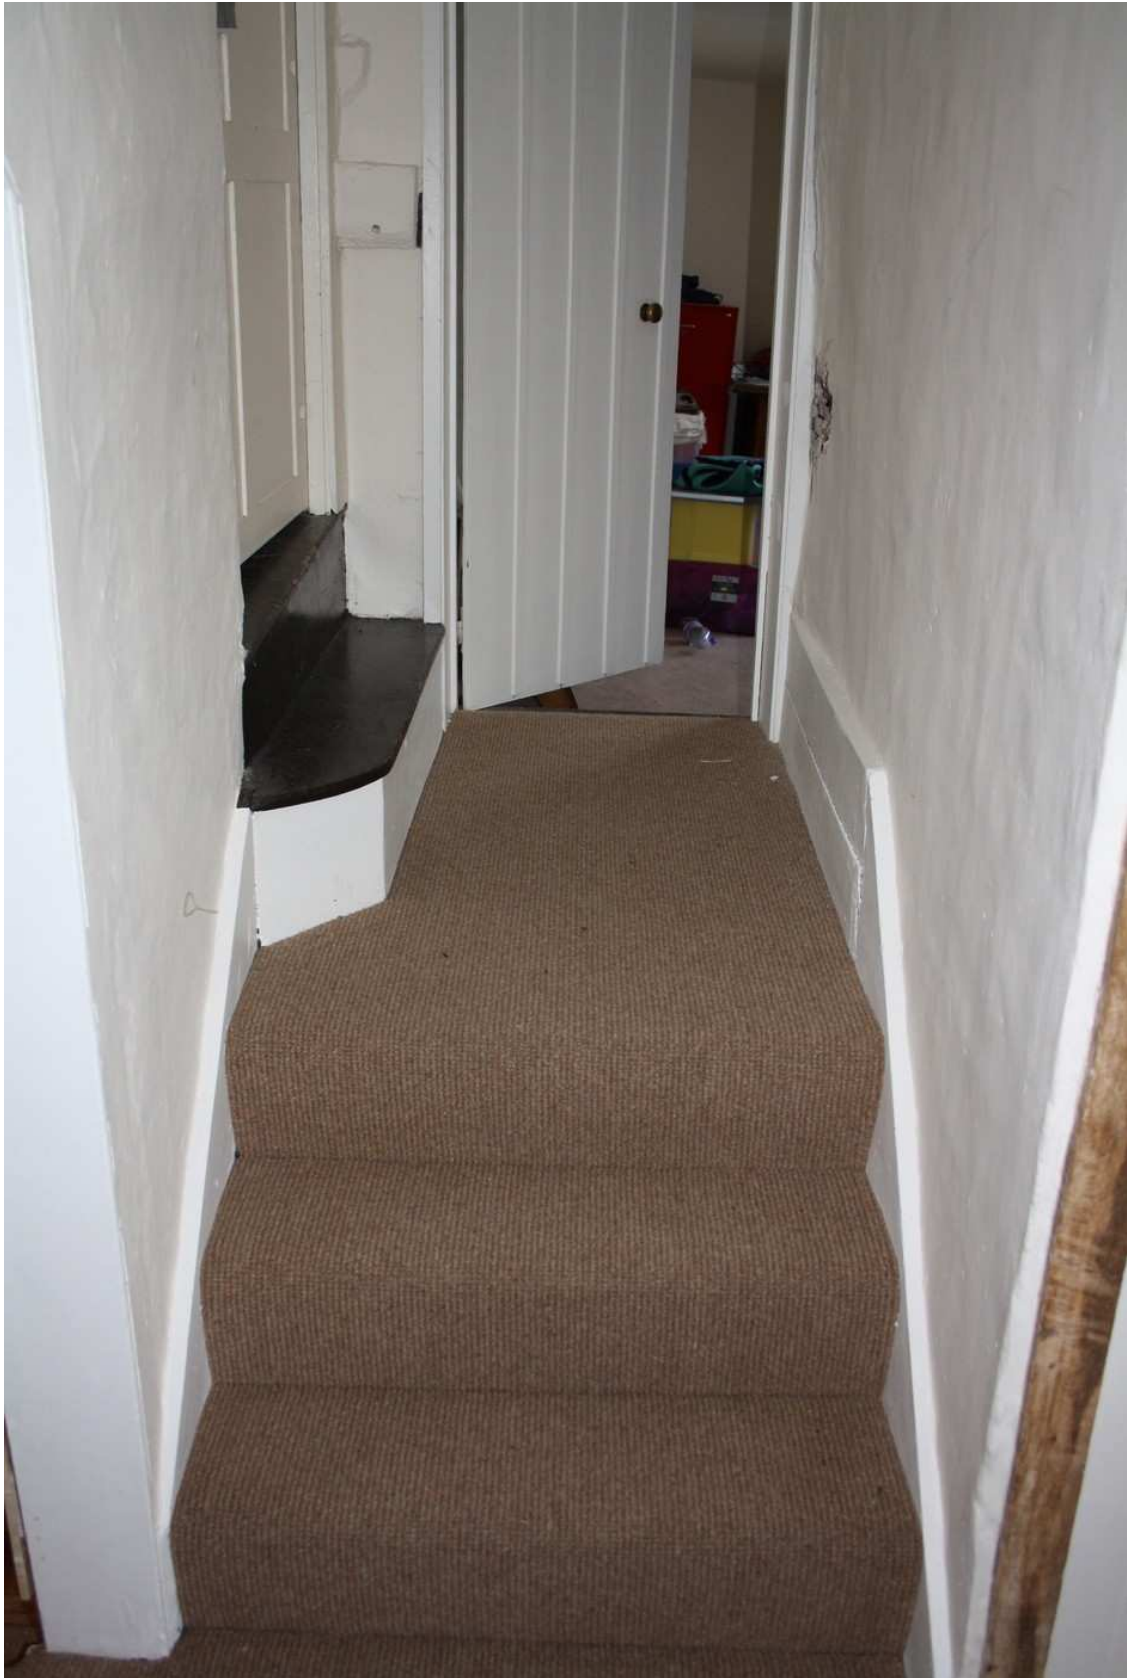
The up and over platform at the attic stair. The whole platform is to be removed and a new opening formed in the wall at the right of this view. The attic stair is to have new winders and the door to the new Library (straight ahead) is to be replaced.

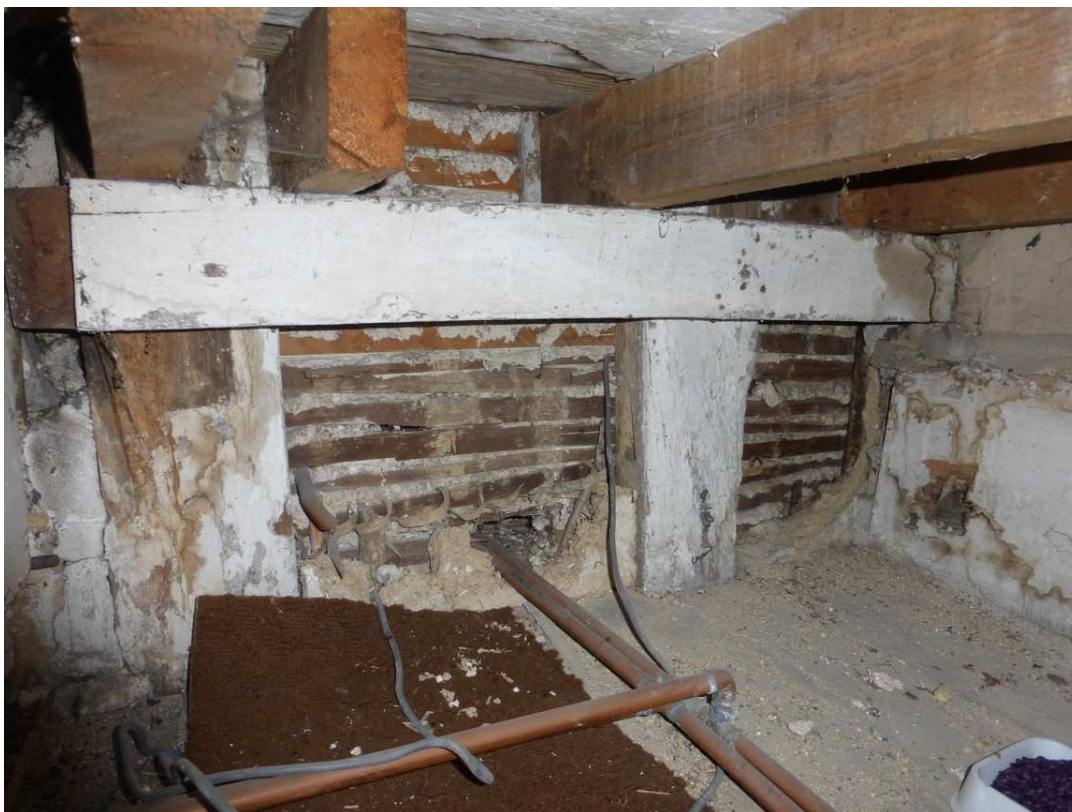
Removal of up and over platform at the Attic stair foot.

Note the softwood joists.

One stud already cut off at the new floor is to be reduced in height.

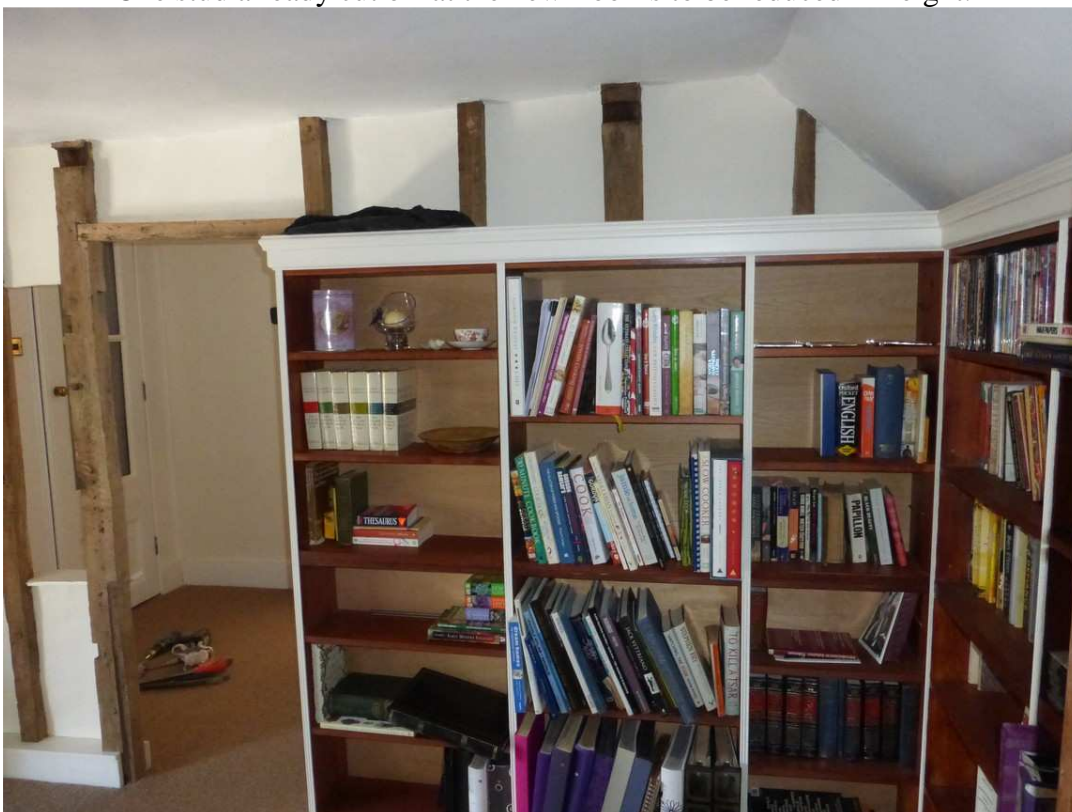
Removal of stud at Library

The studs in this view are all intruded, that to the right is to be removed for a new opening to Landing 2.

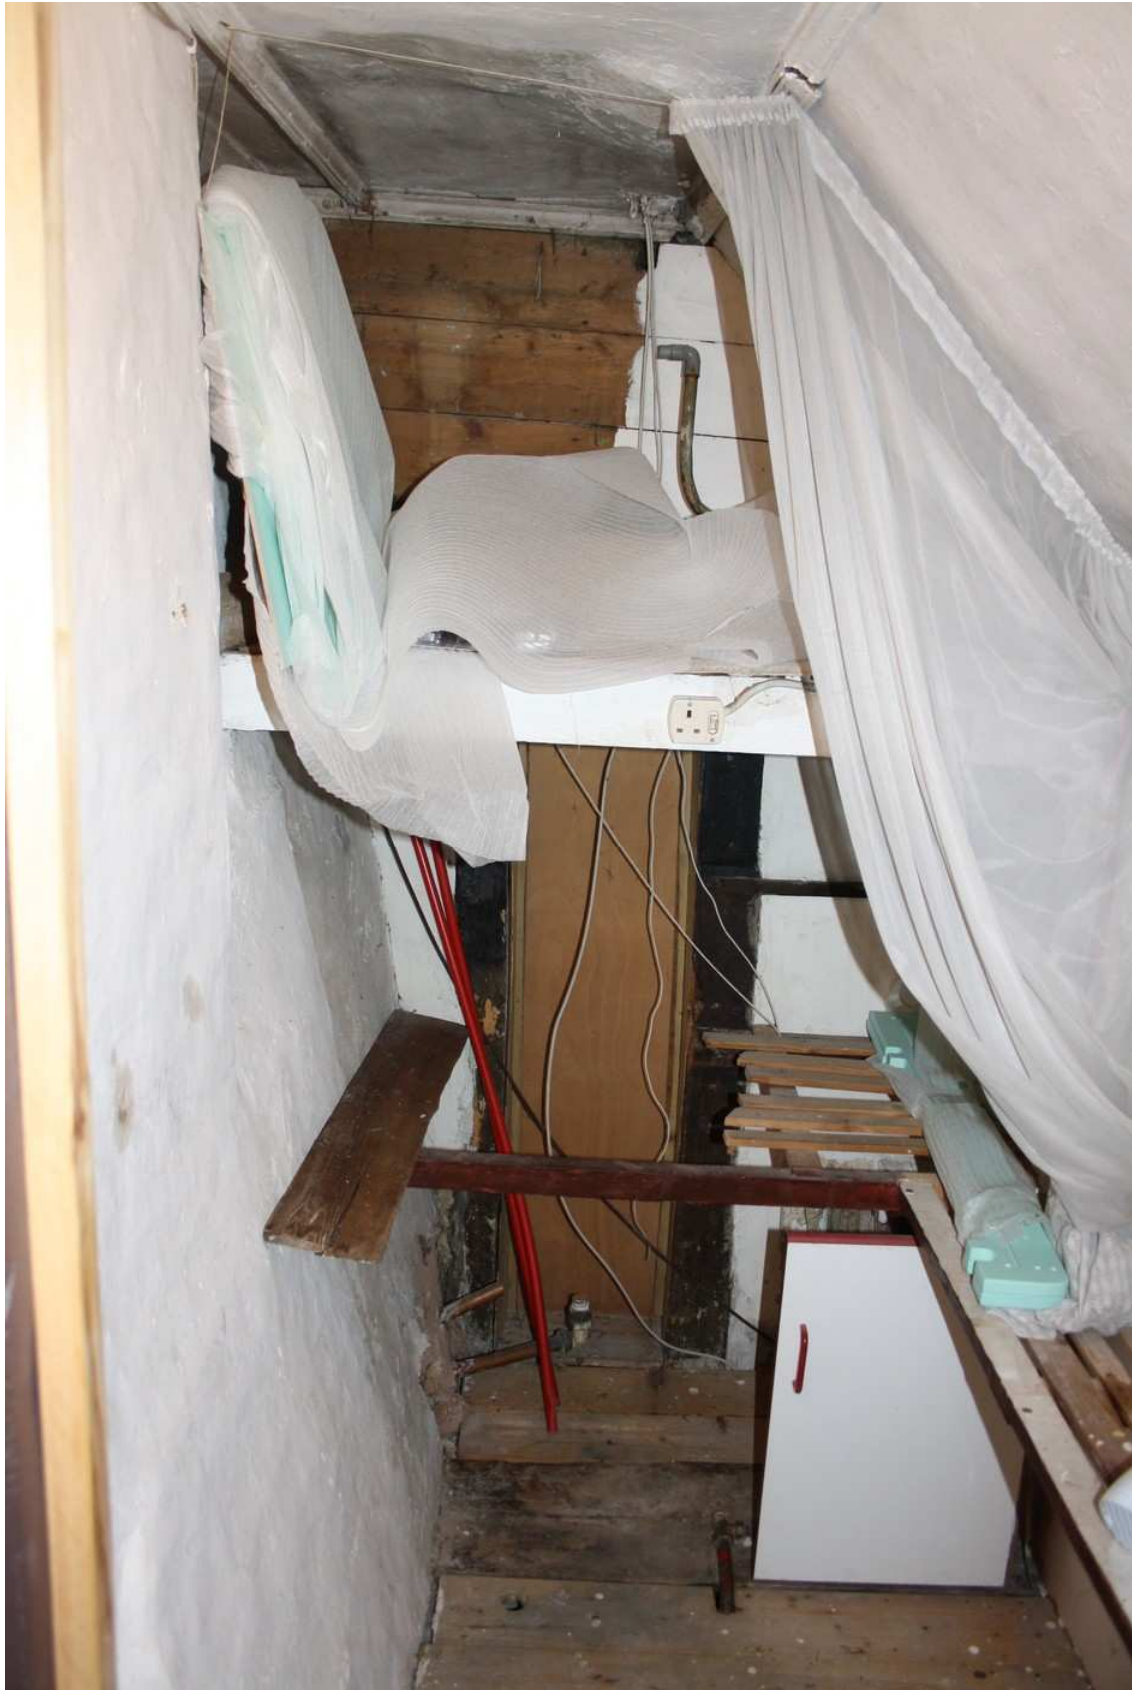
Bathroom 3 shower compartment.

This space is to become a shower with a small cupboard accessible between the studs in the far wall from new Bedroom 3.

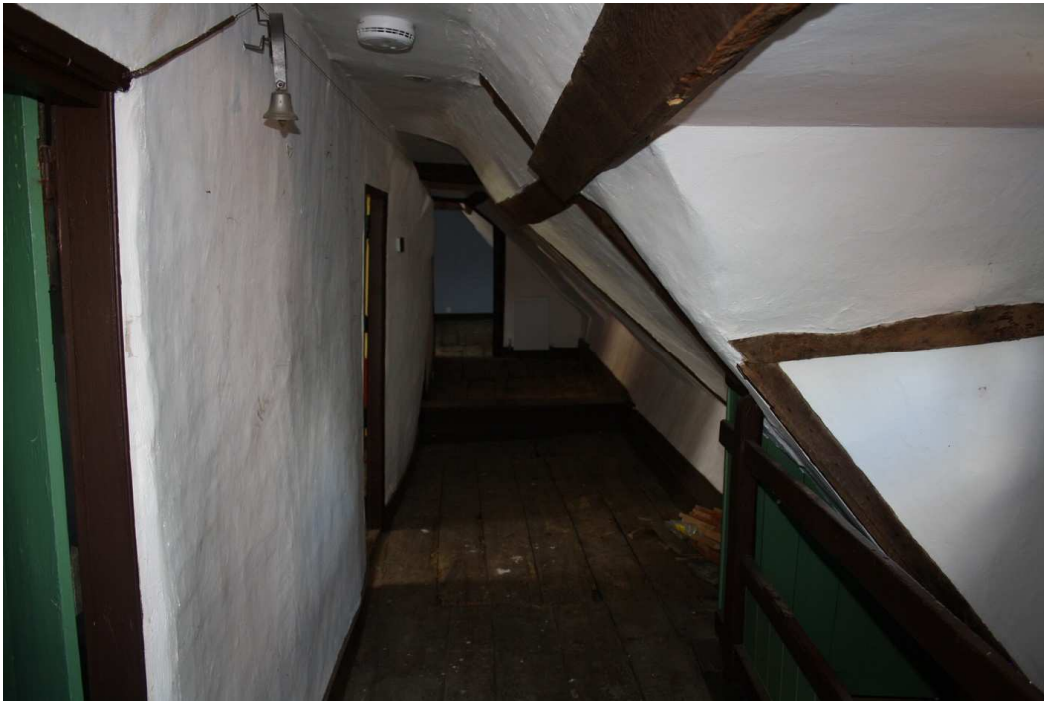
Passage 2

A partition is proposed at the right of the shot to form a new landing and two rooflights to light the passage space.

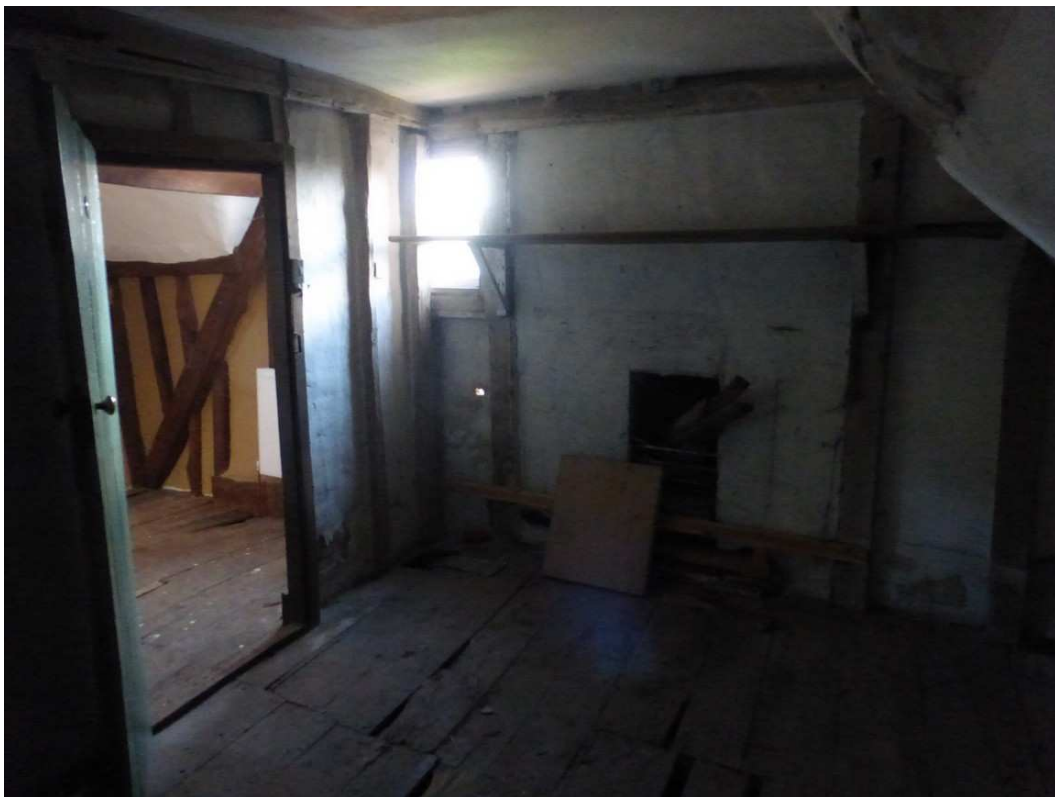
Box Room/Bedroom 7 - the east wall

The fire opening is to be repaired and a boxed skirting with raised hearth put across the wall at floor level to take new drainage and water supply pipes. The small window is to be adapted to take the partition.
