An archaeological evaluation at North Station Road (adjacent to the Victoria Inn), Colchester, Essex

August 2001

CAT Report 163
November 2001

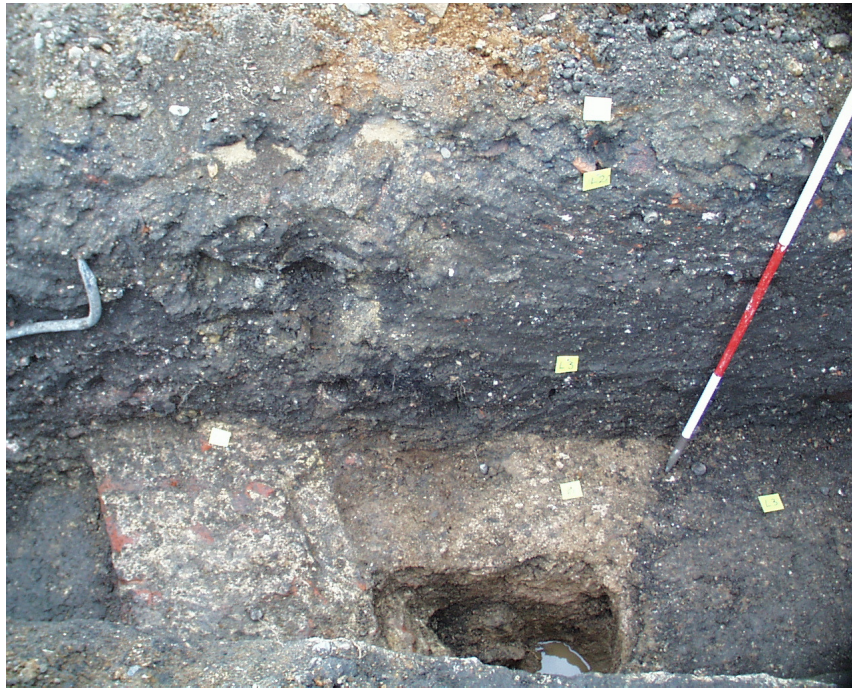
Plate 1 Trench 2: F1 and F2, looking south.

containing lumps of Roman *opus signinum*, wall-plaster, tile and oystershell (F1). The feature which is interpreted as Roman demolition debris ran north to south across the trench and was at least 400mm deep. The feature was half sectioned but it was not possible to excavate it to the base as it filled up with water.

Adjacent to F1, at 1.3m bgl, there was a substantial 690mm-wide brick and mortar Roman building foundation (F2) running at an angle across the trench. This had a stepped western edge which was sealed by F1. F1 may well be made up of demolition debris from this building. The wall is on roughly the same alignment as walls found under the HSBC building and it may be part of the same complex.

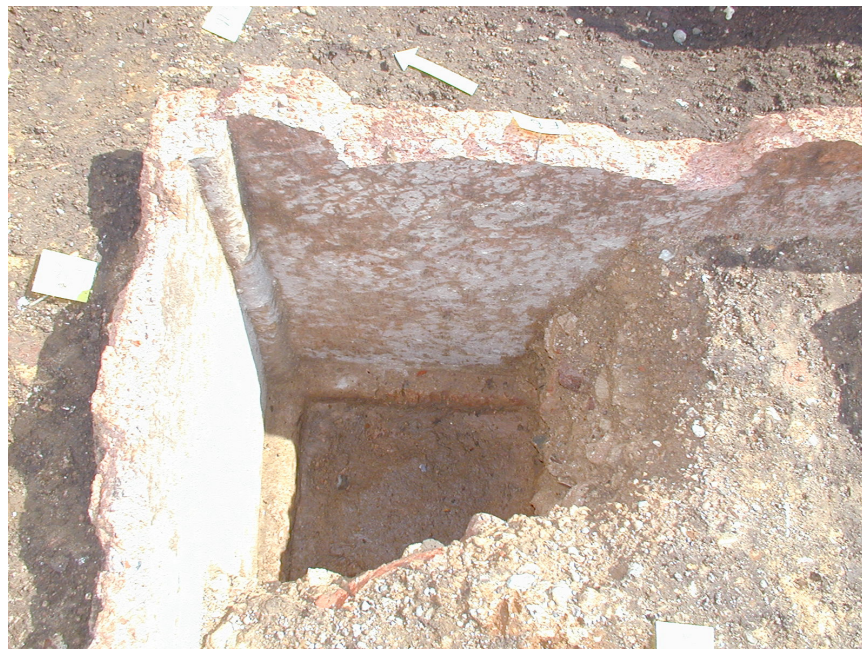
Plate 2 Trench 3: view of F6, from above.

One corner of a square or rectangular Roman structure was exposed in the north-eastern part of the trench (F6). What remained was a 60mm-thick free-standing *opus signinum* structure. The outer face of the *opus signinum* structure was very uneven (Plate 3), and traces of white mortar adhered to it. It was therefore originally on the inner face of a septaria and rubble wall. The top of the structure was very uneven where it had been truncated, but the highest point was only 490mm bgl (6.51m OD). This structure was sealed by and also partly filled by L10. In its north-eastern corner, within L10 and at 600mm bgl, was found a Roman coin dated c AD 367-375. This copper-alloy coin of Valens has the inscription SECVRITAS REIPVBLICAE on the reverse.

The northern wall of the structure was followed but it did not appear to survive beyond 2m to the west, ie to the edge of the mosaic (see below). The eastern wall ran for 1.5m to the south before being cut by the soakaway (F8) to the south-east. Although the southern wall was not identified, the excavation of T3a and T3b (see below) proved that the structure did not extend further to the south.

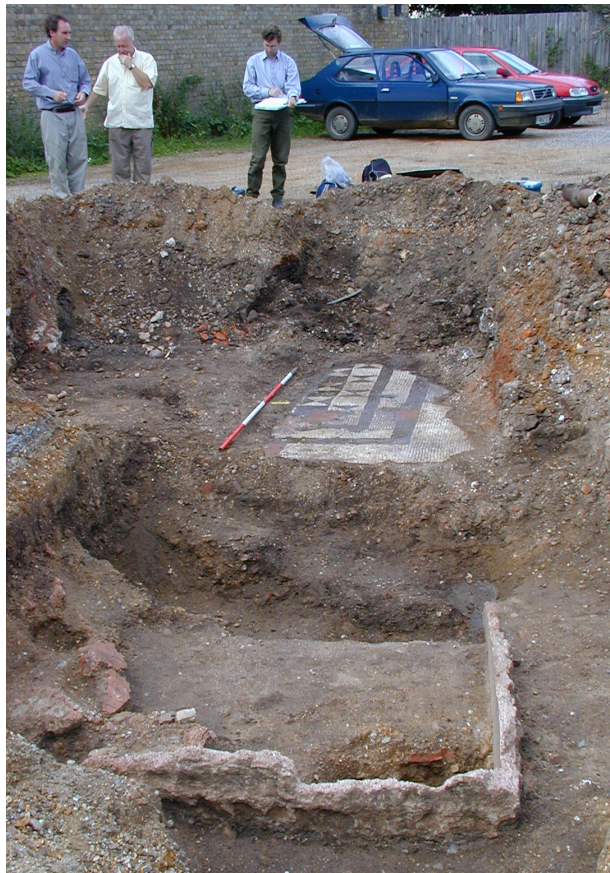
Plate 3 Trench 3: mosaic (F12) and F6, also showing F9, looking south-west.

A pit (F9) had been cut through the probable south wall of the *opus signinum*-lined structure and the demolition debris (L17). The fill was similar to L10 above, a mid brown clayey loam containing Roman brick and tile and painted wall-plaster. The fact that it cuts L17 makes the feature later than the demolition of the house. The feature was 370mm deep and the base of it was 870mm bgl. It was a pit of medieval or post-medieval date.

Approximately 2m by 1m of the mosaic remained. An even edge of slightly raised *tesserae* defined its eastern edge. This and the border shows that the mosaic continued to the south and west but not the north and east. Therefore the surviving mosaic was in the NE corner of the room west of the *opus signinum* structure.

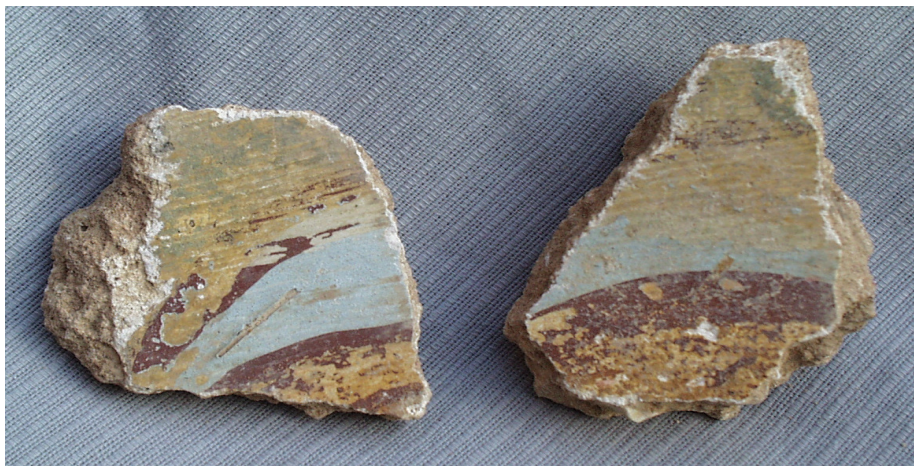
Plate 4 Roman wall-plaster.

Roman wall-plaster is listed in Appendix D. A total of 12 kg of painted wall-plaster was collected showing a variety of colours, mainly a light green and dark red which appear to form panels. Brush strokes in other colours depict some sort of scene, possibly figural, but it is not possible to identify it exactly. Presumably the wall-plaster decorated a room in a high status house on the site. When it was demolished, the wall-plaster was broken up and either fell into or was put into the remains of the *opus signinum* structure.
