**An archaeological evaluation  
on the west side of  
St John's abbey precinct wall,  
along Mersea Road,  
Colchester, Essex**

**February 2002**

**on behalf of  
Purcell Miller Tritton**

**CAT Report 178**  
February 2002

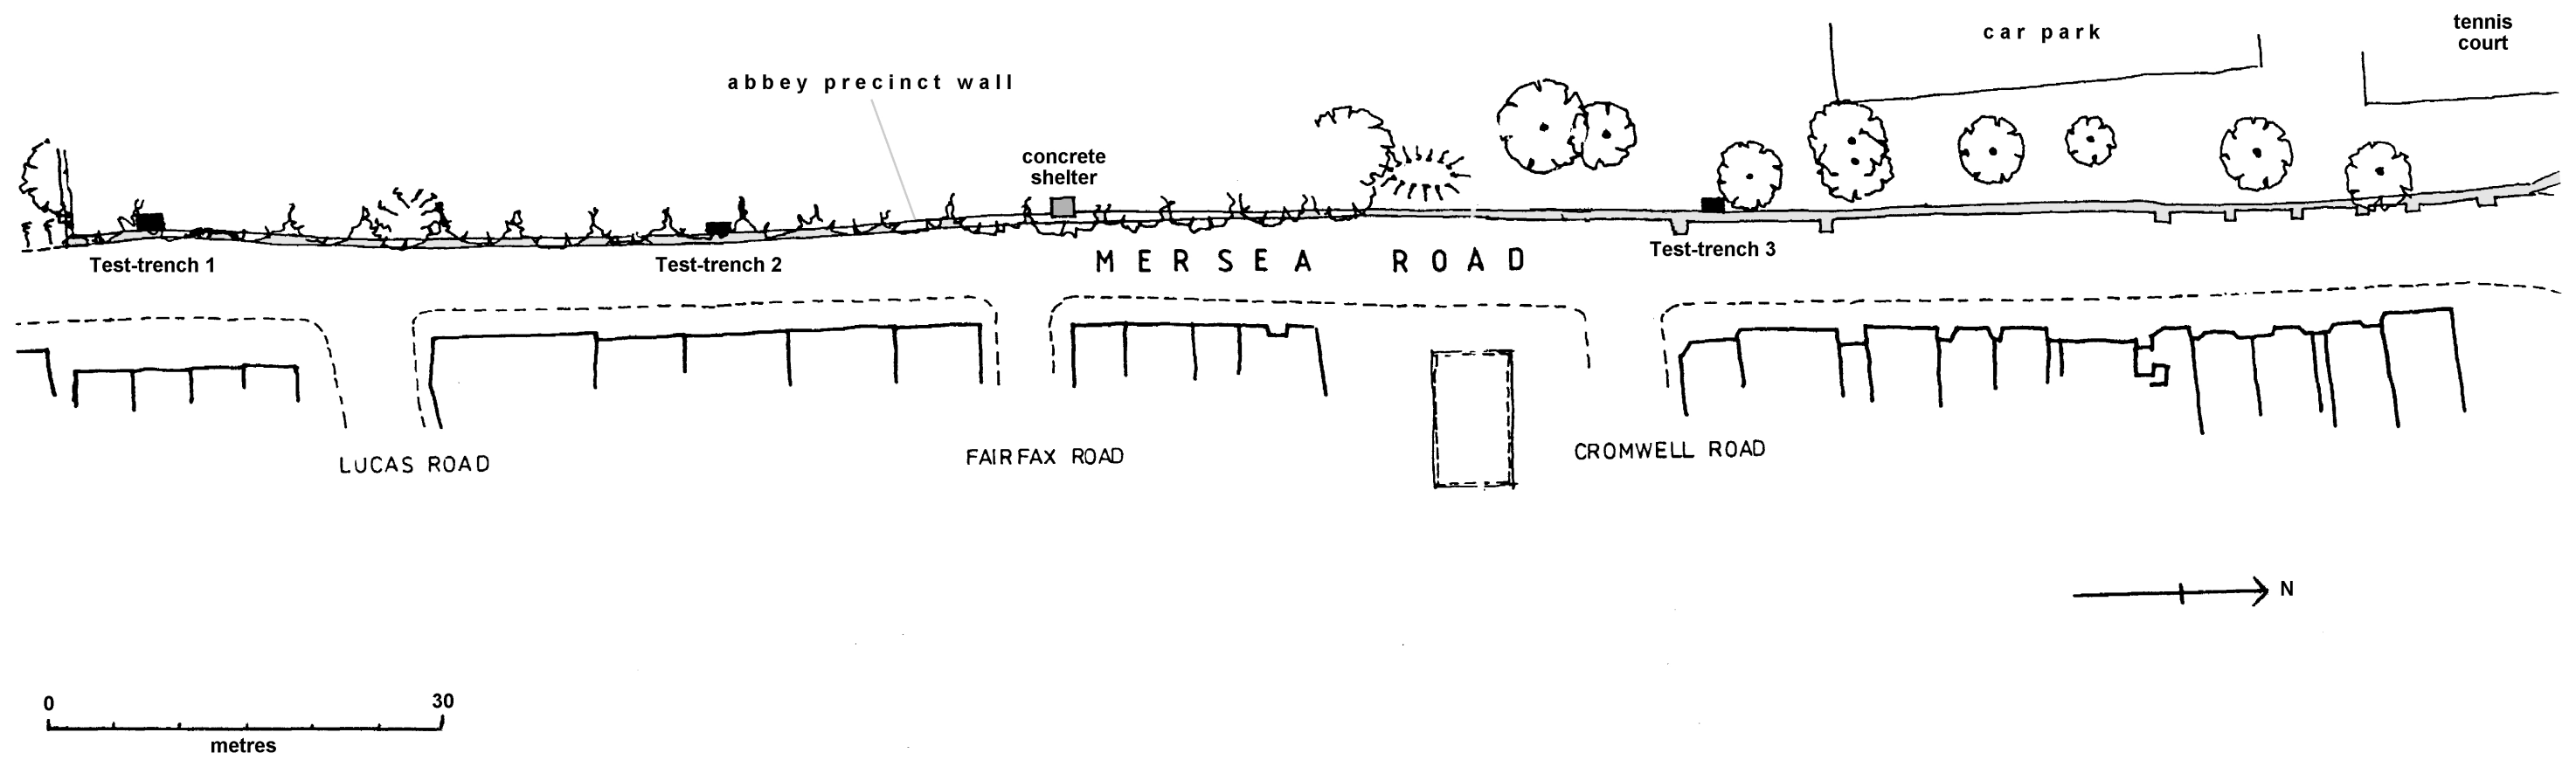
Fig 1 Test-trench locations.

Test-trench 1 was located 5m from the southernmost end of the precinct wall (Fig 1) and was 80 x 80cm. It was excavated with hand tools to a depth of 1.40m after first clearing ivy from the immediate area and from the face of the wall above ground-level. The trench was cut through a dark brown, very organic topsoil layer (Layer or L1) which contained large amounts plant-root activity caused by the scrub woodland in which the site is located. L1 extended to a depth of 60cm, where it interfaced with a light brown sand, L2 (Fig 5). This layer also contained some organic material, possibly indicating a buried topsoil. No features were exposed in either L1 or L2. As the test-trench was excavated, the inner face of the precinct wall was exposed to enable the structural engineer to assess its condition and stability.

Test-trench 2 was located 27.80m from the southern corner of the concrete shelter (Fig 1) and was 100 x 80cm. It was excavated with hand tools to a depth of 1.40m, again after clearing ivy and other plant material away from the surrounding area and from the face of the precinct wall. The trench was cut through a dark brown, very organic topsoil (L1) which contained a large amount of plant material and plant-root activity. L1 extended to a depth of 60cm, where it interfaced with a light brown sand, L2 (Fig 6). As in Test-trench 1, L2 contained some organic material, which indicates that it may be a buried topsoil. No features were exposed in either L1 or L2. As the test-trench was excavated, the inner face of the precinct wall was exposed to enable the structural engineer to assess its condition and stability.

Test-trench 3 was located 52.38m from the north side of the concrete shelter (Fig 1) and was 140 x 100cm. It was excavated with hand tools to a depth of 1.75m after first clearing the surrounding area and the wall of ivy and other plant material. The trench was cut through a dark brown, very organic topsoil (L1) which contained large amounts of plant material and plant-root activity. L1 extended to a depth of 30cm, where it interfaced with a light brown sand (L2) which was probably a buried topsoil. L2 extended to a depth of 30cm before it interfaced with a layer that was not present in either Test-trenches 1 or 2 (L3). L3 was an unconsolidated, non-compacted mix of

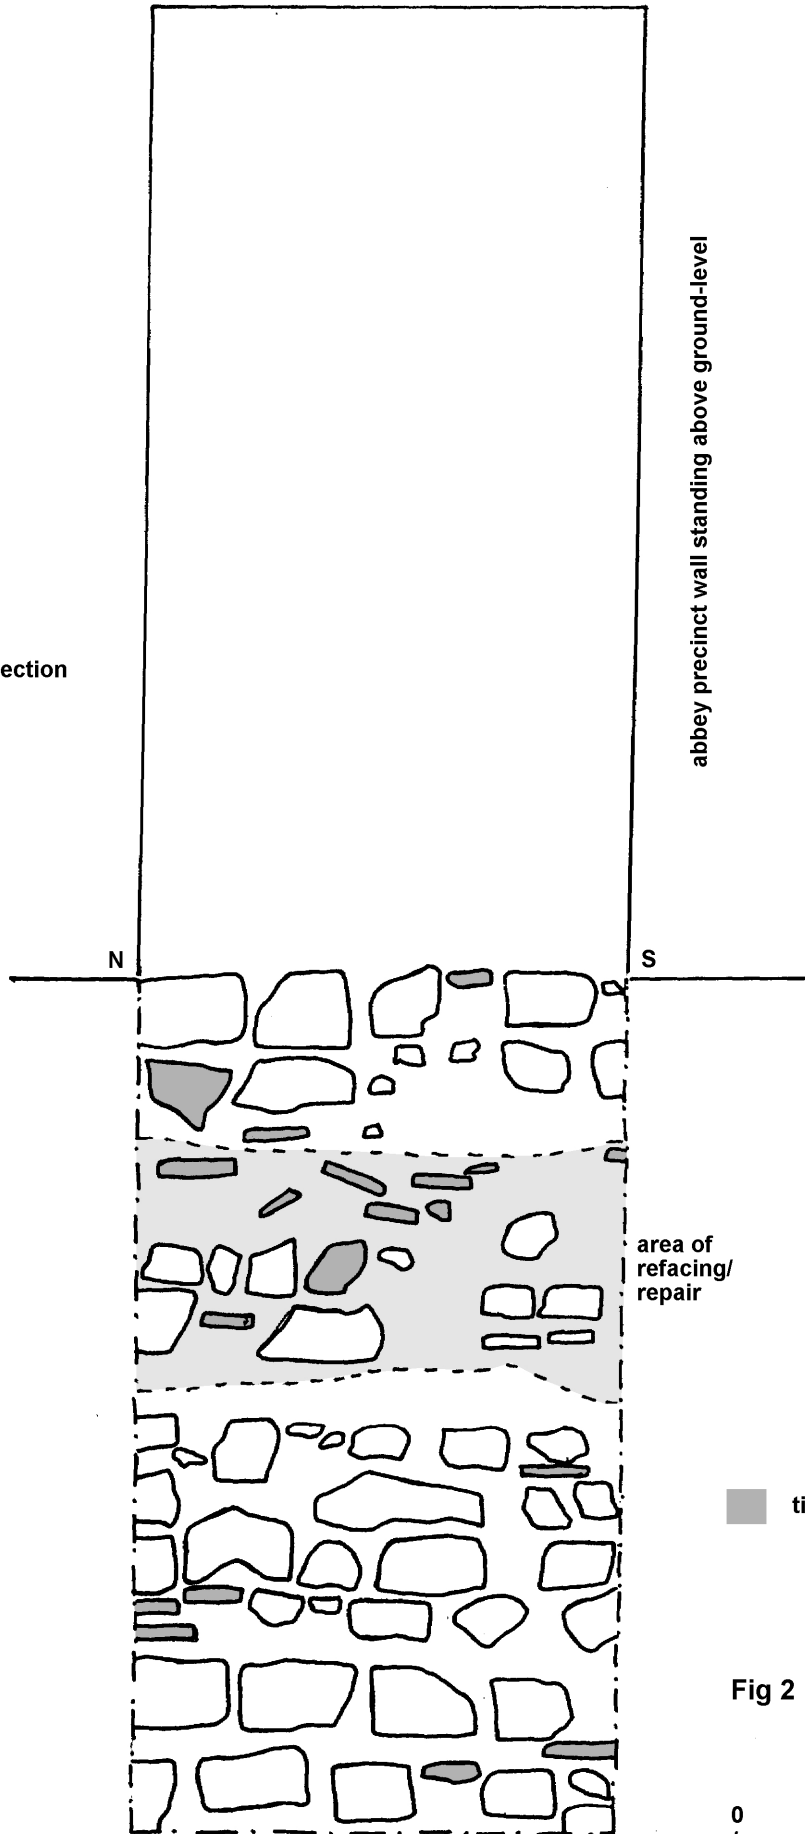
Fig 2 Test-trench 1:  
wall elevation.

The condition of the exposed face of the precinct wall is variable. Above ground-level, where the wall is exposed to the elements, it has suffered from weathering and as a result has also been patched and repaired over time. Some of these repairs have been carried out using modern materials such as brick, while others appear to have reused original materials. Below ground-level, the condition of the wall is also variable (Fig 2). The further down the trench was excavated, the better the state of preservation of the wall became. From ground-level to 60cm, the courses of the wall are dotted with repairs and repointing. One section of the wall face, from 30cm to 60cm, appears to have been completely refaced at some time (the end of this refacing appears to coincide with the interface between the current topsoil L1 and the buried topsoil L2). Below the 60cm level there are more distinctive courses, with much less tile and larger stones used in the construction of the wall. Finds from the test-trench are very mixed; pottery from the trench ranged from modern through the medieval period with a few sherds of Roman pottery. Other finds from the trench included modern glass and building materials such as peg-tile, as well as animal bone, oyster shell and *opus signinum*. The majority of the finds from Test-trench 1 came from the topsoil L1, and look as though they were redeposited against the precinct wall when soil-dumping took place on the site at some time during the post-medieval period (Crummy *et al* 1993, 203). The height of the wall to external road-level is 3.45m, showing the amount of build-up against the inner face of the precinct wall.

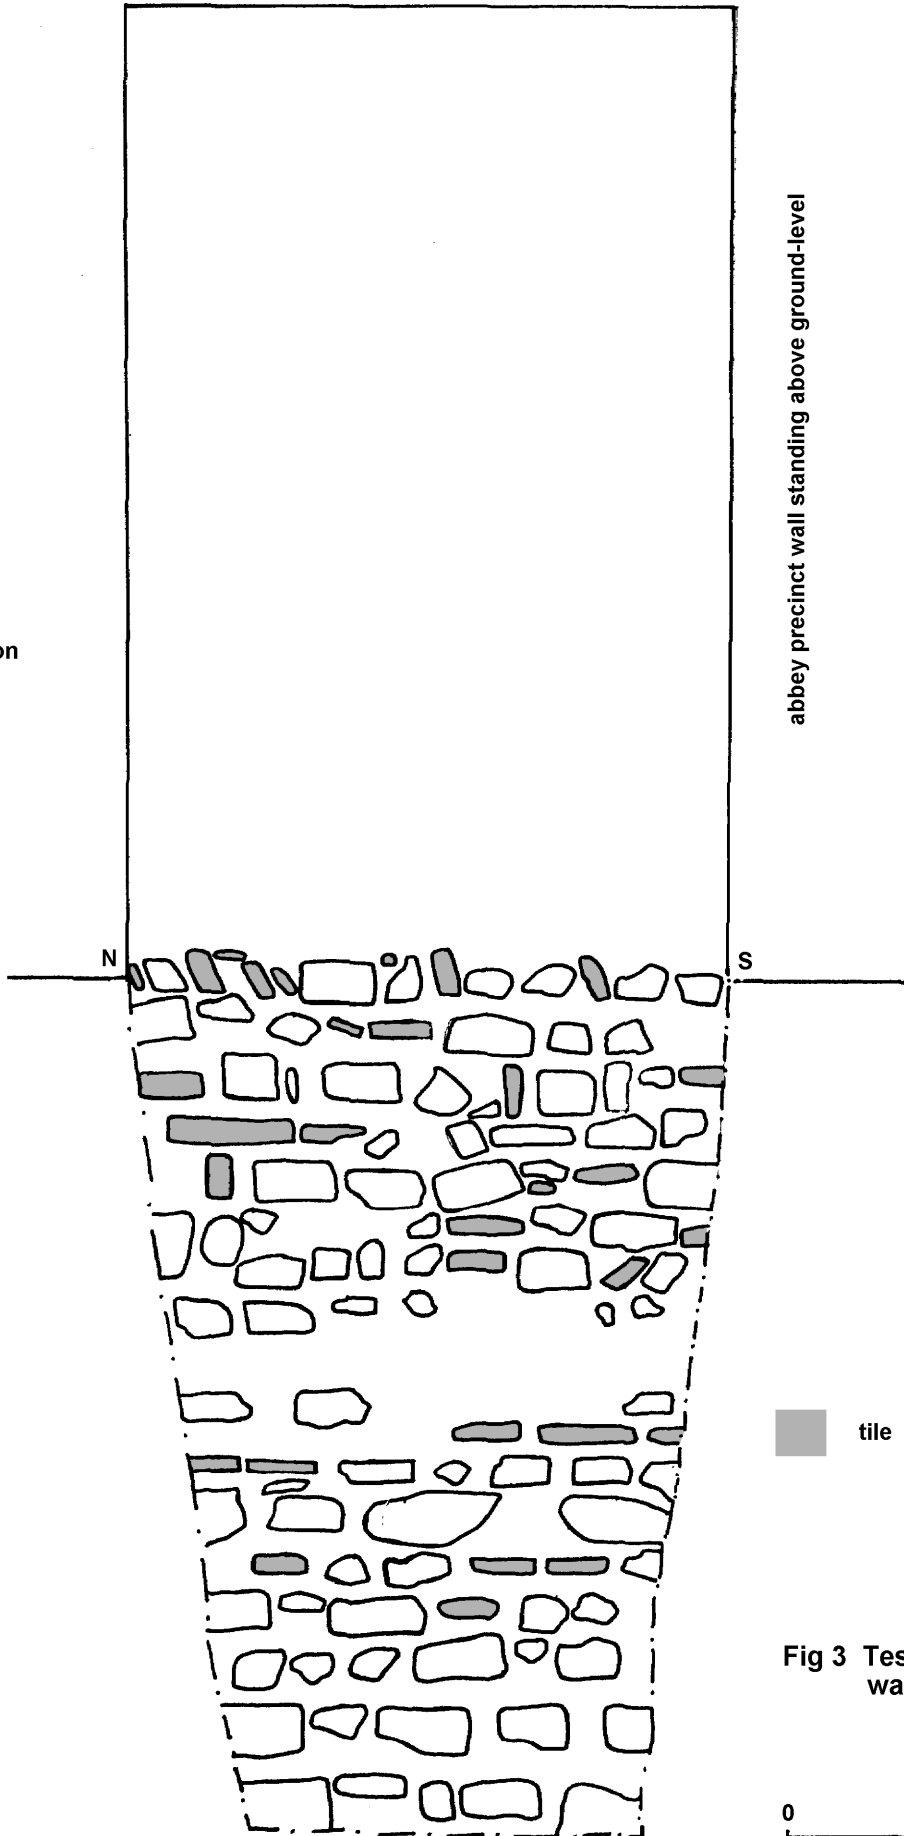
Fig 3 Test-trench 2:  
wall elevation.

The precinct wall above ground-level appears to have been extensively repaired and refaced using modern materials such as brick and peg-tile as well as reused original building materials. In some parts there is only mortar visible in the face of the wall. Below ground (between ground-level and 60cm; Fig 3), courses in the wall are indistinct, and there is evidence of patching and repair using tile and other original materials, and in some places repointing (where there is only mortar visible in the face of the wall). Below 60cm (as in Test-trench 1) there are more distinct courses and there is less use of tile and more large stone blocks. Also as in Test-trench 1, the finds from Test-trench 2 are very mixed. They include modern, medieval and Roman pottery and other finds such as iron objects, modern glass and peg-tile, brick, Roman tile, animal bone, oyster shell, mortar from the construction of the wall, and *opus signinum*. The nature of the material from both the topsoil L1 and from L2, and the fact that the same mixture of finds came from both contexts, indicates that (as in Test-trench 1) there has been significant redeposition due to soil-dumping on the site in the post-medieval period (Crummy *et al* 1993, 203). The height of the wall to the external level of the road is 3.45m, showing the amount of soil build-up against the inside of the precinct wall.

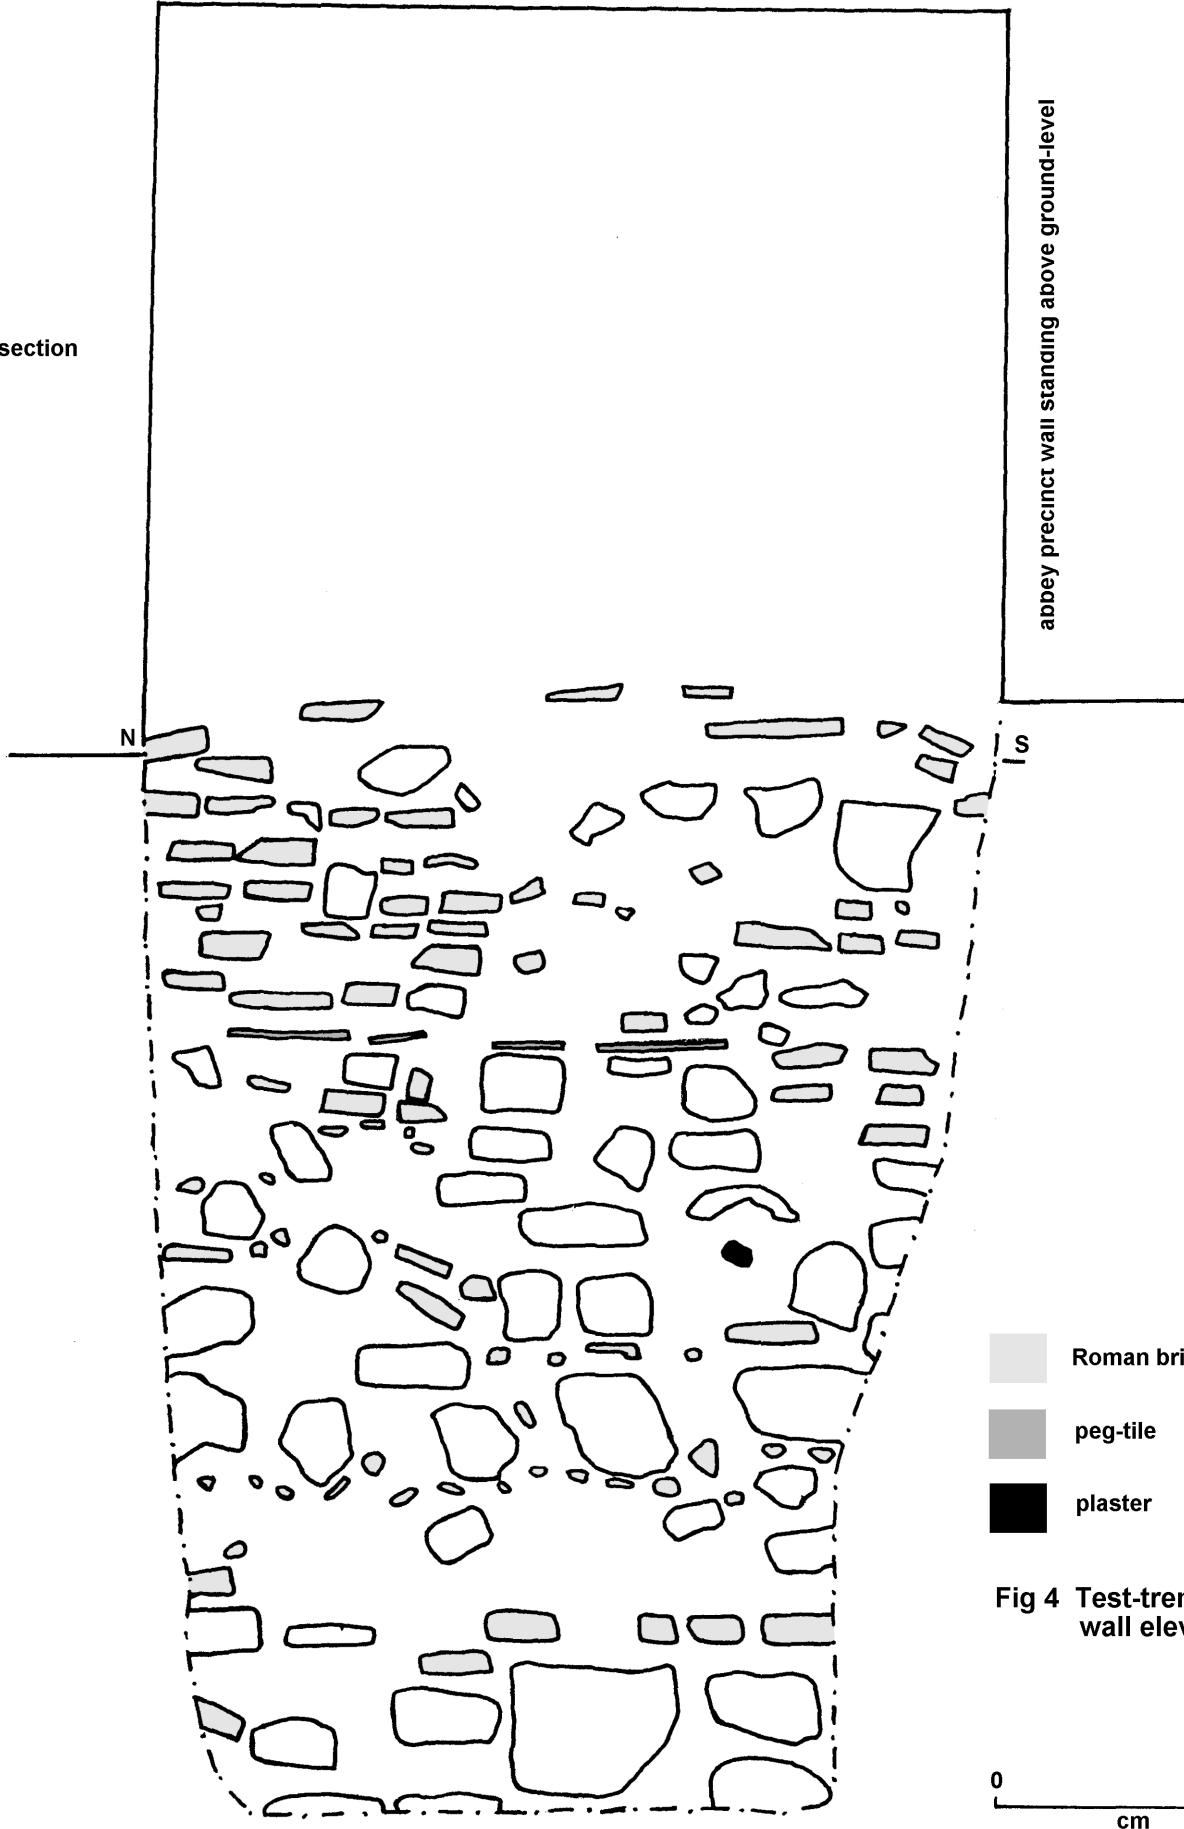
Fig 4 Test-trench 3: wall elevation.

Above ground-level, the precinct wall has been repaired and patched using a combination of both original building materials and modern brick and peg-tile. Below ground-level (Fig 4), the upper 60cm of the wall appears to have been extensively repaired using tile and brick. There is also a course of peg-tile built into the wall at 65cm below ground-level. There is slightly more evidence of visible coursing in the structure of the wall, although there are still large amounts of tile and tile fragments. The whole wall also appears to have been faced at some time, covering the stone and tile. At 80cm there is a fragment of plaster adhering to the surface of the wall, which possibly explains the covering of the wall face. The plaster on the face of the wall also goes some way to explaining the presence of the rubble and mortar of L3. L3 contained building rubble and large amounts of the same kind of plaster as the fragment still attached to the precinct wall. L3 could represent rubble from the demolition of a building or structure that stood against the precinct wall, the inside of which was roughly plastered and then whitewashed. As with Test-trenches 1 and 2, the finds from Test-trench 3 are very mixed. The pottery is as before a mixture of modern, medieval and Roman sherds. The other finds are a mix of material that ranges from peg-tile and modern glass to Roman tile, animal bone and oyster shell. Test-trench 3 does, however, contain the rubble L3 under the organic topsoil L1 and the buried topsoil L2, indicating that the structure had been demolished before these layers were deposited (at a similar period to L1 and L2 in Test-trenches 1 and 2). The soil was probably dumped on the site during the post-medieval period (Crummy *et al* 1993, 203).

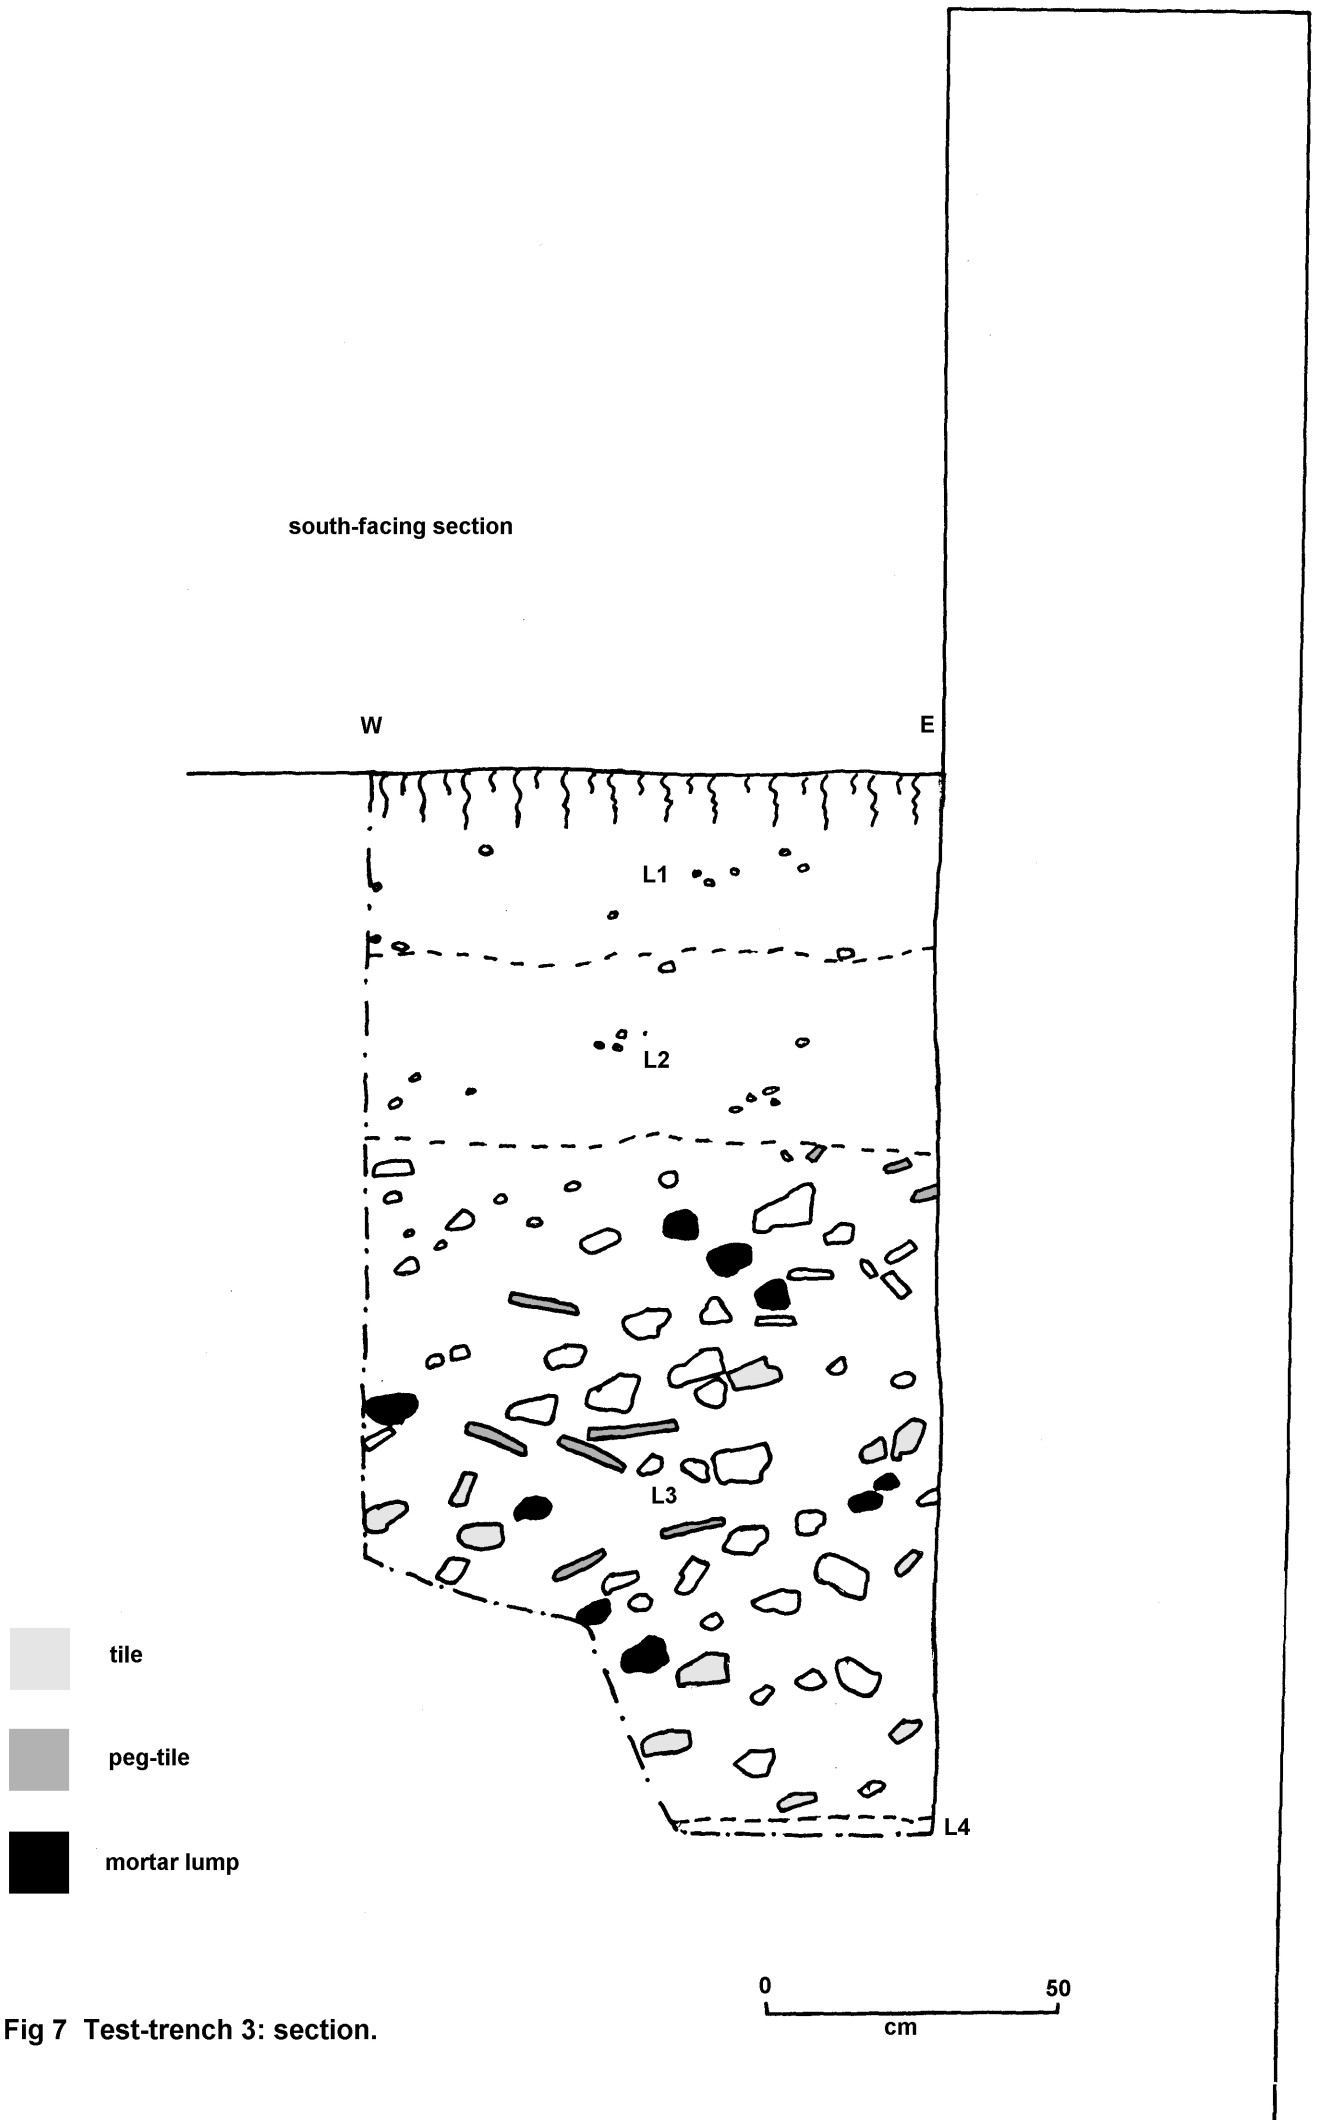
Fig 7 Test-trench 3: section.

rubble and mortar, consisting mainly of peg-tile and mortar lumps and brick. L3 was 1.10m deep and contained much plant-root activity. Below this rubble layer there was a further deposit (L4), which was an orange/brown sand that contained no plant-root activity or organic material and was possibly the natural. No features were exposed in any of the layers L1, L2, L3 or L4. As the test-trench was excavated, the inner face of the precinct wall was exposed to allow the structural engineer to assess its condition and stability.
