**Mill House,
Mill Lane,
Dedham, Essex**

Heritage Asset Assessment

October 2014

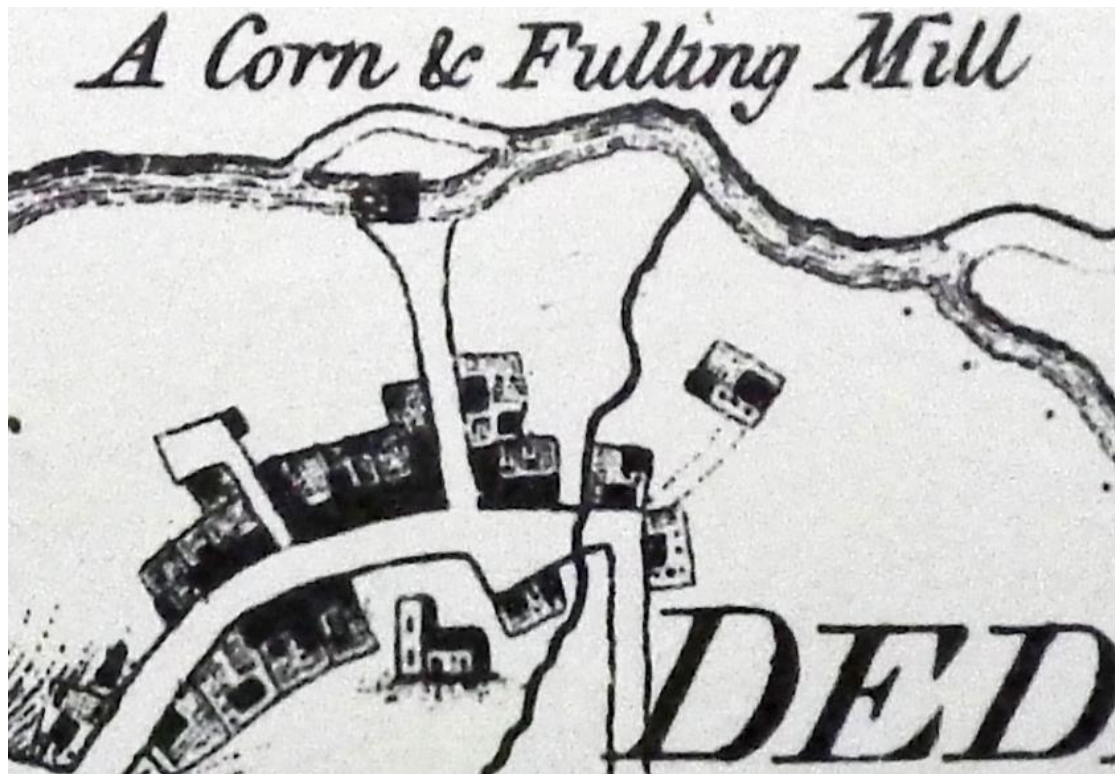
Figure 2. Dedham on Chapman & Andre's map of 1777, showing Mill House as a stylised rectangle on the right-hand side of the road equidistant between the mill to the north and St Mary's church to the south.

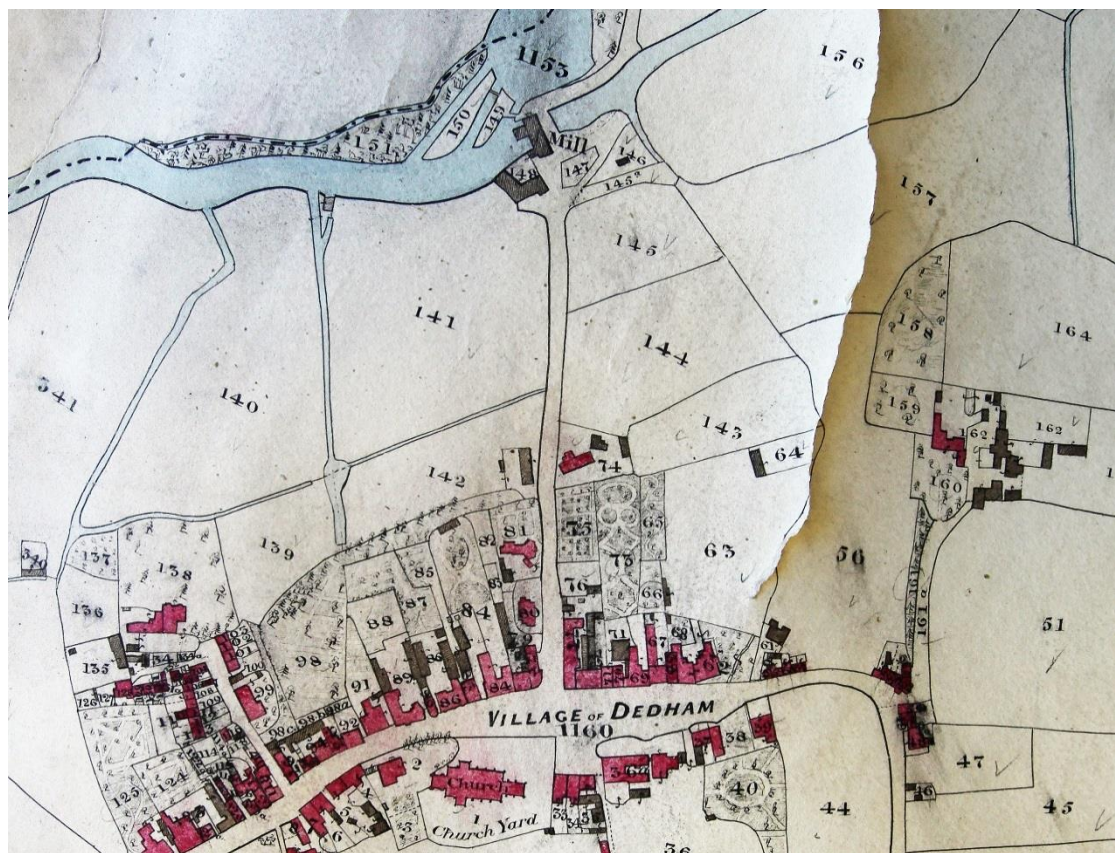
Figure 3. The 1838 tithe map of Dedham. Mill House is conspicuous as the only building depicted in red on the right-hand (eastern) side of Mill Lane. See detail below.

The 1838 tithe map of Dedham parish shows the house in red with a rectangular outline and a stepped projection at the western end of its northern elevation representing the 'office' and lean-to 'hall' of figure 9. A detached outbuilding occupies the approximate position of the existing brick brew-house, almost abutting the north-eastern corner of the house, but its markedly different alignment indicates that it must be a timber-framed predecessor of the present structure. (Tithe maps typically show brick and domestic structures in red with framed outbuildings in grey.) A rectangular outbuilding to the east of the site is likely to represent the weatherboarded southern end of the present stable range as it extends less far to the north: the boundary of the adjoining field curves sharply southwards to meet its north-eastern corner where the current boundary is straight.

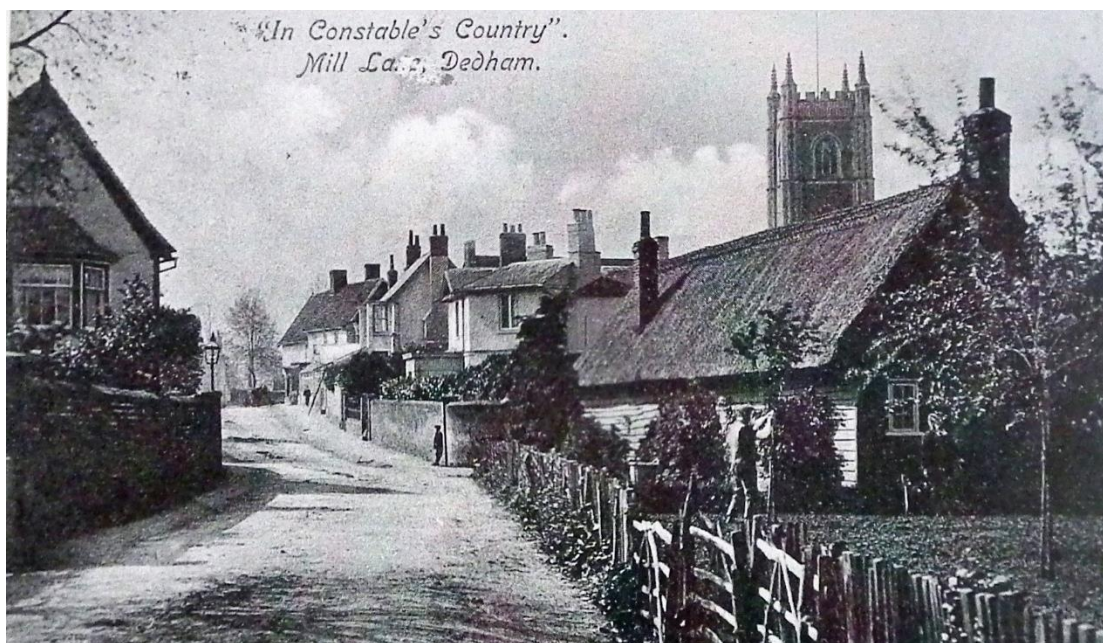
Figure 6. Mill Lane from the north in *circa* 1905. The Mock Tudor restoration of Mill House had not yet taken place as its gable preserves a Victorian canted bay window. (From a postcard published in *Dedham, Flatford and East Bergholt: A Pictorial History*, Ian Yearsley, Phillimore 1996. Pictorial postcards became popular from *circa* 1900.)

Illus. 2. The house from the south, showing the large mid-19th century extension with its canted bay window in the centre. A similar window is visible to the north in figure 6.

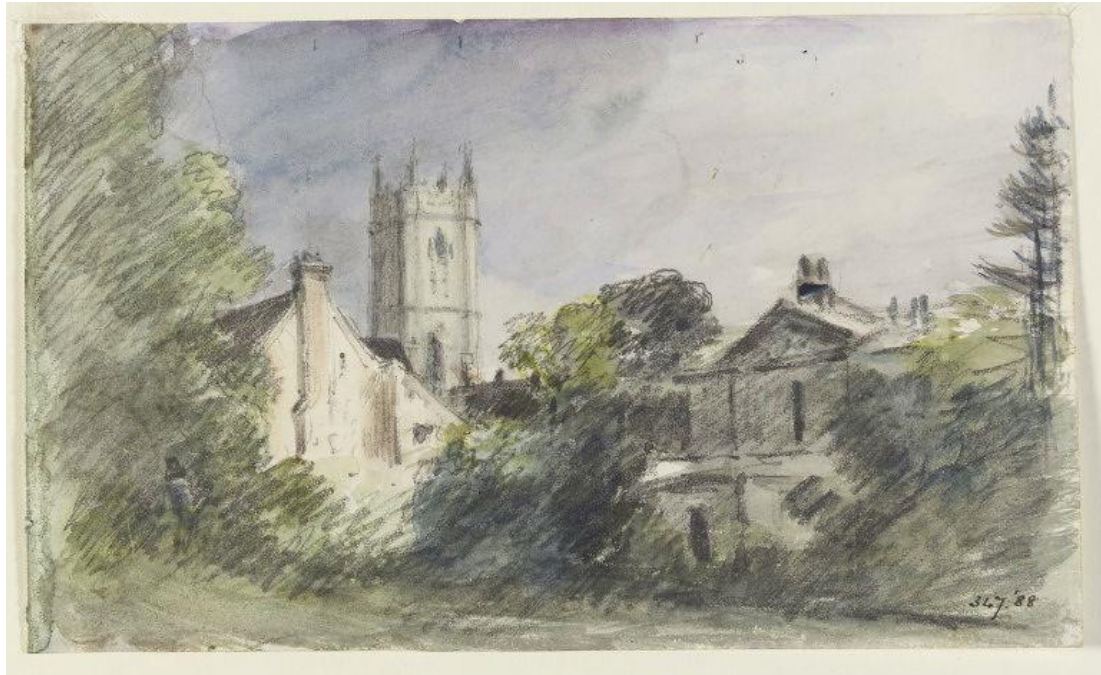
Figure 7. 'Houses in Dedham, with the church tower'. (V&A. Reynolds' *Catalogue of the Constable Collection* no. 370). A watercolour by John Constable painted in *circa* 1832 and identified by Reynolds as a view from Mill House Dedham. The pedimented gable of the house in the centre of figure 6 is visible here to the right.

Mill House is a grade II-listed timber-framed and rendered building on the eastern side of Mill Lane, approximately equidistant between St Mary's church and Dedham Mill. In addition to its historic fabric, which includes fine carved details of the early-17th century, the property is of special importance as the home of John Constable's sister Martha between 1821 and her death in 1843. Constable is known to have visited the house, and a view of Mill Lane apparently painted from a first-floor window is now in the V&A (figure 7).

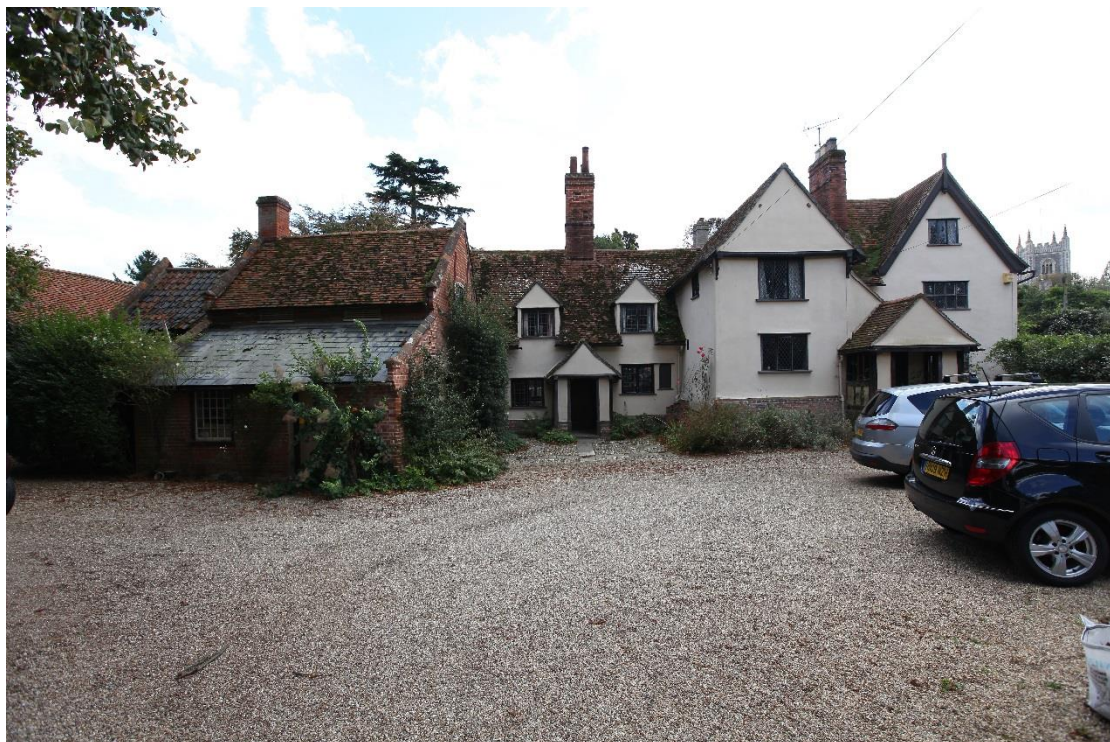
Illus. 1. Mill House from the north, showing St Mary's church to the right, the red-brick brew-house to the left and the roof of the stable to the extreme left. The low section of the house in the centre was built as an open hall in the 16th century and the right-hand parlour cross-wing was added in the 17th century. The central wing is also a 17th century addition and appears to have formed a rare 'closet' tower with an integral cellar.

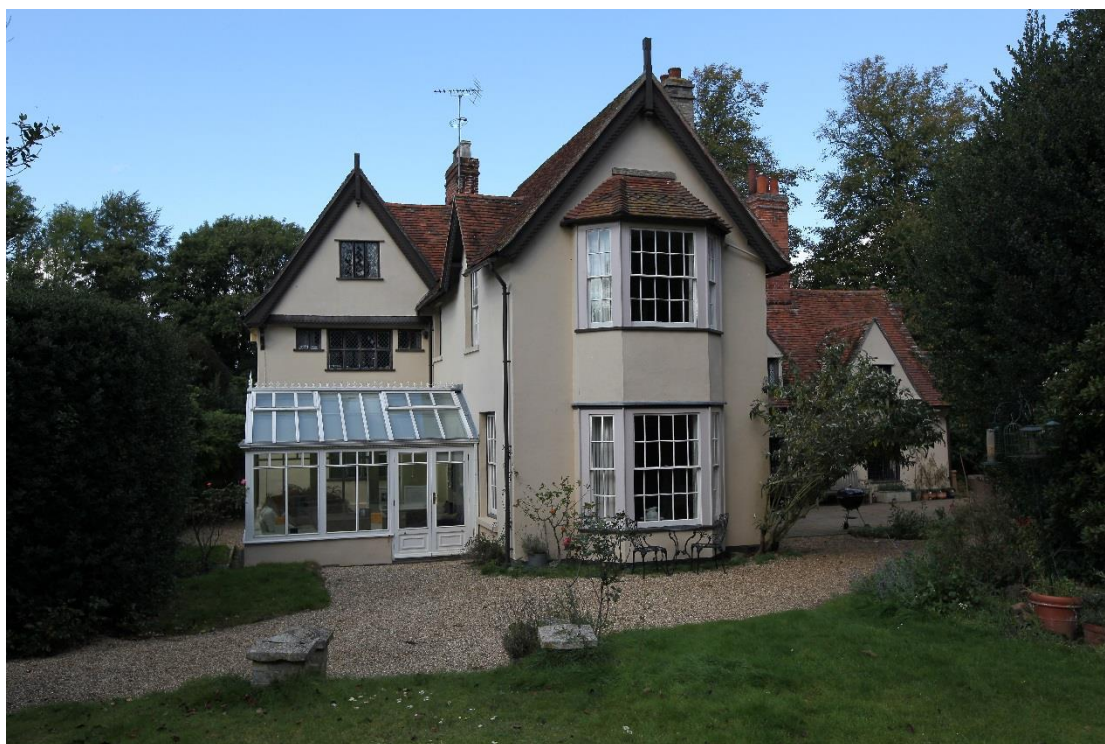
This elevation was the principal façade of the 17th century building and preserves a series of finely carved brackets beneath its gables.

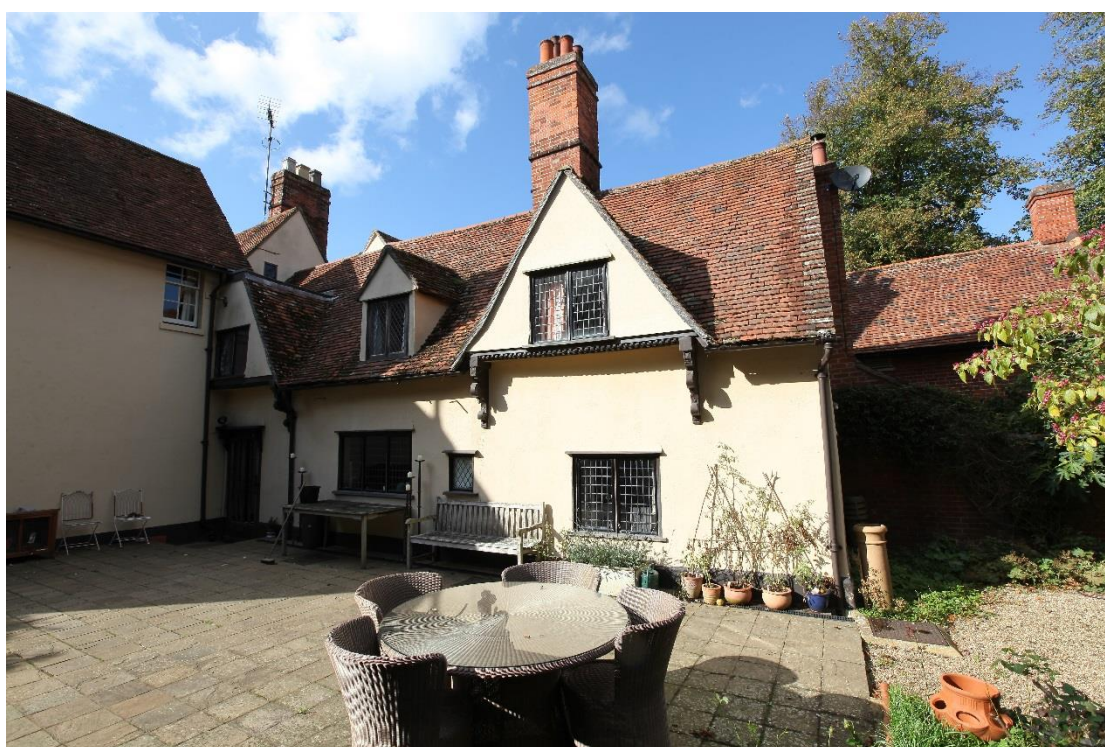
Illus. 3. The best preserved section of the southern façade to the east of the Victorian extension which retains fine early-17th century brackets beneath its projecting gables. The brew-house is visible to the right.

façade is now interrupted by a large Victorian extension (the lounge in figure 9) which obstructs the westernmost gable of the hall as shown in illus. 3 but was typical of its era; many local houses combine low hall and service ranges with much higher 17th century parlours as their medieval predecessors were rebuilt to accommodate changing domestic expectations of scale and comfort. The short section of high roof between the parlour gable and the hall was designed to accommodate a massive chimney stack containing back-to-back fireplaces heating the hall, parlour and parlour chamber, but this has been removed and the present stack is a much later replacement. The 17th century northern wing (the office in figure 9) is a highly unusual feature containing a contemporary half-cellar and small chambers adjoining each floor that probably operated as ‘closets’; a gentleman’s closet at the beginning of the 17th century was expected to measure 12 ft by 12 and functioned as a relatively private dressing room. The ground floor room with a neatly chamfered ceiling may have formed a study in much the same manner as today.

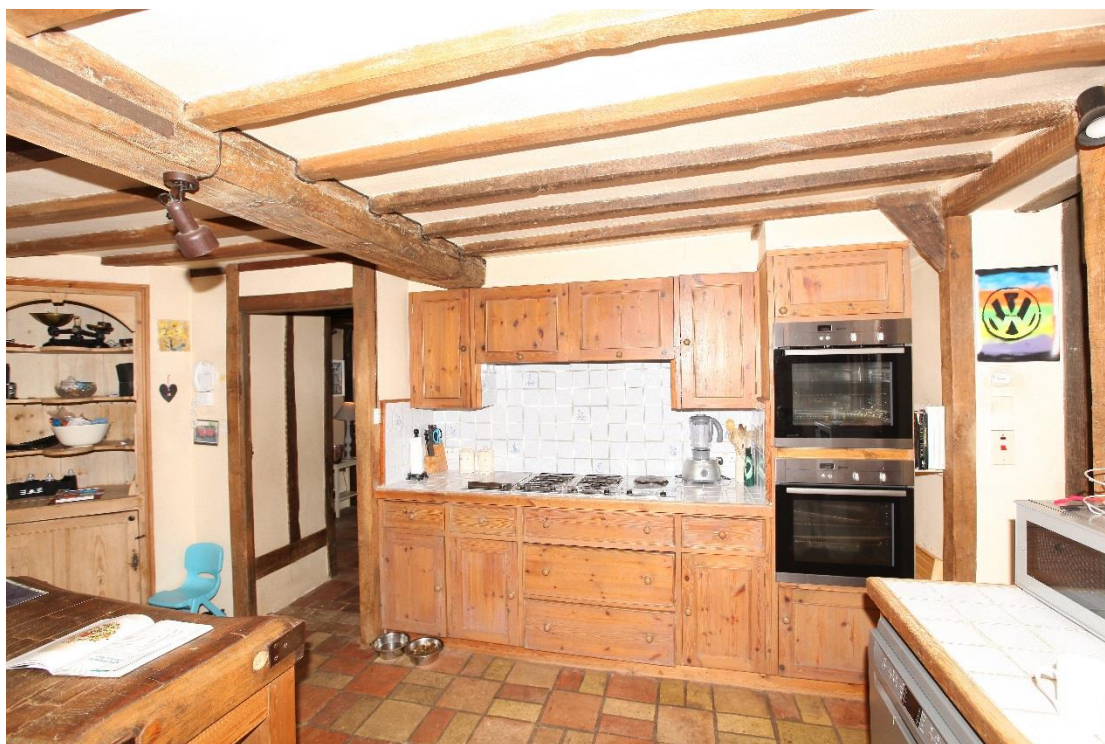
Illus. 4. The kitchen from the east (as named in figure 9) showing the intact 17th century ceiling which interrupts an earlier arch-brace in the top right-hand corner. This brace rose to the tie-beam of a barn-like open hall before the ceiling's insertion.

roof-plate of the chamber over the playroom, and part of an original brace can be seen in the north-western corner of the kitchen (illus. 4). This brace would have risen to a tie-beam that spanned the walls and supported the roof with a central crown-post, but its upper section has been removed along with the northern end of the tie-beam. The central section of the original tie-beam survives intact, having been incorporated into a first-floor partition during the 17th century (illus. 6). This partition now divides a WC from the bathroom above the dining room, and retains some contemporary wattle-and-daub (the coppice poles recently exposed) along with the jambs and lintel of a 17th century doorway. The evidence of a crown-post indicates a date prior to the mid-16th century, when this form of roof disappeared from Essex, but the lack of sooting from an open hearth suggests the hall is a late example of its type, built at the beginning of the same century when many were provided with enclosed chimneys. More detailed analysis of this structure is impossible given its later alterations and the extent to which the framing is either lost or hidden within the modern walls.

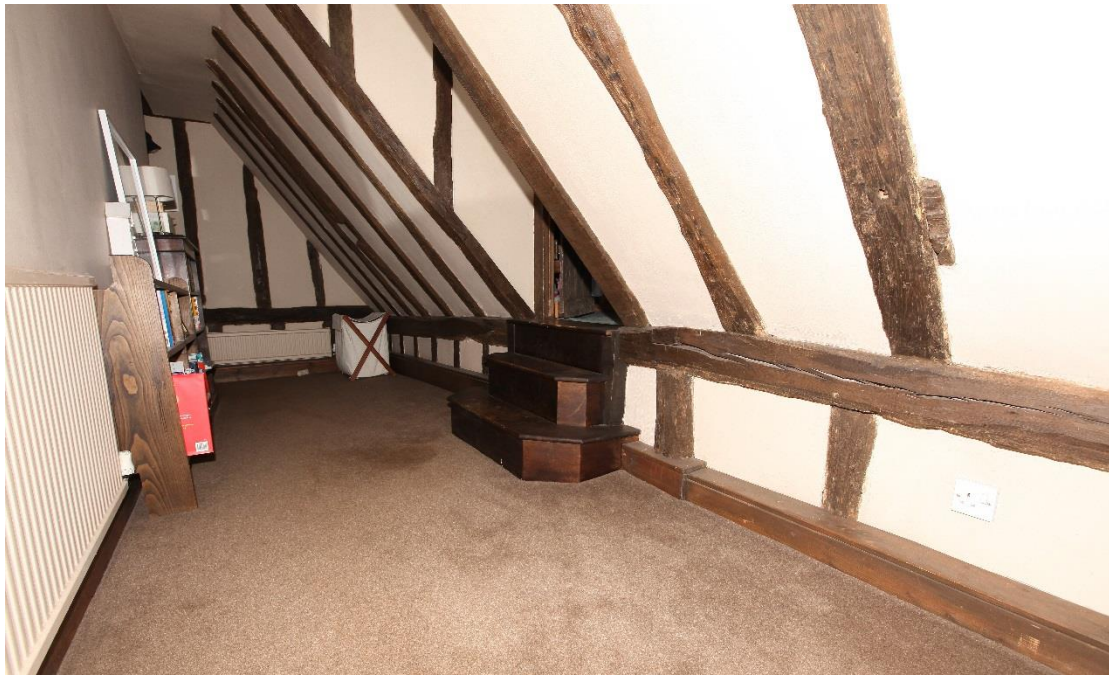
Illus. 5. The first floor corridor immediately above the kitchen, seen from the east. The roof-plate to the right of the steps (which lead to the upper chamber of the ‘closet’ tower) contains a dovetail joint for the missing horizontal tie-beam to which the bracket in illus. 4 originally rose. The central section of the tie-beam survives intact beyond the 20th century partition to the left (illus. 6).

The internal first-floor partitions above the dining room and kitchen form a corridor and bathrooms as shown in illus. 5. These partitions appear to consist of mid- or late-20th century plasterboard and could be remodelled without damaging the historic fabric or integrity of the building. The exception is the partition between the bathroom above the dining room and its small WC, which dates from the 17th century and preserves part of the original 16th century tie-beam as described above and shown in illus. 6. The door frame is part of the 17th century refurbishment but could be blocked without affecting historic fabric. The door between the first-floor corridor and the eastern bedroom is a 17th century feature but hangs on 20th century hinges and is not original to its position. The ground-floor partition between the dining room and kitchen (illus. 4) is also a secondary insertion consisting of re-used studs and including a genuine panelled door. The ceiling joists above these studs contain the nails of a lath-and-plaster ceiling that was removed before their insertion, and the dining room and kitchen was formerly a single space. The partition probably dates from the early-20th century restoration from which much of the property's present character derives, and is accordingly of some historic significance despite its relatively late arrival.

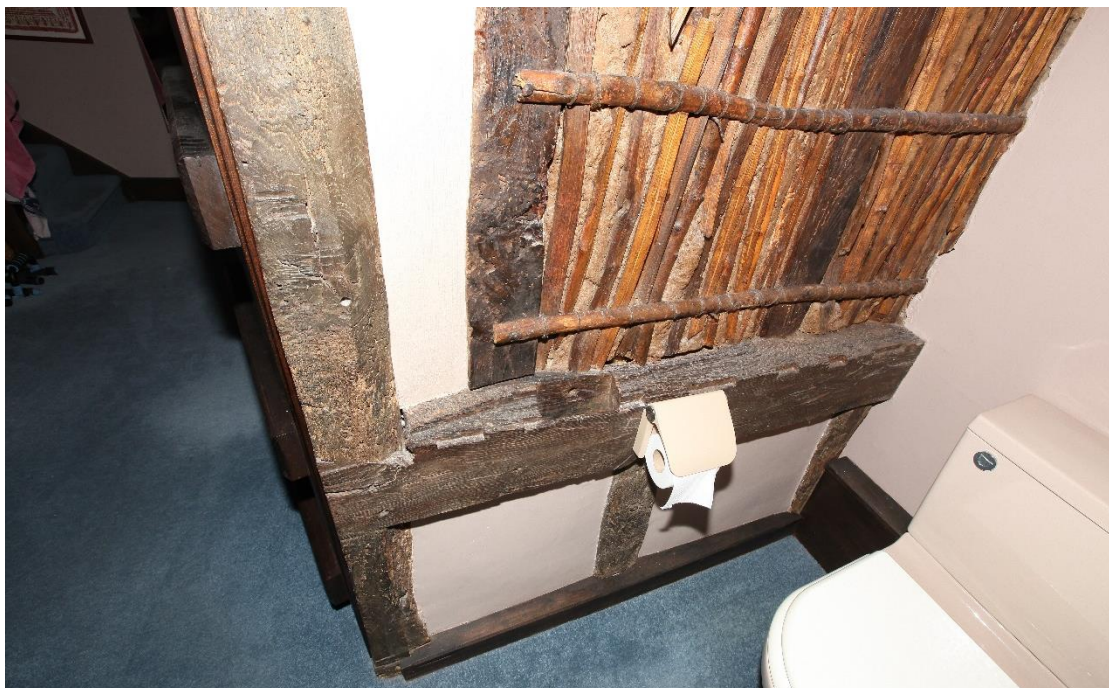
Illus. 6. The intact central section of the tie-beam which spanned the width of the 16th century open hall, seen from the east. The pegged mortise in the centre of the beam (to the left of the toilet-roll holder) held a crown-post which supported the original roof, but this was rebuilt in the 17th century when the present wattle-and-daub partition was inserted. The left-hand section of the beam is interrupted by a 17th century door frame.

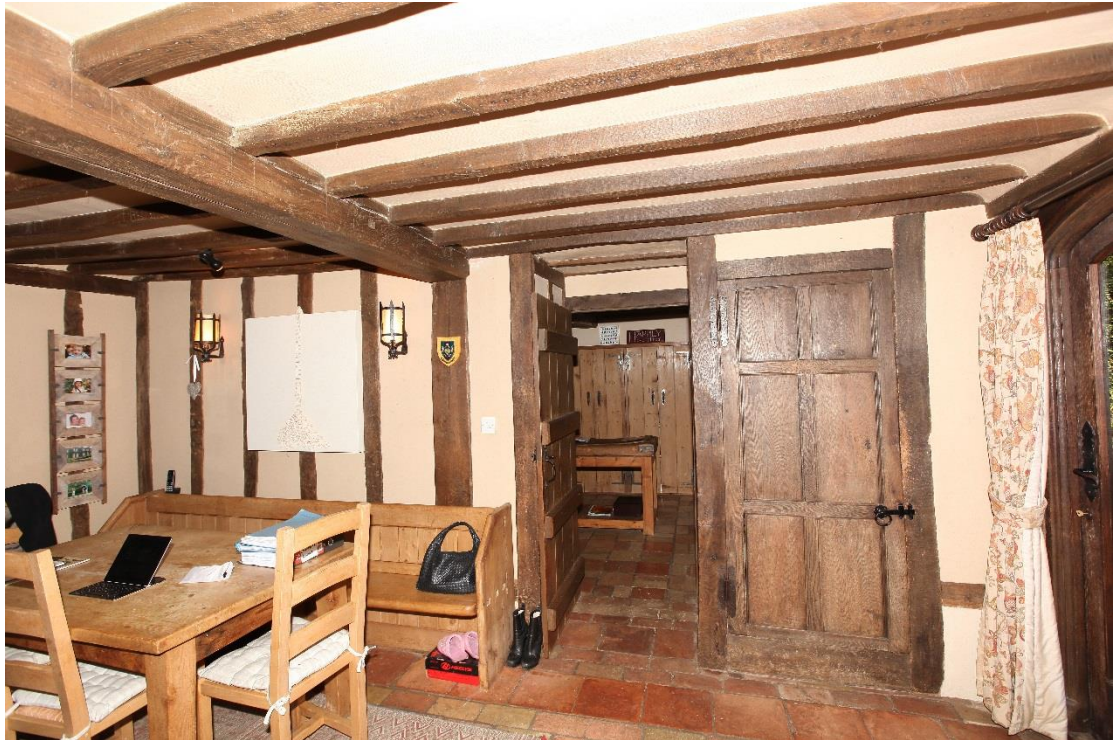
Illus. 7. The dining room from the west, showing the entrance to the kitchen. The dividing partition consists of old timbers and incorporates a 17th century panelled door, but is a 20th century insertion that post-dates the removal of lath-and-plaster from the ceiling joists. The dining room and kitchen originally formed a single hall.

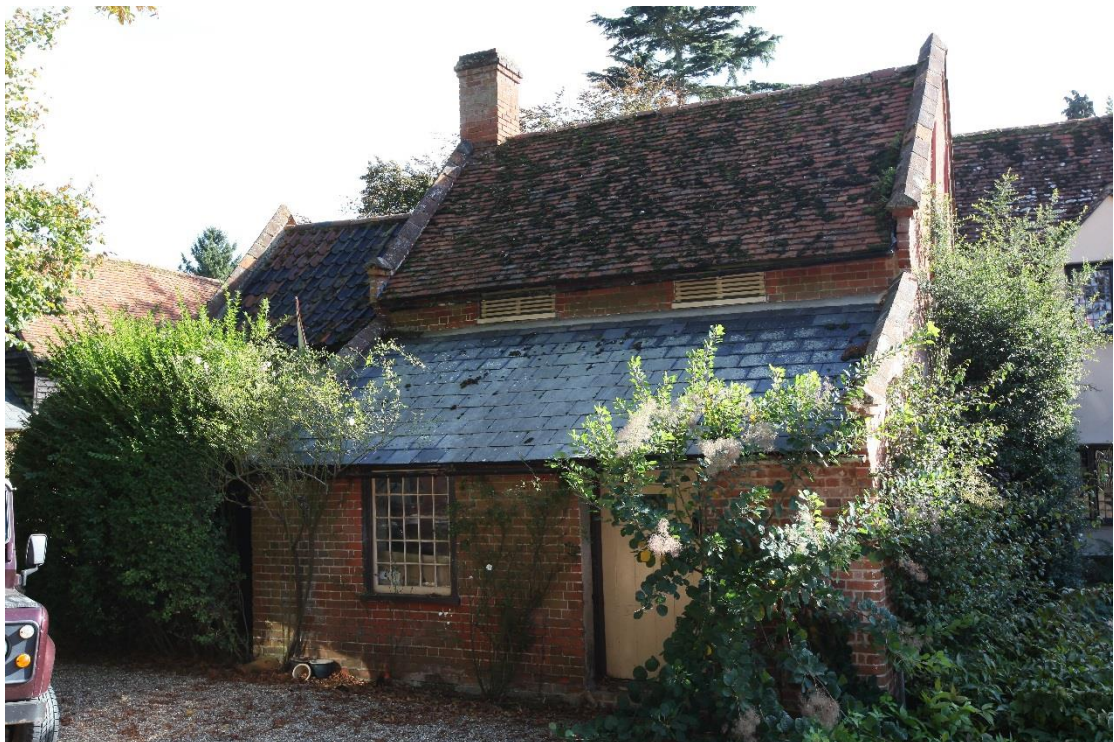
Illus. 8. The unusually well-preserved red-brick brew-house seen from the north. Despite their different roofs the slate lean-to in the foreground and the pantiled shed on the left are integral to the peg-tiled structure. Note the original ventilation louvers above the lean-to wood store. The right-hand (north-western) corner of the lean-to has been rebuilt and its present doorway occupies the position of an original window.

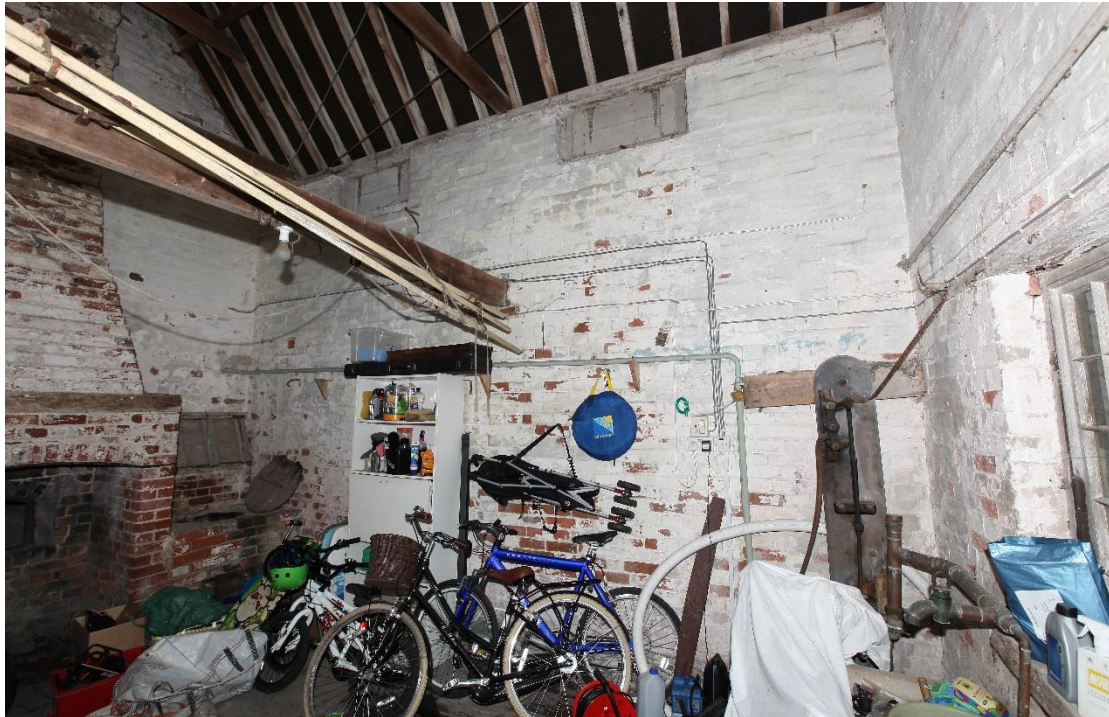
Illus. 9. The southern interior of the brew-house with pump and sink to the right and chimney to the left. Note the vertically hinged shutters to the ventilation louvers matching those of the opposite wall shown in illus. 8. The space has never contained a ceiling and the wooden beam spanning the walls retains a number of meat hooks.

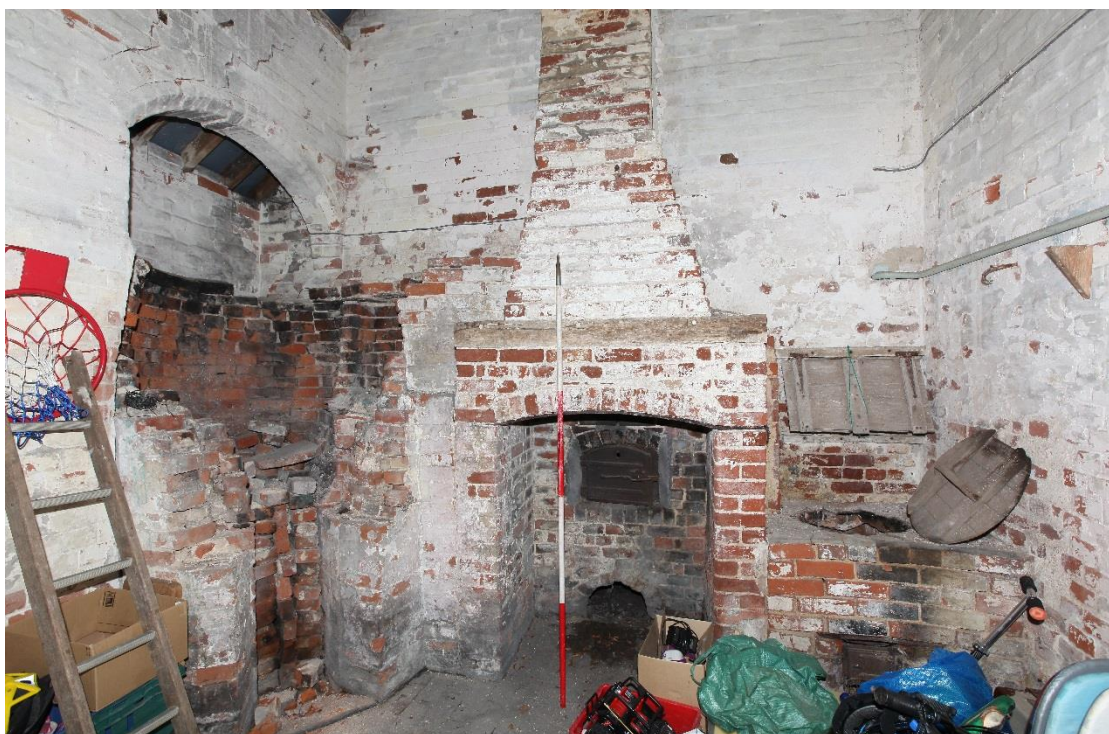
Illus. 10. The impressive original bread oven at the eastern end of the brew-house, with a slightly later copper to the right. The vertically hinged shutter above the lidded copper conceals a series of ventilation loops in the brickwork. The domed oven is intact behind its iron door with an ash hole beneath. The partly destroyed brick structure to the left probably supported a large brewing copper approximately 1 m above the floor, but this has been removed.

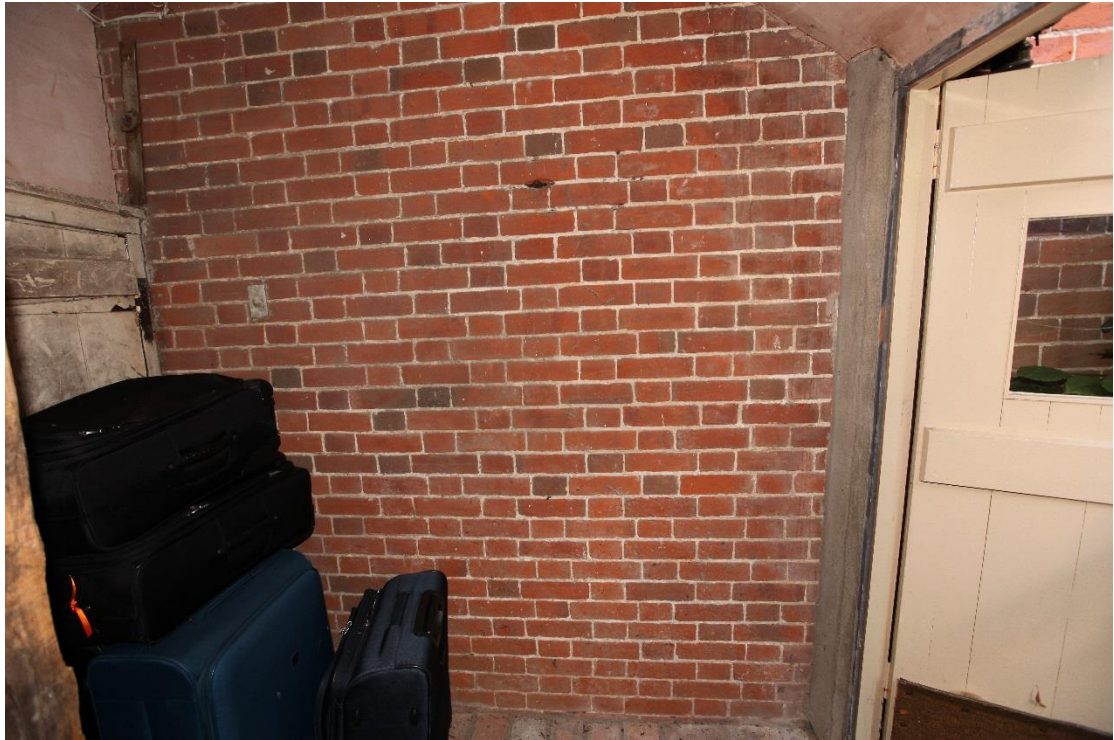
Illus. 11. The southern external wall of the brew-house seen from the secondary ‘lobby’ (figure 9) which now links the structure to the main house - the corner post of which is visible to the left. It should be possible to insert a new door to the right of this wall and so avoid damaging the internal pump in the south-western corner of the brew-house.

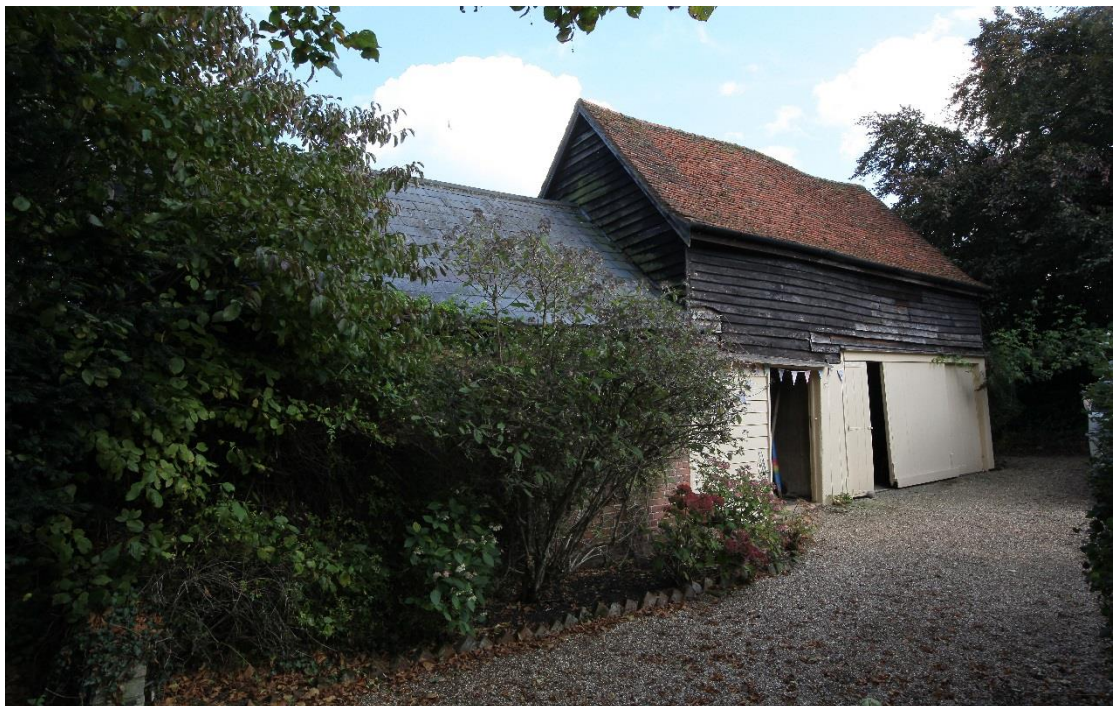
Illus. 12. The western façade of the stable from the north-west. The single-storied red-brick structure on the left is a well preserved mid-19th century stable with its original fixtures and fittings (area A in figure 8). Two windows are hidden behind the undergrowth. The timber-framed structure was probably built as a stable, cart shed and hay loft in the late-18th century (B); the sliding doors to the right-hand section are insertions of the 20th century but much of the chamfered weatherboarding is original.

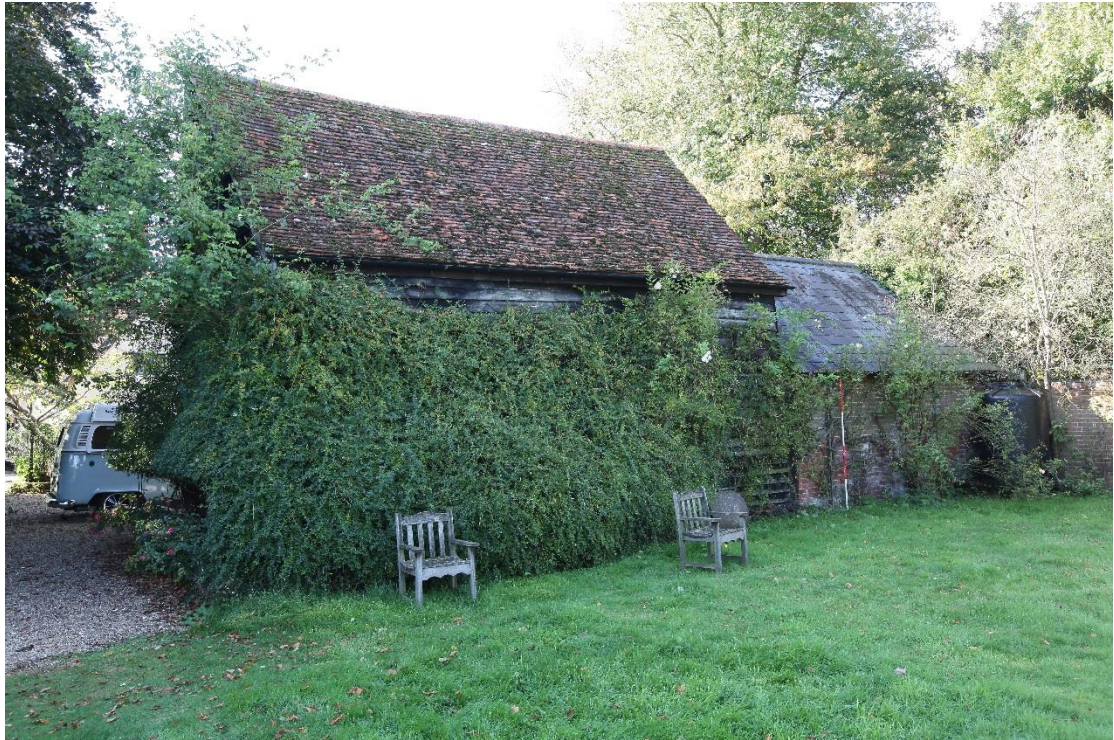
Illus. 13. The stable range from the rear (east). This elevation lacks windows and doors as in the typical manner of early stables which contained mangers and hay racks against their back walls. The tarred weatherboarding of the timber-framed section to the left appears to be intact behind the vegetation.

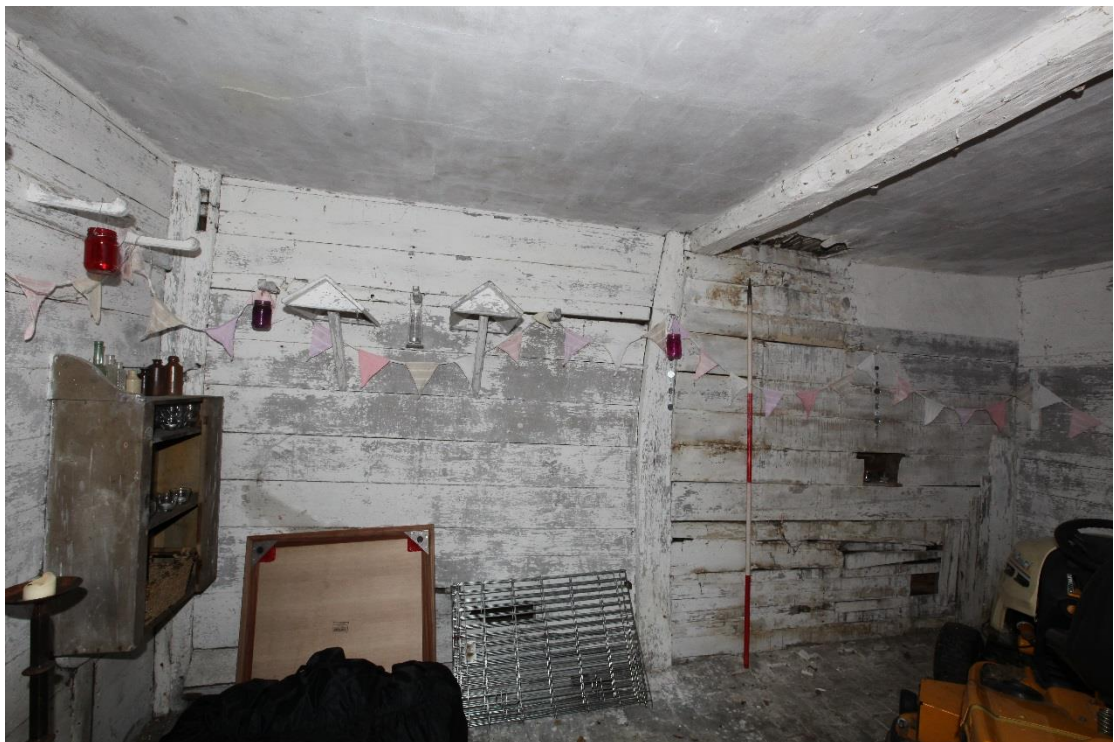
Illus. 14. The rear (eastern) internal elevation of the southern section of the stable, now used as a vehicle shed but with 19th century wooden harness hooks visible to the left. The walls consist chiefly of re-used 16th or 17th century timber but it is possible that a small section survives *in situ* behind the ostensibly original boarding at lower levels.

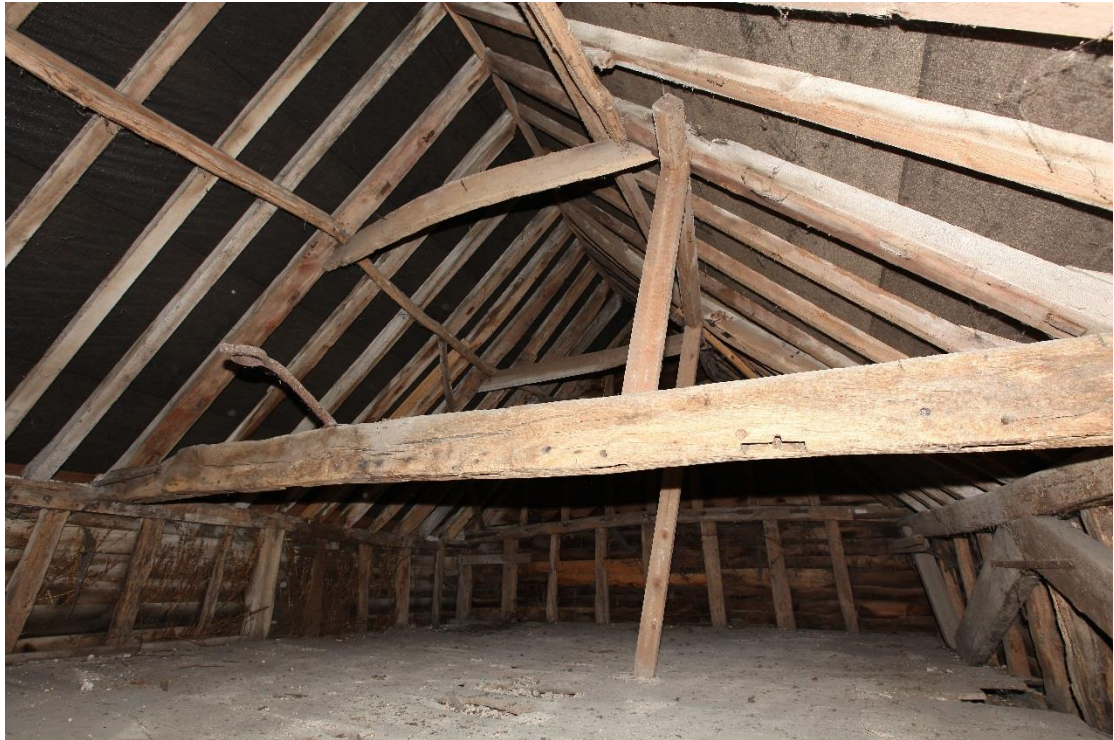
Illus. 15. The loft above the timber-framed stable (B), seen from the north. Almost all the timbers visible here have been re-used from one or more older structures in a manner typical of the 18th century. The (re-used) rear roof-plate to the left contains an edge-halved and bridled scarf joint of the 16th century.

The timber-framed structure extends to 26 ft in length and rises to 11 ft at its eaves with a low loft above its internal ceiling (illus. 15). The wall framing is hidden by internal and external boarding on the lower storey, much of which is original, but where exposed in the loft consists of re-used material from at least two buildings of the 16th and 17th centuries. (The edge-halved scarf joint of the rear (eastern) roof-plate is typical of the 16th century while the face-halved version to the west is not found until the 17th century.) It is possible but unlikely that something earlier survives intact at a lower level. The southern section of the interior forms a cart shed entered by 20th century sliding doors to the west, and retains a number of wooden harness hooks in its north-eastern corner (illus. 14). A narrow horse stall of 9 feet in length at the northern end of the building is entered separately from the west and retains an

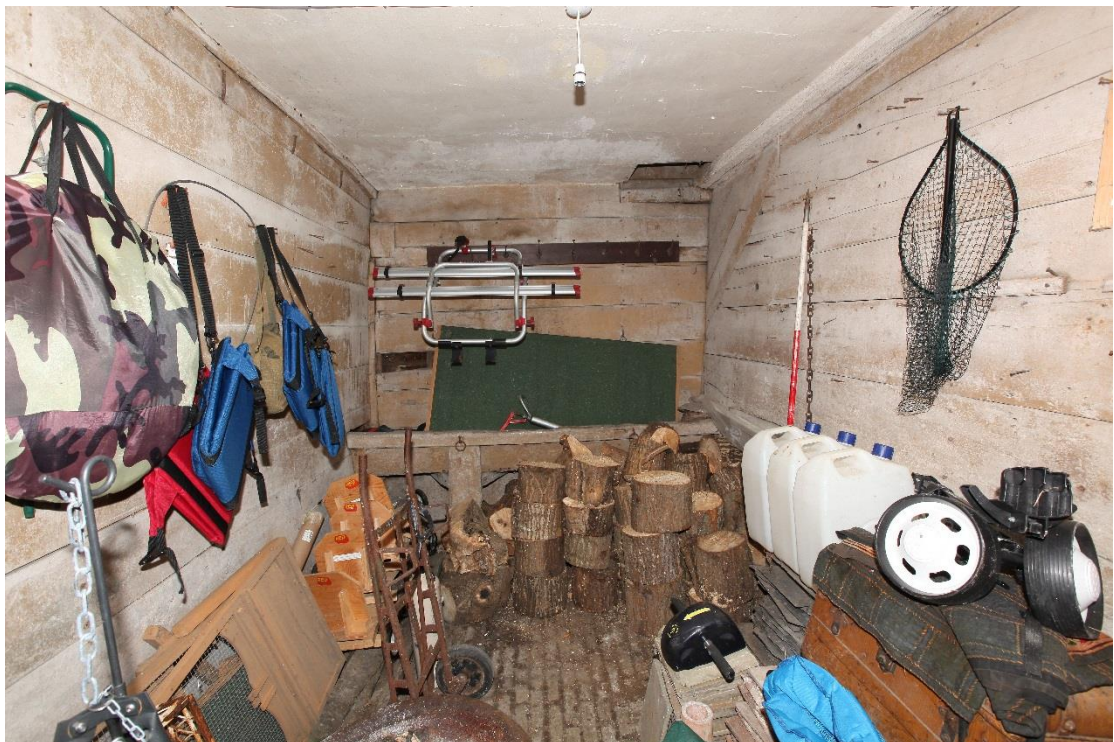
Illus. 16. The stall at the northern end of the timber-framed stable, which retains its impressive late-18th century boarding and brick floor along with a mid-19th century wooden manger. The diagonal scar of a missing hay rack can be seen above the manger to the right. John Constable may well have used this very stall on his visits to the house.

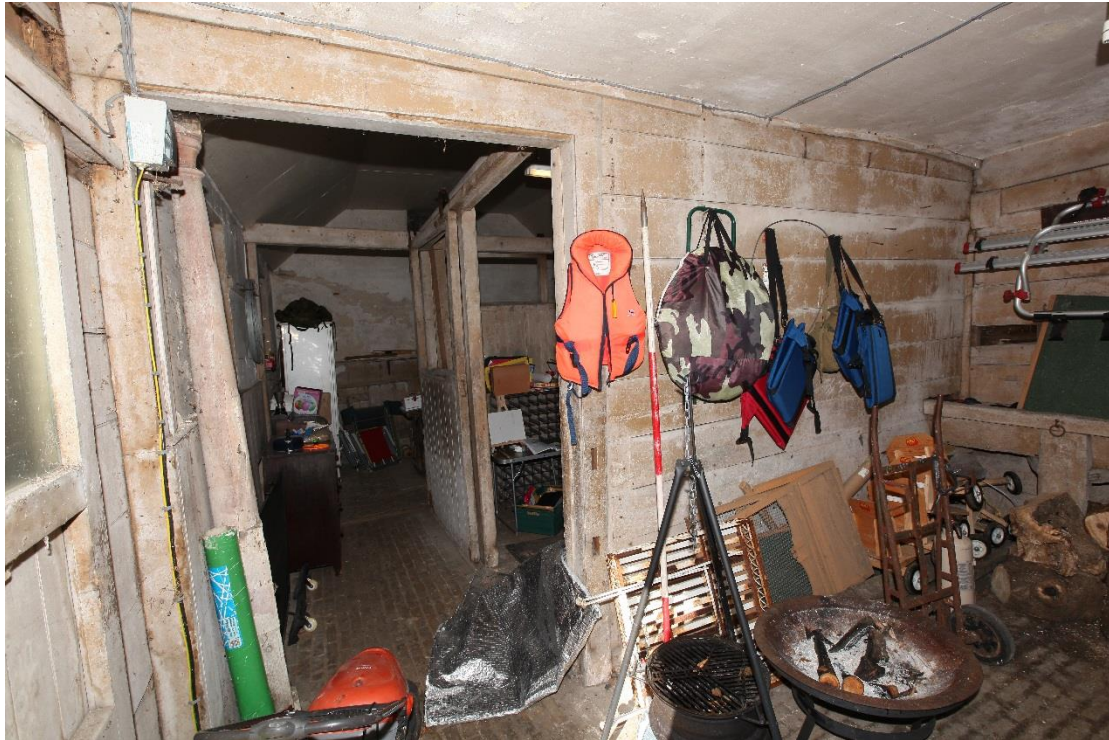
Illus. 17. The interior of the 18th century stable from the south, looking into the single-storied mid-19th century extension which retains almost all its original fixtures and fittings. The turned 17th century column to the left is not part of the structure.

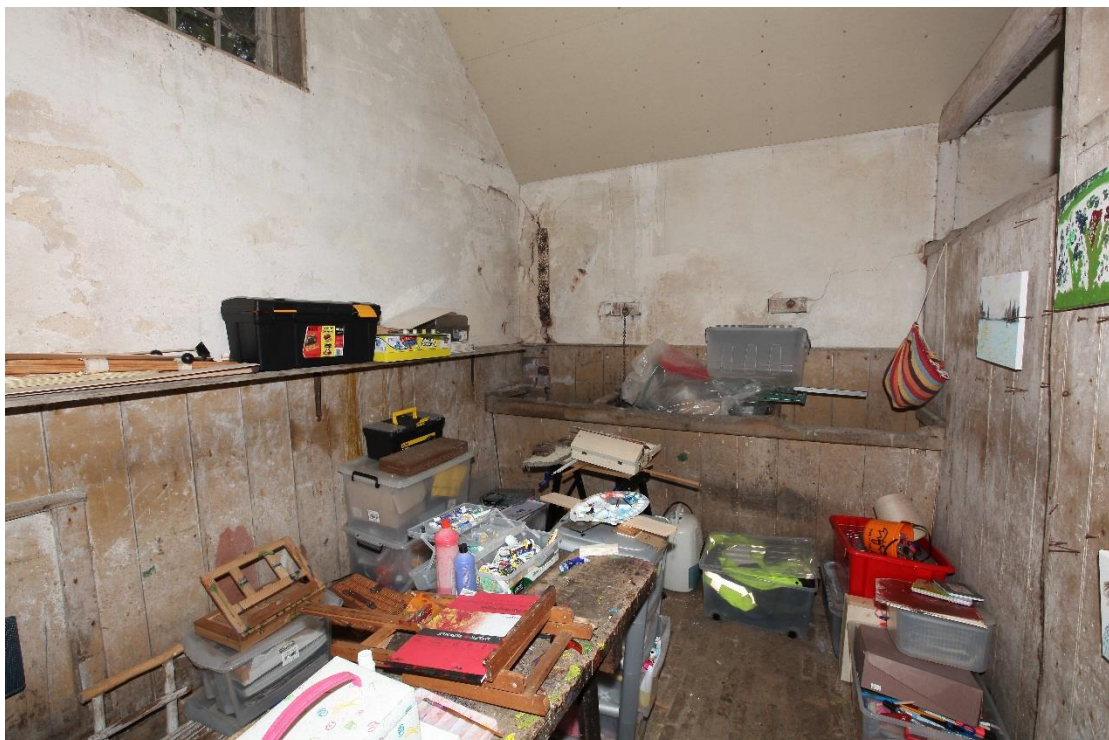
Illus. 18. The stall with its original boarded manger at the northern end of the 19th century red-brick stable, viewed from the west. The wainscot consists of narrow painted boards in contrast to the much larger horizontal boards of the 18th century stall to the south. A small aperture in the northern gable to the extreme left was designed to assist mucking out and is a common feature of early stables.
