Knights Manor, East Lane, Dedham, Essex

Heritage Asset Assessment

Knights Manor,
East Lane, Dedham, Essex
(TM 0613 3223)

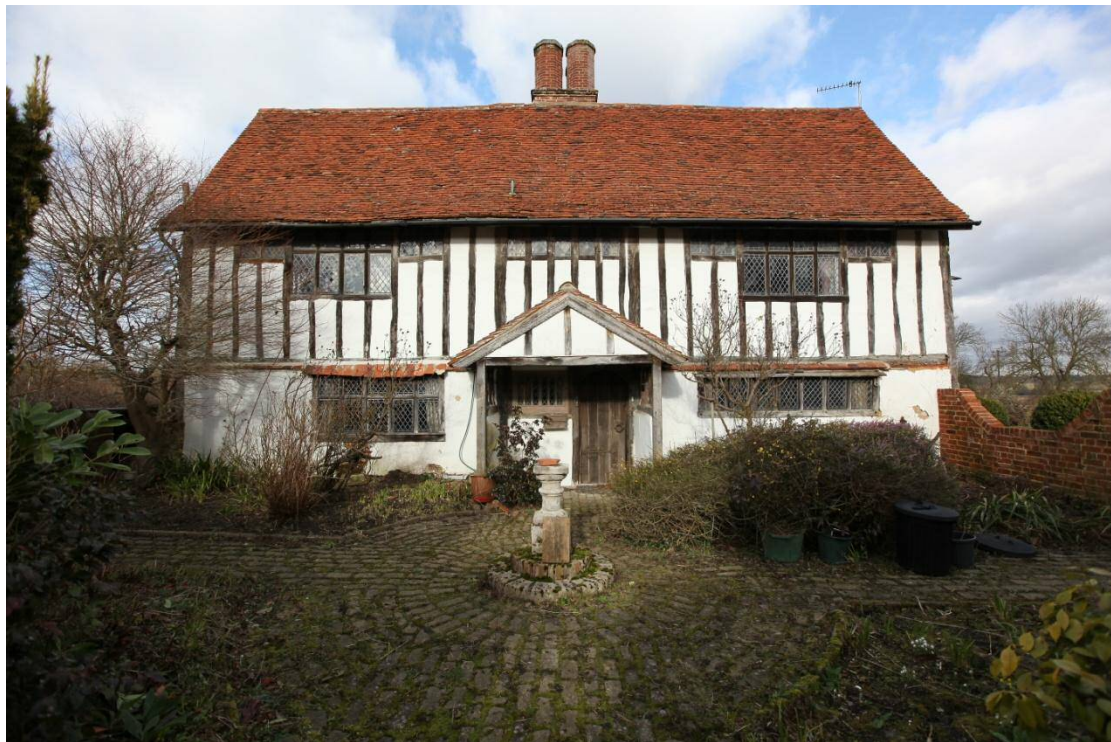
Illus. 1. The southern facade, showing the 1930s porch in the centre. The roof-plate contains mortises for an original two-storied porch and there is evidence of a blocked first-floor door immediately above the present entrance. The side-lights of the main first-floor windows contain 17th century ovolo-moulded mullions, but the glazing and other mullions date only from the restoration. The original principal windows projected from the facade, and the timber frame was rendered and probably pargeted from the outset.

The height of the porch is by no means the only aspect in which the original facade differed from the present. Ironically the exposed timbers found in most medieval and Tudor buildings, and *de rigueur* for any 1930s restorer, were no longer in favour by the period of Knights Manor, and its framing was never meant to be visible externally. With the advent of window glass and multiple fireplaces during the final quarter of the 16th century it became possible to fully insulate domestic interiors by plastering over the inevitable gaps between the timbers and wattle-and-daub; exposed framing quickly went out of fashion, and the best new houses were lime rendered and decorated by often elaborate patterns of pargeting (resembling the designs which survive here on the fireplaces). There is no doubt that the external framing has been covered in the past, as all the timbers bear the distinctive nail holes and stripes of lath-and-plaster, but the lack of old weathering (**such that even the original carpenters' numerals remain visible**), coupled with the narrow proportions of the studs, prove that it was rendered from the beginning. It was exposed to the elements for the first time by Mrs Roper, and although it forms an important element of her Mock Tudor restoration there can be no doubt that the building is more likely to survive for another four centuries if its protective plasterwork is replaced.

Despite the importance of the exposed framing to the character of the Mock Tudor restoration it may be sensible to compromise in the interests of conservation, and re-render the external timbers to protect the building as a whole from weather damage. The timbers were originally concealed by lime render which was probably pargeted with strapwork designs resembling those of the internal fireplaces, and there is now evidence of water penetration and decay. Part of this problem may be solved by replacing the adjoining cement render with lime, but the building is more likely to survive the next four centuries if it is fully plastered once again.

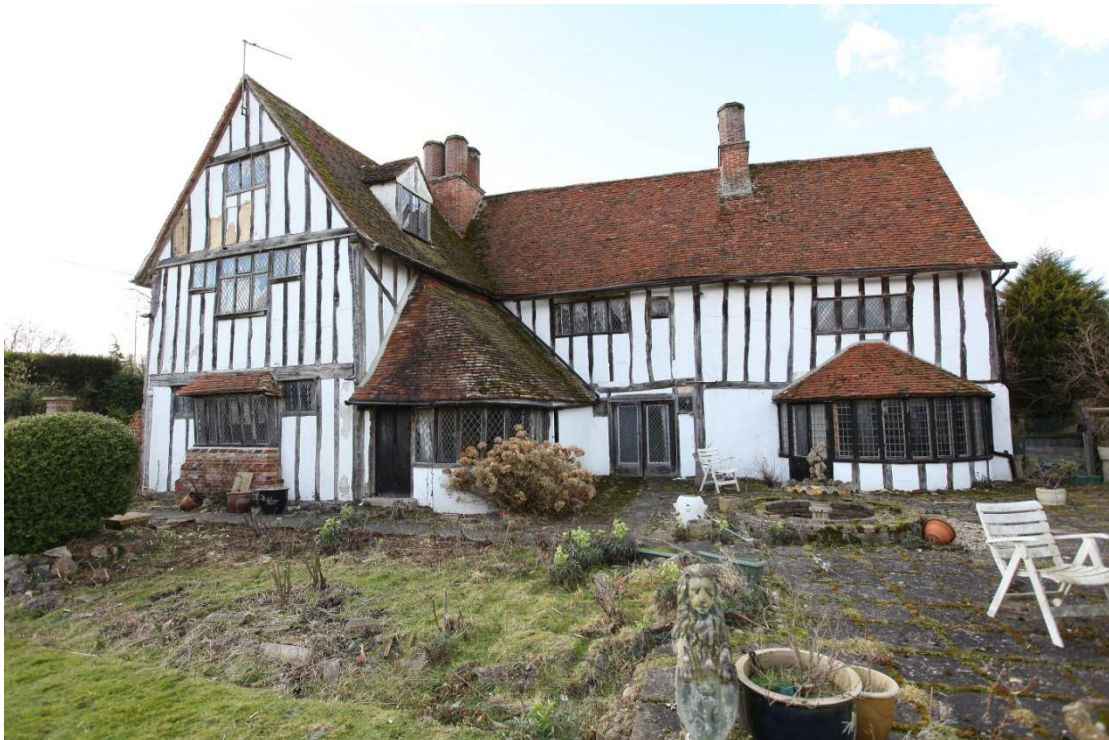
Illus. 2. The building from the garden to the east, showing the distinctively 1930s Lutyens-inspired curved roofs of the bay window and lean-to extension. The octagonal shafts of the main chimney to the left have been reconstructed, but those on the right may be original.

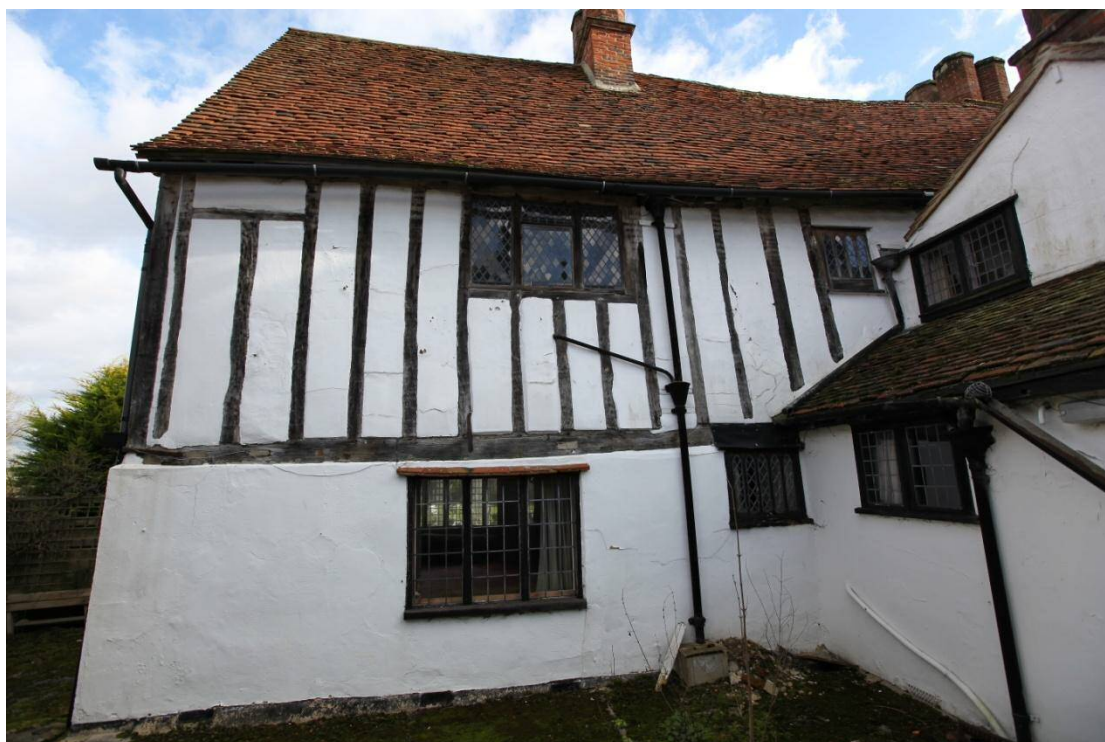
Illus. 3. The rear parlour from the west (marked as the sitting room in figure 7) with the blocked first-floor door on the left. The horizontal lintel is original but the stud beneath is a later insertion. Corresponding mortises in the mid-rail above the ground-floor window suggest the door opened into a demolished garderobe (i.e. a projecting cupboard-like privy). This part of the building appears to pre-date the southern wing but has been much rebuilt.

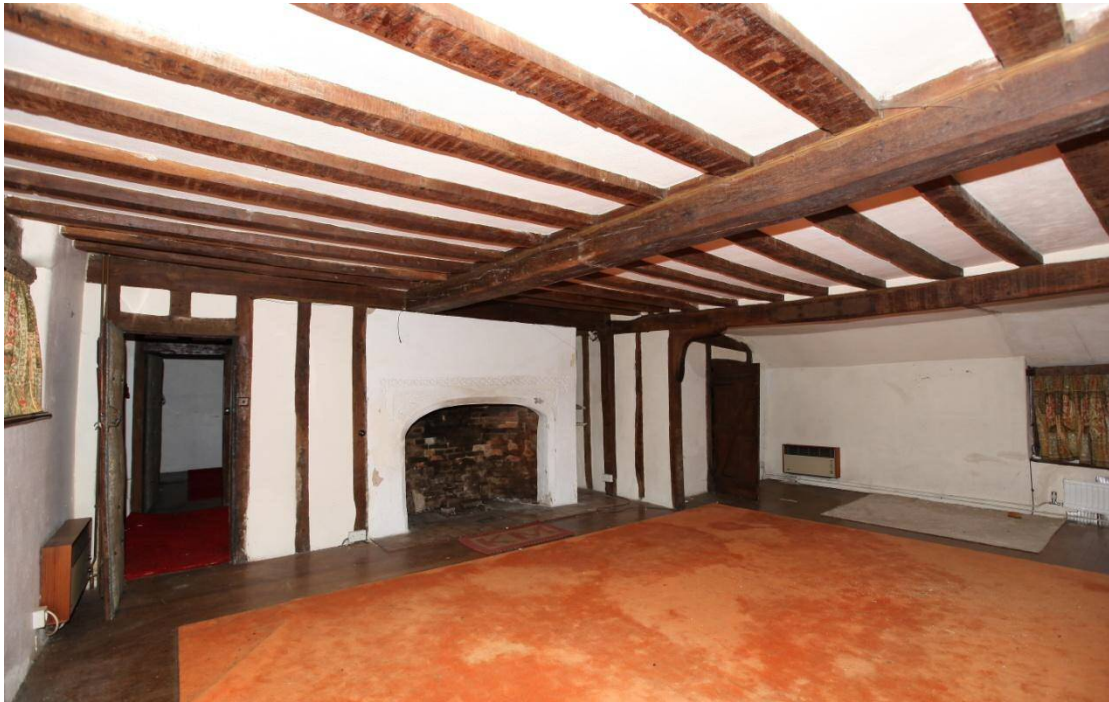
Illus. 4. The ground-floor parlour from the east (the drawing room in figure 7), with the original doorway to the entrance lobby on the left and 1930s lean-to rear extension on the right. The mid-rail of the original rear wall contains an uninterrupted series of mortises for studs that were presumably removed by Mrs Roper.

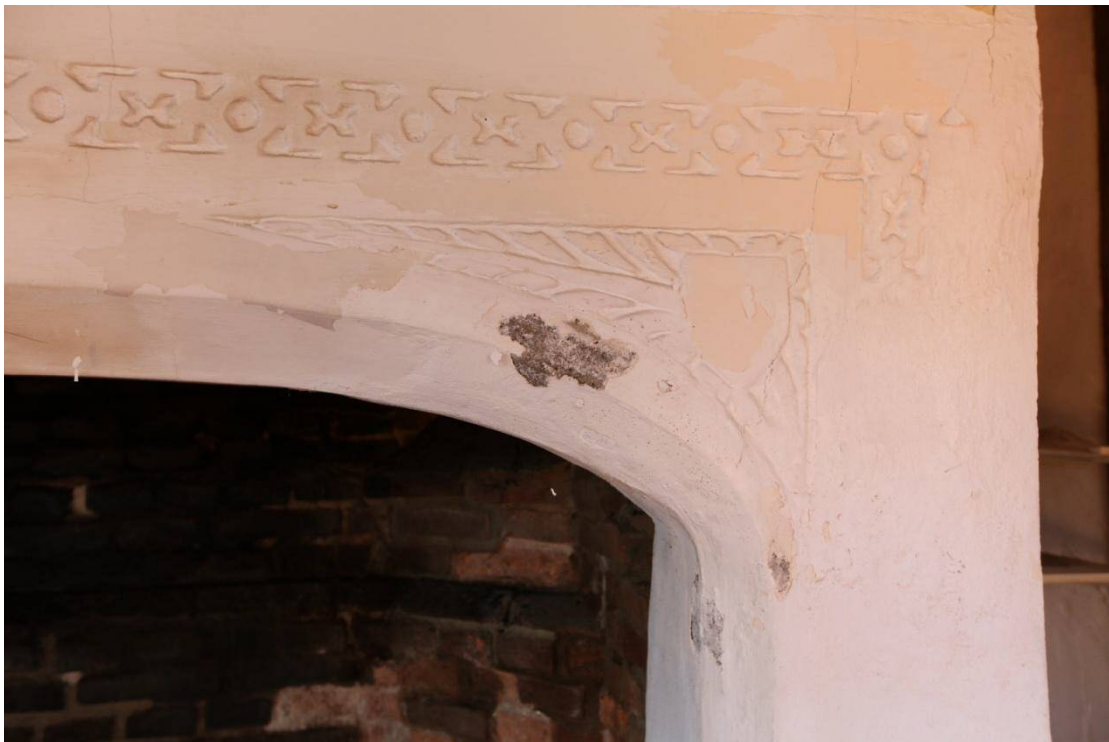
Illus. 5. A detail of the decorative plasterwork to the parlour fireplace, as shown in illus. 4 above. The plaster is covered by layers of whitewash which appears to conceal areas of stone or 20th century repair, but this fireplace may be original to the building.

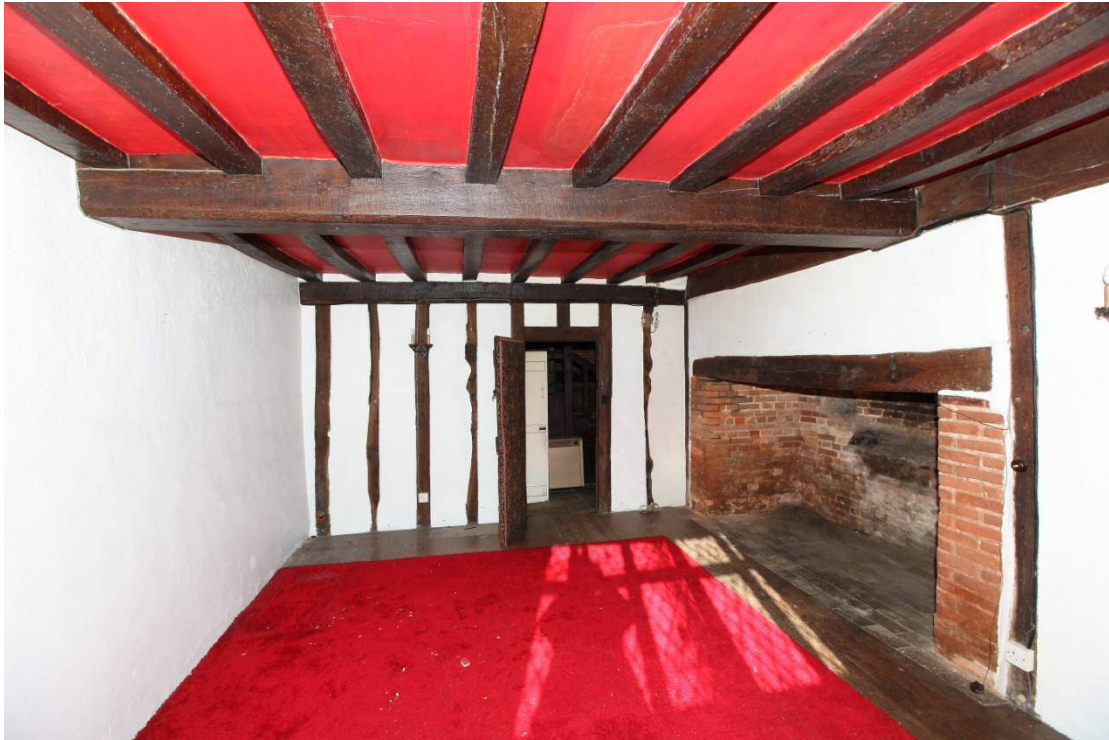
Illus. 6. The main hall (dining room) from the south. The studs of the rear wall have been altered, and the position of any original door is unclear, but the large fireplace to the right is largely intact beneath its original ovolo-moulded (quarter-round) timber lintel. The internal brick partition on the left is a relatively modern insertion of the late-19th century or possibly the 1930s (indicated by a dotted line in figure 6).

The partition at the western end of the central hall in the southern wing consists of late-19th or 20th century brickwork and its removal would restore the hall to its original proportions. The loss of this partition would in my view enhance rather than detract from the building's historic integrity.

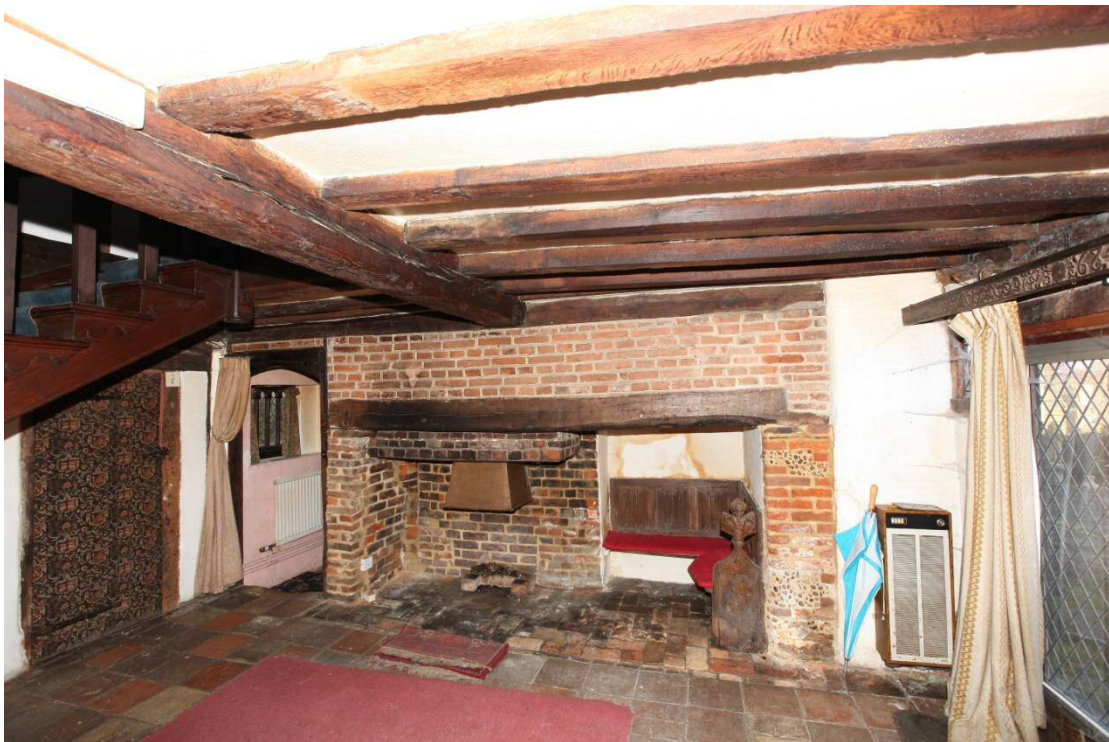
Illus. 7. The large 17th century fireplace in the rear hall (reception hall) from the south, with the intruded 18th century fireplace serving the rear parlour (sitting room) on the left and the rare 15th century bench end and linenfold panelling inserted in the 1930s to **create a fashionable ‘snug’ on the right.**

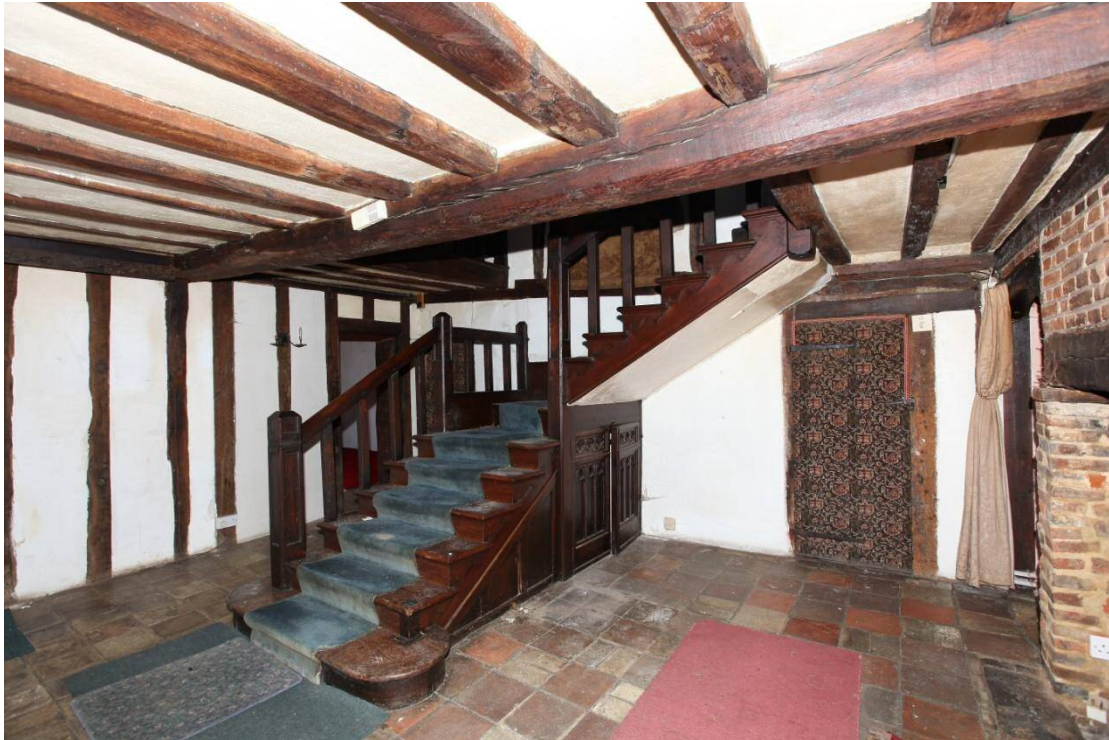
Illus. 8. The rear hall (reception hall) from the east, showing the solid Arts and Crafts style 1930s staircase from which the right-hand hand rail has been removed.

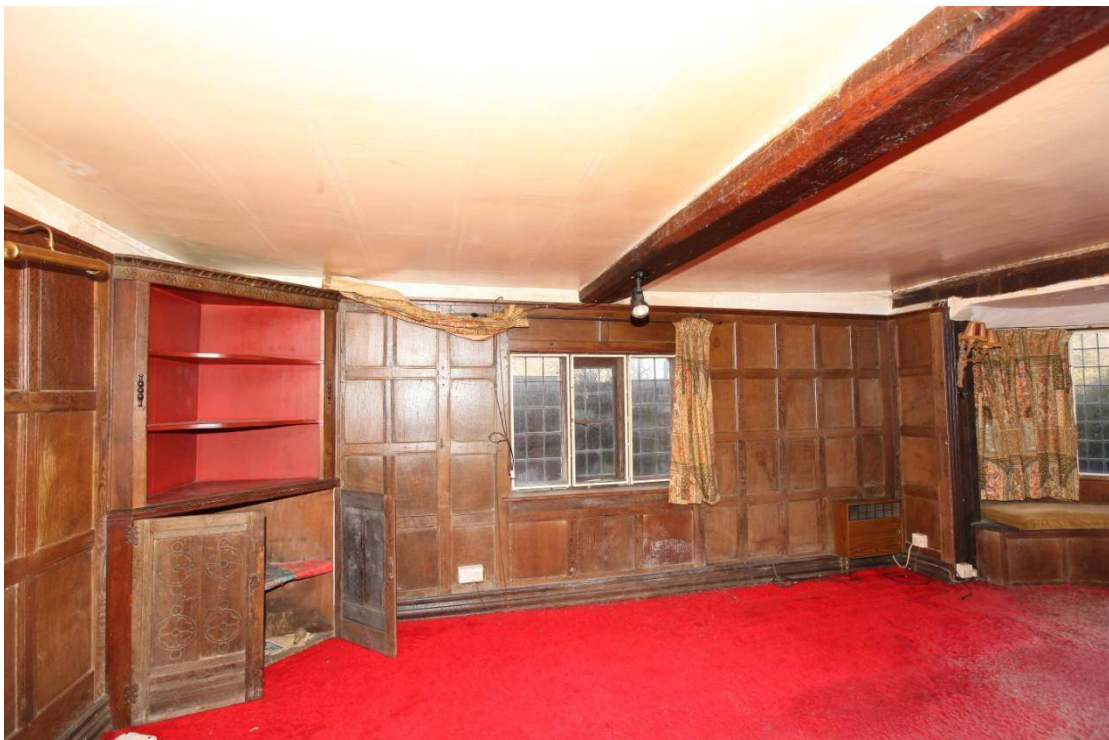
Illus. 9. The 17th century panelling in the rear parlour (sitting room) seen from the south, with the curved bay window on the right. The panelling was imported during Mrs **Roper's restoration, and this space is now highly evocative of the 1930s. The door to the room (behind the camera) contains 16th century 'Romayne' portrait heads and linenfold panels set into a 1930s frame.**

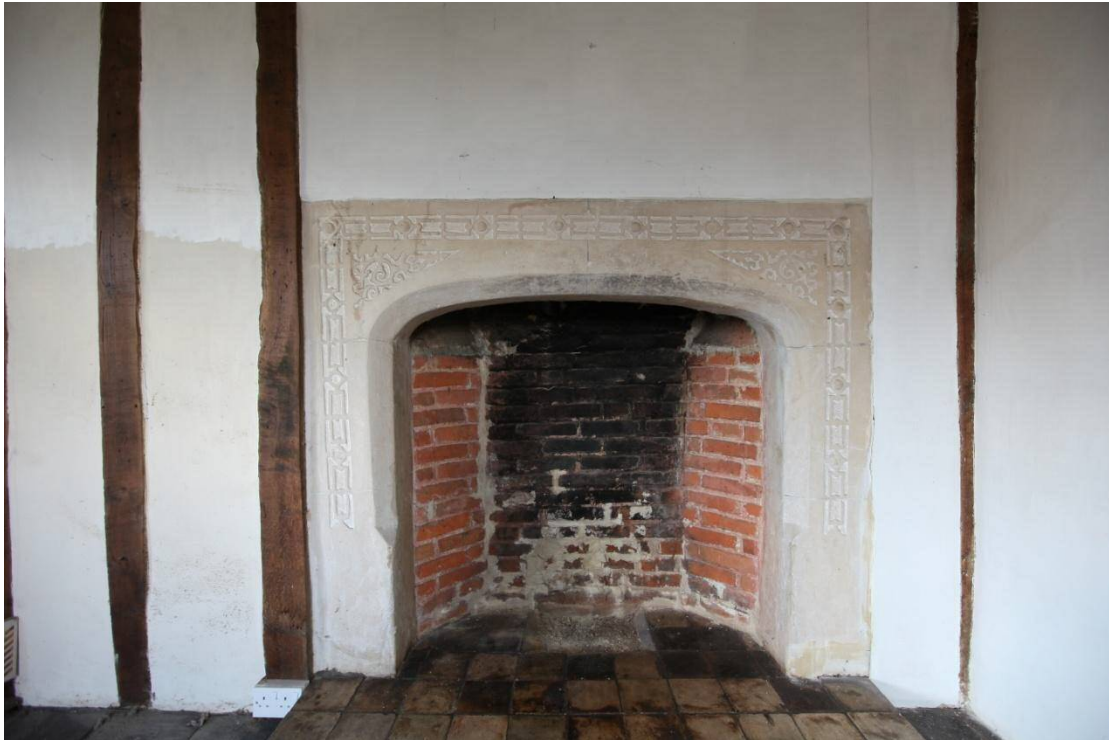
Illus. 10. The fine original stone fireplace in the parlour chamber (i.e. the bedroom above the drawing room as labelled in figure 7). Many early-17th century fireplaces used plaster to imitate stone, but this is entirely genuine and represents a rare survival. The brickwork retains original red-ochre pigment, and the whitewash above may conceal a contemporary overmantel painting.

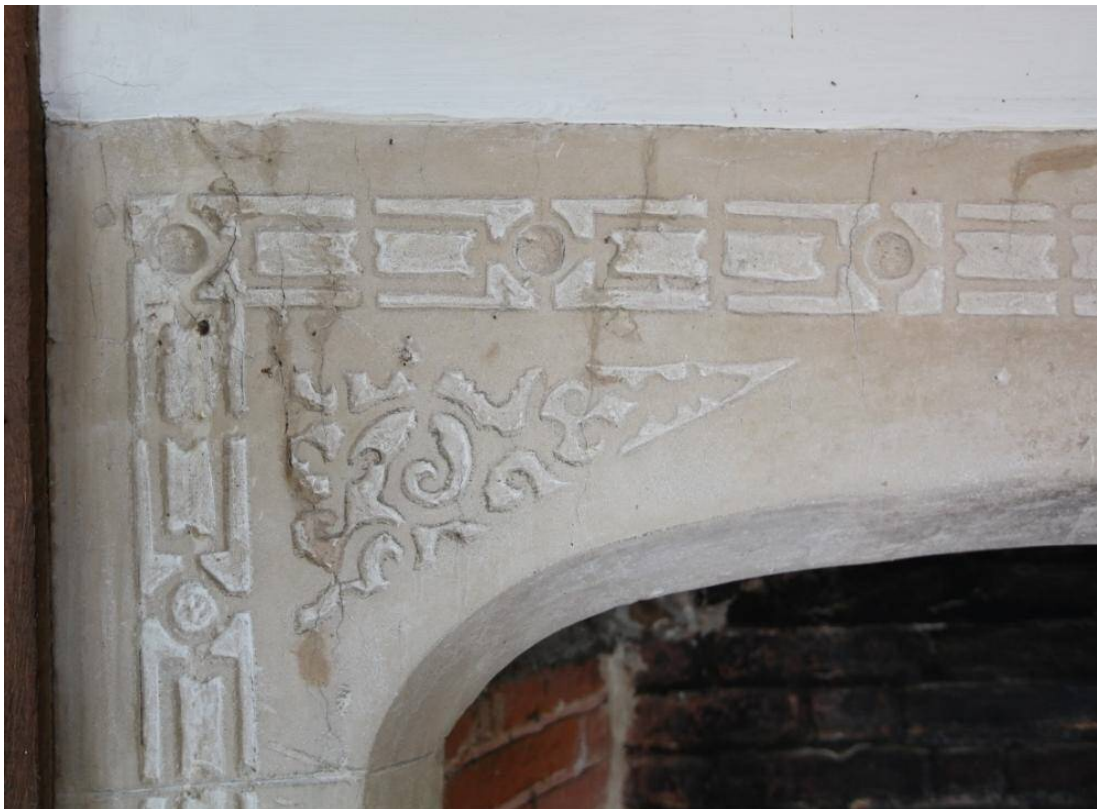
Illus. 11. A detail of the strapwork carving to the stone fireplace in the parlour chamber.

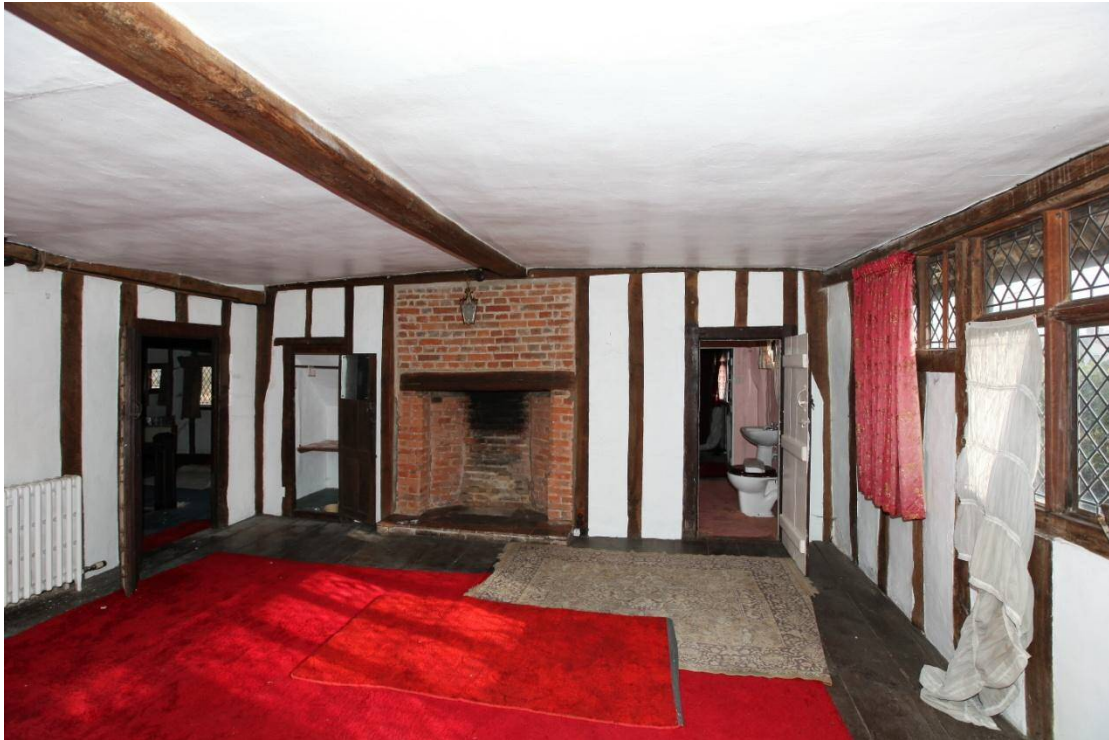
Illus. 12. The hall chamber (the bedroom over the modern dining room) from the west. The fireplace is original, with an ovolo-moulded lintel and red-ochre to the brick piers, but the upper brickwork would have been rendered. The door on the right would have given access to the original stair landing, and to the small chamber above the two-storied porch.

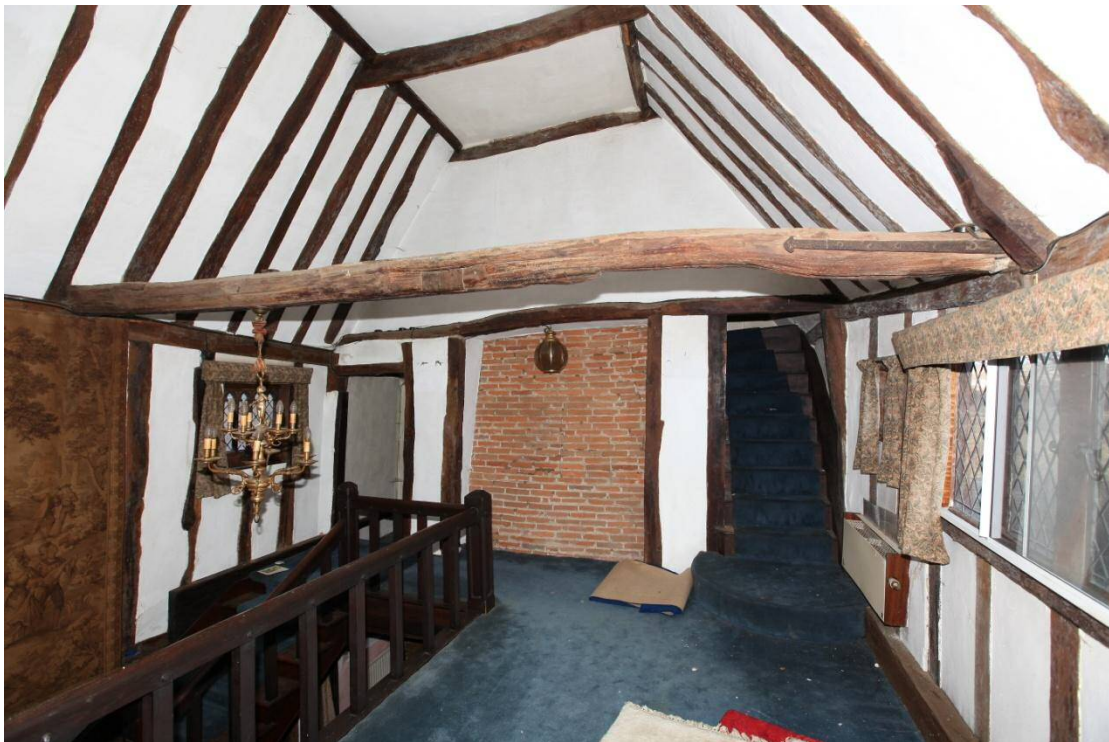
Illus. 13. The chamber over the rear hall (reception hall) from the south. Many timbers in this section of the house are soot encrusted but contain mortises that bear no relationship to their present positions and were re-used in the 17th century from a medieval open hall that may have occupied the same site.

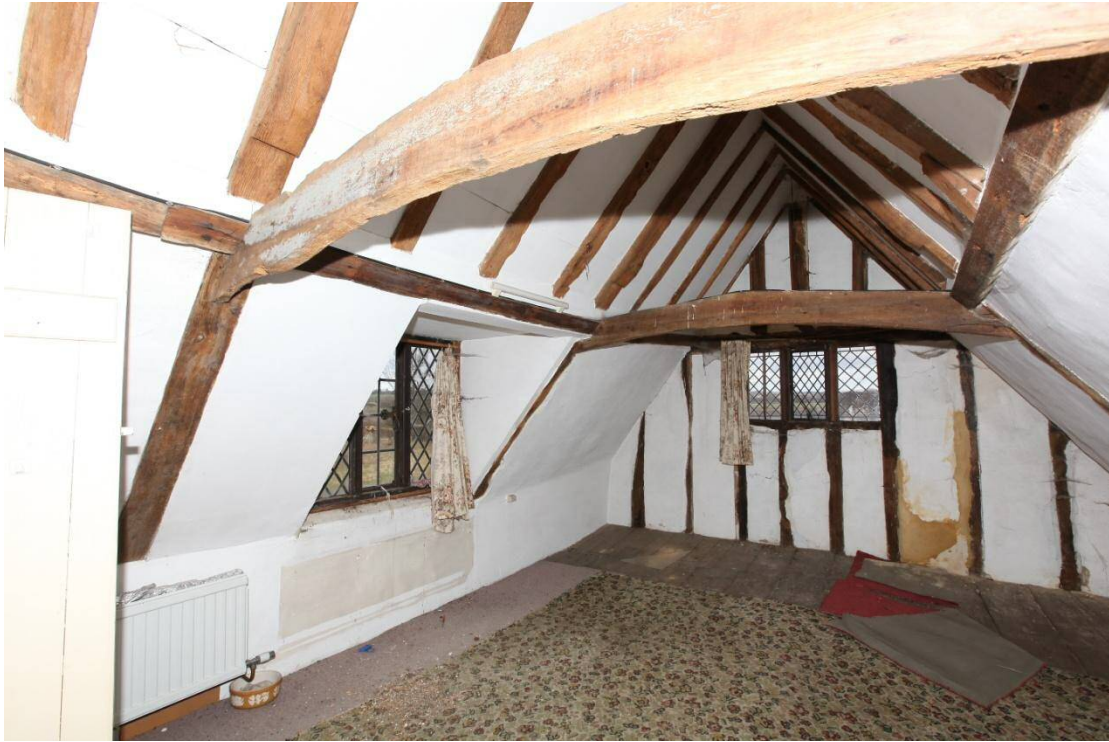
Illus. 14. The clapsed-purlin roof of the southern range, showing its eastern gable to the right. The principal rafters contain pegs for curved wind-braces that are either hidden by plaster or lacking, and with the face-halved and bladed scarf joints in its roof-plates this structure is typical of the early-17th century.

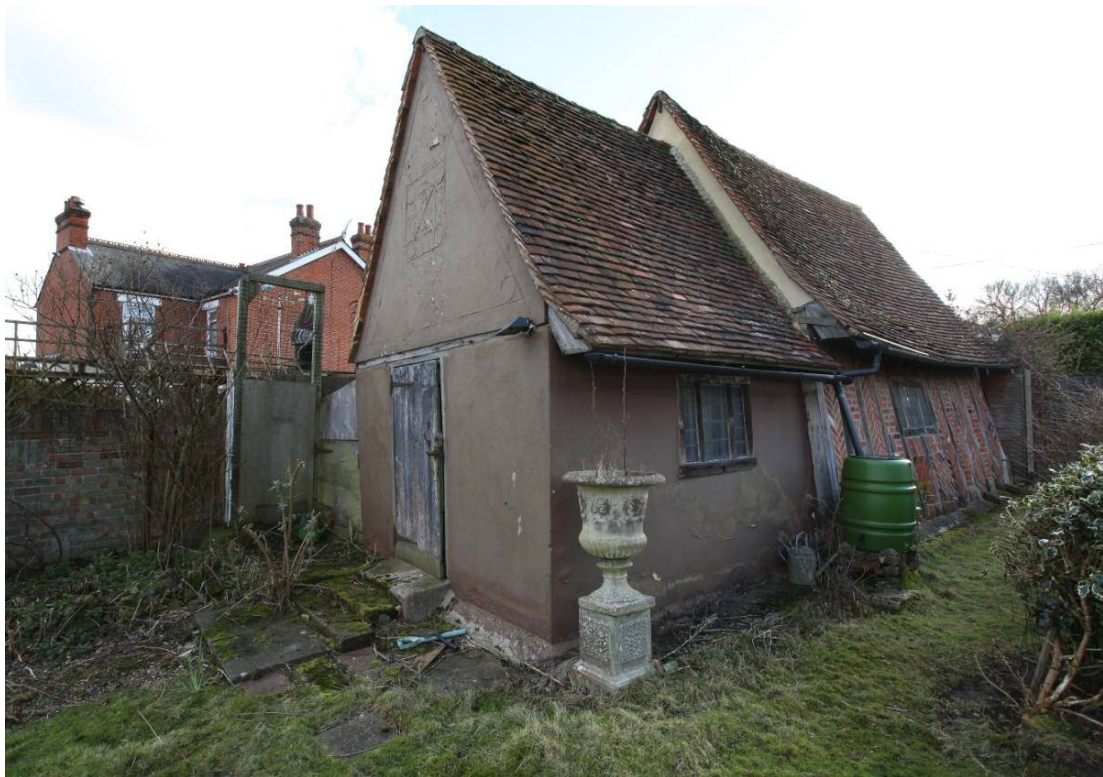
Illus. 15. The outbuilding adjoining the eastern boundary of the garden, viewed from the north-west. The taller section to the right, with a brick-infilled frame of re-used timbers, dates from the 1930s restoration, but the section in the foreground is a later extension. Both have been re-roofed in recent years and are leaning perilously.
