# **The George Hotel, Colchester, Essex**

## **Heritage Asset Assessment**

**The George Hotel,  
116-117 High Street,  
Colchester, Essex**

*This assessment is intended to inform and accompany a Listed Building Application to Colchester Borough Council.*

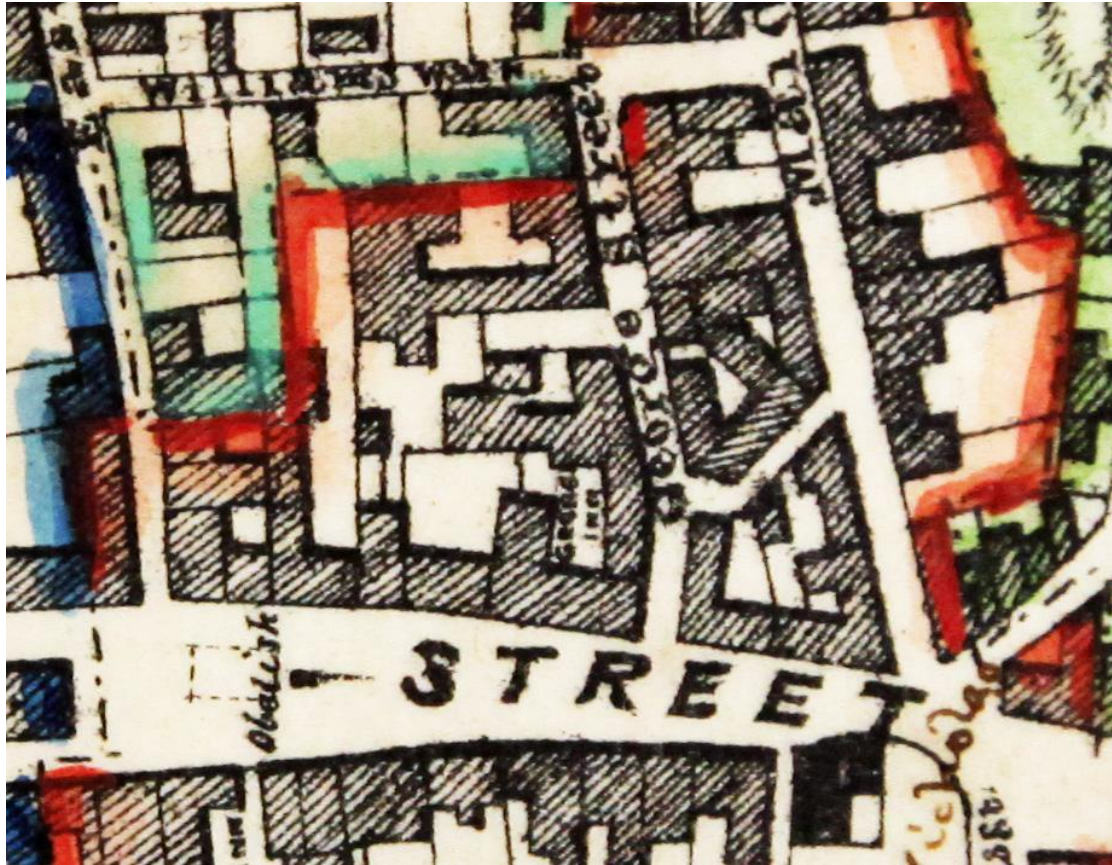
**Figure 4**

A detail of the Monson map of Colchester in 1848, labelling the 'George Inn' on the corner of the High Street and George Street. The southern entrance of 1745 had disappeared by this date, and the left-hand rear wing had been truncated – no longer meeting the northern range of the yard. A new block of outbuildings that consisted chiefly of stables had been added to the formerly empty land between the inn on the south and William's Walk on the north (see figure 7). The red line marks the boundary of St Nicholas's parish, with the church shown at bottom right.

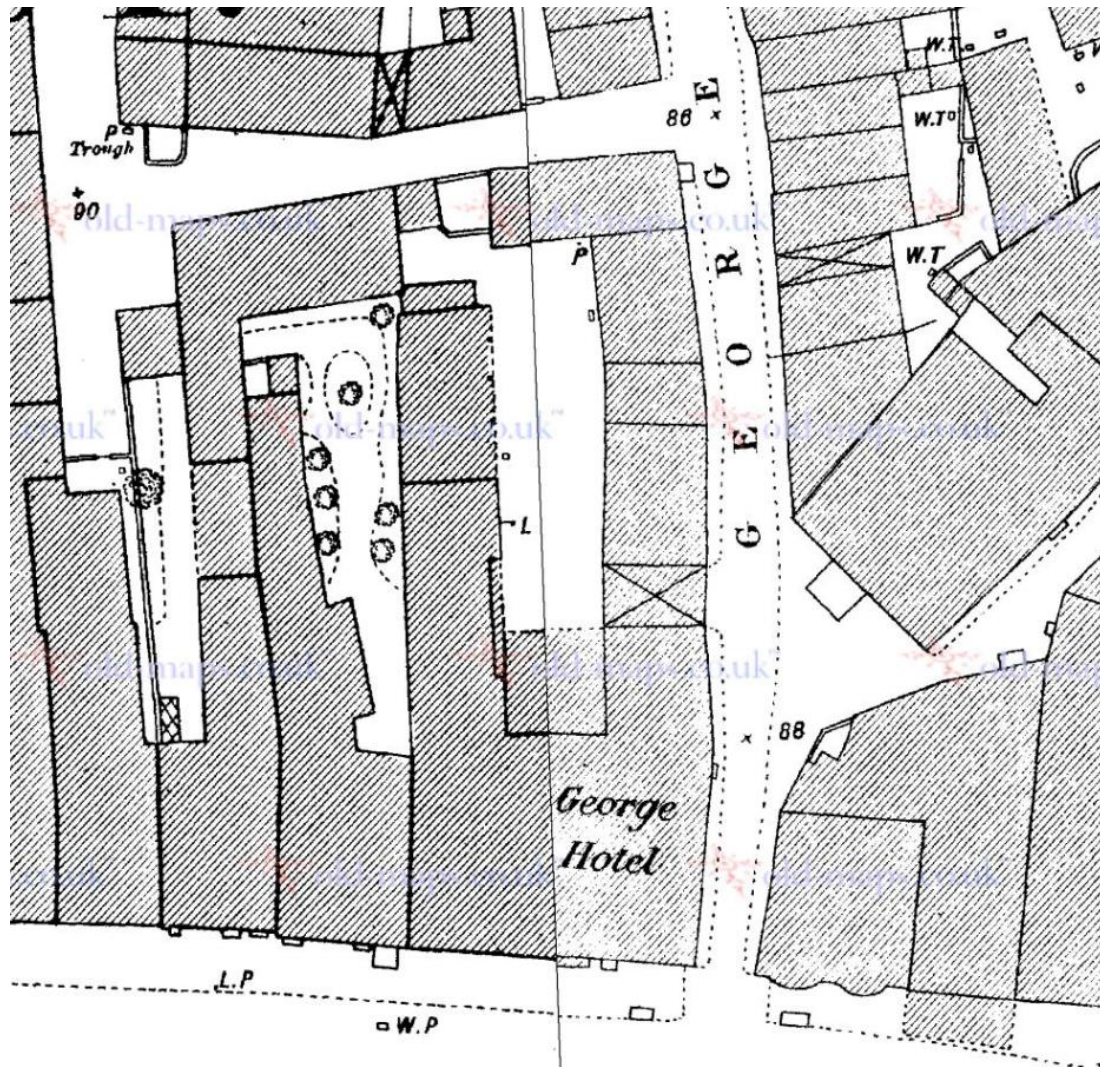
Figure 5

The First Edition 1:500 Ordnance Survey of 1876. The main courtyard had been extensively remodelled and extended northwards with the northern range of 1848 demolished and the western range to the left either rebuilt or extended. Dotted lines indicate the latter's open-sided eastern elevation as shown in early-20<sup>th</sup> century photographs (figures 13 & 14). The stable forming the new northern end of the yard also appears to have been built since 1848, increasing the length of the older eastern range.

The crossed section of the eastern range marks the arched medieval gateway, and indicates that it was still in use. Note the large covered area behind the street range with an open-sided wall adjoining the courtyard. The vertical line bisecting the inn is caused by a join in two sheets of the map.

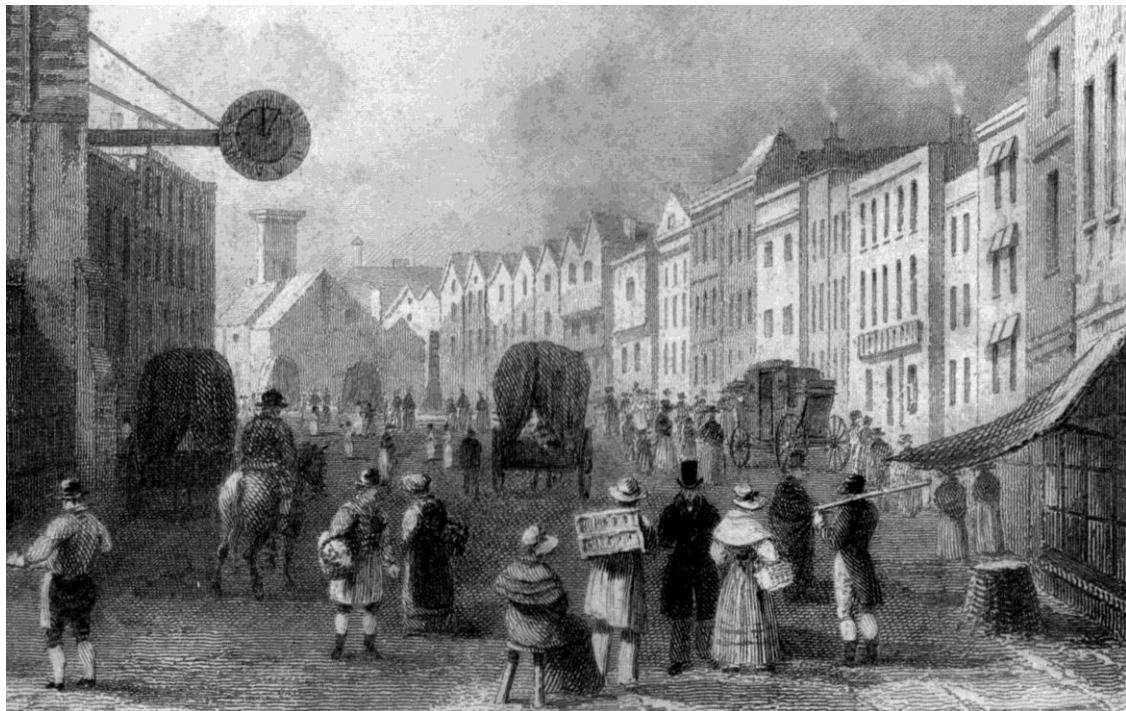
Figure 12. Colchester High Street from the east, by W. Bartlett, published in 1831. The George lies to the right of the stage coach, and appears much as today with five windows on each floor and a balcony between the ground and first storeys. The projecting clock belonged to St Nicholas's church, which lay opposite Maidenburgh Street and was demolished by the Church of England in 1955.

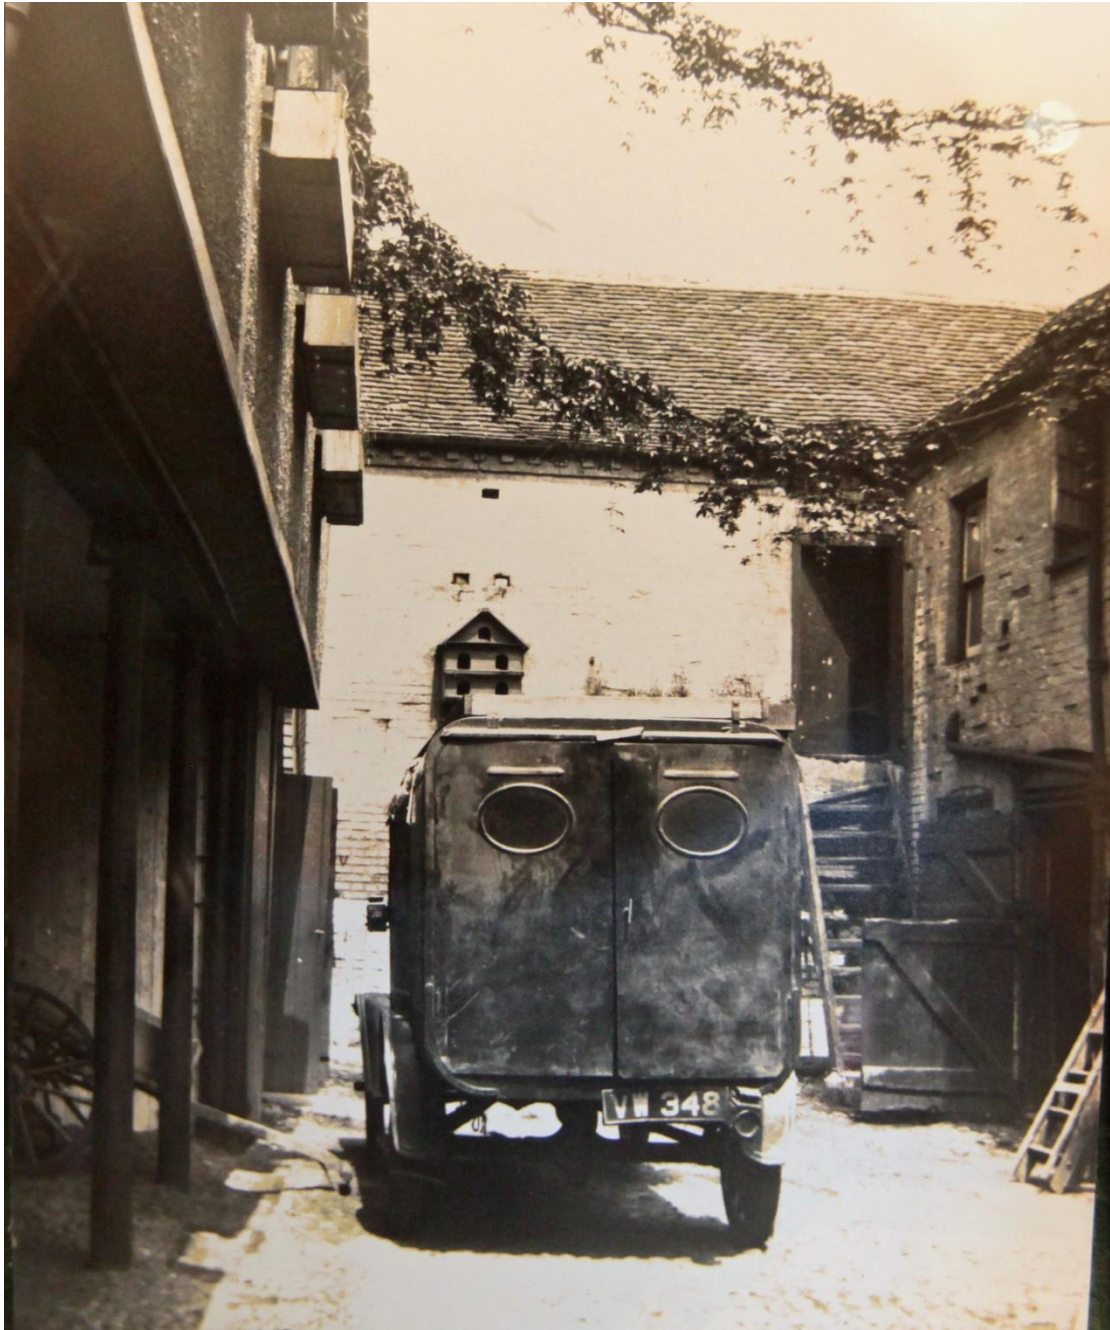
**Figure 13**

**The courtyard from the south in the 1920s (judging by the vehicle) showing the stable with its first-floor loft reached by external steps at the northern end of the yard, with the open-sided western wing on the left. Both the stable and the western wing were built between 1848 and 1876 (figures 4 & 5 above).**

**Note the half-hung stable door on the right.**

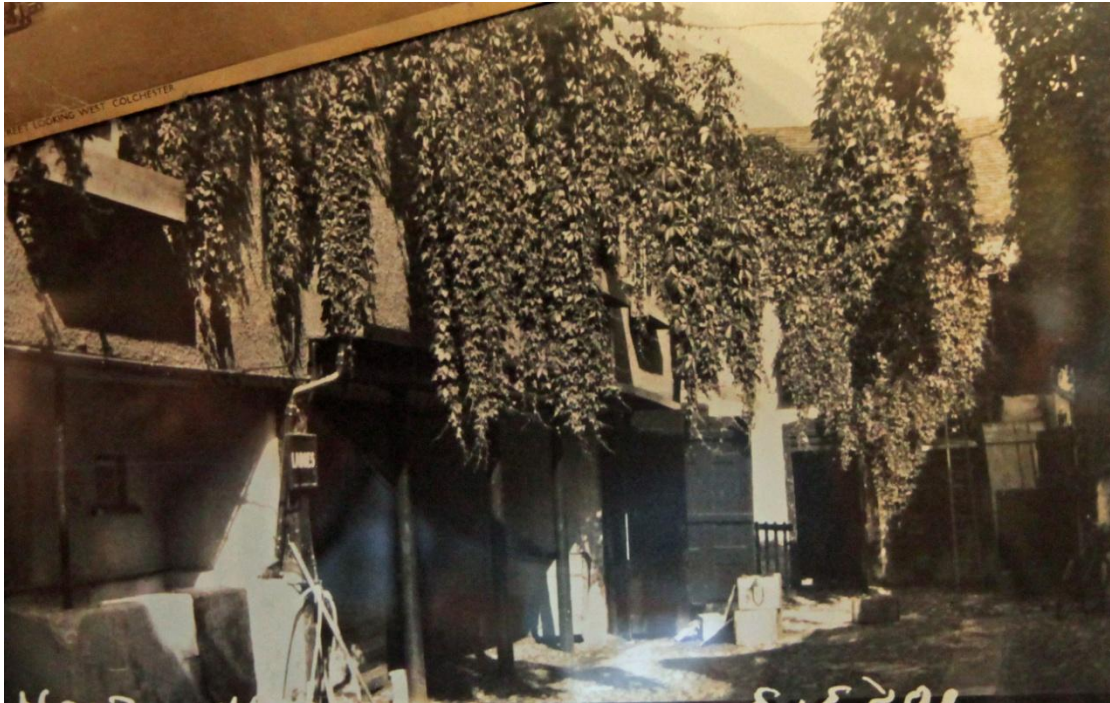
**Figure 14.** The overgrown open-sided elevation of the western courtyard range before the construction of the present bay-fronted single storied extension between 1933 and 1943. There is no trace of the upper storey with its gallery and continuous windows which was presumably added at the same time. From a photograph on display in the hotel's reception (with an overlapping postcard obscuring its top left-hand corner).

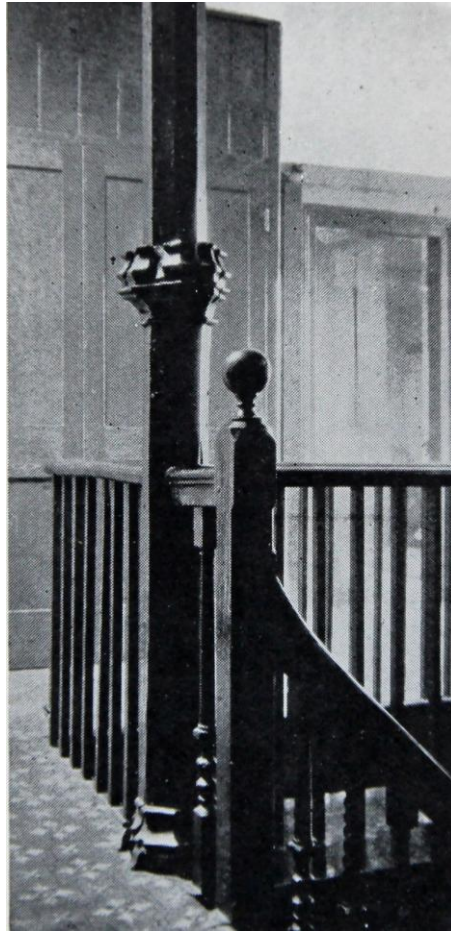
**Figure 16.** A photograph of the finely carved medieval crown post incorporated into the 19<sup>th</sup> century staircase, published in the Royal Commission Survey of North-East Essex in 1922. The Commission described it as king post following a convention that changed in the 1950s when a new term was introduced to distinguish different types of post that had hitherto shared one name. The crown post has since been incorporated into a partition and is less conspicuous (illus. 23).

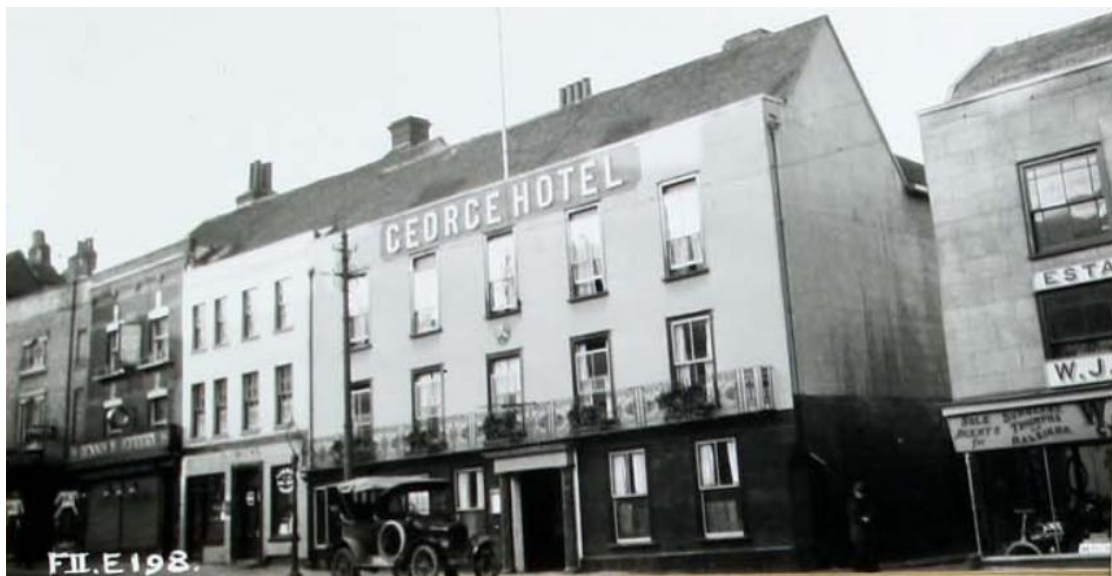
**Figure 17.** High Street facade from a Royal Commission photo dated 1929. Note the large-paned Victorian sash windows which have since been 're-Georgianised'.

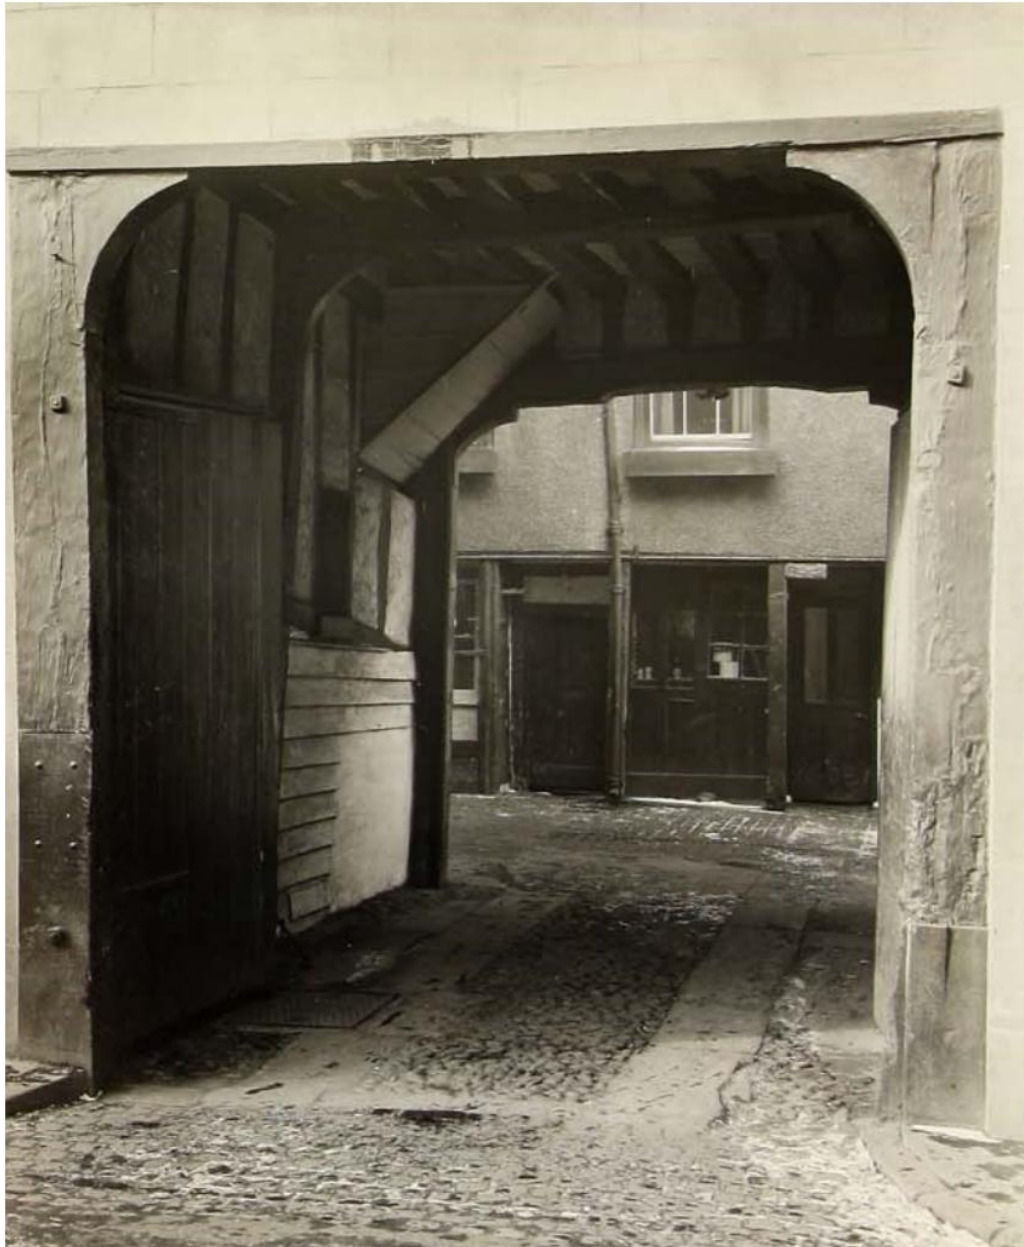
**Figure 18**

**The George Street gateway from a photograph possibly of 1929 in the archive of the Royal Commission on Historic Monuments of England (published online). (The adjoining photograph of the High Street facade in the same collection is dated 1929.)**

Area 8 forms a medieval gateway linking George Street to the courtyard. Although structurally separate from the adjoining 15<sup>th</sup> century range on the south (7) this may relate to a need for greater height to admit vehicles and the two may be contemporary. The chamber over the gate was jettied to the street, as indicated by bracket mortises at the tops of both gate posts, but this has been cut off. Mortises are visible at the bottoms of both posts for large foot-braces that projected out into the street to stabilise the structure in the absence of a ground sill and to protect the posts from turning carts. The courtyard elevation lacked foot-braces and was not jettied, and the roof was rebuilt in the 19<sup>th</sup> century. All four corner brackets of this gateway are original, fully pegged and tenoned to the posts, and represent rare survivals, particularly as the gateway remained in use as recently as the 1930s (figures 8 & 18).

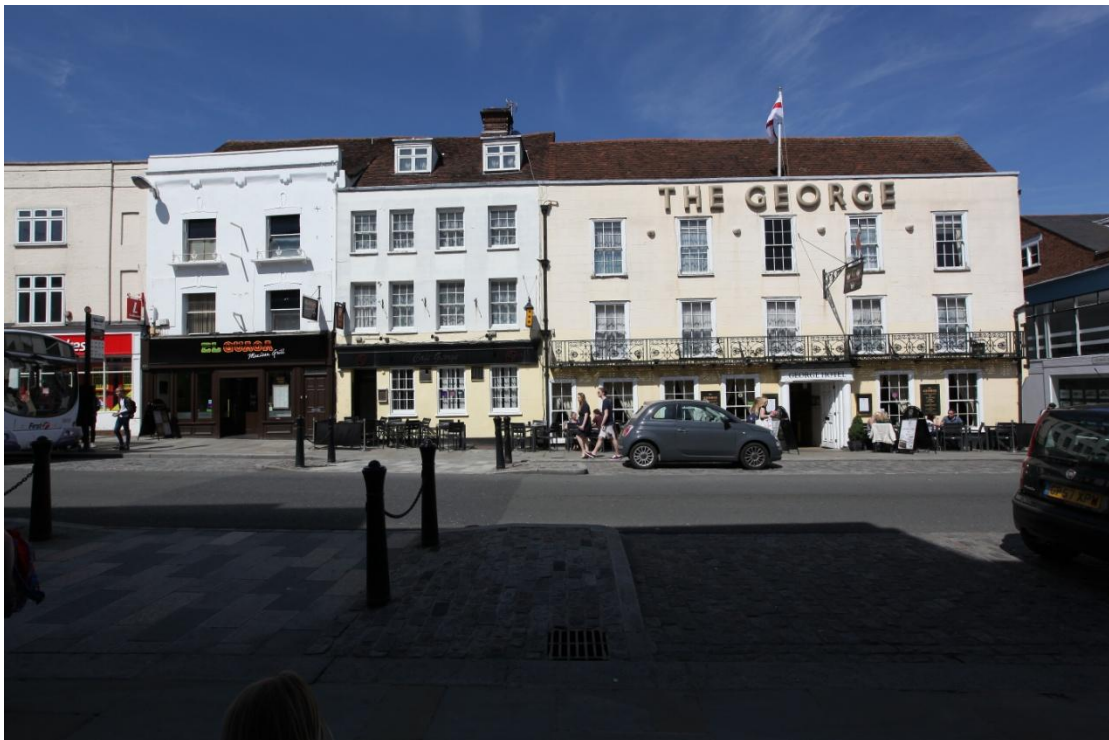
**Illus. 1**

**The High Street frontage showing the elegant late-Georgian facade of the inn to the right (i.e. of the late-18<sup>th</sup> or – more probably – the early-19<sup>th</sup> century). The sash windows are later replacements, as indicated by the 'horns' projecting downwards from the lower rails of the upper sashes (a feature introduced in the late-19th century). Figure 17 shows large Victorian panes of glass. The 17<sup>th</sup> century roof behind the parapet terminates in a gable window above the letter 'T' indicating a former gap between this point and the neighbouring three-storied jettied early-16<sup>th</sup> century building hidden behind no. 117 to the left (illus. 28-31). The map of 1745 shows this as an entrance to the courtyard. No. 118 on the extreme left (El Guaga) is yet another three-storied early-16<sup>th</sup> century structure and preserves a fine original roof in the unlit attic room behind its high parapet. Nos. 117-118 may have dwarfed the George until its top storey was added in the 17<sup>th</sup> century. The new roof projected further into the street and the facade was jettied at both the first and second floors, matching the nearby Red Lion Hotel, before the ground storey was pushed out and the upper jetty cut off by the Georgian remodelling.**

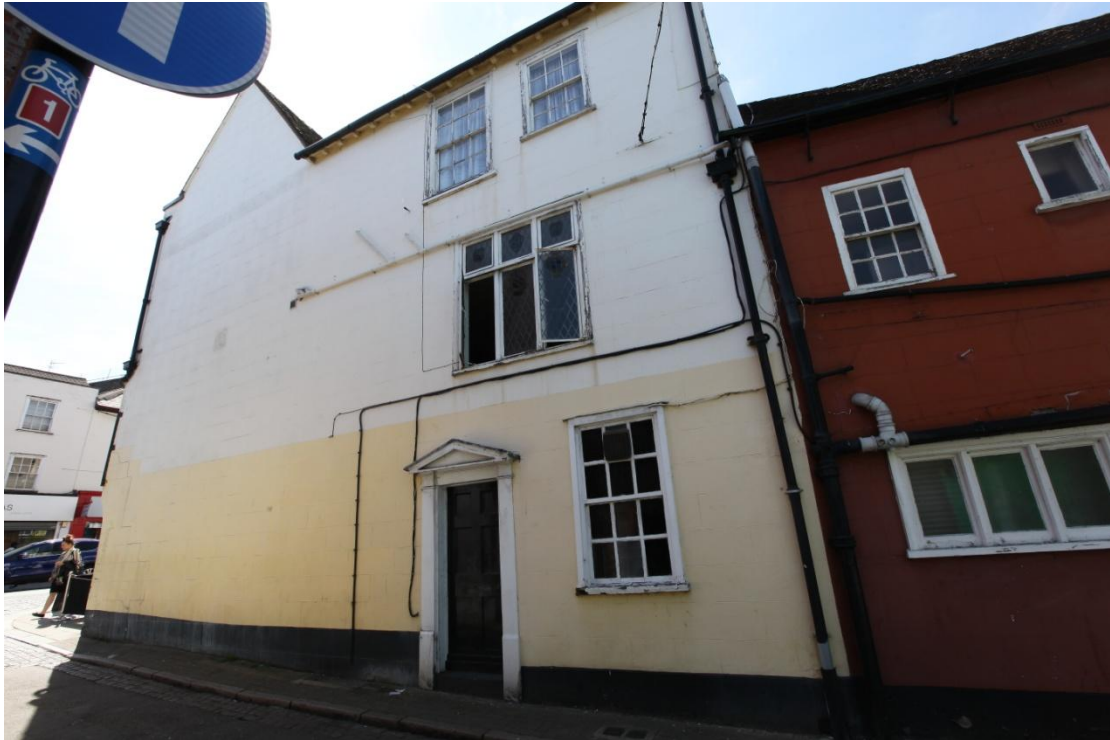
**Illus. 2. The eastern elevation to George Street with an original Georgian triangular door pediment. The white area appears to have part of the original late 14<sup>th</sup> century building with the shop front shown in illus. 13 to the left. Its jettied (overhanging) first storey has been cut off, as has the jettied second storey of its 17<sup>th</sup> century upward extension. The roof timbers of the present roof gable at top left have been truncated.**

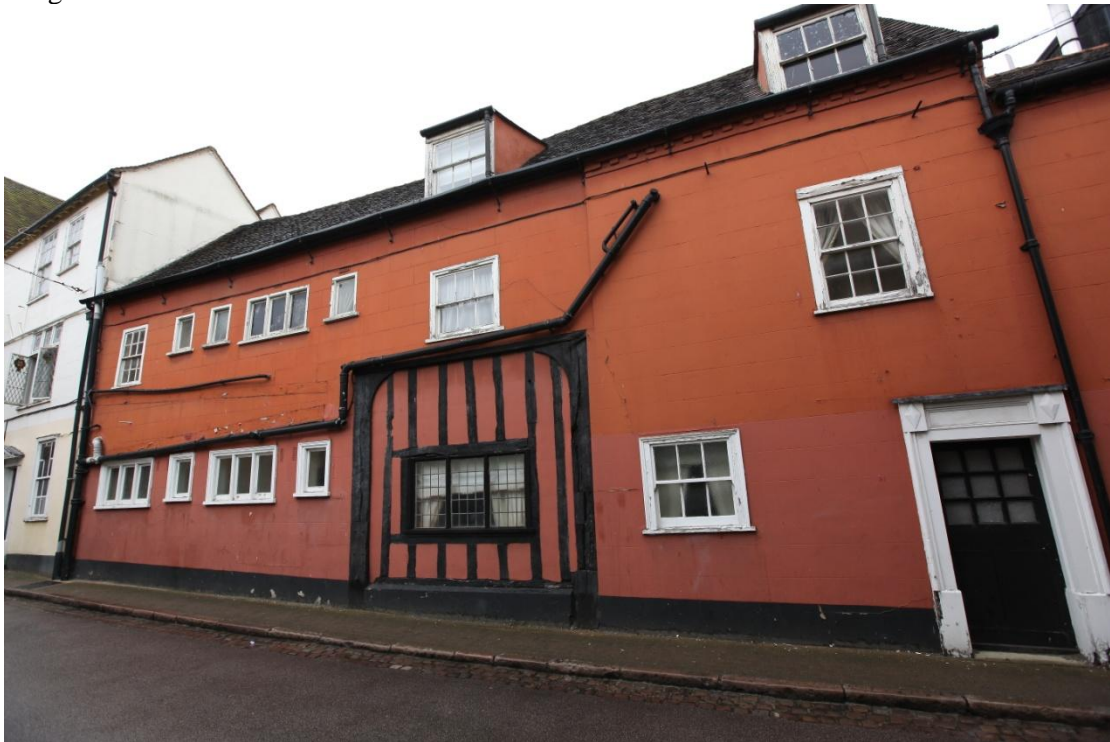
**Illus. 3. The eastern range facing George Street, built in several stages. The section to the left of the gateway (7) is a 15<sup>th</sup> century addition retaining its original crown-post roof (illus. 27), while the gateway – only blocked in the 1930s – is either contemporary or a slightly later addition with a rebuilt roof (8). Both structures have lost jetties and the gate posts contain mortises for foot-braces that projected into the street. The two structures of different heights to the right of the gate are of rendered brick, probably of the 18<sup>th</sup> century but with 19<sup>th</sup> century roofs (9 & 10).**

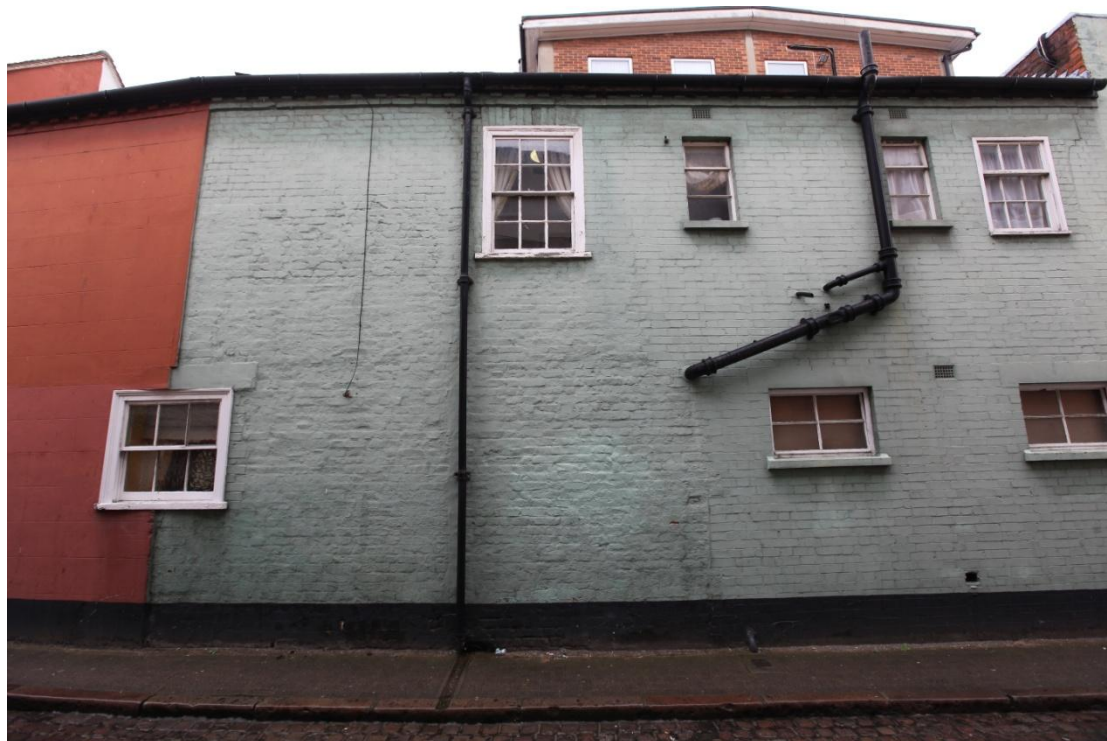
**Illus. 4. The George Street frontage showing the junction between the worn 18<sup>th</sup> century brickwork in Monk Bond (9 & 10) and the new work of the 1930s (i.e. between 1933 and 1943) to the right of the diagonal pipe. The upper courses of the 18<sup>th</sup> century brickwork were renewed in the 19<sup>th</sup> century. The 1980s addition is visible above (14).**

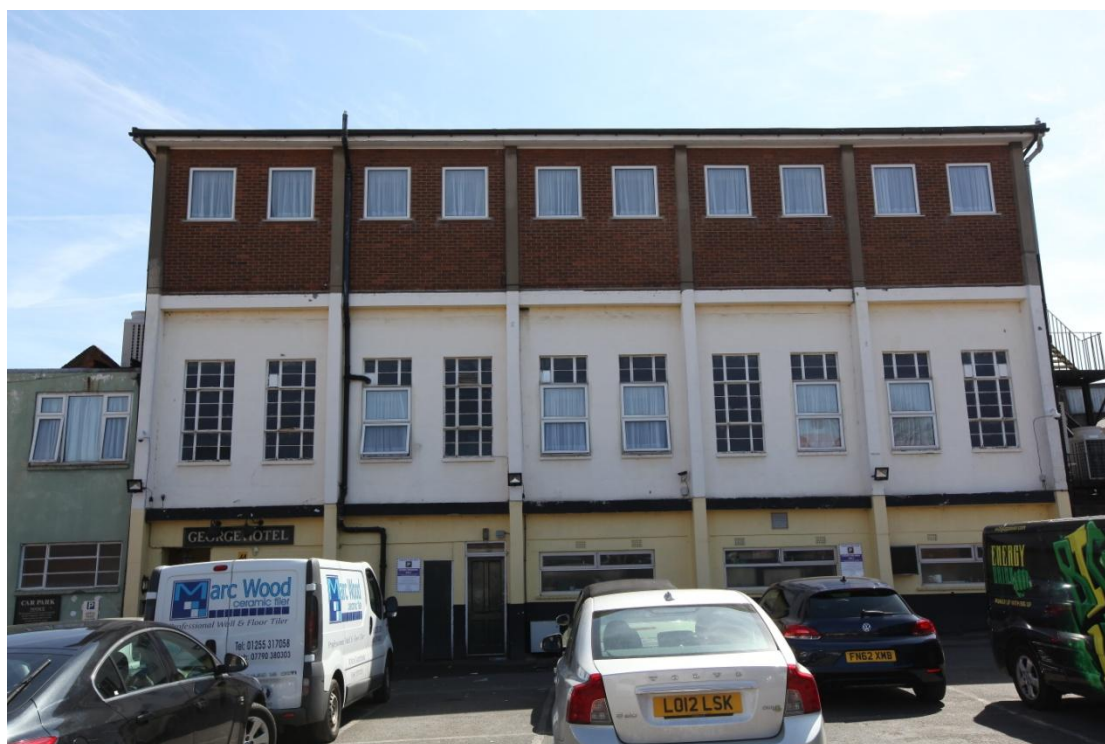
**Illus. 5. The rear (northern) elevation from the car park on the site of the demolished stables. The painted ground and first storeys date from the 1930s, retaining their metal-framed Crittall windows, while the brick upper storey was added in 1984 or later. The green-painted structure to the left also dates from the 1930s. The ground floor originally housed the kitchens while the well-lit first floor was a dance hall (figure 9).**

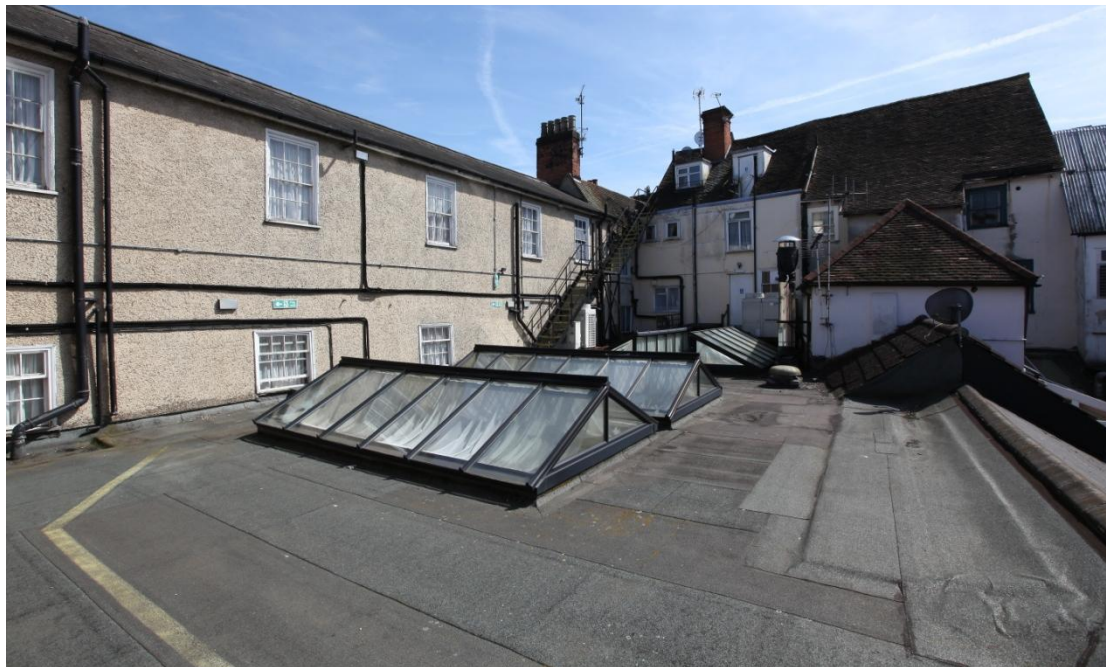
**Illus. 6. The flat-roof of the function room of 1984 or later (13) looking south to the early-16<sup>th</sup> century structure of nos. 117 (left) and 118. No. 117 is understood to have been purchased by the owners of the George in 1982, thereby facilitating its westward expansion. The slate-roofed pebble-dashed western range of the courtyard on the left was first built in the mid-19<sup>th</sup> century (after 1848 and before 1876) but its upper storey is not shown in early-20<sup>th</sup> century photographs (figures 13 & 14) and was presumably added in the 1930s, albeit in a more traditional style.**

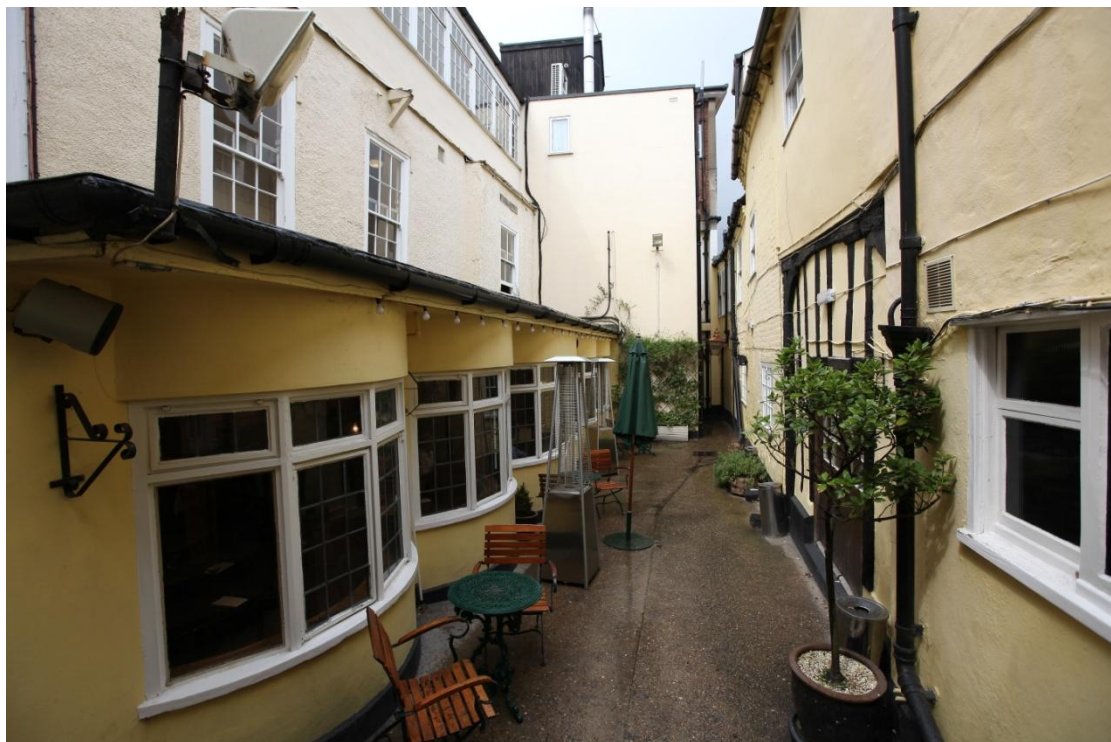
**Illus. 7. The courtyard seen from the south, with the 15<sup>th</sup> century gateway (8) on the right and the bay-fronted flat-roofed extension of 1933-1943 to the formerly open-sided mid-19<sup>th</sup> century western range on the left. The latter's top storey, with its Georgian-style continuous windows, was probably added at the same time. The tall block in the rear is also part of the 1930s kitchen range, shown in 1943 but not 1933 (figures 8 & 9).**

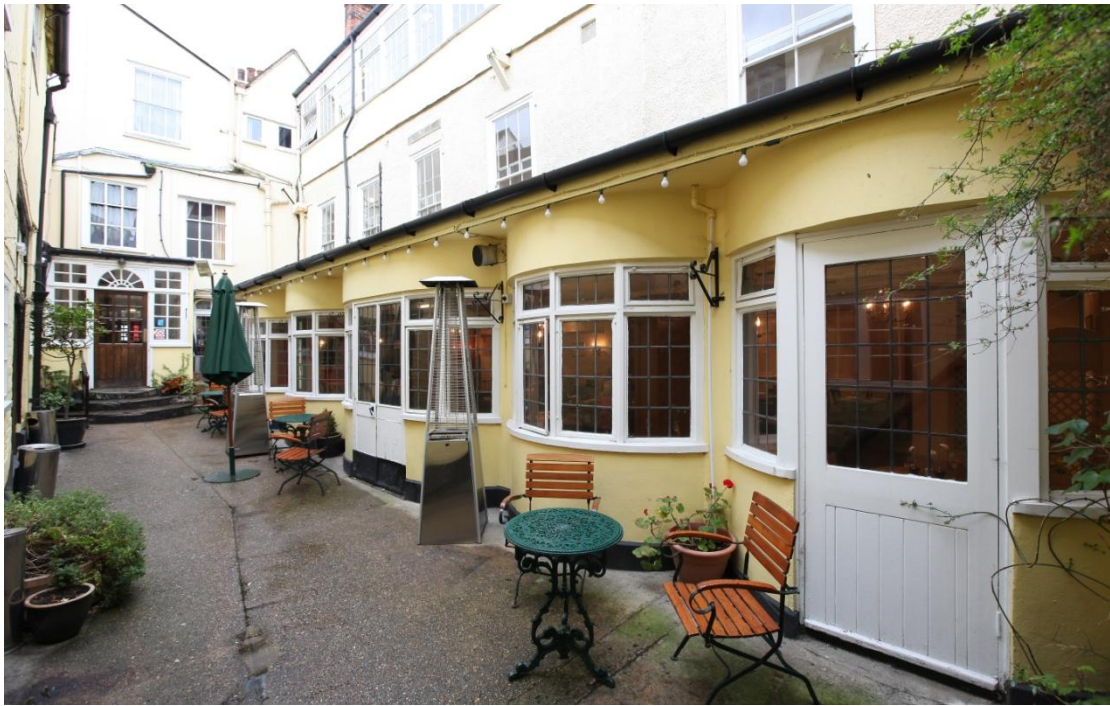
**Illus. 8. The courtyard seen from the north , with the bow-front extension of 1933-43 on the right and the flat-roofed porch of the same date in the rear. This porch replaced a much larger, open-sided structure which filled the width of the yard and protected the external entrance to the cellar.**

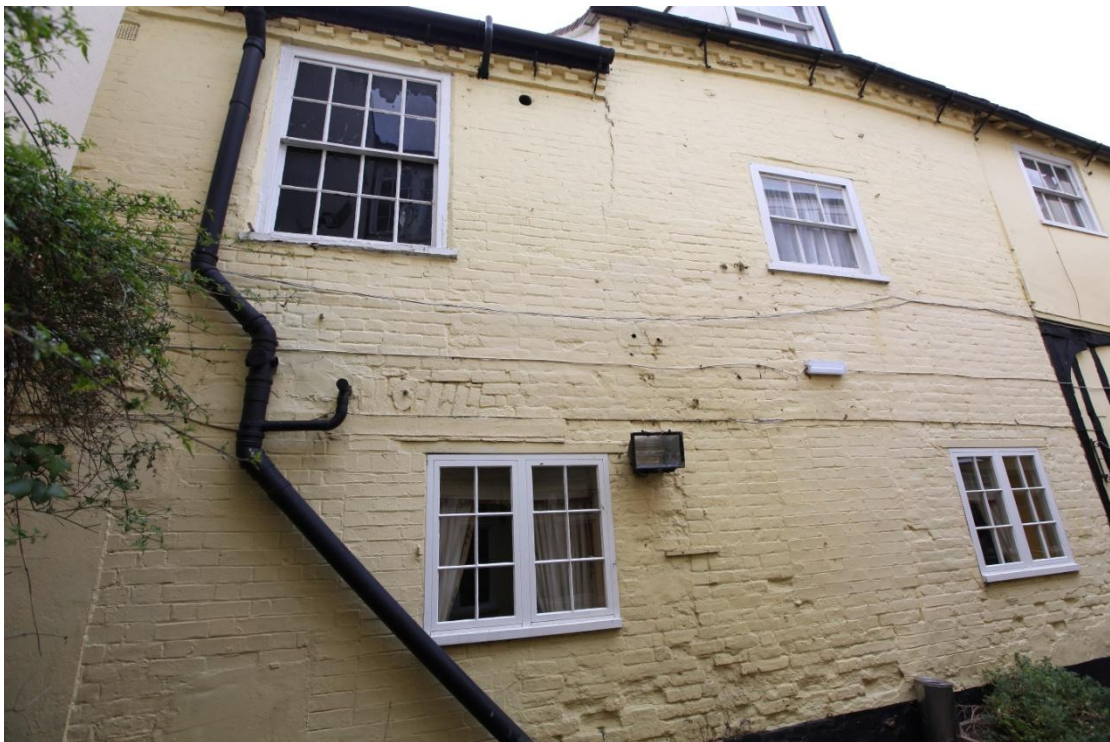
**Illus. 9. The brick structure at the northern end of the courtyard's eastern range (9), with the gateway on the right. The brickwork is laid in Monk Bond (two stretchers between each header) and may date from as early as the late-17<sup>th</sup> century, but has been much altered. A stable door opens into the ground storey in figure 13.**

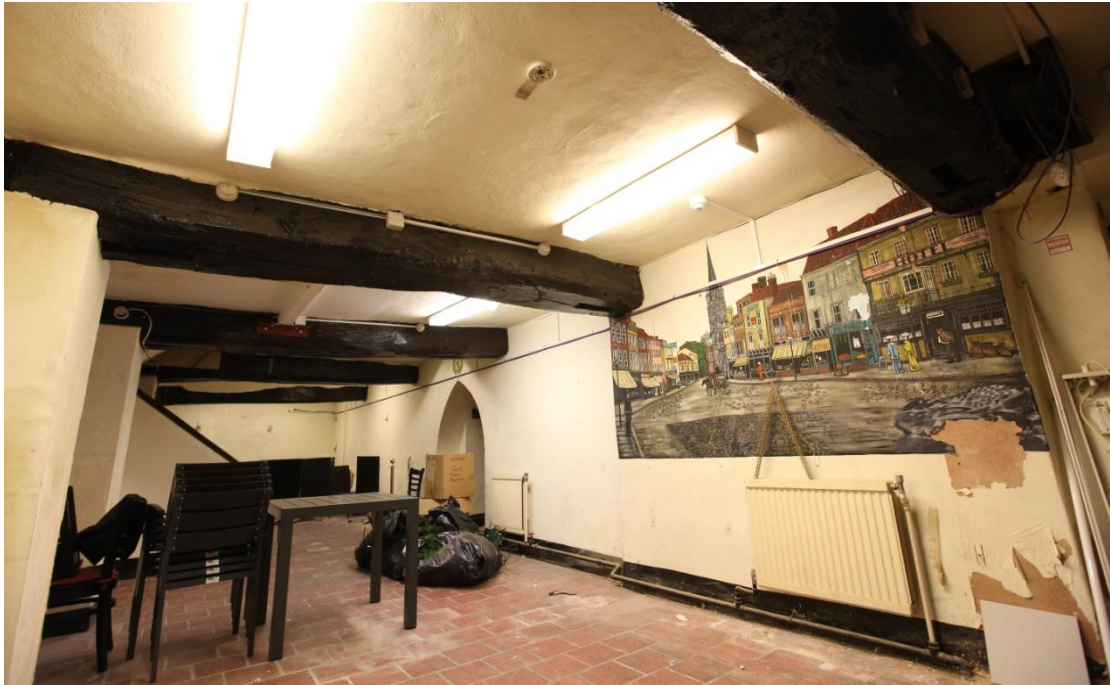
**Illus. 10.** The front (southern) section of the cellar viewed from the east, showing its massive 14 inch square ceiling joists with mortises for missing brackets at both ends. These brackets were presumably supported by missing corbel blocks in the walls. The 1922 Royal Commission describes two fireplaces with four-centred heads and ‘vent holes’ above their arches in the central spine wall on the right, along with a door beneath a two-centred brick arch that presumably equates to the present pointed doorway. The original wall fabric is now hidden by modern plaster and dry-lining.

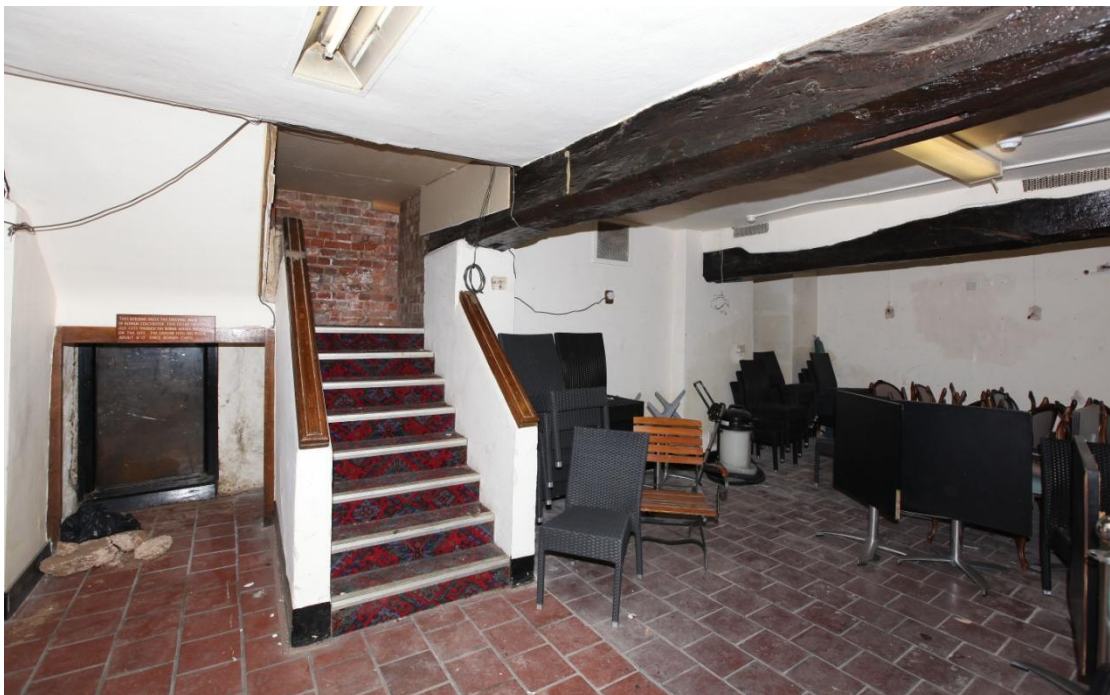
**Illus. 11.** The southern wall of the cellar showing the 20<sup>th</sup> century staircase descending from the lounge above (area 5). This staircase is understood to have been blocked during the most recent refurbishment in the 1990s. The glazed niche in the original flint-rubble wall to the left exposes layers of archaeology which may include a Roman gravel pavement but not the reputed Boudiccan destruction layer.

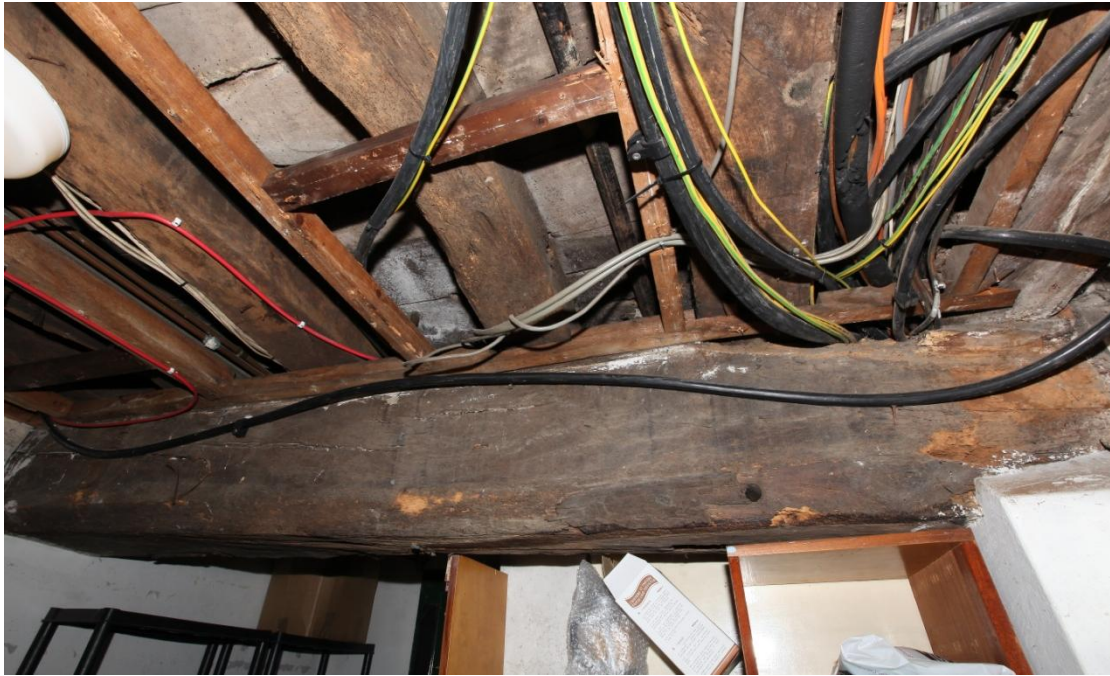
**Illus. 12.** A detail of the ceiling in the rear (northern) half of the cellar, viewed from the east (in the maintenance workshop). The common joists are lodged on top of the principal joist rather than tenoned to it, in a manner usually found only in the 13<sup>th</sup> century or before. Some of the rear principals contain bracket mortises but others don't.

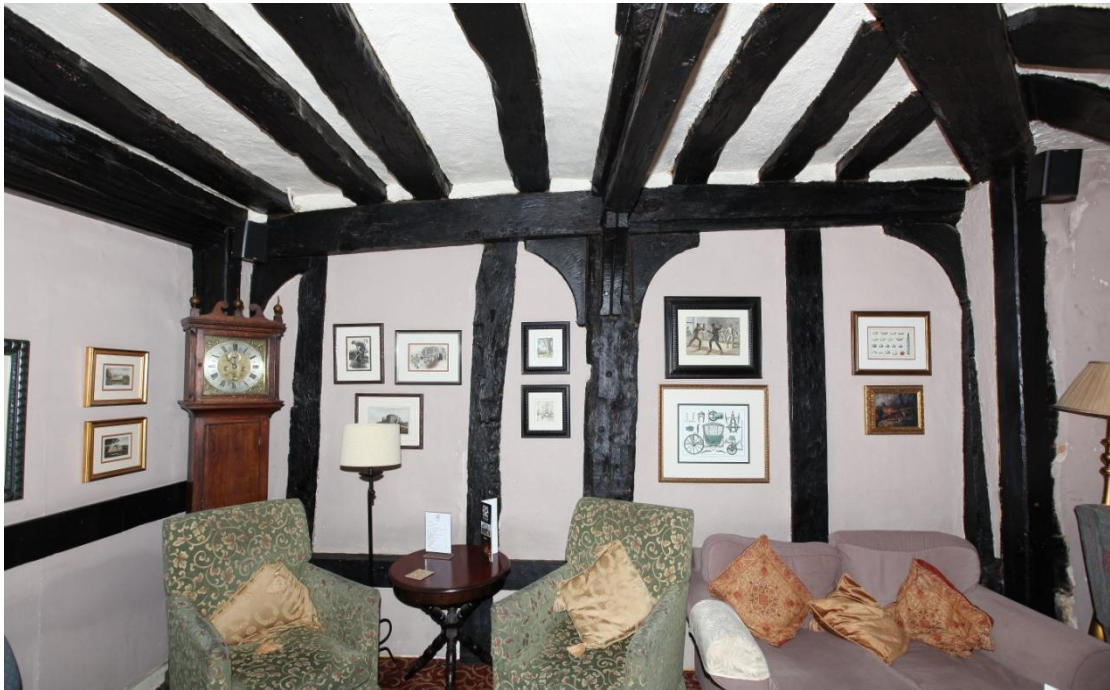
**Illus. 13.** The fine late-14<sup>th</sup> or early-15<sup>th</sup> century shop front in the eastern wall of the corner lounge (4). The right hand section was an open arched window, now with a later central post, and the two vertical studs on the left are the jambs of a blocked door. The two left-hand corner brackets are modern copies of the originals on the right. The moulded rail on the left is a re-used timber similar to others in the roof and the front wall on the right was formerly jettied but has been pushed out into the High Street. The roughly hewn, square joists are typical of the Middle Ages and are rare survivors in Colchester.

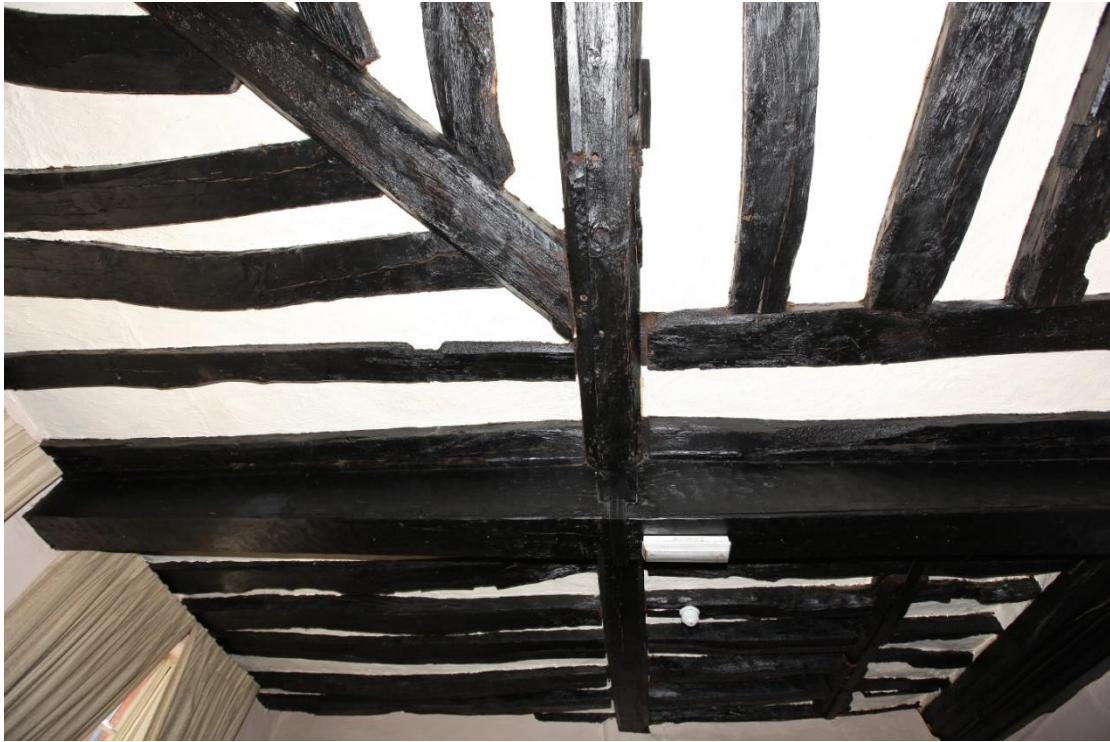
**Illus. 14. The ceiling of the lounge on the corner of the High Street and George Street (4) viewed from the east. The central supporting beam is modern (possibly a boxed RSJ), but empty mortises for a missing original wall dividing the corner shop from another narrow room are visible immediately in front. A blocked trap is visible in the bottom right-hand corner for an original stair rising from the modern passage (illus. 15).**

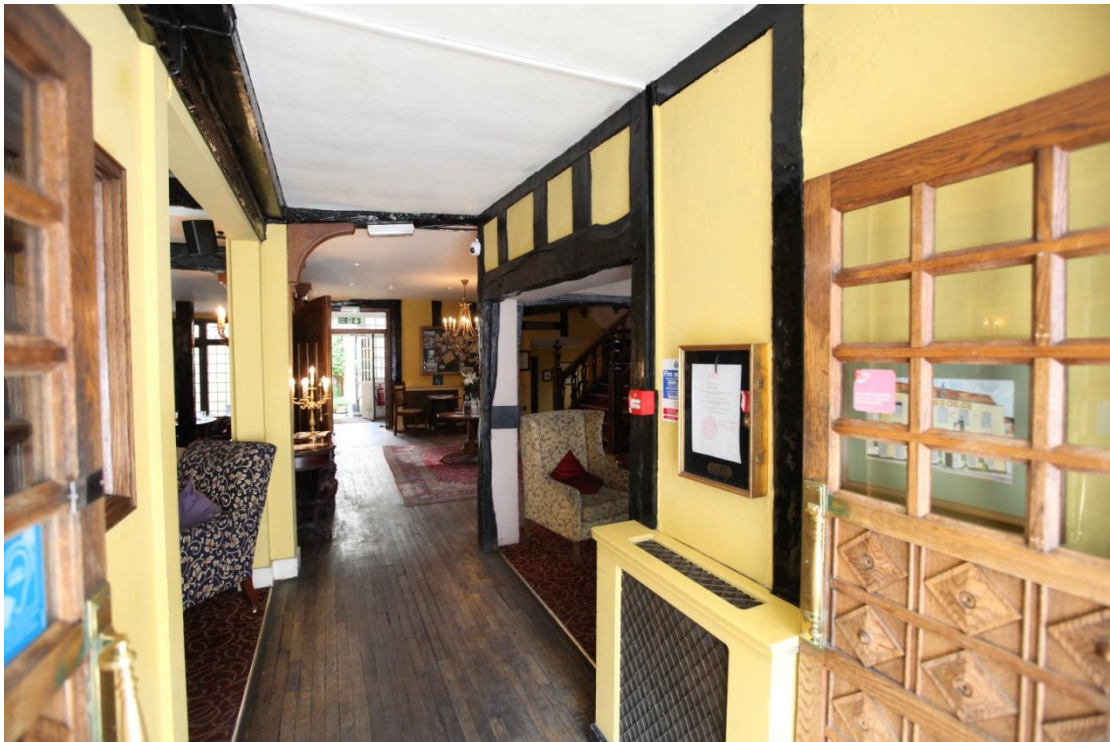
**Illus. 15. The hotel entrance seen from the High Street to the south. The timbers on the right are false but are likely to occupy the position of an original wall with a door to the left opening onto a staircase (the trap of which is shown in illus. 14). This area now lies beneath the 17<sup>th</sup> century roof but may have formed a medieval cross-passage.**
