# **The George Hotel, Colchester, Essex**

## **Heritage Asset Assessment**

**The George Hotel,  
116-117 High Street,  
Colchester, Essex**

*This assessment is intended to inform and accompany a Listed Building Application to Colchester Borough Council.*

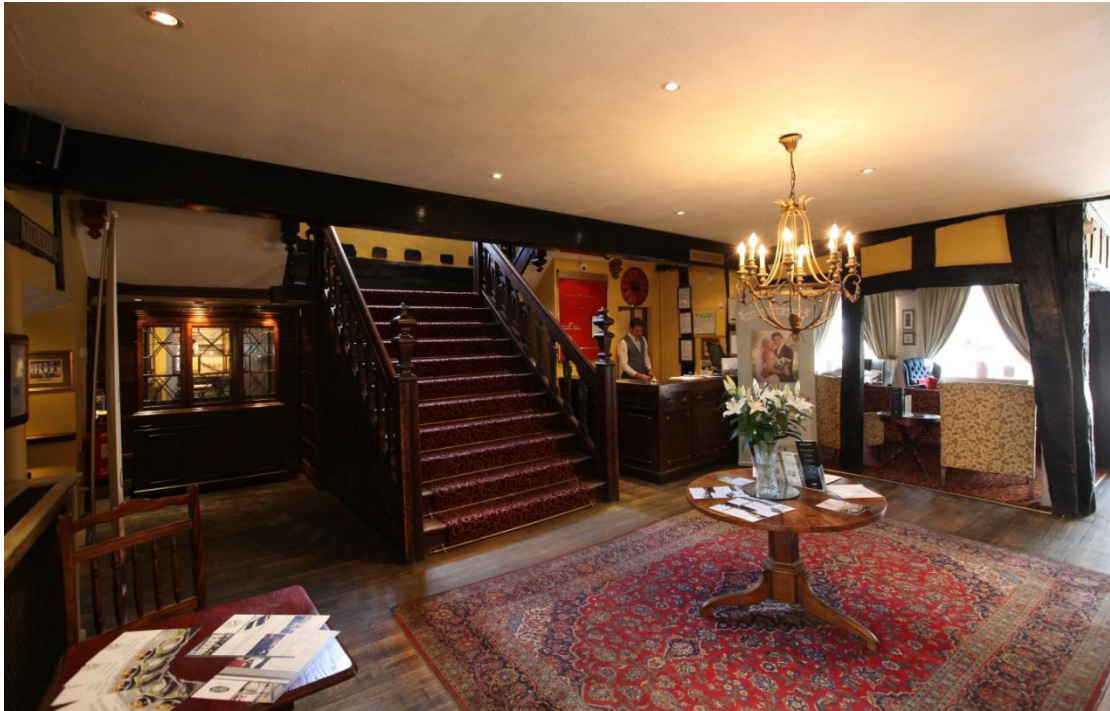
**Illus. 16.** The hotel's reception area (3) showing the Victorian Mock Gothic staircase on the left and the entrance passage on the extreme right. This area formed part of the medieval structure and must have been sub-divided, but has been much altered and concealed. The cut-off ends of the jettied ceiling joists adjoining George Street are visible above the staircase, and both posts on the right appear to be later insertions.

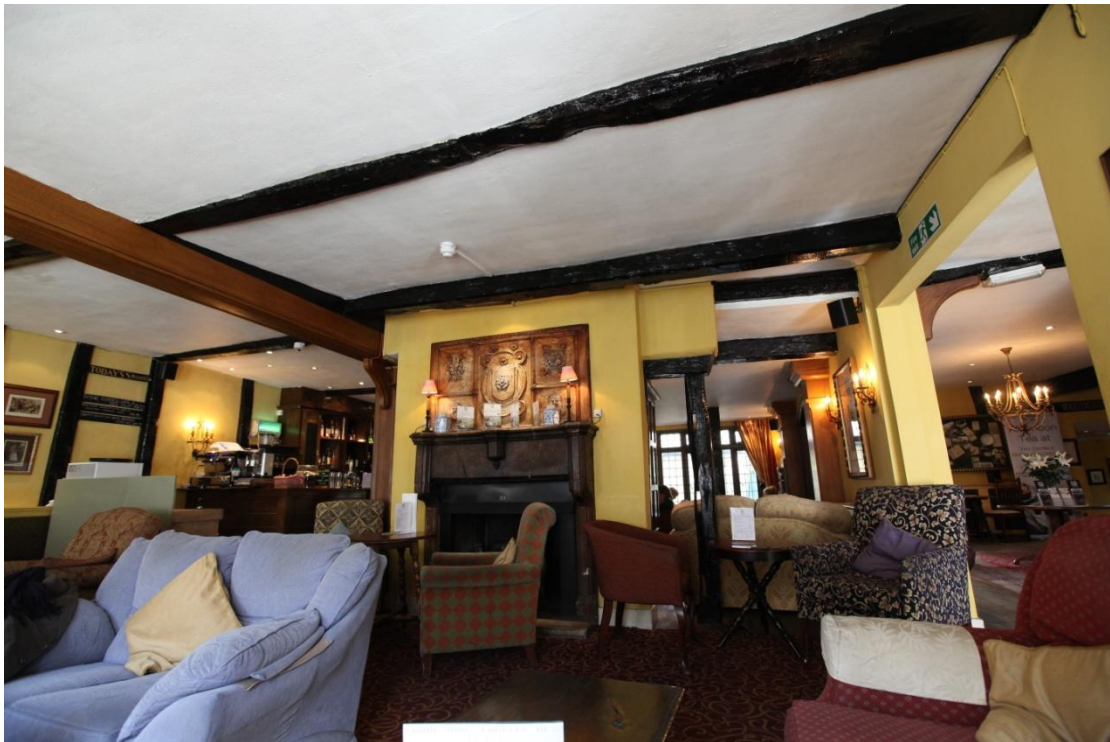
**Illus. 17.** The front lounge showing the central 15<sup>th</sup> century-style fireplace resting on the spine wall of the cellar. Whether this chimney contains any early fabric is unclear. This area (5) lies beneath the 17<sup>th</sup> century roof with a window above the brown-painted ceiling beam on the left, and the area occupied by the bar (6) beyond was an open passage linking the High Street to the rear yard as shown in 1745 (figure 3).

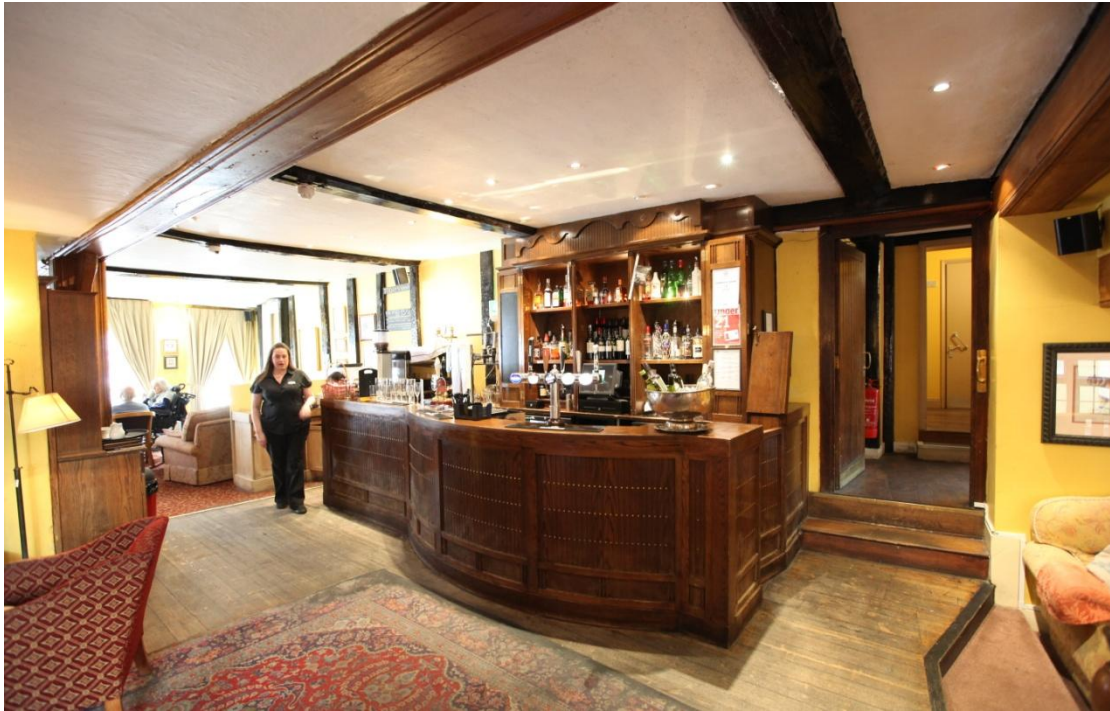
**Illus. 18.** The main bar seen from the east. This area (1) may have formed a medieval parlour, with a dividing wall beneath the brown-painted ceiling beam at top left, but has been much altered. The wall behind the bar adjoins the neighbouring early-16<sup>th</sup> century structure at no. 117, but without further investigation of the fabric it is unclear whether its widely spaced studs are *in situ* or later insertions.

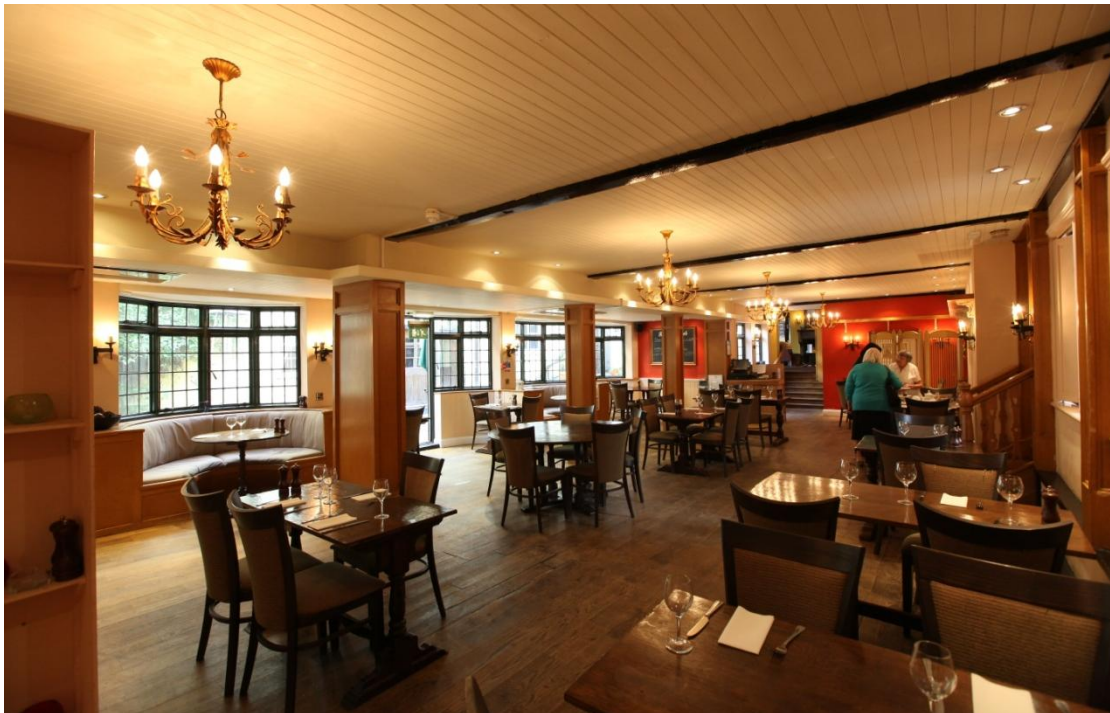
**Illus. 19.** The dining room in the western range (11), seen from the north with the bow-fronted extension of 1933-43 (12) on the left. This range dates from the mid-19<sup>th</sup> century (1848-1876) with no evidence of the smaller, earlier structure which occupied its southern end. Each ceiling beam contains two mortises for vertical supporting posts, suggesting this space was designed as an open cart lodge divided into narrow bays.

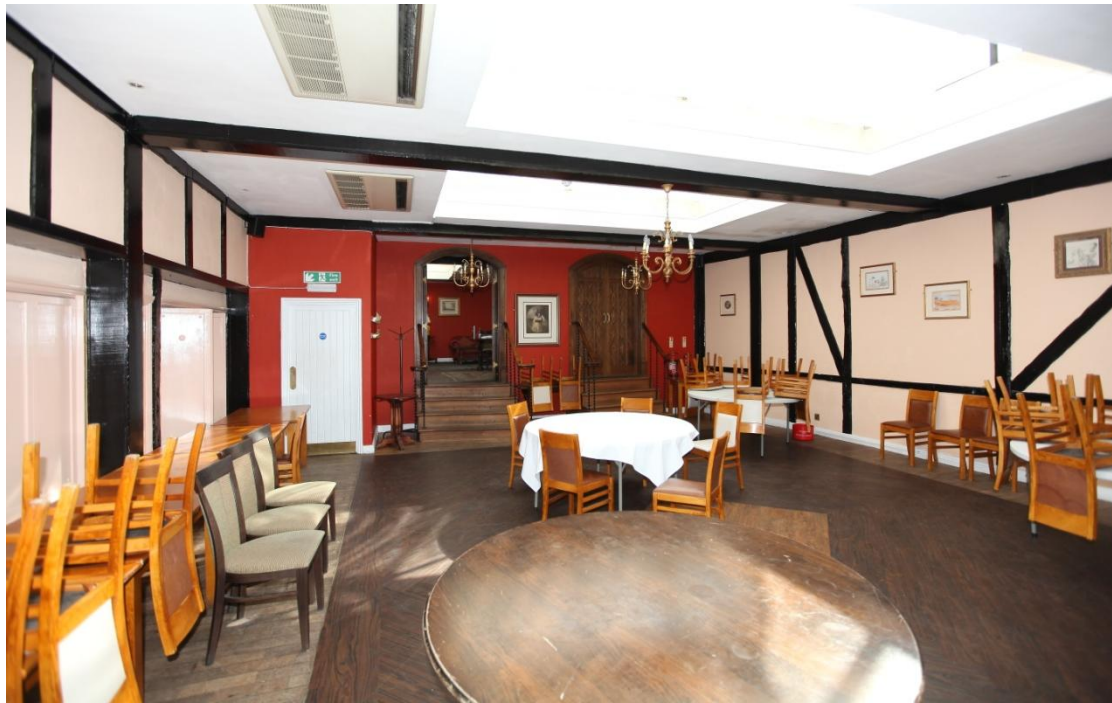
**Illus. 20.** The flat-roofed function room behind no. 117, seen from the north. This part of the inn was added in or after 1984 and its black-painted beams are not genuine.

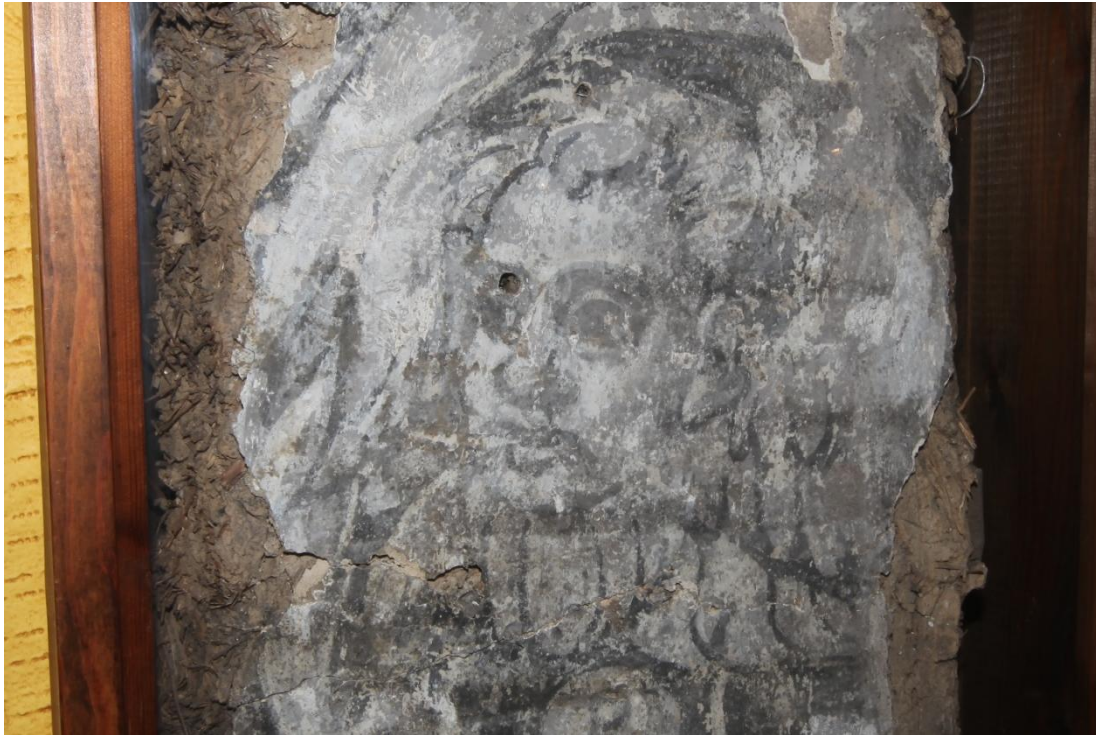
**Illus. 22.** A detail of the late-16<sup>th</sup> or (more probably) early-17<sup>th</sup> century wall painting displayed in a cabinet on the stair landing (illus. 21). The foliate design with cherubs in black and white (a style known as grisaille) is typical its period, and would have covered the room like wall paper. It is understood to have been found in 1984 in the adjoining room (presumably 502 or possibly 201), where more survives behind modern dry-lining.

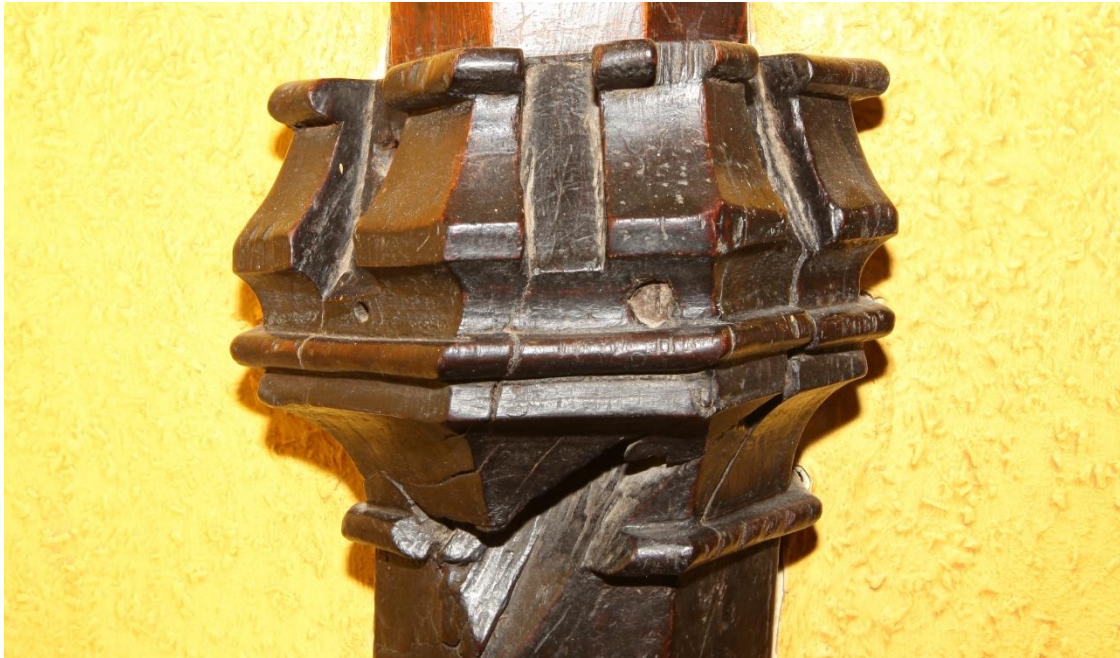
**Illus. 24. A detail of the carved crenellated capital of the crown post. This is a fine piece of medieval carving which may be contemporary with the late-14<sup>th</sup> century hall but is also consistent with a 15<sup>th</sup> century date. It is not *in situ* and there is no guarantee it was not re-used from elsewhere like many other timbers in the inn.**

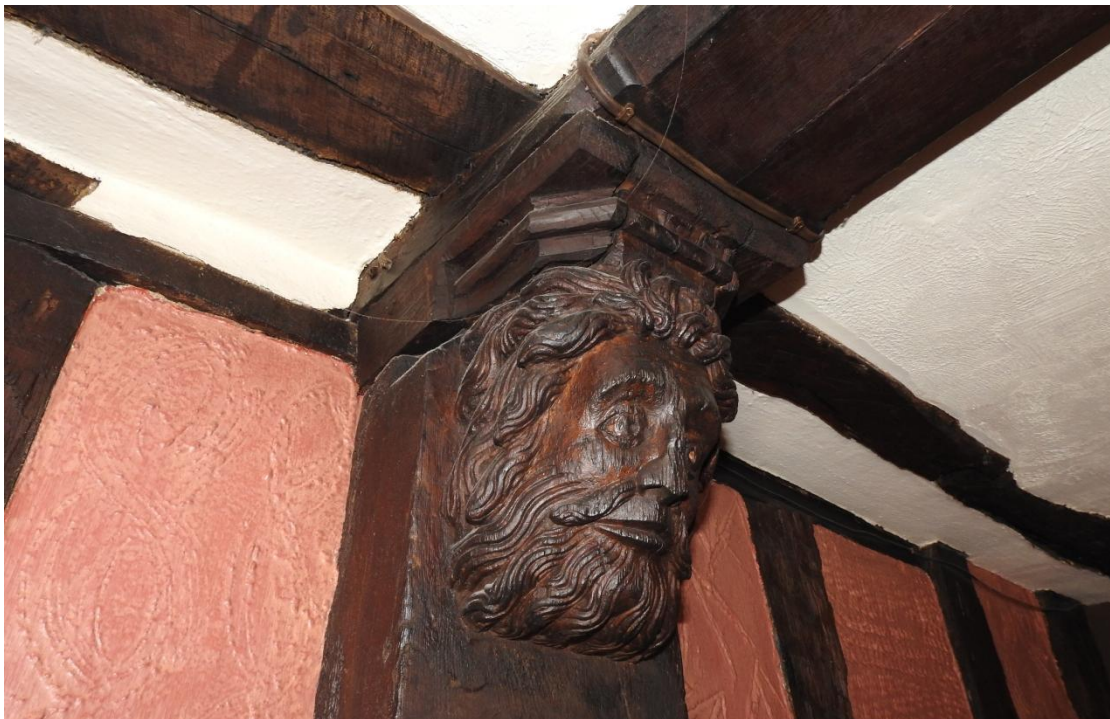
**Illus. 25. The carved late-medieval or early-16<sup>th</sup> century corbel block which is integral to the post supporting the main east-west ceiling beam of room 503 in the southern range (6f). In 1922 the Royal Commission wrote ‘On the ground floor the kitchen has a ceiling-beam with a curved brace resting on a corbel carved with a bearded head’. The kitchen may have been the area beneath the first-floor hall (2), which is likely to have been the principal room of the medieval inn. The ceiling of room 503 is a later insertion consisting almost entirely of re-used timber and appears to occupy the ‘gap’ of 1745. The incised patterns in its plaster are modern.**

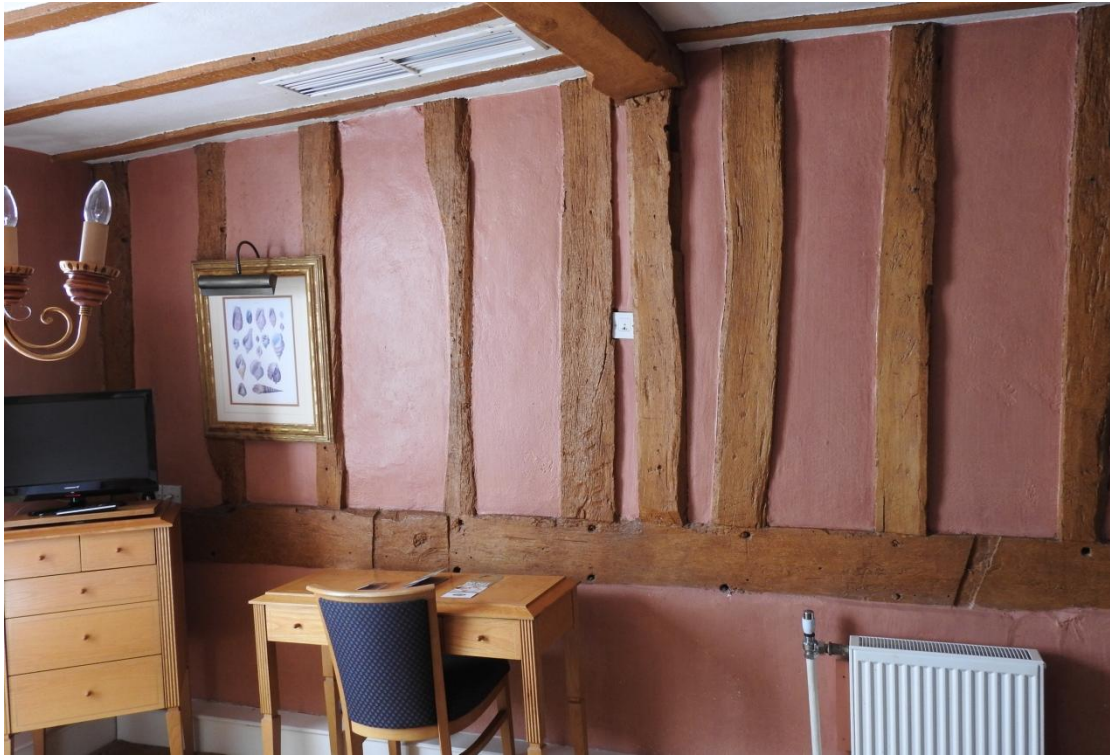
**Illus. 26. The closely spaced early-16<sup>th</sup> century studs of the eastern wall of room 307 on the upper storey – immediately above room 503 (6f2). This wall belongs to the adjoining high-status three-storeyed building at no. 117, and the room's inserted ceiling is supported by a later stud resting on its horizontal rail. The end of a jetty-plate is obscured by the chest of drawers to the right, and the roof gable above retains traces of external pargeting (illus. 31) so this room was formerly a gap in the street. The studs are not weathered and Roman carpenter's numerals are still visible at the foot of each.**

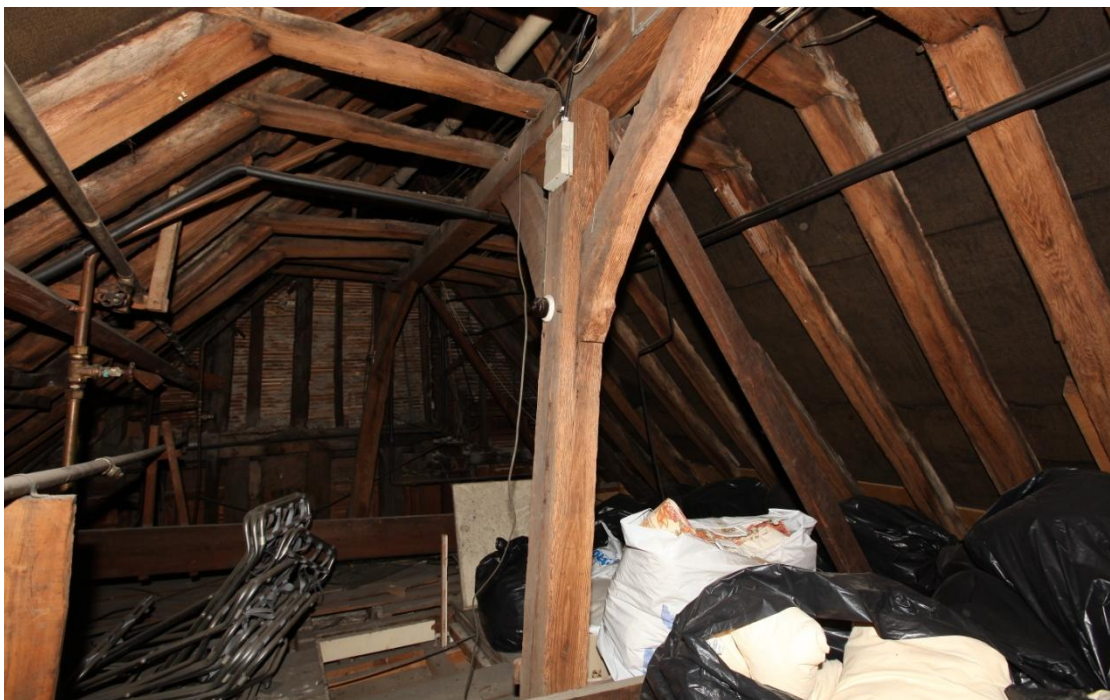
**Illus. 27. The plain 15<sup>th</sup> century crown-post in the southern section of the eastern range (7) showing the heavy studs and either the mid-rail or tie-beam of the earlier structure (3) in the rear (but not the roof-plate as studs survive both above and below).**

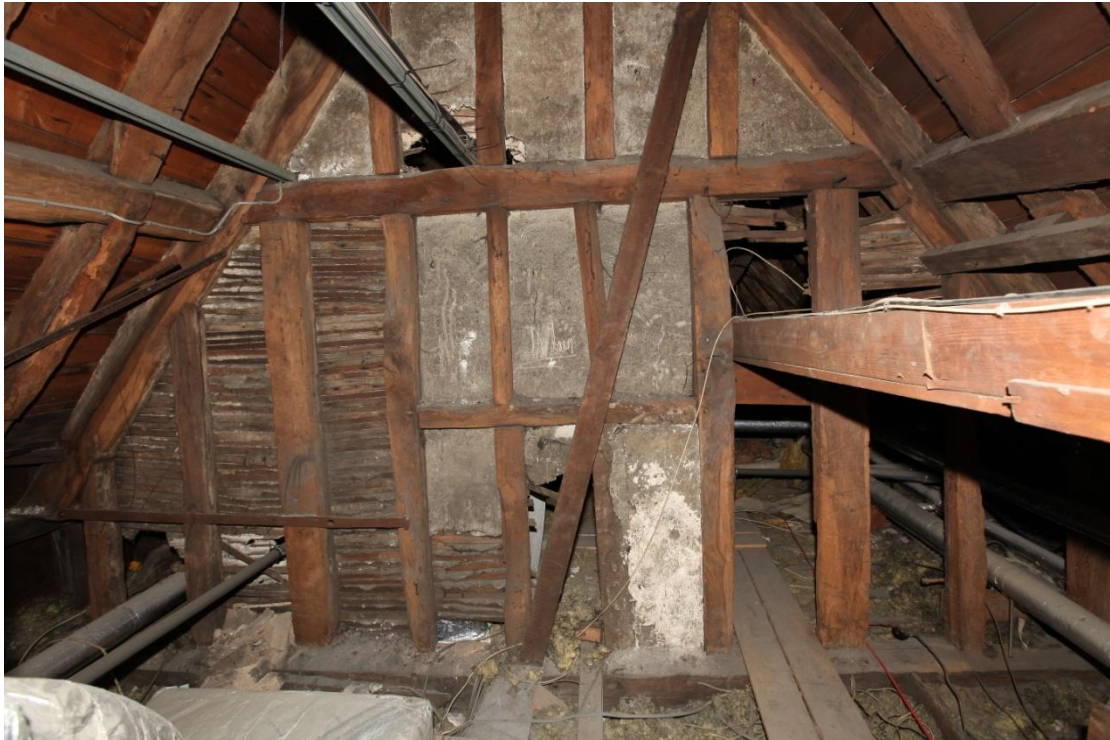
**Illus. 28. The blocked window in the internal western gable of the 17<sup>th</sup> century roof above the High Street range (i.e. above area 5 on the ground floor, looking east to area 6). The roof structure of staggered butt-purlins consists largely of re-used timber, with the rafters interrupted by the purlins. The feet of the rafters have been truncated by the present High Street wall on the left and originally projected by approximately 18 inches further – forming a jettied second storey. The boarded channel on the right contains modern pipes.**

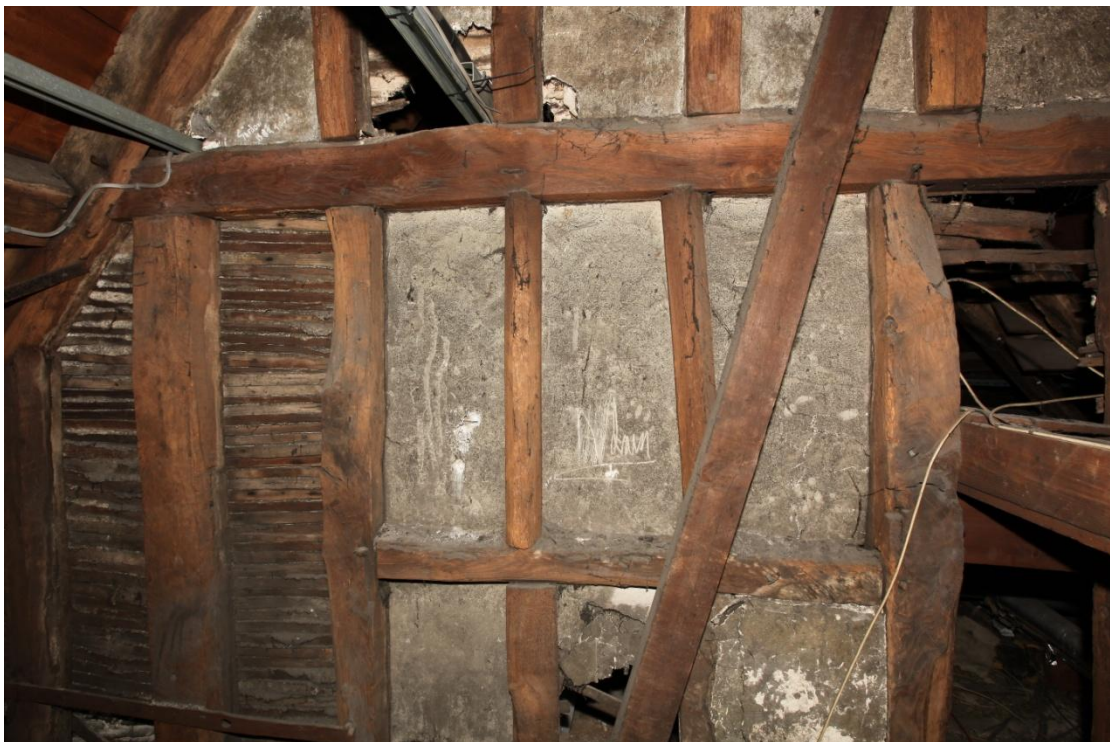
**Illus. 29. A detail of the blocked 17<sup>th</sup> century window with its two original chamfered mullions *in situ*. The tenoned mullions appear to be plainly chamfered externally as well.**

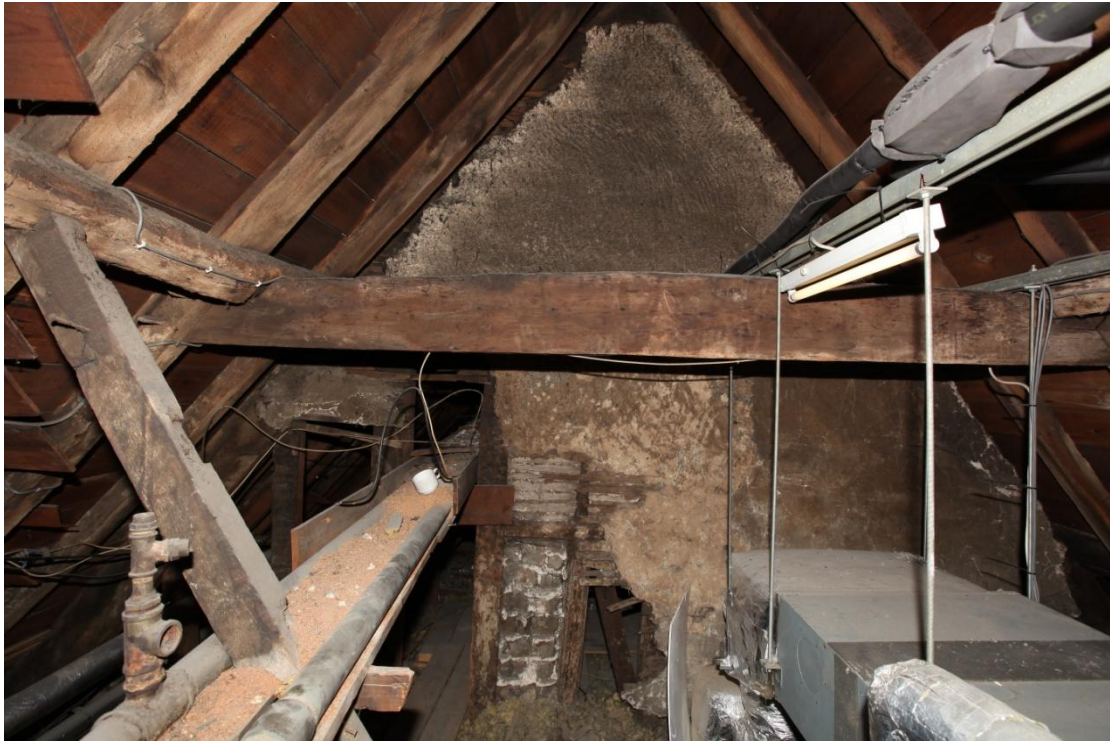
**Illus. 30.** The exterior of the gable shown in illus. 28, looking east from the later clasped-purlin roof above area 6 on the ground floor, with the blocked window in the centre. The lime plaster is decorated with a basket-weave pattern which pre-dates the blocking of the window and was clearly exposed to the street as indicated in 1745 (figure 3).

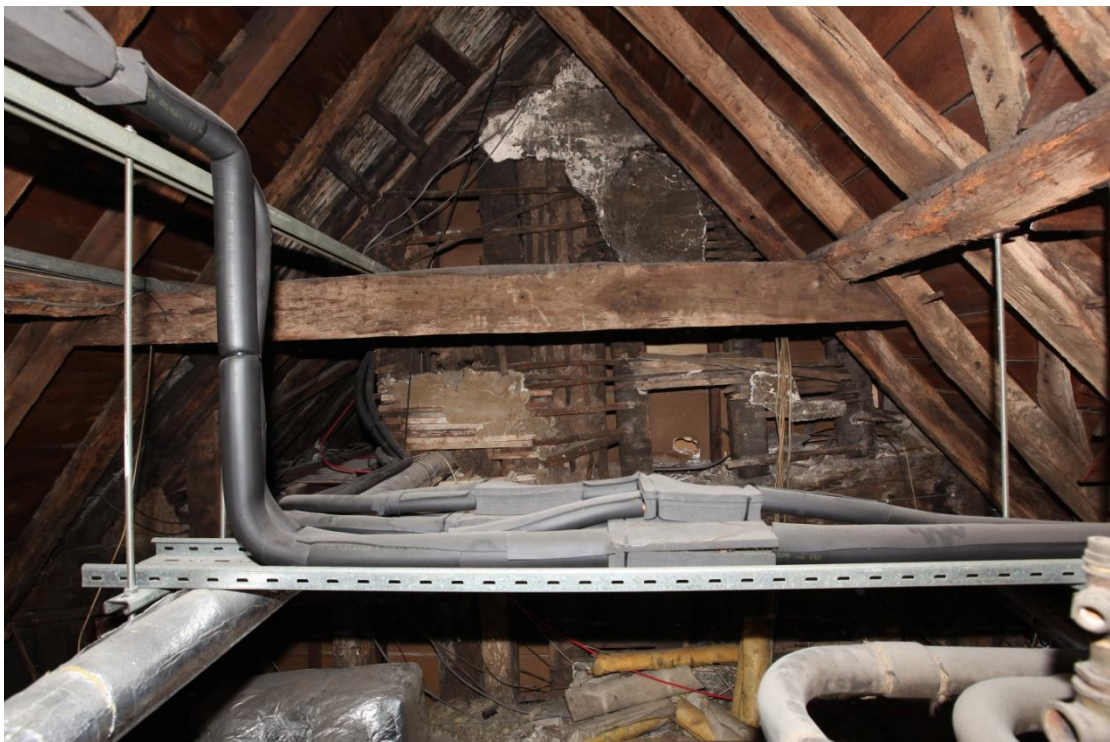
**Illus. 31.** The timber-framed wall of no. 117 from the roof above area 6. The plaster of this wall was also exposed to the street but is not decorated with pargeting. Instead it appears to be covered in a thick layer of brown paint – or dirt. The roof of no. 117 beyond is a later reconstruction visible in the attic room above no. 308.

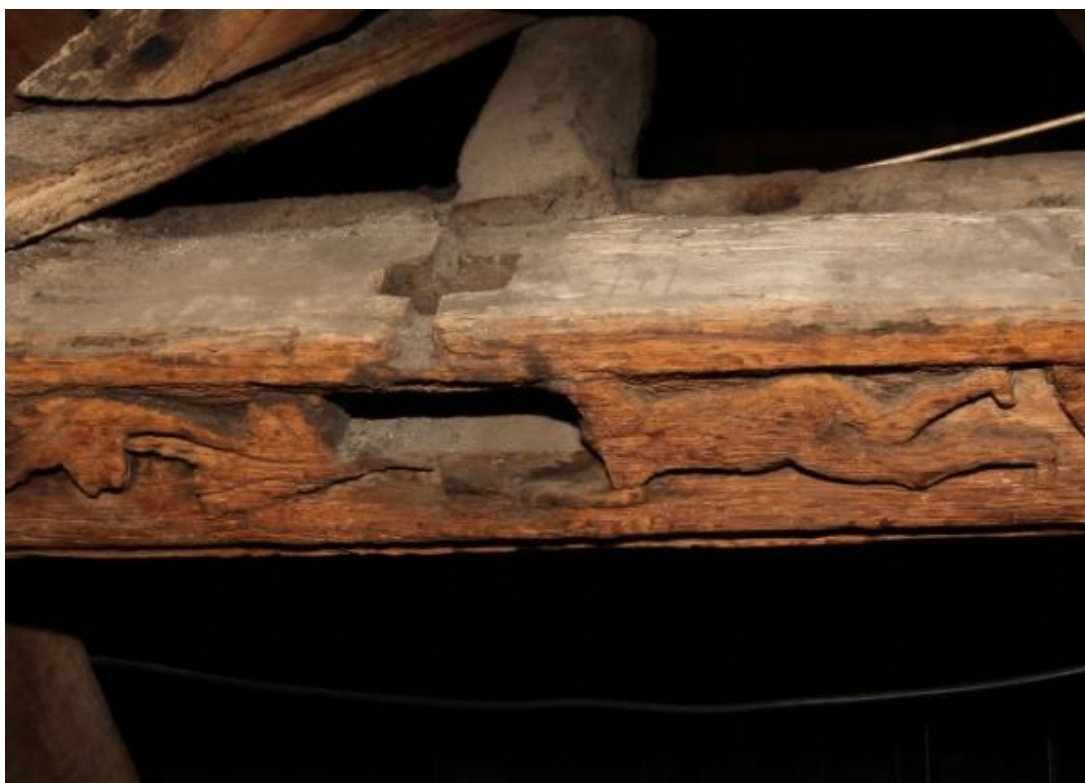
**Illus. 32. A detail of a re-used carved mid-16<sup>th</sup> century window sill in the 17<sup>th</sup> century roof above room 305 (area 4f2). An apparently naked figure is holding a scroll of leaves. The roof contains many other re-used timbers, including sections of roll-moulded cornice similar to that of area 4 on the ground floor, but no others are carved.**
