A survey of the Town Wall in the Bus Depot, Queen Street, Colchester, Essex

On behalf of Colchester Borough Council

CAT Report 955
May 2016, rev July 2016

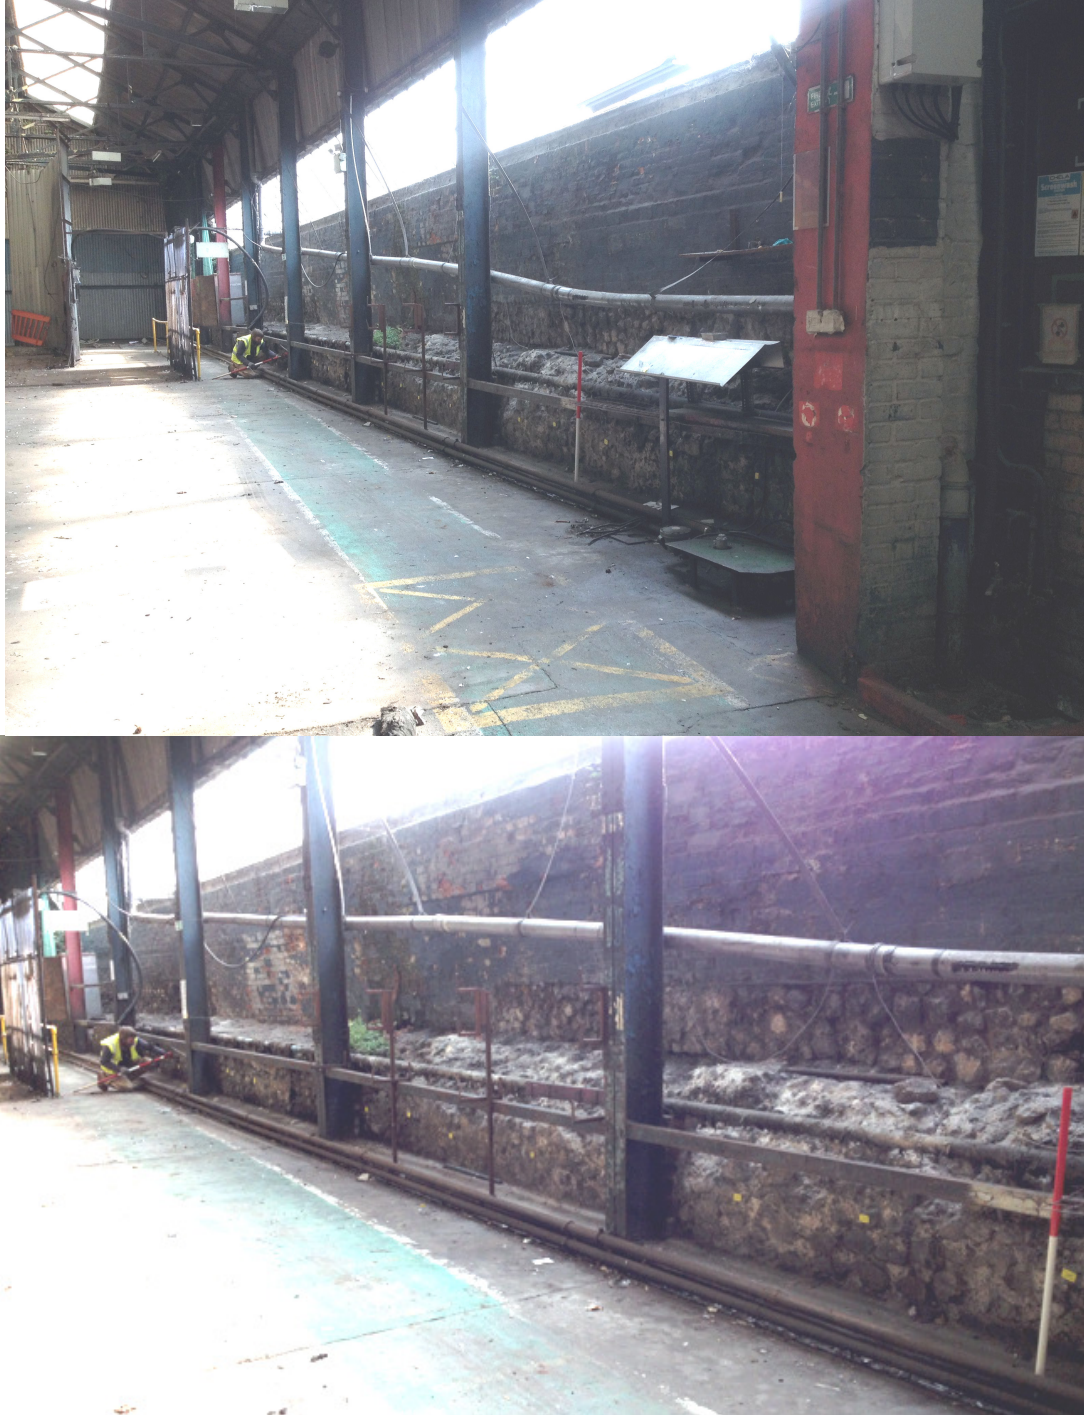
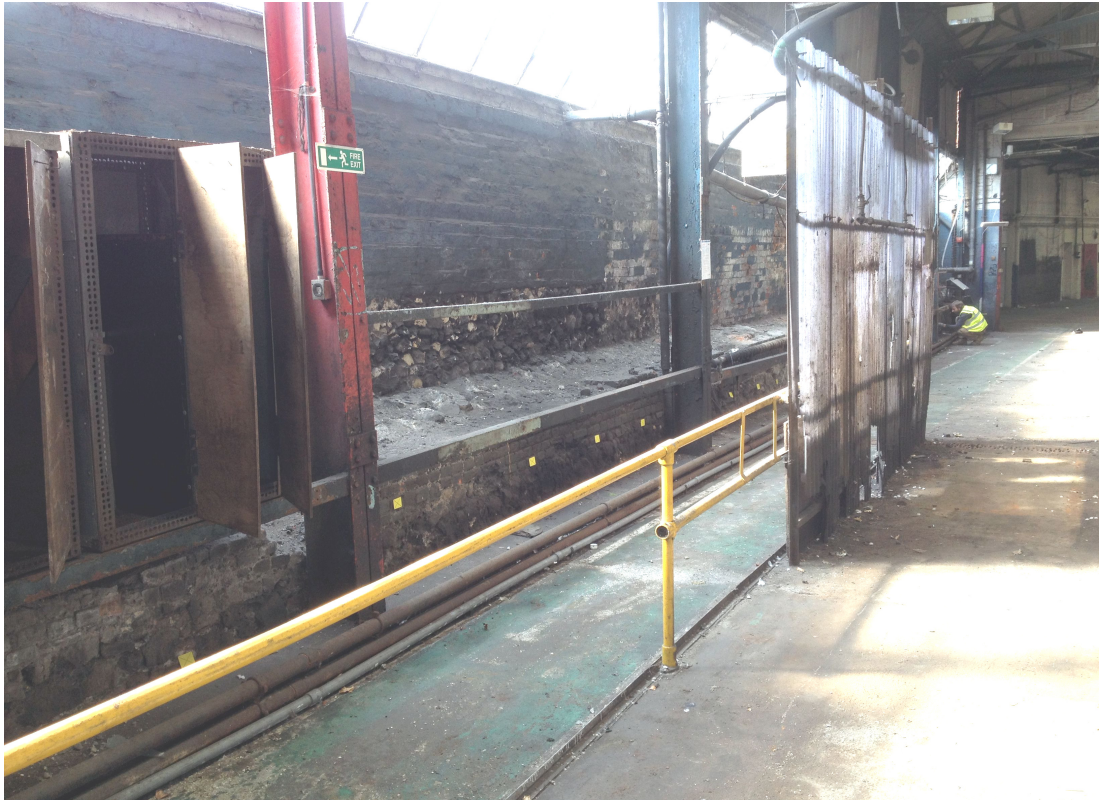
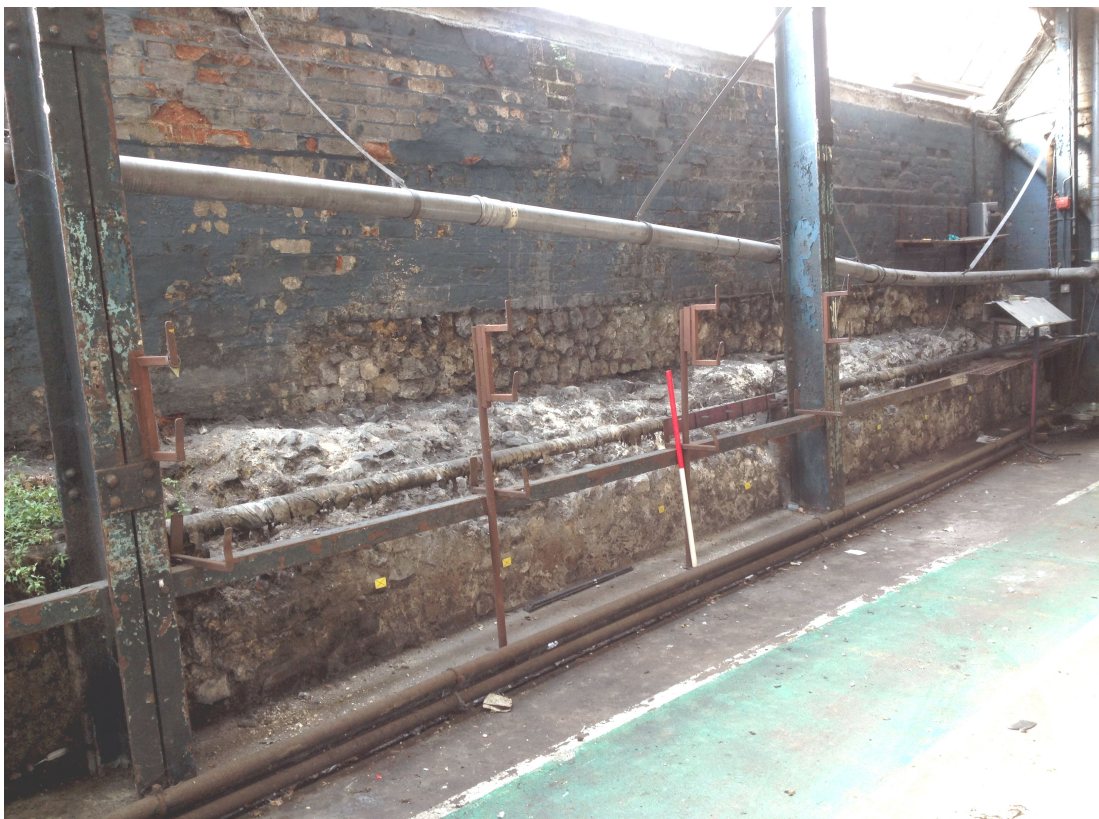
Plates 1a, b: View east showing the town wall, behind the steel structure of the Bus Depot. (The skylights are not helpful for photography).

Plates 1c, d: View west showing the town wall, behind the steel structure of the Bus Depot. (The skylights are not helpful for photography).

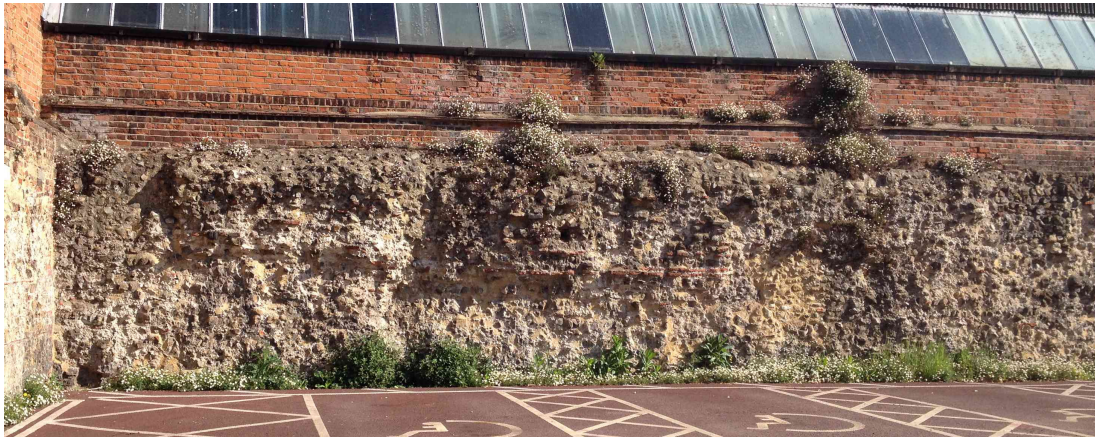
Plate 2a: View north of the outer face of the town wall in Priory Street (the reverse side of the Bus Depot wall). Showing the brickwork and skylights on top of the wall.

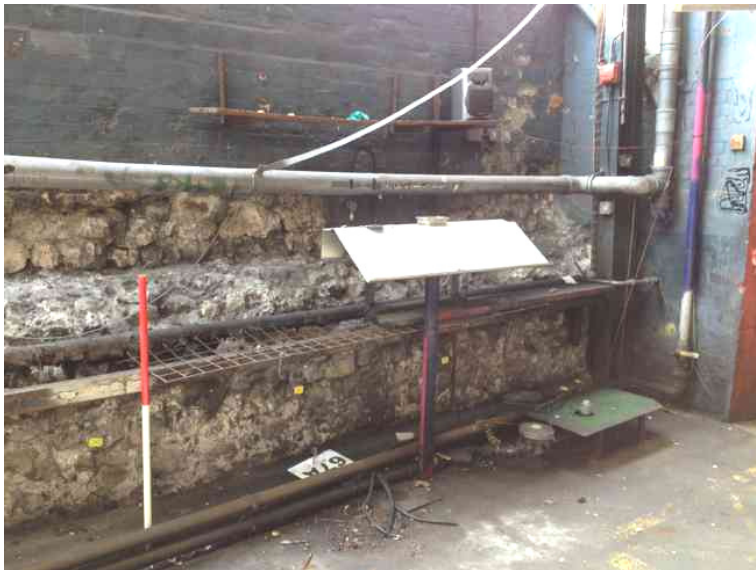
Plate 3: View west of the western end of the surviving town wall, showing the pipes and bus depot paraphernalia.

This was a very difficult job, because the wall is obscured by huge screens, lockers, pipework, steel frames, and other impediments associated with the Bus Depot. Environmental hazards include a covering of pigeon droppings and a covering of soot from bus exhausts.

None of these conditions make for an ideal survey. There is no question that a better survey could be done if the site were cleaned up (netting removed, pigeon droppings cleared, exhaust deposits cleaned off wall, leaves swept up) and all encumbrances removed (lockers, the two huge screens, and redundant pipework).

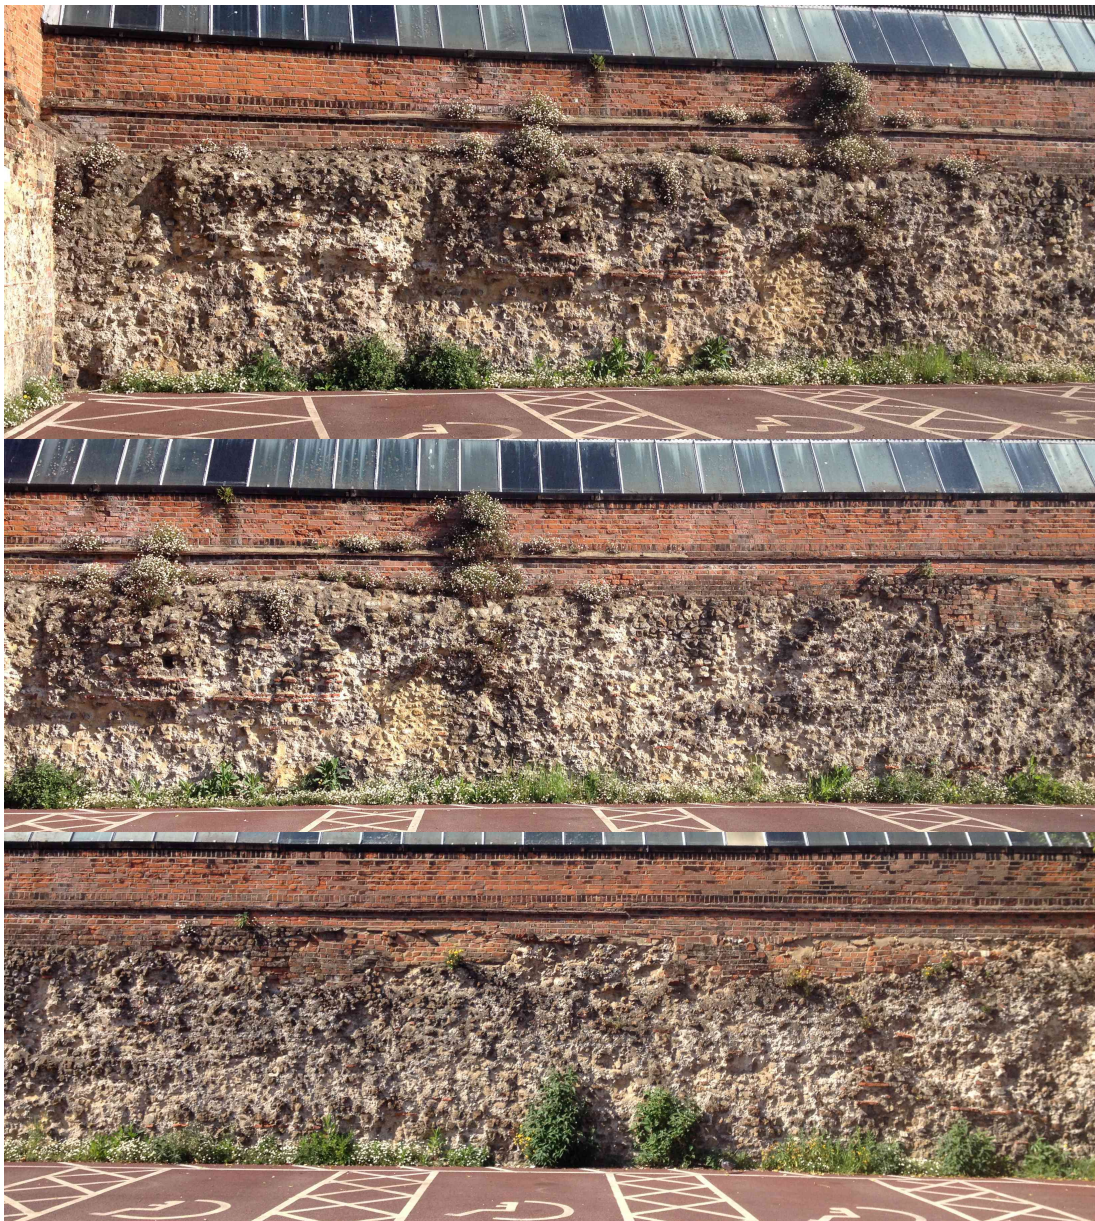
Plates 4-6. View north, from west to east, of the outer face of the town wall (2016)

It is helpful to first look at a photographs of the other side of this wall, as seen in Priory Street car park (Plates 4-6). This will give us a way in to the discussion and understanding of the Bus Depot wall. The Priory Street wall consists of two elements: first, the rubble and tile/brick outer face: second, on top of the older wall, courses of post-medieval bricks which support the frame of a row of skylights. One point which is not obvious from Plates 3-5 is that the post-medieval brick courses are not laid uniformly over the older rubble wall. At the western end of the wall (plate 4), the brick wall is set back by 0.4-0.5m from the rubble wall face, whereas at the eastern end of the wall (plate 6), the brick wall is more nearly flush with the rubble wall face.

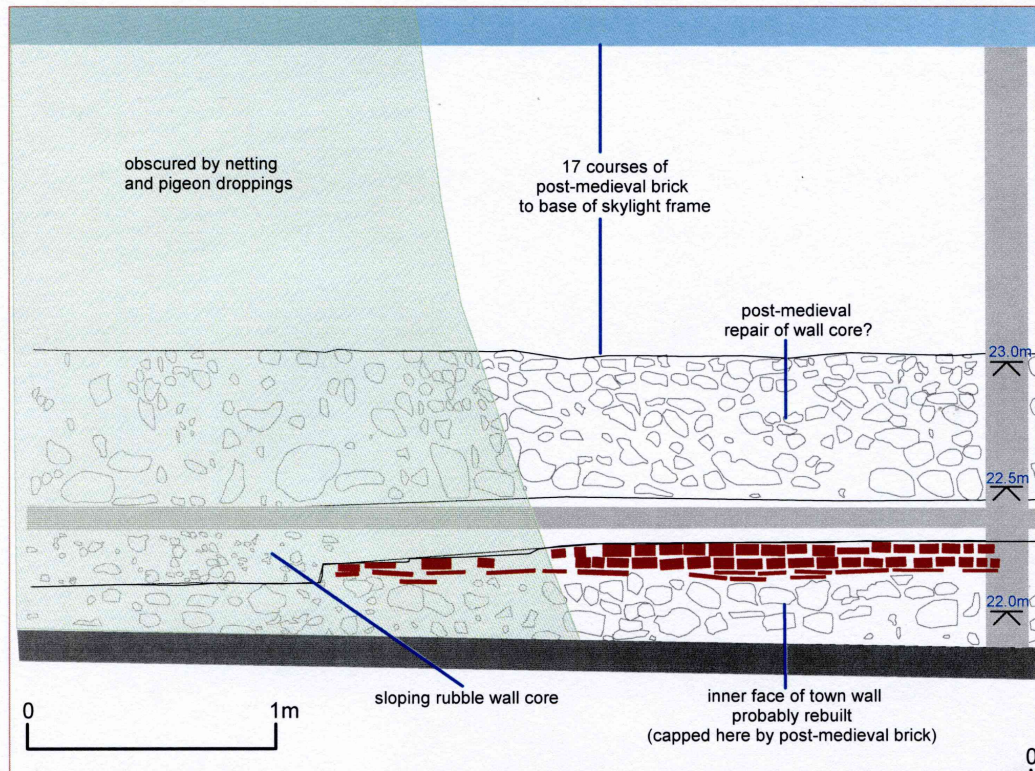
Bay 1 is at the east end of the Bus Depot. The eastern end of the Bay 1 wall face survives badly, standing only 0.3m high³. The western end survives 0.43m high, the top 0.13m being a capping of one or two courses of peg-tile, supporting two courses of post-medieval brick ('Tudors'). The width of the wall could not be measured here, but is 1.5m on the Survey Solutions (SS) survey (31/07/14 - drawing number 14543se-01).

To the rear of the inner face, the wall core slopes up gently to meet a near-vertical face of mortared septaria (also visible from Priory Street), 0.89m rear of the inner face, and standing 0.6m high above the wall core. This is 0.3m wide on the SS survey.

On top of the rubble wall inner face are 17 courses of post-medieval brick, split into two parts by a row of headers half-way up. The top 7 courses and the capping header row fit so neatly under the wooden skylight frame that they must be contemporary with the construction of the Bus Depot (it would be too much of a coincidence that there was a convenient brick wall of the correct height already there when the Bus Depot was built). However, the lower headers and the 9 courses below may well be an earlier build.

The wall core appears to have been trimmed down to the height of the Bus Depot steel frame along most of the exposed length. Particularly difficult to survey here due to obstacles (netting, pipes, steel frame, leaves and debris, pigeon droppings).

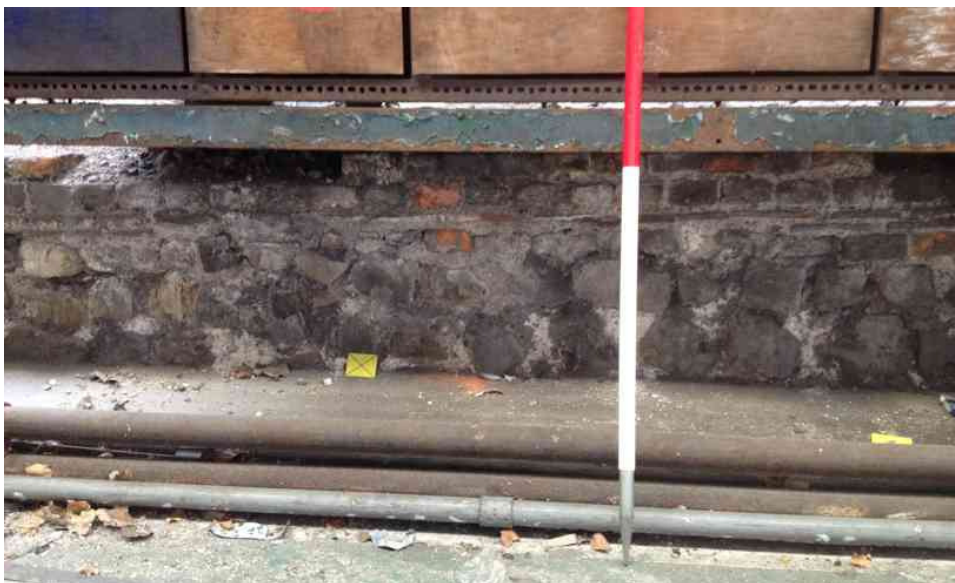
Plate 8: under lockers in Bay 2 the septaria is more regularly-coursed than elsewhere in depot, but this is not Roman-period.

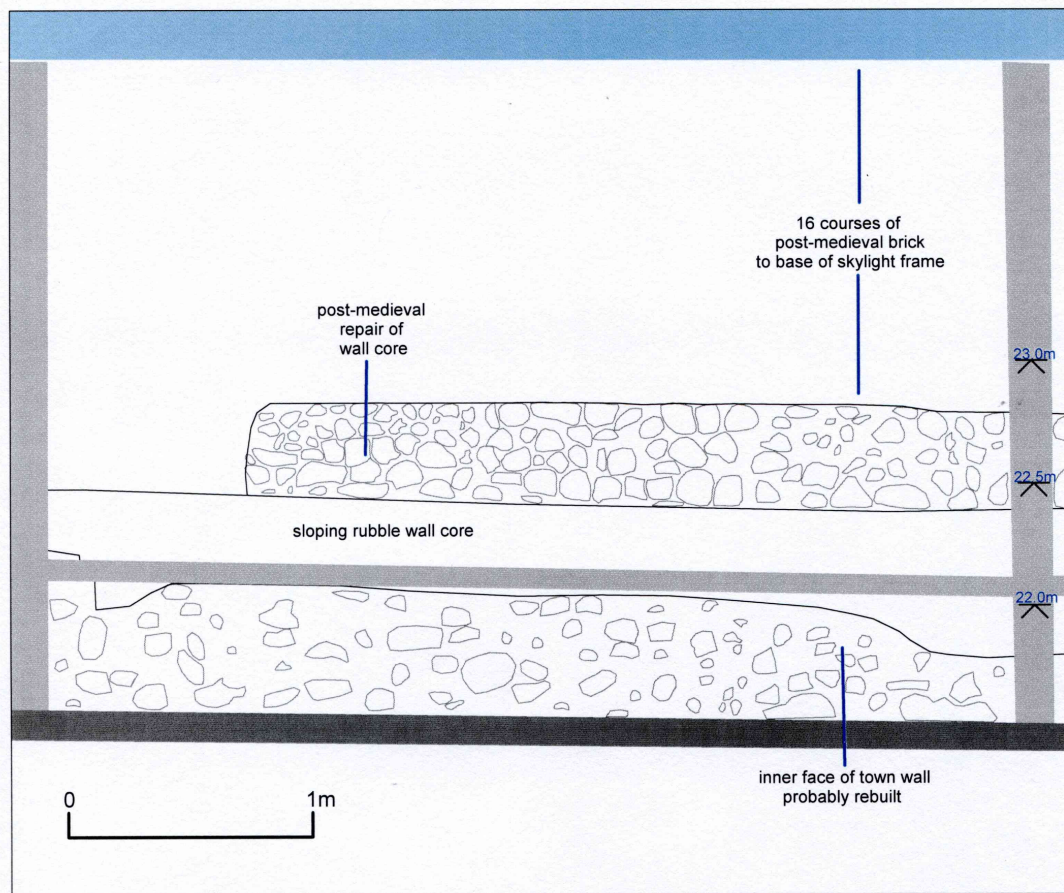
Bay 6

There is no brickwork in the inner wall face in this bay. The inner wall face (rubble only) has been severely hacked here, and survives to varying heights from 0.25m to 0.65m. It is noticeable how exposed the rubble wall core is here, and that it slopes more than in any other bay (i.e., there is a difference of between 0.35m and 0.60m in height between the top of the inner face and the bottom of the rear rubble face).

The width of the wall could not be measured here, but is given as 1.5m on the SS survey.

To the rear of the inner face, the wall core slopes up gently to meet a near-vertical face of mortared septaria (absent in Bay 5 to the east), 0.66m rear of the inner face, and standing 0.40m high above the wall core. It was not possible to measure the width of this face, but the SS survey indicates it is 30cm wide. Unlike Bays 3 and 4, there are no Tudor bricks in this inner wall face.

The wall core severely damaged here, and the wall face is heavily plastered over, making it difficult to see individual septaria stones.

Obstacles: pipes, steel frame.

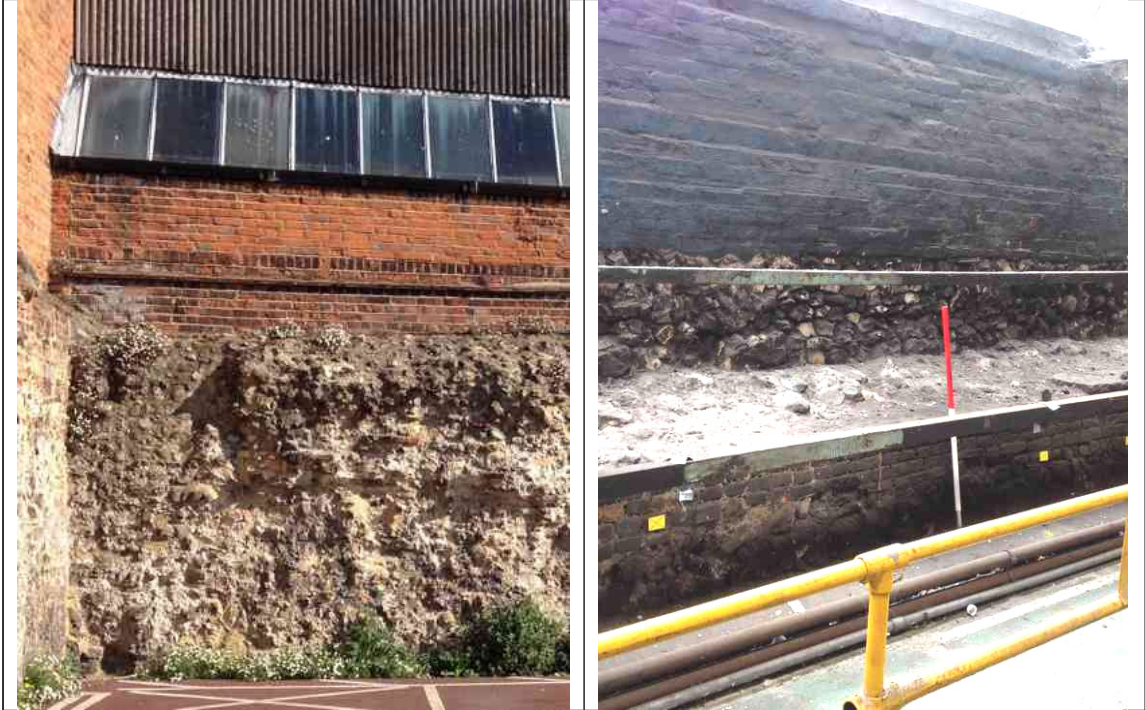
Plate 10: views of wall from Priory Street, and inside Bus Depot

It is interesting that the view from Priory Street suggests a two-part structure - brickwork over rubble wall - whereas in the Bus Depot it appears as a three-part structure - wall core, inner rubble face, and brickwork (Plate 10). It seems that the view from inside is misleading - the wall core has been hacked back in the Bus Depot, leaving only a thin rubble wall (0.3m wide) standing over a more solid core.

It can also be seen from Priory Street that the brickwork is in two distinct colours (Plate 10). This probably indicates two distinct structural phases - later one being the upper seven courses supporting the Bus Depot roof, and the earlier one being the lower seven courses (or more) on top of the Roman wall, each phase being topped by a course of headers. Some support for this view is shown in Plate 11, where it can be seen that to the south of the old Bus Park (now VAF), the Roman wall is similarly topped by a post-medieval brick wall (seven courses plus headers). It can therefore be concluded that the brick wall on top of the Bus Depot wall is indeed of two periods - an earlier (post-medieval or Victorian) wall on top of the Roman wall, and a mid-20th-century wall built to support the Bus Depot roof.

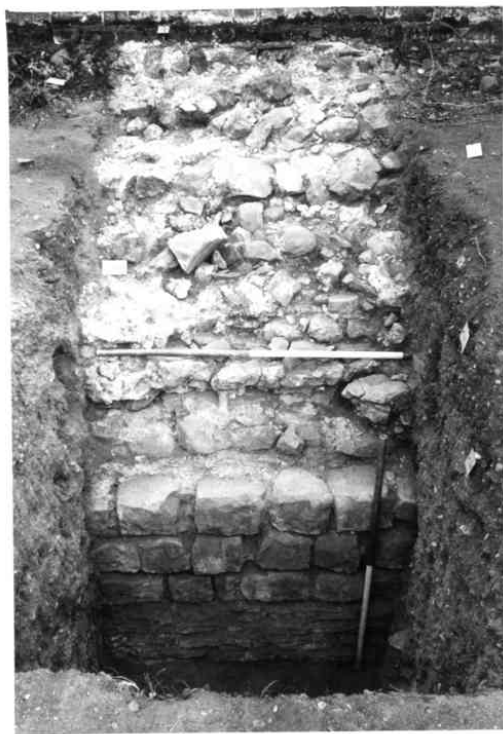
Plate 12: Inner wall face exposed in 1990 evaluation Trench 2, 33m east of the east wall of the Bus Depot. Note the neat coursing of the in situ Roman wall face. The highest point on this surviving coursing is 21.25m (view south: scales are 1m long)

In this context, it can be noted that the top of the surviving original Roman wall facing exposed 33m to the east in Trench 2 of the 1990 evaluation was at 21.25m. This height, projected into the Bus Depot, is approximately 0.70m below the floor level at the east end of the Bus Depot (i.e., bay 1) and approximately 0.25m below the floor at the west end (Bay 7).

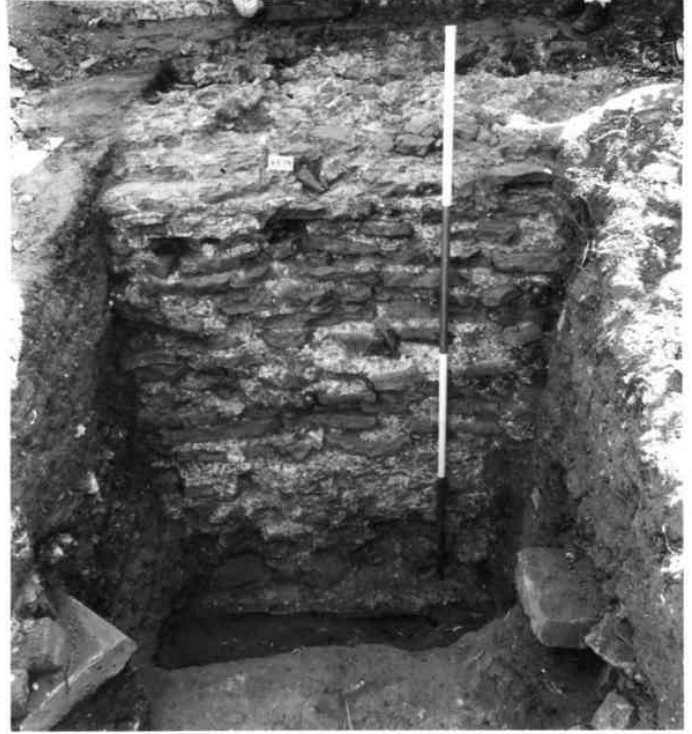
Plate 13: Inner wall face exposed in 1990 evaluation Trench 3, 78m east of the east wall of the Bus Depot. Note the bonding courses of Roman brick, heavily mortared here (view south: scale is 2m long)

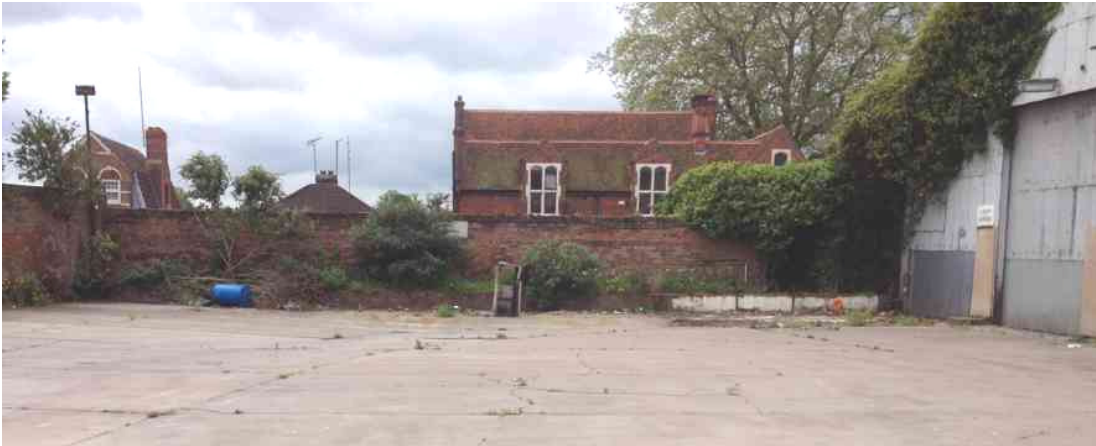
Plate 14: the wall Hull saw in 1931 is at the south edge of the bus yard (view south here). The wall is heavily overgrown.

Of course, the piece of wall reported by Hull here is, beyond Bastion 5, a direct continuation of the face surveyed here inside the Bus Depot (Plates 14-17). We share Hull's view that the wall face is not original Roman, but a post-medieval rebuild (the Roman or medieval core may survive behind it).

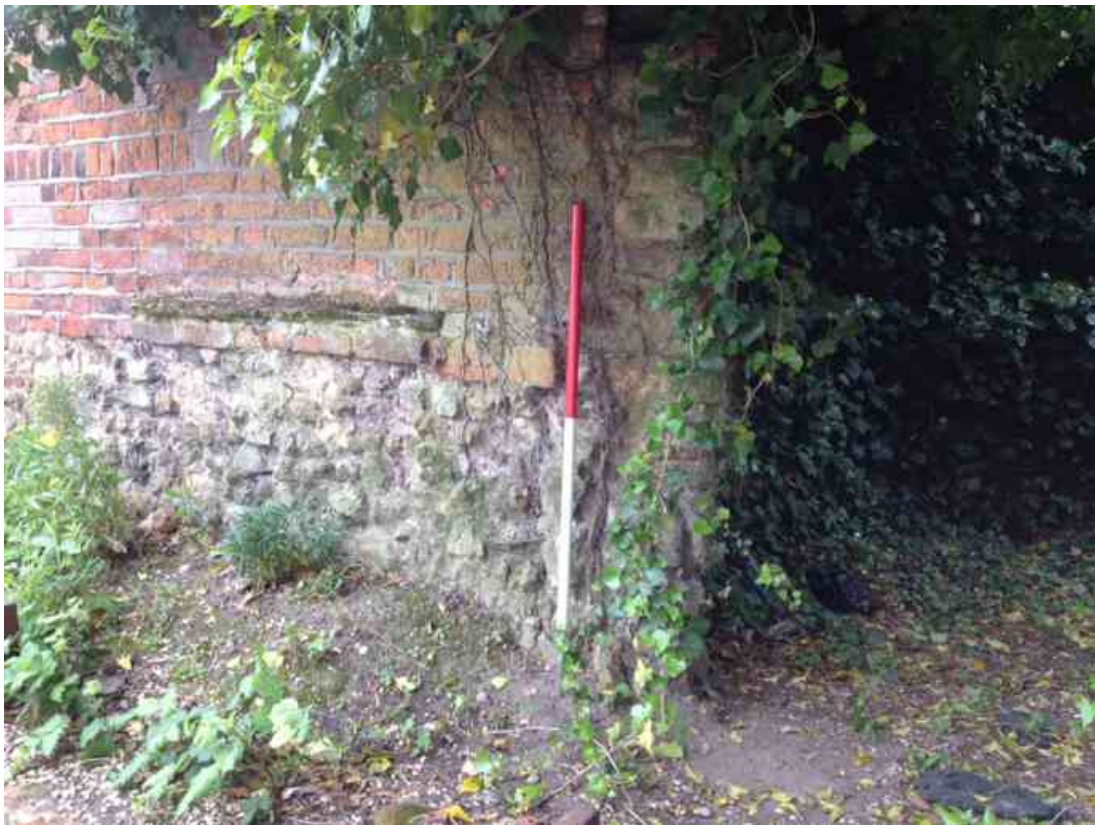
Plate 17: eastern side of Bastion 5, interior is overgrown.

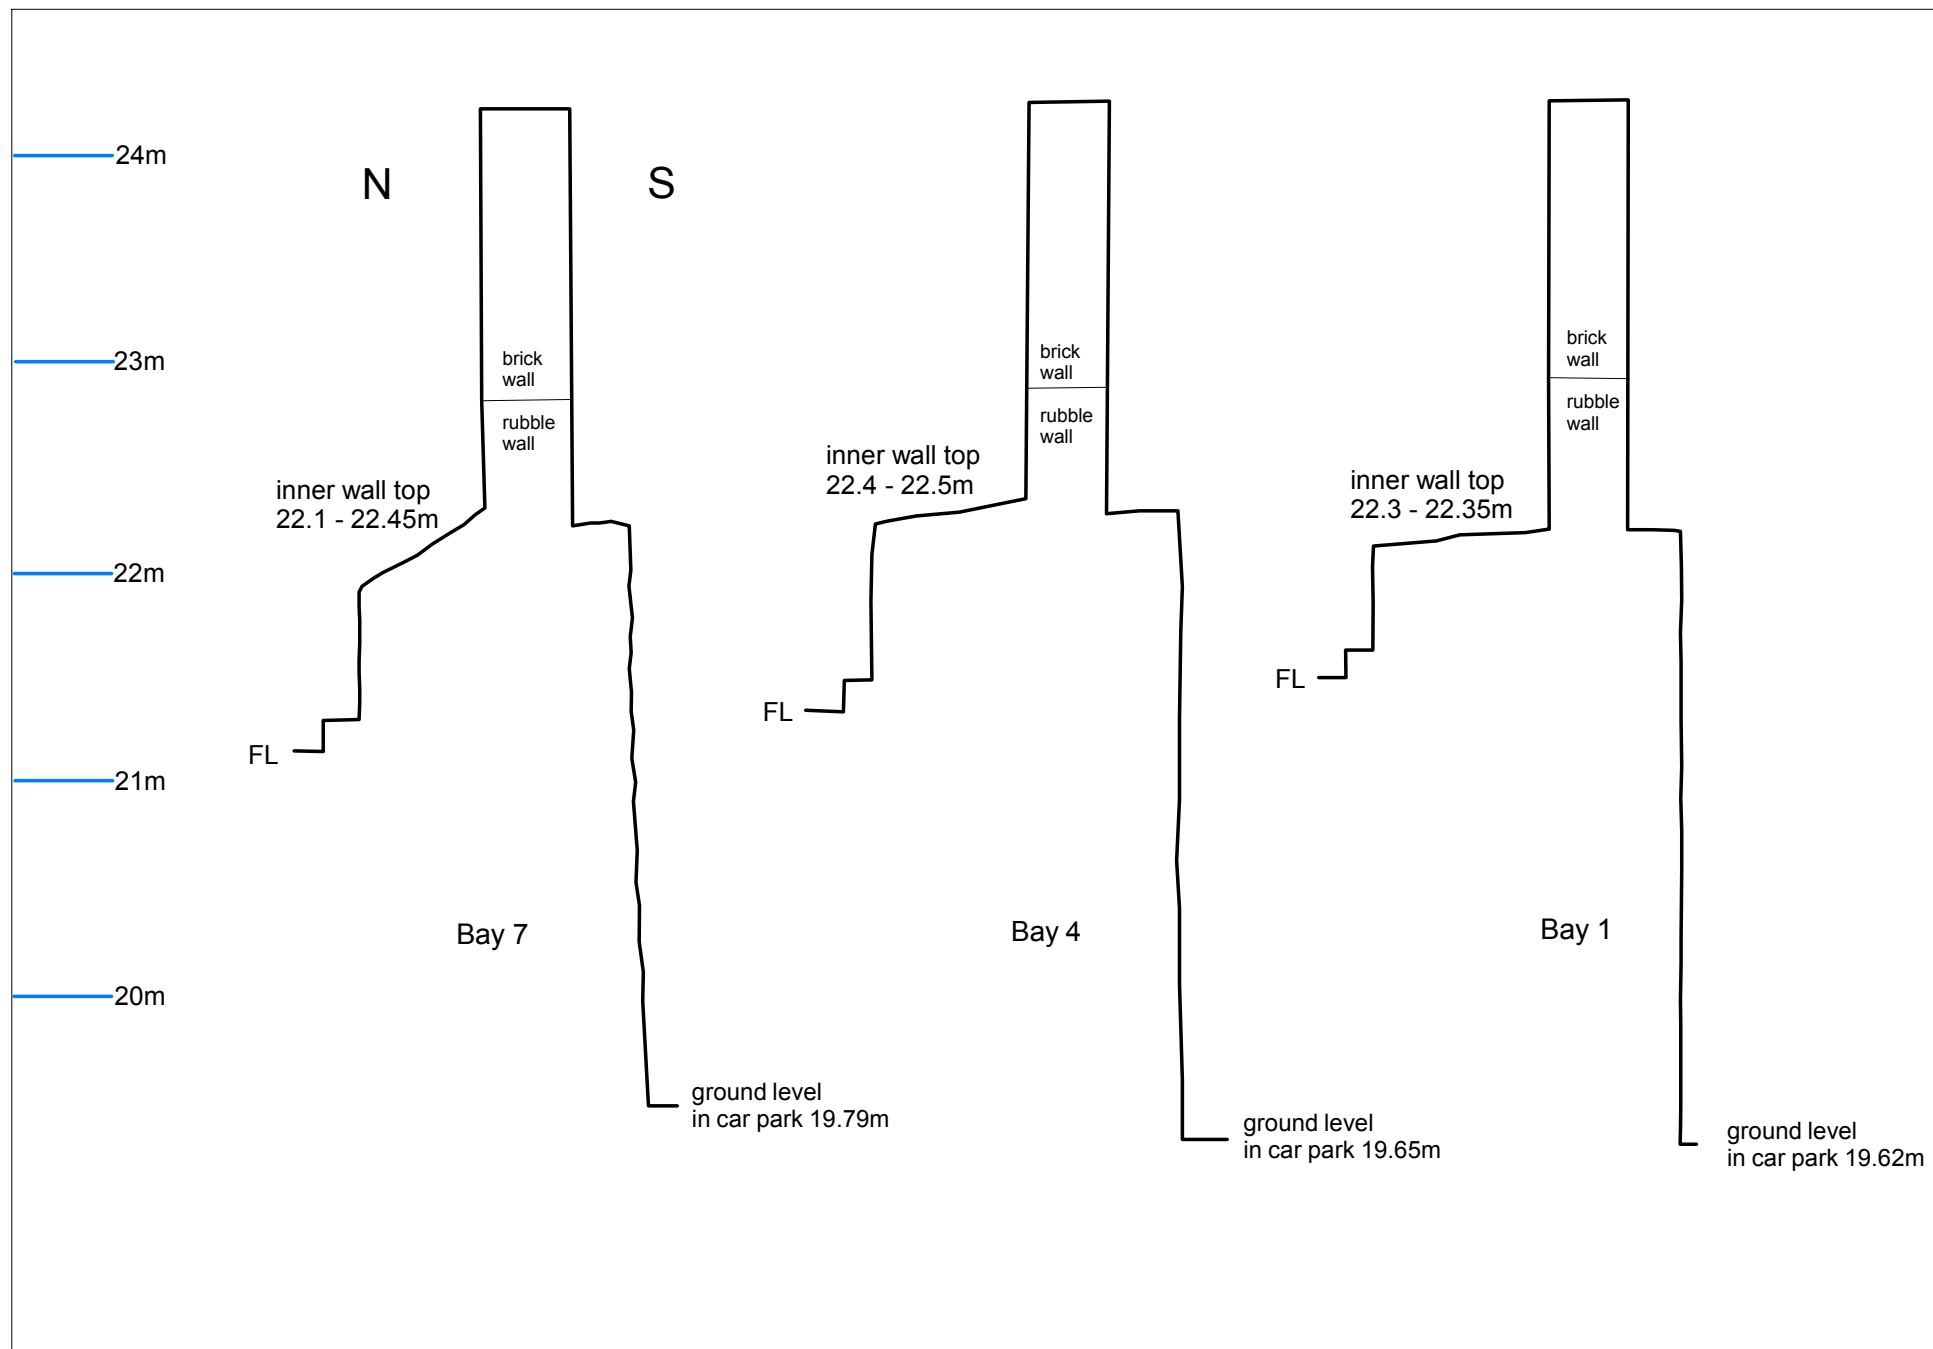
Fig 6 Profile across town wall from Bus Depot to Priory Street car park
Left, Bay 7 (western bay inside Bus Depot), centre, Bay 4 (centre), right, Bay 1 (easternmost bay).
