The Excavation of the Roman Theatre at Gosbecks

By ROSALIND DUNNETT

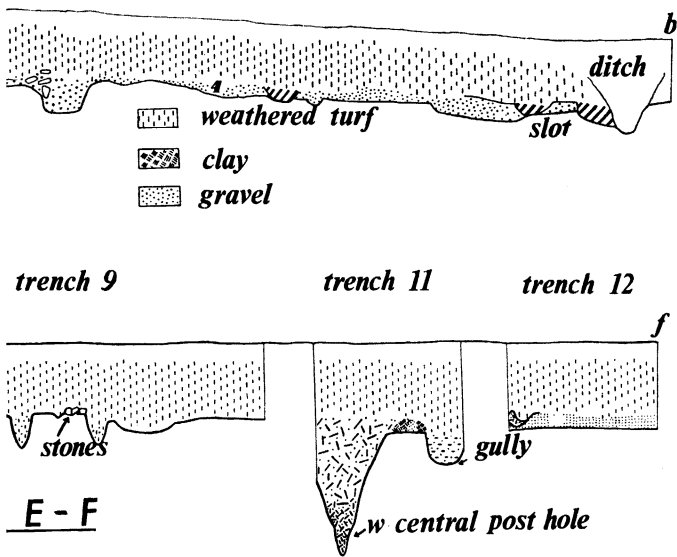
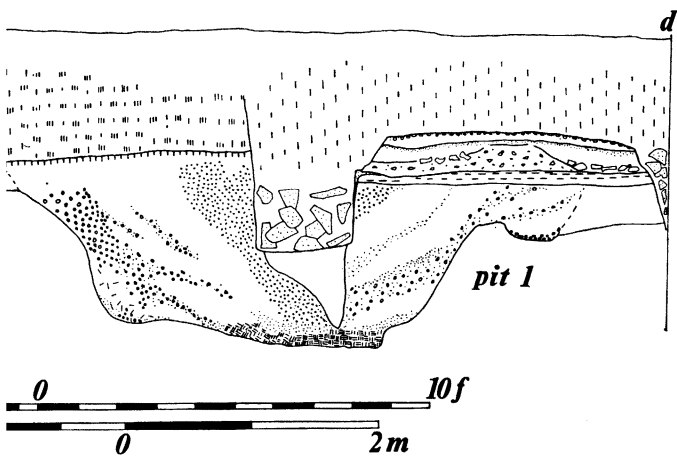
FIG. 4
The Sections.

SECTION A - B

Section C - D

Pit 1. An oval pit, 12 ft. by 7 ft. and $3\frac{1}{2}$ ft. deep (FIG. 2). It was steep-sided with a flat base (FIG. 4, section C-D) and completely filled with layers of silt interspersed with bands of clean gravel. This was doubtless due to natural silting, a process which in the loose gravel subsoil must have occurred fairly rapidly. The top layer of silt yielded a couple of sherds of hand-made pottery (see FIG. 6, No. 21). *Pits III-IV.* These three pits were shallower than Pit 1, with a depth of only 18 in. to 2 ft., but their filling was identical. Pit III produced from its base a small lump of iron, possibly a nail head. All four pits were certainly artificial, but had become completely silted up and sealed by a thick turf-line before the erection of the earliest Roman building on the site. No other pre-theatre structures were found, but lying on the old turf-line beneath the *cavea* were a number of pieces of Iron-Age pottery, identical with that from Pit 1. Further examples were found in the actual body of the *cavea* (p. 44f). Since, as will be shown below, the turf of which the mound was built must have been gathered from over a wide area, and the pottery presumably with it, its occurrence here cannot be taken as further evidence for pre-Roman occupation on the actual theatre-site itself. Presumably, however, the turf came from the immediately surrounding area, and if so suggests an earlier occupation there. The presence of the pottery in the pits *may* be fortuitous, but in any case both pits and pottery pre-dated the Roman theatre by many years. The discovery of pre-Belgic pottery in the area is of considerable interest in view of Professor Hawkes's suggestion of the pre-Belgic importance of the Gosbecks site and the primary date of the Heath Farm dyke among the Camulodunum defences.⁷ It must be emphasized, however, that the pottery was all extremely fragmentary and cannot be taken as evidence of any concentration of occupation in the area.

The actual plan of these timbers can only be tentatively restored. Those north of the slot have already been suggested as floor-supports. Although the southernmost post-hole is 20 ft. south of the slot, the structure associated with it was probably only about 11 ft. wide. The line of post-holes approximately 11-12 ft. south of the slot, though not quite parallel to it, seems more likely to mark the back of the structure, since one of the two shallow clay-lined gullies in the area started on this line and it is difficult to see why such a gully should start *beneath* a structure. The second gully ran south from the orchestra and presumably went under the stage. The fact that both gullies were clay-lined suggested that they were designed to carry off surplus water, an arrangement which would not normally have been necessary in the easily drained gravel subsoil; but if, as has already been suggested, the orchestra was both timber-floored and sunk to a level lower than the surrounding area, some such provision might well be needed to prevent rainwater accumulating in it. An iron collar found unstratified in the south of the orchestra is unlikely to have been connected with either gully; it was more probably a binding for the base of a post. As mentioned already, these features pre-dated the later structure in the stage area which was cut through layer 4, and in any case four of the post-holes in Trenches 6 and 7 can be stratigraphically associated with the orchestra depression (FIG. 4, Section A-B).

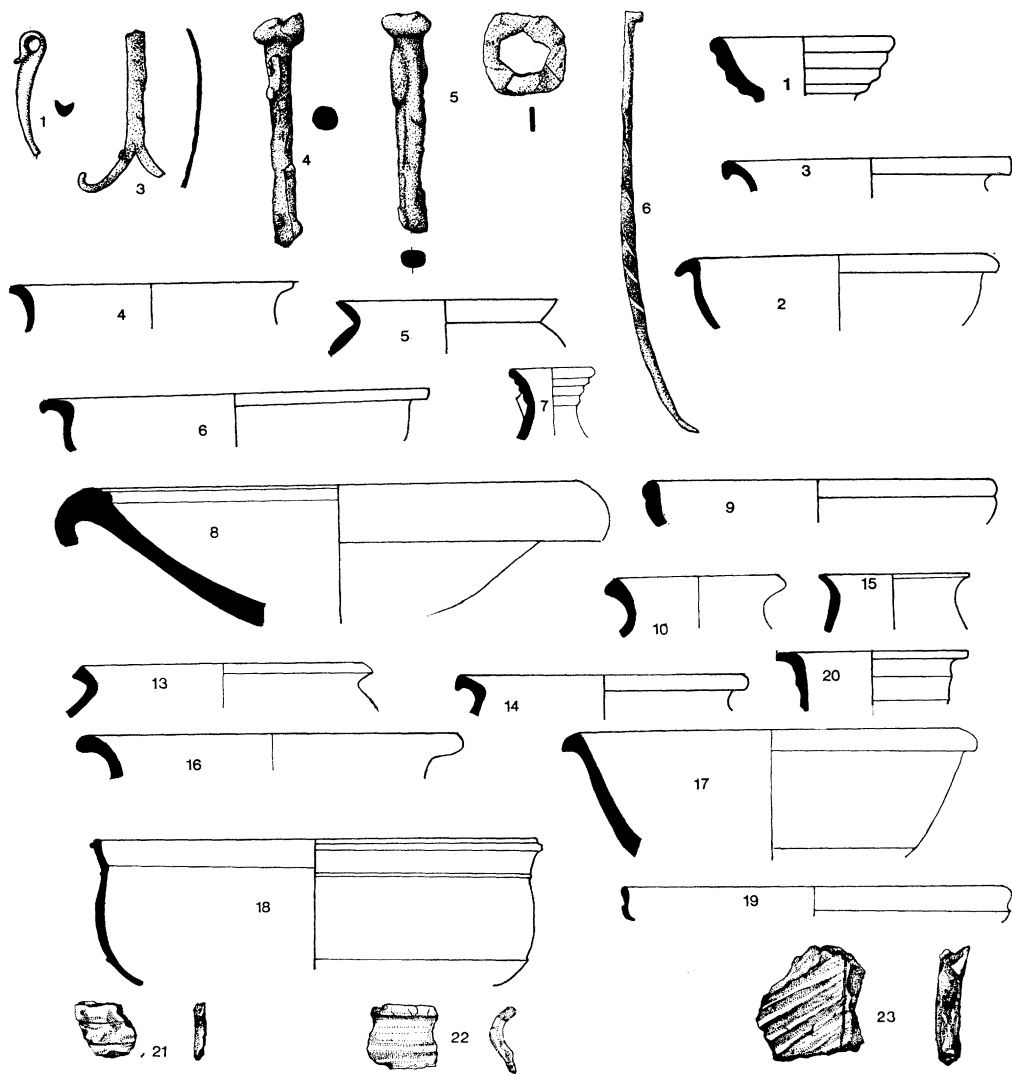
FIG. 6

The pottery and small finds of bronze (No. 1) and iron (Nos. 2-6) ($\frac{1}{4}$).

- Small bronze object consisting of a small loop with a long curved tang, triangular in section with one side pronouncedly concave. The loop is rounded with marked signs of wear on the upper side. Similar objects are not uncommon in Colchester.²² They have been described by Hull as amulets. The present example obviously hung from either a strap or chain as is indicated by the degree of wear on the upper edge of the loop: a harness pendant seems as likely an explanation for it as an amulet. From the turf of the *cavea* mound. Phase 2, Trench 18.

- Fragment of a heavy iron bolt (not illustrated), Trench 10. Weathered turf from stage area.
- Fragment of iron strap with a flat cross-section and two terminals, one of them with a recurved tip, the other broken. The fragment is slightly bent longitudinally. There is no sign of any means of attachment to anything. Trench 22. Robber trench fill.
- Iron bolt with heavy rounded head. Trench 10. Weathered turf from stage area.
- Iron bolt and washer. The washer was found round the neck of the bolt immediately beneath the round head. Trench 9. Weathered turf from stage area.
- Iron bar. Square-sectioned with one end pointed and the other bent over. Trench 10. Weathered turf from stage area.

- Sealed in pre-Roman Pit 1 under entrance. Very weathered. Rather micaceous. Reddish brown surface, grey in interior. Unusual in that the exterior is decorated with two incised horizontal lines (Fig. 6, 21).
- Rim of necked jar with a faint cordon on the shoulder, made in the usual red/brown fabric, but the dark surface is burnished. Lying in the make-up for the Phase II theatre (Fig. 6, 22).

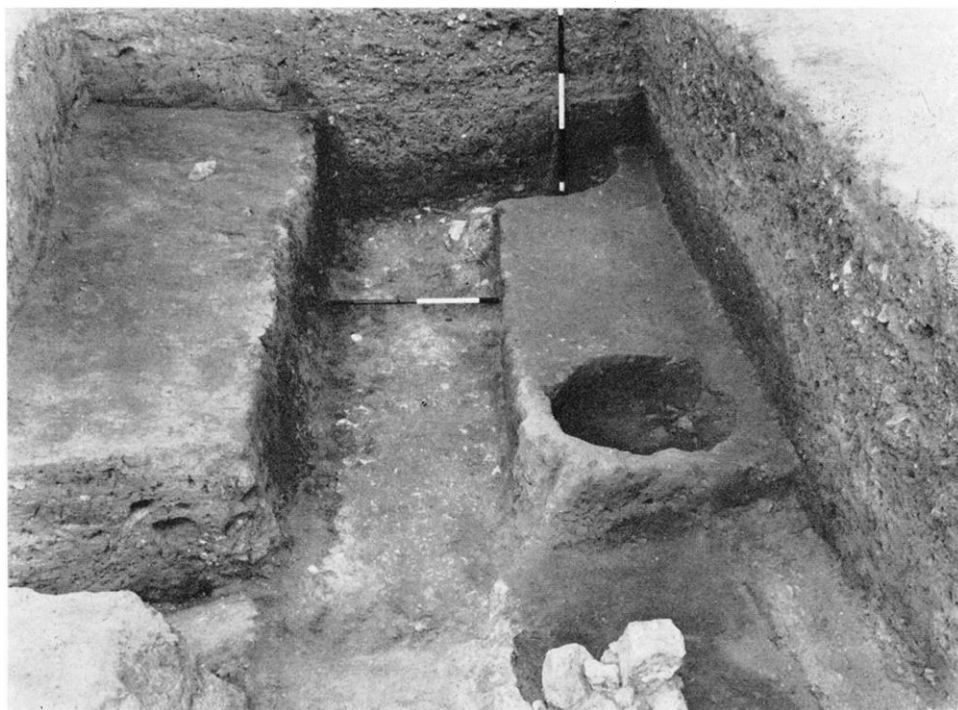
A. Gosbecks Theatre: two post-pits of Phase I south of the robbed *cavea* wall of Phase II in Trench 18, looking E. (p. 31).

In Trench 18, immediately south of the south-west radial wall of the later *cavea* and partly overlain by it, was a line of three massive post-pits, 20–30 in. in diameter and 2 ft. 5 in. deep (PL. VIII A). As no trace of the actual posts could be found, the exact dimensions of the uprights are not known. Almost certainly the timbers had eventually been dug out. Another post-hole, 2 ft. 6 in. deep, with a diameter of 10 in. and a discernible post-pit, was found partially sealed by a later staircase on the north-western edge of the *cavea*, while a stakehole of similar stratigraphical date, 2 ft. east of the end of the later south-west *cavea* wall, may be a continuation of the line of holes in Trench 18. With the exception of the last, the loamy filling of all the holes had been disturbed by the foundations of the succeeding theatre but were themselves cut through the old turf-line. They also must be assigned to an intermediate phase, and taken with the beam-slots as part of the timber theatre.

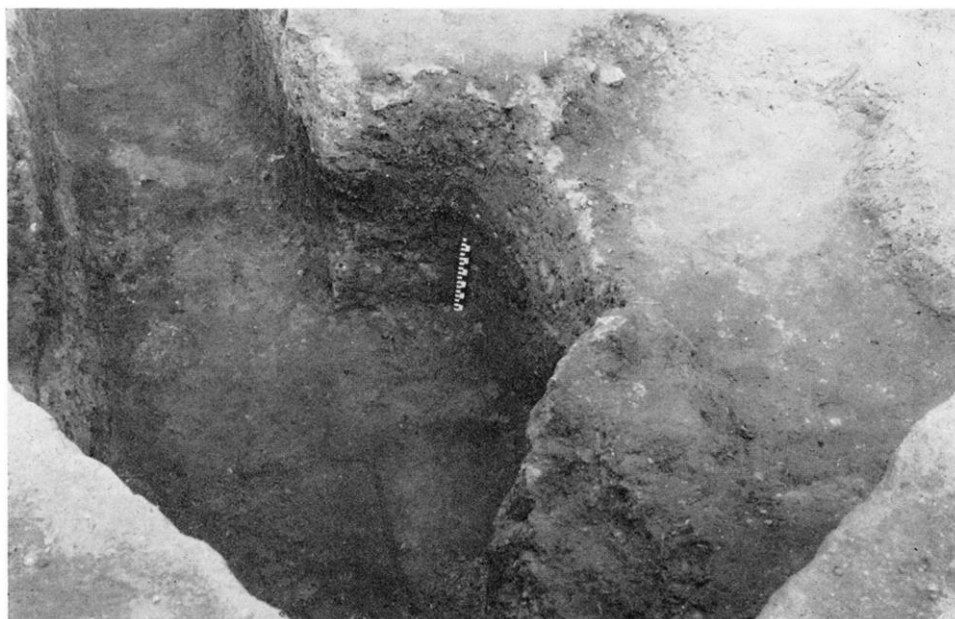
B. Gosbecks Theatre: robber-trench of *cavea* wall and buttress No. 6 in Trench 20, looking N. (p. 37).

of Nos. 7 and 19 show that they were of one build with the *cavea* wall. They occurred at intervals of 9 ft., were 5 ft. broad and projected 2 ft. from the wall (PL. VIII B). On the south wall they were smaller still, 3 ft. by 11 in., in keeping with the slighter character of the wall itself on this side.

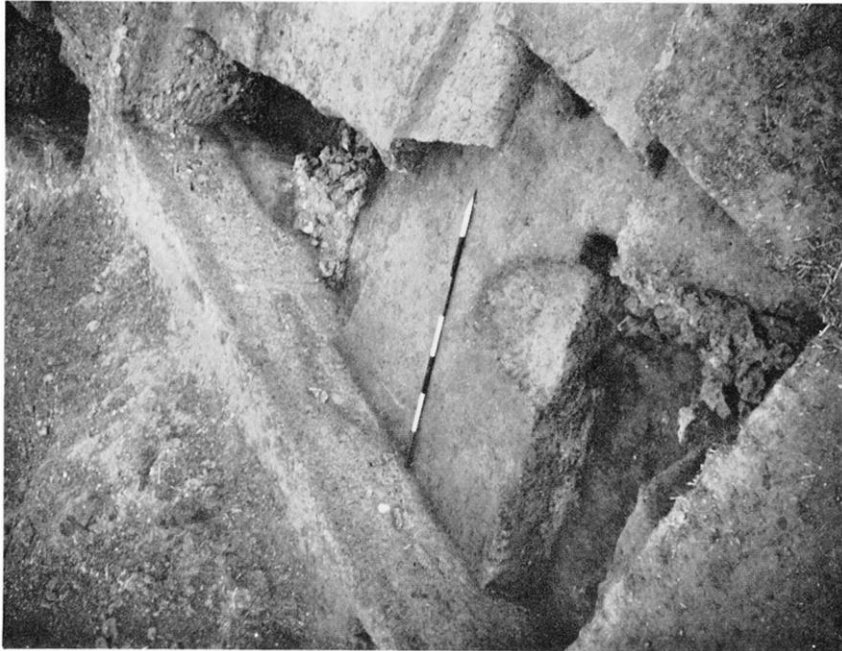
A. Gosbecks Theatre: Staircase 2 in Trench 22, looking E., with remains of semicircular depression at the end of the *cavea* wall west of the gap (foreground) and turf bank blocking it (right, centre) (pp. 35, 37).

This was normally entirely robbed out, though in a few places the lowest courses of the foundations survived (PL. IX A). The only superstructure to survive was a short length on the east side of the entrance, so here alone could the character of the wall be assessed. The foundations, wherever they survived, were trench-built of alternate layers of septaria, often quite small chips, and hard yellow mortar. Above ground, Kentish ragstone and a rather paler mortar were used and the wall was faced with high-quality ashlar. The difference in mortar does not indicate a difference in building periods. Numerous small pieces of ragstone occurred all along the robber trench of the *cavea* wall, indicating that the superstructure elsewhere was also built of ragstone. The width of the wall above foundation level was 2 ft. 4 in.; the footings were roughly 6 in. wider. Normally the foundations were dug 2 ft.–2 ft. 6 in. below the contemporary ground surface, though on the south side of the *cavea* they were only 1 ft. deep.

The projecting masonry found by Mr. Hull in 1950 (FIG. 3, Trench 15) can now be seen to be pilaster 24, and the irregularity in the *cavea* wall near the south-east corner, revealed by him in 1949, must also have been caused by a pilaster, now numbered No. 17 (FIG. 5). The west wall of the entrance, and presumably the east one also, projected 2 ft. north of the main *cavea* wall, thus forming two more pilasters symmetrically placed 10 ft. apart from No. 7 and the hypothetical No. 10, east of the entrance. At two points, at the east end of the south-west radial wall of the *cavea* and the west side of staircase 2, the *cavea* wall ended in a shallow semi-circular depression 1 ft. deep and filled with very fine-grained rubble rather different from the filling of the actual robber-trench.¹³ The function of these features is not certain, but it is possible that they represent the remains of earlier (Phase 1) features obliterated elsewhere by the wall trench (PL. IX A).

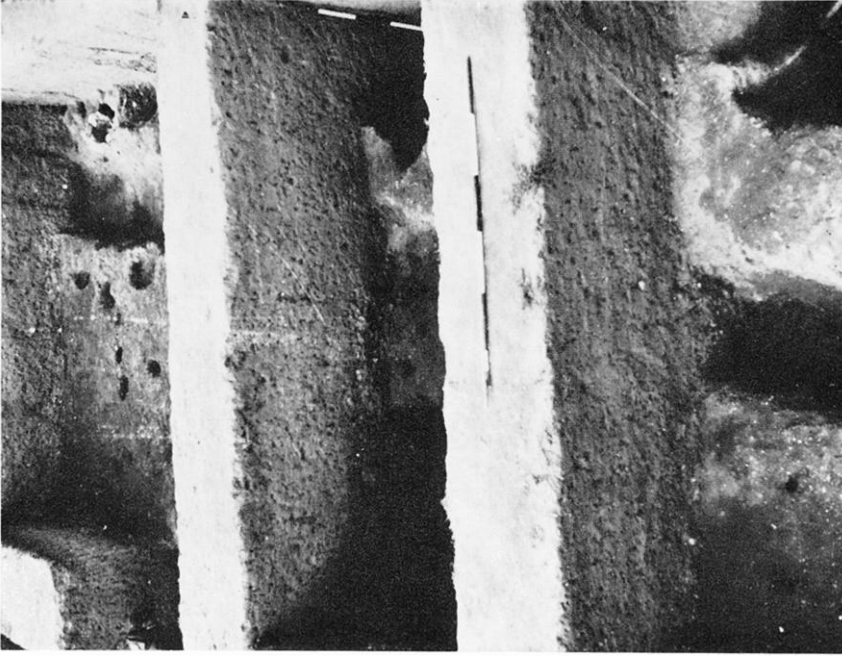
B. Gosbecks Theatre: Front of the stage showing Trenches 9, 11 and 12, looking W. The upright staff stands in the west central post-hole in front of the stage of Phase II (p. 39).

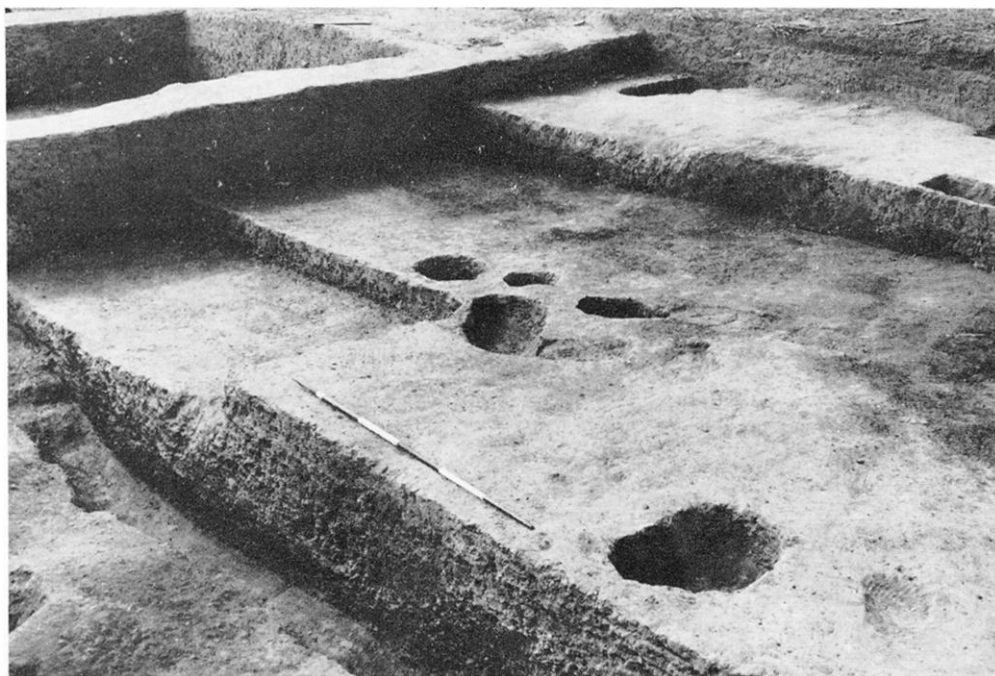
A. Gosbecks Theatre: post-pits of the orchestra wall, Trench 6, looking SW. In foreground the make-up of the orchestra floor of Phase II has been removed to show the Phase I surface (p. 39).
