**Historic building recording at
Town Wall Section 11,
rear of 62 Priory Street (Priory Lodge),
Colchester, CO1 2QE**

August 2017

**commissioned by
Colchester Borough Council**

CAT Report 1184
November 2017

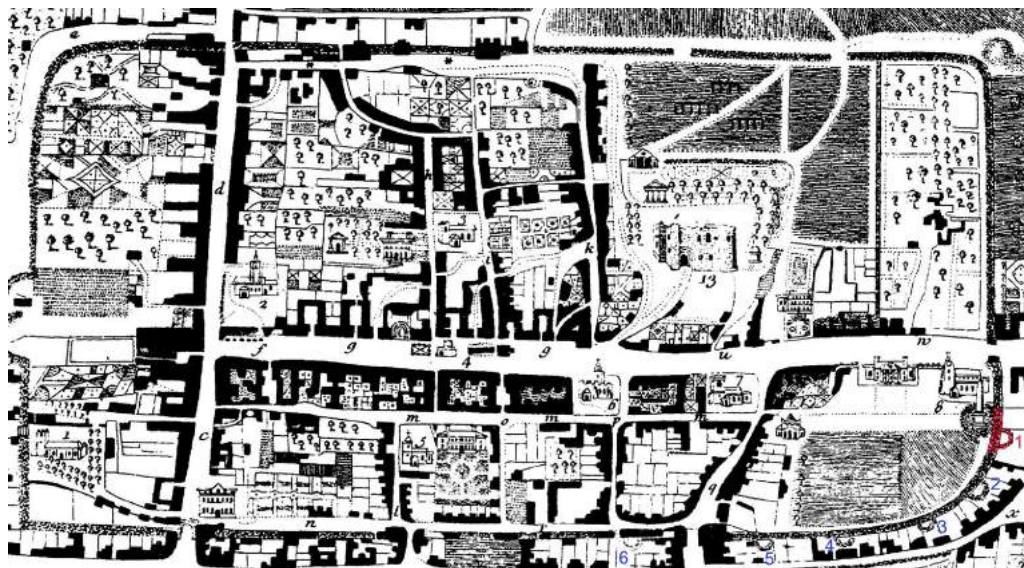
Philip Morant's map of Colchester from 1748 (Map 2) shows the town in more detail, and again shows no buildings adjacent to Section 11. The section of wall forms part of the boundary of Berryfields (now East Hill House) and the closest building to Section 11 is an obelisk (topping an ornate icehouse) in its grounds, near St James's Church.

This map also shows that parts of the town wall are starting to be demolished or built upon to make way for new construction, particularly to the north and south of the town. Only six of the original eight bastions are still standing.

Map 2 Philip Morant's map of Colchester, 1748. Location of Section 11 highlighted in red. Surviving bastions numbered.

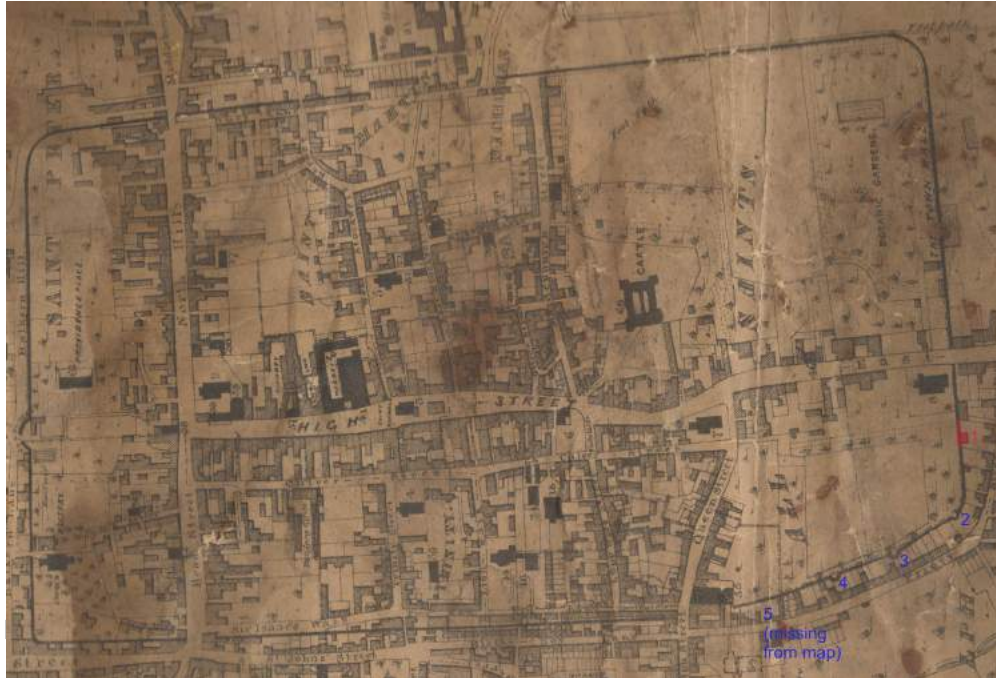
Monson's Map of Colchester from 1848 (Map 3) again shows Section 11 as free-standing. Bastion 1 is depicted as a square structure rather than a bastion. This is probably due to the presence of a structure on top of the bastion (see later mapping). Further along the wall, Bastion 5, which is still standing today, was omitted from the map and is not shown at all.

Map 3 Monson's map of Colchester, 1848. Location of Section 11 highlighted in red. Surviving bastions numbered.

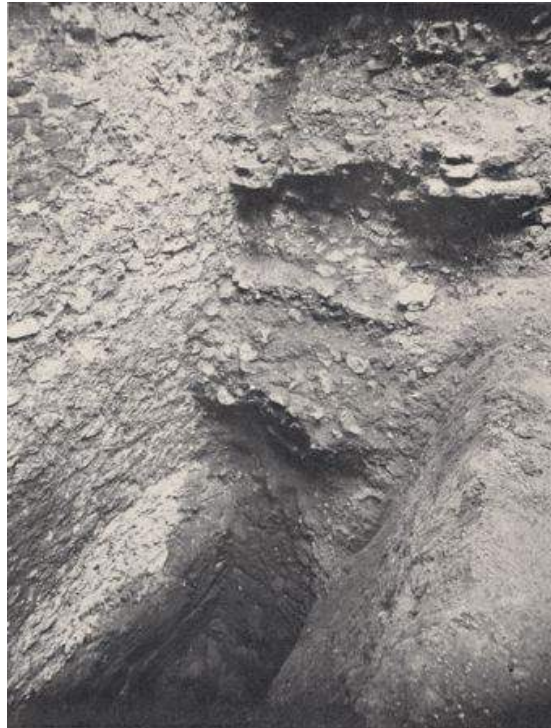
Photograph 1 Photograph of interior of Bastion 1 during excavation in 1923. To right and back of the frame is the face of the town wall, to the left is the foundations of Bastion 1. Taken from Roman Colchester (Hull 1958, pl XI B). For the location of this trench see Fig 2.

The interior of Bastion 1 was excavated in 1923 by P.G. Laver, who exposed the partially robbed town wall behind the medieval bastion (Fig 2). He also uncovered the bastion's foundations, which started 1ft below the foundations of the wall itself (Photograph 1). The soil within the interior of the bastion contained some residual Roman finds but nothing else of interest (Hull 1958, 45-6).

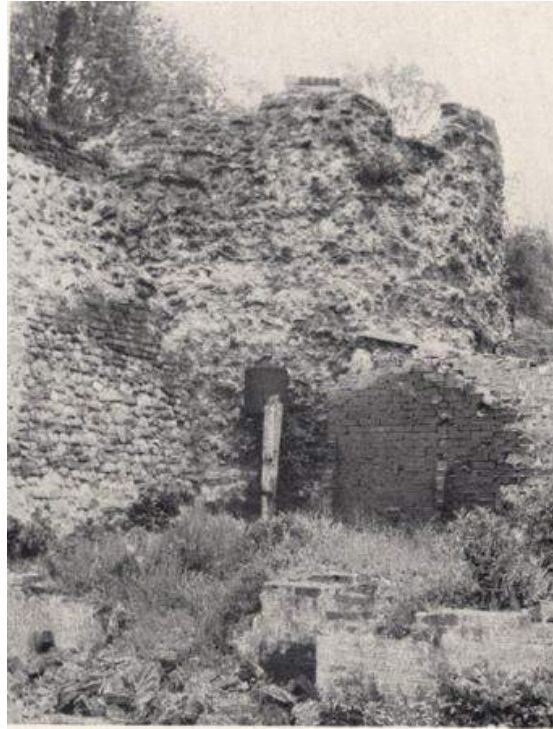
Hull (1958, 45) notes that at the top of the bastion are some foundations that probably belong to some 'eighteenth century ornamental garden work': this is undoubtedly the building visible atop of the bastion on Monson's, and the 1896 OS, map. A photograph of the bastion in Roman Colchester (Hull 1958) shows these foundations. It also shows a small brick building built up against the east elevation of the bastion, partially obscuring it (Photograph 2).

Photograph 2 Photograph of Bastion 1 from Roman Colchester (Hull 1958, pl XI D). Note the remains of later foundations on top of the bastion. Photograph taken facing north-west.

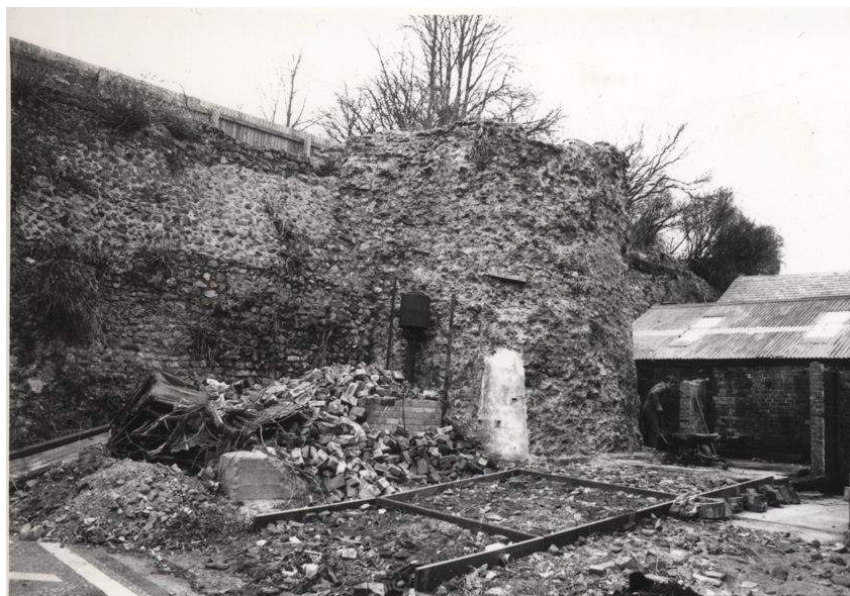
In the CAT photographic archive are a series of photographs of Bastion 1 taken in 1986 after the adjoining building was demolished (Photographs 3-5). Although there is no associated written record, comparing these photos to the current wall (see descriptive record below) shows that Section 11 and Bastion 1 are (although overgrown) in much the same state as they were 31 years ago. The photos show that the foundations on top of the bastion have partially collapsed, but are still visible on one elevation (Photograph 5). Today no evidence of these foundations remains (see descriptive record below).

Photograph 3 Section 11 and Bastion 1, taken in 1986 after demolition of a nearby building. Photograph taken facing north-west.

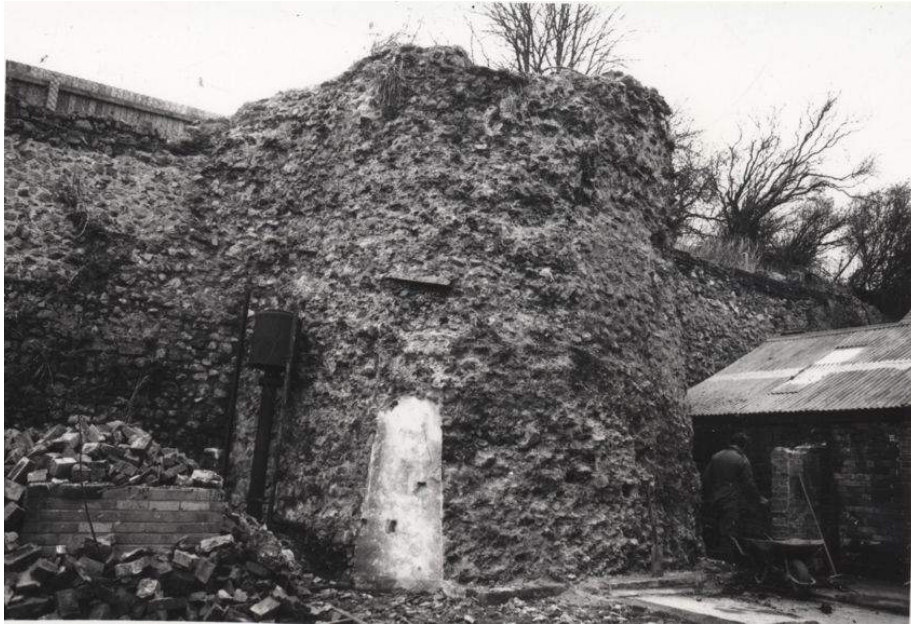
Photograph 4 Detailed shot of Bastion 1, taken in 1986 after demolition of a nearby building. Photograph taken facing north-west.

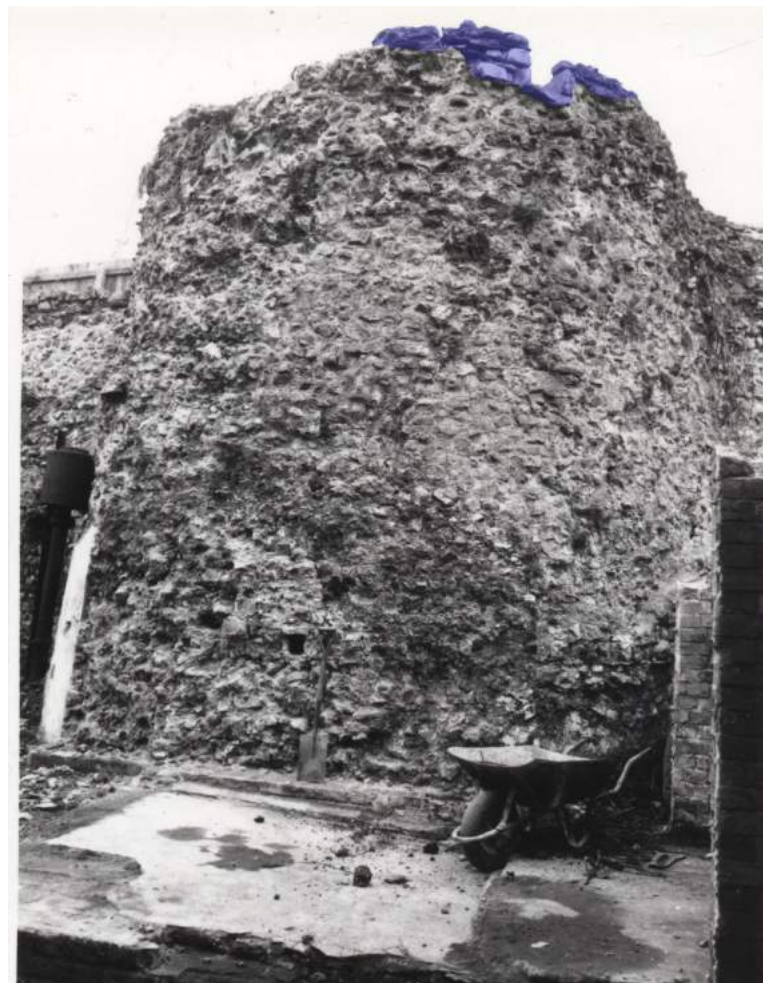
Photograph 5 Detailed shot of Bastion 1, taken in 1986 after demolition of a nearby building. Highlighted in blue at the top of the bastion is the remains of a structure seen on mapping in 1848 and 1896. Photograph taken facing south-west.

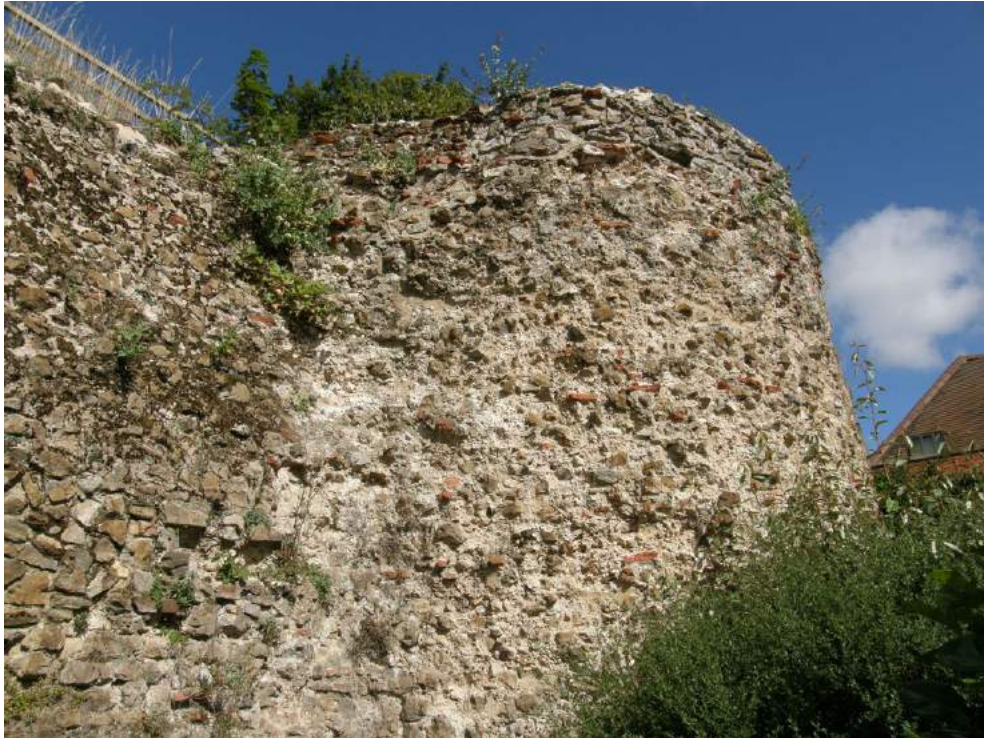
Photograph 6 Section 11 of the town wall, including Bastion 1, prior to removal of overgrowth. Photograph taken facing north-west.

Section 11 is 16.9m in length, and survives to a height of approximately 4.5m above modern ground level to the south of Bastion 1, and 5.6m to the north (although what is visible is mostly medieval or later in origin). The original height of the wall would have been at least 6m (Crummy 1997, 89), although, as mentioned below, modern ground level outside the walls appears to be below the base of the wall foundation.

Section 11 is constructed of a mix of septaria, Roman tile and modern bricks (Photographs 6-11). On top of the wall to the north of the bastion is 300-400mm of uneven red brick courses. The top 250mm of the wall to the south of the bastion has been 'capped' by lime mortar, recently added to the wall in 2014 in an attempt to prevent water seeping into its fabric (Universal Stone 2014). The top of the bastion shows no surviving evidence of the structure visible on the 1896 OS map (or the photographs from 1923 and 1986). The top 700-900mm of the bastion is constructed of large stones, concrete slabs and re-used Roman tile and septaria, all bound in concrete. The large stones appear to be reclaimed and re-used from sources other than the wall, and include fragments of possible Kentish ragstone and broken pieces of worked limestone.

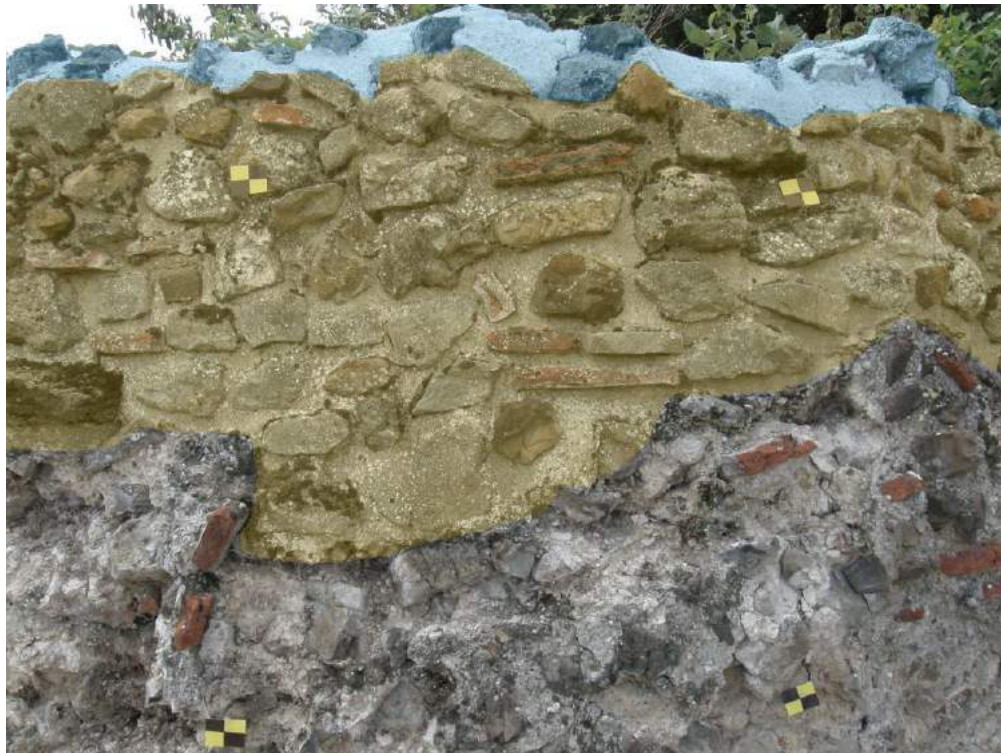
On top of this concrete capping is a later capping of lime mortar, which is modern in origin and corresponds with the wall to the south of the bastion (Photograph 7).

Photograph 7 Section of the top of the bastion photographed during survey (for location see Fig 4). Three phases highlighted; at the top, the modern lime mortar capping, in the middle, stones and re-used Roman tile bound in concrete, and at the bottom, the original bastion material of re-used Roman tile and septaria. Photograph taken facing west.

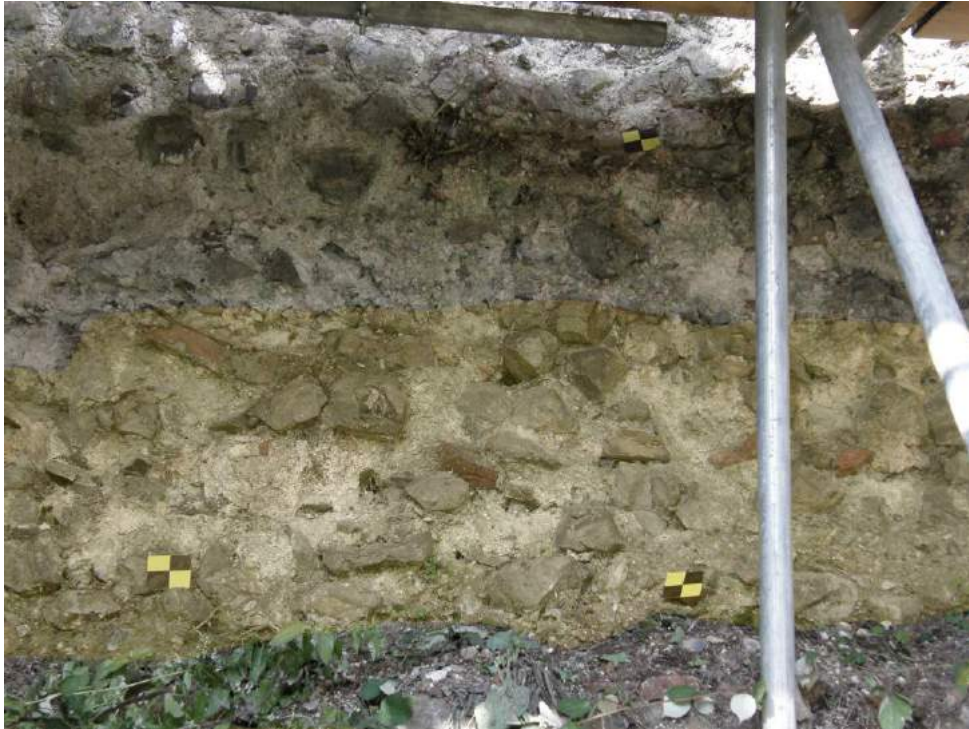
In some areas at the base of the wall in Section 11 there seems to be evidence of underpinning (Fig 4), which, combined with the evidence from the 1923 excavation, suggests that the foundation of the town wall in Priory Street is indeed above modern ground level. Where visible, this underpinning is constructed of re-used Roman tile and septaria bound in lime mortar, and is presumably medieval in origin (Photograph 8). As with the rest of the wall, however, much of the underpinning has been refaced in the

post-medieval period. The need for underpinning would also account for why it was deemed necessary to construct bastions along this part of the wall in the 14th century.

Photograph 8 Section of the base of the wall photographed during survey (for location see Fig 4). Highlighted section shows possible underpinning of wall below foundation. Photograph taken facing west.

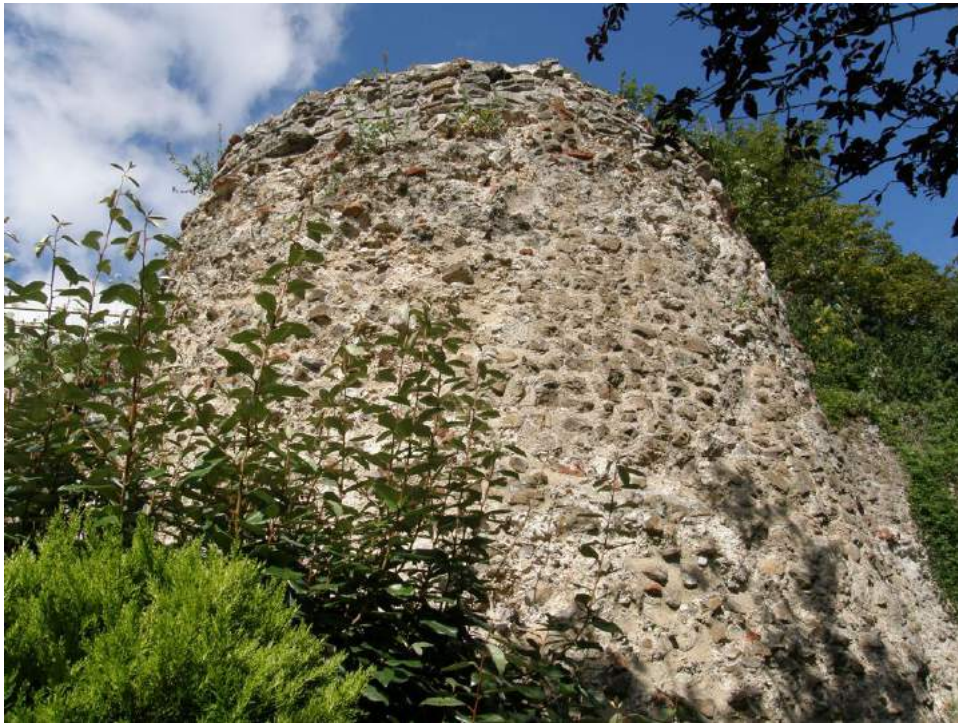
Photograph 10 Bastion 1 prior to removal of overgrowth. Photograph taken facing west.

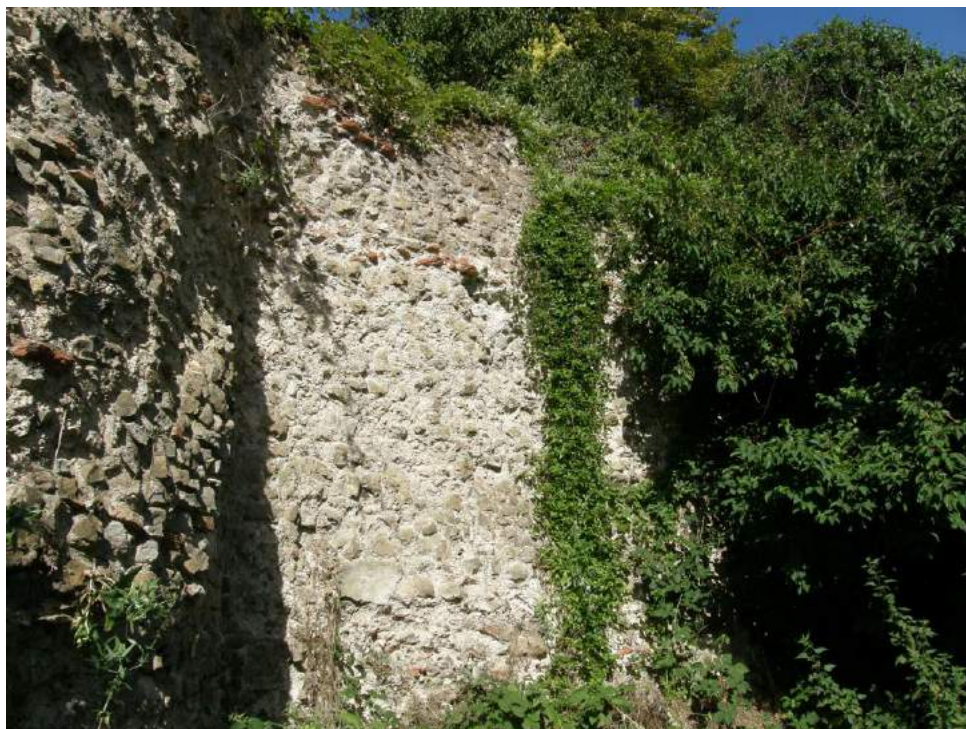
Towards the base of the wall to the north of the bastion (Fig 4) part of the later repairs have collapsed, exposing the Roman septaria and mortar core. Towards the top of the wall in the same area are remnants of the Roman face, with partial courses of tiles (Photograph 9) lining up with coursing seen further to the south in Section 10 (Figs 5 and 6). In Section 10 similar courses were identified as being the back of the inner (west) face of the wall, and given that the width of the wall does not change significantly between Sections 10 and 11, this is also probably the case here.

Photograph 11 Section of wall to the north of Bastion 1 prior to removal of overgrowth. Remains of tile courses visible towards the top of the wall. Photograph taken facing west.

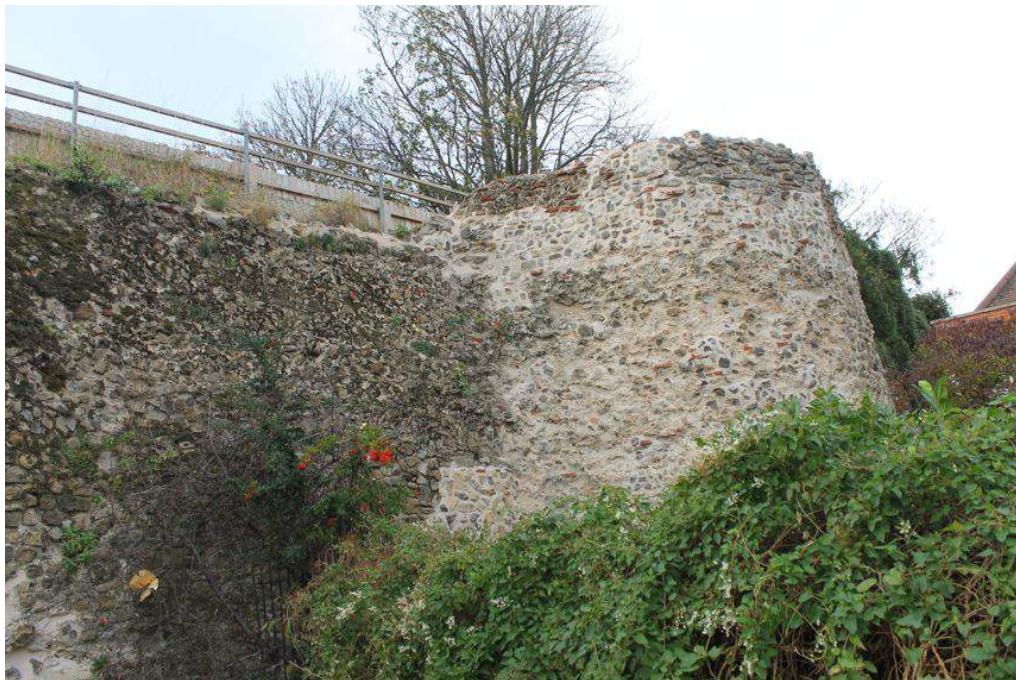
Photograph 12 Section 11 and Bastion 1 after conservation. Photograph taken facing north-west.

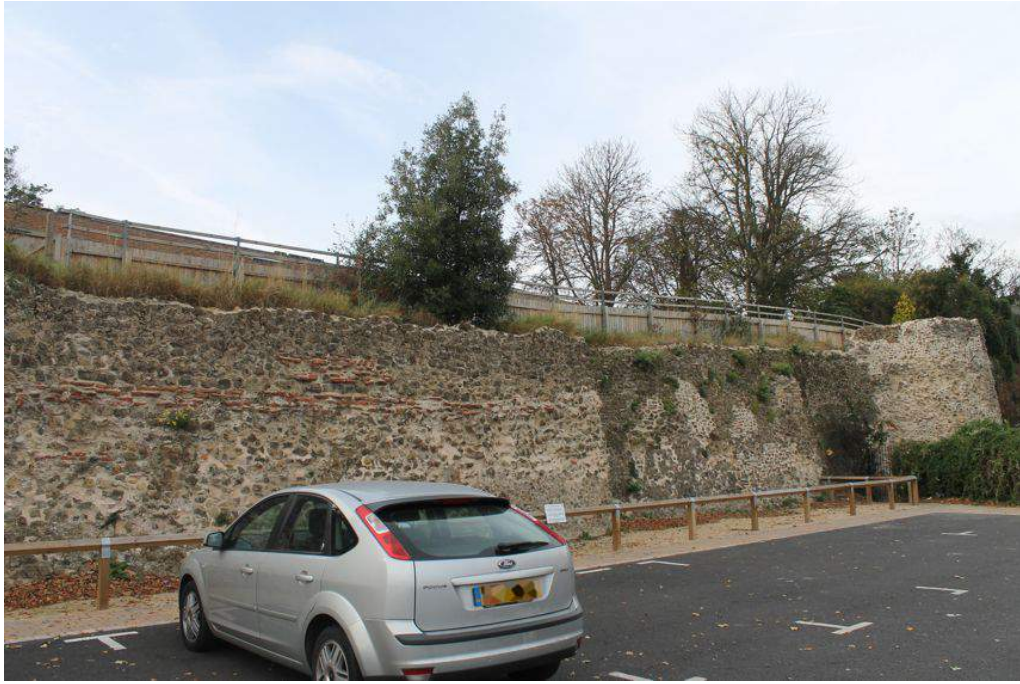
Photograph 13 Section 11 (to right of frame) and part of Section 10 (drawn in Figs 5 and 6). All after conservation. Photograph taken facing north-west.

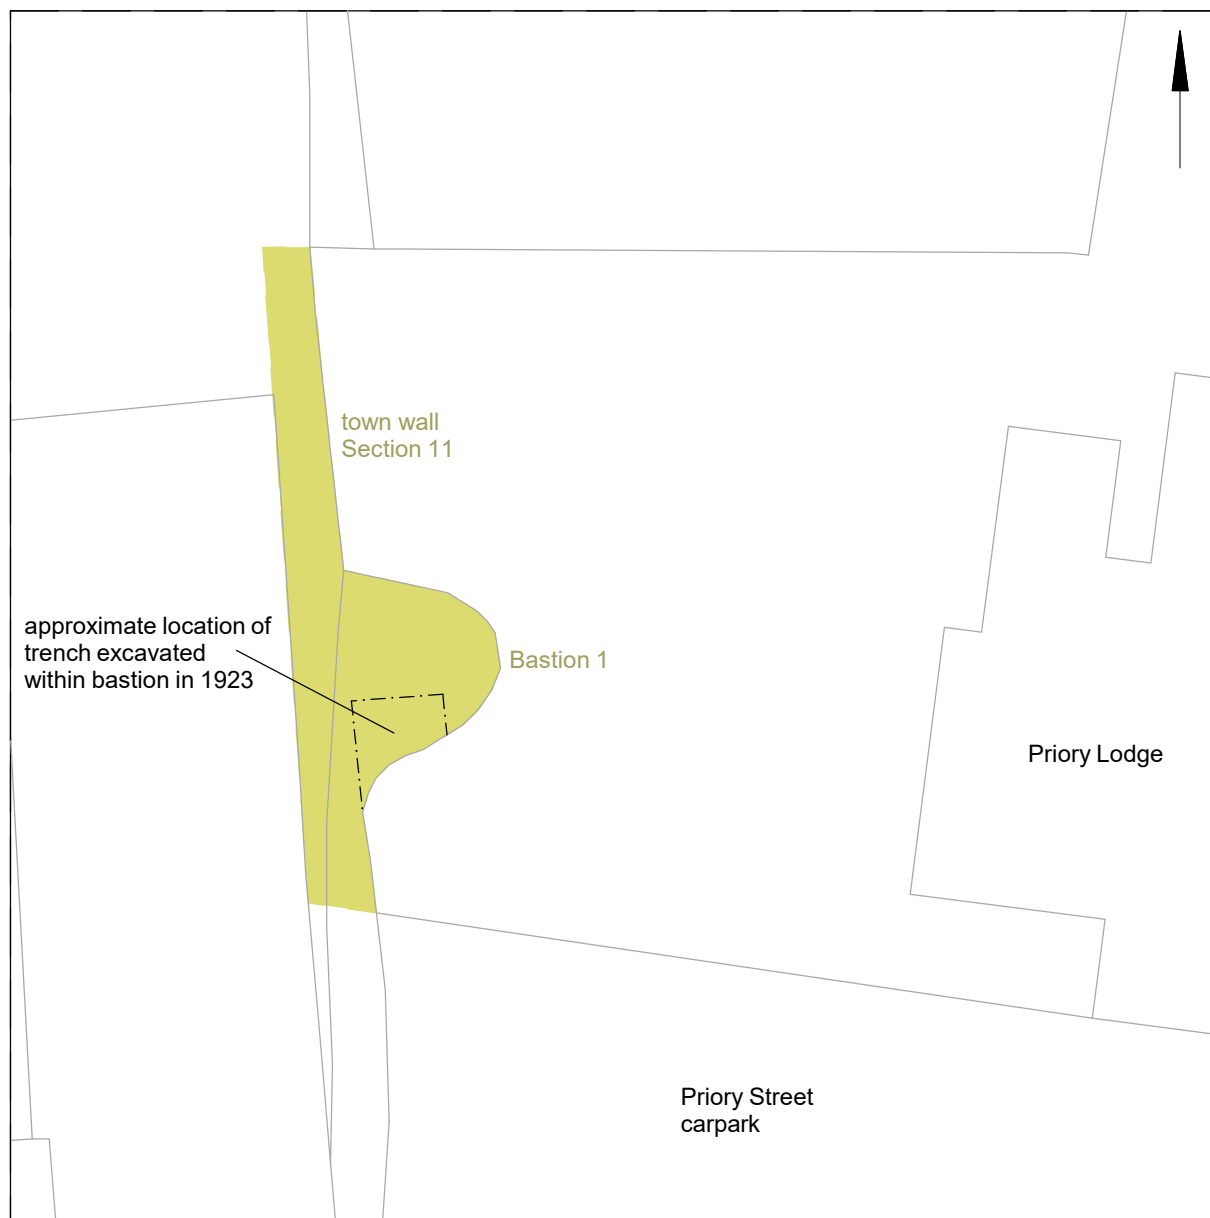
A modern plan of the site (Figs 1 and 2) shows the majority of the buildings constructed against the wall in Priory Street have been demolished and replaced with a car-park. Section 11 is just to the north of this car park, within the gardens of Priory Lodge residential home at 62 Priory Street (Fig 2).

Fig 2 Detailed plan of site.
