Jankes Barn
Jankes Green, Wakes Colne
Heritage Statement

Project Team

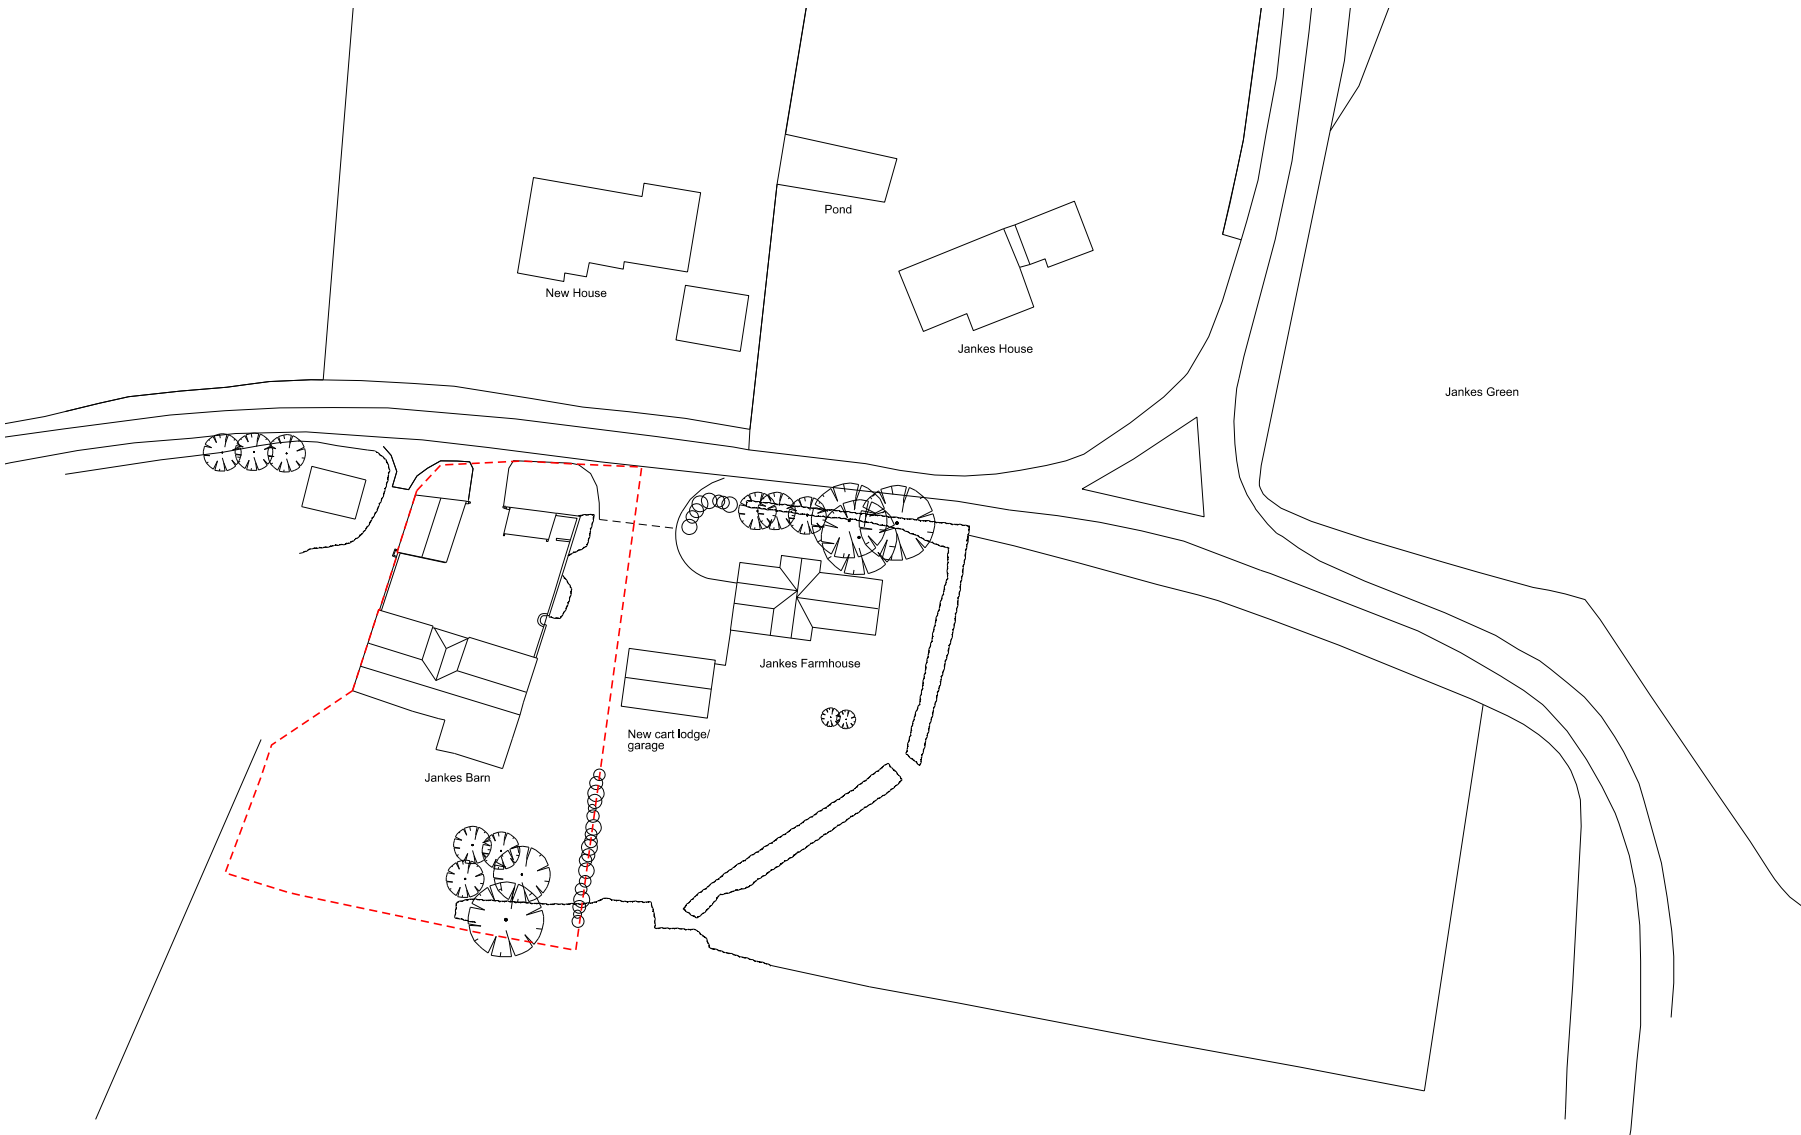
1 Existing site plan

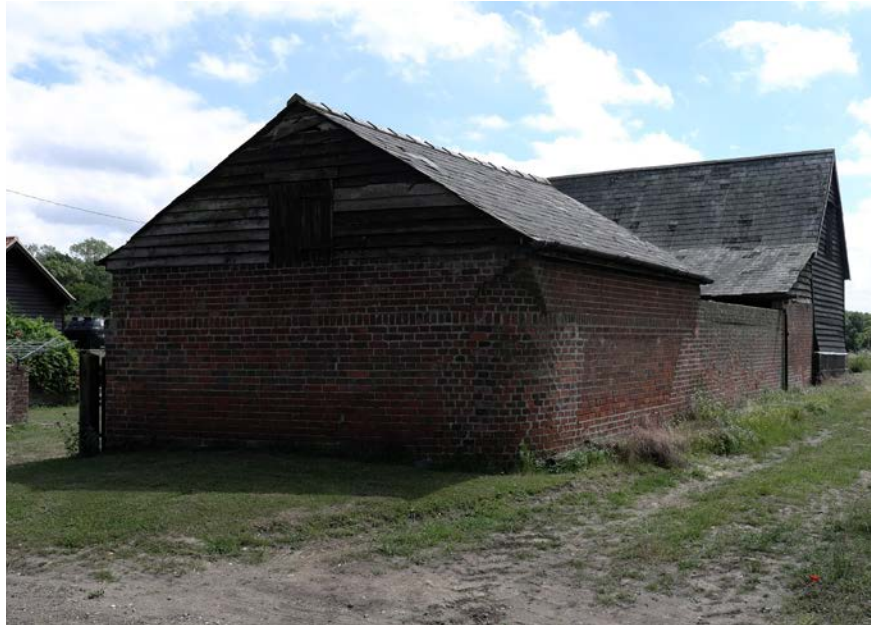
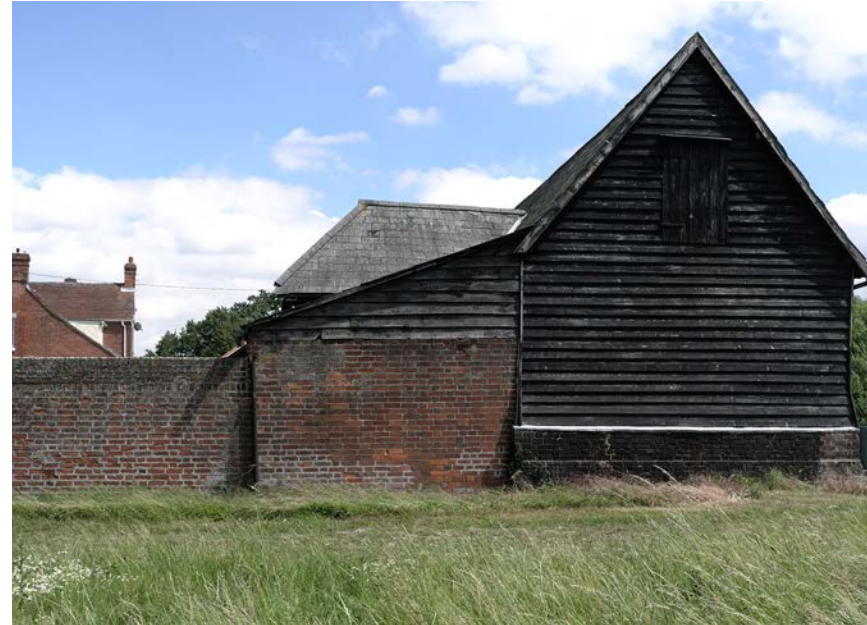
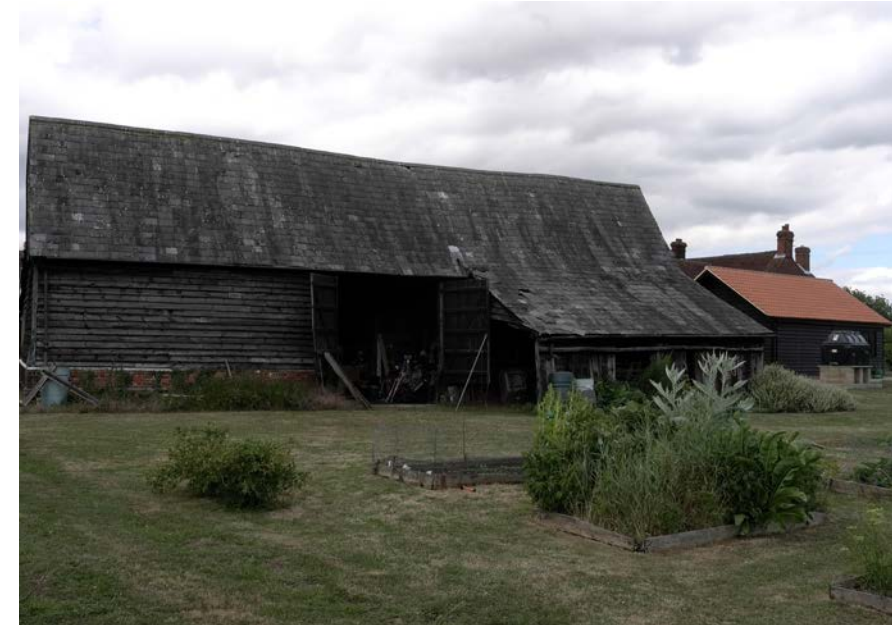
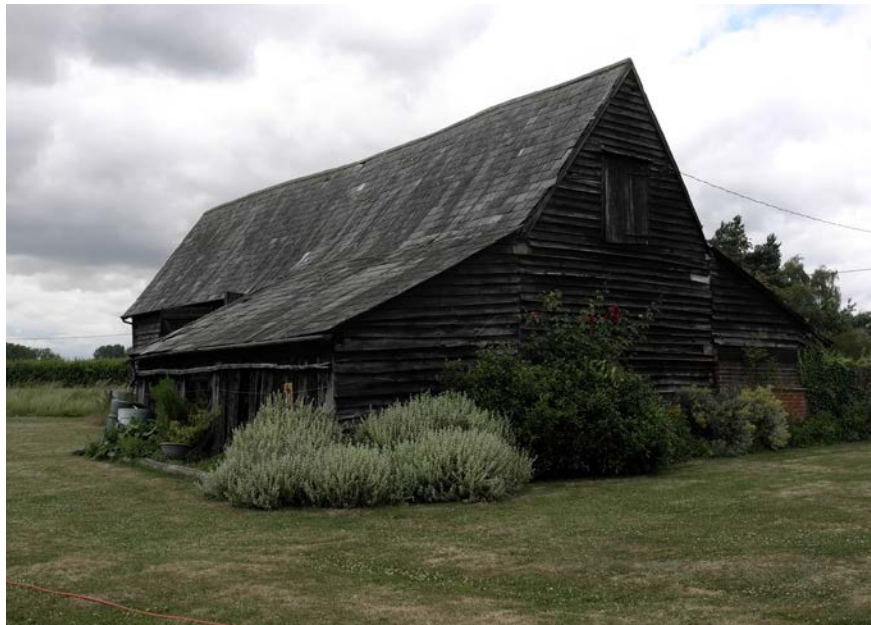
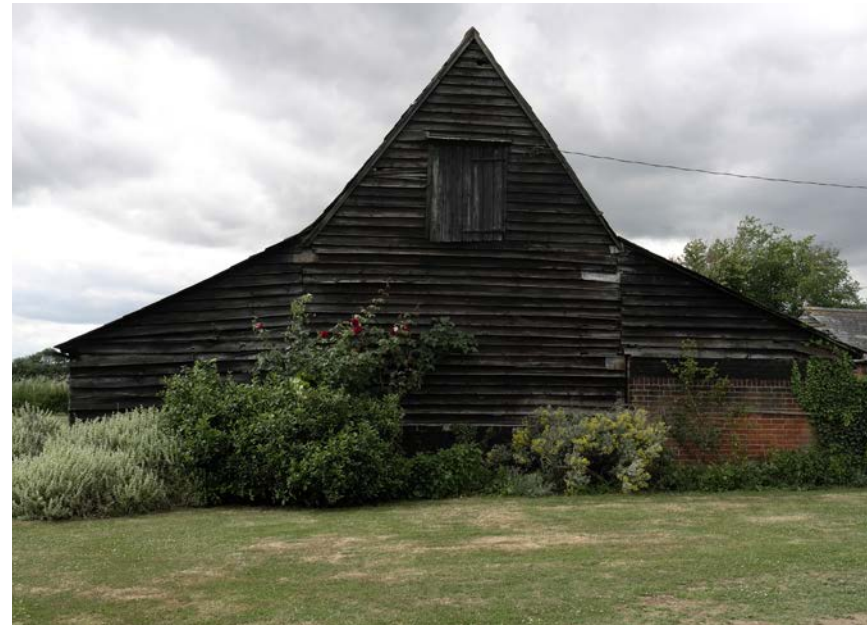
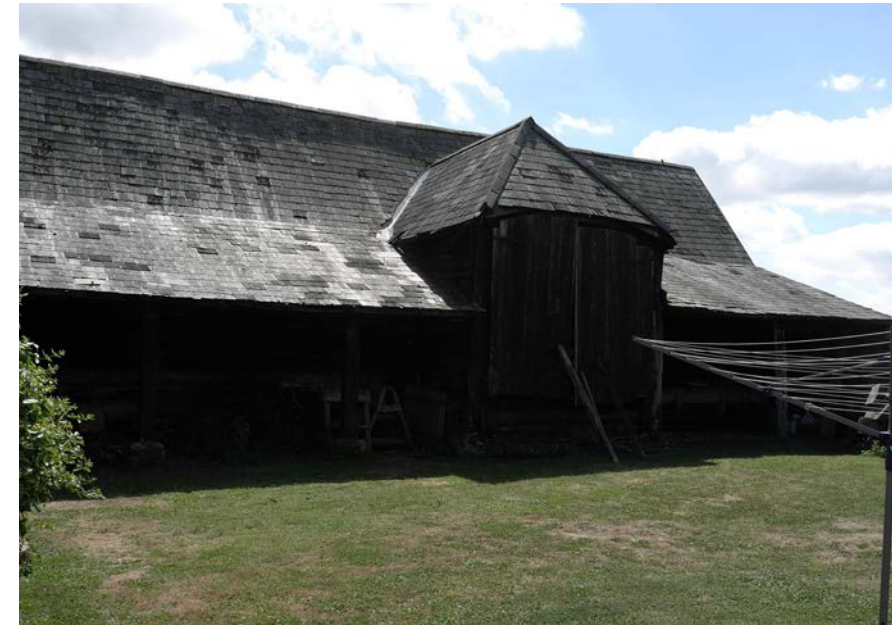
Existing site photographs **1** Stable outbuilding with barn behind looking south **2** West gable of barn **3** South elevation of barn **4** Southeast corner of barn **5** East gable of barn **6** North elevation of barn looking southwest from within courtyard

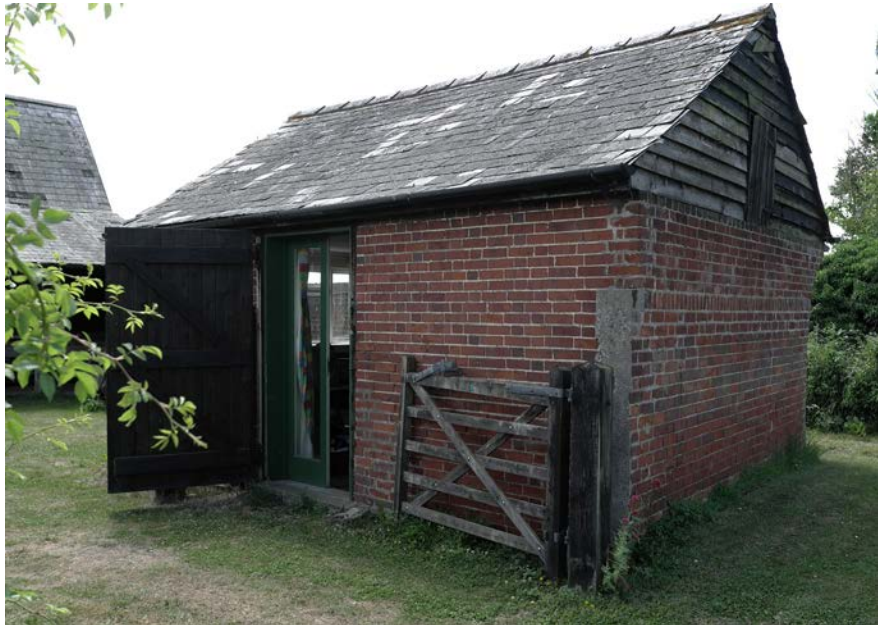
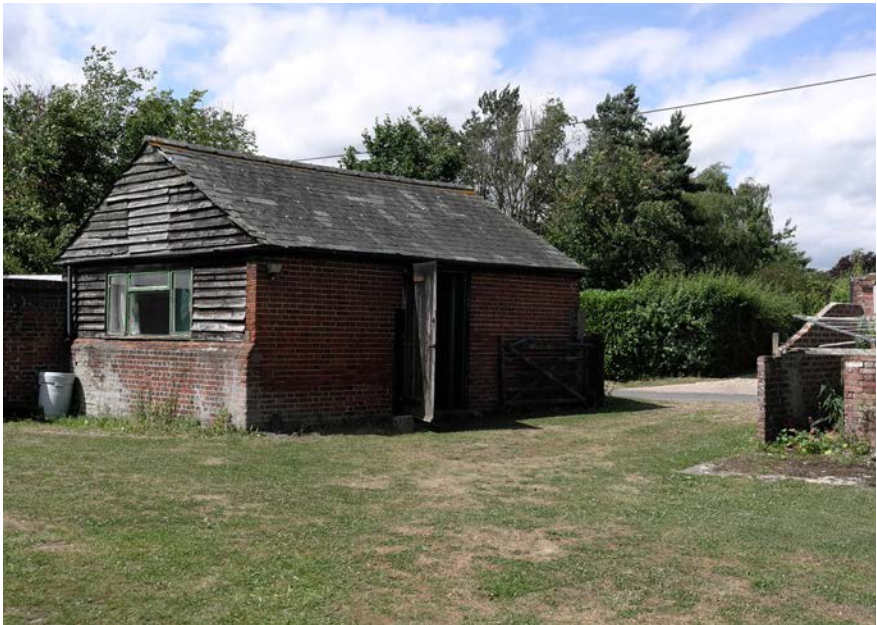
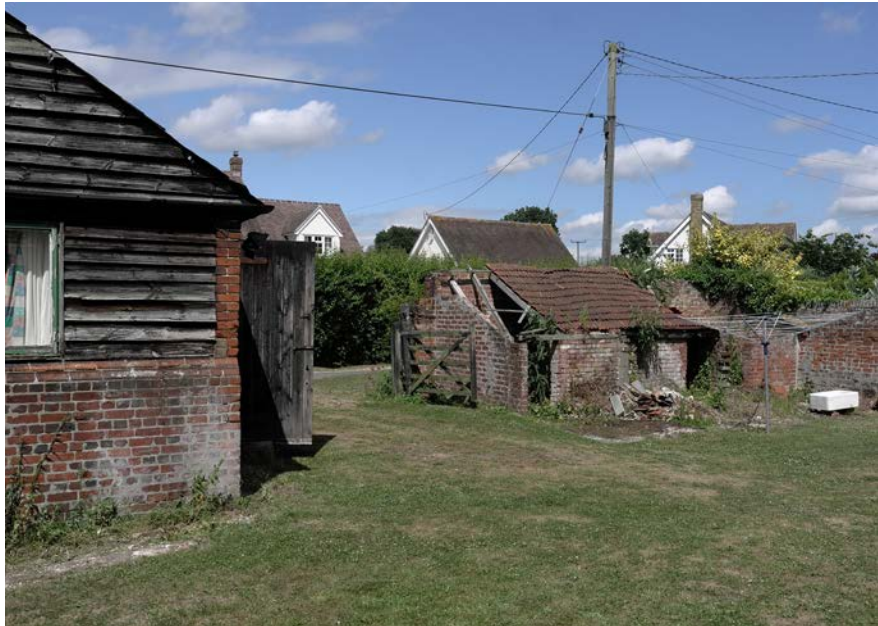
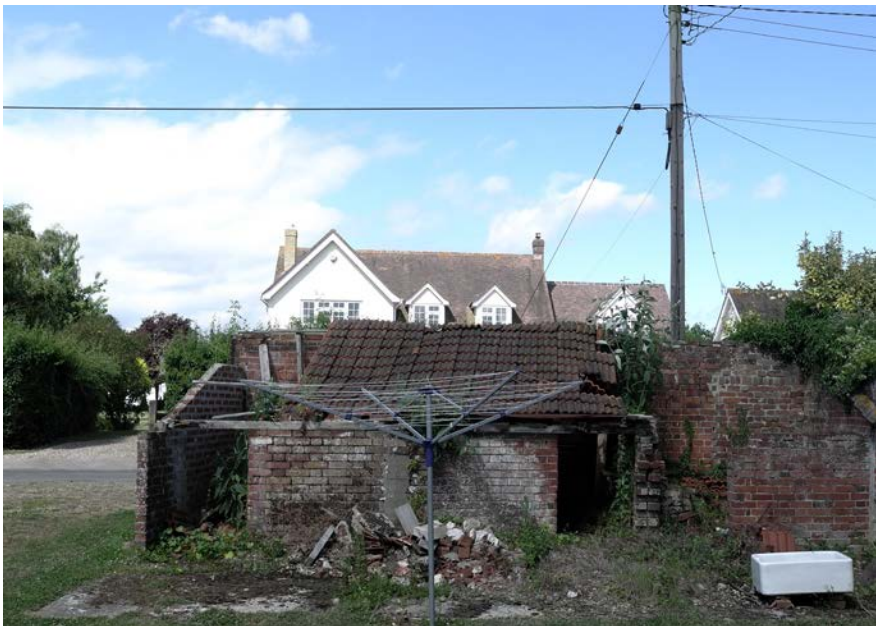
Existing site photographs **1** North-east corner of stable outbuilding showing existing inner and outer doors **2** Stable showing window on south elevation **3** Relationship between stable and piggery outbuildings situated either side of gateway **4** South elevation of dilapidated piggery

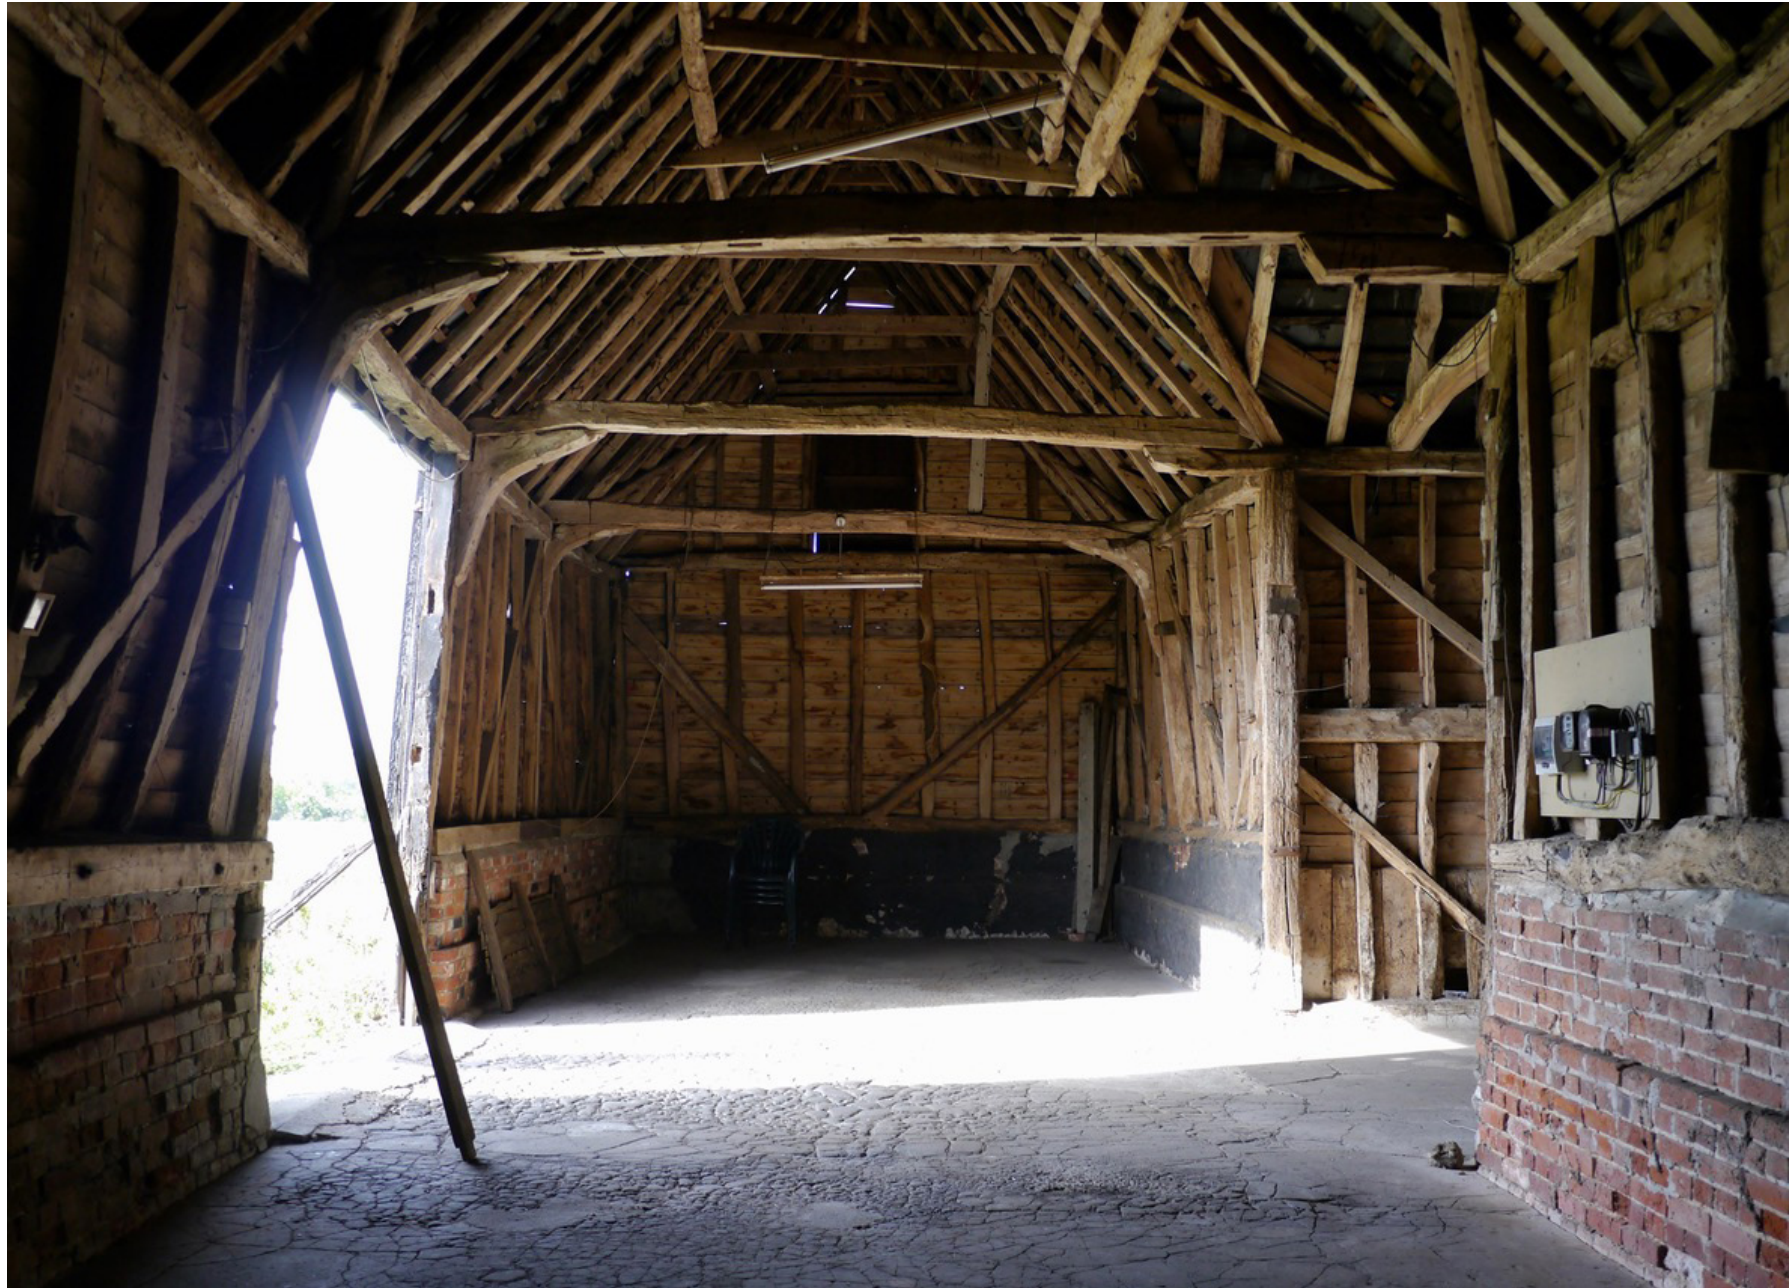
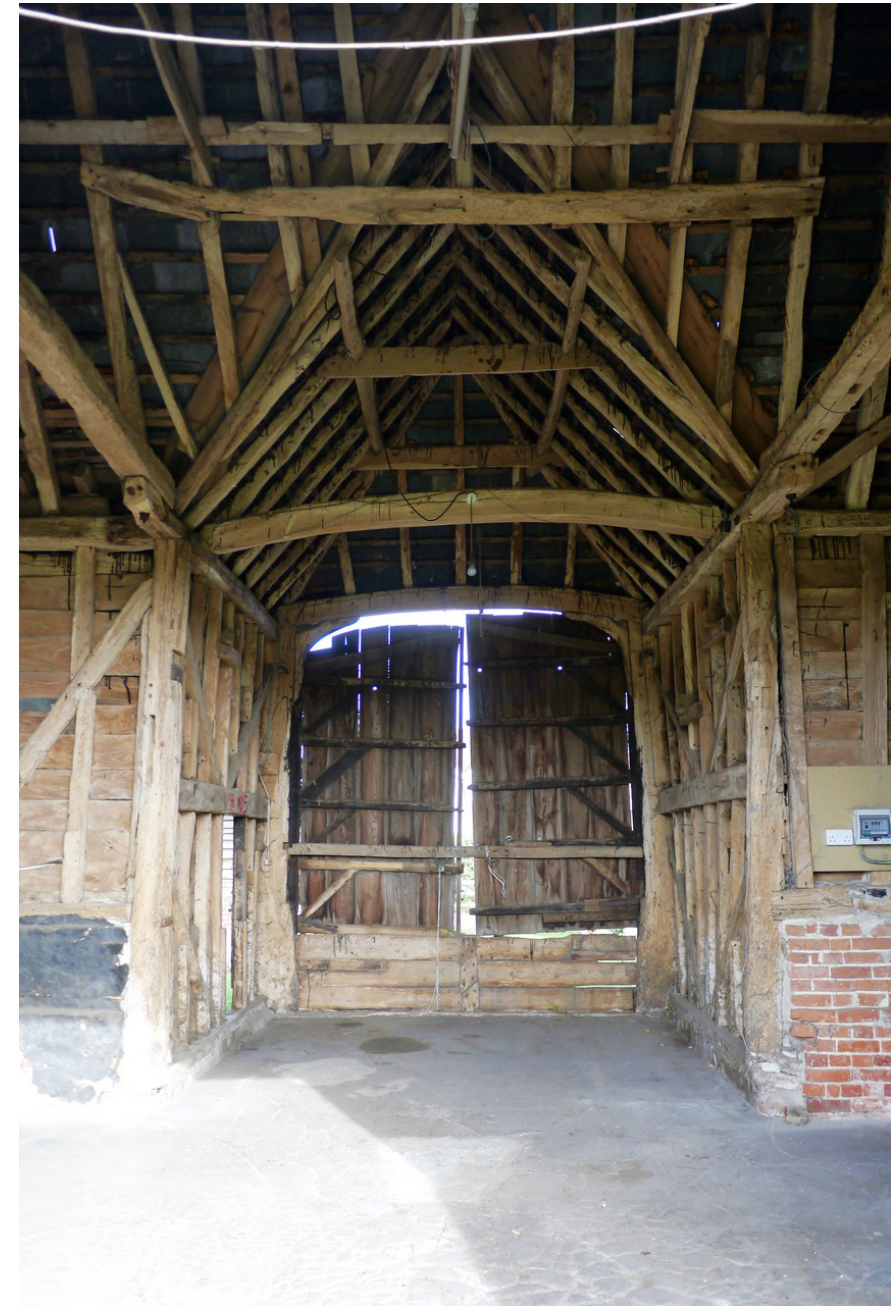
1 Photograph of the existing barn looking west 2 Photograph of the existing barn looking east 3 Photograph of the existing barn looking north towards the midstre

Jankes Barn is Grade II listed and is thought to date back to the early 1700s. It is a fine example of an Essex threshing barn, on an east-west orientation with five bays and a midstrey on the north side in the middle bay. The main volume measures 18 x 5m in plan. Large double doors on the north side of the midstrey and the south side of the barn open up to create a clear route through the middle of the building. There are two lean-tos on the north side of the building, open to the courtyard – an enclosure bounded by red brick walls and two outbuildings, a stable and a piggery. On the southeast side of the barn is a further lean-to, enclosed by vertical railway sleepers and open to the west.

The barn has red brick plinth walls up to a height of approximately 1.1m internally. The timber structure above is largely original and remains in good condition considering its date. Externally the timber walls are clad in black stained horizontal weatherboarding, originally Elm with some later Pine replacement. The roofs are slated, with the exception of the piggery, whose roof has collapsed and is of red pan tiles. Inside the barn, the floor is a rough, uneven concrete finish.

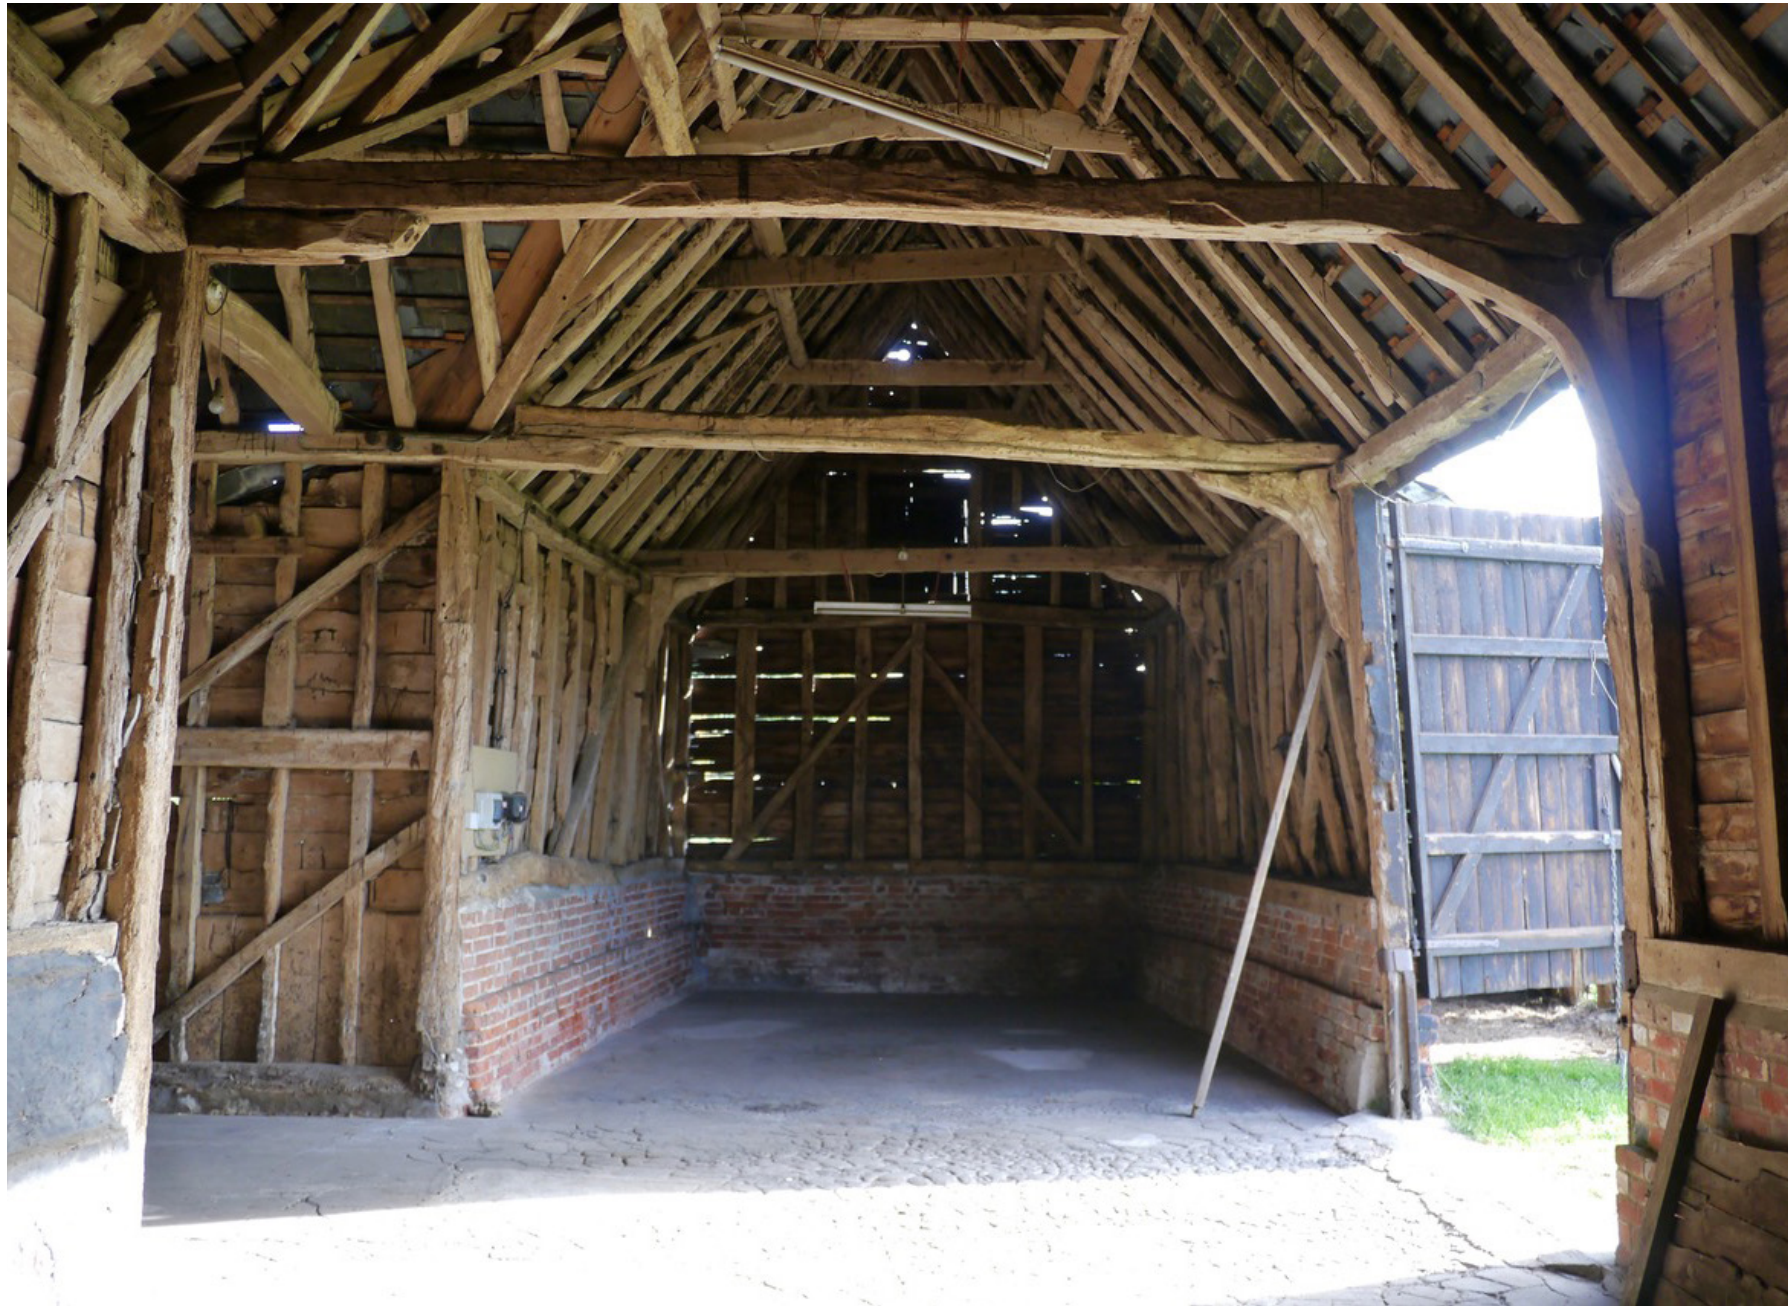
Internally, the original timber structure remains largely intact. The timber survey identifies the species of the timber structure as a combination of historic Oak and Elm, with various later, non-original hardwood and softwood structural interventions. The wall studs and rafters are at approximately 550mm centres giving a repetitive rhythm to the whole volume and the midstreys. The five bays of the barn are defined by four roof ties spanning north-south at eaves height, with collars at mid-bay locations. There are intermittent sections of non-original ridge board, inserted where some of the lapped peg joints at the top of the rafters have failed. The timber survey includes drawings that identify the failed structural elements.

The timber structure of the north-facing lean-to consists of tie beams bearing onto an eaves beam supported by posts along the front edge, tied into the timber midstreys walls and red brick garden walls on either side. The lean-to on the south side consists of a similar roof structure, with an open western end and a timber wall to the east.

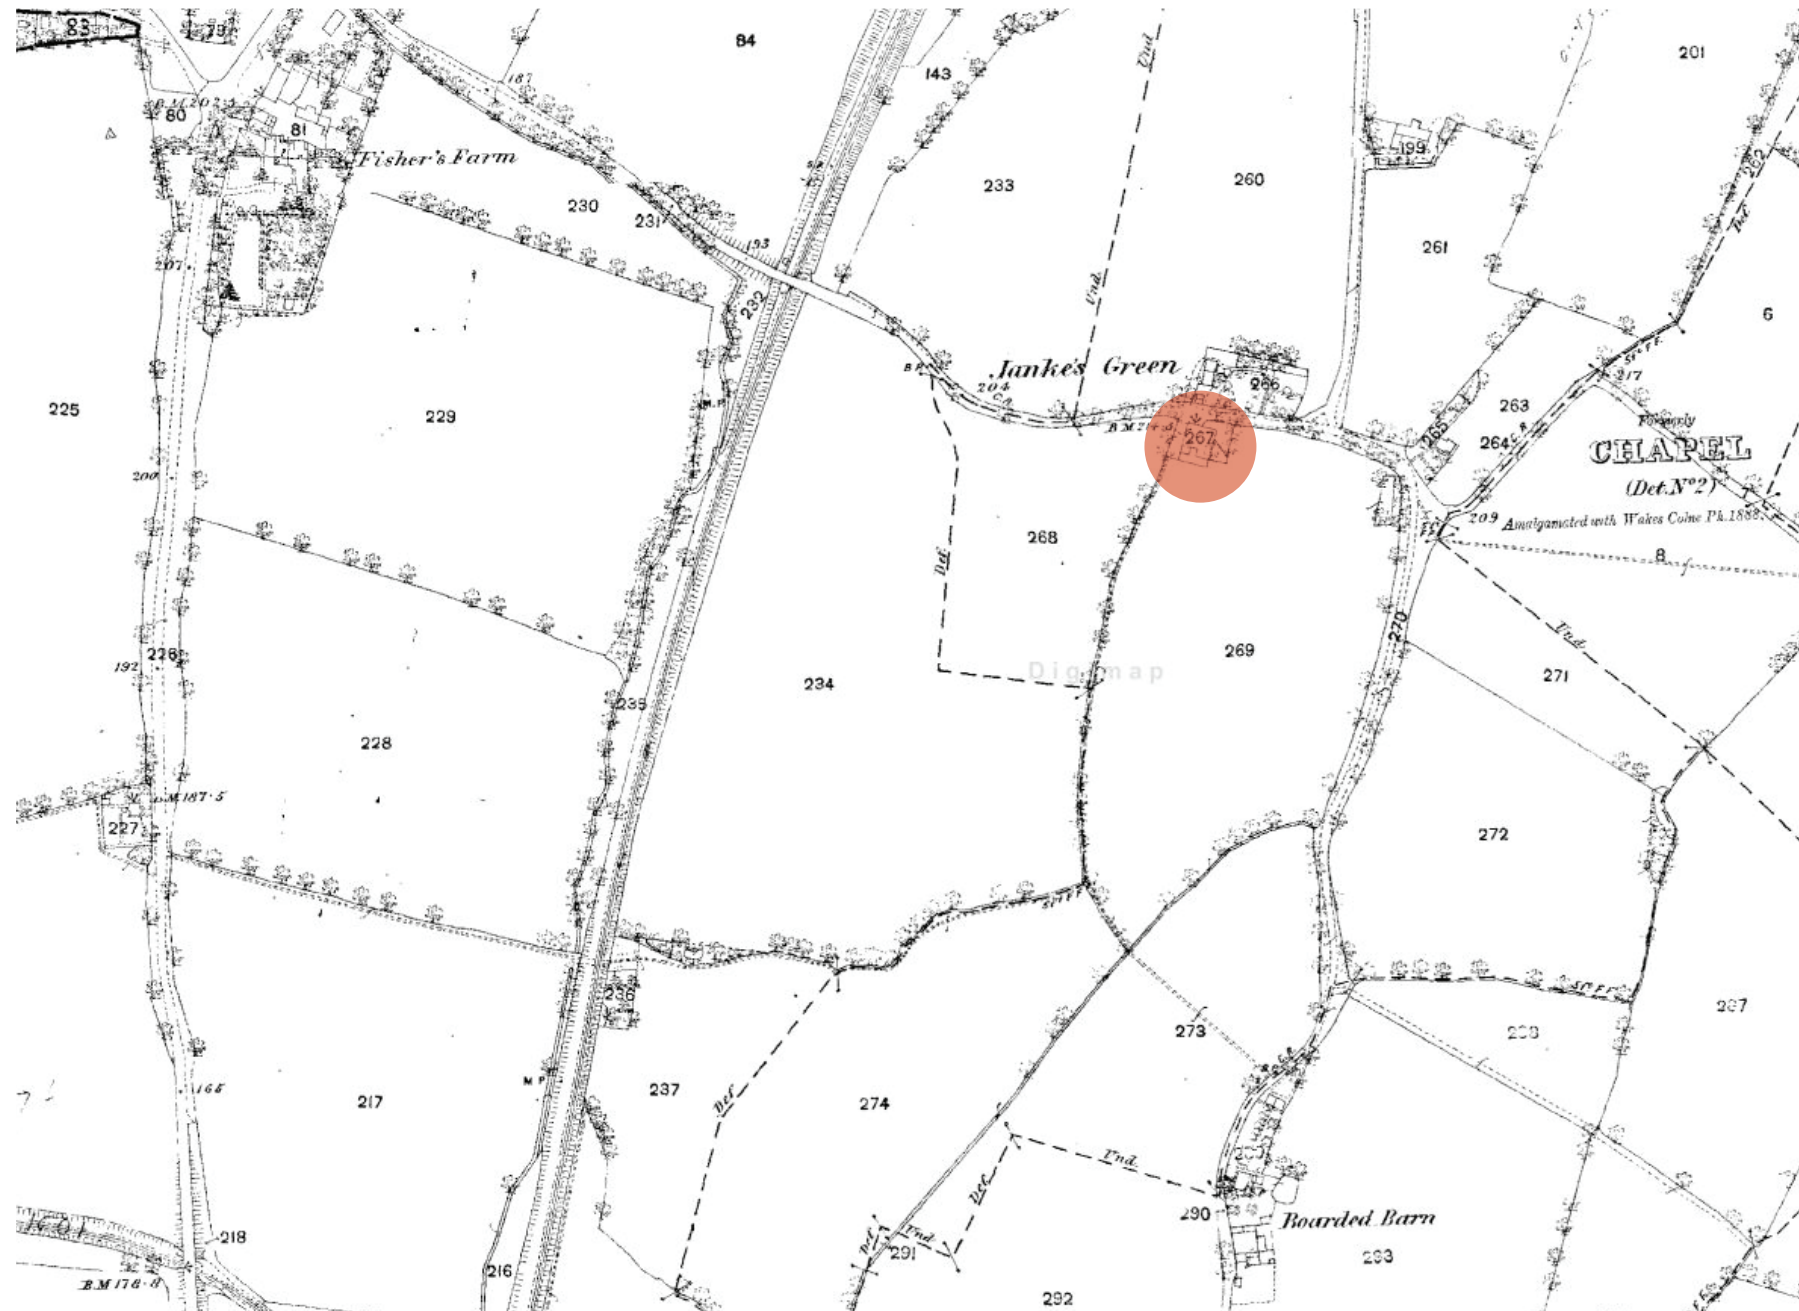
Historic Map 1870

Location of Jankes Barn indicated with red dot
 No lean-tos shown to Barn

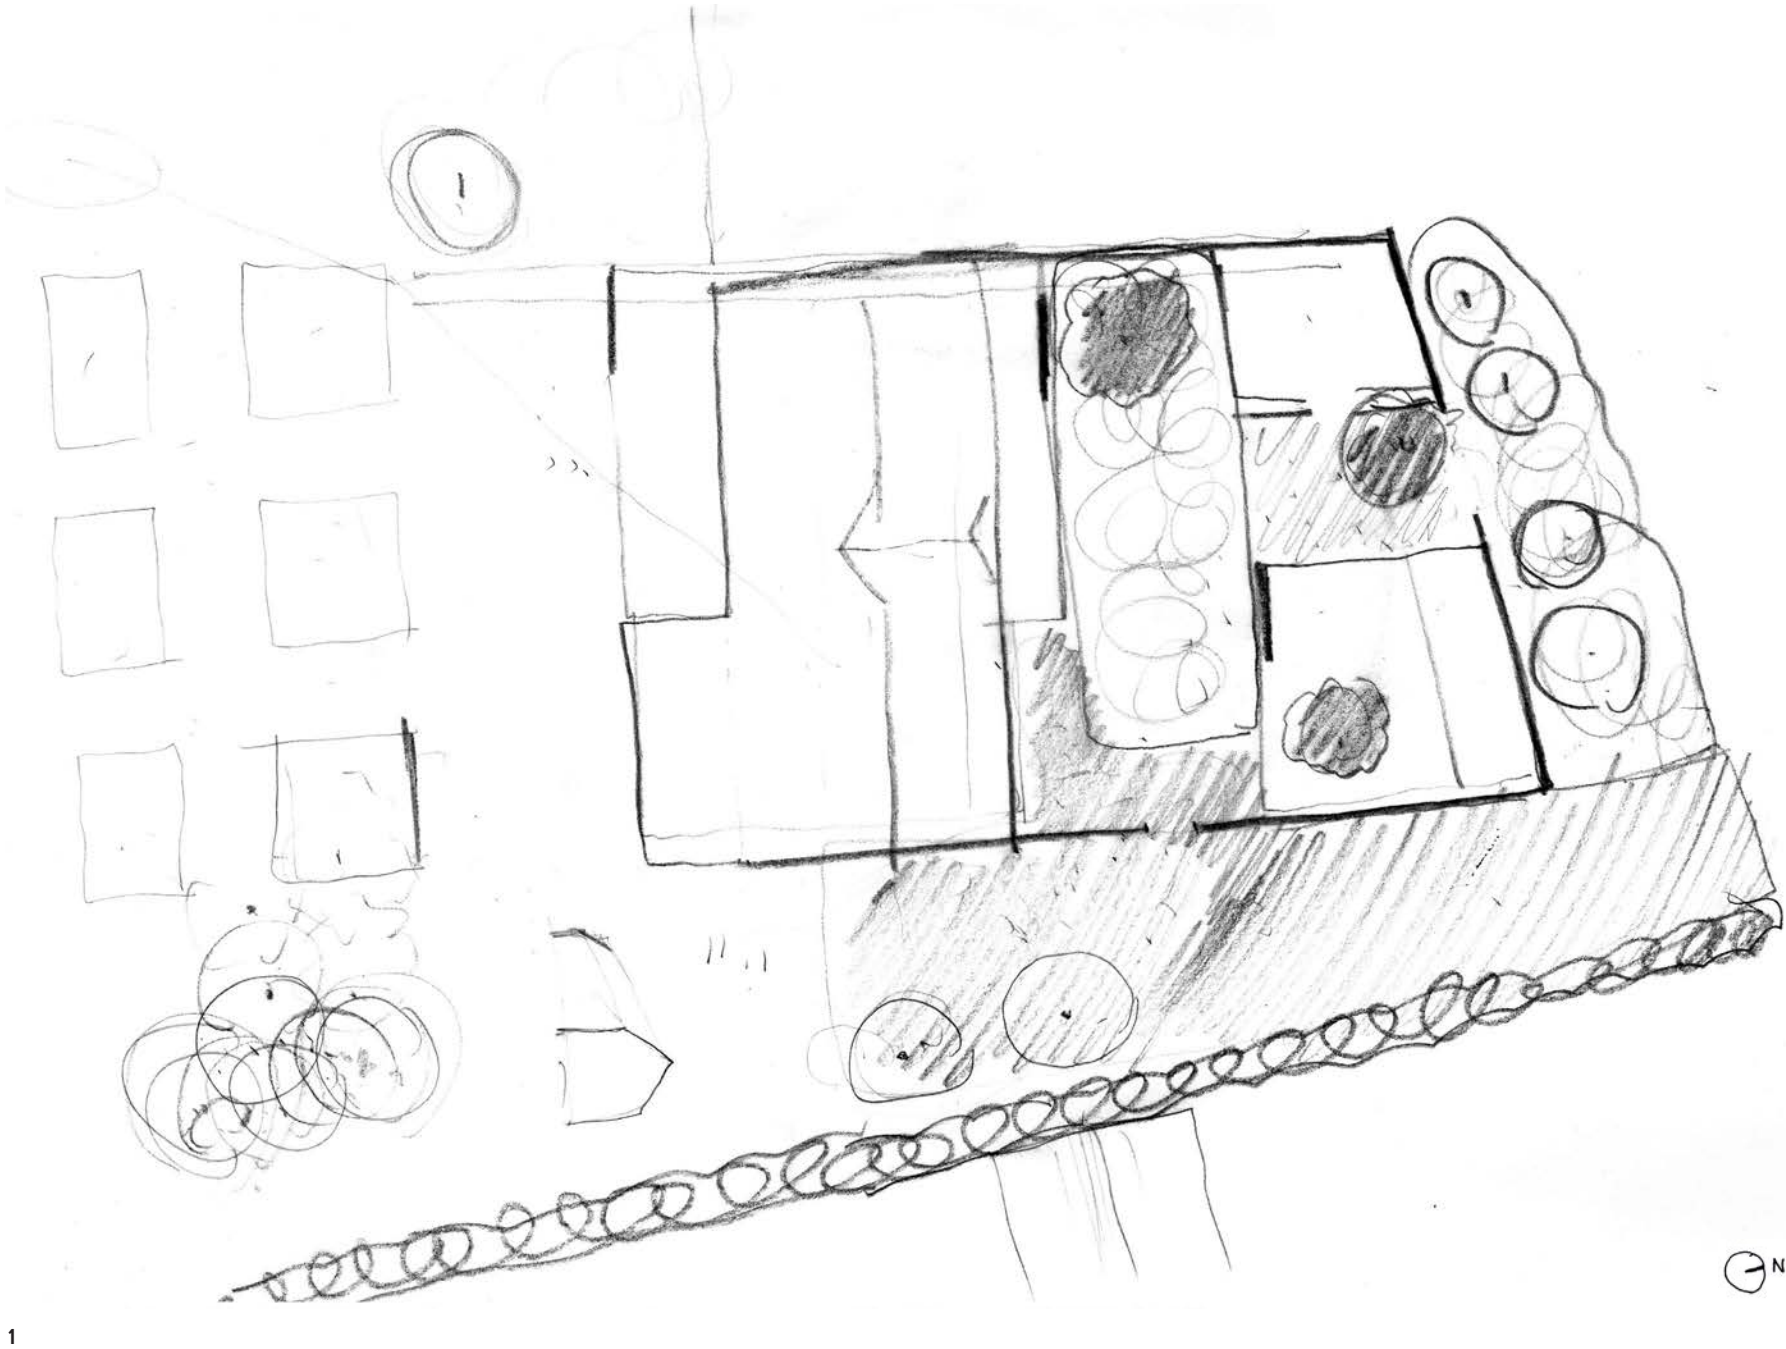
1 Sketch showing site plan with landscape concept

A new brick 'ground' unites the internal volumes of the barn and outbuildings. Terraces of brick pavers provide extended thresholds that project into the contained space of the courtyard to the north and the open garden to the south, to provide outdoor rooms. The terraces are positioned to provide shelter and sunny spots at various times of the day, and to the south, views out over the open countryside. In the courtyard, a large planting bed enclosed by the garden walls and outbuildings, and bounded by the terraces of brick pavers, gives a feeling of 'fullness'. Routes connecting the brick terraces around the planting bed will be laid with fine, self-binding gravel, which will extend into the driveway to the east of the courtyard. The placement of three new trees in the courtyard gives a degree of visual privacy between the bedrooms of the lean-tos, the stable building and lane.

In the garden to the south, Joanne Bernstein has proposed a geometric arrangement of planting beds with a single, square reflecting pond at the centre. The prairie-style planting will complement the cereal-based crops cultivated in the surrounding fields. The small existing fruit trees in the southeast corner of the garden are deformed from poor establishment and are proposed to be replaced by a cluster of new trees. Two additional trees are proposed beside the east gable of the barn, in part to screen the new cart lodge that belongs to the neighbouring property, Jankes Farmhouse, and to provide privacy from the road. A further, single new tree is proposed along the west boundary of the garden. All new trees are native species, or related, and have been selected for their small to medium size and in some cases for their flowers (which will provide early pollen and nectar for insects) and their winter fruits (a source of food for birds). Historic maps and aerial photographs show that the Barn was never separated from the surrounding fields; therefore it is intended to introduce simple stock fencing to keep out deer whilst retaining the barn's openness to the landscape.

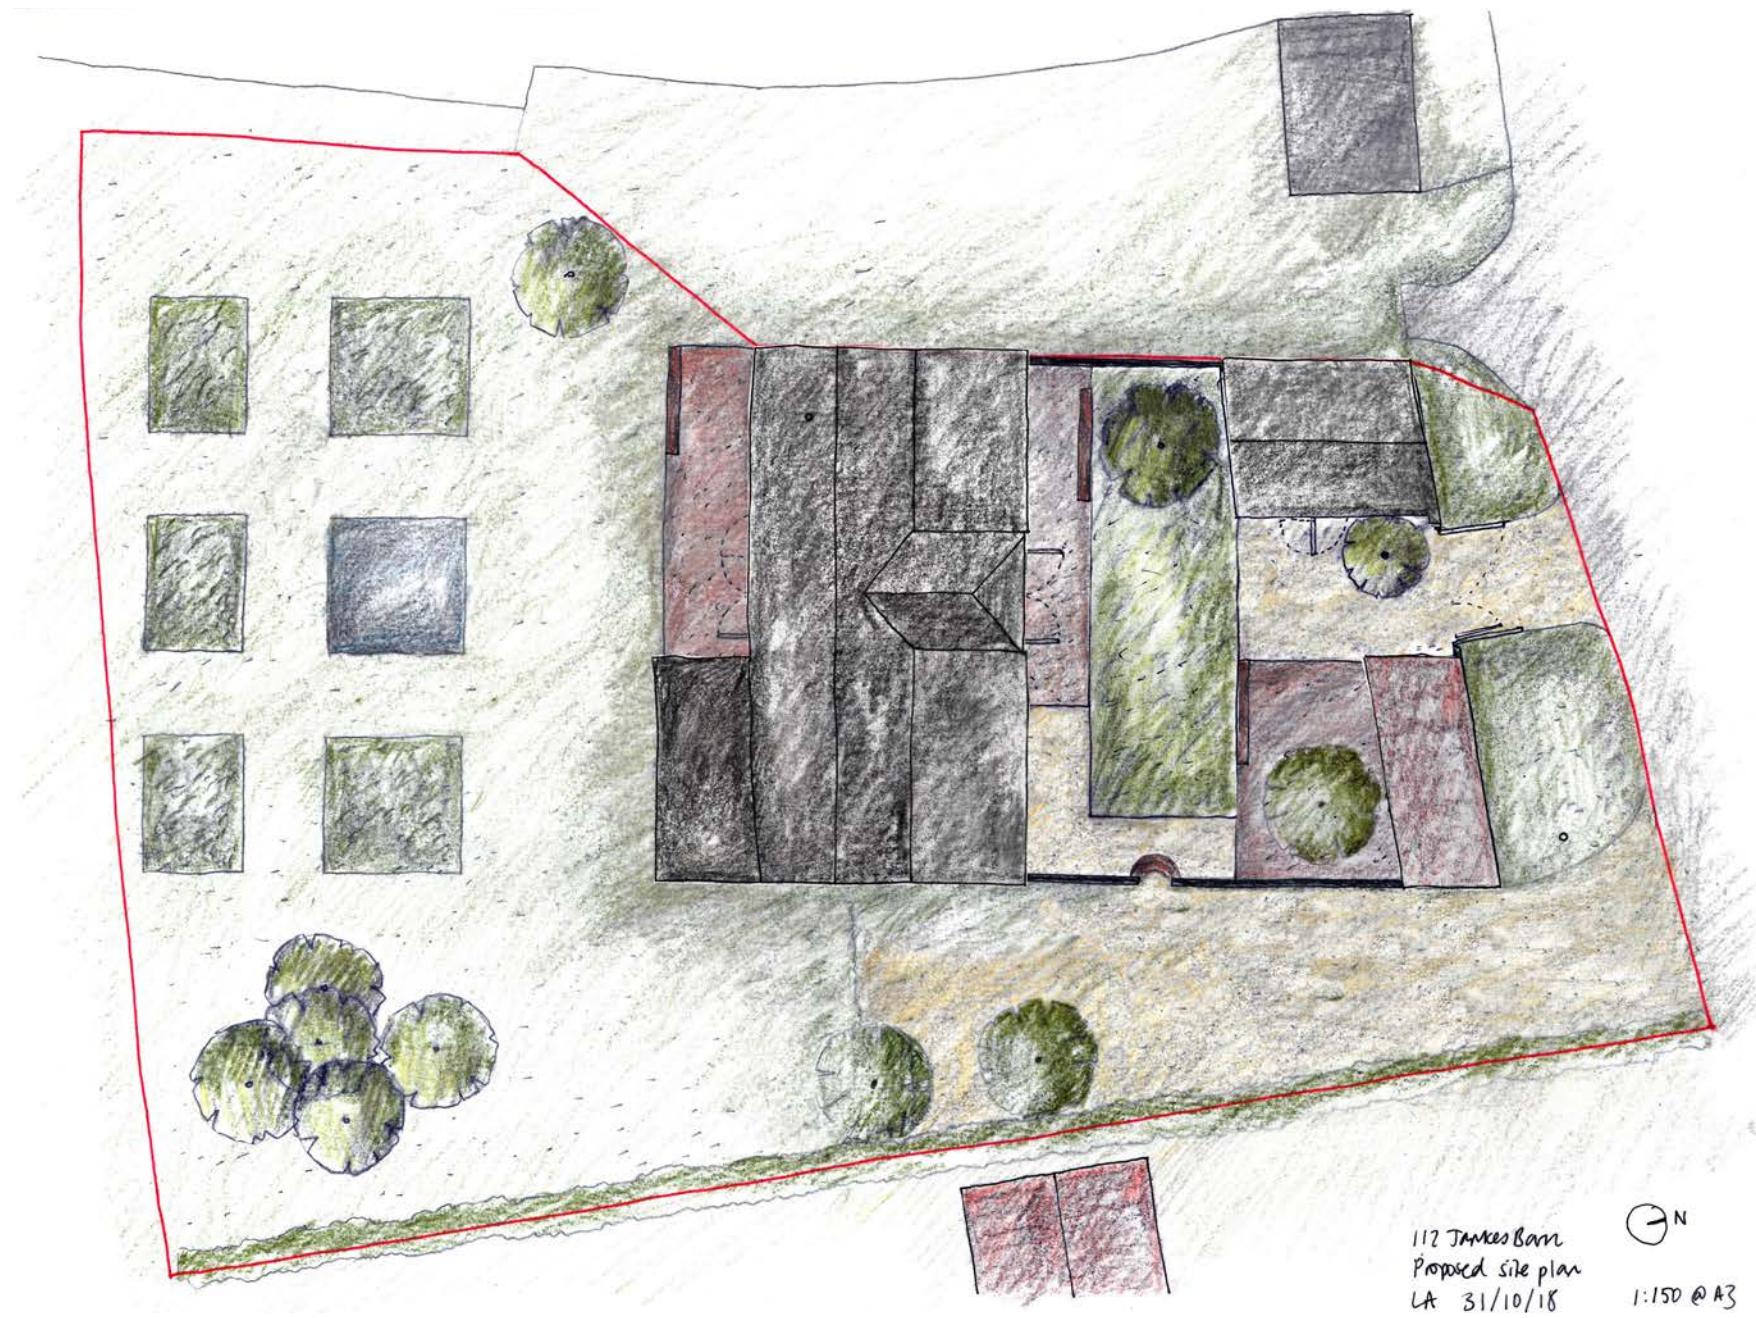
1 Proposed roof plan showing integrated landscape proposals
