Jankes Barn
Jankes Green, Wakes Colne
Heritage Statement

Project Team

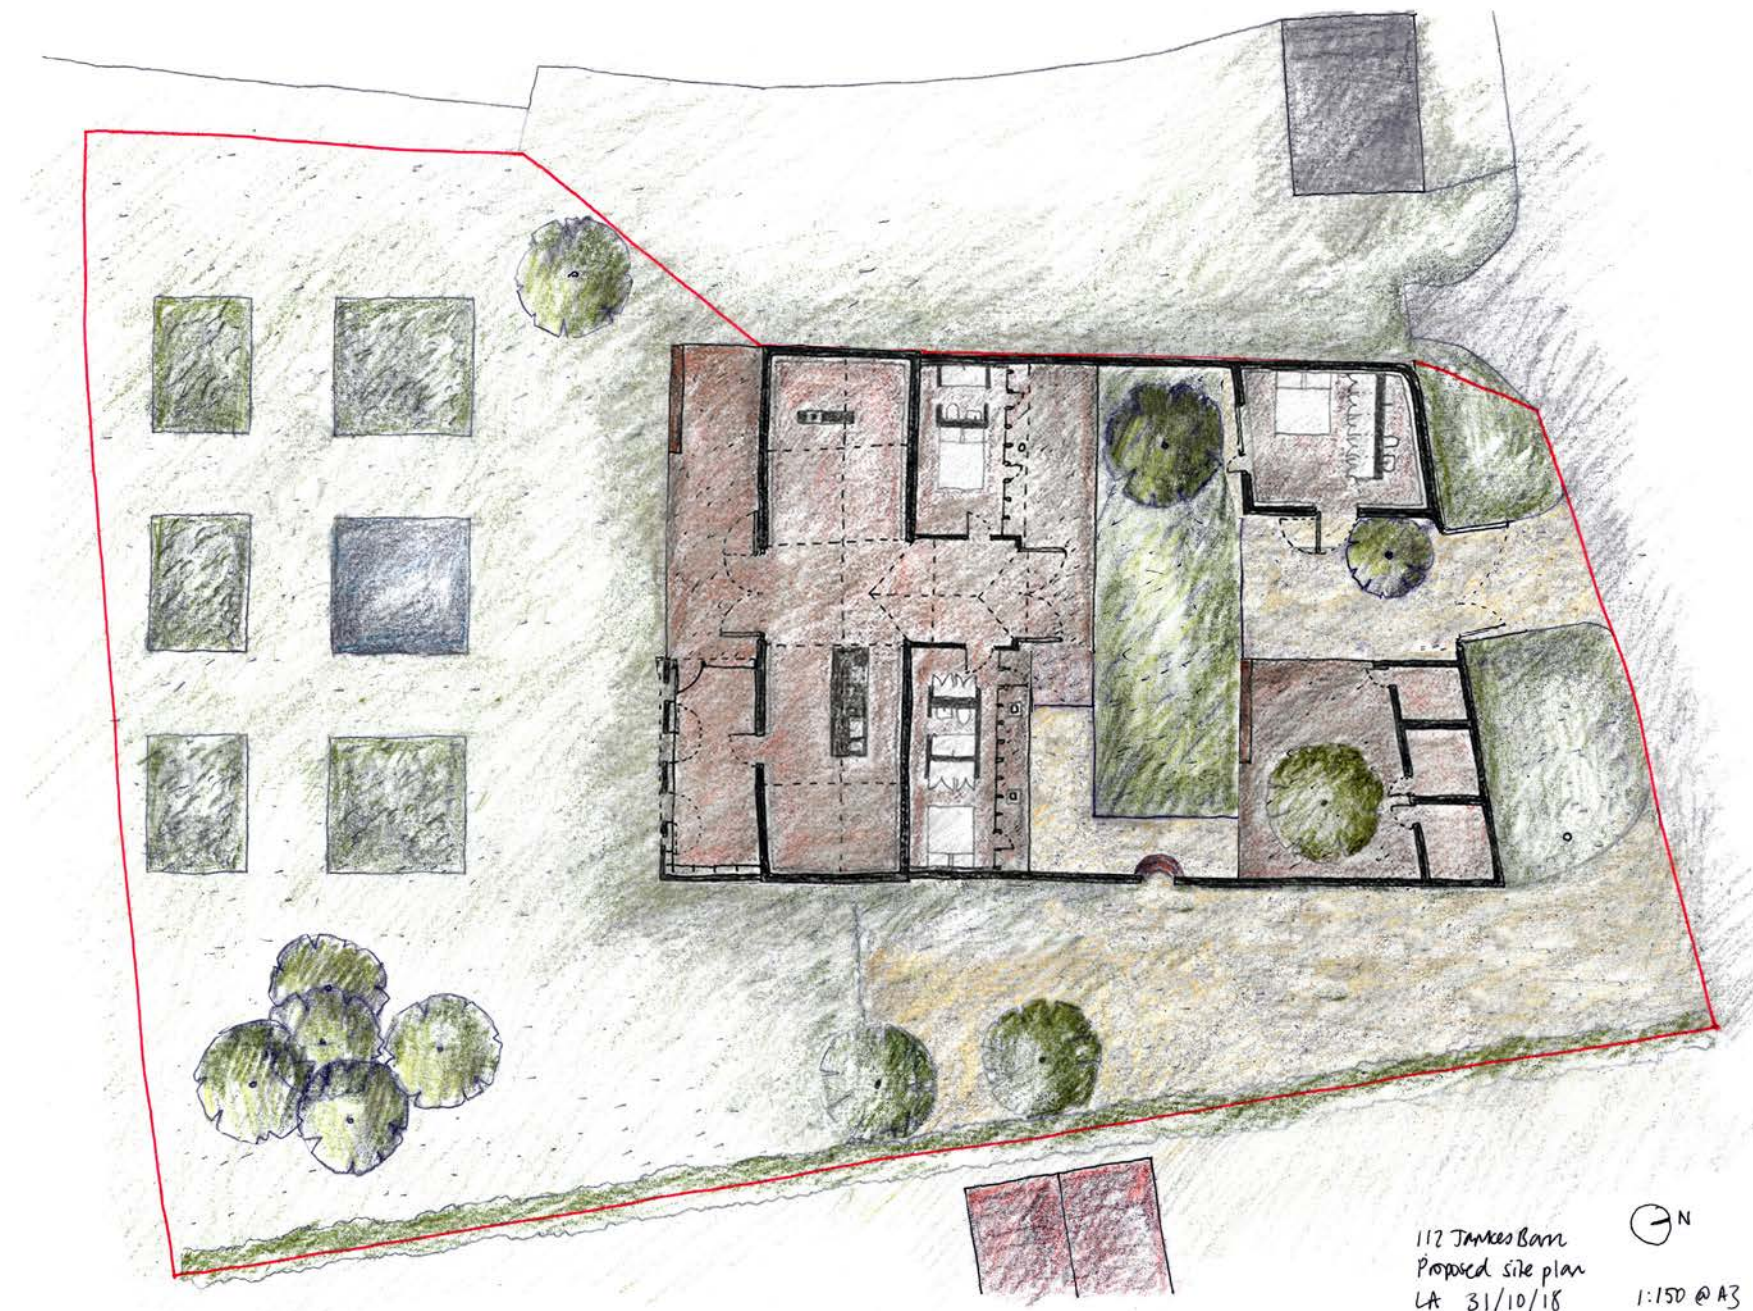
1 Proposed site plan showing integrated landscape proposals

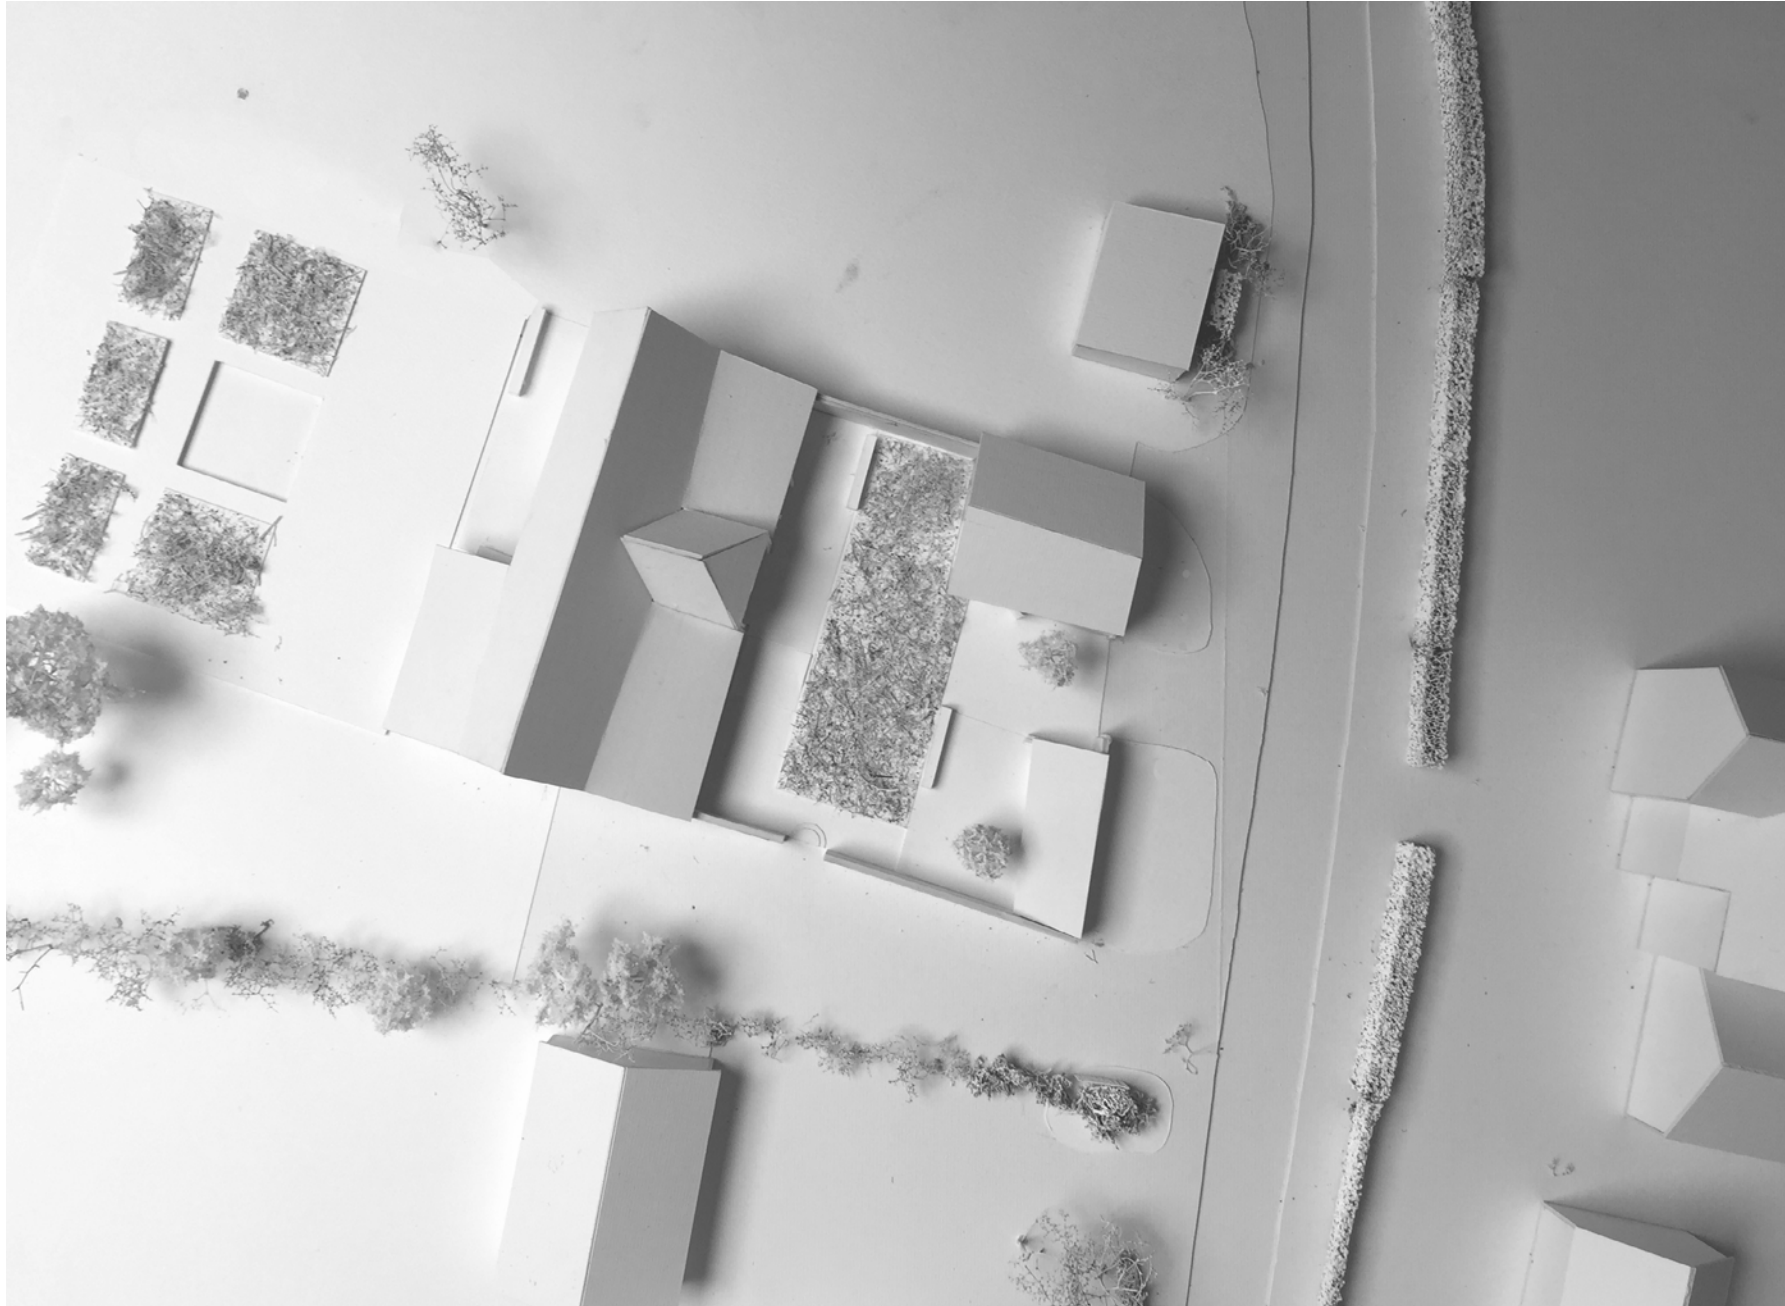
1 Photograph of 1:200 site model from above

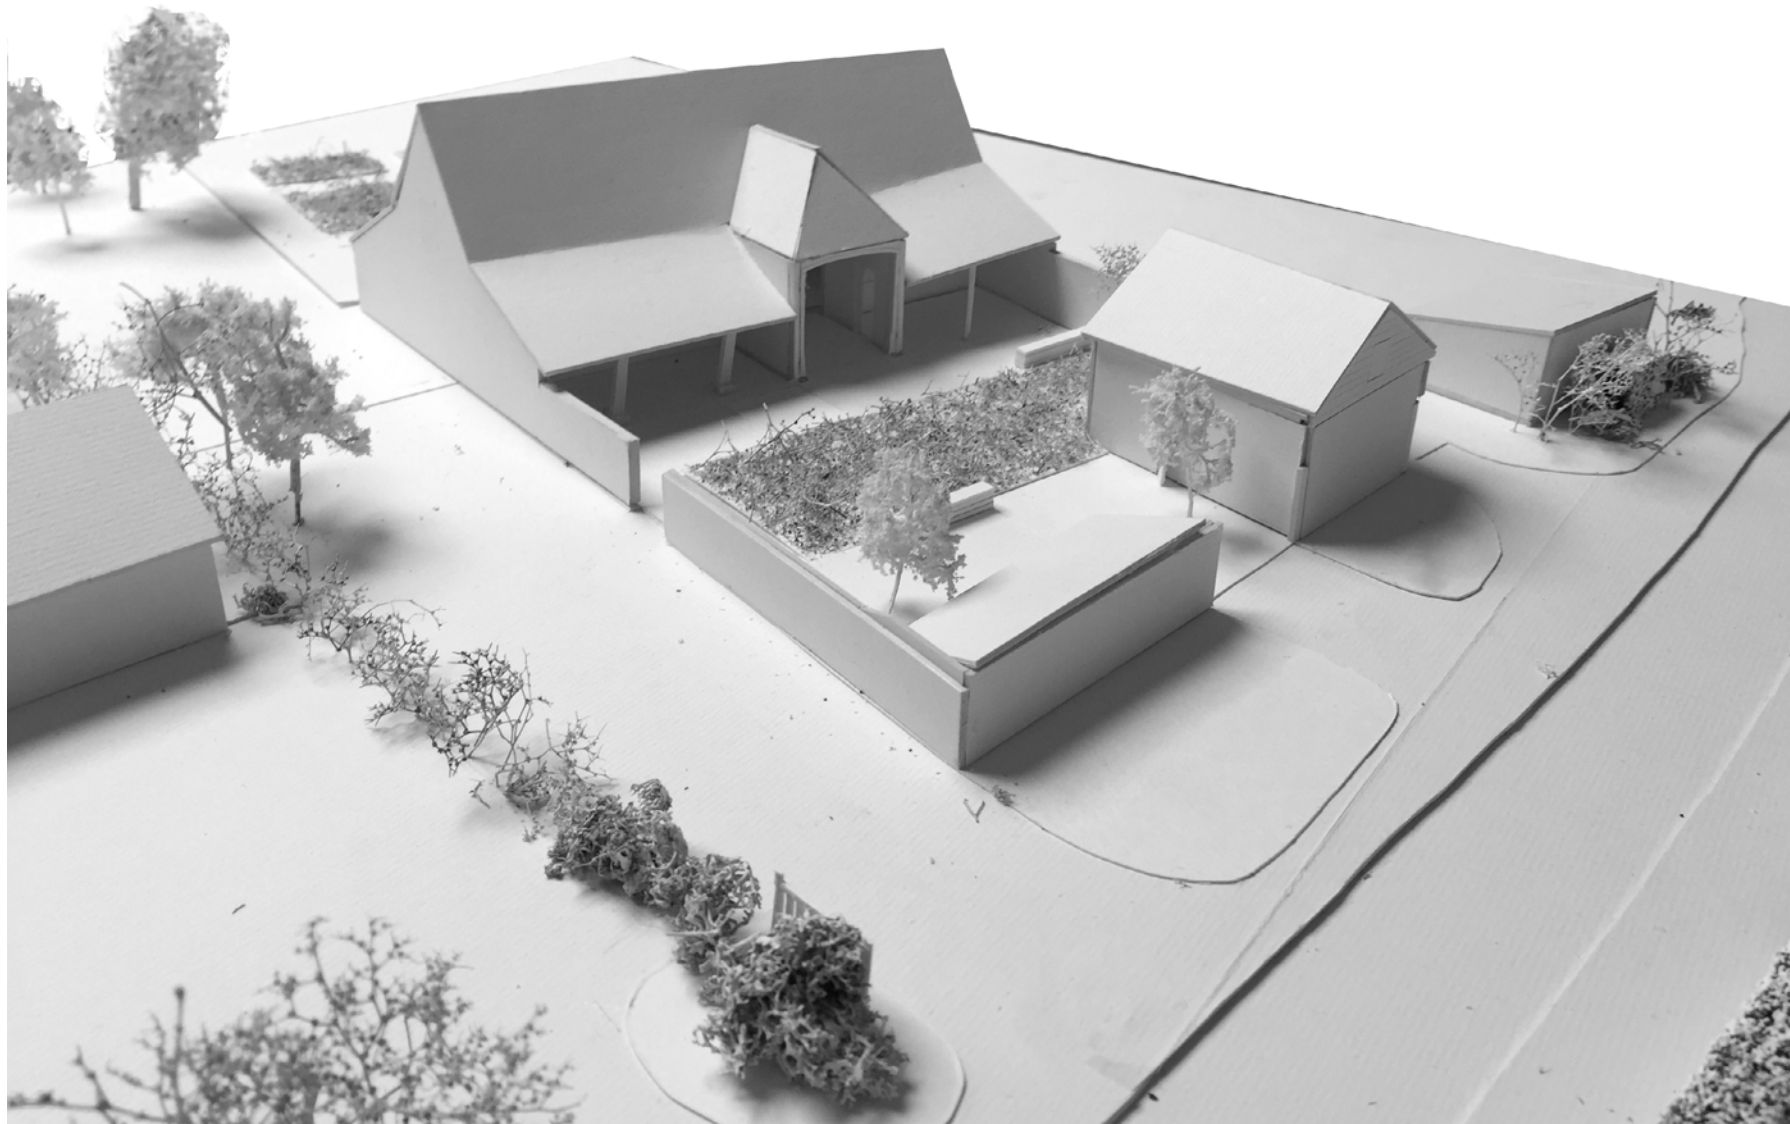
1 Photograph of 1:200 site model from above looking southwest

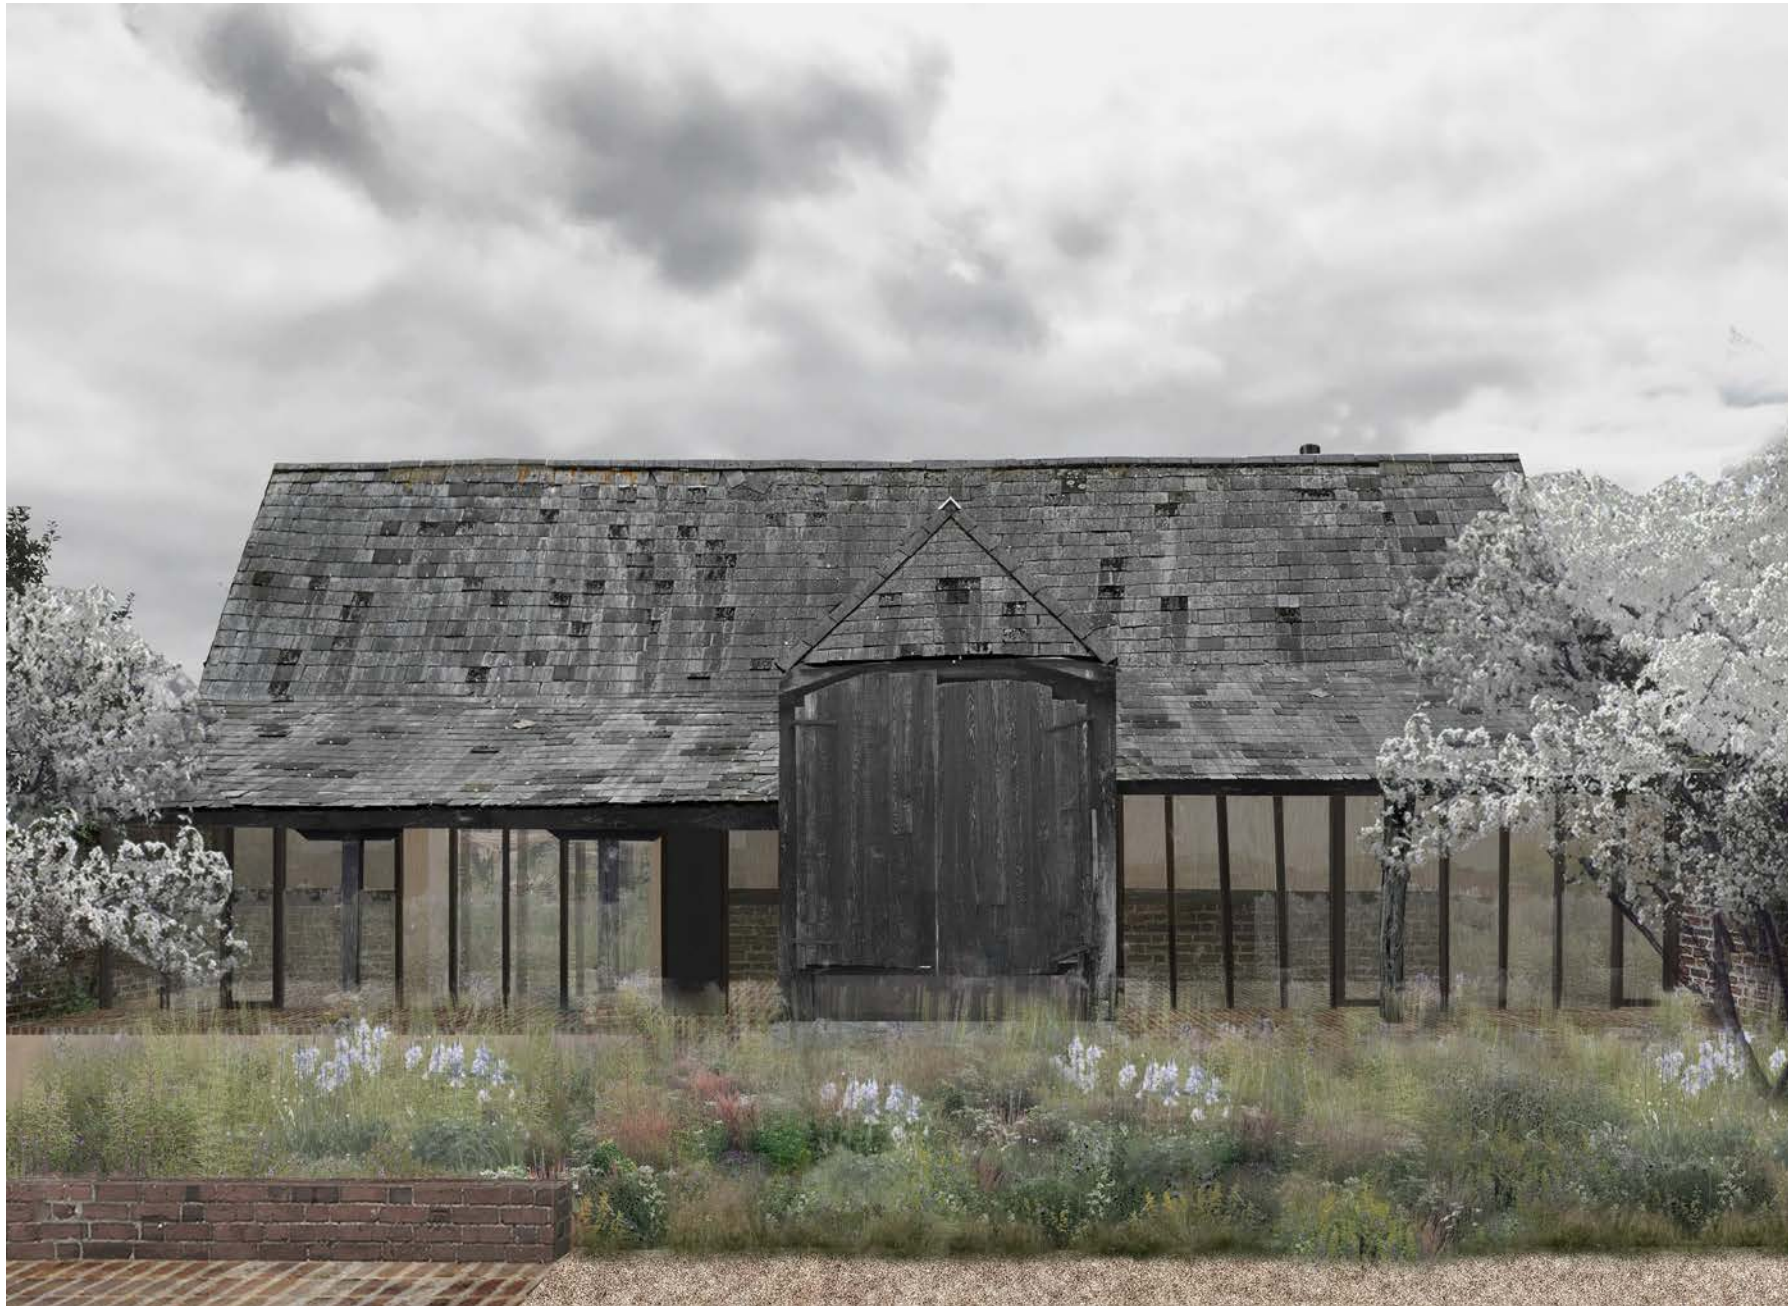
1 Collage showing proposed north elevation looking south from courtyard with retained timber barn doors closed

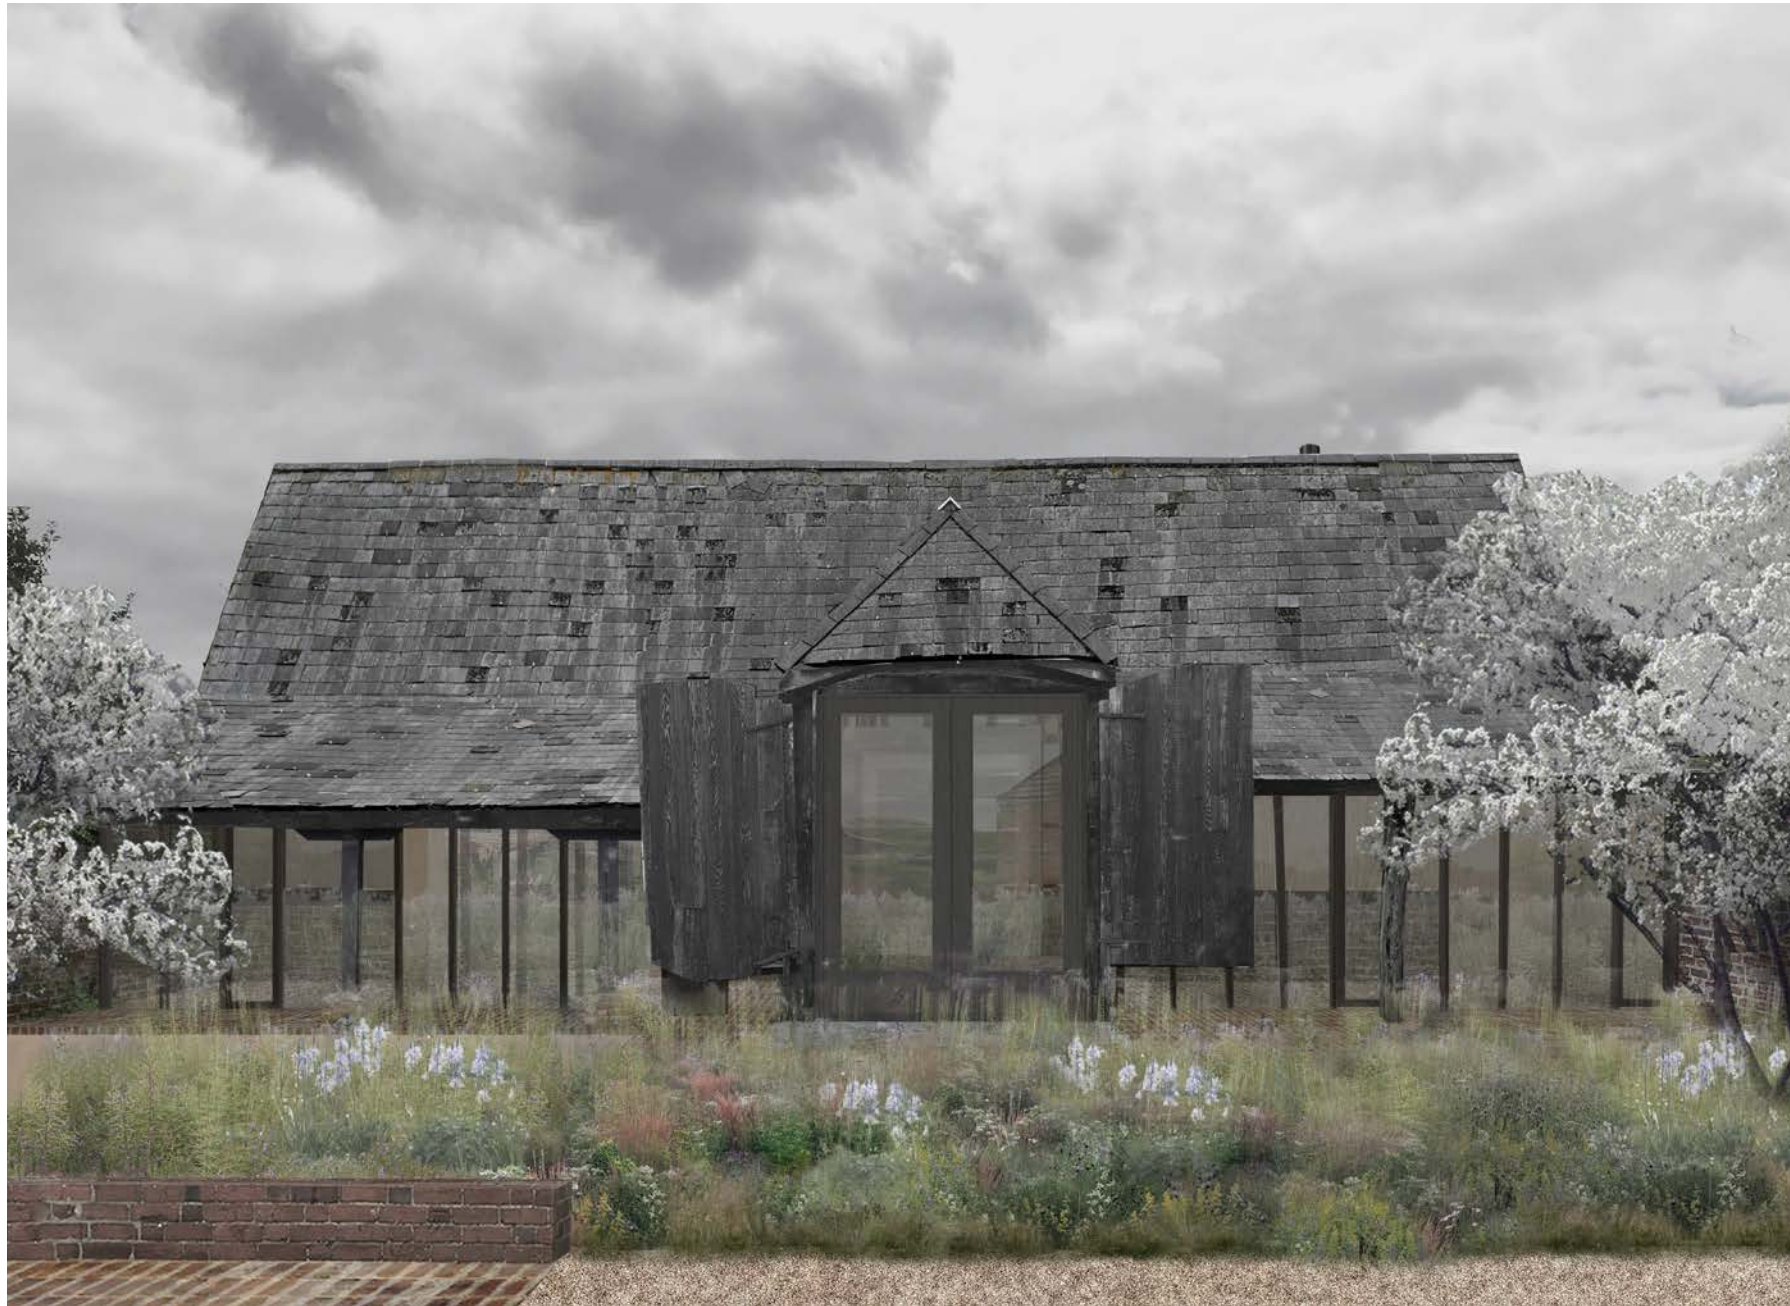
1 Collage showing proposed north elevation looking south from courtyard with retained timber barn open revealing internal set of glazed doors

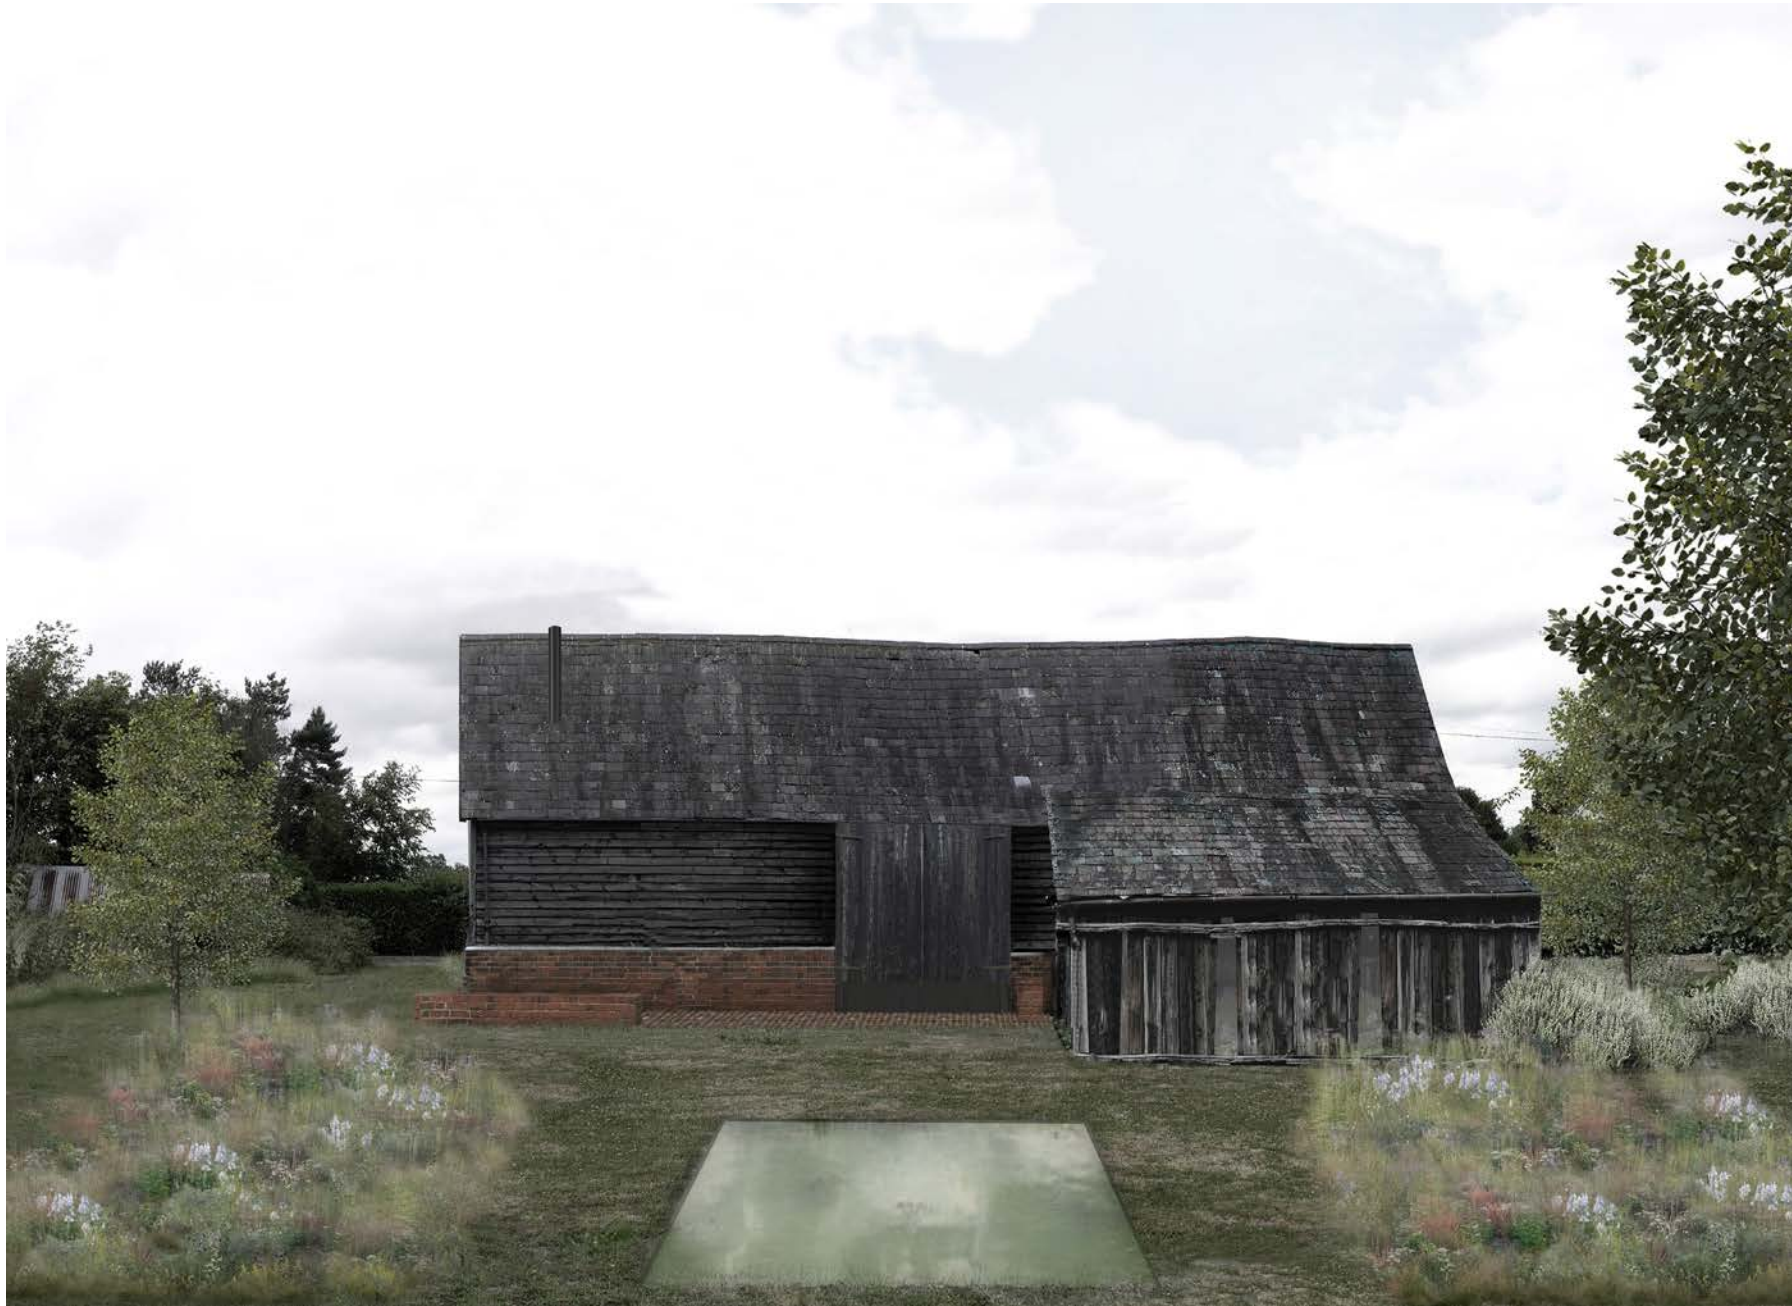
1 Collage showing proposed south elevation looking north from garden with retained timber barn doors closed

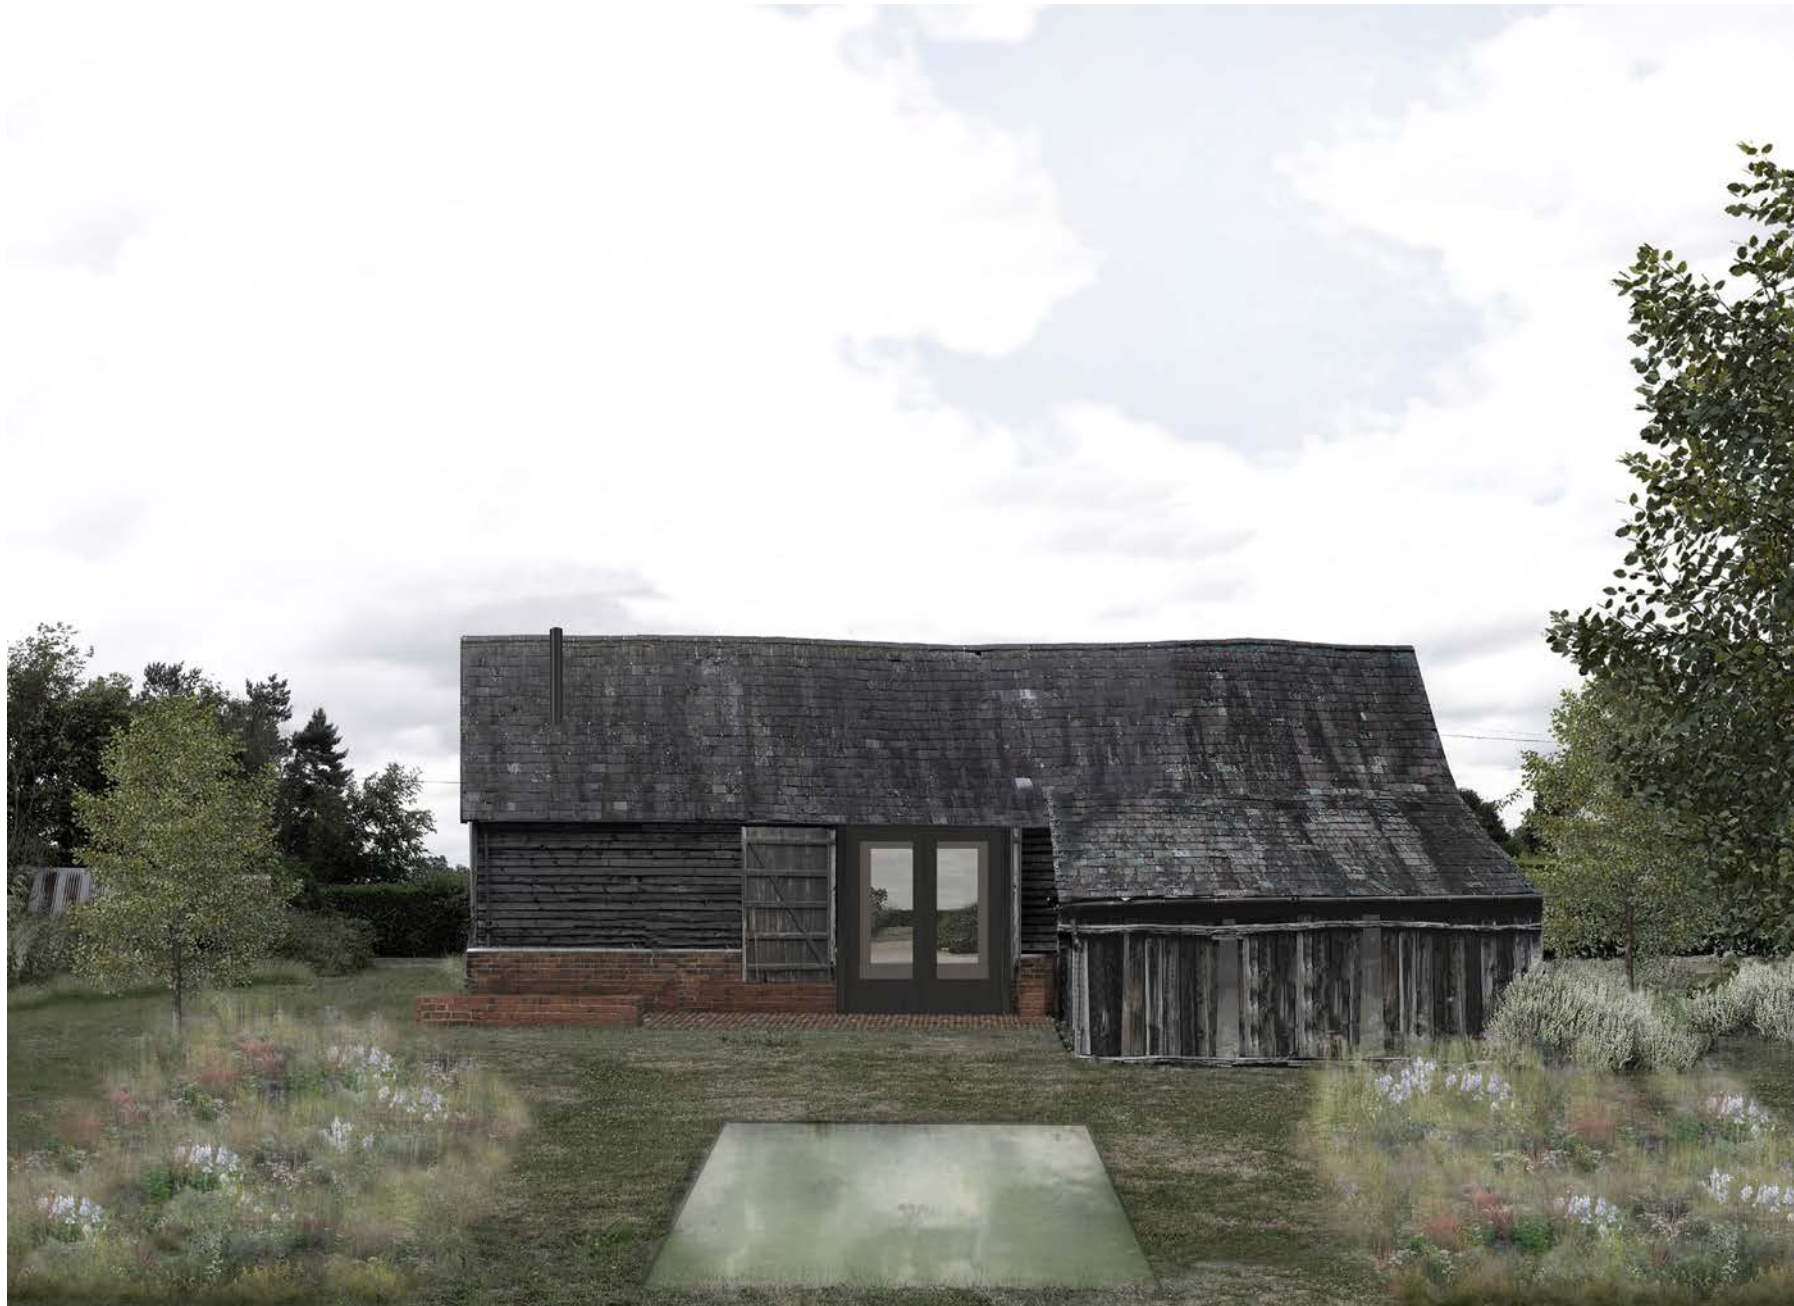
1 Collage showing proposed south elevation looking north from garden with retained timber barn open revealing internal set of glazed doors

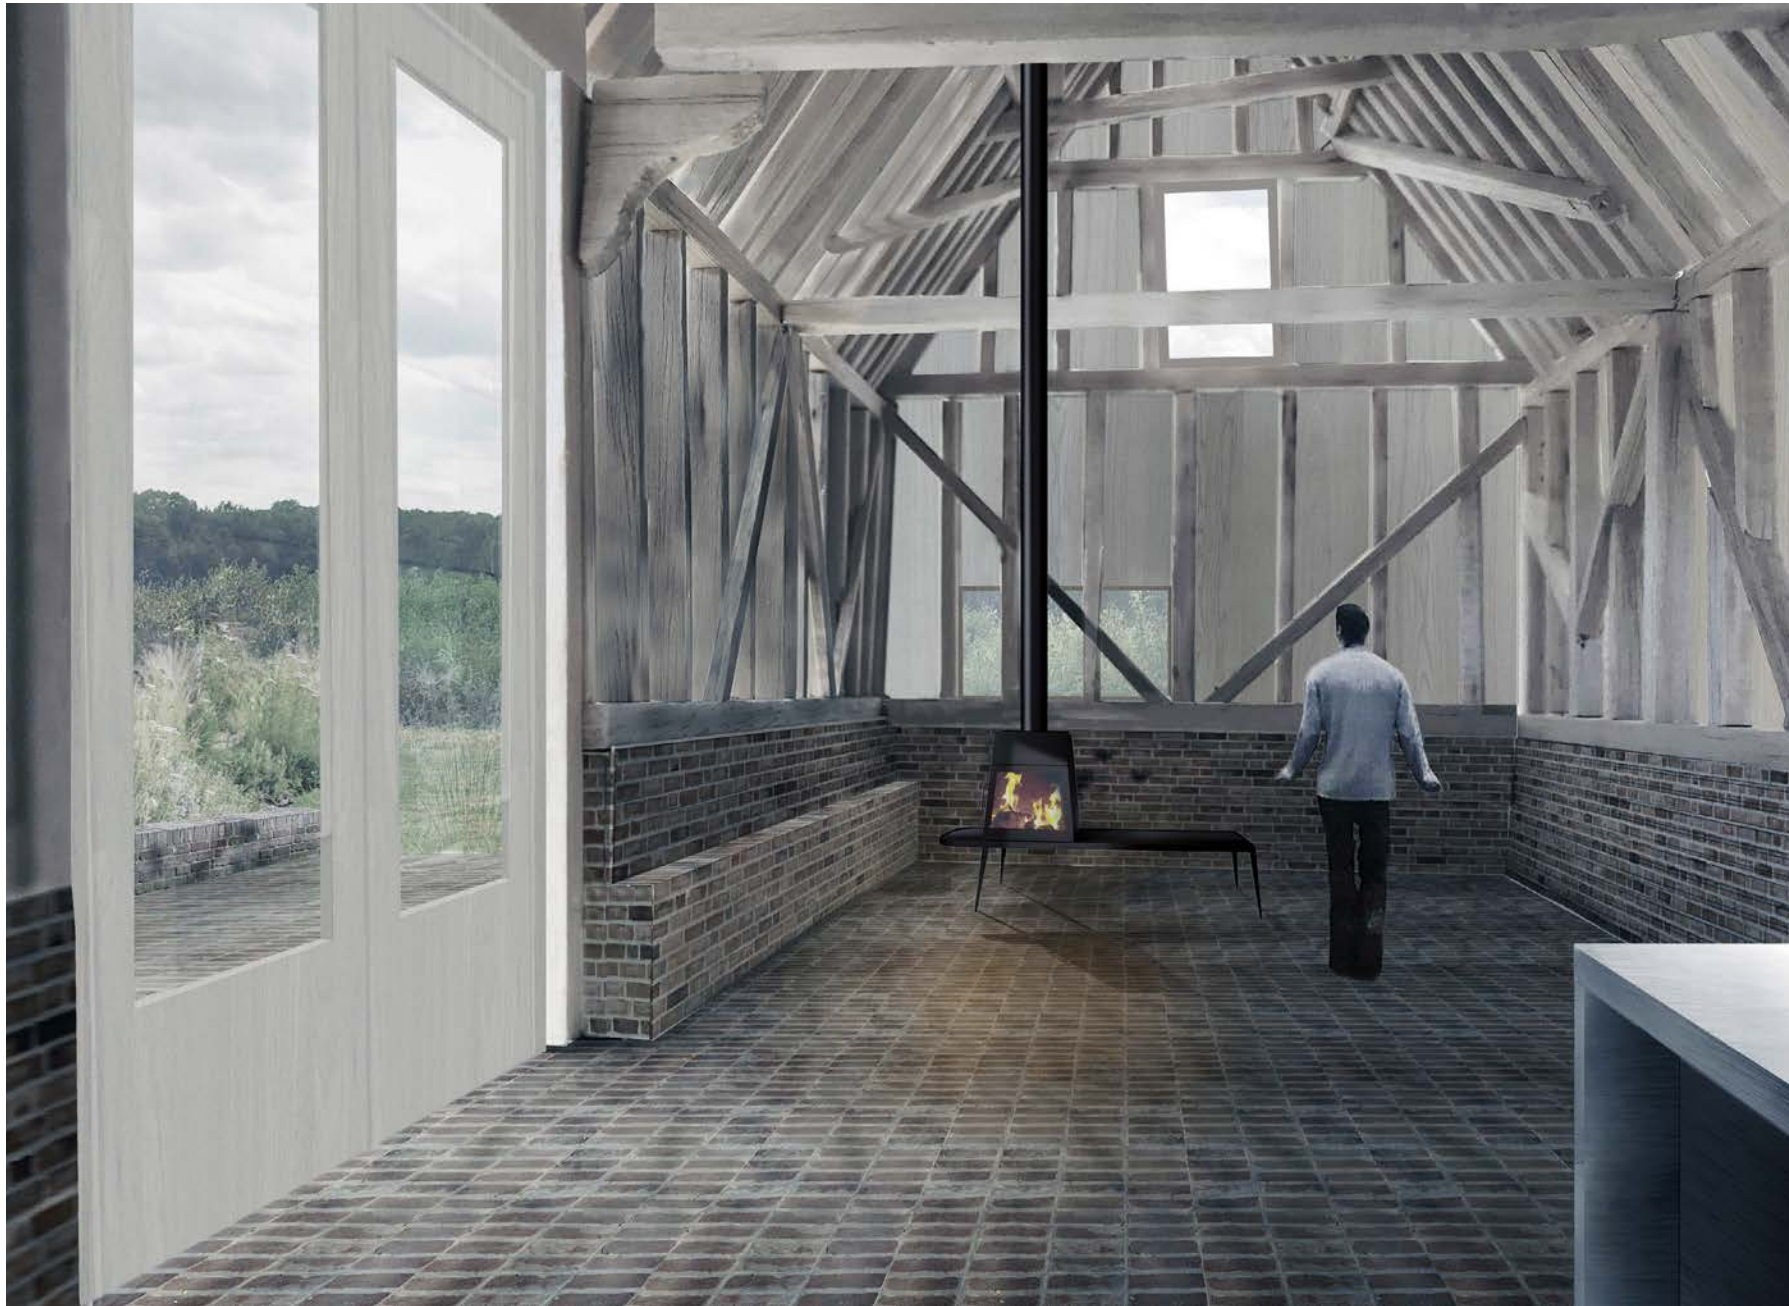
1 Collage showing interior of barn looking west with retained timber barn open showing internal set of glazed doors

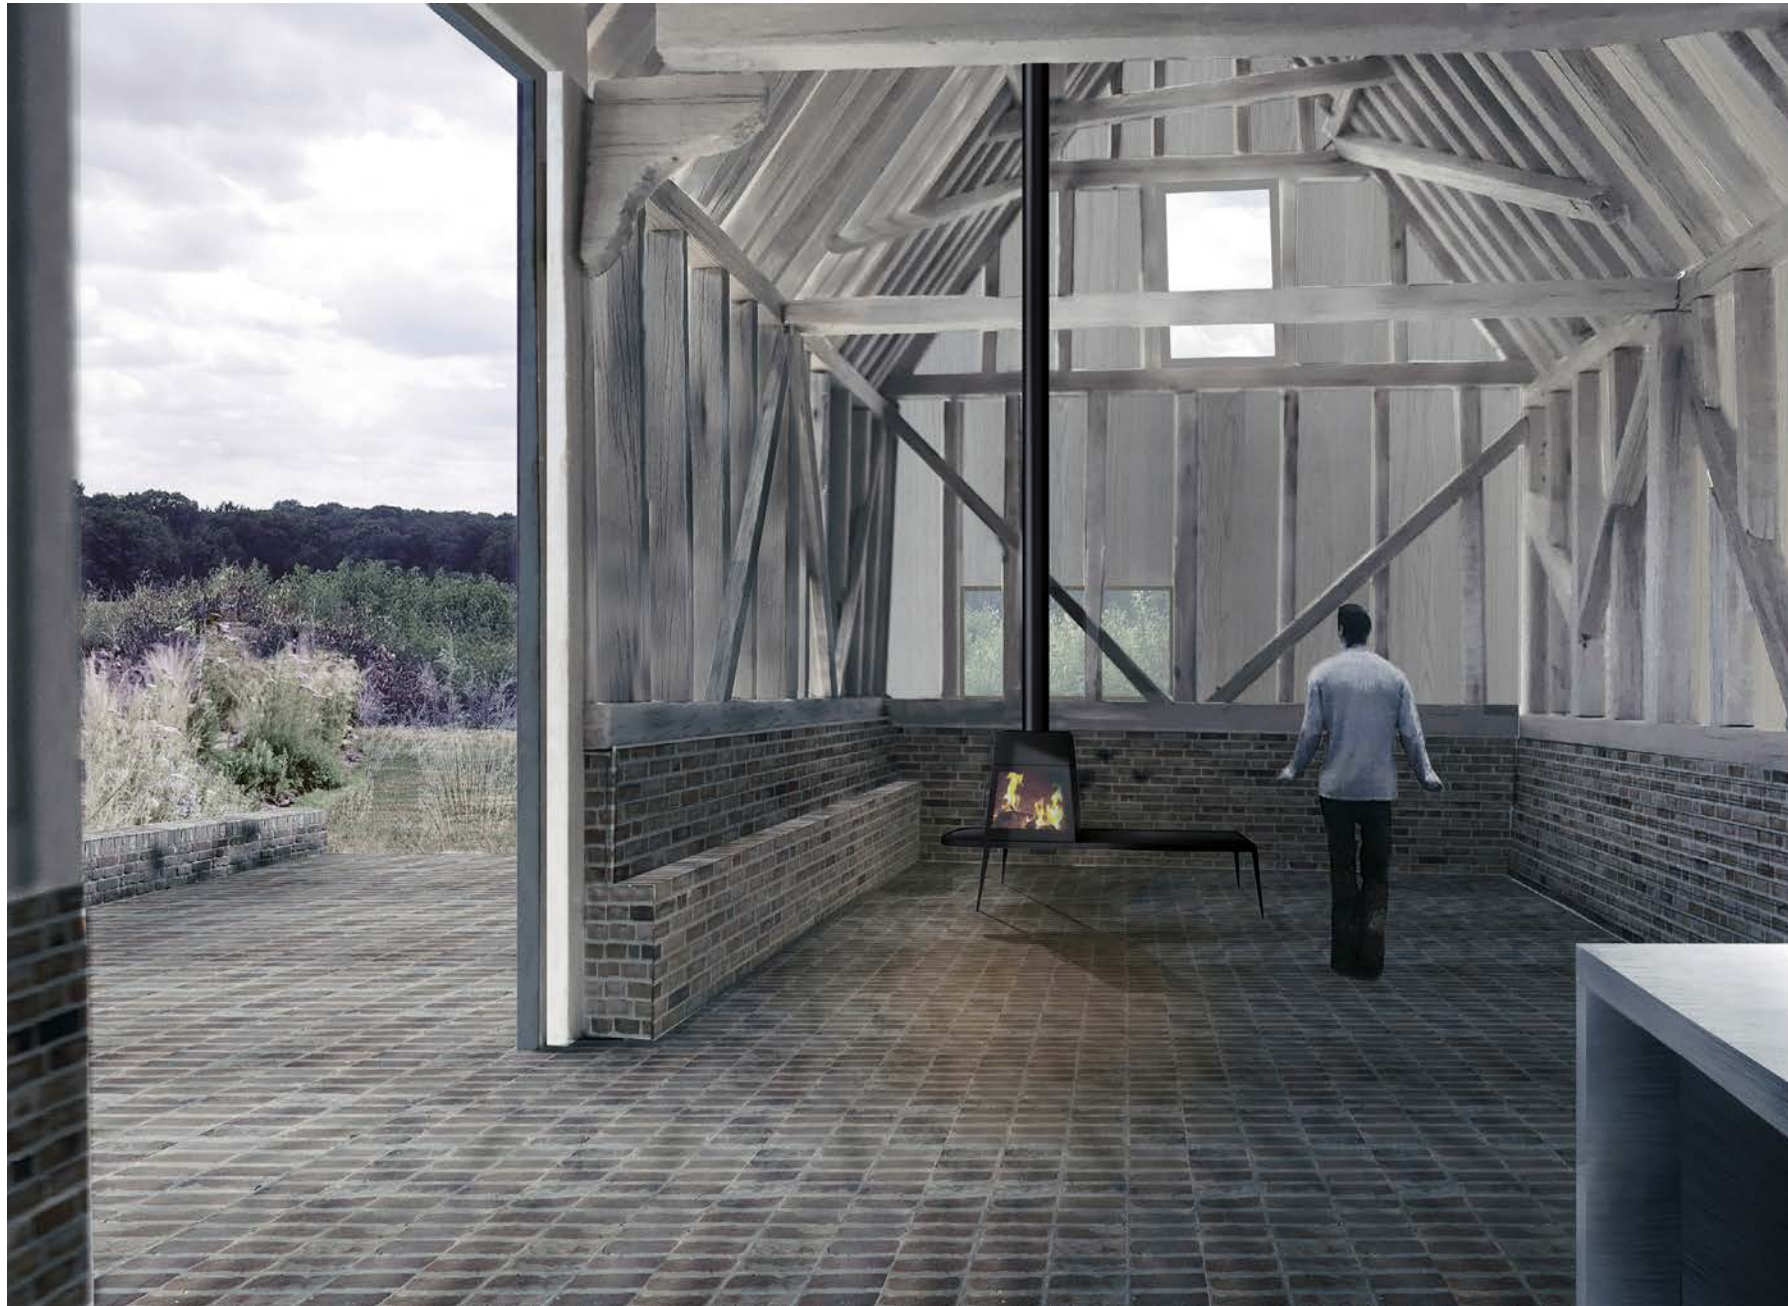
1 Collage showing interior of barn looking west with retained timber barn doors and new internal glazed doors open

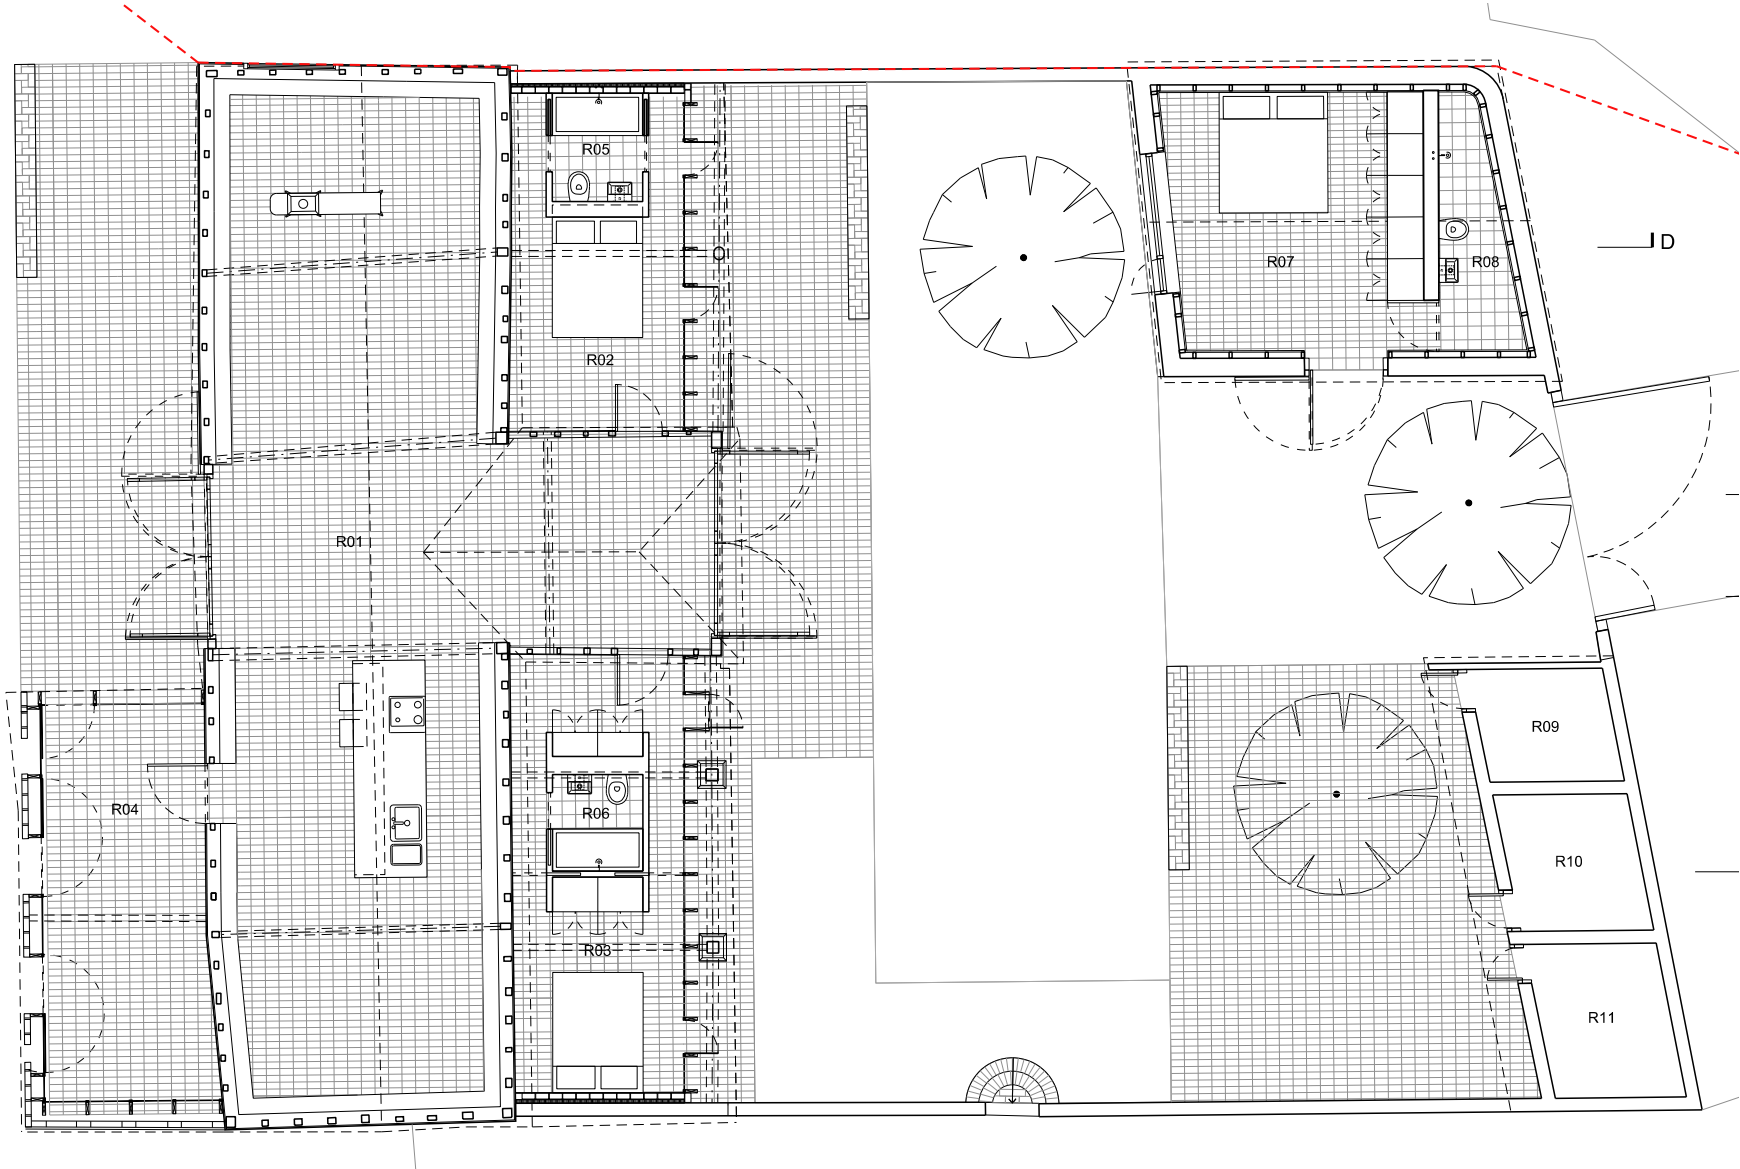
1 Lynch Architects proposed ground floor plan
