Historic building recording and test-pit evaluation at Duncan's Gate, Colchester, CO1 1UN

July 2016

CAT Report 1022
November 2016

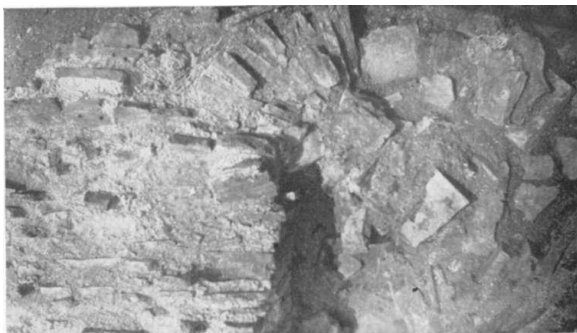
Photograph 2 Detailed photo of window arch visible in collapsed masonry (reproduced from Roman Colchester, 1958, plate IVb).

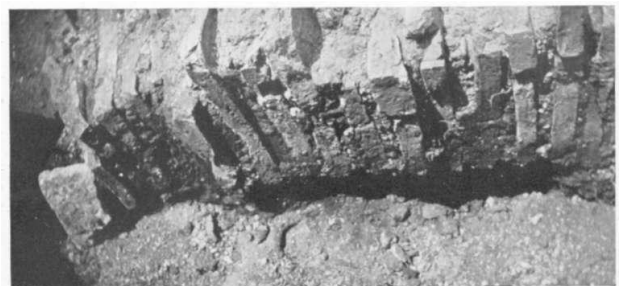
Photograph 3 Detailed photo of window arch visible in collapsed masonry (reproduced from Roman Colchester, 1958, plate IVc).

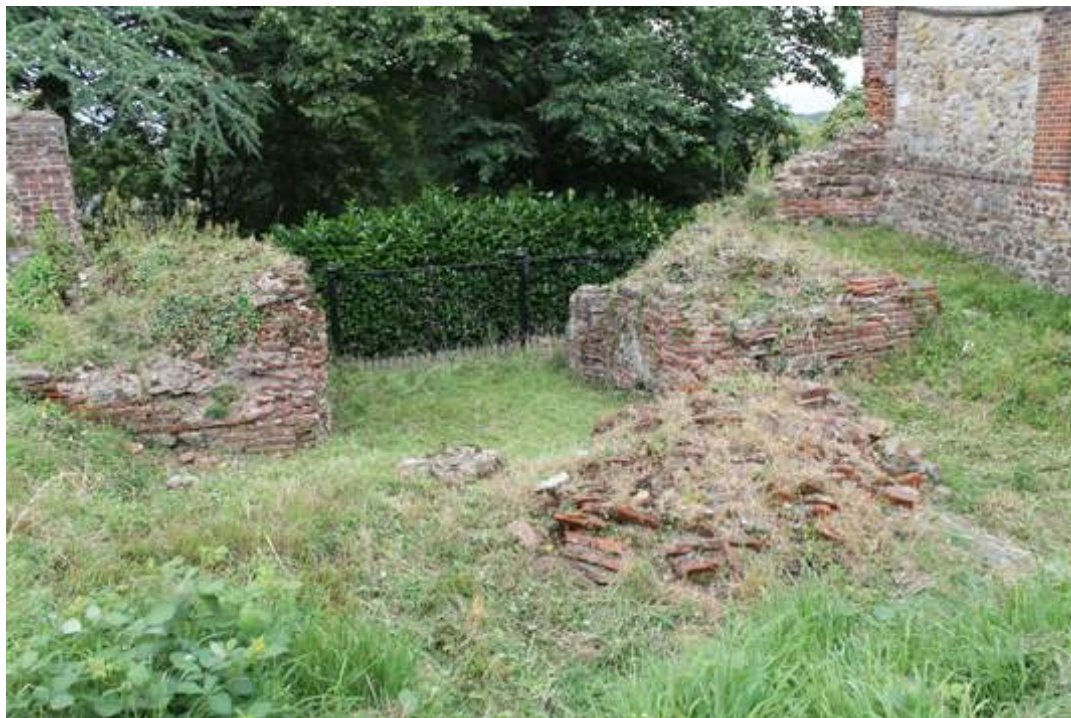
Duncan's Gate is located on the north-east corner of Colchester town wall (Photograph 7). It has two sides coming south off from the main wall at right angles, leaving an opening 3.7m wide (Fig 2). Each side of the gate extends 5.4m south of the north face of the wall. Each side is 2.6m wide, and their outer and inner faces are identical to the town wall proper: four courses of septaria alternating with four courses of brick, all bonded together with lime mortar. The interior make-up of the sides, where visible, also mirrors that of the town wall (i.e. irregular layers of septaria and mortar).

Photograph 7 General shot of Duncan's Gate. Collapsed masonry visible in foreground. Photograph taken facing north-east.

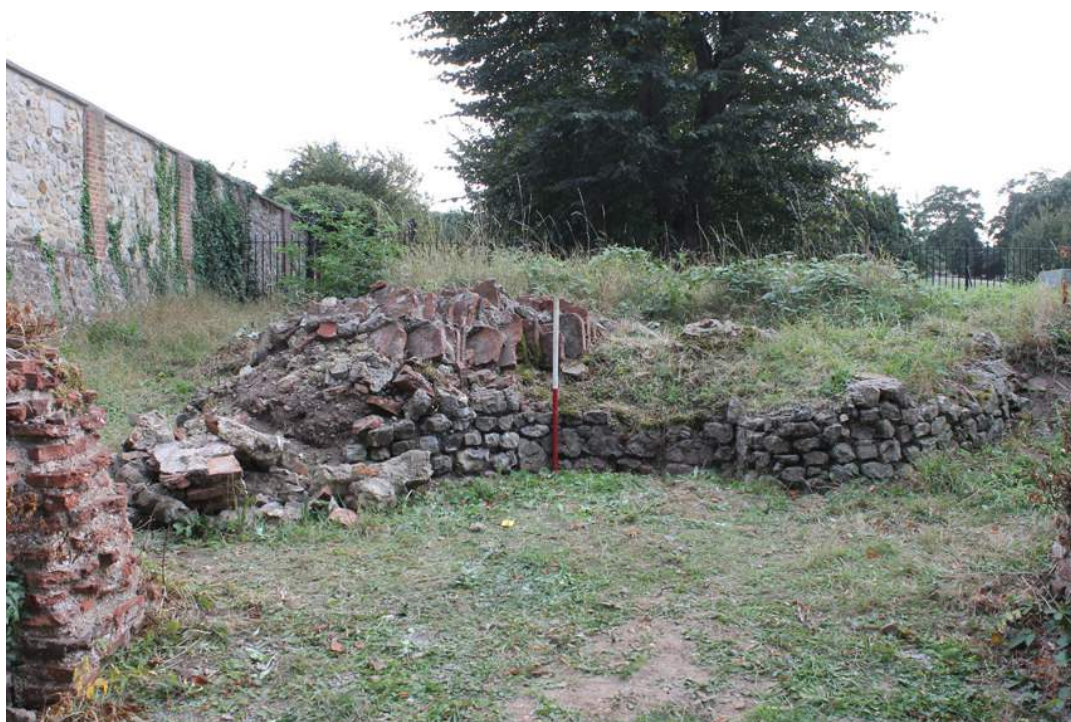
The collapsed masonry lies approximately 1m to the south of Duncan's Gate, and is heavily overgrown (Photograph 12). Even after removal of a substantial amount of overgrowth, the only section identifiable on the surface were the tile courses (with some occasional septaria fragments) defining the windows of the gate tower (Photographs 13, 14 and 19). The entire western half of the collapsed masonry is covered in grass, making any identification impossible. Although the limits of the collapse are difficult to define, the masonry appears to be about 10 square metres in area.

Photograph 13 Collapsed masonry after the removal of overgrowth. Photograph taken facing south.

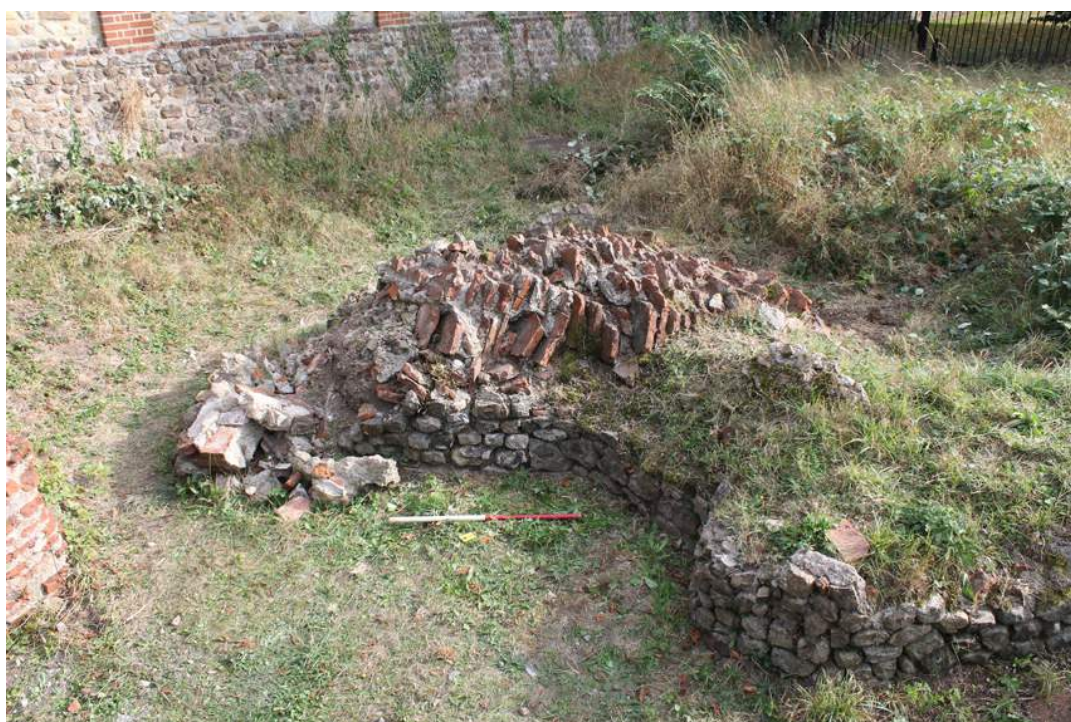
Photograph 14 Collapsed masonry after the removal of overgrowth. Photograph taken facing south-east.

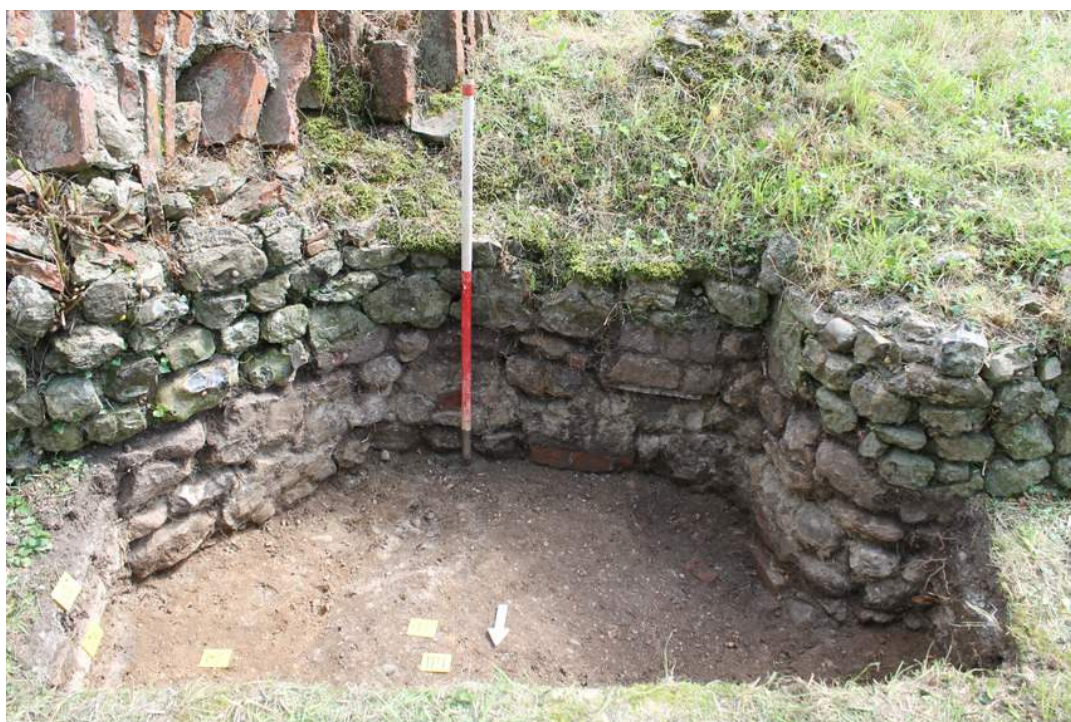
The masonry was heavily modified and conserved in the 20th century. Like the south faces of the gate itself, the collapsed tile courses and the entire exterior of the masonry (where visible) was re-rendered in modern concrete (Photograph 15). The entire north side of the masonry has had a crescent-shaped retaining wall built against it, constructed of septaria and modern brick (Photograph 16). How much this retaining wall represents the original extent of the collapse is unclear.

Photograph 16 View of retaining wall after test-pit excavation. Modern brick and septaria visible in make-up. Photograph taken facing south.

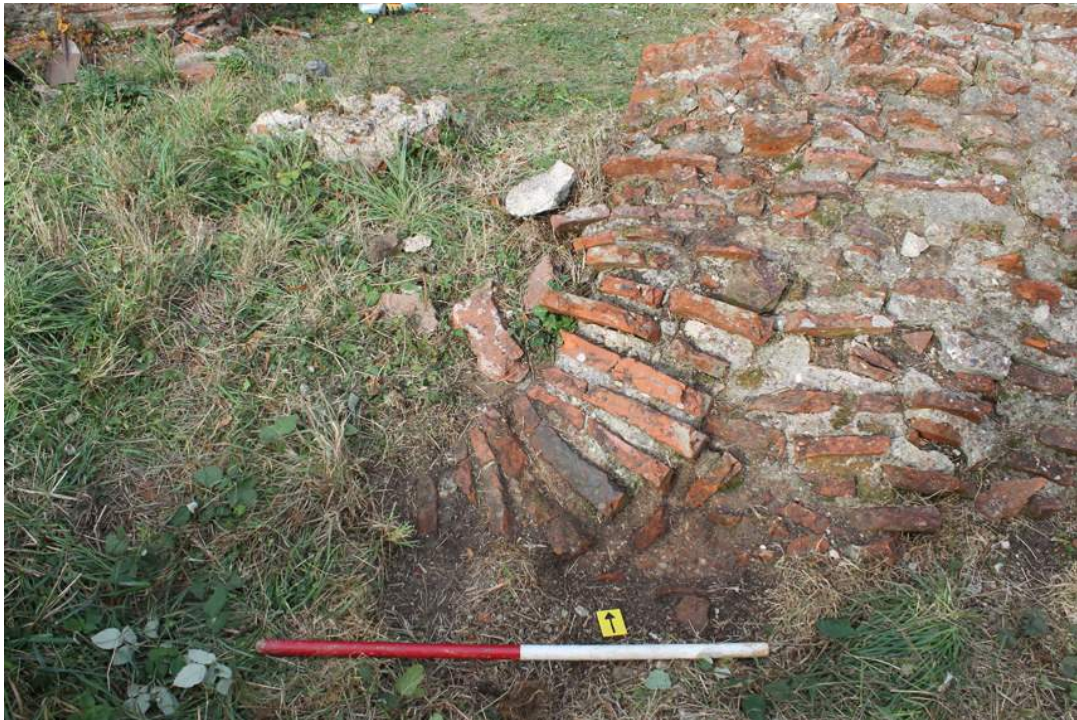
Photograph 19 Arch of window in collapsed masonry. Photograph taken facing north.

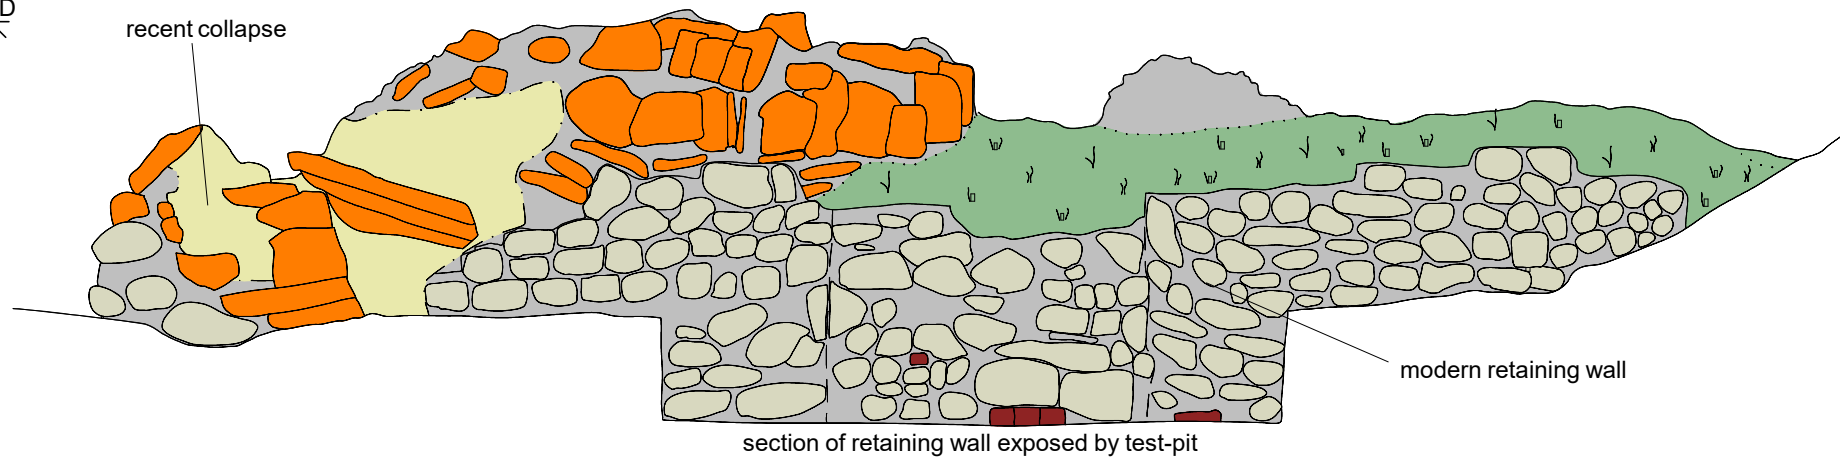
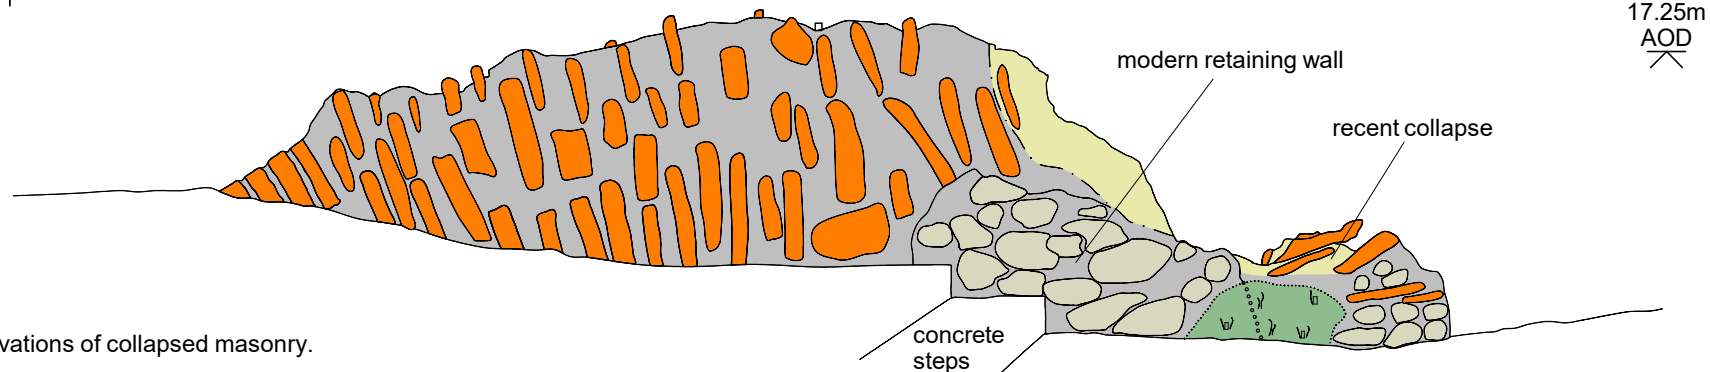
Due to the irregular size, footprint and overgrown nature of the masonry, it was decided the best way to record elevations would be as two sections – one east to west across the whole footprint, and one south-west to north-east, following the arch of a collapsed window (Fig 3).
