FINGRINGHOE CHURCH

Historic Buildings and Conservation
Essex County Council

Report commissioned by the Parochial Church Council and prepared by
Karen Fielder with assistance from David Andrews, 2007

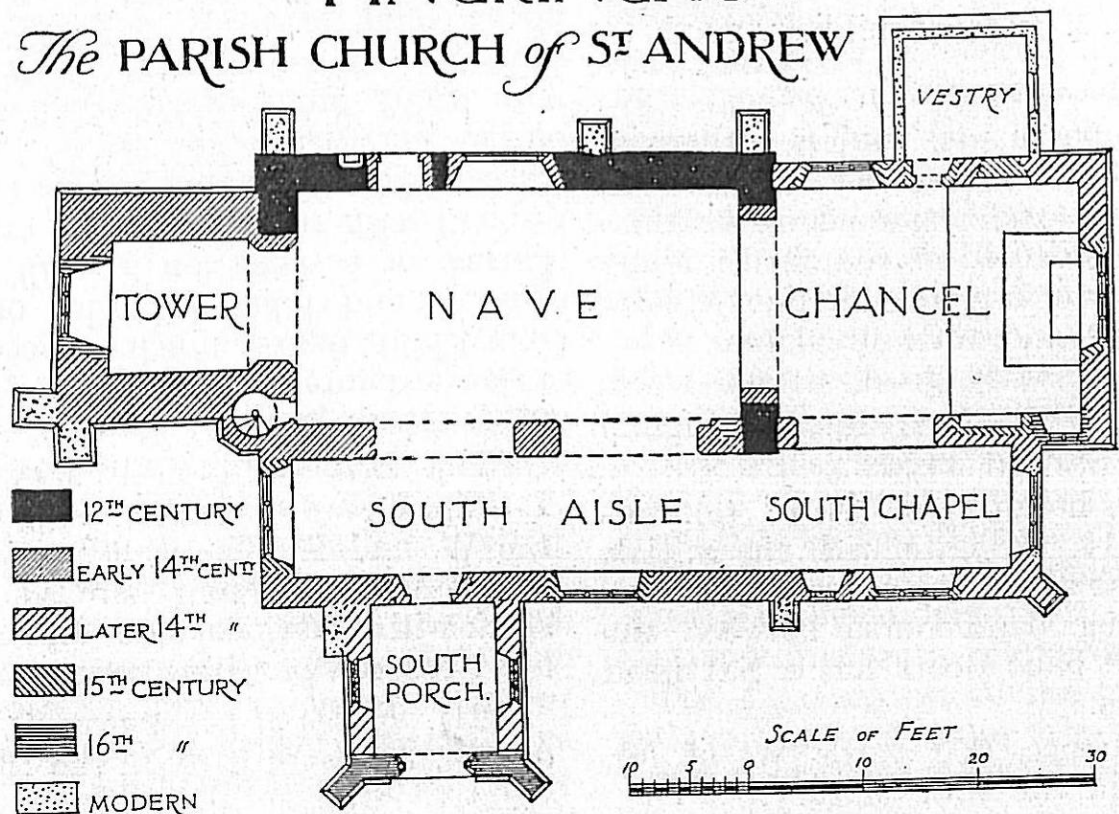
Fig. 1 Phased plan of Fingringhoe church. Reproduced from The Royal Commission on Historical Monuments (England).

The plan below (*Fig. 1*) extracted from the Royal Commission on Historic Monuments publication, provides a phased plan of the church.
