**Historic building recording at B Mess,
formerly the Officers' Quarters,
Le Cateau Barracks, Colchester,
Essex,
November 2013 and December 2019**

**report prepared by
Chris Lister and Mark Baister**

CAT Report 1512
February 2020

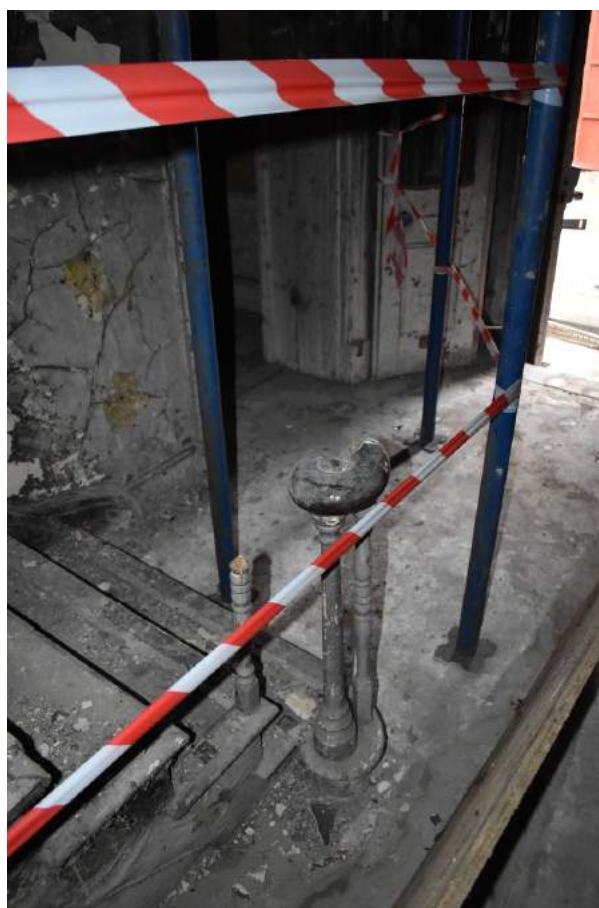
Plate 3 Stairwell iv, detail of the mahogany banister with spiral end and the turned balusters of the open string staircase. Photo from November 2013 above, photo from December 2019 below.

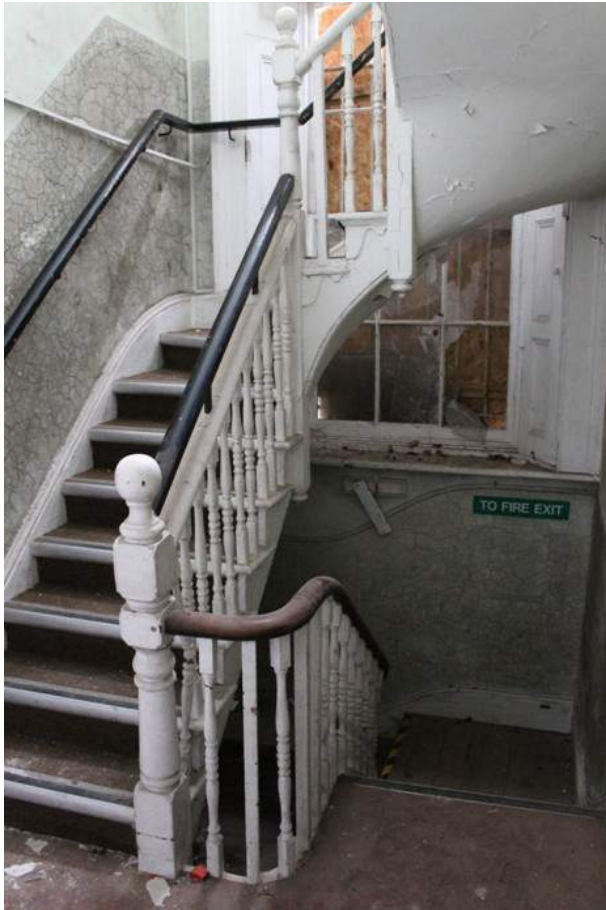
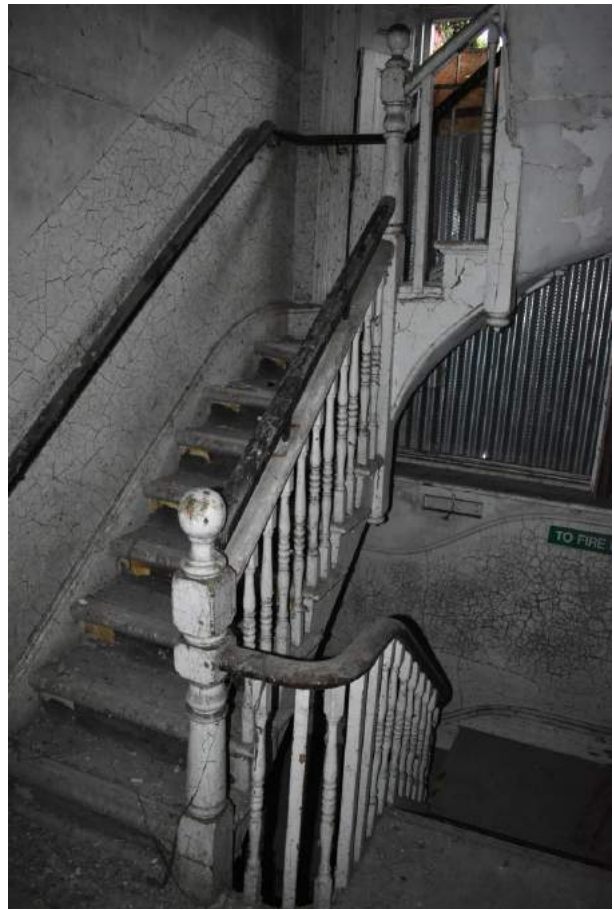
Plate 11 Servants' stairwell v, with the original access to the basement and the inserted staircase to the first floor - view west. Photo from November 2013 left, photo from December 2019 right.

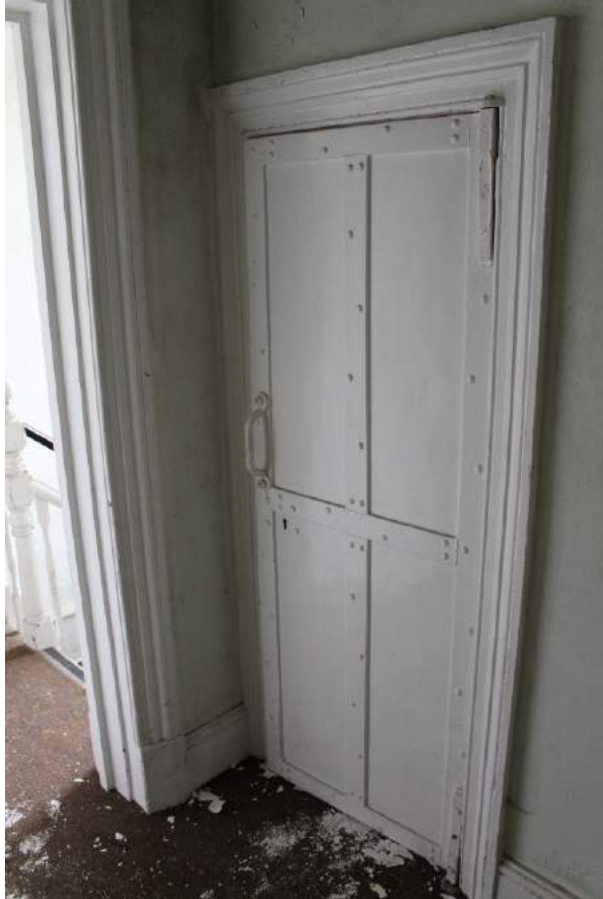
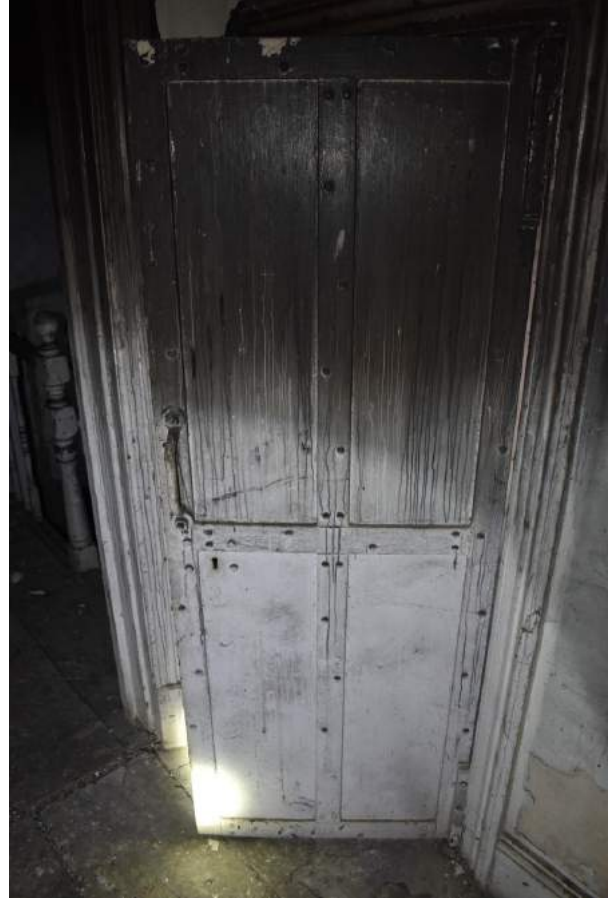
Plate 17 Iron door to strongroom 20, converted from the former servants' quarters for Officers Nos.2 and 3 - view west. Photo from November 2013 left, photo from December 2019 right.

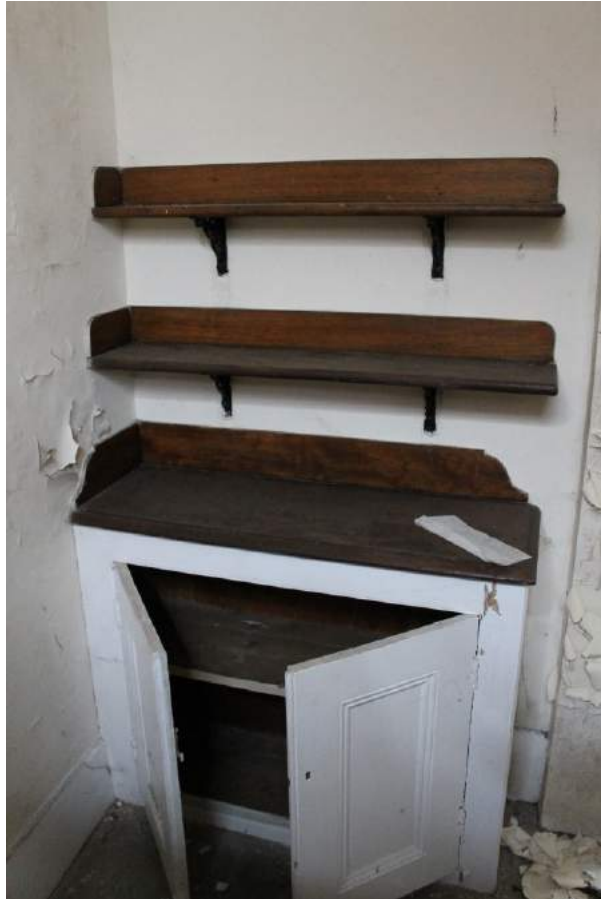
Plate 18 Detail of relocated dresser in room 20, showing the unpainted finish – view north-east. Photo from November 2013 above, photo from December 2019 below.

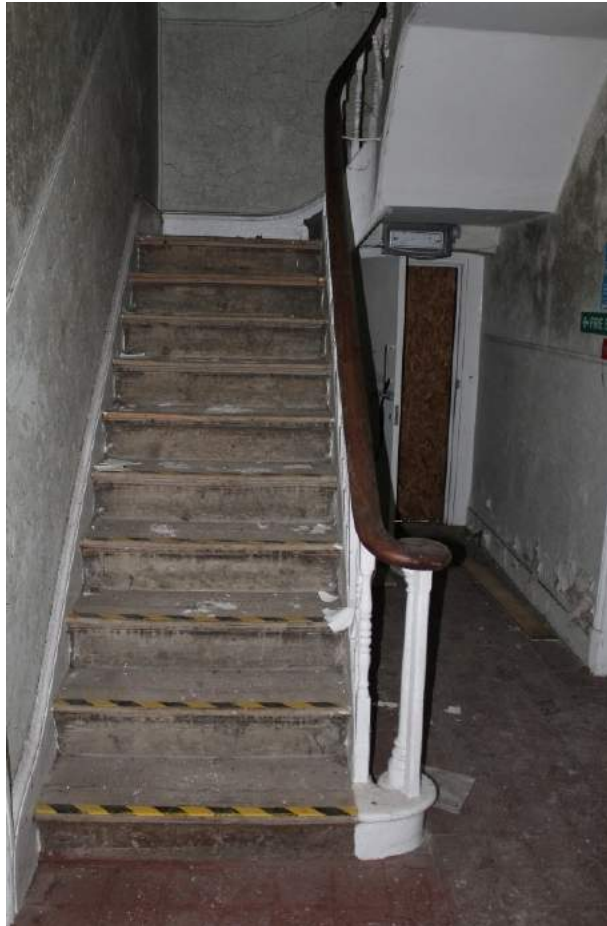
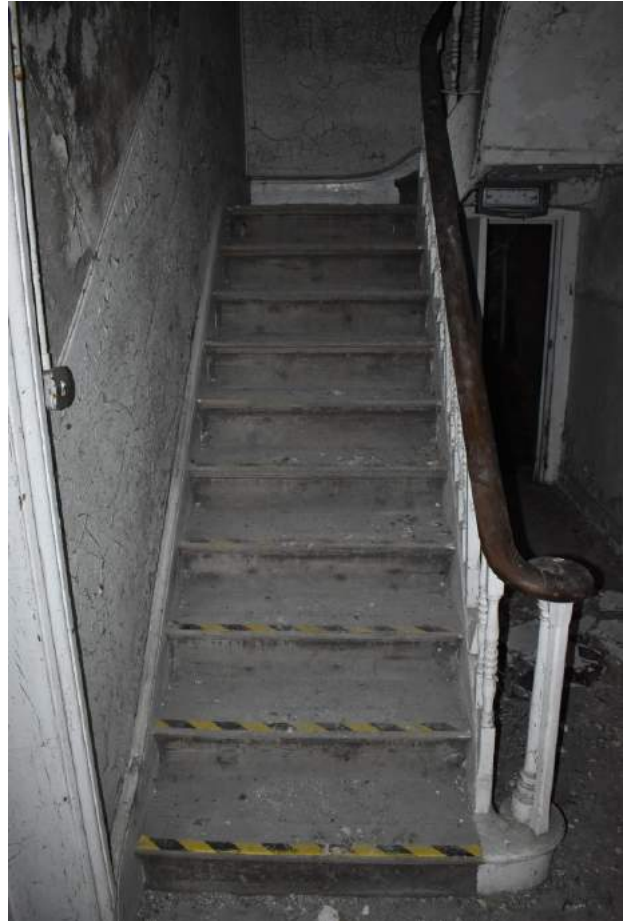
Plate 21 Stairwell v, the basement stairs with the same mahogany banister with spiral end and turned balusters as the staircases of the entrance ways – view north-west. Photo from November 2013 left, photo from December 2019 right.
