# Jankes Barn

Jankes Green, Wakes Colne

Building Record (Planning Condition 7)

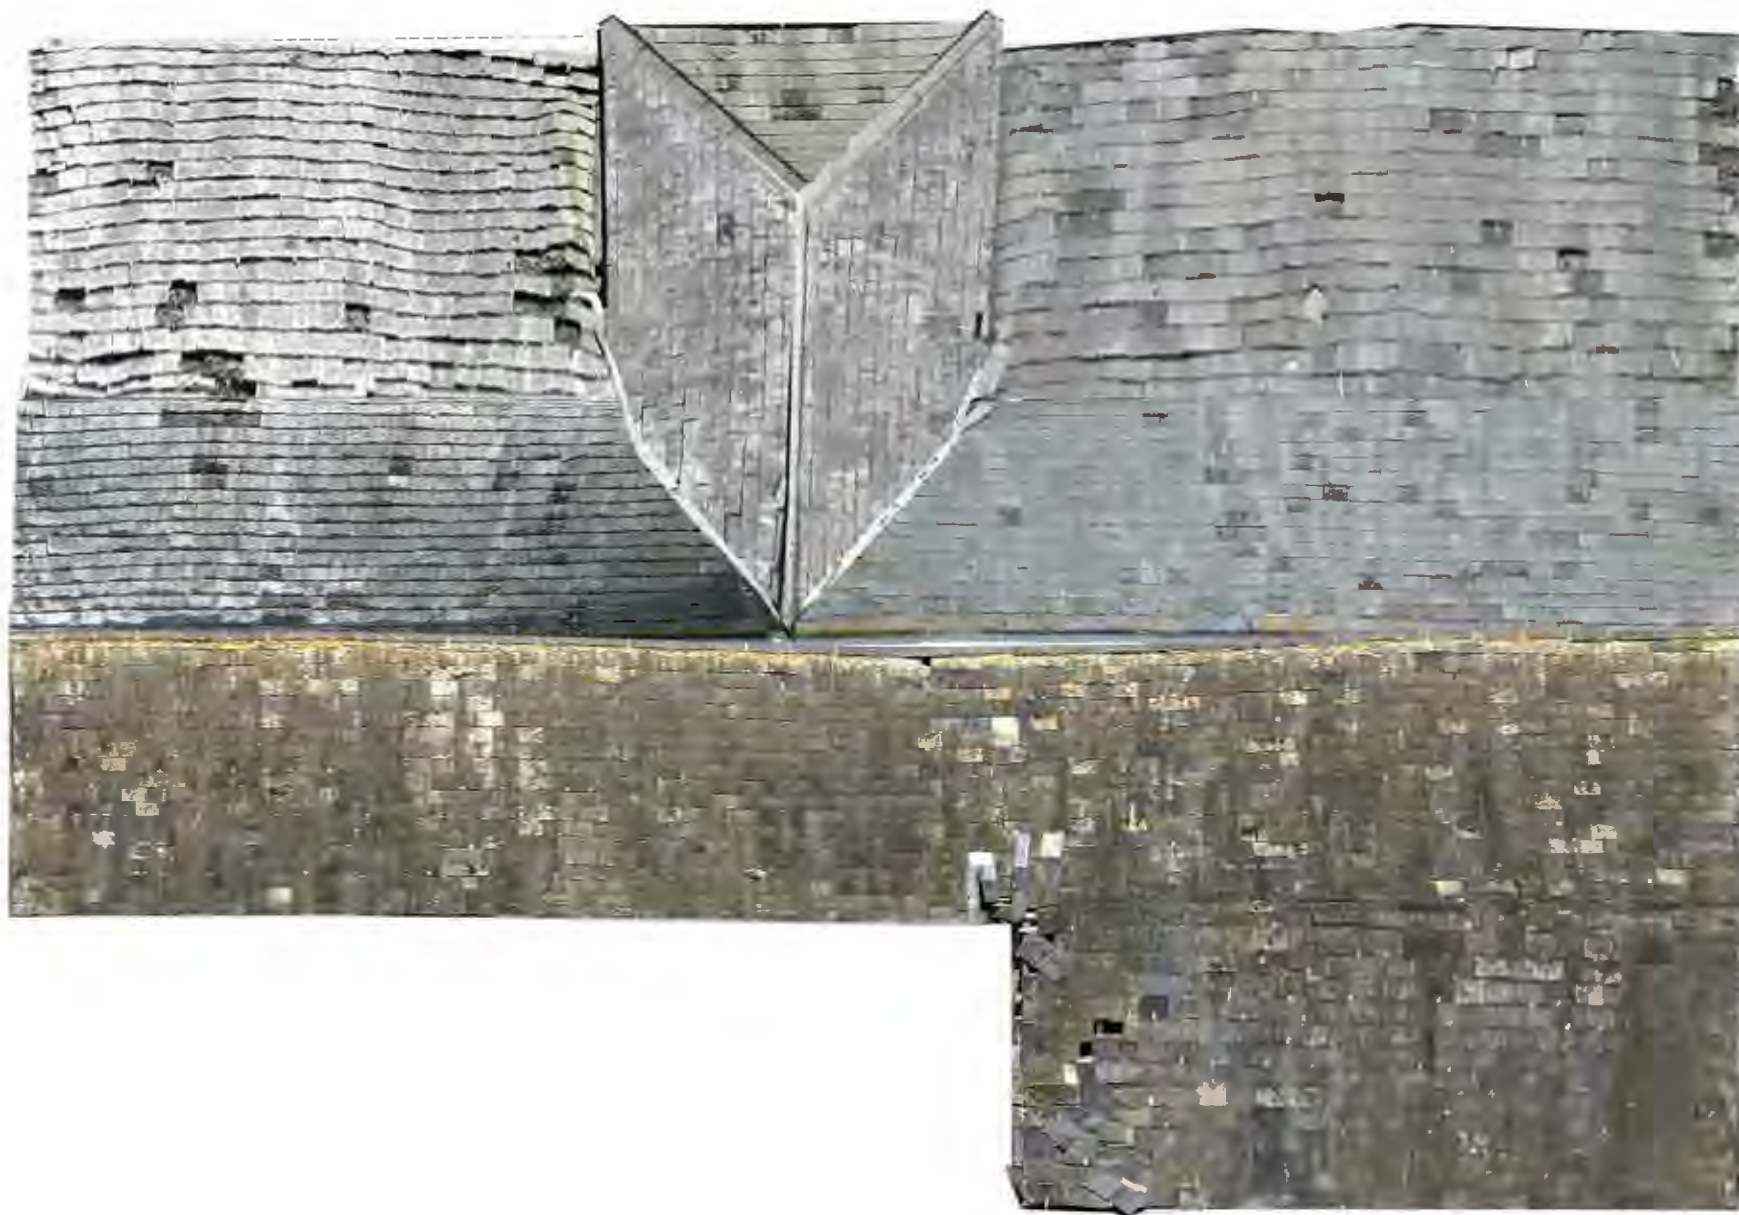
Roof composite showing condition of existing slates

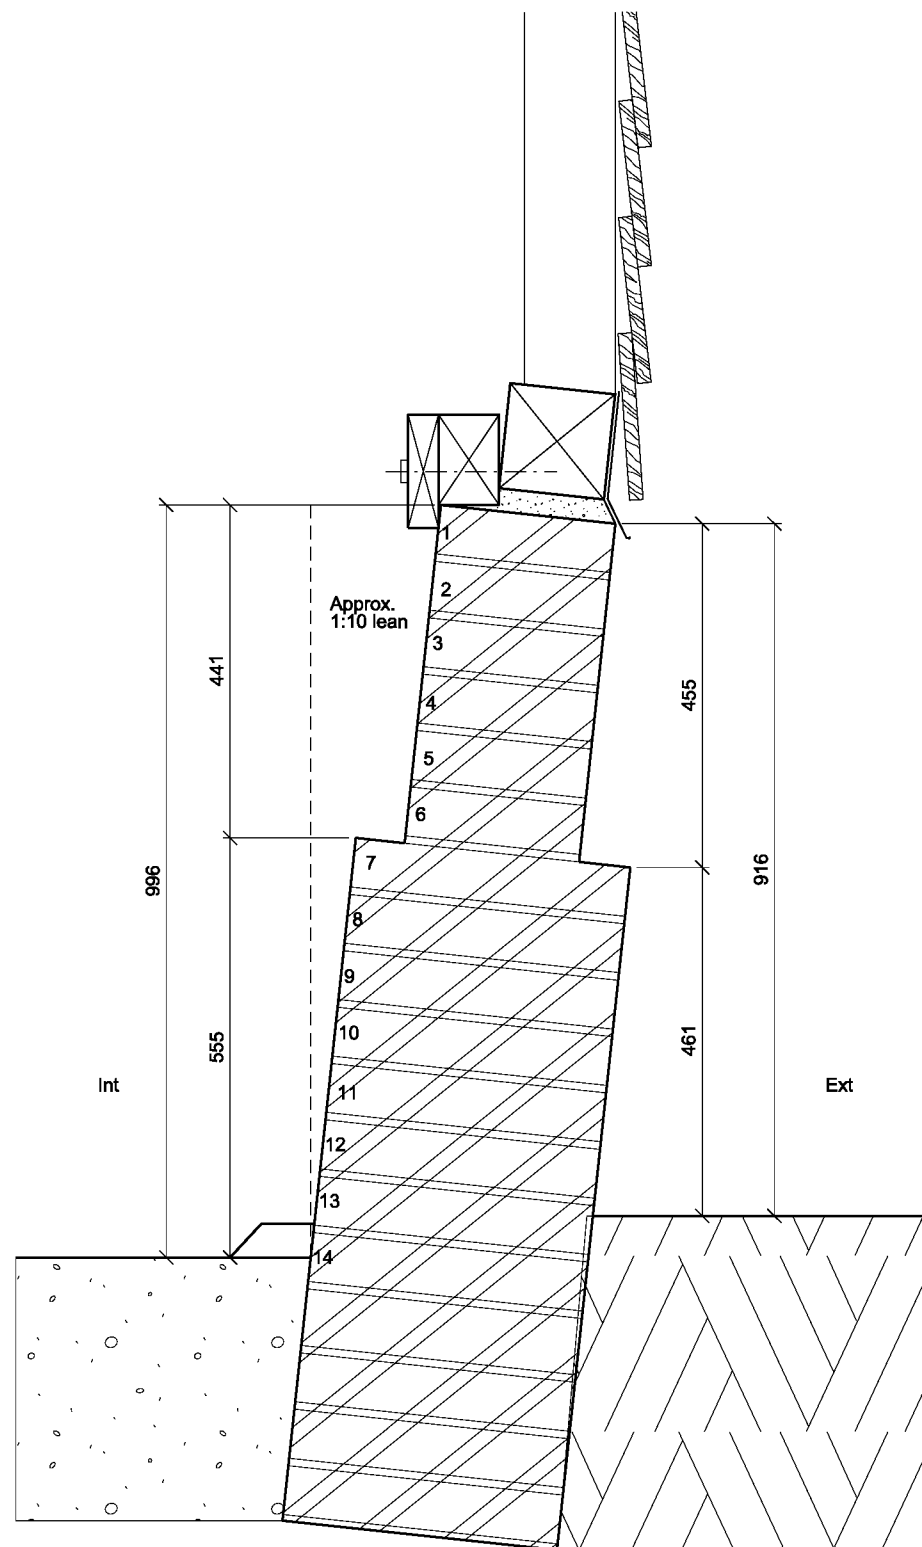
Plinth Section BB  
Existing

**Note: This section of wall is structurally unsound and needs to be rebuilt**

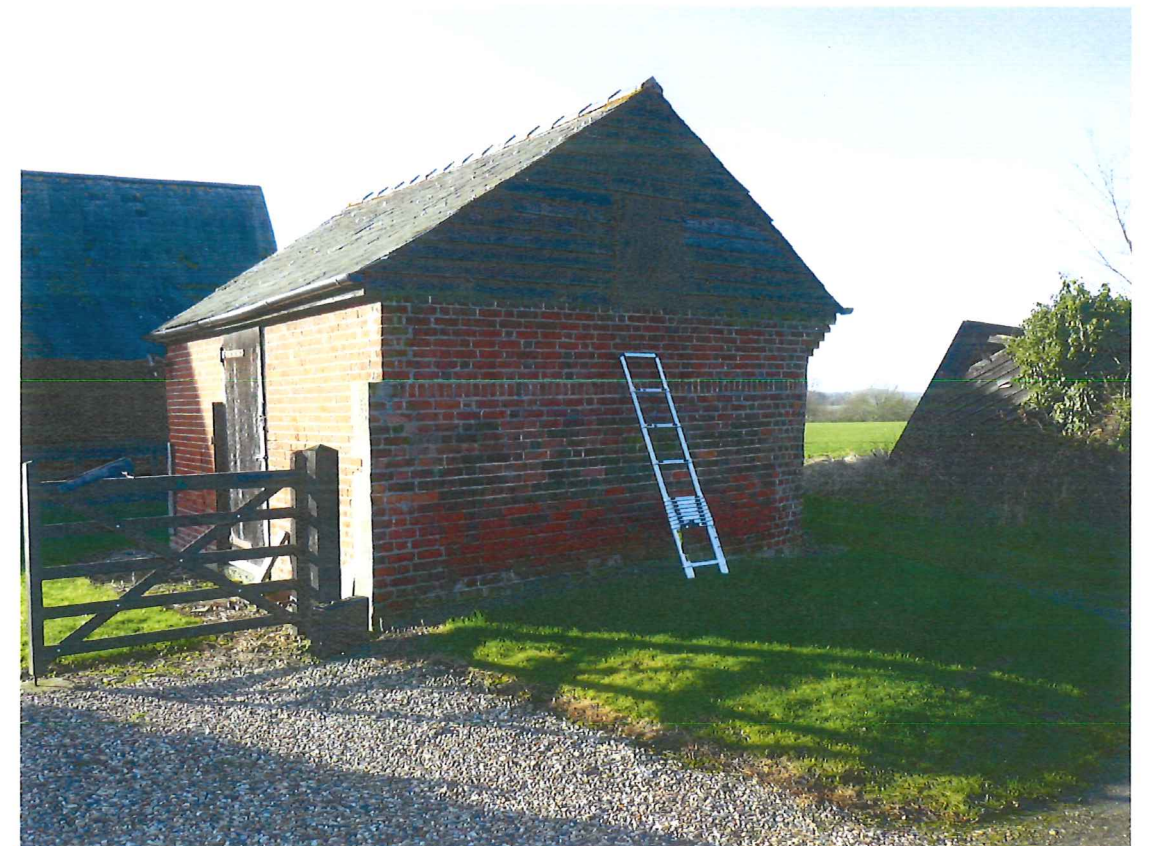
Photo 12  
Outbuilding – Front Elevation

The outbuilding roof structure is a conventional timber cut roof covered in tiles. The roof structure is slightly deflected but from the limited internal inspection carried out the roof lintels appear to be in satisfactory condition and most are suitable for reuse. Additional collars will need to be provided together with hangers and binders to support the overspanned ceiling joists.

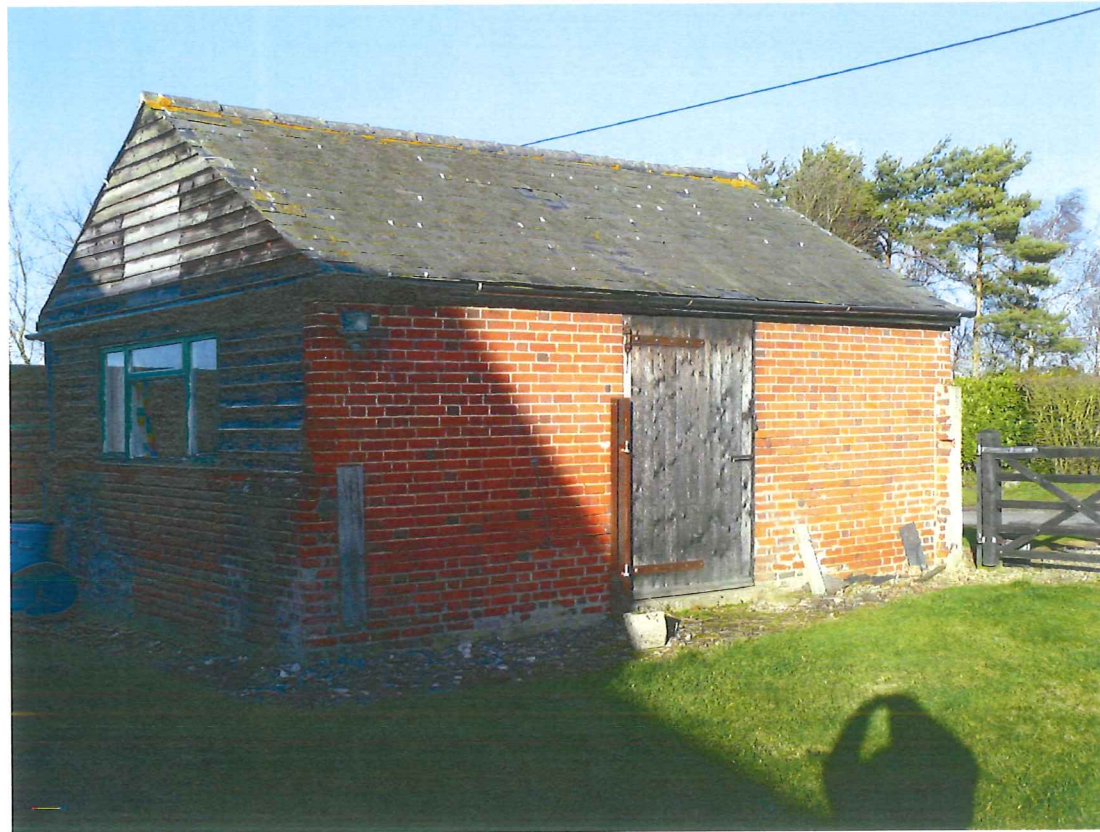
Photo 13  
Outbuilding – Left Elevation

The existing solid brick walls are not significantly distorted and are generally in satisfactory condition for reuse as are the timber framed gable walls, though some remedial works may be required to the sole plates when these are inspected in detail.

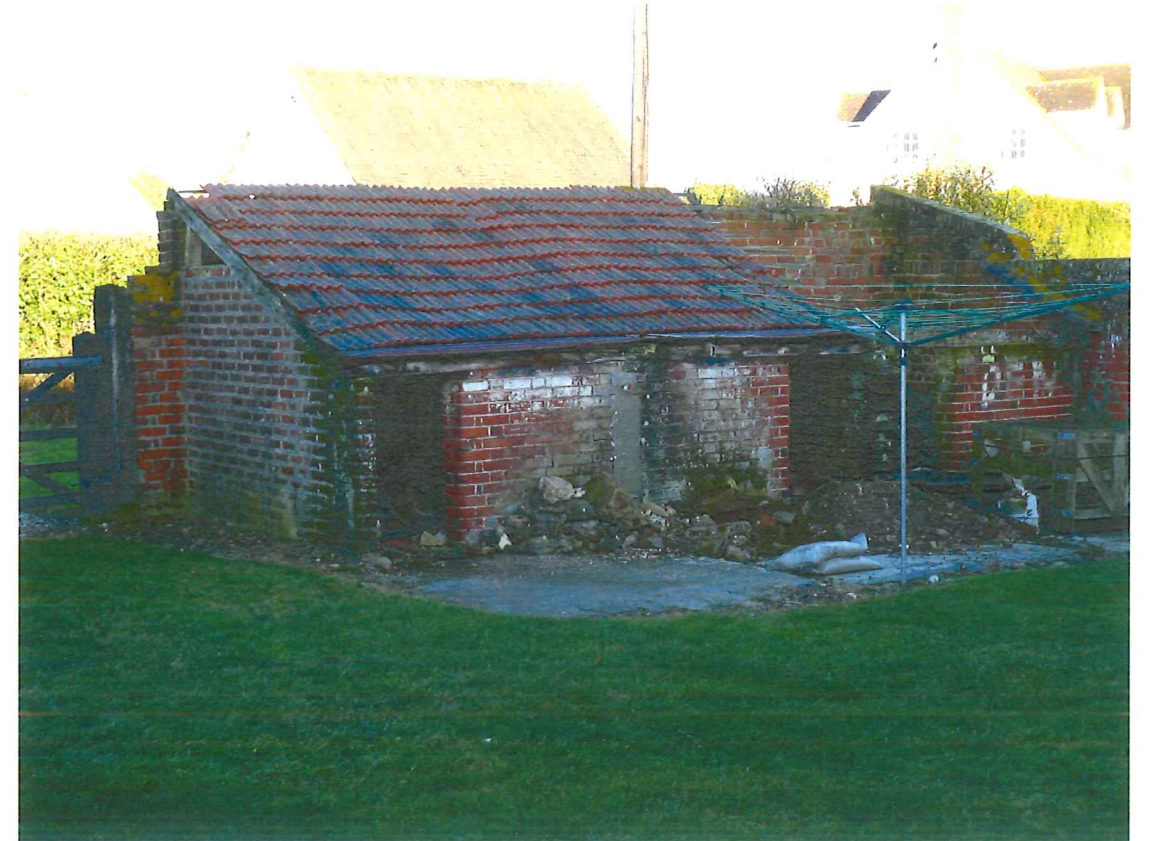
Picture 15  
Piggery - Rear Elevation

The former piggery is a single low height lean-to building and unsuitable for residential occupation. It can however be refurbished for storage use by replacement of the collapsed section of roof structure and sections of decayed wall plates, together with local repairs to deteriorated areas of brickwork.

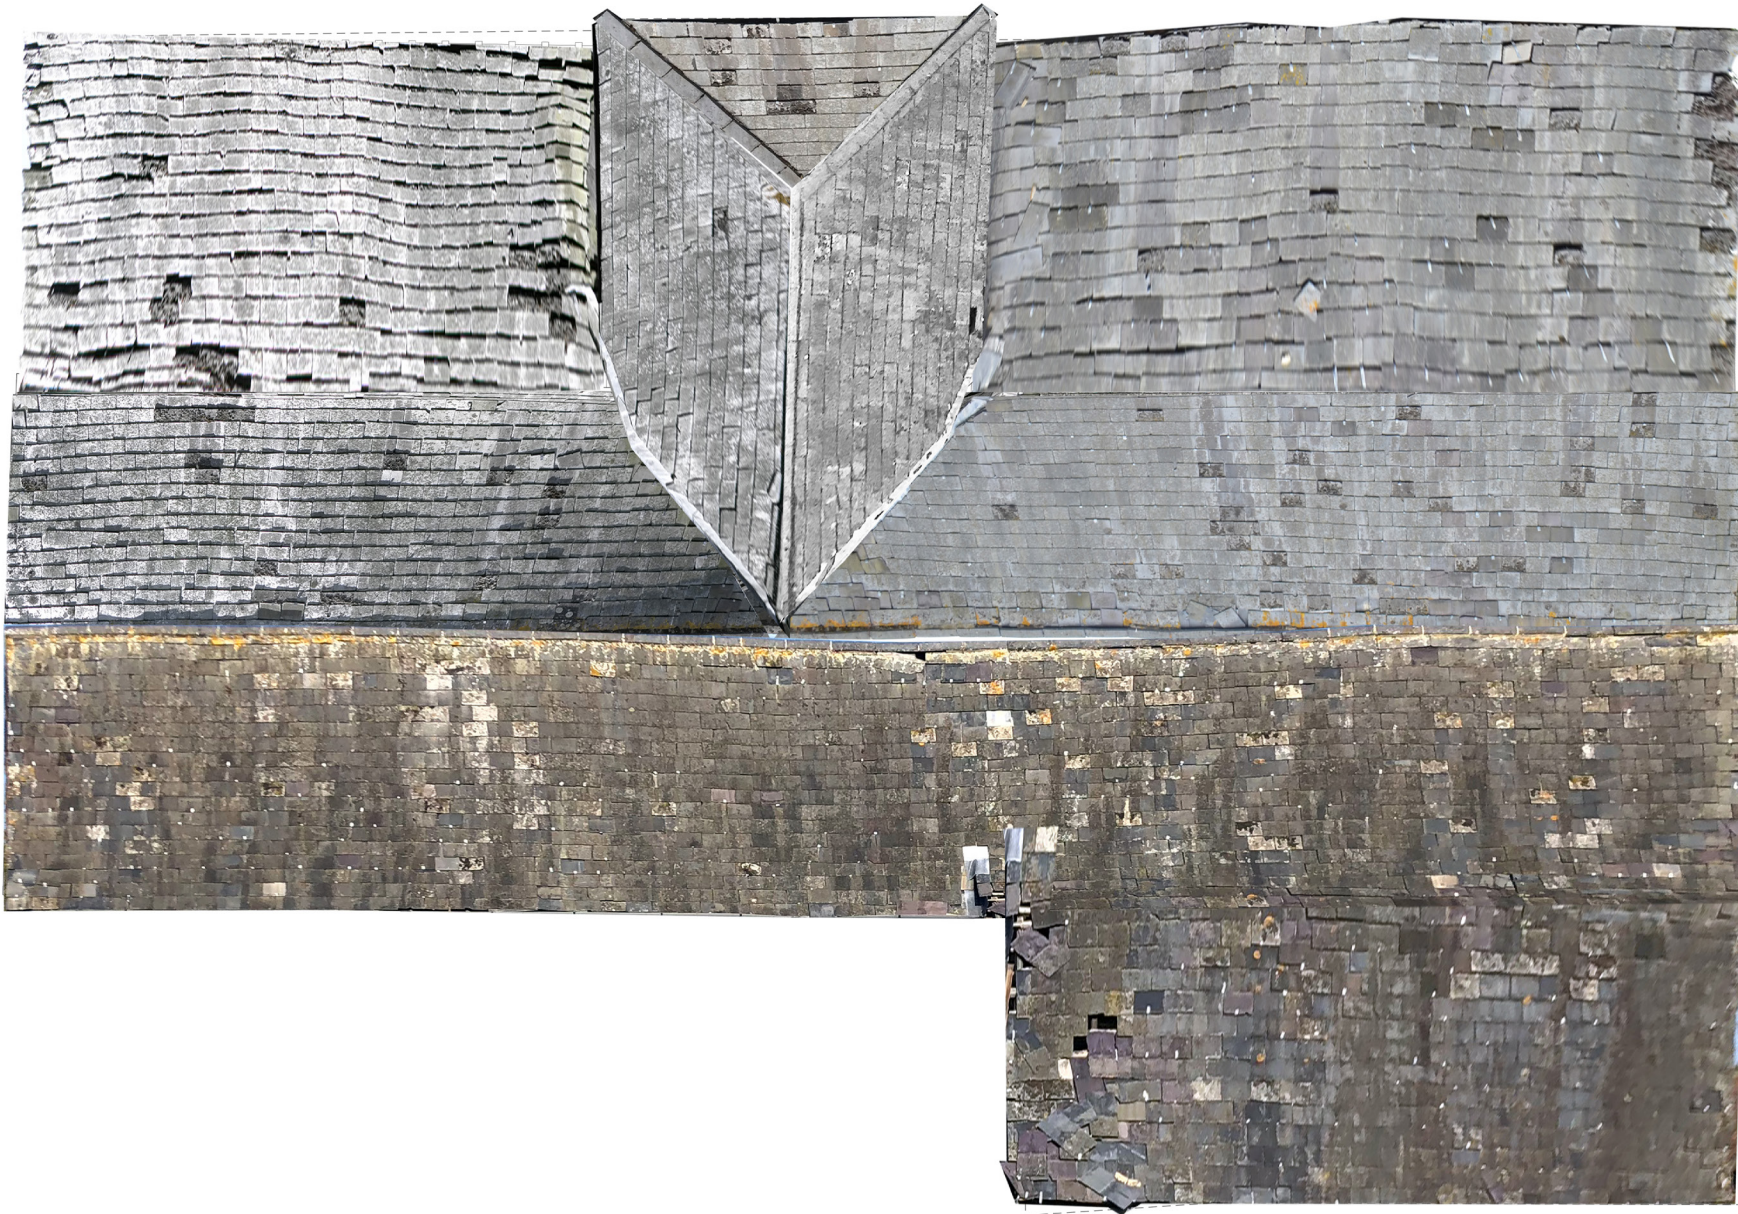
Roof composite showing condition of existing slates

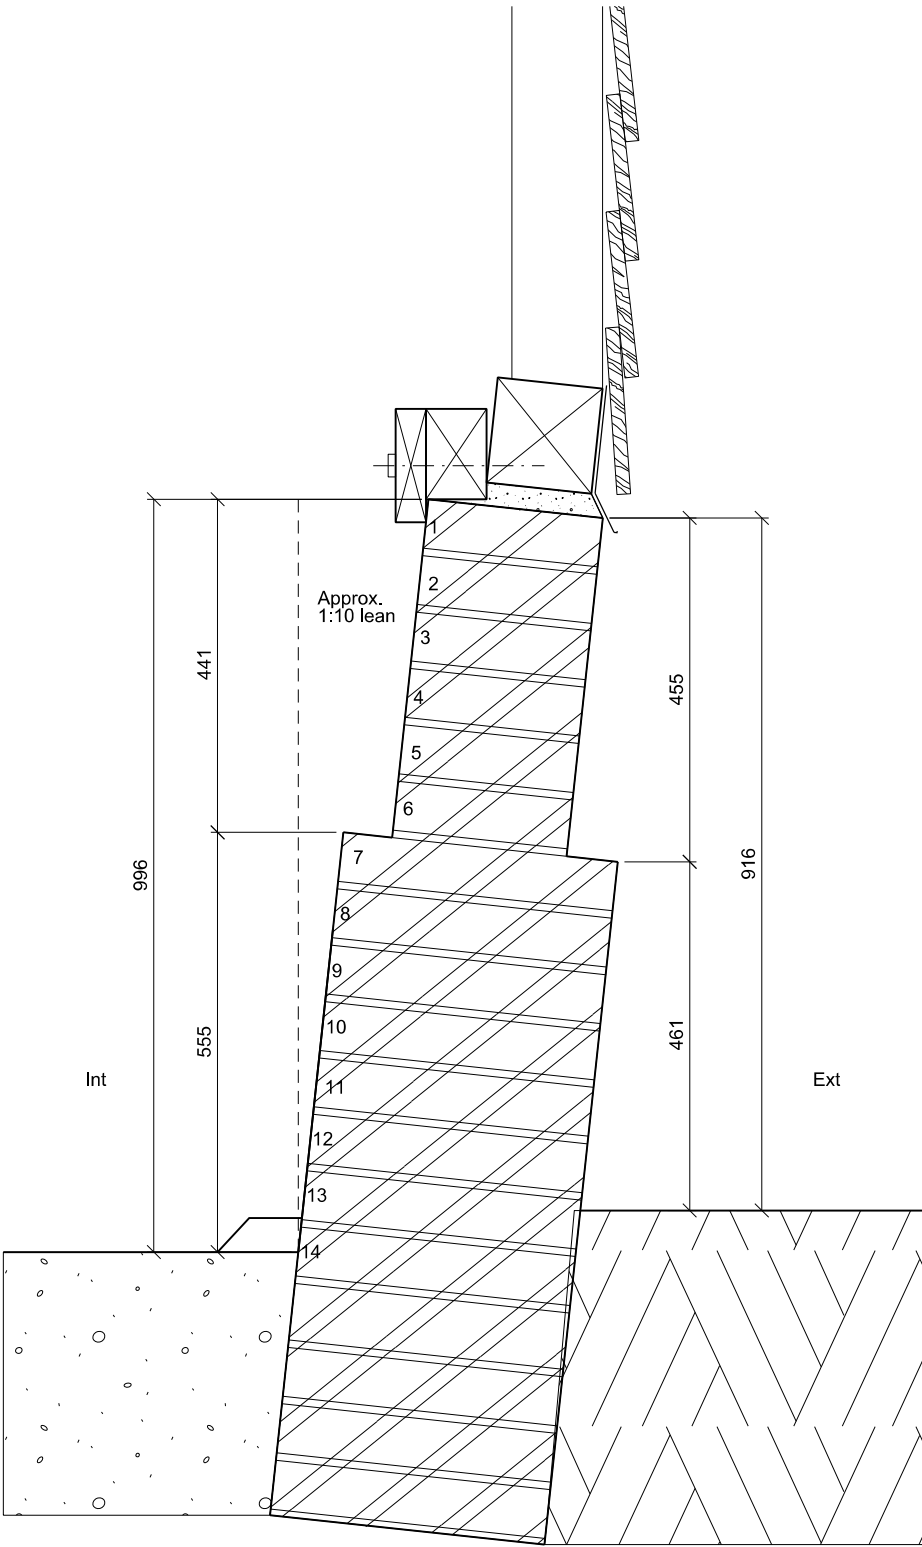
Plinth Section BB  
Existing  
*Note: This section of wall is structurally unsound and needs to be rebuilt*

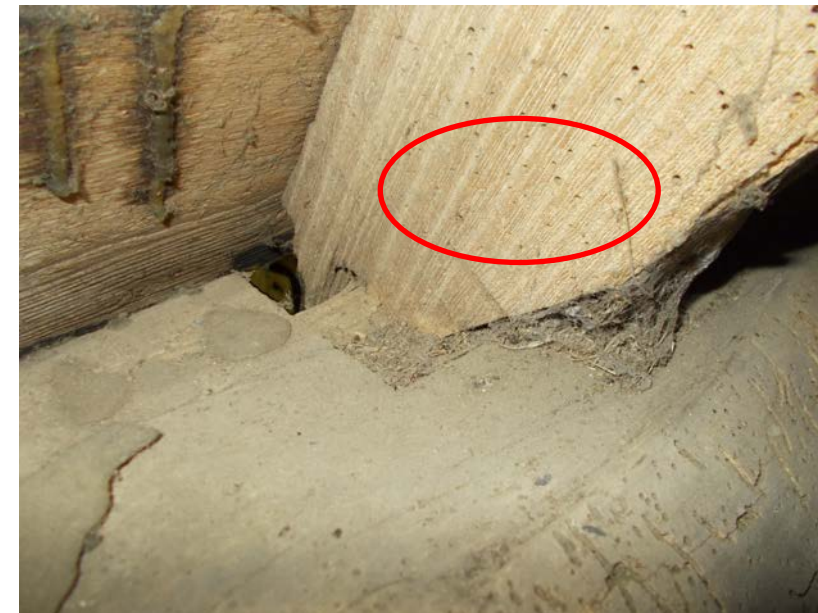
Fig 2:

Jankes barn; showing one of the rafters at the joint with the top plate. The nature of the grain on the rafter as well as the pattern of insect attack identified the timber as elm (*Ulmus minor*)

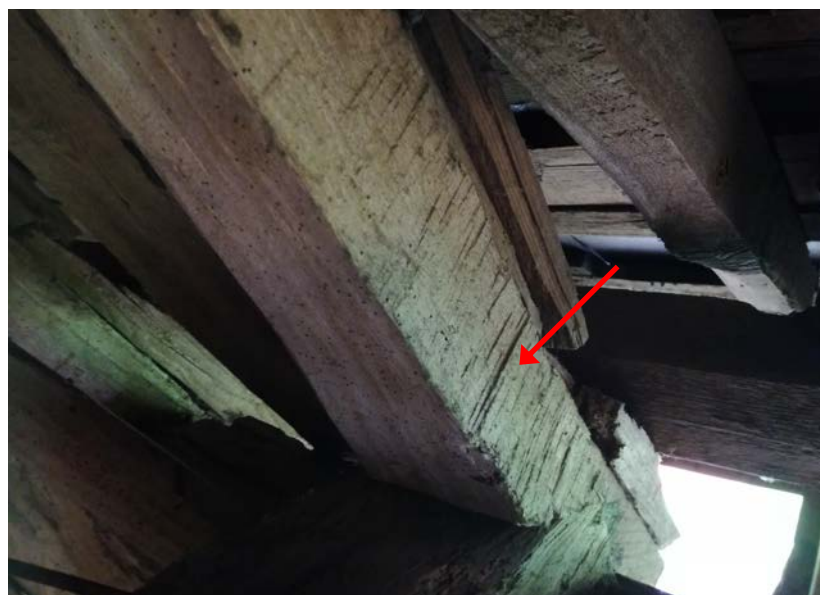
**Fig 3:**

Jankes barn; showing some conversion marks on one of the rafters on the north side. The marks are consistent with the hand-sawing action of pit sawn timber conversion

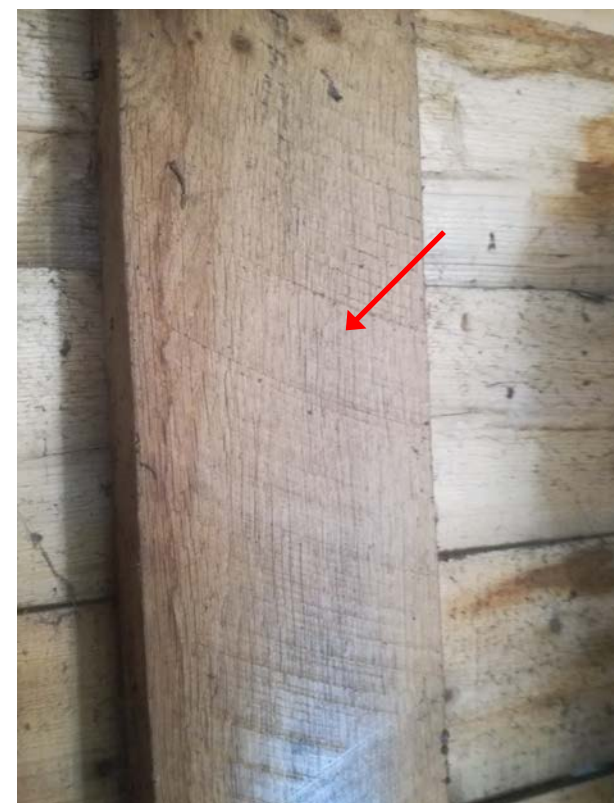
**Fig 5:**

Jankes barn; showing the clear marks left by a mechanised circular saw on an oak timber element in the west end of the barn

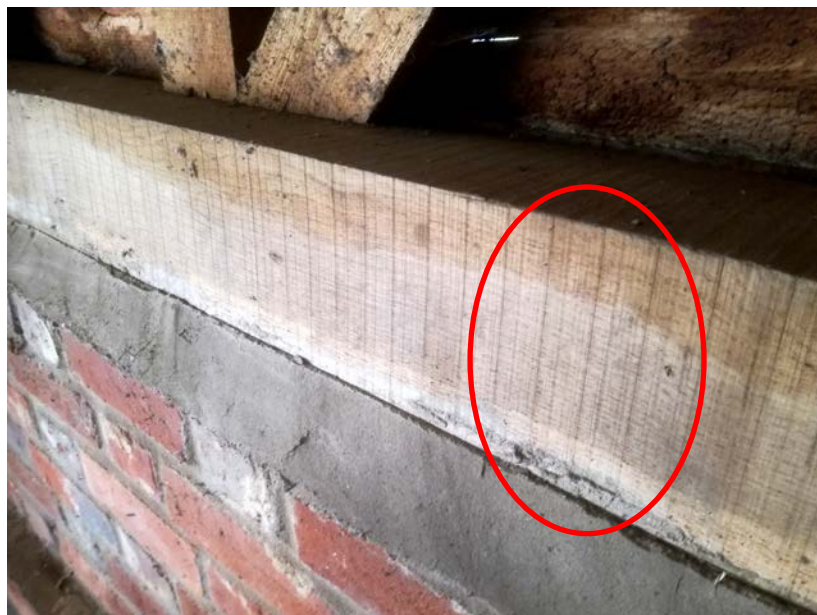
**Fig 7:**

Jankes barn; showing some of the mechanical bandsaw marks to the timbers comprising the rebuilt wall to the south-west. The strong vertical marks with fainter marks between are common marks caused when a mechanical bandsaw is very slightly misaligned

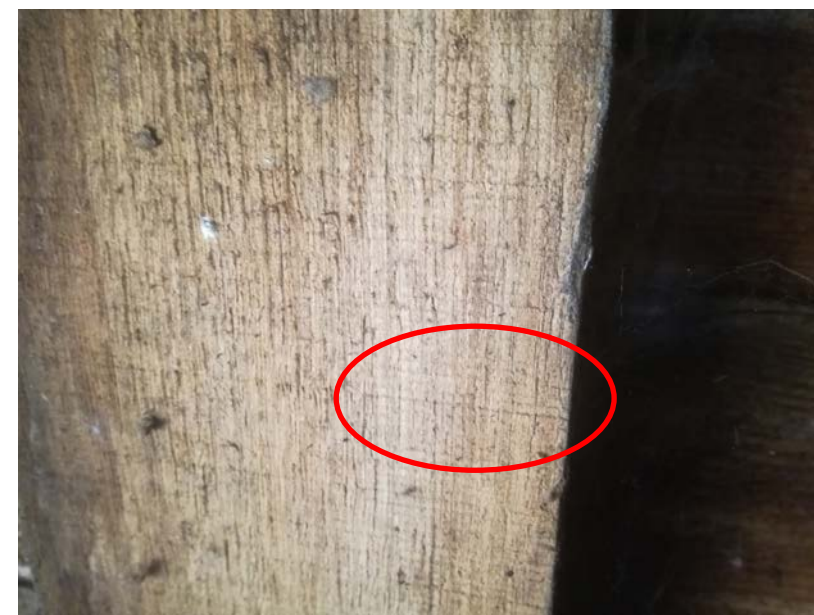
**Fig 9:**

Jankes barn; showing some horizontal marks on one of the timber studs. Very close together marks such as these are most commonly caused from use of a modern planer/thicknesser machine which shapes timber to the required section-size using a rotating cylindrical blade

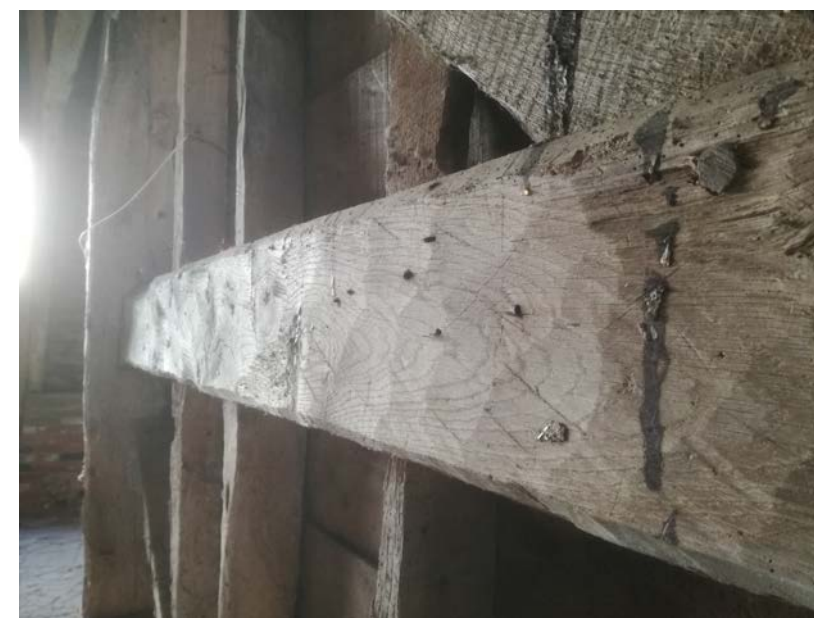
**Fig 10:**

Jankes barn; showing some very clear adze marks to one of the midstrey timbers

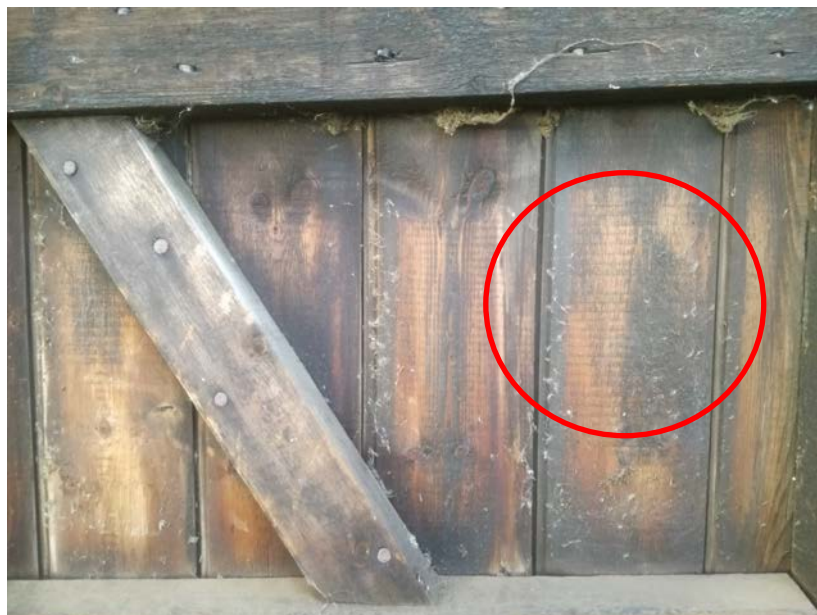
**Fig 11:**

Jankes barn; showing the south doors and the signs of modern machining marks to the boards suggesting they may not be as old as the remainder of the building and most likely date from the mid to late 20th century

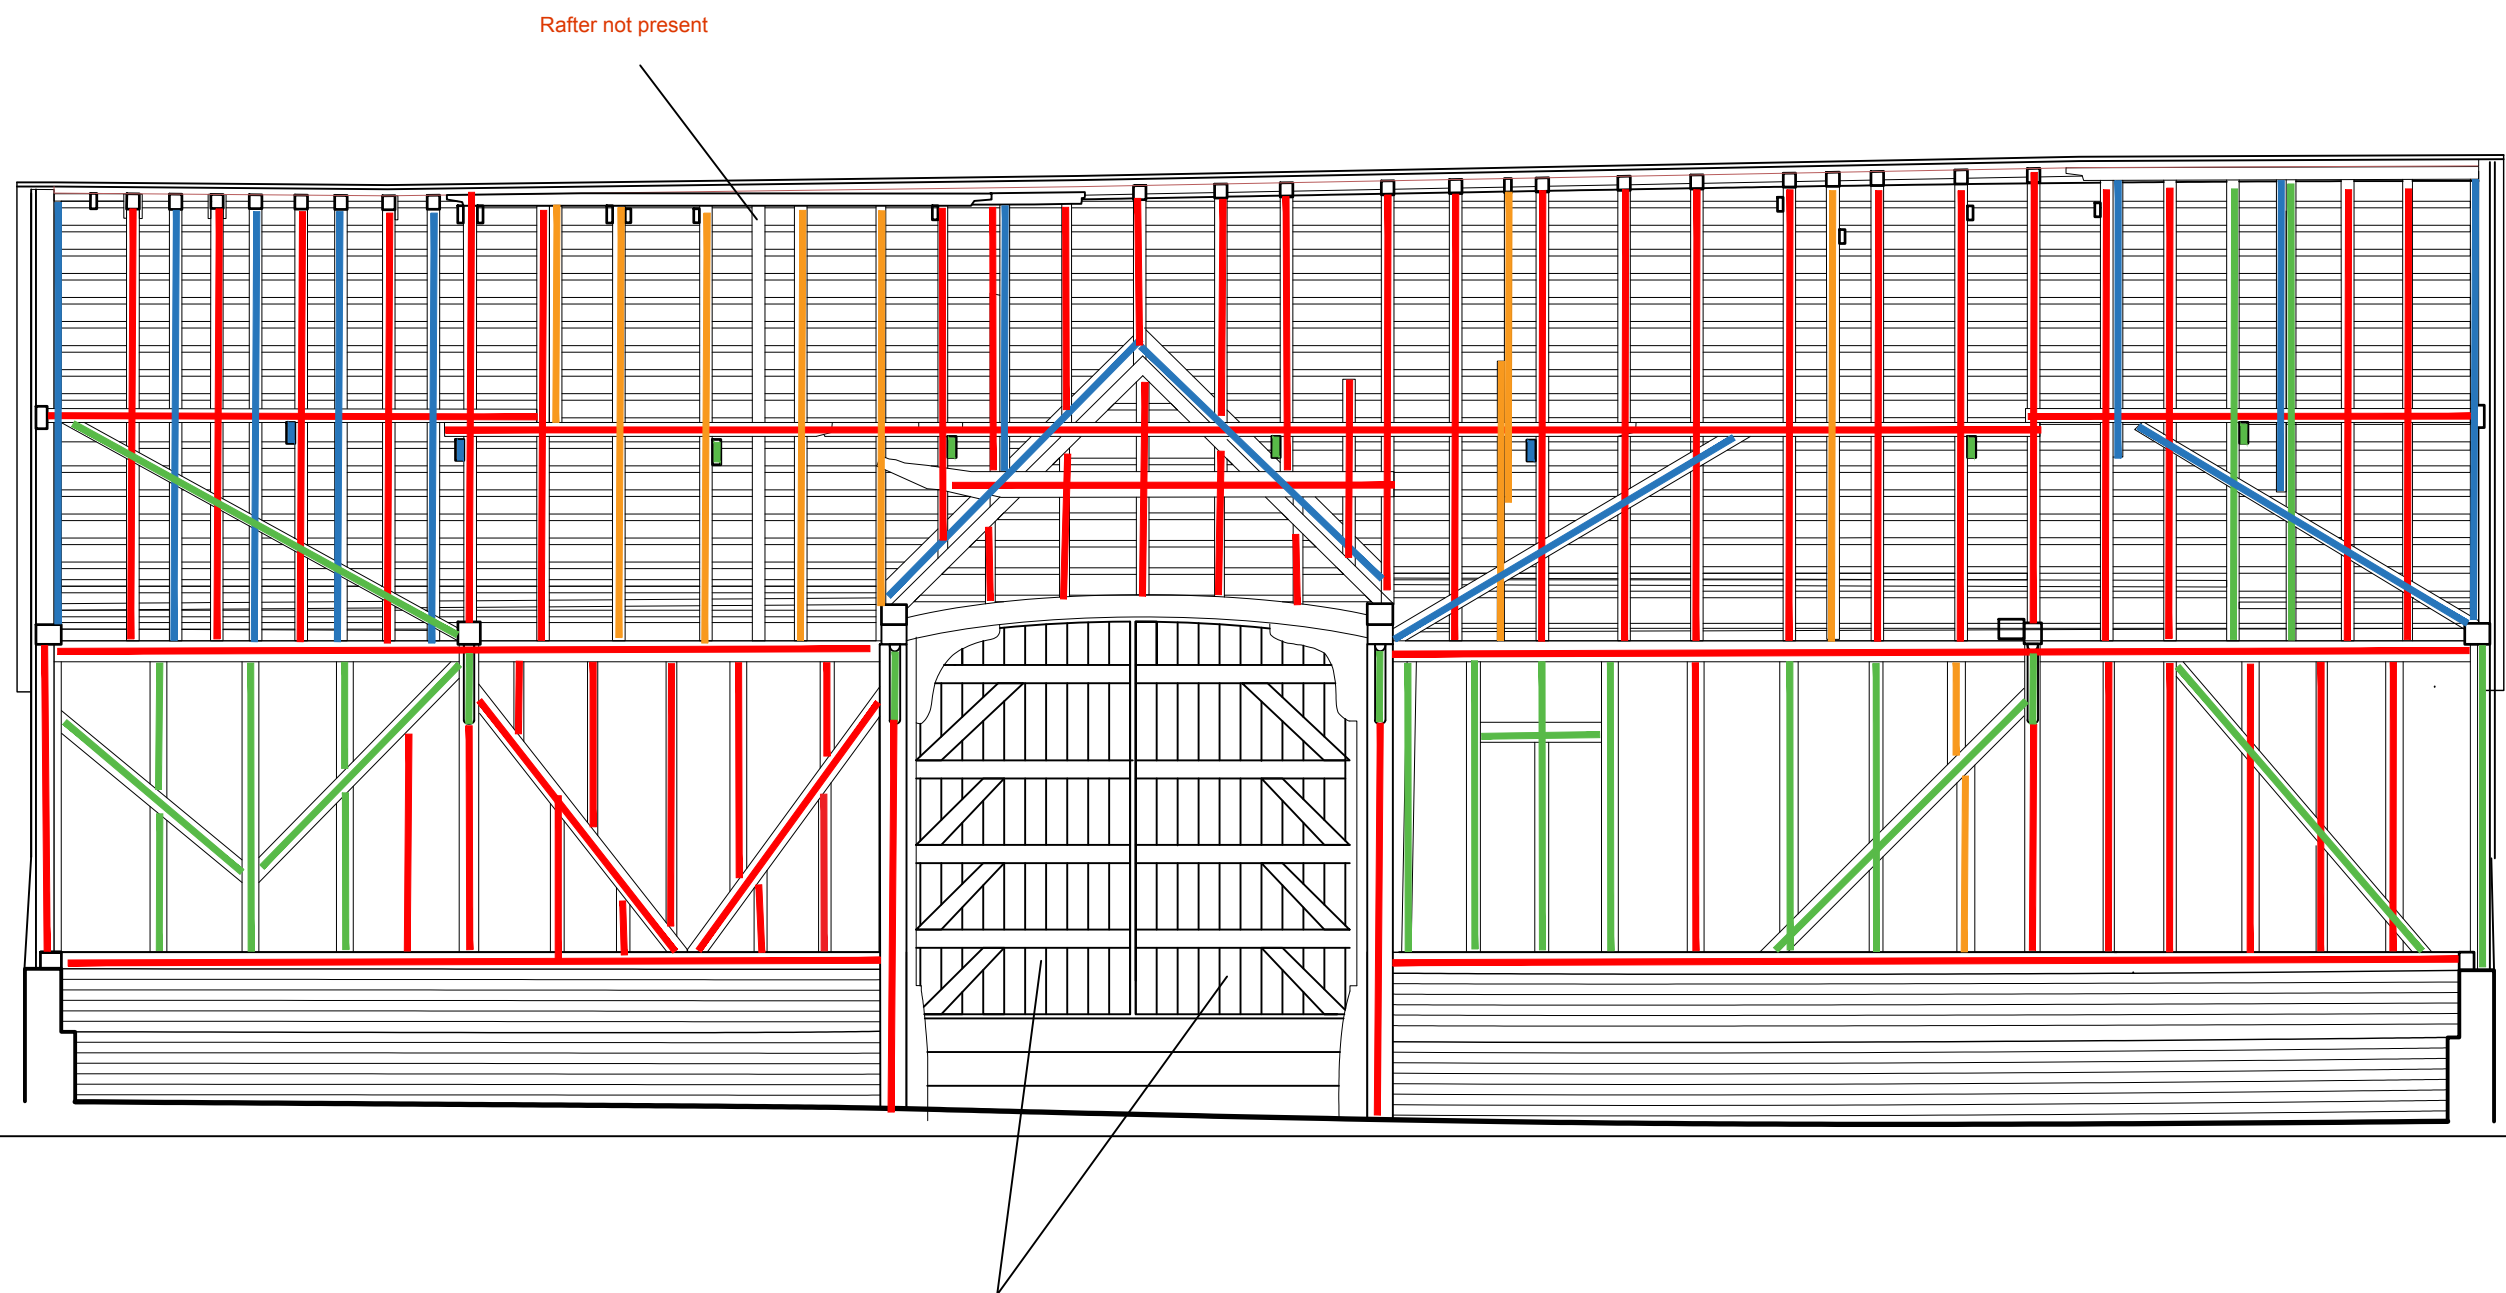
Door rails and braces were generally elm w/ modern softwood repairs and softwood T&G beaded boards

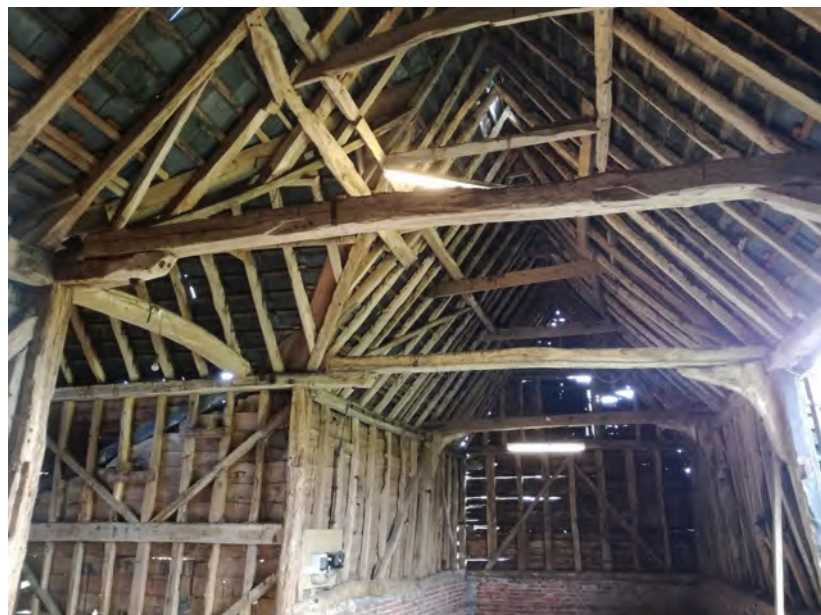
**Fig 1:**

Jankes barn, image in general looking east; showing the main barn is of 5 no. bays with an out-shot (or midstrey) to the north extending the original threshing area to the central bay. Timber elements were predominantly of oak and elm wood with some softwood repairs. Sill level sat upon a brick plinth and walls were of close stud framing

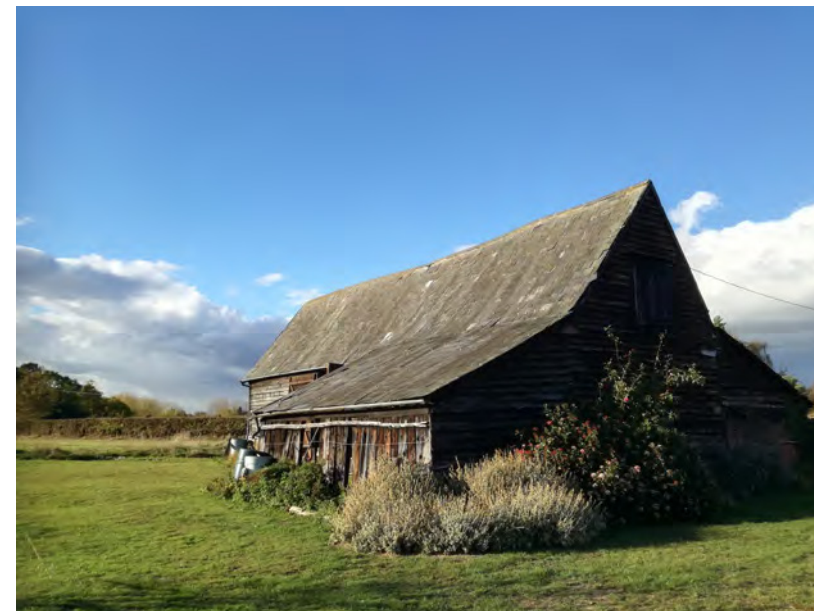
**Fig 3:**

Jankes barn; showing external image of structure from the south-east. Note the later addition catslide to the rear of the structure and the full gabled roof

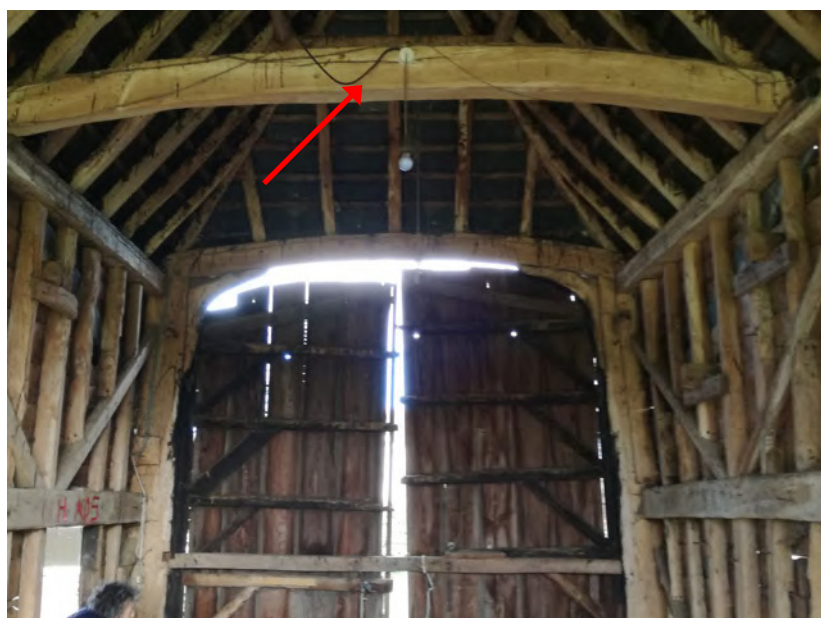
**Fig 2:**

Midstrey, looking north; showing hipped roof structure and additional arched elm tie beam giving further support to structure at centre of strey

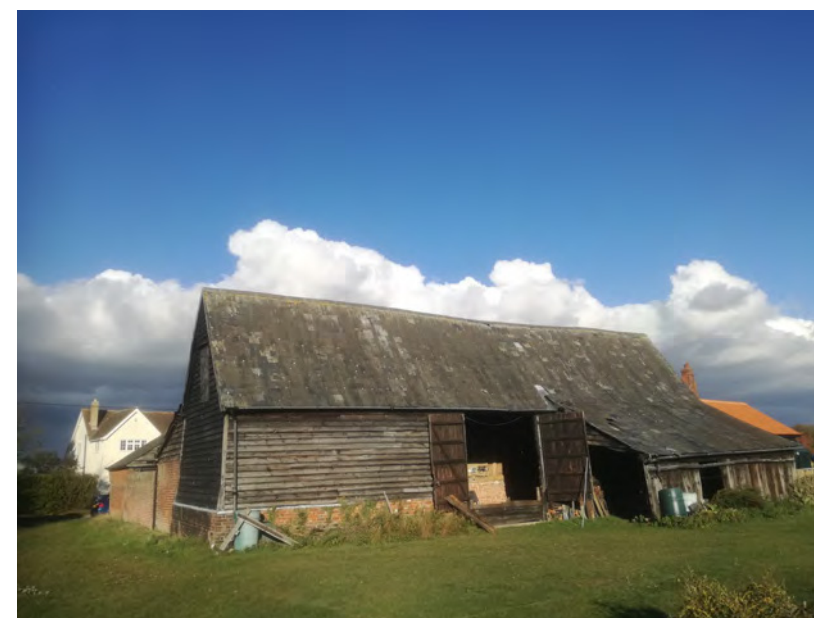
**Fig 4:**

Jankes barn; showing external image of structure from the south. Note full gabled construction with catslides to the north and south elevation

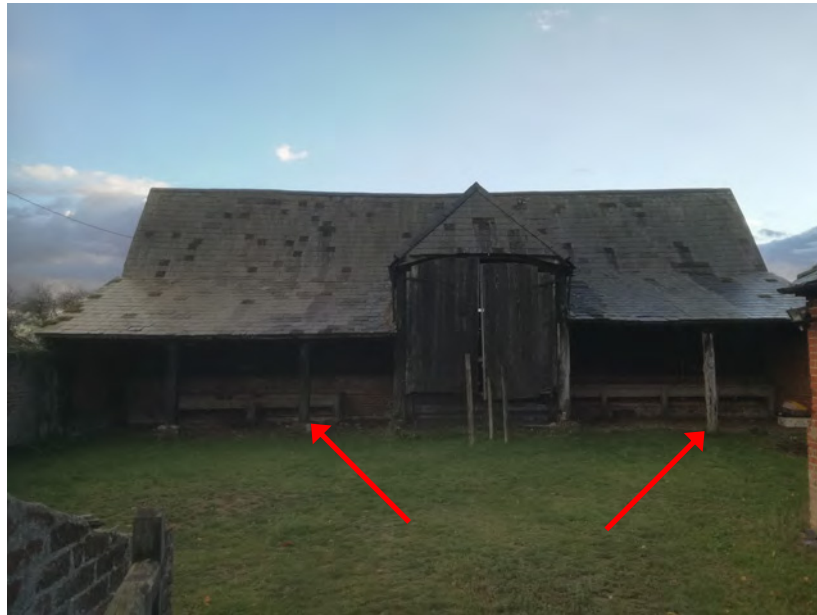
**Fig 5:**

Jankes barn; showing external image of structure from the north-east. Note open-sided catslides to east and west of central midstrey with an earth fast main post to the west and 2 no. main posts supported on brick plinths to the east

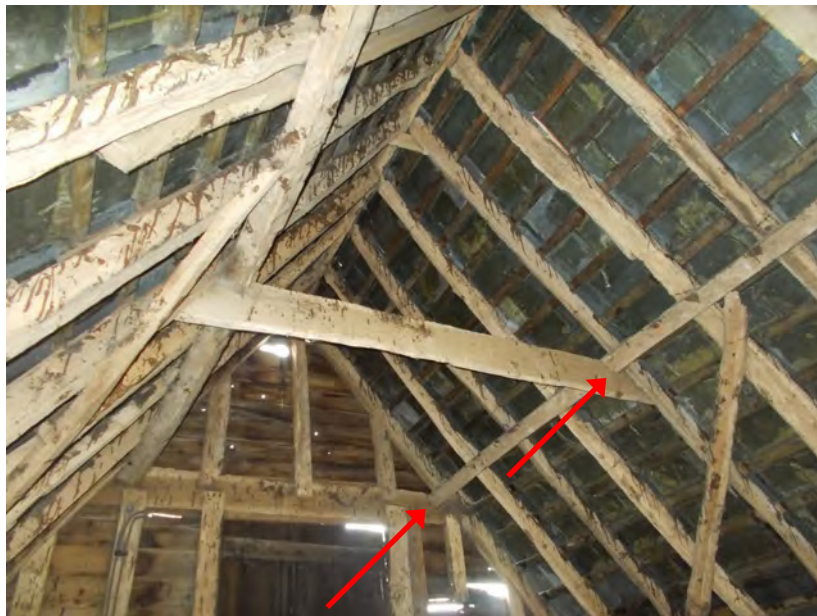
**Fig 7:**

Roof; looking west showing non-historic elm purlins along the south pitched roof supported by a non-historic softwood collar. Note also diagonal brace has broken away near its point of genesis

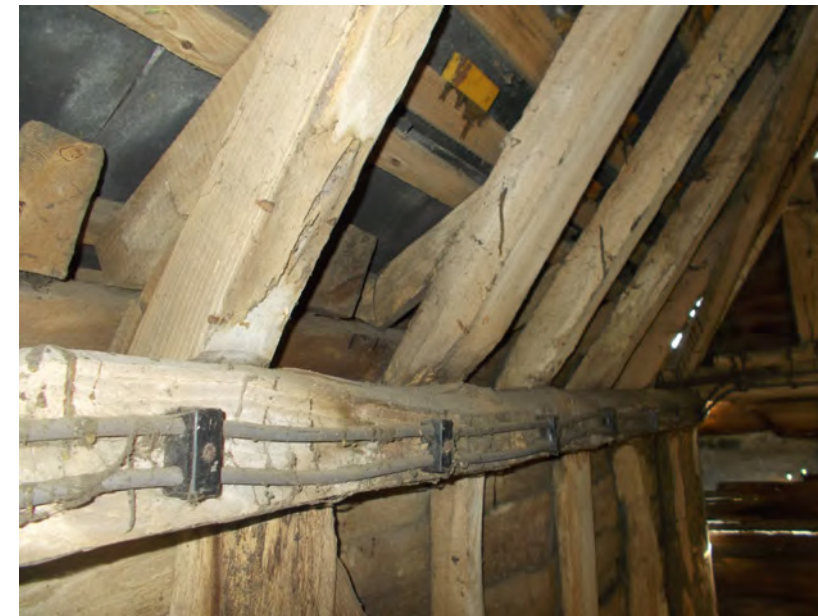
**Fig 6:**

Roof; showing east end. Note the 'clasped purlin' construction whereby the purlin is housed into the collar. Note the collars are supported at the gable ends via the lower studs however, the remainder of the collars within the roof structure are self supporting. Note there has been a softwood ridge board inserted between the historic rafters within this bay

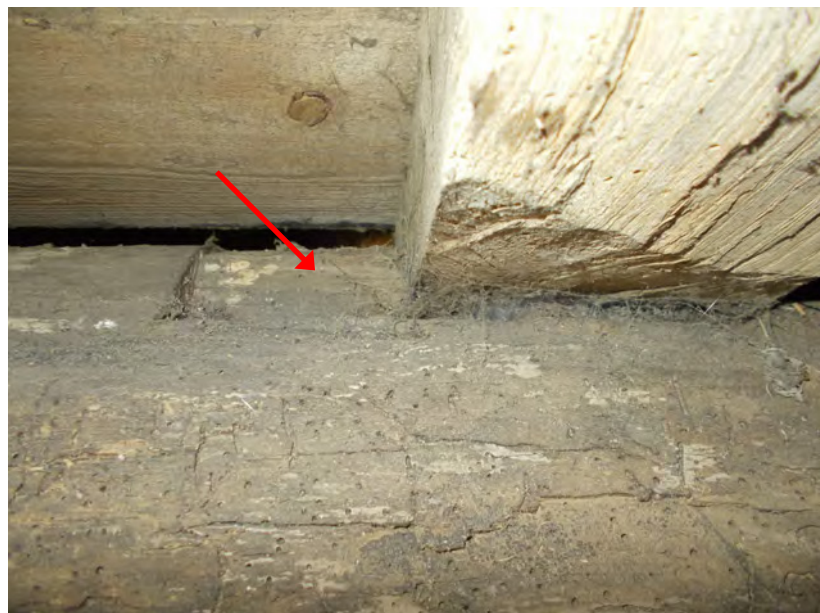
**Fig 9:**

Roof; showing where a rafter foot meets the rafter plate. Note the 'scotched' housing is deliberately oversized as a likely result of speeding up production by pre-cutting the scotches

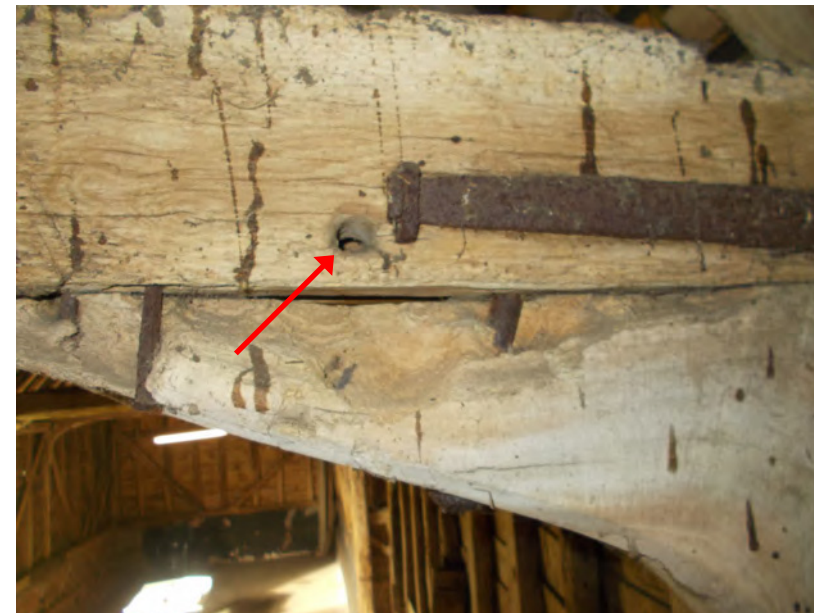
**Fig 11:**

Roof; showing Truss 2 north end. Note the peg has failed within the joint for the knee. Effort should be made in locations such as these to remove the broken section of peg and re-fasten with a fresh oak peg (3/4" in diameter) in order to pull the shoulders tight once more

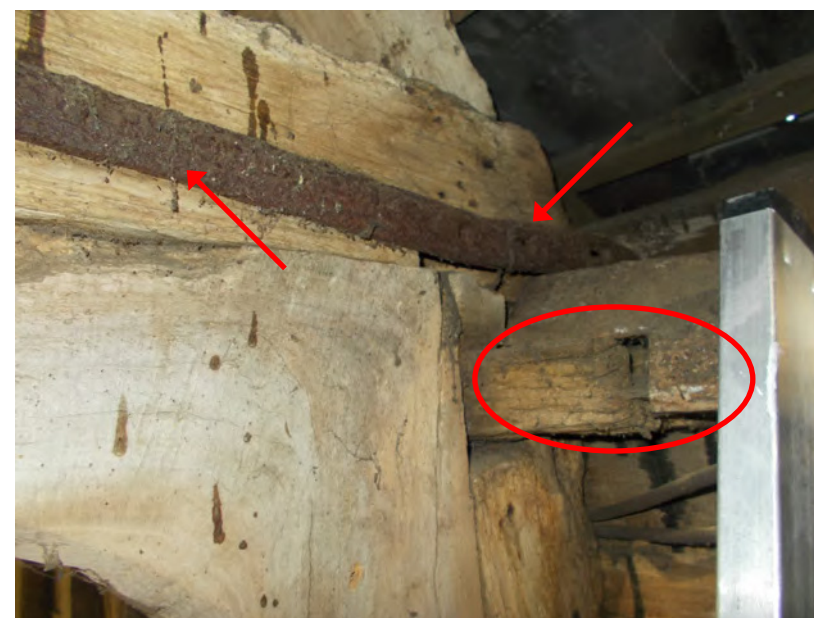
**Fig 12:**

Roof; showing joint between knee, tie beam, main post and rafter plate to form the north end of truss 2. Note partial failure to the rafter plate lap joint. Also note an old carriage wheel hoop iron has been used as remedial strapping for the tie beam. This is distinguishable from its curved edges from wear during use and the evenly spaced square fixing holes 'hot punched' into the iron at even intervals
