# Jankes Barn

Jankes Green, Wakes Colne

Building Record (Planning Condition 7)

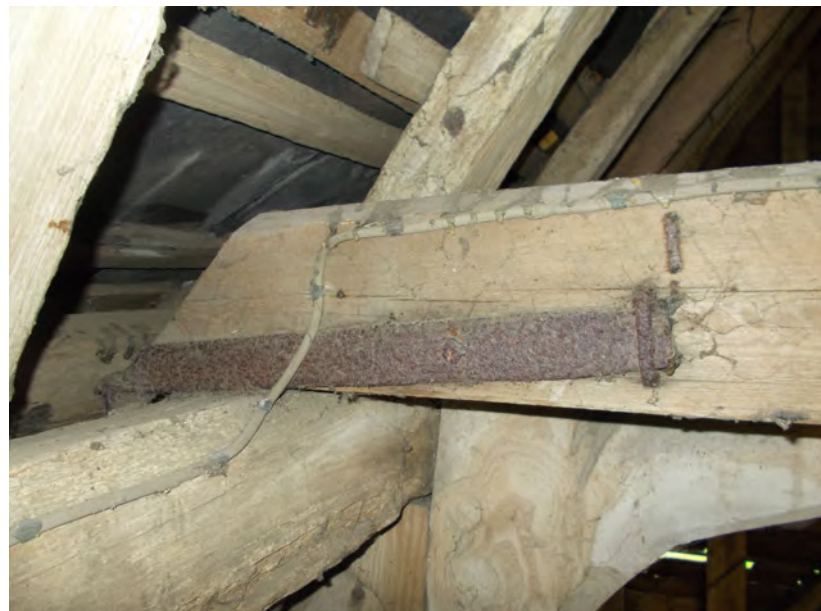
**Fig 13:**

Roof; showing truss 3 with non-original softwood tie beam coupled alongside historic member and retained with metal strapping

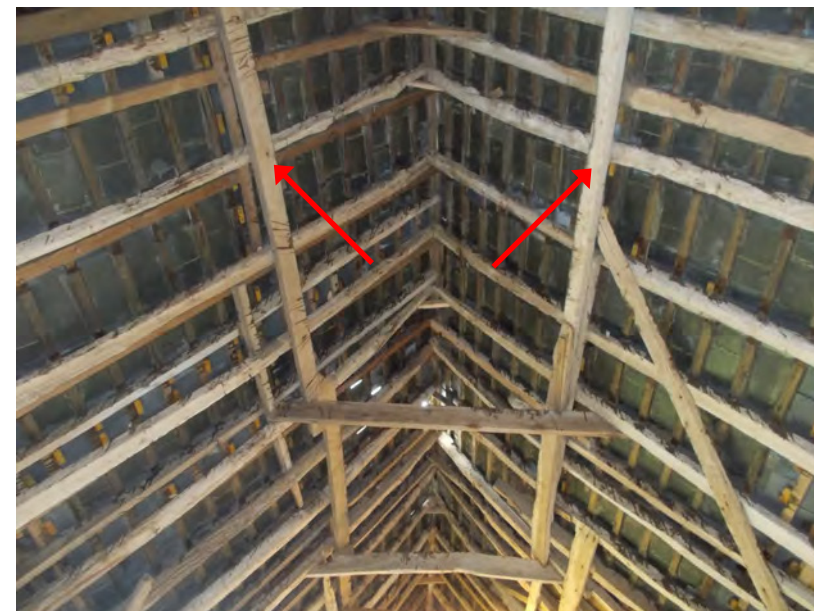
**Fig 15:**

Roof; showing roof structure. Note historic collars to the north (right side), and non-historic elm purlins to the south. Also note the common rafters are lapped and pegged together to form the ridge apex in this area

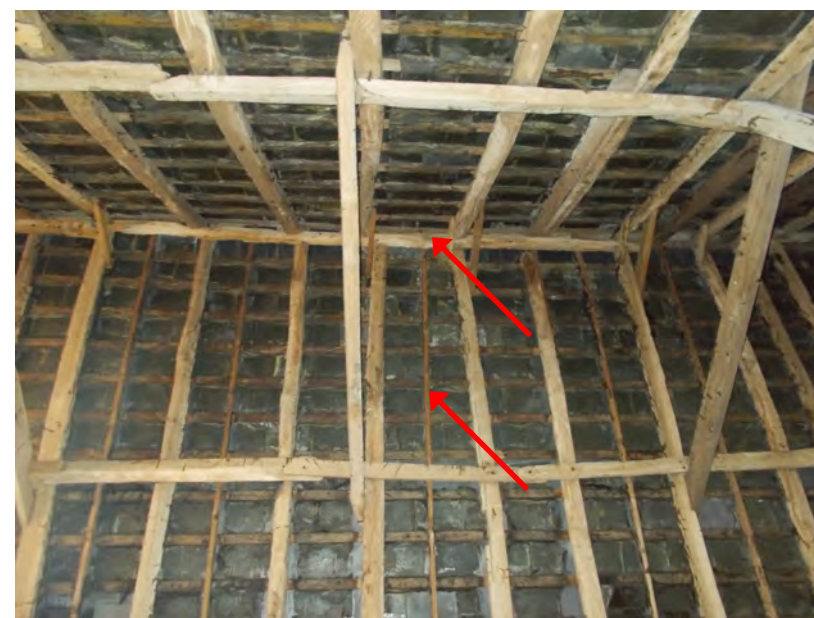
**Fig 16:**

Roof; showing south-west area of roof. Note how tile battens have been used inappropriately for mid-span common rafters between historic common rafters. Also note a ridge board has been introduced in this area

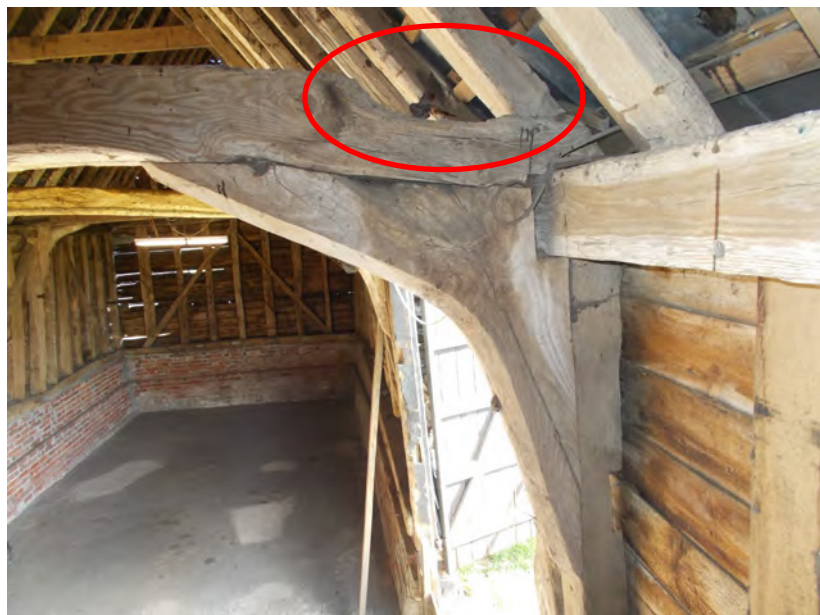
**Fig 17:**

Roof; showing truss 4 north end. Note how all of the sapwood to the back of the tie beam has been historically removed before the bolt was put in position to retain the knee. This was a common measure by historic carpenters as they would have known that sapwood is vulnerable to wood boring insect and subsequent decay

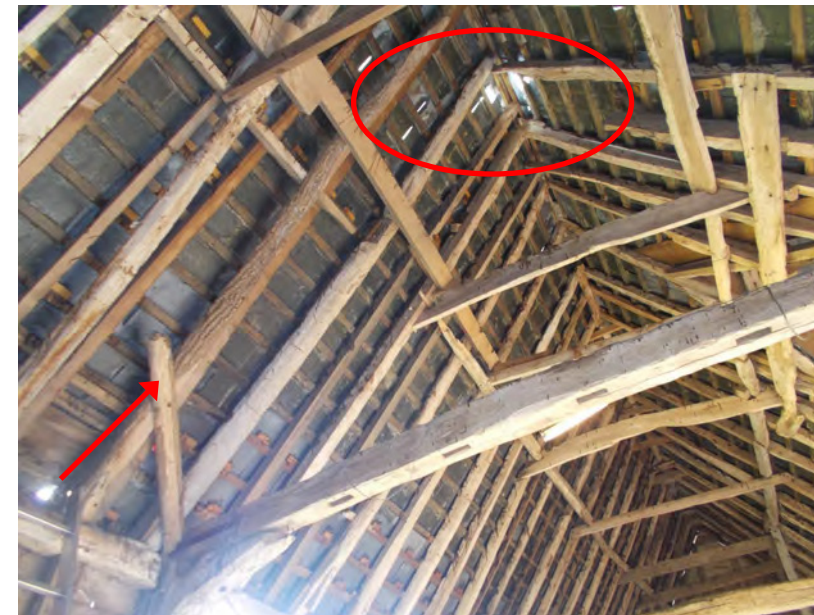
**Fig 19:**

Roof; showing roof structure with failed tiles at ridge level. Moisture is being allowed to penetrate the structure at this location potentially providing the conditions for damp and decay to the elements below. Also note broken wind brace to south pitch roof showing signs of active wood boring insect attack

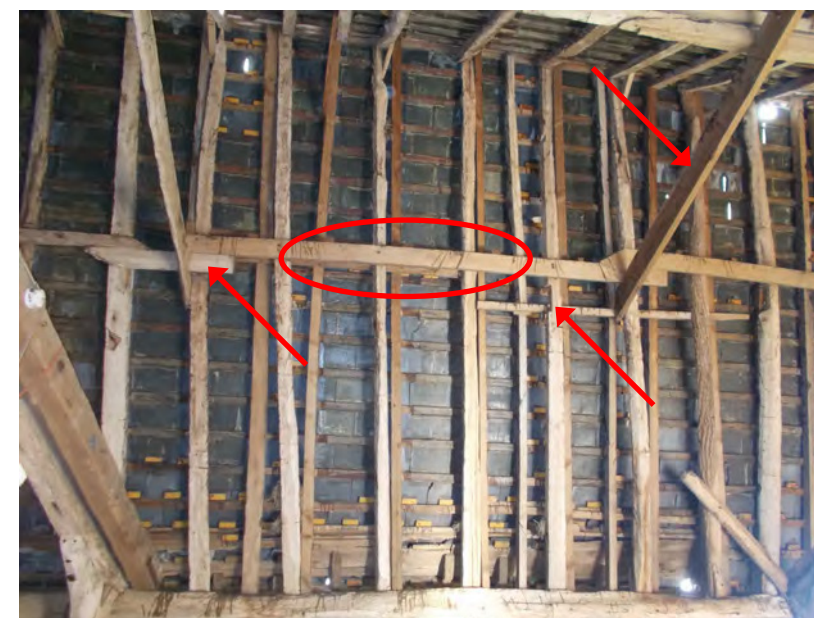
**Fig 20:**

Roof; showing bay 2 roof structure. Note how the historic purlin at truss 2 has been cut short but is still supporting the replacement elm purlins. Also note the right purlin in the image is non-historic and would have originally been further east to support the original purlin joint locations. Potentially historic timber locations could be re-introduced in this location and remedial efforts removed subject to approval from the conservation officer

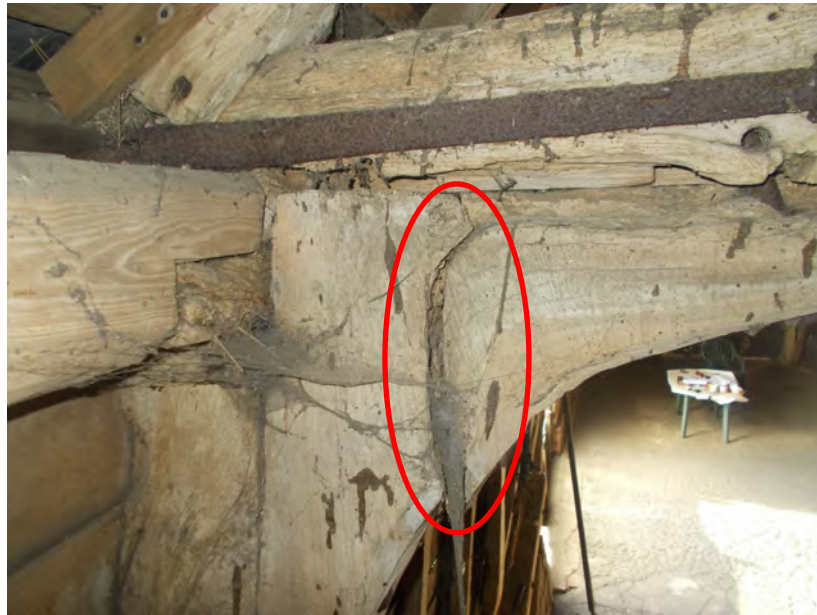
**Fig 21:**

Roof; showing the knee to the south end of truss 2. Note the knee has structurally failed. It is not likely this timber element is salvageable if it is to continue in its structural role

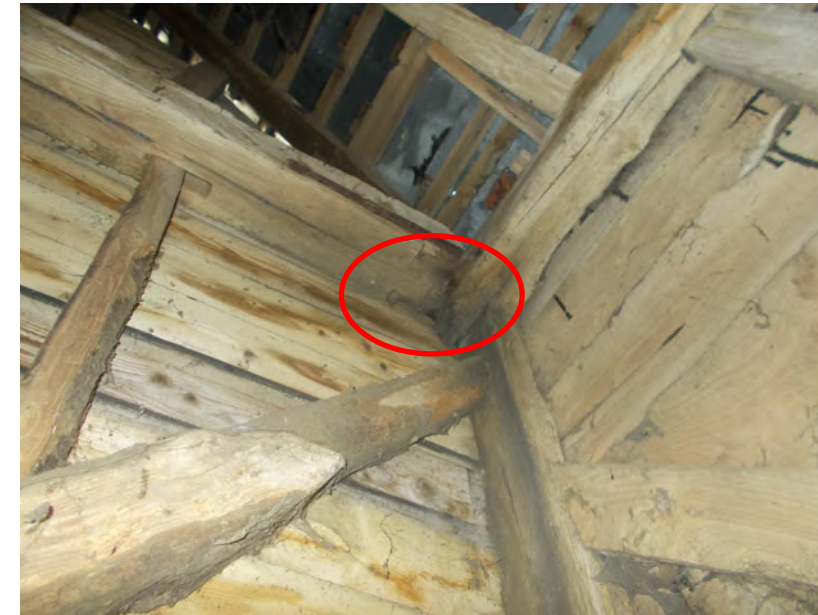
**Fig 23:**

Roof; showing the north-west corner of bay 5. Note there has been significant historic movement to the truss at this gable end and the tie beam now has limited bearing upon the rafter plate. Note the underside of the 'dovetail cog' is now visible by up to ~100mm. Structural engineer to comment. Provisionally allow for wall frame to be pulled back to upright to correct bearing end in this location

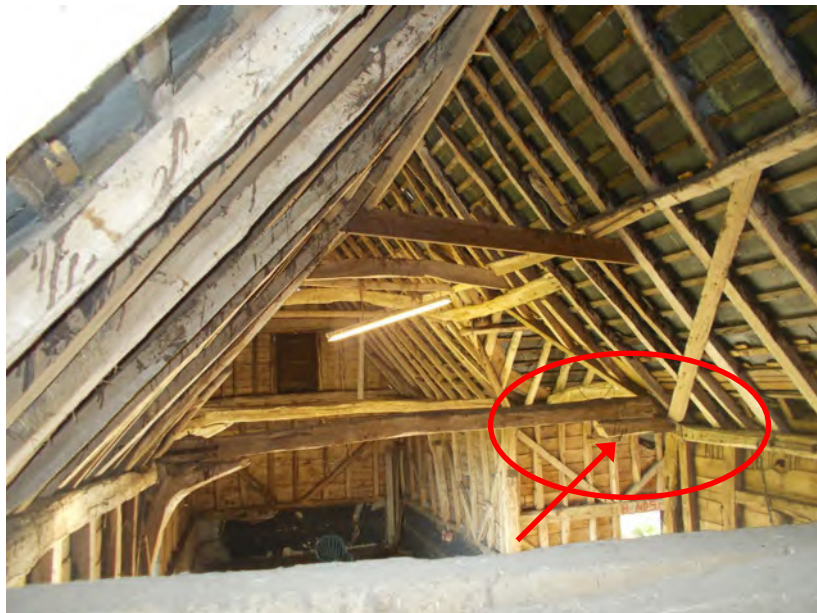
**Fig 22:**

Roof; showing roof structure in general looking west. Note the two trusses flanking the original threshing bay (Bay 3) lap onto the overshooting rafter plates of the strey and are bolted together with historic ironwork. There are no diagonal supports to this location

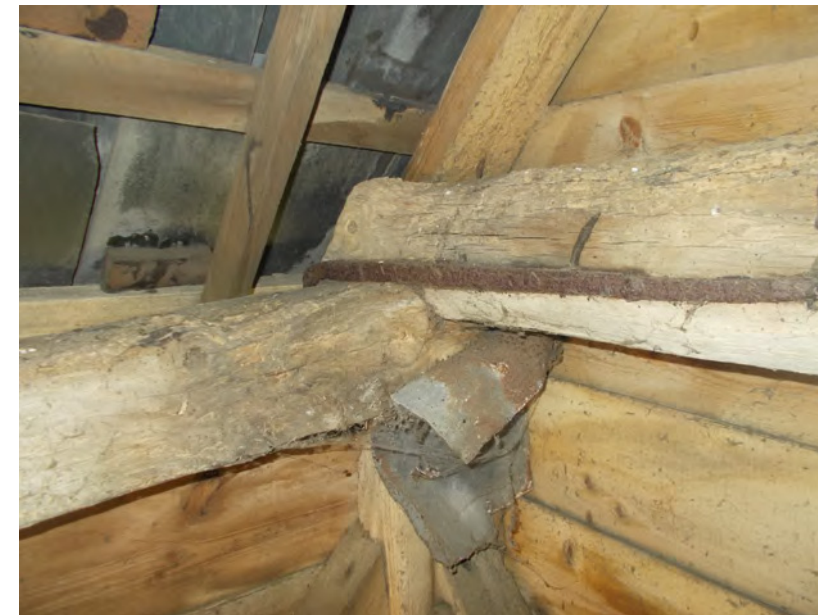
**Fig 24:**

Roof; showing south corner of truss 6. Note the historic cast iron strapping may have passed its service life. Provisionally allow for supplementary or replacement steelwork in keeping with historic fabric of the structure

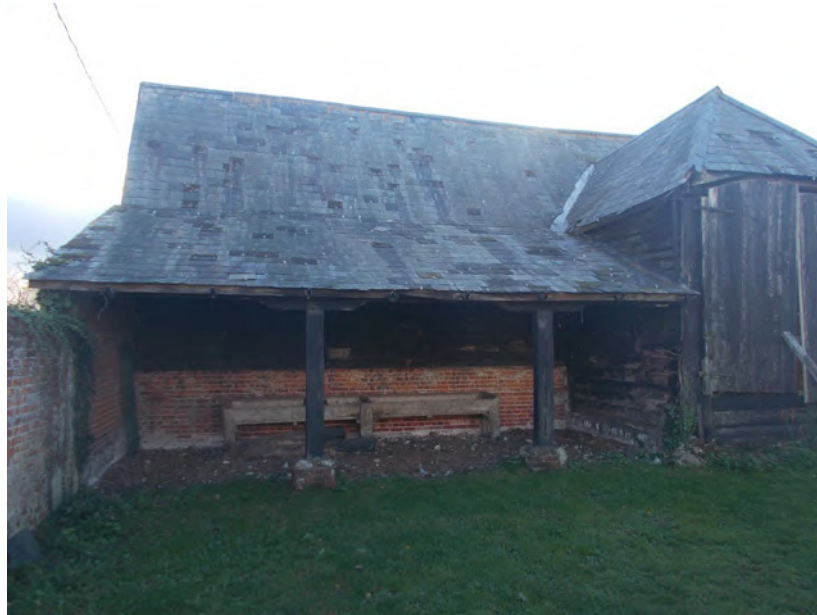
**Fig 25:**

Roof; showing catslide 2 altering the main pitch of the roof. Roof of simple lean-to design and likely not original to structures construction

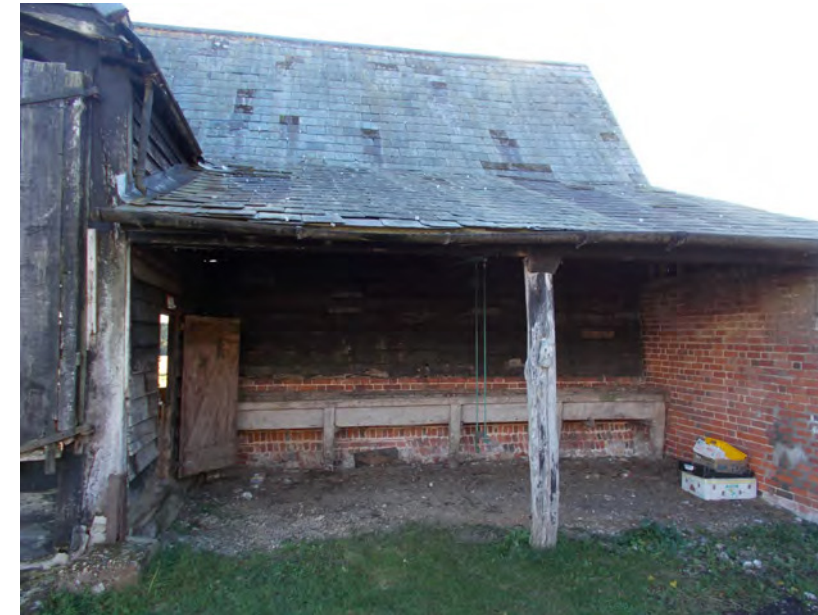
**Fig 27:**

Roof; showing catslide 1 supported by single earth-fast round section main post. Note catslide 1 has a slightly shallower pitch than catslide 2 otherwise construction is much the same

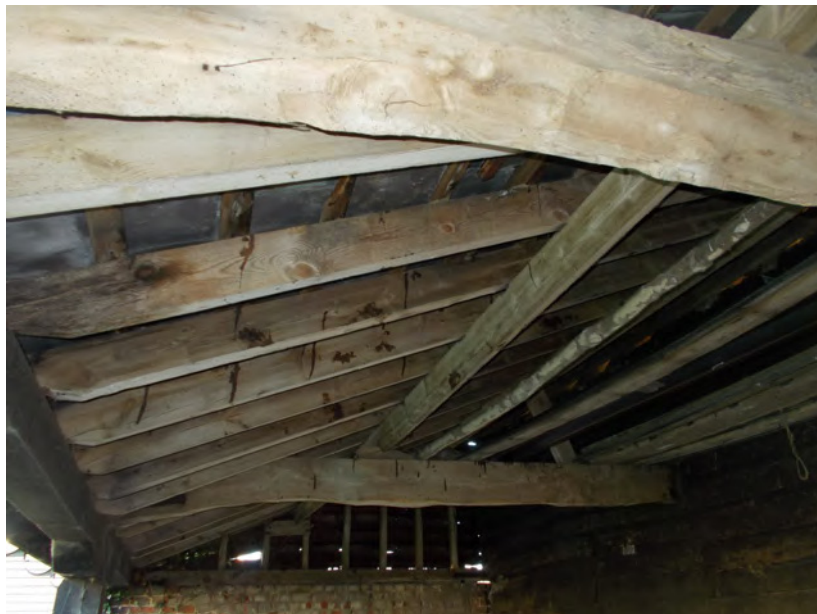
**Fig 26:**

Roof; showing catslide 2, featuring 2 no. historic elm half-ties supporting a largely 20th century softwood roof consisting of raking struts, 2 no. purlins, common rafters, and rafter plate. Note the rafter plate and main posts have been treated in a bitumen type preservative

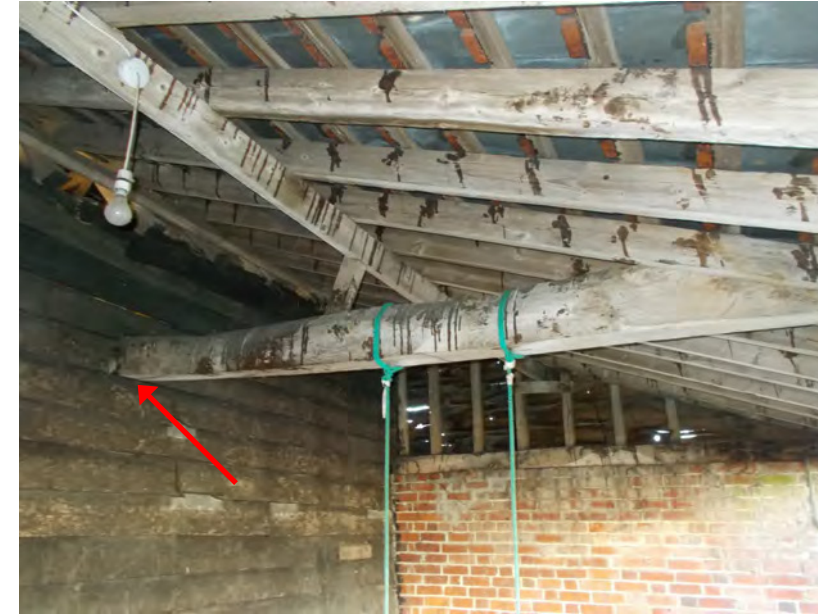
**Fig 28:**

Roof; showing roof structure of catslide 1. Note the purlin is supported by a short raking strut off of the half-tie (in elm). Remainder of roof elements in softwood. Also note poor provision for support to half-tie where it meets the main barn structure

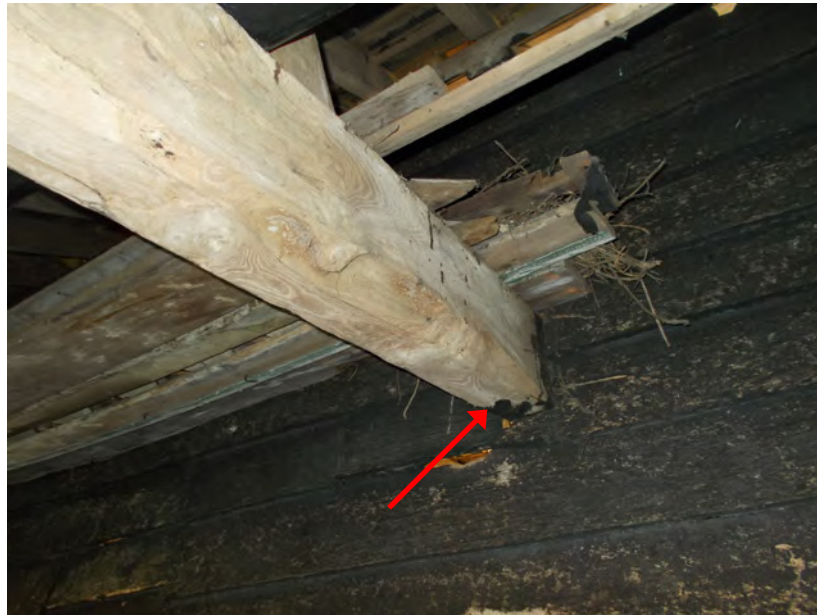
**Fig 29:**

Roof; showing cat slide 2 half-tie element where it meets the main barn. Note little provision has been made to support this timber adequately. Structural engineer to comment

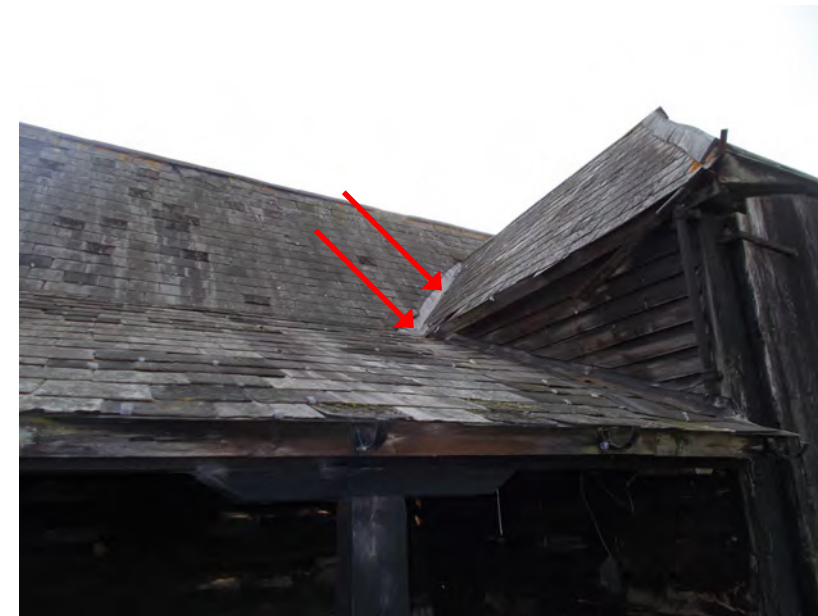
**Fig 32:**

Roof; showing valley location where moisture is likely being allowed to penetrate structures beneath causing the conditions for damp and decay to the midstrey east elements

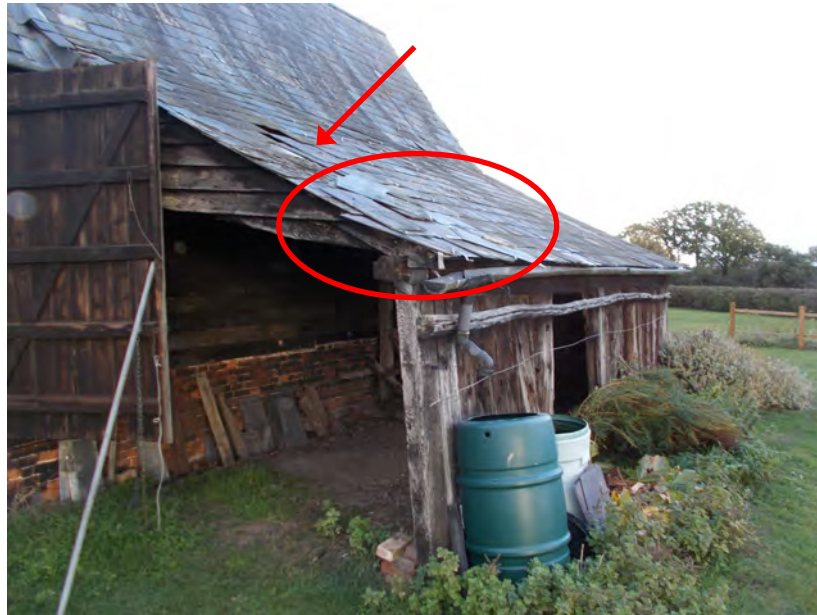
**Fig 33:**

Roof; showing rear catslide no 3. Note the change in pitch to the roof as well as a number of slipped tiles. Roof structure constructed much the same way as catslides 1 and 2

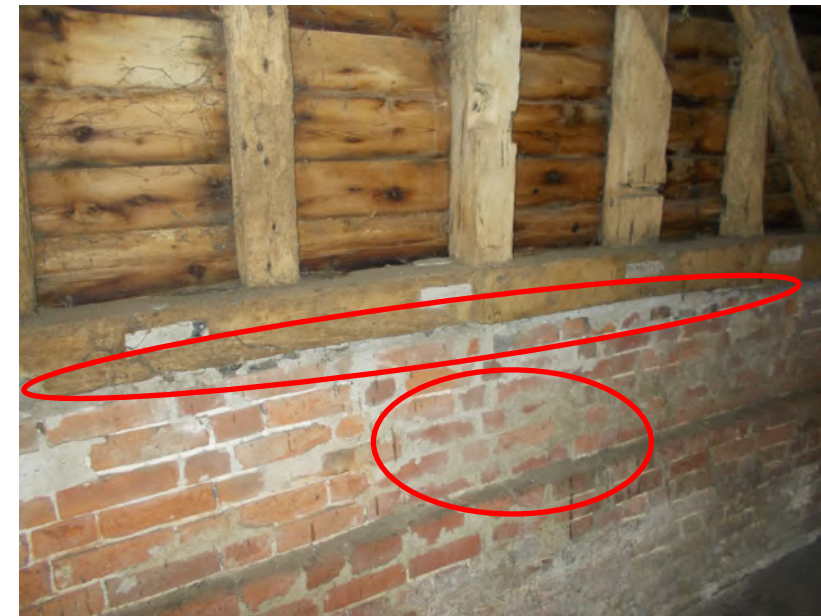
**Fig 36:**

Timber frame; showing plinth wall without bituminous coating. Note how the lower wall is of English bond whereas the top courses are of Flemish bond. The change in method may be due to the change in thickness of the wall structure. Also note significant areas of unsuitable repair to brick work in a cement based mortar. This relatively modern material is not harmonious with the historic lime based mortar and provisionally should be removed and repointed in lime mortar

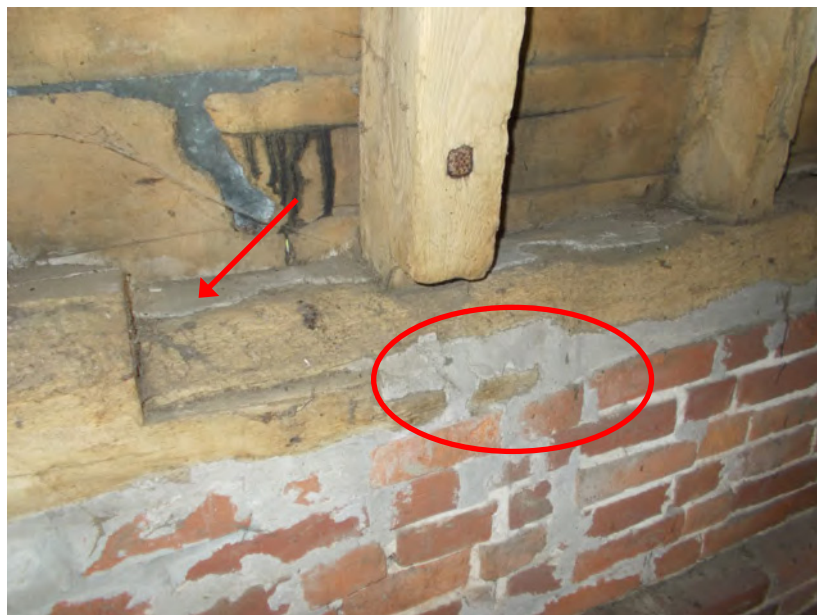
**Fig 37:**

Timber frame; showing where main north end of truss 2 meets the sill. Note the sill has lost 25 per cent of its section to historic decay. Also note it has been repaired unsuitably with a cement based mortar pointing. This is likely to be trapping moisture inside the timber and creating the conditions for damp and decay. Lastly note the relatively simple lap joint between sill lengths; as this element was under-compression a more complex joint was not necessary

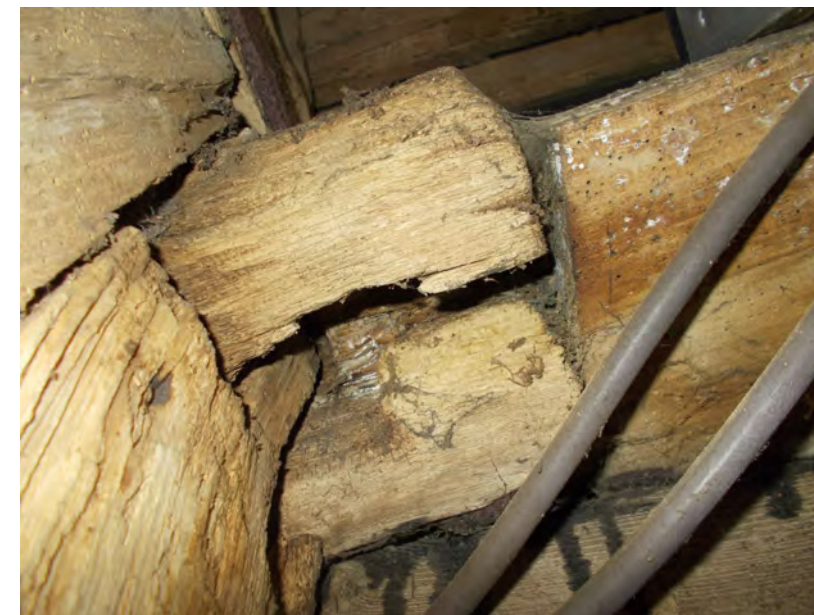
**Fig 39:**

Timber frame; showing partially failed rafter plate scarf joint at the north end of truss 2

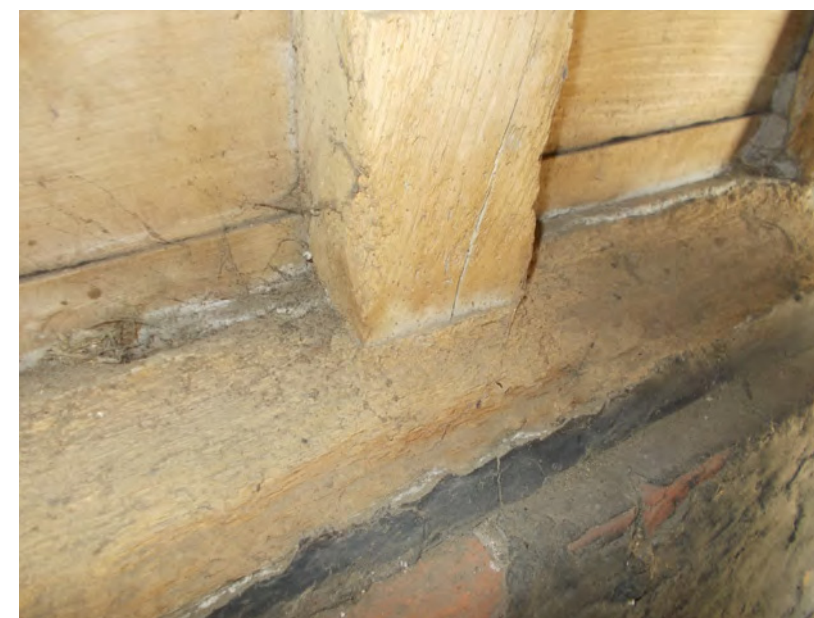
**Fig 40:**

Timber frame; showing oak stud meeting oak sill. Note how all of the sapwood band to the sill has been historically eaten away leaving only the heartwood remaining. Note remaining timber was deep drilled and moisture contents were taken. No decay detected

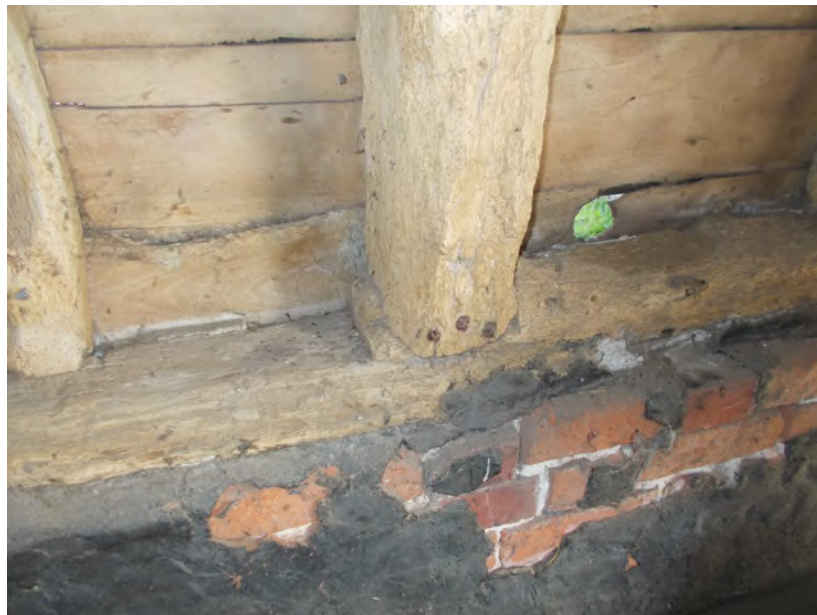
**Fig 41:**

Timber frame; showing a pleasing carpentry detail where the stud has been well scribed to meet the sloped face of the sill which is also lapped over another sill section. Then all three elements fixed through with three hand forged rose head nails

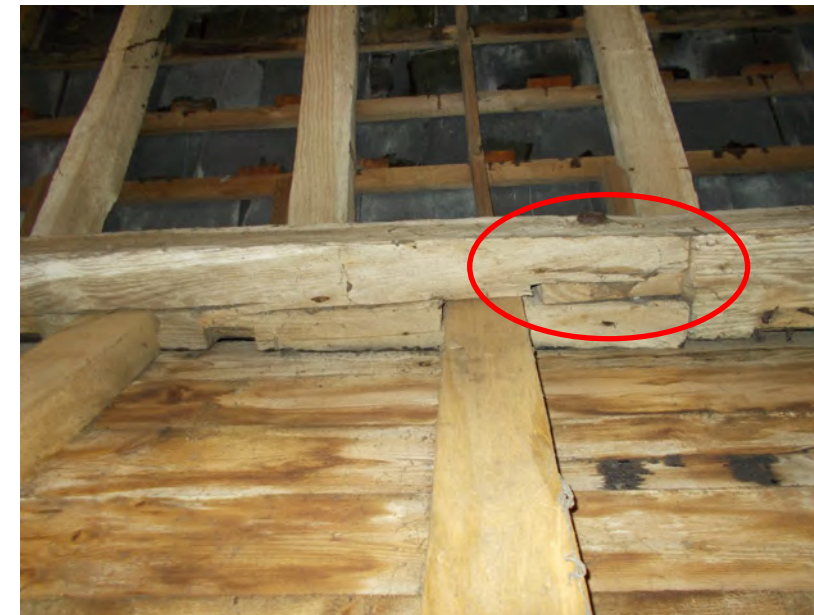
**Fig 43:**

Timber frame; showing partial failure to underside of rafter plate joint. Note the tenon is now visible from below. Also note the joint had been historically repaired with an iron bolt

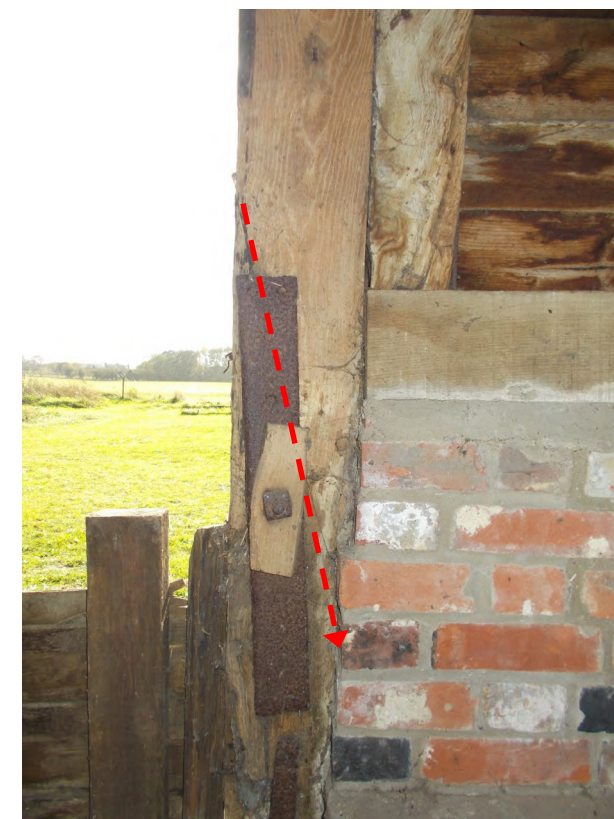
**Fig 44:**

Timber frame; showing south main post of truss 4. Note that the elm post foot had been historically repaired with a new section of oak spliced into it at a very steep angle and should be assessed by the structural engineer. Provisionally allow for additional fixings to be implemented to this joint

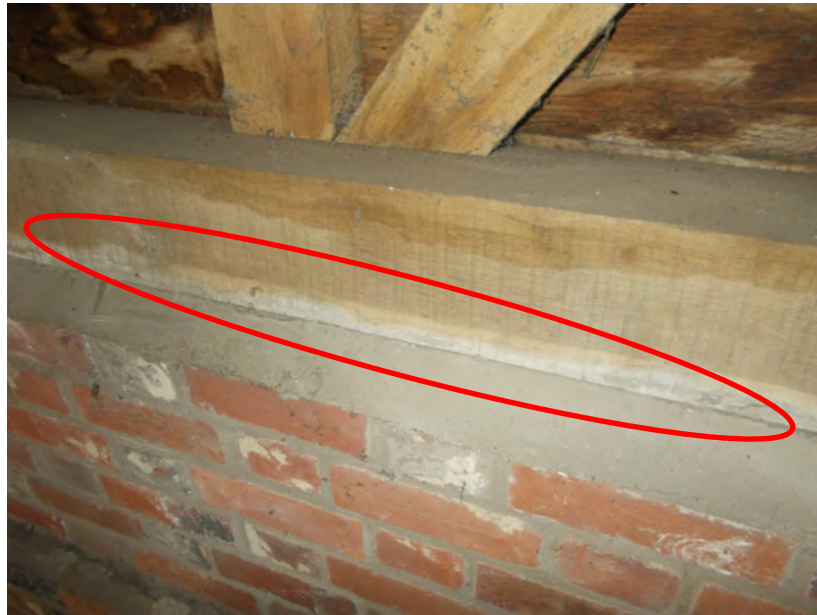
**Fig 45:**

Timber frame; showing repaired timber frame wall to south side of bays 4 and 5. Repaired circa 1980's, band-sawn oak was used which has dried well with relatively low amount of checking. However sap wood band to underside of sill is vulnerable to decay due to proximity to cement-based pointing of repaired plinth wall below. Provisionally allow for pointing in this area to be replaced with a lime based mortar that will allow timber to breath sufficiently. New timbers should be isolated from masonry via a damp-proof material

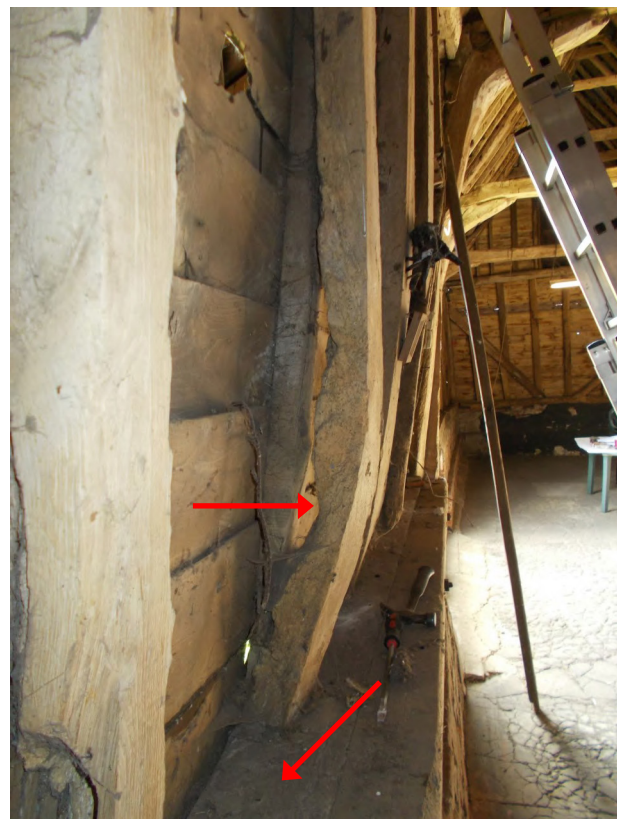
**Fig 47:**

Timber frame; showing main post at south side of truss 2. Note how the post foot has been historically repaired by a scarfed-in lap joint. No fixings were visible to this scarf joint at the time of survey (should be assessed externally when weather boarding is removed). Provisionally allow for 2 no. coach screws to be added to this joint. Also note main post foot is embedded into a cement-based mortar which will be trapping moisture and creating the conditions for damp and decay

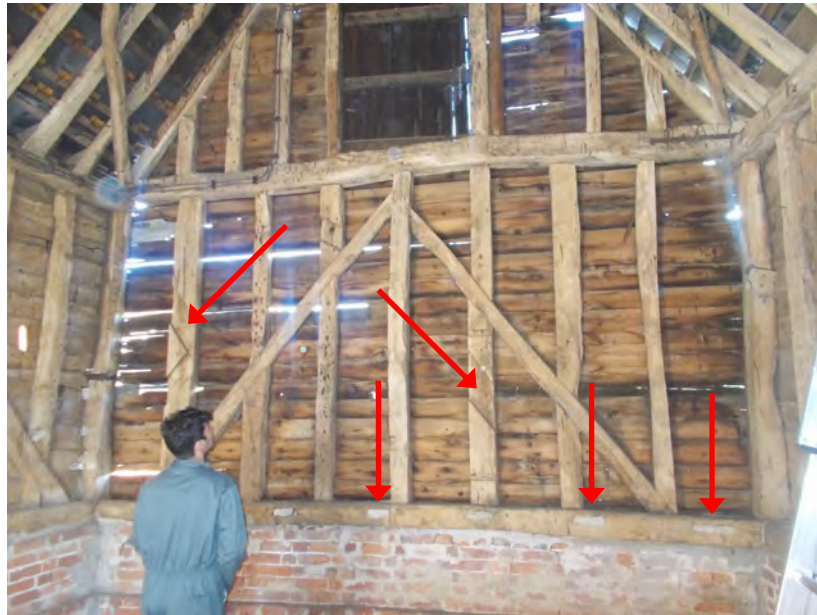
**Fig 49:**

Timber frame; showing east gable end. Note the evenly spaced filled mortice locations in the sill plate suggesting this was a recycled timber. Additionally the diagonal cut outs (or housings) to the upright studs also suggest these are recycled elements from a previous structure

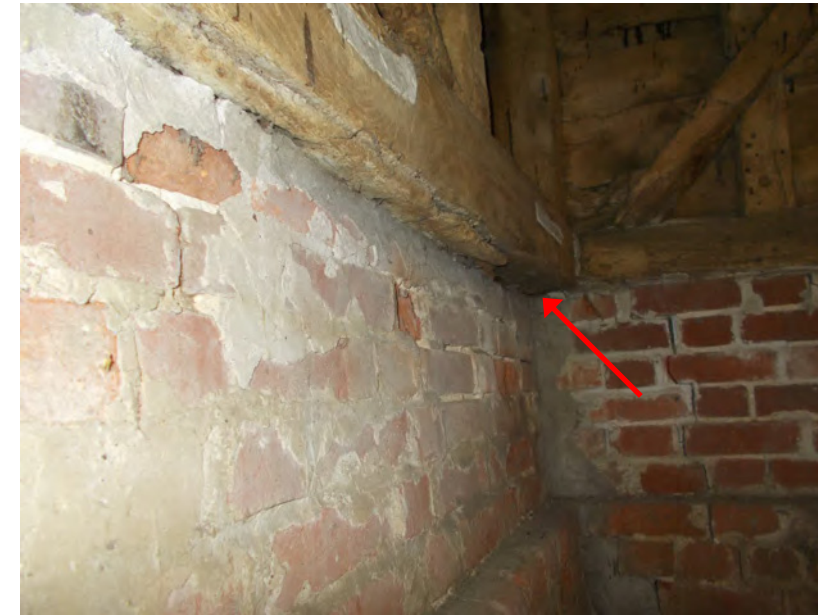
**Fig 51:**

Timber frame; showing south end of east gable end. Note how the sill has an overhang of up to ~150mm and therefore has minimal bearing upon the brick structure beneath. Provisionally allow for additional support to this area. Structural engineer to comment

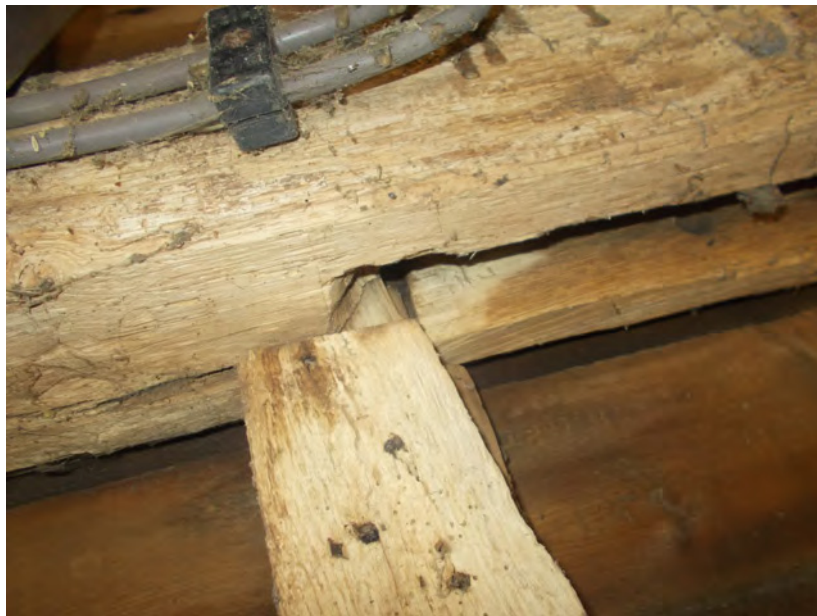
**Fig 50:**

Timber frame; showing historic location of mortice for a brace location in the tie beam of the east gable end. There is no other evidence to suggest this tie beam was braced in its current situation and it is therefore likely to be a salvaged element. Also note how the stud mortice location intercedes with the historic defunct mortice but is still doing its job appropriately

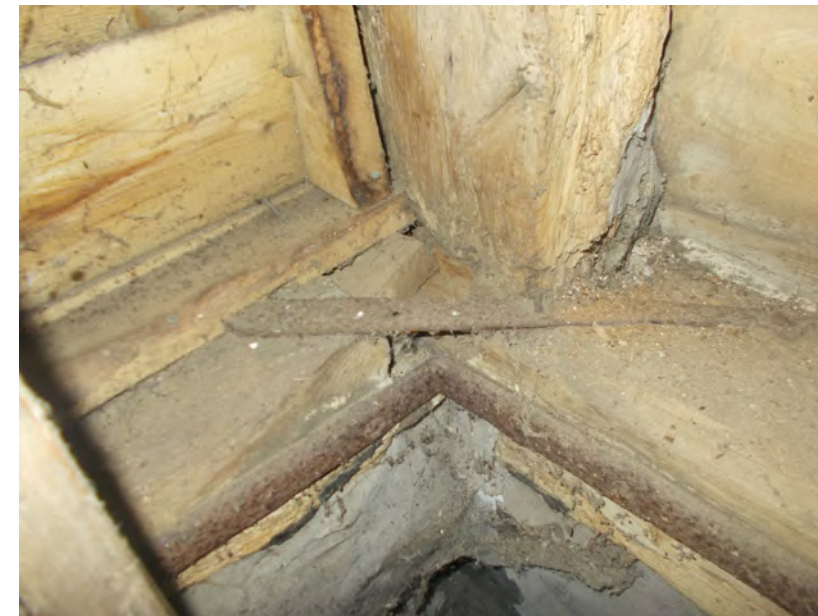
**Fig 52:**

Timber frame; showing failed joint between north-west corner post and west gable end sill plate. Note the historic remedial efforts of using iron straps to maintain structural adequacy. This method appears to have been effective, however the ironwork appears to be approaching the end of its service life. Provisionally allow for repair to location with dry oak scarfs

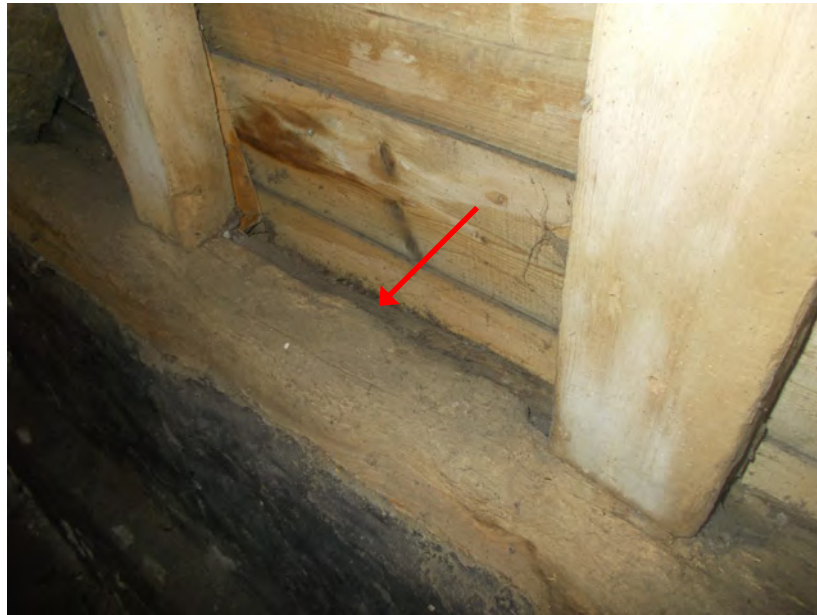
**Fig 53:**

Timber frame; showing north side of bay 4. Note the exterior edge of the sill appears to have significantly degraded due to historic water penetration from failed clapboarding and wind driven rain. Provisionally allow for a face scarf to the exterior of the sill in this location to reform and strengthen the mortice pockets

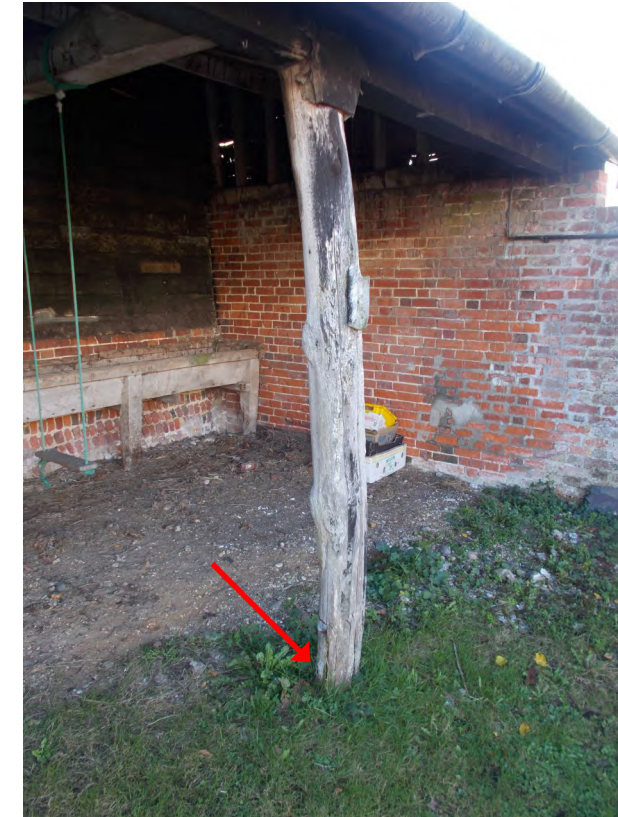
**Fig 55:**

Timber frame; showing main post to catslide 1. Note how the post foot is earth fast and is vulnerable to rapid decay. Provisionally allow for re-detailing of this to match that of catslide 2. Also note the lack of bracing to the posts to this entire elevation. Likely as a result of animal traffic to and from the covered trough areas

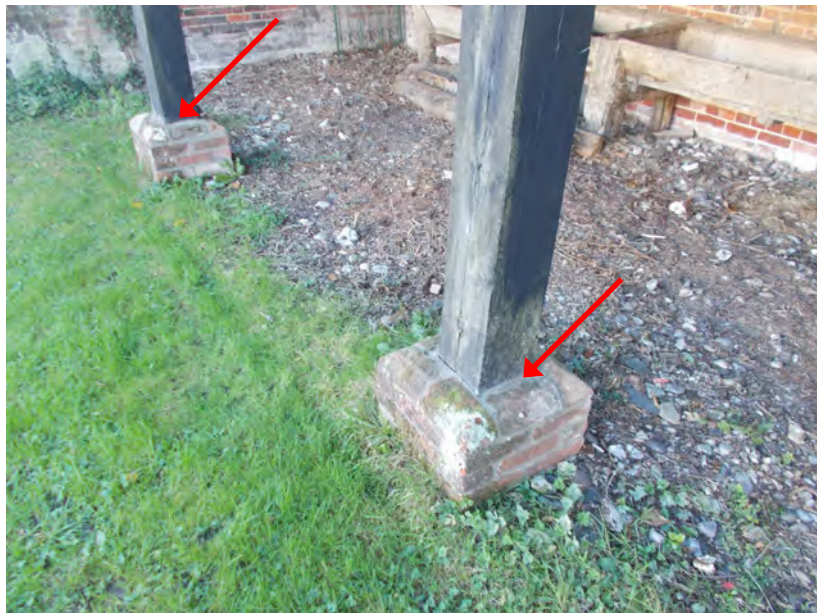
**Fig 54:**

Timber frame; showing post feet of catslide 2 have been raised off the ground and set on brick plinths. However, the post feet have been embedded with the brick plinth which is likely to be trapping moisture and creating the conditions for damp and decay. An alternative detailing to this would be to cut back the timber posts and isolate from the masonry via the use of a damp-proof material

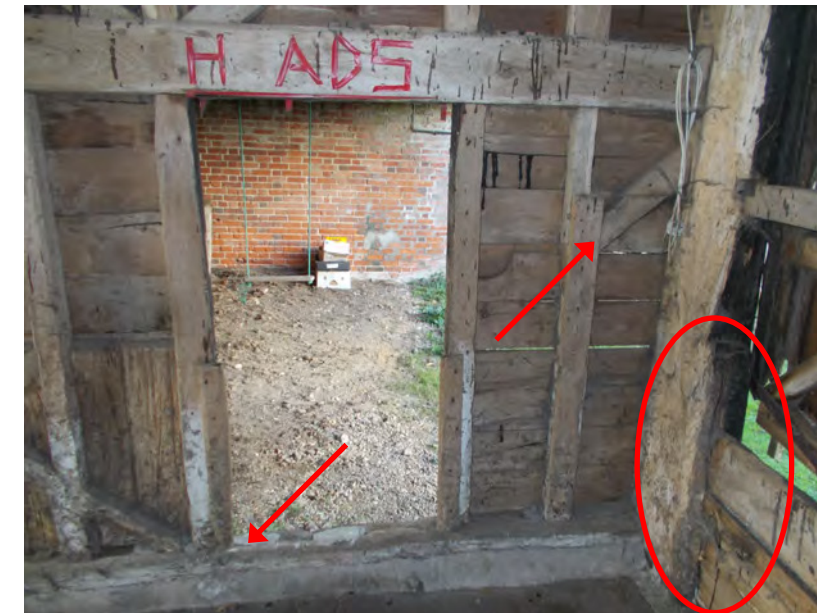
**Fig 56:**

Timber frame; showing midstrete west wall. Note how the entrance is a later addition as it has necessitated the cutting short of the diagonal bracing member. Also note the threshing boards still in situ (hence the term 'threshold') fitted into the purposefully carved channels in the main post feet. An excellent historic detail

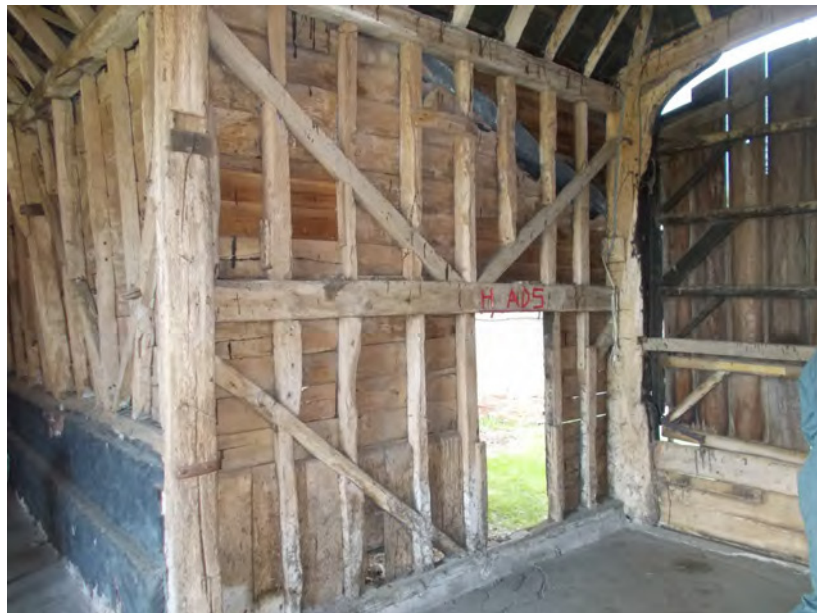
**Fig 57:**

Timber frame; showing midstreys west wall with historic kickboards to the lower sections. Note the cement-based mortar build-up below the sill plate. This has caused localised decay to the sill at both ends. See drawings at attachment B for details

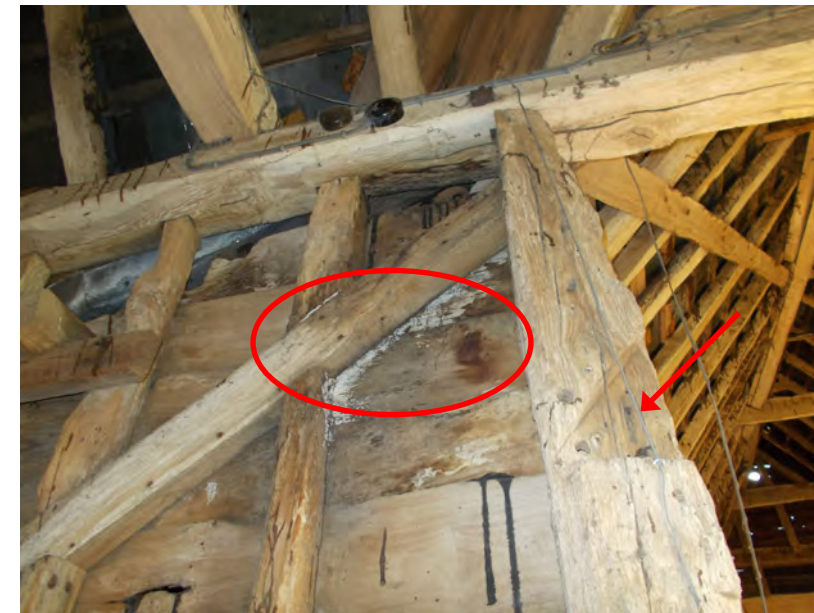
**Fig 59:**

Timber frame; showing midstreys east wall. Note the localised wet rot decay to the clapboarding and studs/diagonal brace. This is likely a result of defective valley flashing detailing above. Also note notch cut out of the post of truss 2. This is a likely location of an historic brace that would have supported the tie beam and is matched on its opposite post at truss 3

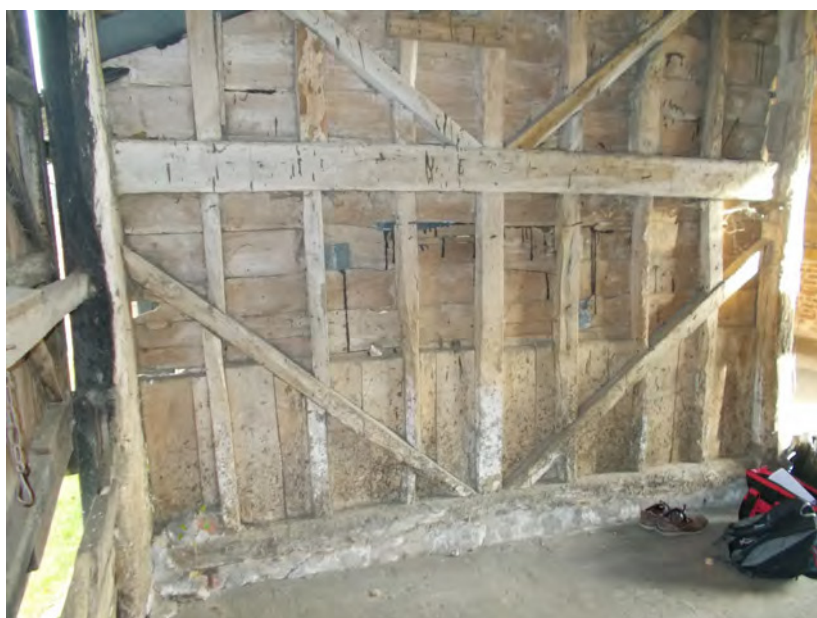
**Fig 58:**

Timber frame; showing midstreys east wall with complete run of historic kick boards set into stud divisions. Note also this sill plate has been set on a bed of cement-based mortar which will be creating the conditions for damp and decay. However, the timber was deep drilled and probed and no decay was detected. Provisionally allow for removal of all cement-based mortar and replacement with a lime-based mixture

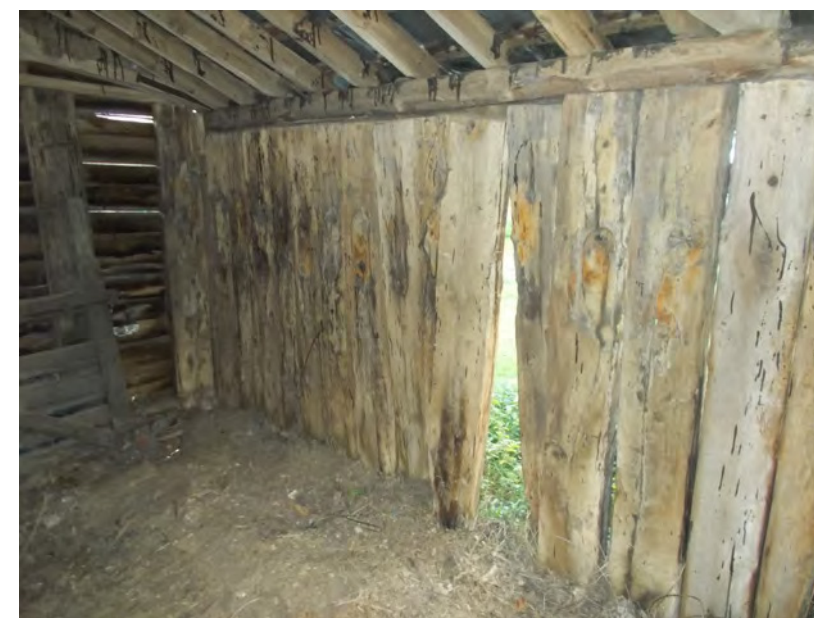
**Fig 60:**

Timber frame; showing catslide 3 to the rear of the structure. Walls formed of earth fast recycled railway sleepers now much decayed at their bases with very limited remaining service life. Provisionally allow for complete re-detailing of this structure for refurbishment

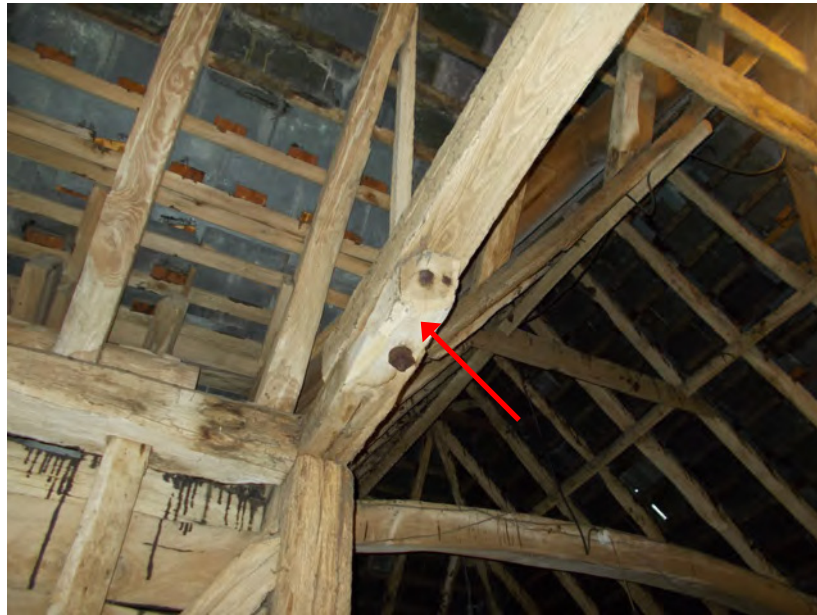
**Fig 61:**

Timber frame; showing truss 4 where it meets the midstrey rafter plate. Note the historic iron fixings and no current provision for diagonal bracing of this structure. These areas were deep drilled and probed. No decay detected at the time of the survey. Structural engineer to review lifespan of historic metal fixings and their adequacy for refurbishment
