# Jankes Barn

Jankes Green, Wakes Colne

Building Record (Planning Condition 7)

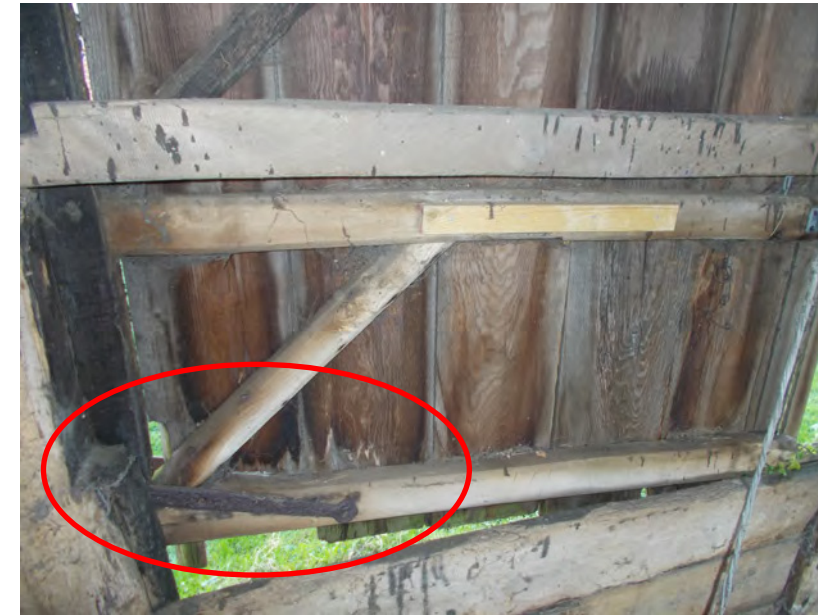
**Fig 63:**

Barn doors; showing the repaired rail and brace on the west door. Note the severe decay to the lower rail and boards

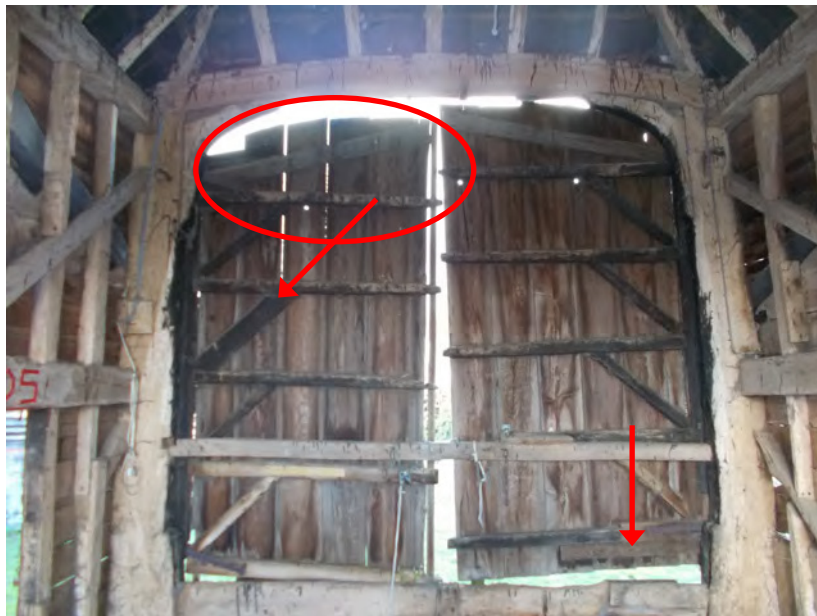
**Fig 62:**

Barn doors; showing north midstrey barn doors. The doors were dropping towards the centre meeting edges due to the failing braces and hinge posts. Note the numerous repairs

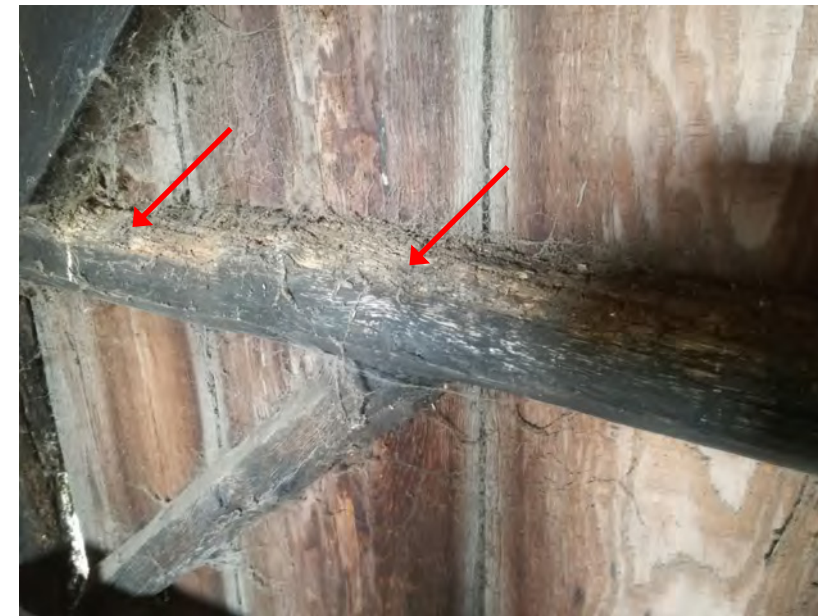
**Fig 64:**

Barn doors; showing some decay to one of the rails on the north doors. Most of the rails and braces were decayed or partially decayed

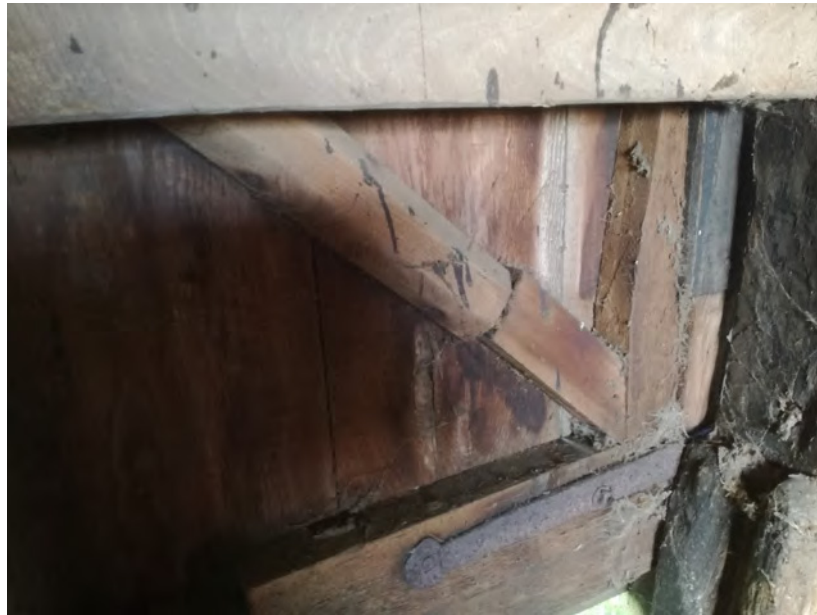
**Fig 65:**

Barn doors; showing one of the recent repairs in softwood timber to a brace on the north doors

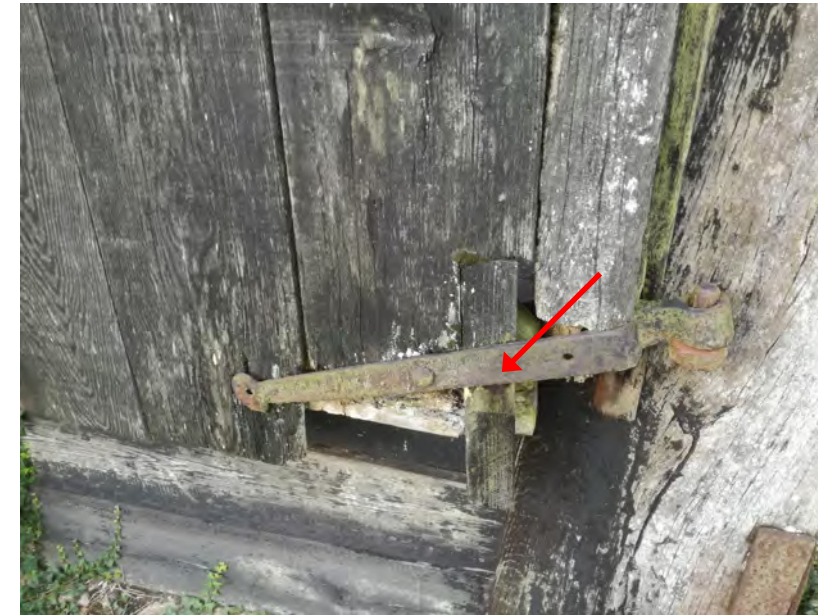
**Fig 67:**

Barn doors; showing the north doors and the bottom of the west door. The boards were decayed in this location and the hinge had subsequently failed

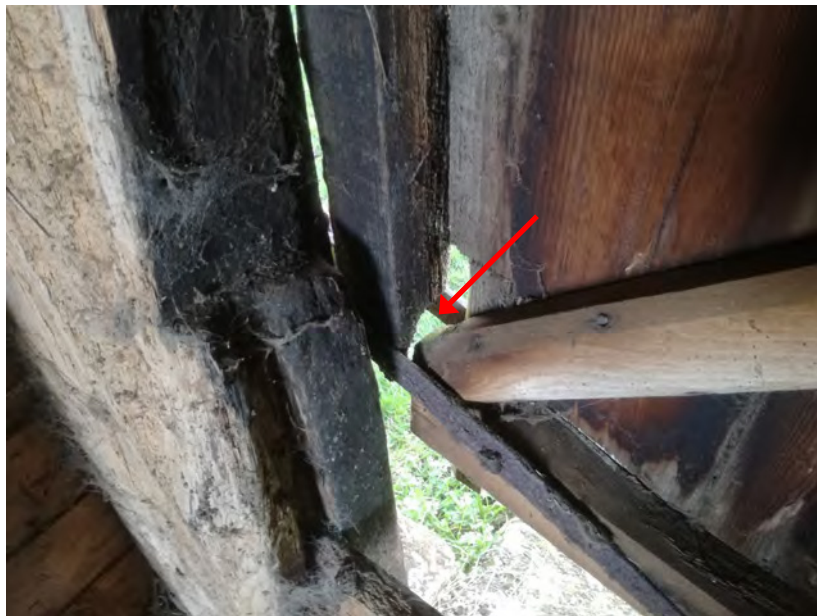
**Fig 66:**

Barn doors; showing the north doors and the decay to the bottom stile of the west door. The boards in this area were also badly damaged

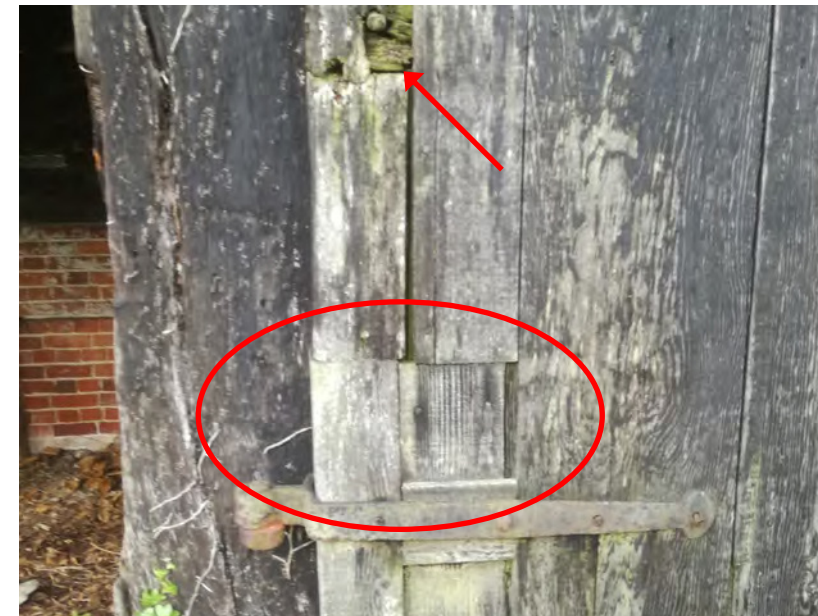
**Fig 68:**

Barn doors; showing the north doors and the previous repair work conducted. Note the decayed mortice cheek around the dowelled rail joint above

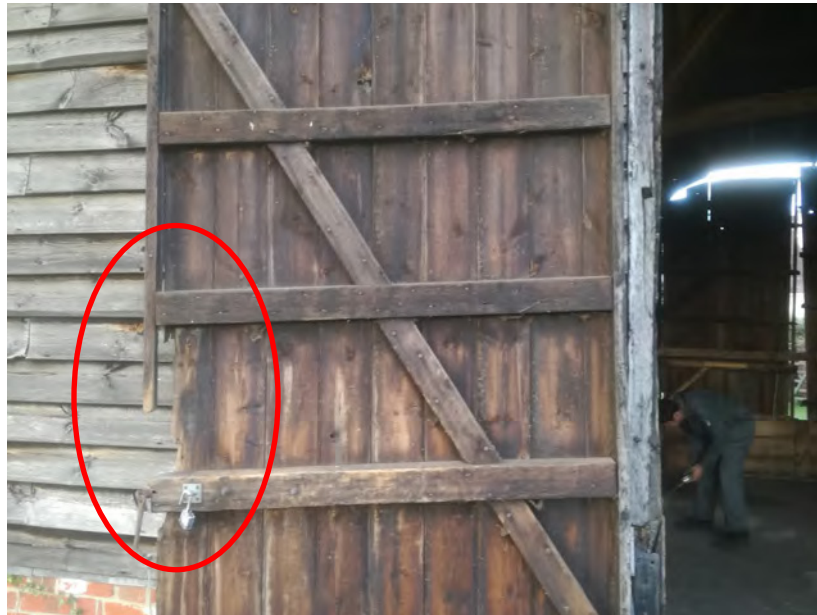
**Fig 69:**

Barn doors; showing the south doors and the severely damaged closing side of the west door. The boards of this door were also significantly decayed at the base

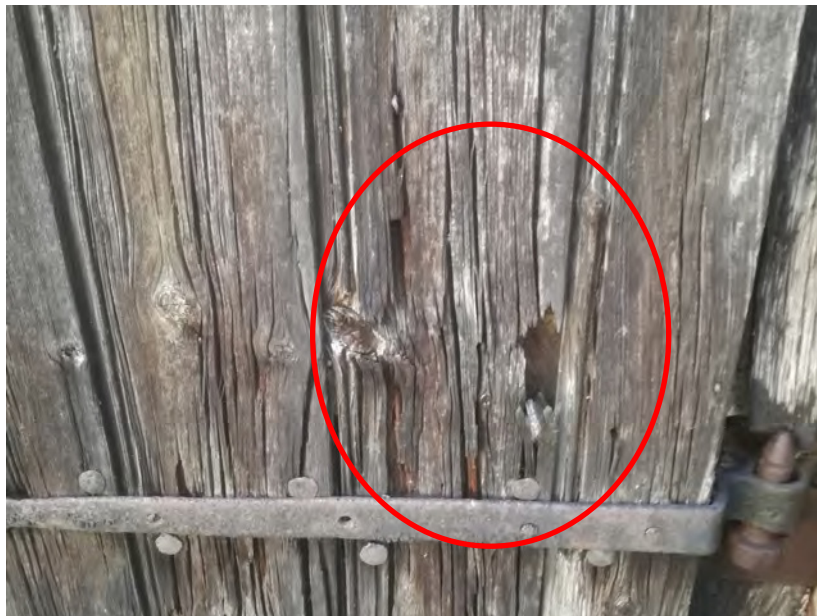
**Fig 70:**

Barn doors; showing the south doors and the severe decay to the boards at the base of the east door. All of the boards of the south pair of doors were significantly weather damaged
