Forge Cottage and The Forge, Church Road, Peldon, Essex CO5 7PS
Description and analysis of the House and former Forge. Recorded 16 02 2013.
Revisited 28 07 2015.

Scope of this Report.

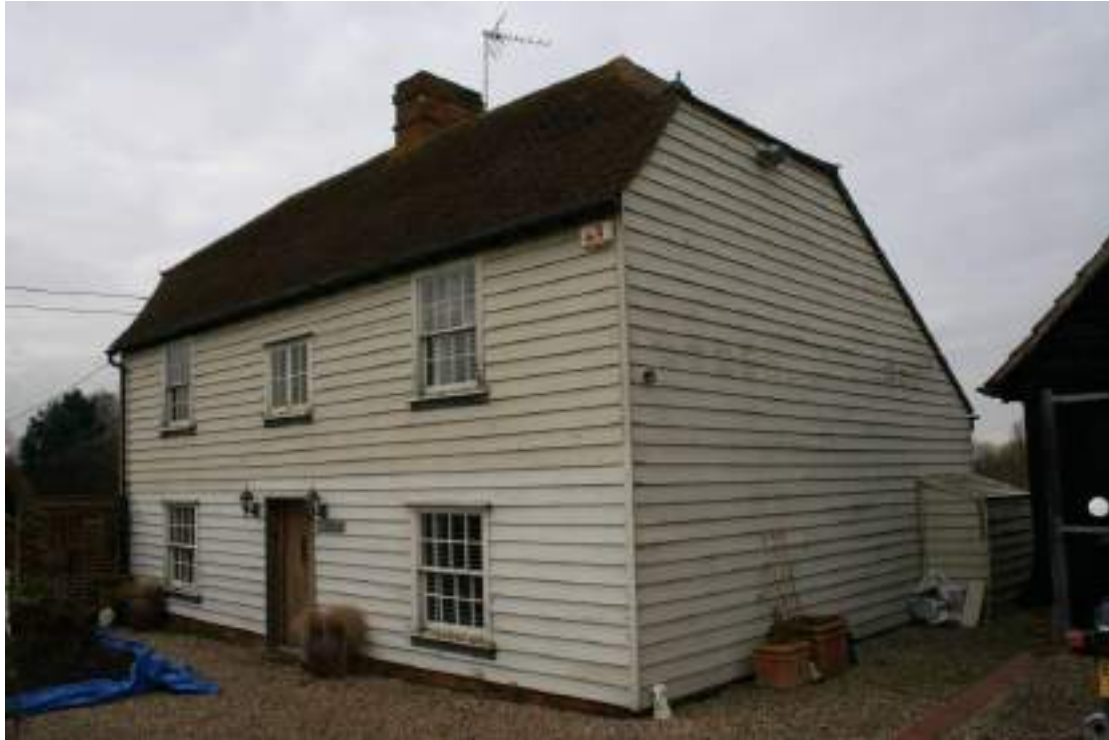
NE and SE Elevations.

The blank NE elevation and the front SE facade.

Forge Cottage is a timber-framed building clad with LC20th, 7in wide, very thin, weather-boards fastened with galvanised French nails. It is known that the frame was stripped completely, sheathed in plywood and the boards applied. The NE elevation has been left blank of windows and doors.

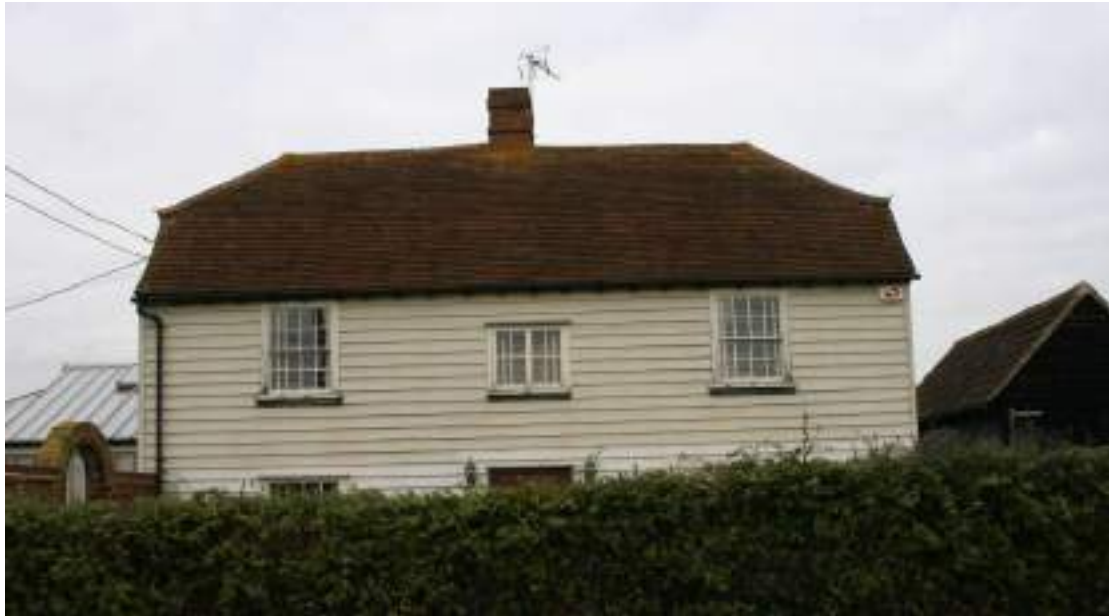
Note the slight asymmetry of the roof lines.

The roof is a gambrel roof with half hips at either end. The hips are slightly different and the roof line kicks up near the centrally placed brick chimney stack to different heights. This usually indicates a rebuild in more than one phase (perhaps due to split ownership). The chimney is LC19th or C20th in character and repointed with grey cement. The rainwater goods are black plastic.

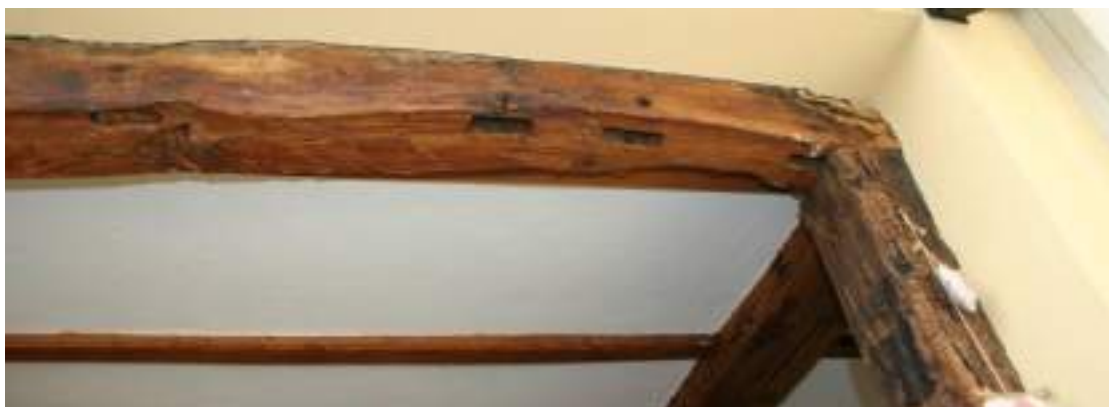
Looking upwards at the frame into the Dining Room. Note the rounded mortices.

There is also a wide opening leading into the Dining Room. While the plate forming the ill is original to the frame and has round-ended and square cut mortices to indicate a door or window frame, the supporting posts are reused from elsewhere. They are notably a different colour to the rest of the frame and have a series of redundant mortices and peg holes.

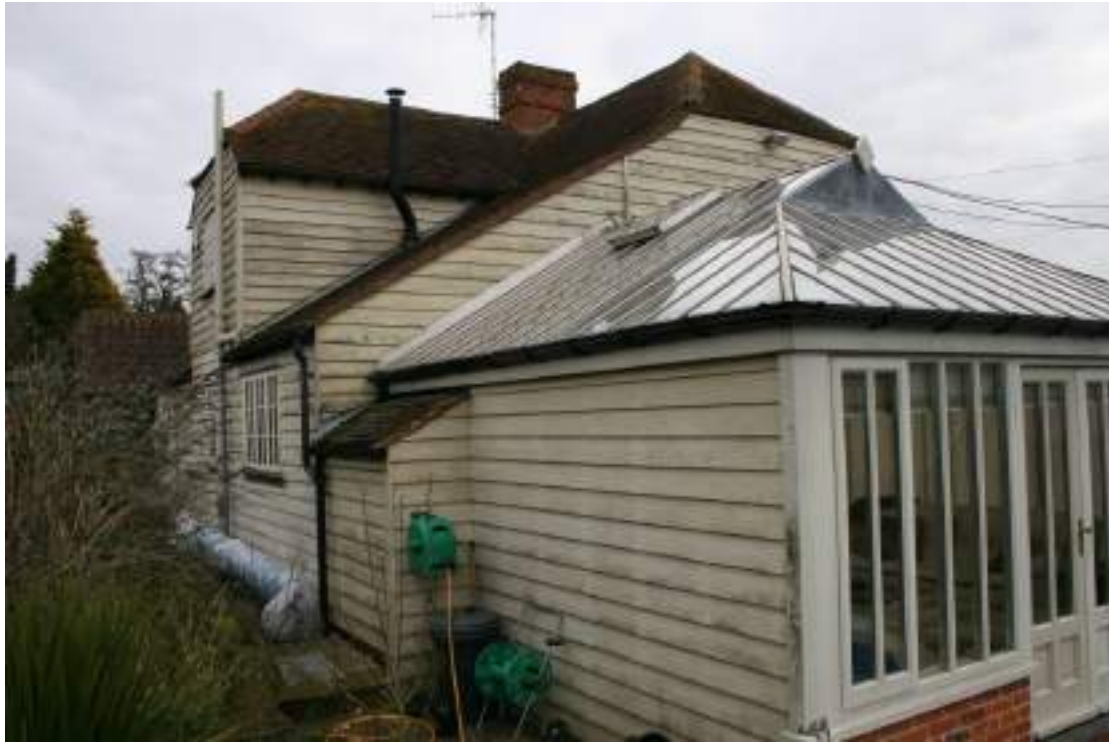
The NW Elevation.

The NW elevation is the rear of the house.

The NW elevation is the rear of house close to the boundary line with the fields. Here can be seen the large rear extensions made to the house in 1982. There is a centrally placed two storey bay with a half-hipped roof and this is flanked with two outshots under catslide roofs. The two storey bay houses the new staircase and bathrooms while the outshots contain the Kitchen and Office.

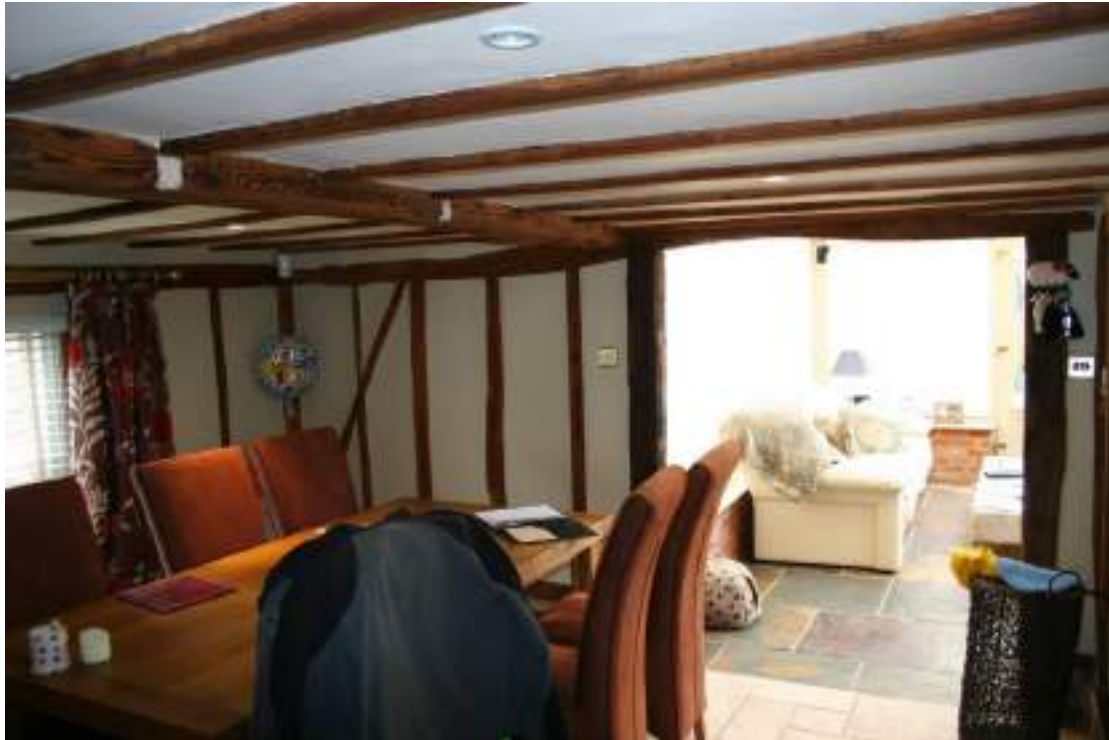
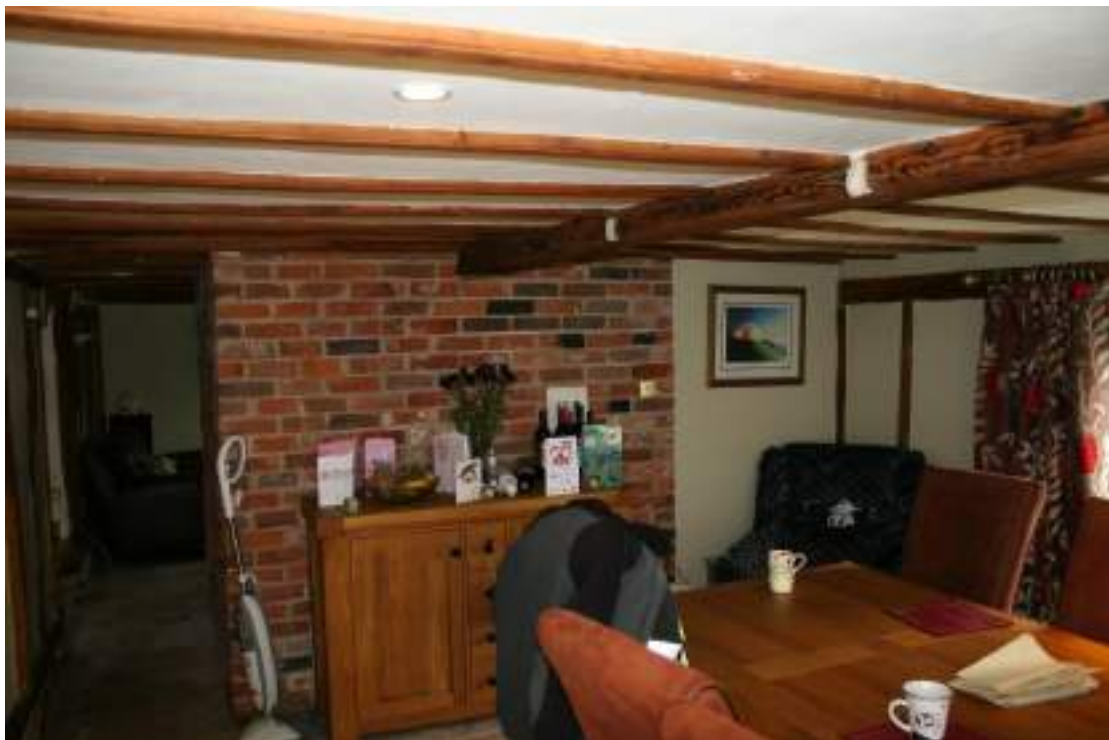
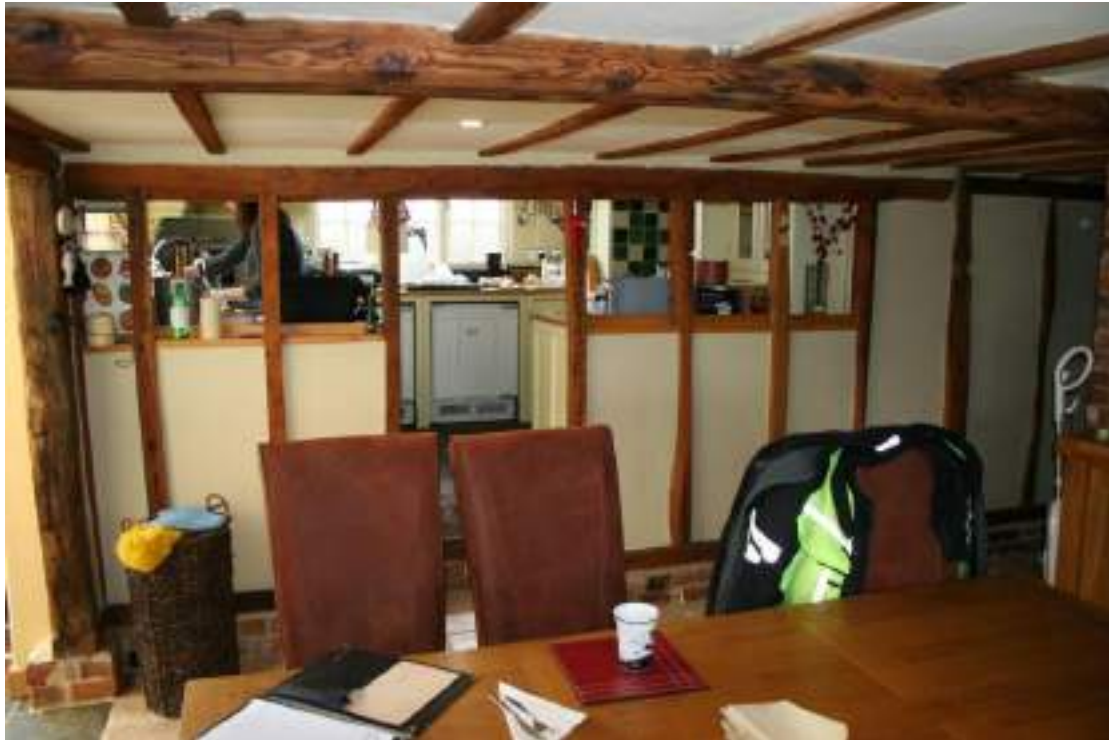
The Dining Room.

The Dining Room looking SW to the Garden Room. Note primary brace.

The Dining Room looking NE. The fireplace was rebuilt and blocked in at the end of 1982.

The Dining Room has the frame exposed in all the walls which is ironic as it is a primary braced, interrupted stud scantling frame that was designed to be clad with lath and plaster and never meant to be seen. Each stud is peppered with nail holes but it can be seen that some have been rotated or moved out of place and it may be assumed this was done in 1982. The frame has been shot-blasted and stained losing the patina of the original timbers but it seems that the studs may be elm while the principal timbers are knotty softwoods.

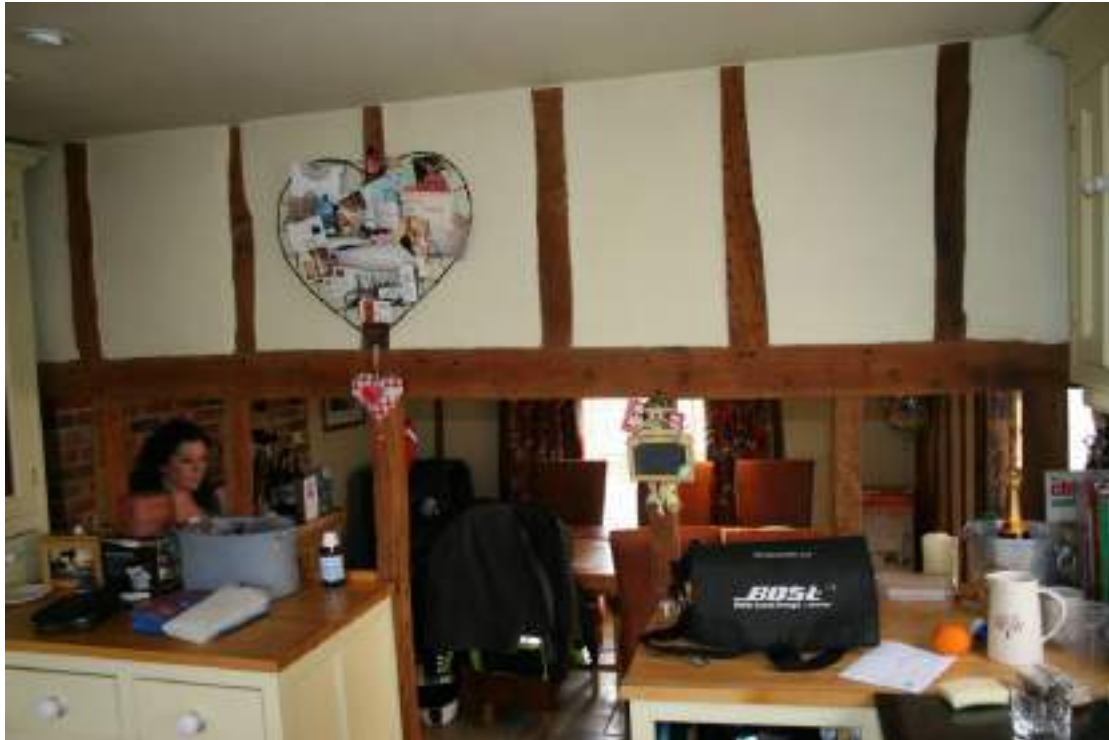
The Kitchen.

The timber-frame as seen from the Kitchen. Looking SE.

The Kitchen itself is a modern outshot but the exterior of the frame can be seen. The studs are 3x4in set at 18in centres and the joints marked on the outside of the frame with a narrow blade. Two studs have been removed to form the entrance to the Kitchen. The studs above the mid-rail are peppered with nail holes in some but not others. In this case it suggests the studs were reused. In general the nail patterns suggest the building was always weather-boarded externally rather than lath and plastered.

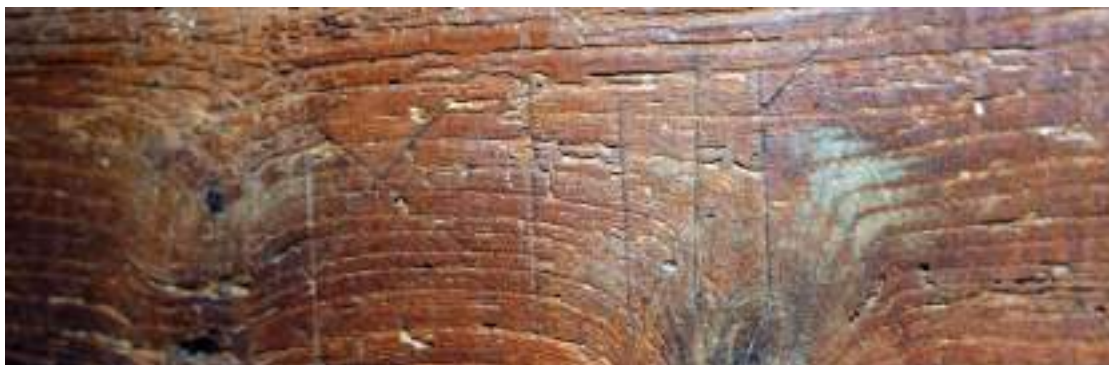
Carpenter's mark on the mid-rail visible in the Kitchen. Reads XIII(tag)

The tag on the carpenter's mark differentiates one part of the frame from another and it is likely the frame is marked on the exterior right round the building.

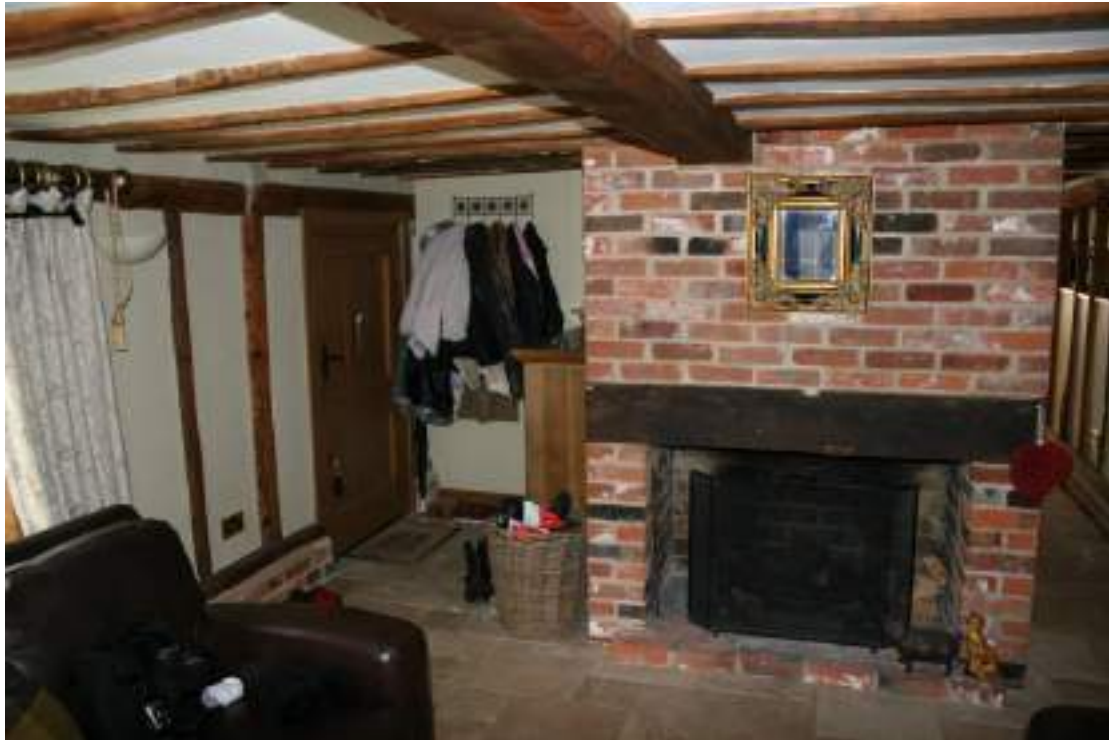
The Living Room fireplace is a rebuild of 1982/3. Looking SW.

The timber-frame is exposed in the front and rear walls of the Living Room but not the end (NE) wall. The wall frame has the same characteristics and sizes as that in the Dining Room but the ceiling/first floor framing is markedly different. That in the Dining Room has a very knotty pine axial joist with 2in wide common rafters set at 19in centres each with a slight edge-moulding. In the Living Room there is a heavy oak axial joist with a deep chamfer with 2.25-2.75in wide pitsawn rafters set at 18in centres. It is evident that both axial joists are modern replacements.

The ceiling height is unnaturally low at only 7ft3in to the common joists and about 6ft8in to the underside of the axial joists. The wall frames are stood on rebuilt brick plinths and the floor has been brought up with Florentine granite slabs. The common joists do not sit on the mid-rails as might be expected but are lodged higher up, presumably on applied plates as part of the 1982 works.

In the Living Room is an open fireplace with a deep timber bressummer. All this was created as part of the 1982 works and there are plans to show this specific detail. The bricks are reused and repointed with grey cement. A plan follows identifying a reinforced concrete lintel behind the reused timber bressummer.

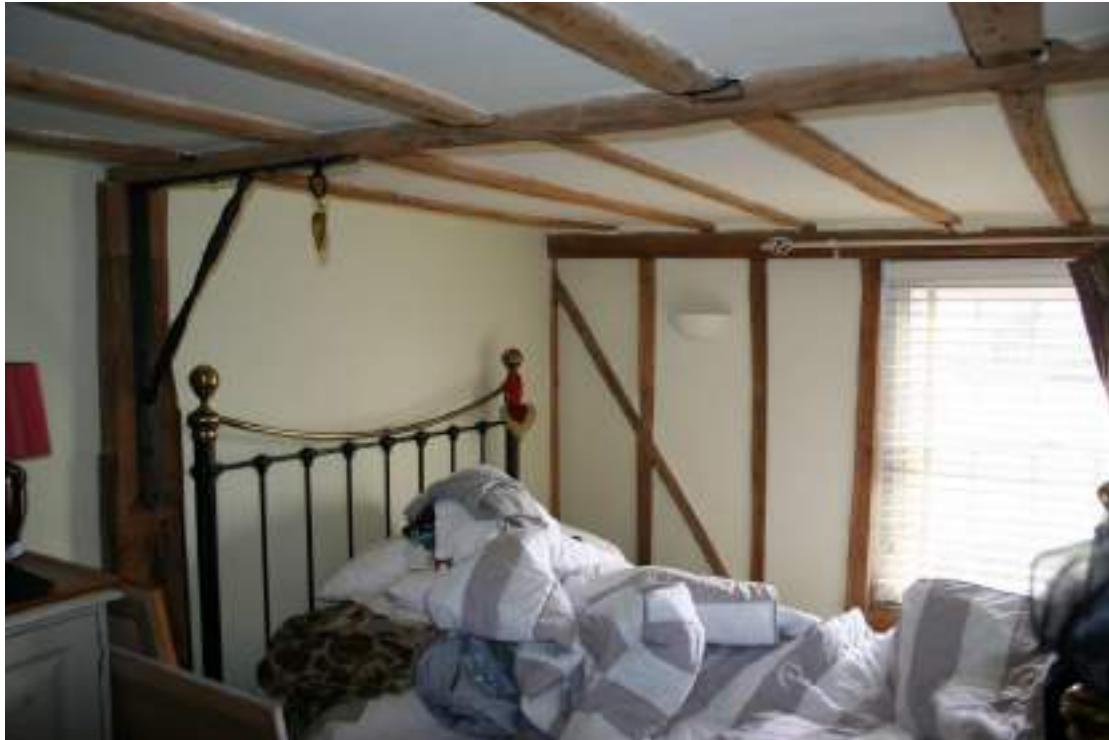
Looking SE in Bedroom 3. Note the bracing on the frame.

Bedroom 3 is to the NE of the House and is the only one to display the frame in the walls and ceiling. The frame is of the same primary braced, interrupted scantling studwork as downstairs and is also visible in the other bedrooms. The ceiling has a fragile 3.5in wide axial joist with 2.25-3in common joists connected with scarfed terminals in rectangular mortices. The axial joist is lodged in the chimney stack at the SW end and supported on a wide storey post in the end wall.

Unusually, the storey post is scarfed and then retained with large wrought iron nails and the two long EC20th straps seen in the Living Room. There is also a LC20th wrought steel angle bracket with decorative terminals and a suspension ring for a lamp. The joints are welded.

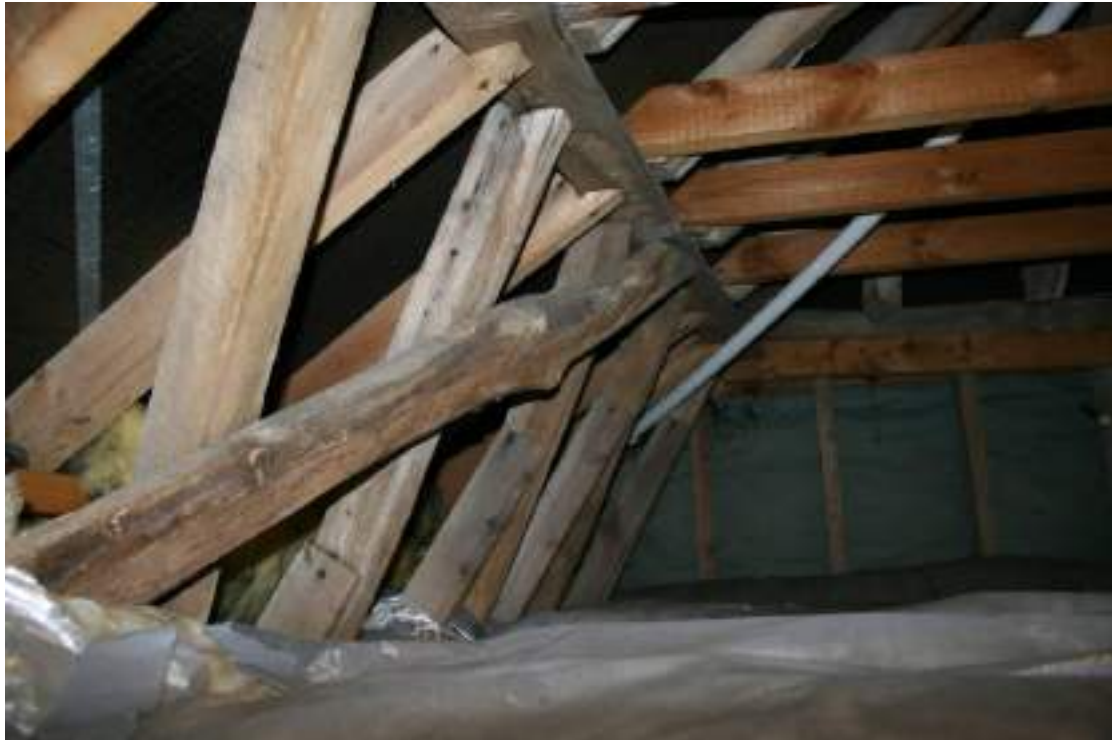
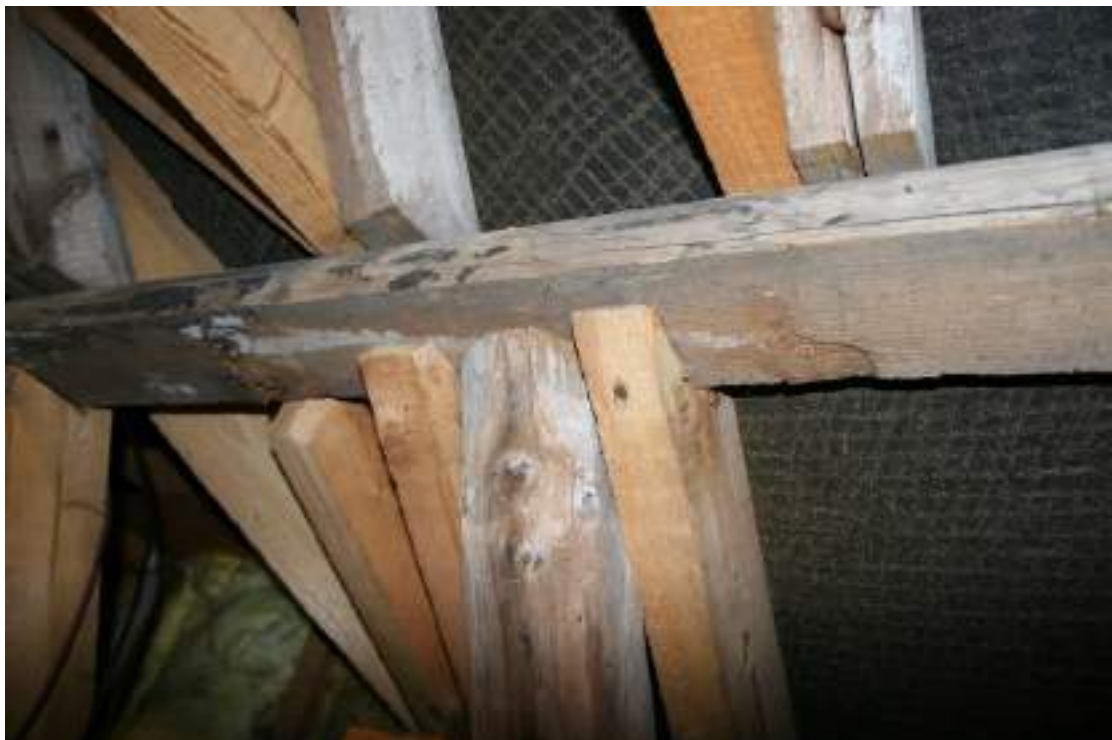
Roof Structure.

The roof can be viewed through a hatch on the landing. It is a gambrel roof with half pole side purlins where the rafters are birds-mouthed or simply nailed across. There are three clear phases of rebuild. The original roof, of which there is very little, has roughly squared pitsawn elm short members or half poles in the lower pitch of the gambrel. Above this the roof has been completely rebuilt with LC19th or EC20th circular sawn softwood where the rafters are made of 1.5x4in nailed pairs fixed to a ridge piece. Finally, there are the fresh timbers associated with the 1982 works. Photos follow.

Some early timbers remain below the half pole purlin. Looking NE.

An early elm strut reused with later paired rafters above. Fresh timber dates to 1982.

The roof also has an asphalt membrane indicating that the entire roof was dismantled and relaid in 1982.

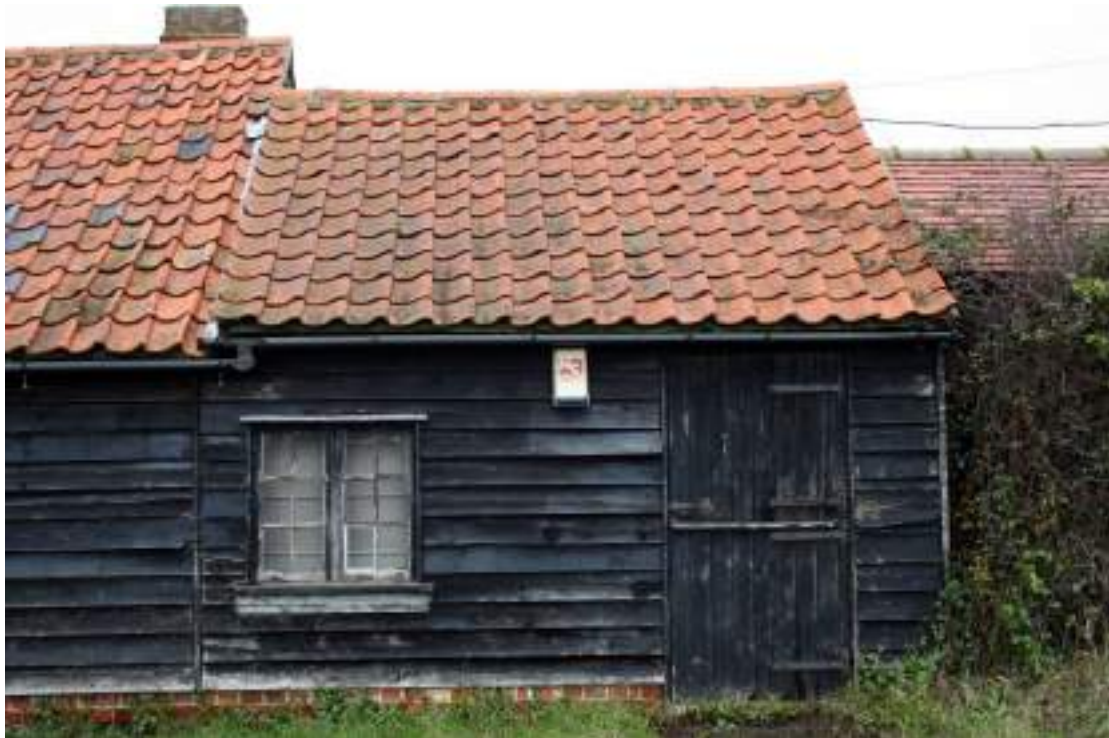
The Forge Room.

The Forge is split into two distinct builds. To the NE is small two bay single story timber-framed building clad with LC20th weather-boarding in poor condition, fastened with galvanised nails. Where it has failed it can be seen that the scantling frame has been first clad with plywood sheeting.

The smaller unit is called the Forge and features a LC20th, 6 light pair of casements and a LC20th replica split stable door. The single pitch roof is clad with replica and C19th pantiles. The rainwater goods are plastic. It shares a common plinth with the larger unit which was originally open-sided for some of its life.

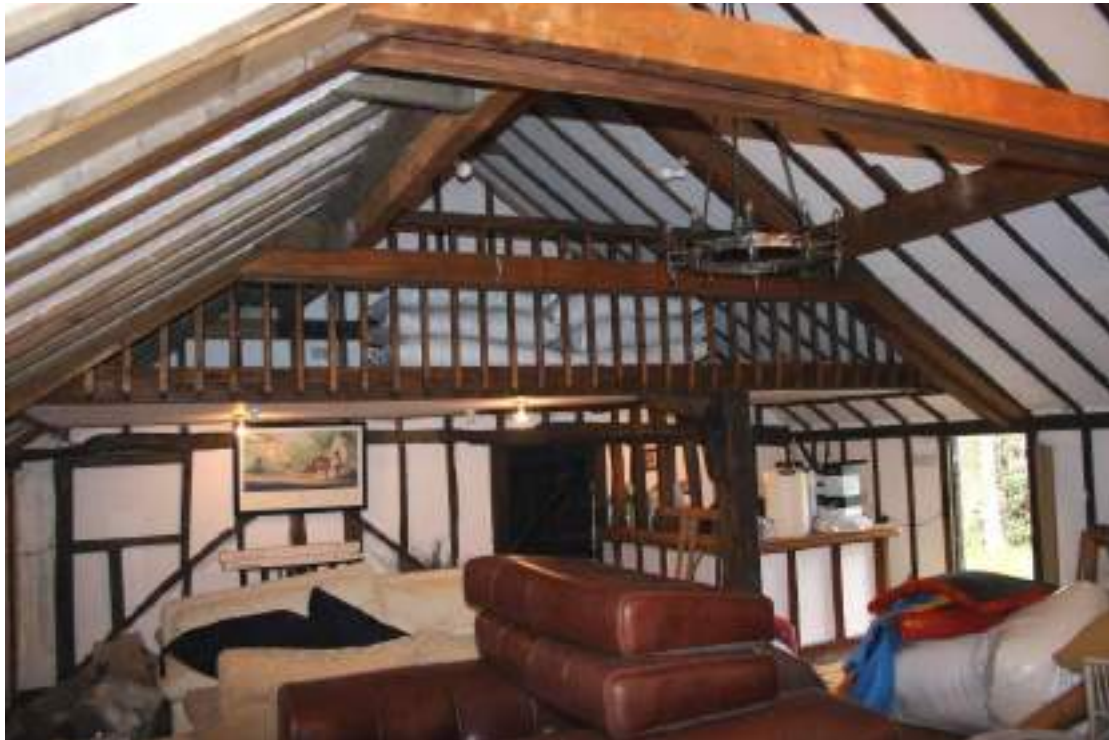
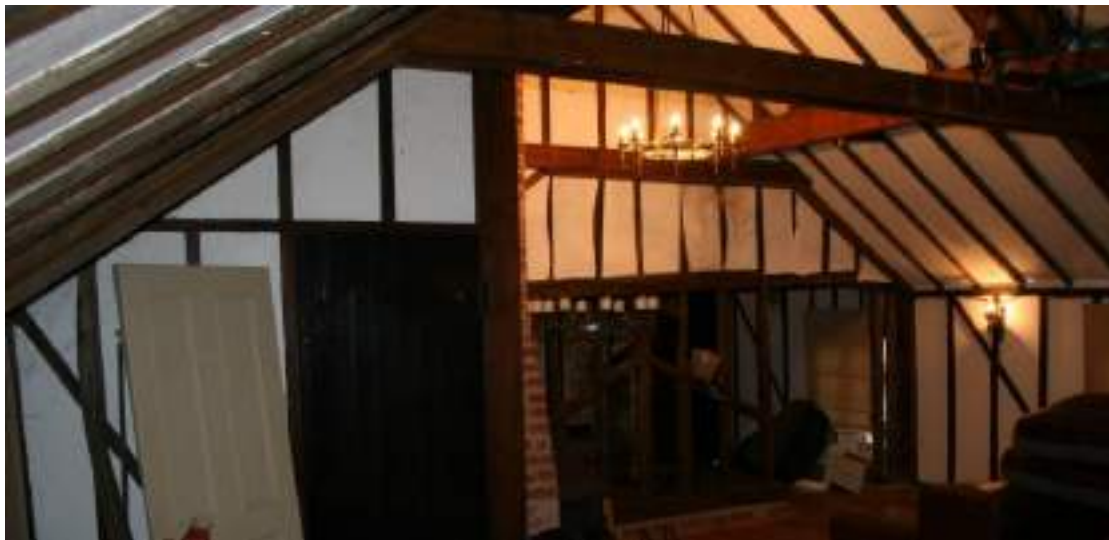
Inside the Wheelwright's Shop looking W.

Inside the Wheelwright's Shop looking E at the Forge.

The interior of the Wheelwright's Shop displays the scantling frame in much the same way as the House. Made of poor quality timber, cleaned and stained dark brown the SW and NW walls retain part of a primary braced, interrupted and nailed studwork frame. Large parts of the NW wall and all of the SE wall are made from 2x4in softwood. The SE wall however is almost all LC20th and part of the 1982/3 works.

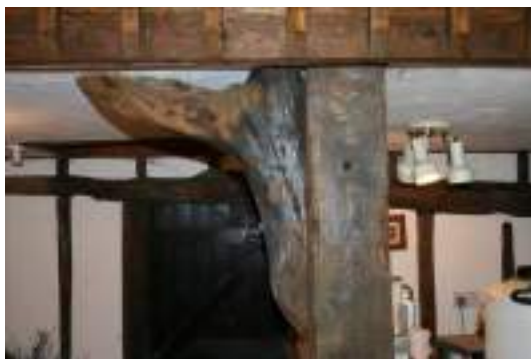
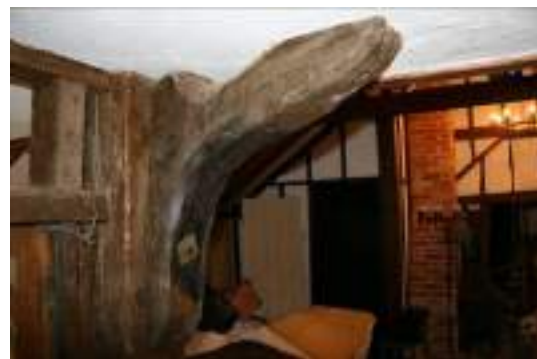
Detail of a single remaining hanging knee cut from a tree branch.

A single old bracket in the form of a hanging knee cut from a branch or tree root has been incorporated into the structure perhaps as a reminder of the original form. Secured with a modern bolt it could have come from anywhere.

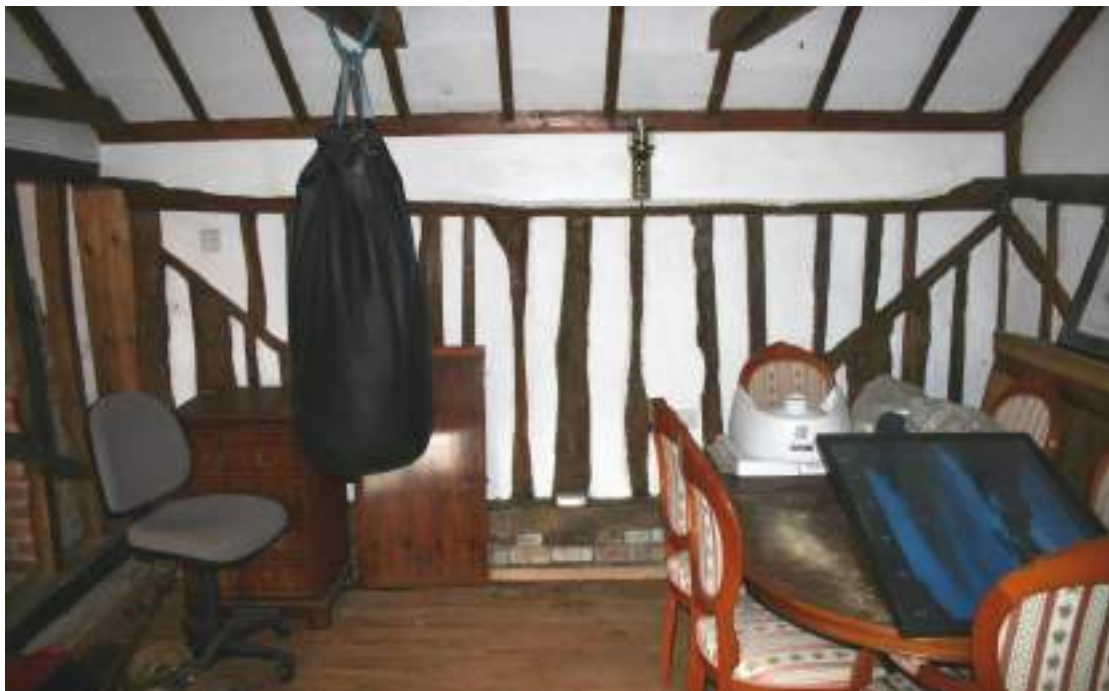
The NW wall of the Forge. Note the raised roof plate and modern roof.

The Forge retains a rather rustic interrupted stud wall where the studs are closely spaced and very irregular widths representing a continual battle with repairs. The roof has been raised as part of the 1982/3 works and incorporates machine softwood paired collars and older 2x4in softwood rafters.

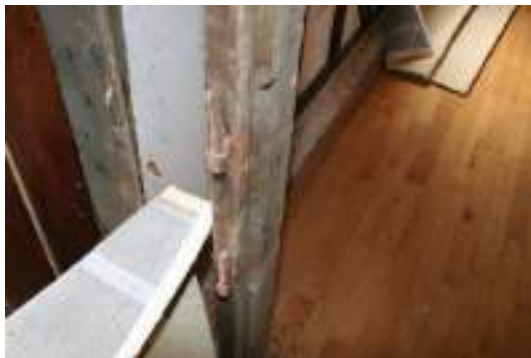
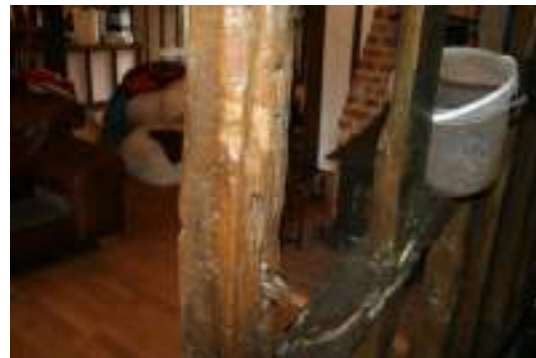
The door jambs in the partition between the Forge and the Wheelwright's Shop.

There is clear evidence for a connecting door between the two builds in the partition. Two studs, acting as door jambs have pintle hinges and a catch plate for a split stable door.

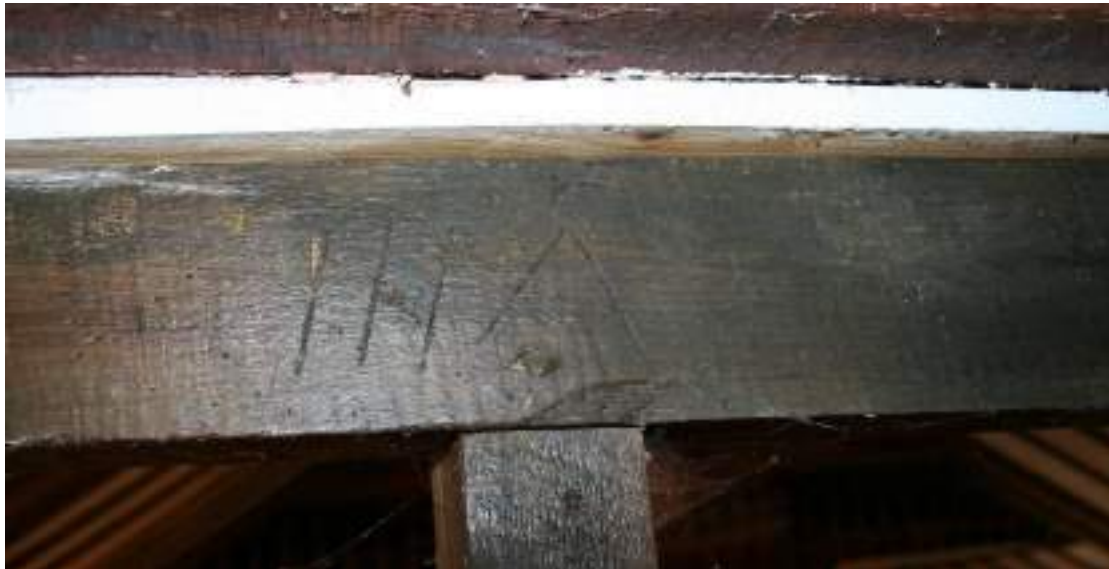
Carpenter's mark on the exposed partition wall. Note pitsaw marks.

The partition between the Forge and the Wheelwright's Shop is marked up with a race knife on the pitsawn timber that equates to the top-plate of the Forge. Unusually it is on the inside but as this wall has been completely rebuilt it may have been accidentally reversed.

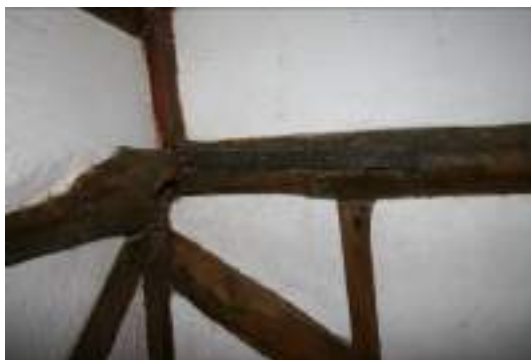
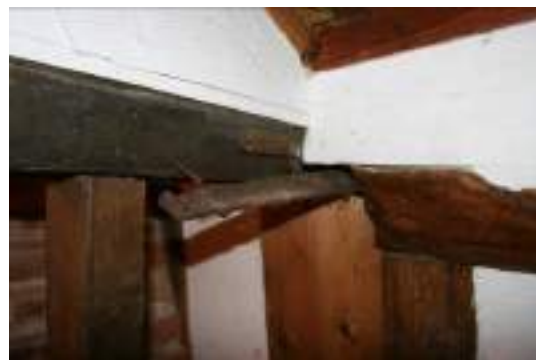
Wrought iron L-ties used to reinforce the corners of the frame,

Unsurprisingly for a forge there are plenty of small iron fittings used to reinforce the frame from its first fix through a long series of alterations and repairs. The wrought iron L-ties securing the corners of the frame are EC19th in design and fabrication.
