Heritage Statement

Bridgewick Hall, Chappel, Essex

The Architectural History Practice Limited

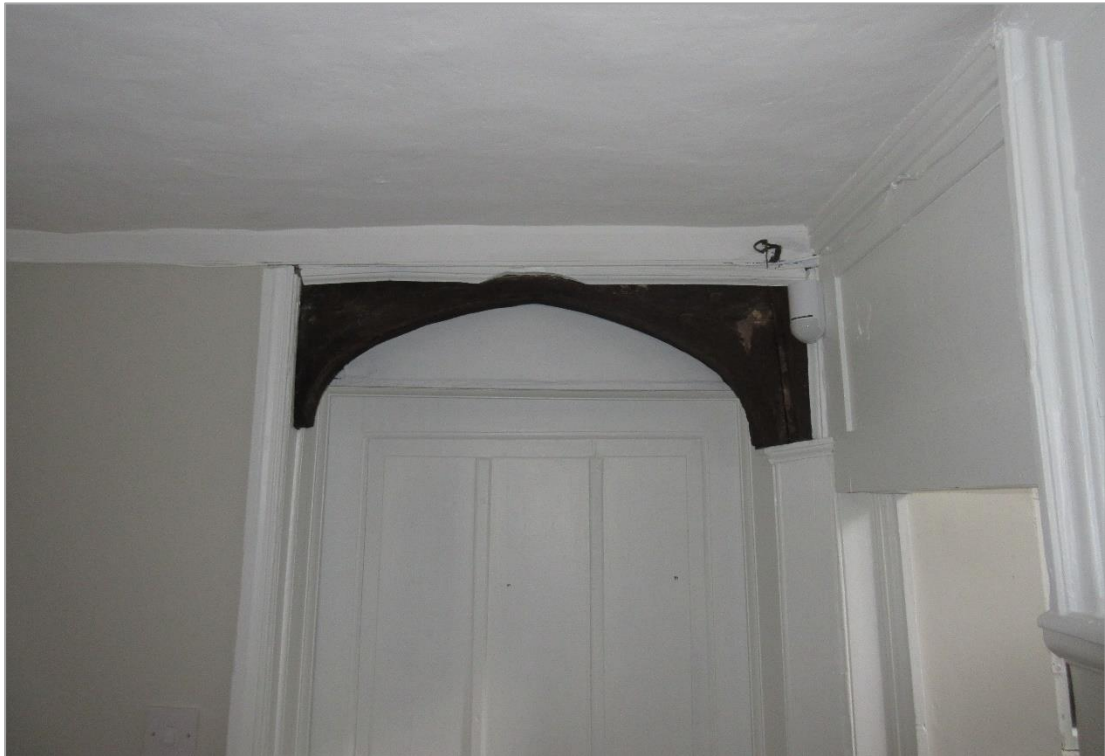
Figure 2: Medieval arch in entrance hall

VCH suggests that it originated as a fourteenth century hall with a two-storeyed end in line to the west. This would be represented by the present entrance hall (the hall) and drawing room - excluding the northern projection - and bedroom above (the parlour and solar). An arched medieval door head in the hall may denote the position of the opening from the hall to the parlour.

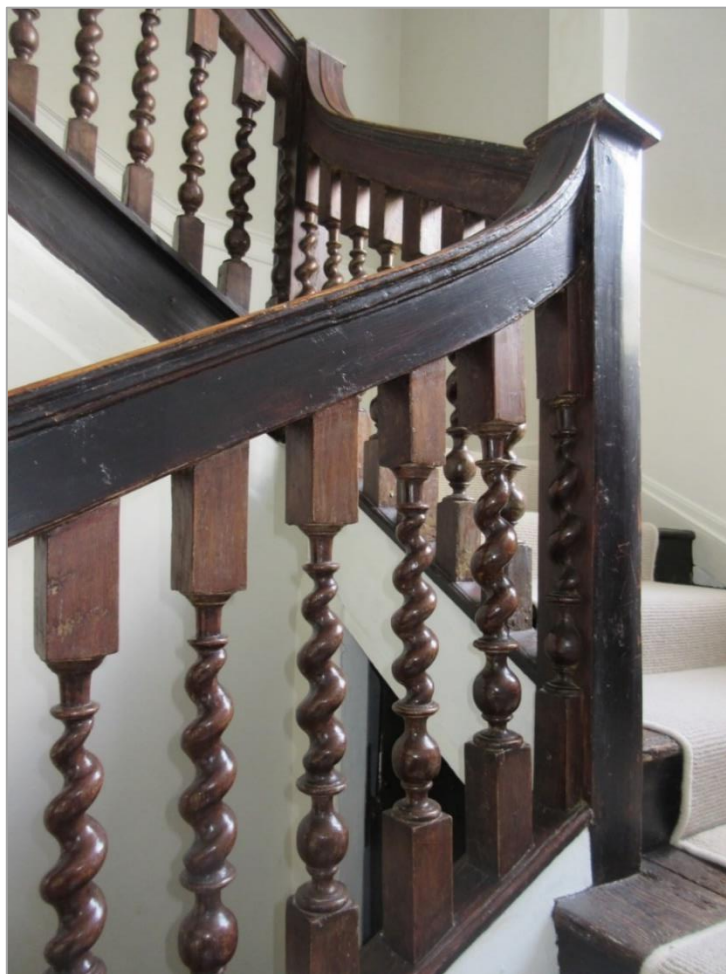
Figure 3: Late C17/early C18 stair

- 2.2.1 In 1680 Bridgewick Hall was acquired by Solomon Grimston, a local landowner (steward of Crepping Hall manor) and lawyer. He owned the house until 1747, during which time he added the main staircase addition to the north of the entrance hall (figure 3), extended the main range eastwards (the present dining room), raised the house to give taller first-floor rooms and attics (where a graffito bearing the date 1722 is to be found), and rebuilt the end stacks. Bolection moulded panelling was installed in the entrance hall, drawing room and principal (central) bedroom.

- 5.2.3 In the **understair cupboard** repairs will be made to the rotten framework, the staircase under-drawn with fire resistant material, glue blocks added as required to strengthen the staircase and the floor finishes lifted and re-laid on a new sub-base. This work is required to secure the repair and conservation of the staircase (figure 3), an element of considerable significance.

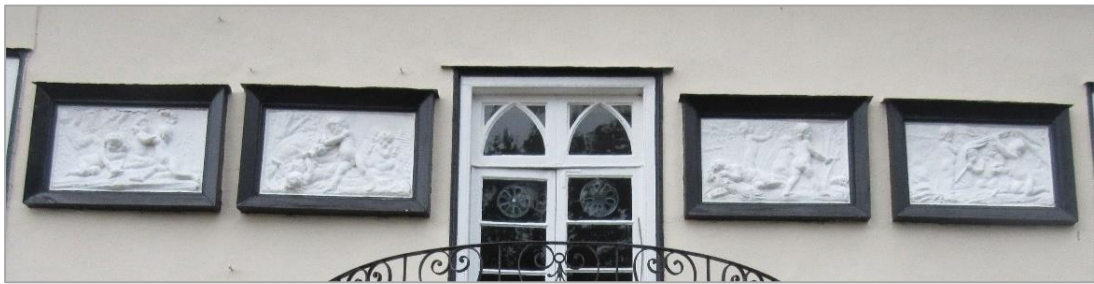
Figure 4: Four Seasons panels on the front elevation

- 2.3.1 Late Georgian alterations include raised and fielded panelling in two bedrooms and on the dado of the main stair. The house was again altered in the early nineteenth century, by William Penn Gaskell, who remodelled the front to create a symmetrical elevation, with central porch and large sash windows. Neoclassical plaster panels based on allegorical themes were installed on the front elevation: two roundels depicting Night and Day (after well-known and much-copied roundels of 1815 and 1816 by the Danish sculptor Betel Thorvaldsen) and four rectangular panels depicting the Four Seasons (copies of panels on Edmé Bouchardon's Fontaine des Quatre Saisons, Paris, 1745, figure 4).

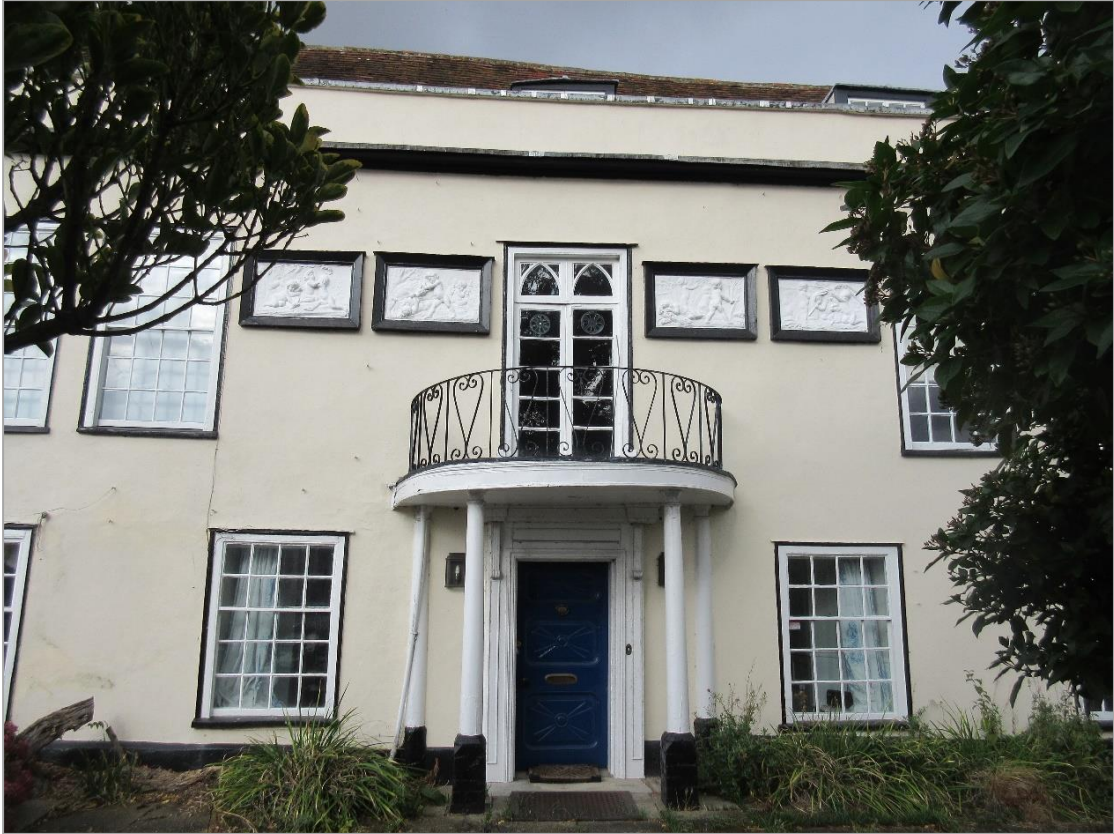
Figure 6: Front elevation. This will be repaired, with a new lime-based render finish. The inappropriate railings over the porch will be replaced with new railings of more sympathetic design

- 5.1.6 At present the **porch** roof causes flooding into the upstairs bedroom (proposed master bedroom). It is proposed to repair/rebuild the structure as necessary, re-roofing it in lead, and to repair the existing entablature fascia and mouldings, columns and plinths.

The negative/intrusive modern railings on top of the porch (figure 6) will be replaced with new railings incorporating a gothic pattern, echoing the design of the French doors to the central first floor bedroom.

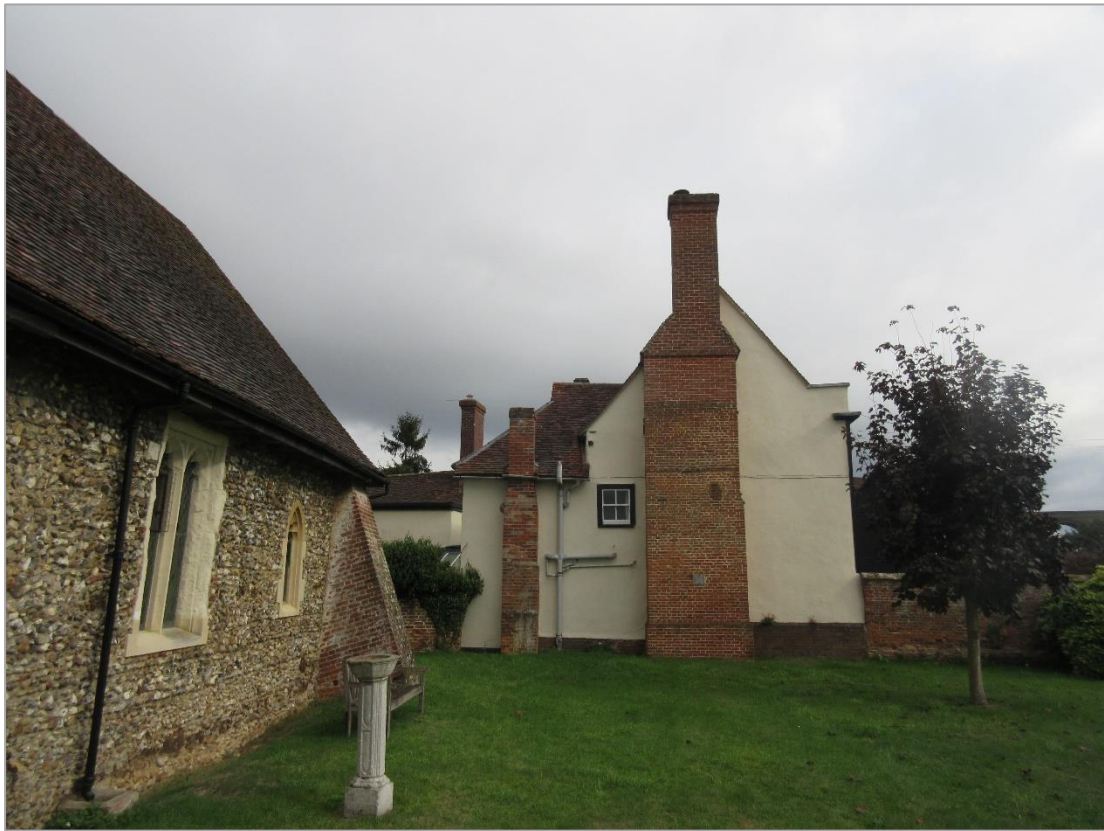
Figure 7: West elevation towards churchyard. Apart from repairs, the only alteration proposed here is a small attic window in the gable end

- 5.1.7 Small additional **window openings** of traditional design are proposed on the east and west gable elevations. That on the east gable end appears to be in the position of a previous window. The precise size and position of the proposed opening on the west gable (figure 7) will need to be confirmed after opening up, and will be governed by the need to avoid damage to any timber framing. The appropriate replacement of a number of negative/intrusive modern-off-the-peg windows in existing openings in the north range (figure 8) is also proposed.

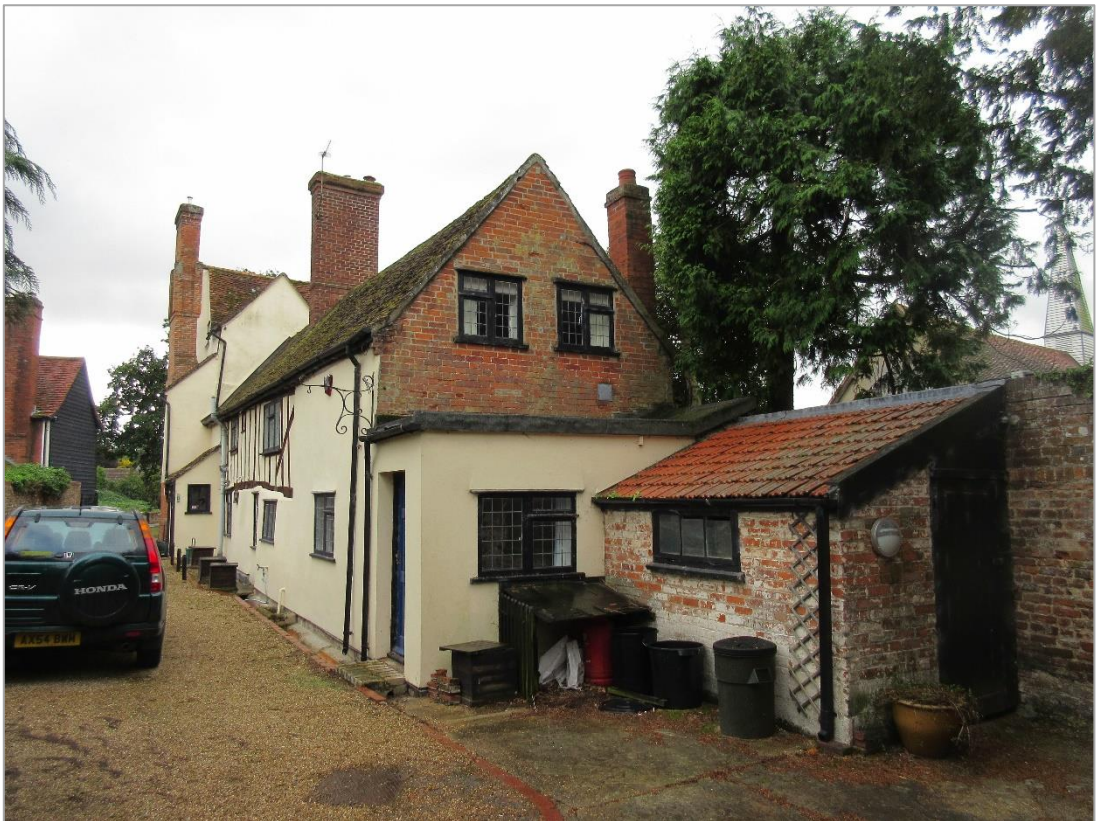
Figure 8: N range, looking S. This will be repaired and the negative/intrusive modern windows replaced with bespoke windows of more suitable design. The flat-roofed boot room will be given a pitched slate roof, and the brick shed slated and clad in shiplap boarding for insulation.

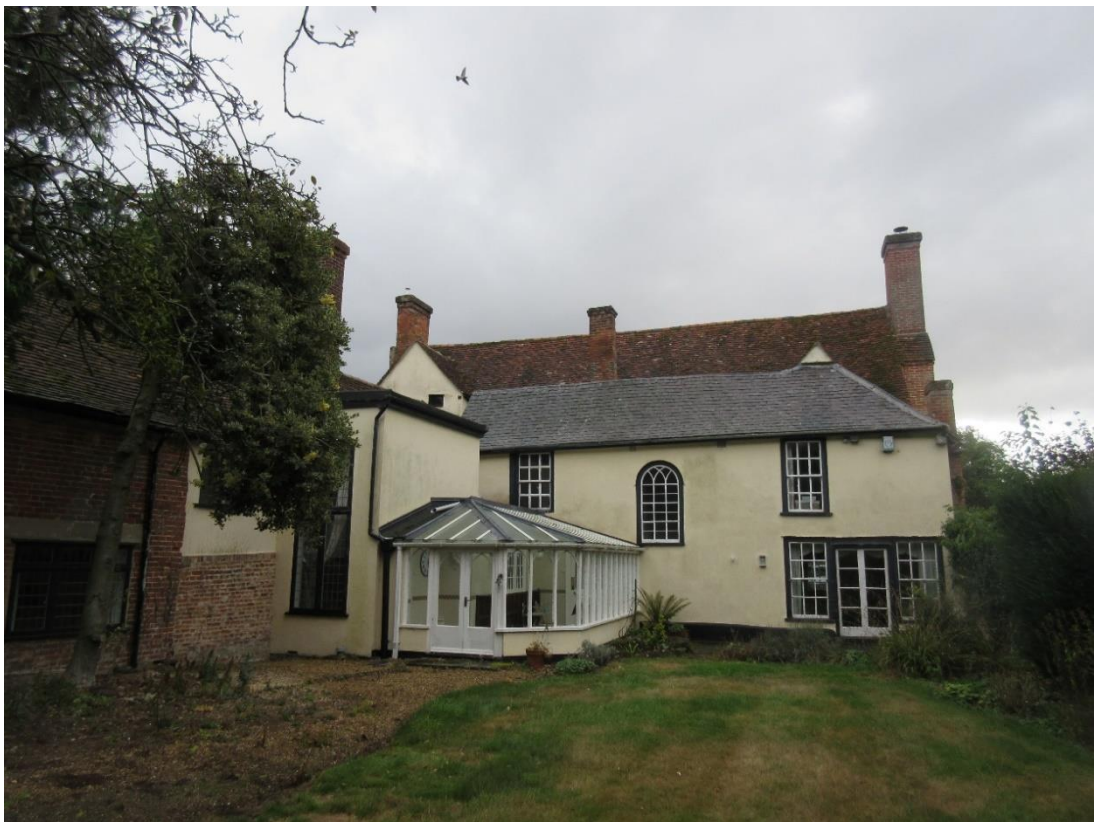
Figure 9: Rear elevation, with modern conservatory and flat-roofed stair addition to left. These will be removed to allow for the construction of the new stair turret and garden room. The modern French doors to the right will also be replaced.

- 5.1.8 At the rear, the modern conservatory, utility room, WC, and north stair addition will be demolished. These (figure 9) are all later additions of little significance. A **new stair turret** and **garden room** are proposed in place of the conservatory and stair enclosure. The design approach for this new work is set out in the Design and Access Statement.

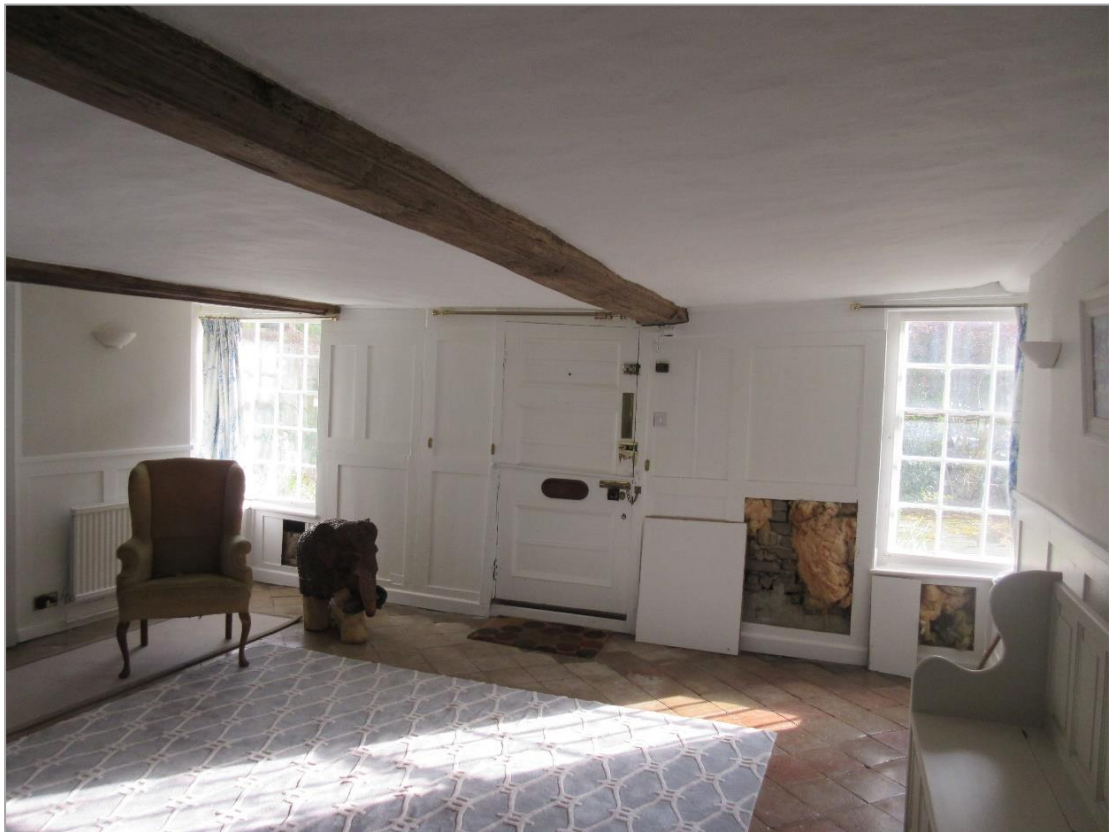
Figure 10: The entrance hall, view towards the front door, with the moulded and stop-chamfered spine beams of the late-C16 inserted floor and C17 and C18 panelling, some reset

- 5.2.1 The front door will be refurbished and draft-proofed. In the **entrance hall** (figure 10), historic panelling will be temporarily removed to allow for repairs to the timber framing of the external wall, followed by reinstatement. The pavement floor tiles will be lifted and re-laid to allow for installation of underfloor heating (and thereby the removal of the unsightly existing radiators). A modern door and door frame to Lobby 2 (figure 11) will be removed, thereby returning the archway beyond to the main space of the entrance hall. These works will secure the repair, conservation and better presentation of elements of considerable significance, and involve the removal only of later elements of little significance.

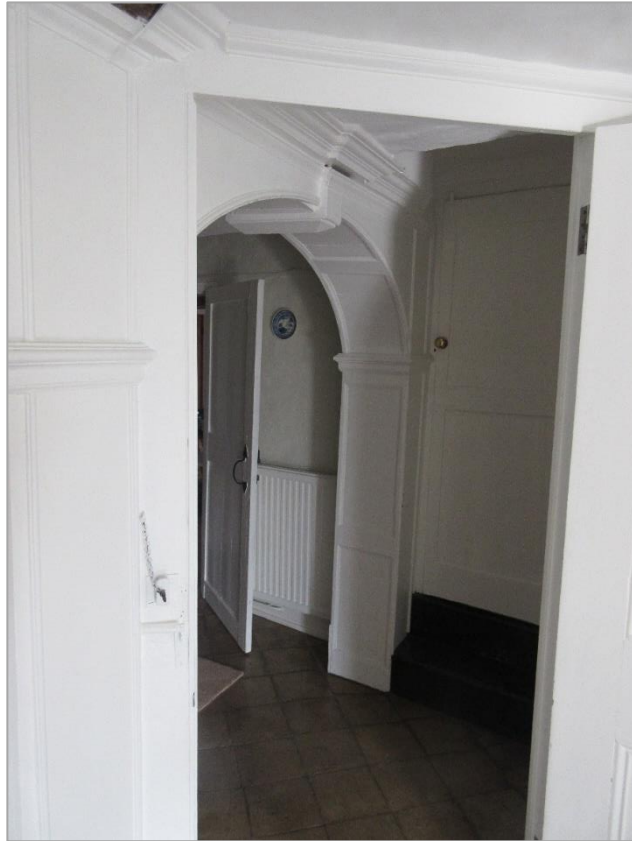
Figure 11: Removal of an inserted door and door frame (foreground) will allow the C17 arch to be returned to the entrance hall space

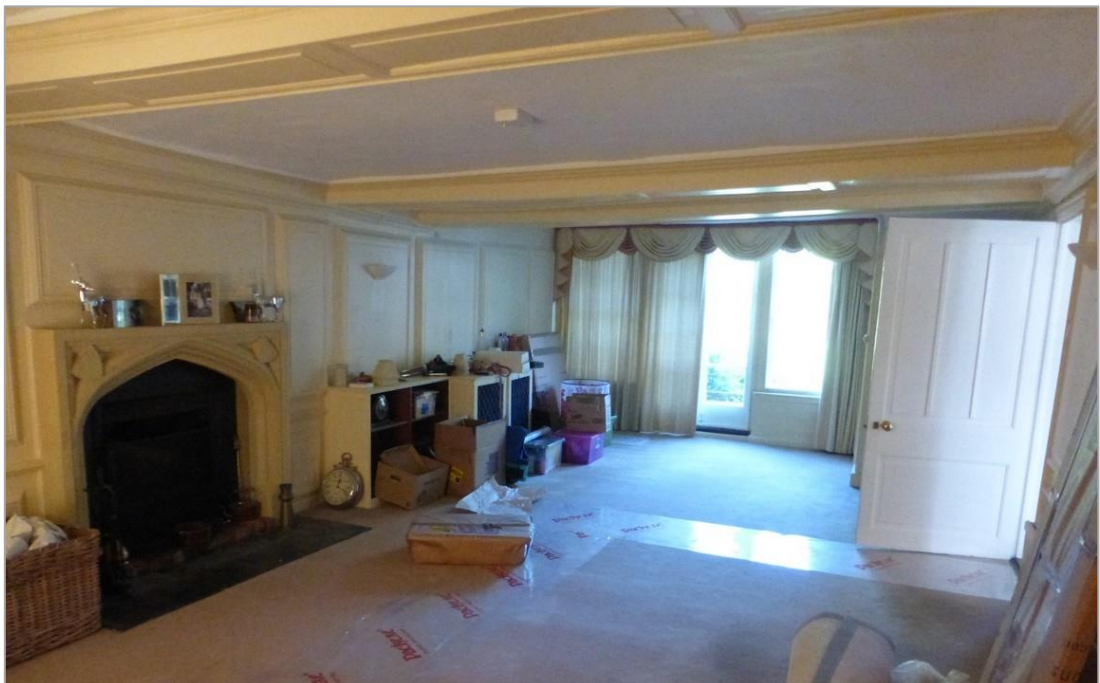
Figure 12: Drawing room, looking N. Previously two rooms, this was opened up to form a single space in the C20, with the panelling reused/replicated. The stone gothic fireplace is modern (Photo Rodney Black Design Studios)

- 5.2.2 Similarly, in the **drawing room** (figure 12) the bolelection moulded panelling will be temporarily removed in order to carry out repairs to rotted areas of the timber frame. The frame will be repaired in a like-for-like manner, or firmed up in masonry where it has disappeared, with improved insulation and damp-proofing. The panelling will then be reinstated. A fitted, low cabinet will be removed and the panelling made good. The negative/intrusive modern stone fireplace and hearth will be replaced with a new fire surround and hearth more sympathetic with the character of the room. The French doors will be replaced with new French doors of improved design, and repair and discreet strengthening will be carried out on the deflecting beams spanning the room. Again, these works are necessary to secure the repair, conservation and better presentation of elements of considerable significance, and involve only the removal of later elements which are of little significance or negative/intrusive.

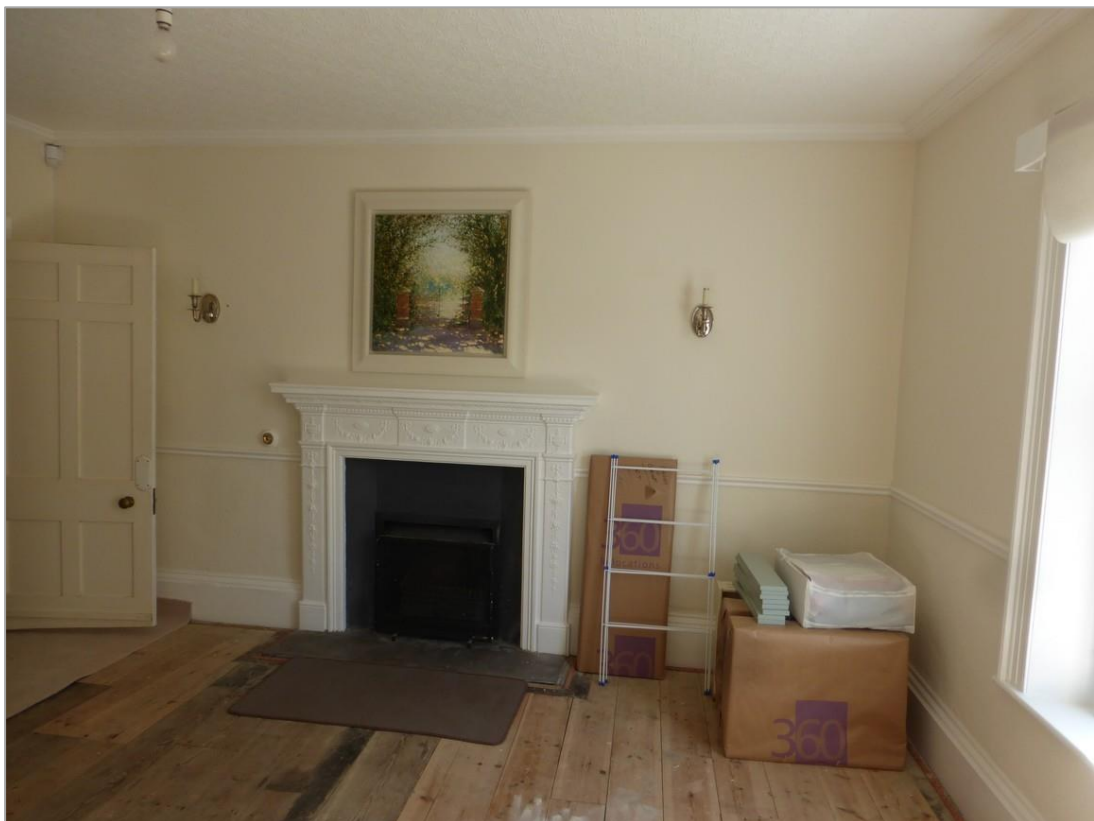
Figure 13: The dining room has a C19 character (Photo Rodney Black Design Studios)

- 5.2.4 In the **dining room** (figure 13), wall finishes will be temporarily removed to carry out repairs as described for the entrance hall and drawing room, prior to reinstatement. These works are necessary to secure the repair and conservation of elements of considerable significance and will not require the removal of significant fabric.

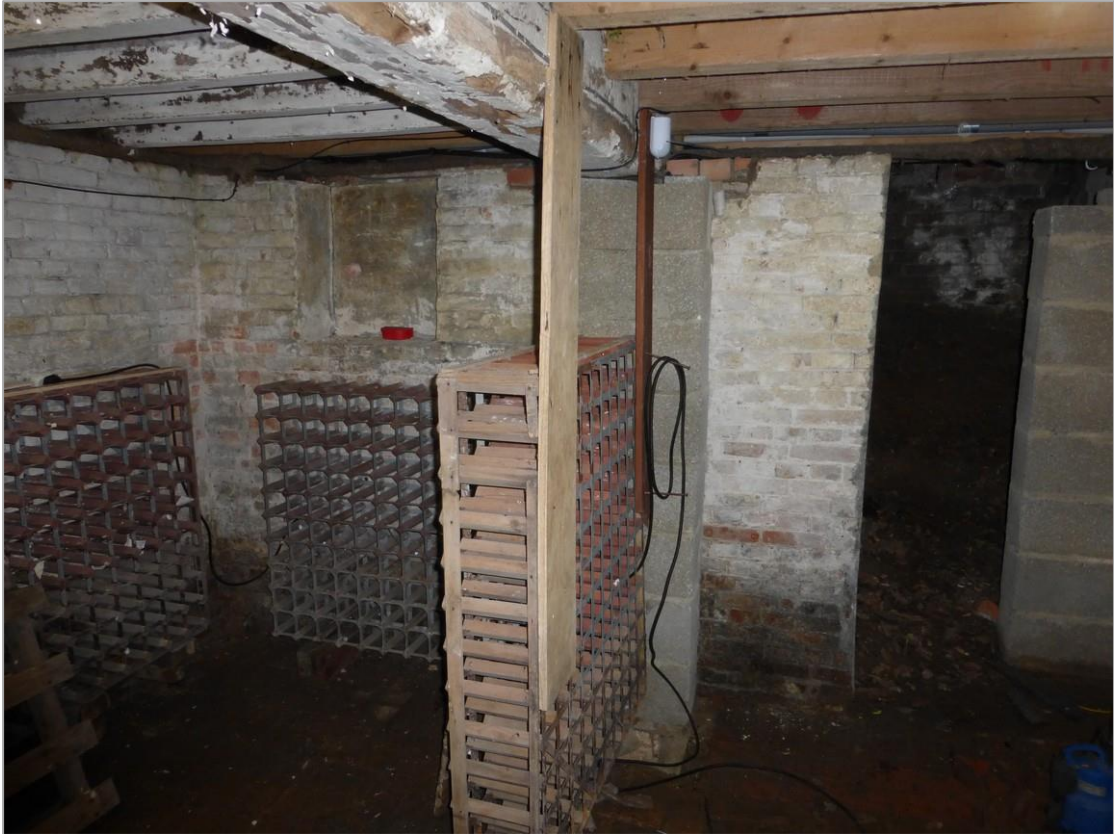
Figure 14: The cellar below the dining room was probably created in the C18 or C19 (Photo Rodney Black Design Studios)

- 5.2.5 Below the dining room, minor works involving upgrading of finishes and security are proposed in the **cellar** (figure 14), along with the construction of wine bins. This is an area of moderate significance and the impact of these works on its character and significance will be low.

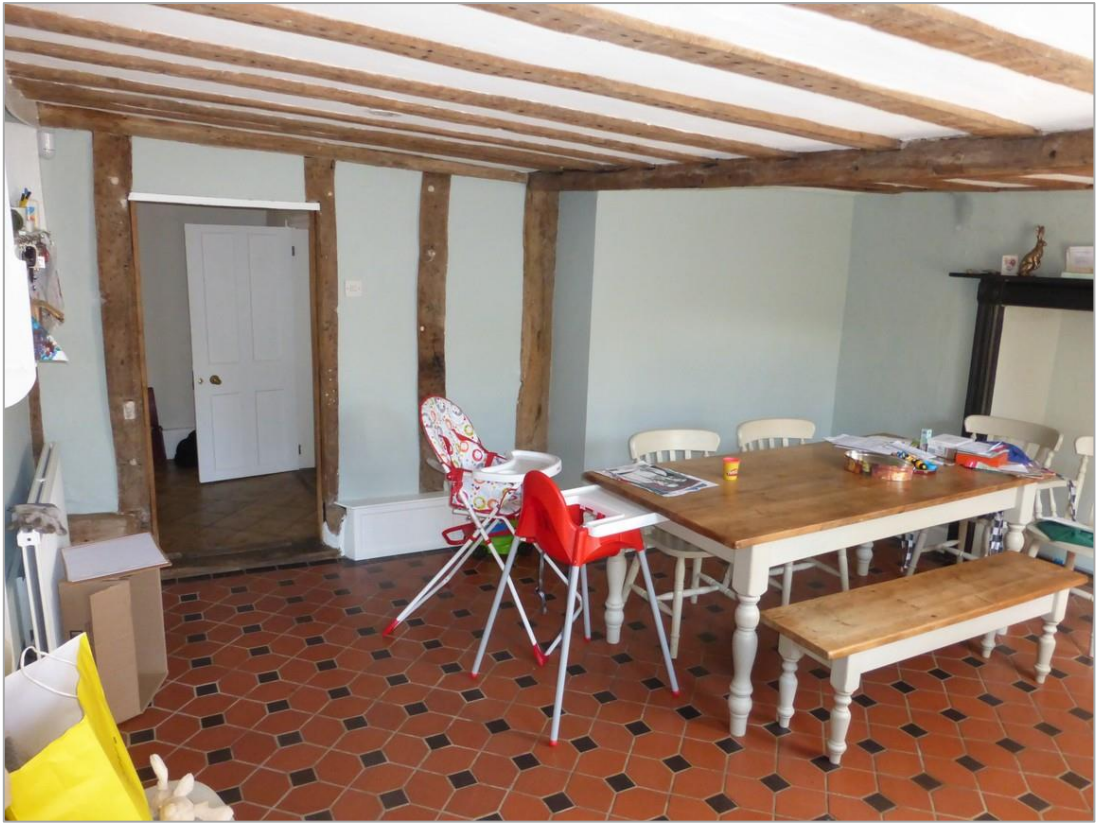
Figure 15: The rear hall in the north range (Photo Rodney Black Design Studios)

- 5.2.7 Improvements will be made to the **rear hall**, in the north range (figure 15). Temporary removal of cladding/wall finishes will allow for repairs to the timber framing. The modern quarry tile floor finishes will be lifted and re-laid or renewed, to incorporate underfloor heating. Adjustments will be made to the floor levels in the twentieth century lobby/porch. The inner door to the porch will be removed and the outer door upgraded. These works will improve the layout and servicing of the house, and do not involve the removal of significant fabric or finishes. The timber framing will remain exposed.

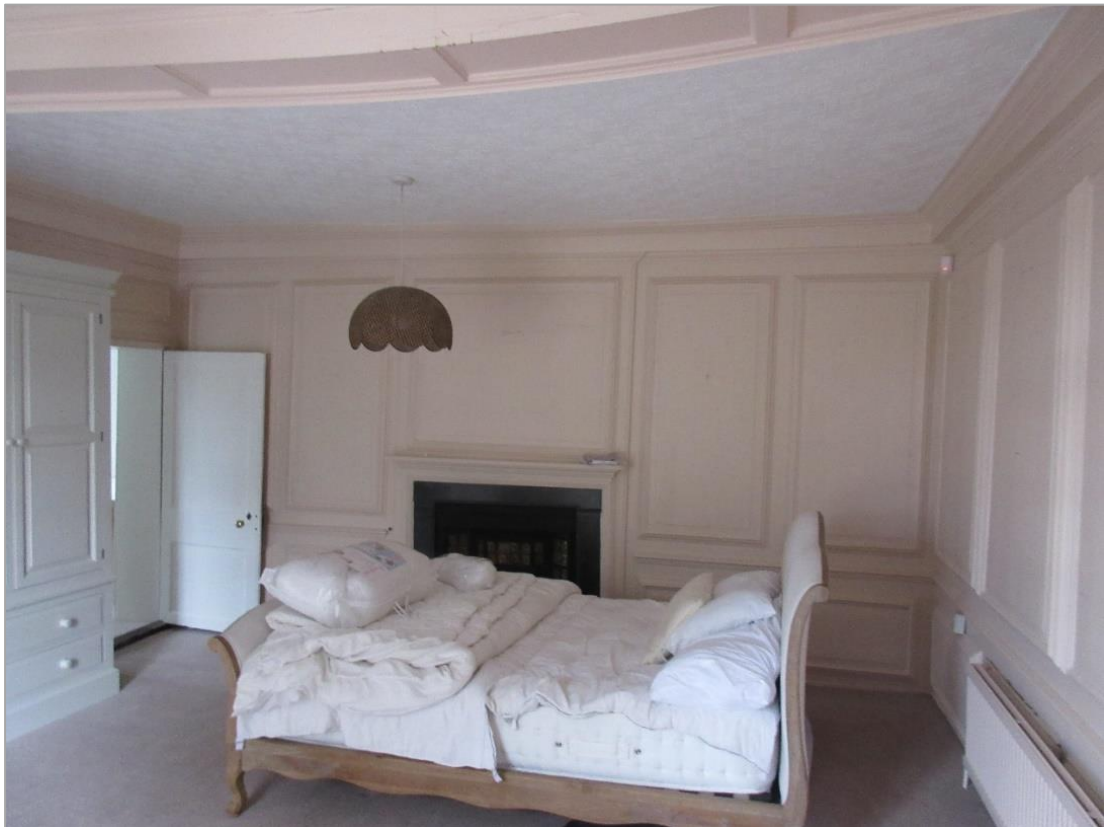
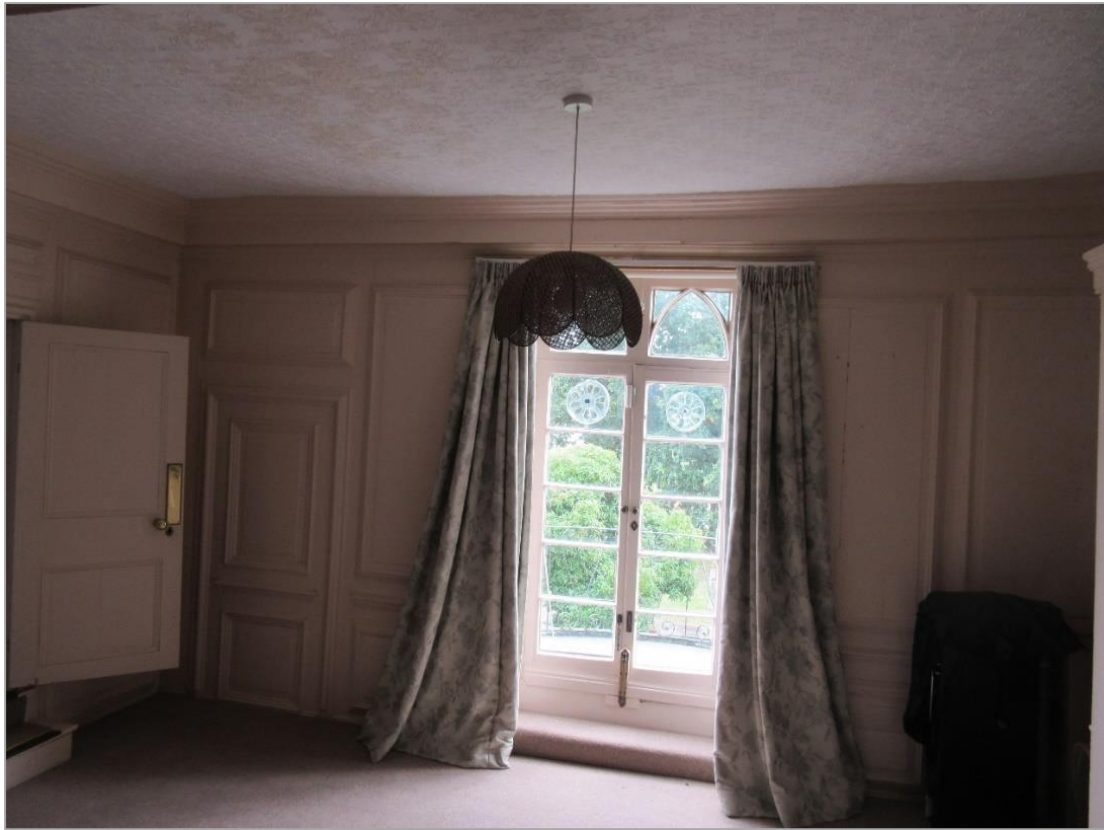
Figure 16: Master bedroom, looking north

Figure 17: Master bedroom, looking south, showing false door in panelling

5.3.2 The **master bedroom** (figures 16 and 17) will be the middle room of the main east west range, occupying the space over the entrance hall. It is lined with bolection moulded seventeenth-century panelling, some of it evidently reset. A chimneypiece is located on the north side of the room. This is a space of considerable significance, and only minor changes are proposed. The door to bedroom 2 will be fixed shut. A non-functioning door and the panel over it in the panelling of the south wall will be relocated to serve as a functioning door to the proposed library to the north, with the panelling thus displaced relocated to the space left on the south wall. Otherwise only localised repairs are proposed.

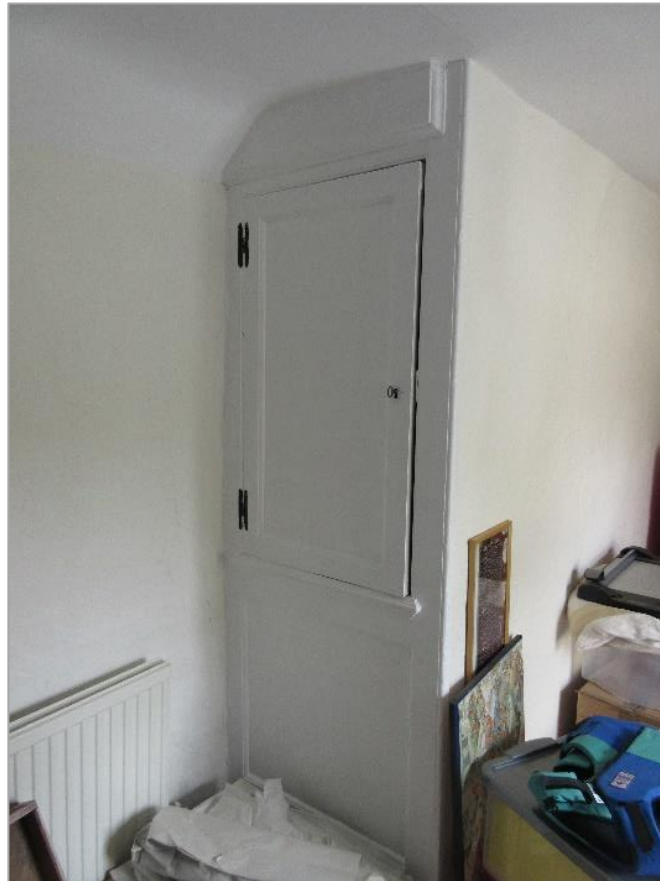
Figure 18: C18 cupboard in side of stack, proposed library

5.3.3 The new opening to the proposed **library** from the master bedroom will require some adaptation of the brickwork in the side of the stack. This stack has been entirely removed entirely at ground floor level, and the small part to be removed at first floor level is well clear of the existing master bedroom fireplace and the position of the chimney where it protrudes through the roof. An eighteenth century cupboard door (figure 18) will be reset within a modified cupboard recess. On the east side of the room, a higher door and frame will be provided to the guest landing.

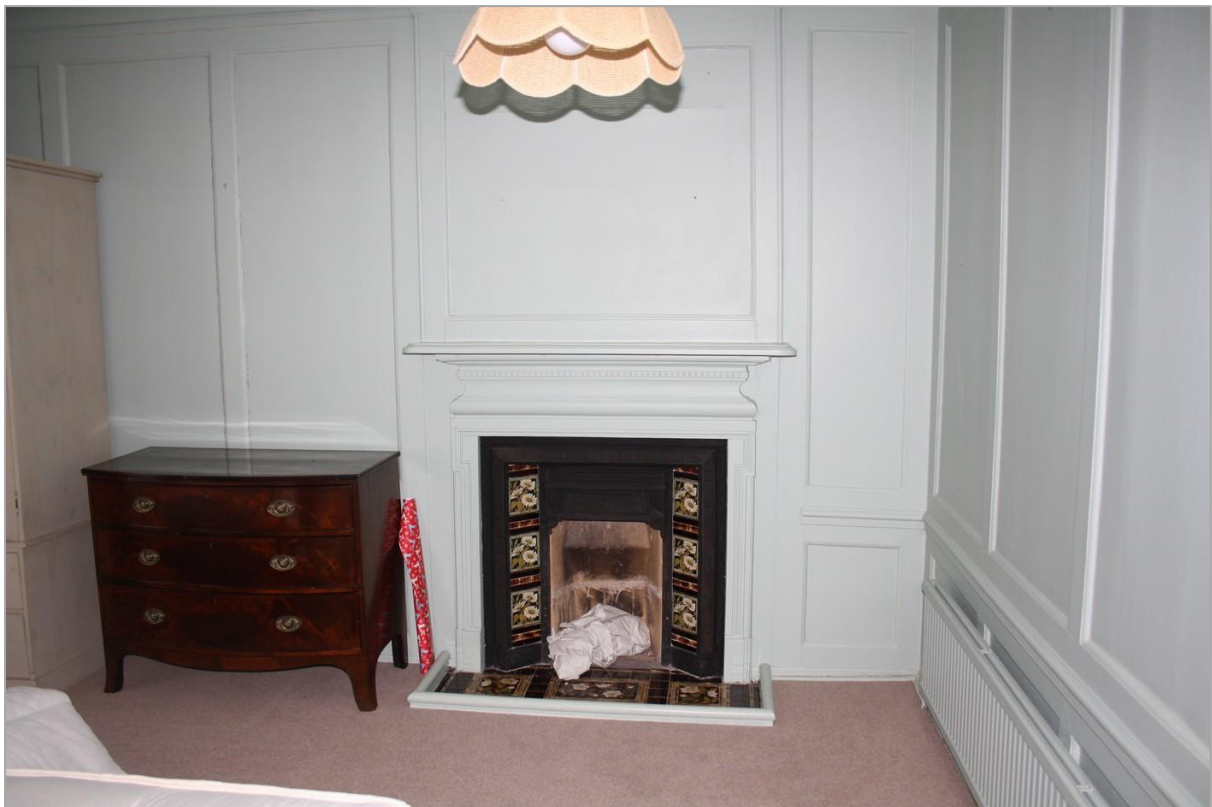
Figure 19: The western first floor bedroom will become the dressing room. It has C18 raised and fielded panelling and a C19 fireplace insert

- 5.3.4 The bedroom to the west of the master bedroom (figure 19) is fitted out with raised and fielded panelling of eighteenth century character, of considerable significance. This will become the **dress**ing room; the only proposed changes are a new cupboard and fitted wardrobe, which will be scribed around the panelling.

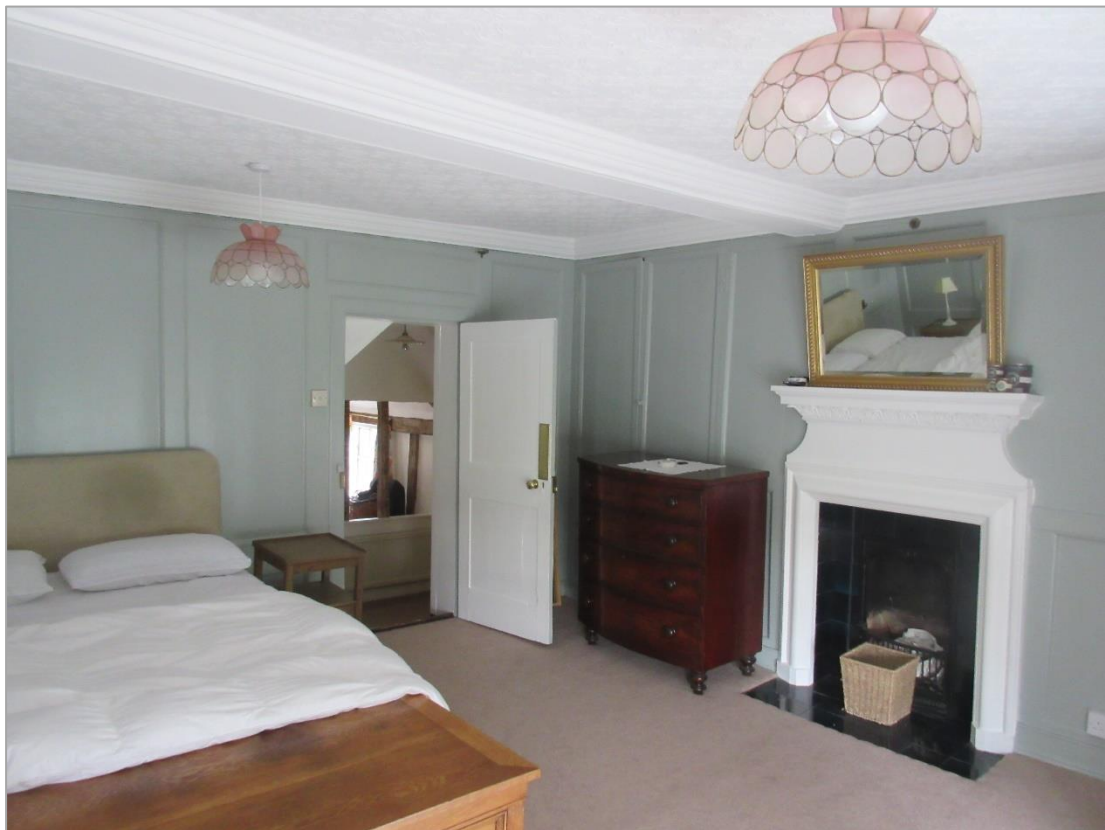
Figure 20: C18 raised and fielded panelling and chimneypiece in bedroom 2

- 5.4.2 The guest bedroom (**bedroom 2**, figure 20) is located to the east of the master bedroom and was described as ‘the bachelor’s bedroom’ in sale particulars of 1912. It is fitted out with raised and fielded panelling of eighteenth century character and is a space of considerable significance. Apart from the closure of the door linking it to the master bedroom, only minor repairs are proposed.

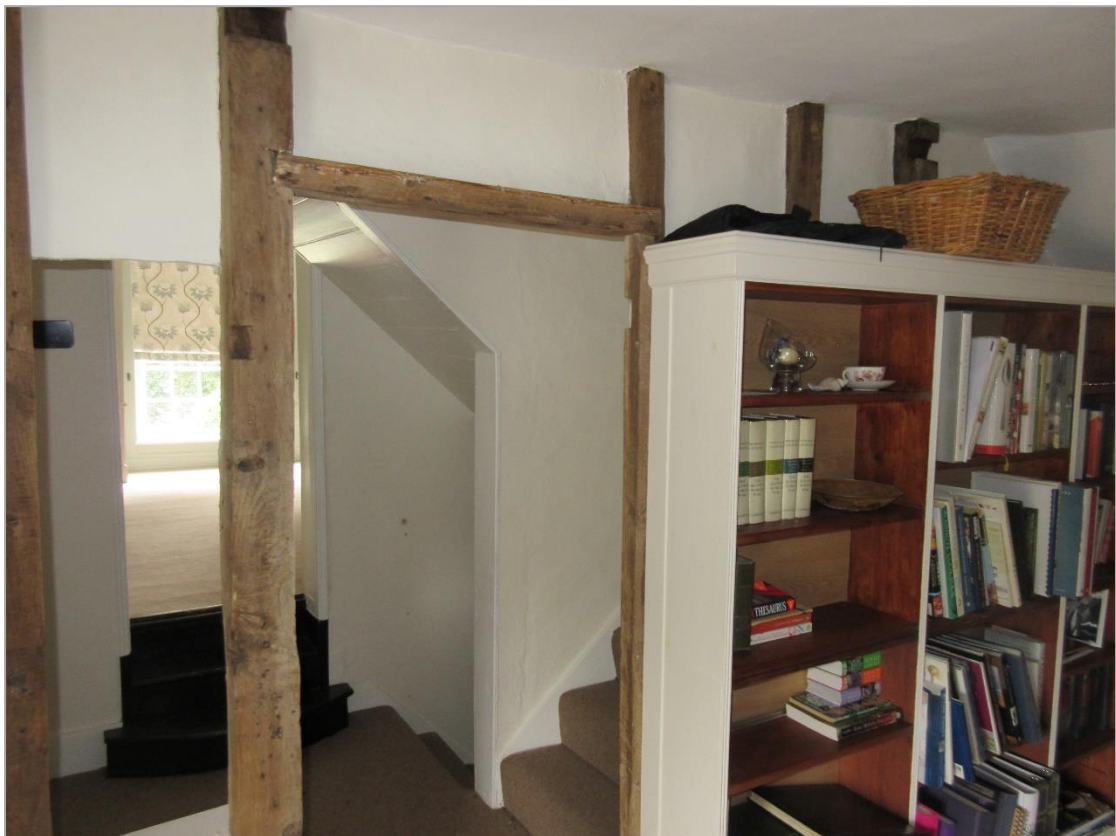
Figure 21: Inserted stud partition on first floor landing, looking south to bedroom 2

5.4.3 Moving into the **north range**, on the guest landing outside the guest bedroom (landing 2), a laylight with light shaft up to a new rooflight and a small new window in the east elevation are proposed. This is in order to light what would become a gloomy space following the proposed formation of a bathroom in this area. This raises no concerns as regards historic fabric; there is evidence of a previous opening where the new window is proposed, and a stud proposed for the proposed lobby linking to the north range belongs to a modern stud partition constructed of reused timbers (figure 21), which will otherwise be infilled to enclose the guest bathroom.

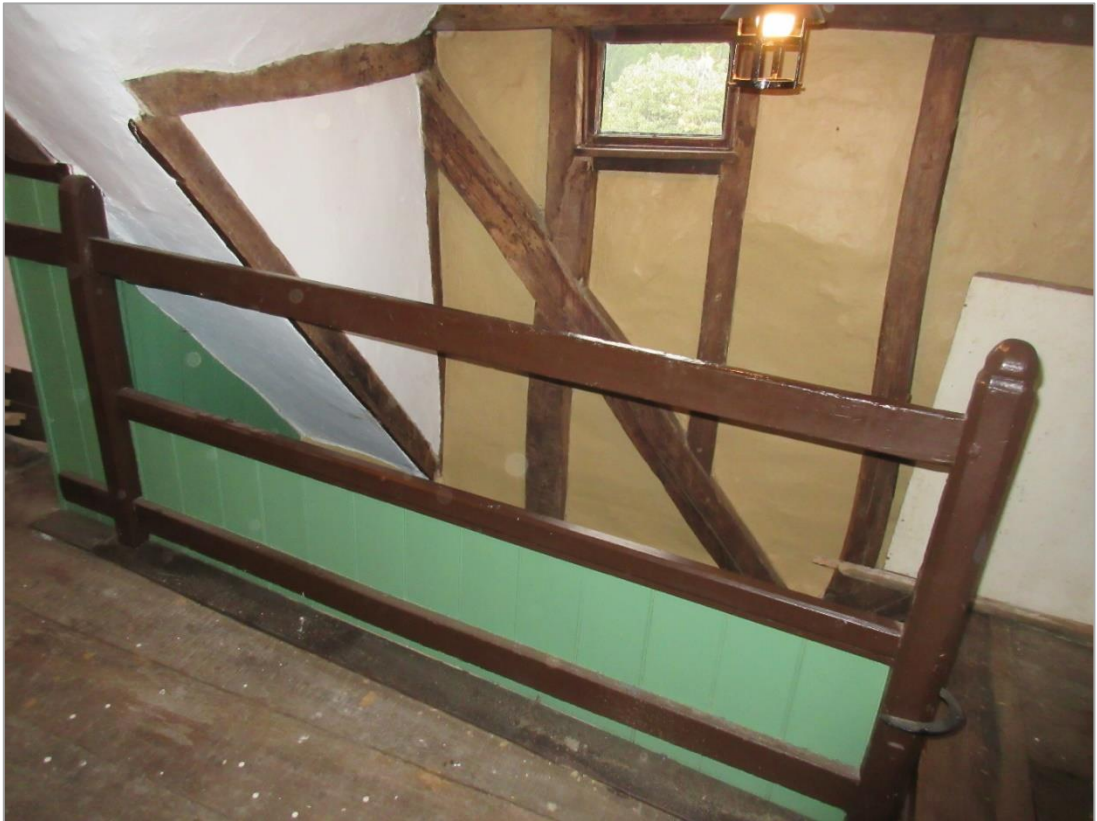
Figure 22: Balustrade at head of stair to attic

- 5.5.1 The stair from the first floor to the attic will be adapted with new winders at the bottom, provision of a handrail and addition of a partition and door at the head (figure 22) to provide fire separation.
