Vol.49 2009

FLISPES, EASTHORPE: A RADITIONAL TIMBER-FRAMED BUILDING

Richard Shackle

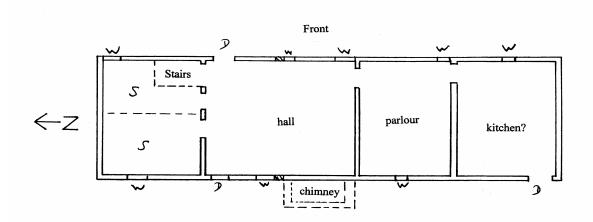
Figure 1: Flispes, Easthorpe, plan of ground floor

The plan of the ground floor (Fig1), as originally built, was as follows. Starting at the north end, the first bay was the service area, next to the cross passage. There were three doors off the cross passage into the service area, one led into the buttery (wet stores such as milk), one led into the pantry (dry stores such as bread) and the final one opened outwards and gave access to the stairs. The next two bays were a floored hall with a cross passage at the north end. As far as I could tell, there was no partition between the cross passage and the hall. The east wall of the hall had the cross passage door in one bay and a hall window with diamond mullions in the other bay. The west wall had the cross passage door and a small window in one bay and a lateral chimney stack in the other. In the south wall there was a door through to the parlour and peg holes for a high end bench. The parlour was the same size as the service bay. It had one small window in the east wall and another in the west wall, so it would have been poorly lit. It would not have been as cosy as most parlours as it acted as a passage to the fifth bay of unknown purpose. The extra bay had one door to the parlour, one door through the rear elevation (west) and a door in north elevation on the upper floor. This presumably was accessed by a staircase and led to the room over the parlour. The room open to the roof had only one window, on the east side of the ground floor. The interior of the south wall had a series of mortices, vertical and horizontal, which must relate to either a kitchen or a craft workshop.

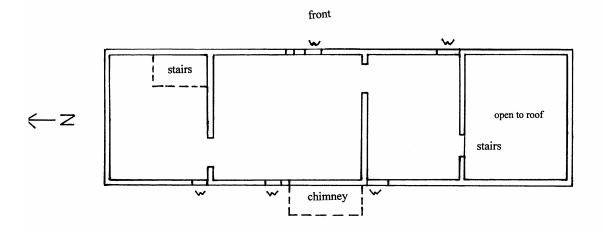
Figure2: Flispes, easthorpe, plan of upper floor

The upper floor consists of three rooms (Fig2). The one over the service bay, which is accessed by a staircase from the cross passage, is lit only by a small window in the rear elevation. A door led from this room into the large room over the hall. This room is lit by a small window in both the front and rear walls. It seems likely that there was a fireplace in this room but as the chimney has long gone we cannot be sure. This room has a door leading into the room over the parlour. This room has one window in the front wall and one in the rear, but in opposite corners. This room has a door in its southern wall, which presumably led via a staircase to the kitchen/workshop.

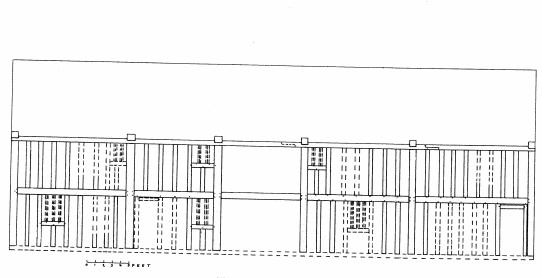
Figure 4: Flispes, Easthorpe, rear elevation

The rear elevation (Fig4) has a similar symmetry to the front. If you exclude the extra bay you can see that the outer bays are mirror images of each other. The high end bay of the hall is completely unframed, showing that there was a lateral chimney stack. As the upper floor is also completely unframed it suggests that there was a large fireplace in the room over the hall. We cannot tell whether it was timber or brick. The door into the kitchen/workshop has a very plain door head, as did the cross passage doors, but they no longer survive.

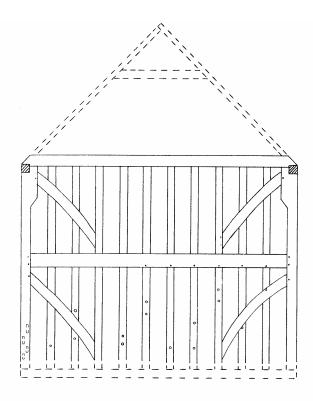
Figure 5: Flispes, Easthorpe, truss K/L

We will now consider the individual trusses, starting with K/L (Fig5) at the north end of the service bay. There are peg holes in the lower studs, several of which line up horizontally, suggesting shelves in service rooms. Outside of the north east post you can see four small vertical mortices. These suggest that a small fence was attached to the building at this point. The roof had been lost from this truss but it undoubtedly would have been very similar to the other roof truss. Truss I/J (Fig6) had lost some of its lower timbers but these can easily be reconstructed using the empty pegged mortices. There were two service doors which opened inwards and a stair door to the east which opened outwards. On the upper floor there was a door connecting the room over the service bay to the room over the hall. The lack of framing above this and all the other internal trusses except one added to the lack of privacy that the inhabitants suffered. Truss G/H (Fig7) is the central truss of the hall. There are no braces on either floor to triangulate the building. The queen strut roof with windbraces is probably decorative to make the main room over the hall look more impressive. Truss E/F (Fig8) separates the hall from the parlour. There are two narrow plain doorways one above the other. The peg holes for the high end bench can be seen in the lower studs. Truss C/D (fig 9) separates the house proper from the kitchen/ workshop. There are two very plain doorways one on each floor, the upper one presumably had a staircase up to it. Note that the roof above the tie beam is fully framed, suggesting that there was a need to keep smoke or smell from going into the house from the kitchen/ workshop.

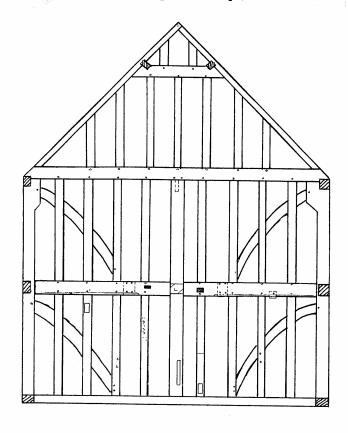
Figure 10 : Flispes, Easthorpe, truss A/B

Truss A/B (Fig 10 internal view) is very complex. There are many mortices in the mid plates, both facing outwards and down through the middle of the mid plates. The chamfers on the mid plates seem to stop about a foot short, on either side of the central post. What these features represent is hard to say, but they could be something to do with cooking, brewing or weaving. The bridging joist seen in cross section half way up the central post is for a later inserted floor. The truss is fully framed right up to the apex.

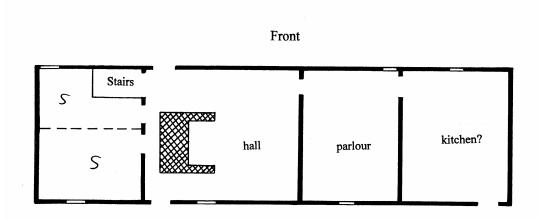
Figure 11: Flispes, Easthorpe, plan of phase 2

The only major change to the building was the demolition of the lateral chimney stack. The empty bay in the west wall, on both floors, was filled with rough timbers, wedged in. A large new brick chimney stack (Fig 11) was built backing on to the cross passage. This made the cross passage at this point very narrow with barely enough room to get to the service room doors. It may be that a new door was made in truss I/J, just inside the west door. The studs were missing from this part of the wall. This would have enabled people to go past the chimney straight into the service area, where there may not have been a dividing wall between the two rooms. The cooking may have been done at this new fireplace, allowing the old kitchen (?) to be floored over to create more space. The siting of the new chimney would allow the householder to sit on his bench at the high end and face the fire, even though it would be abut 15 foot away. Another change was the construction of a new screen against the flank of the stairs in the service room. This screen was made up of vertical boards, painted white with at least two horizontal battens.

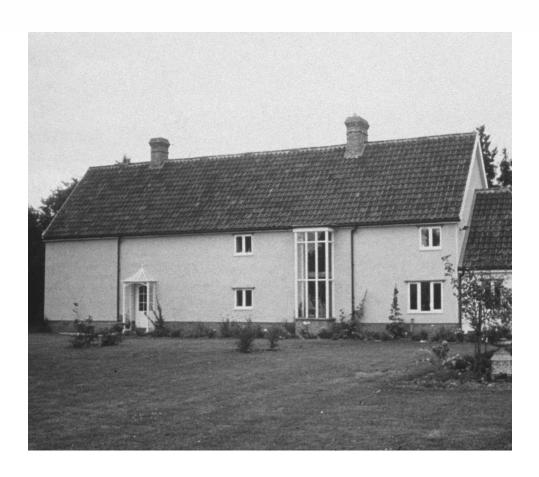
Flispes, Easthorpe, after renovation, with bay window replacing chimney stack.
