# Colchester Cellar Survey 1999-2000

- 1) Property Address: 118 HIGH ST.
- 2) Property Description: 3 STOREYS + CELLAR TIMBER FRAMED WITH GEORGIAN FRONT
- 3) Owners/Tenant's Name: MR JEFFERY

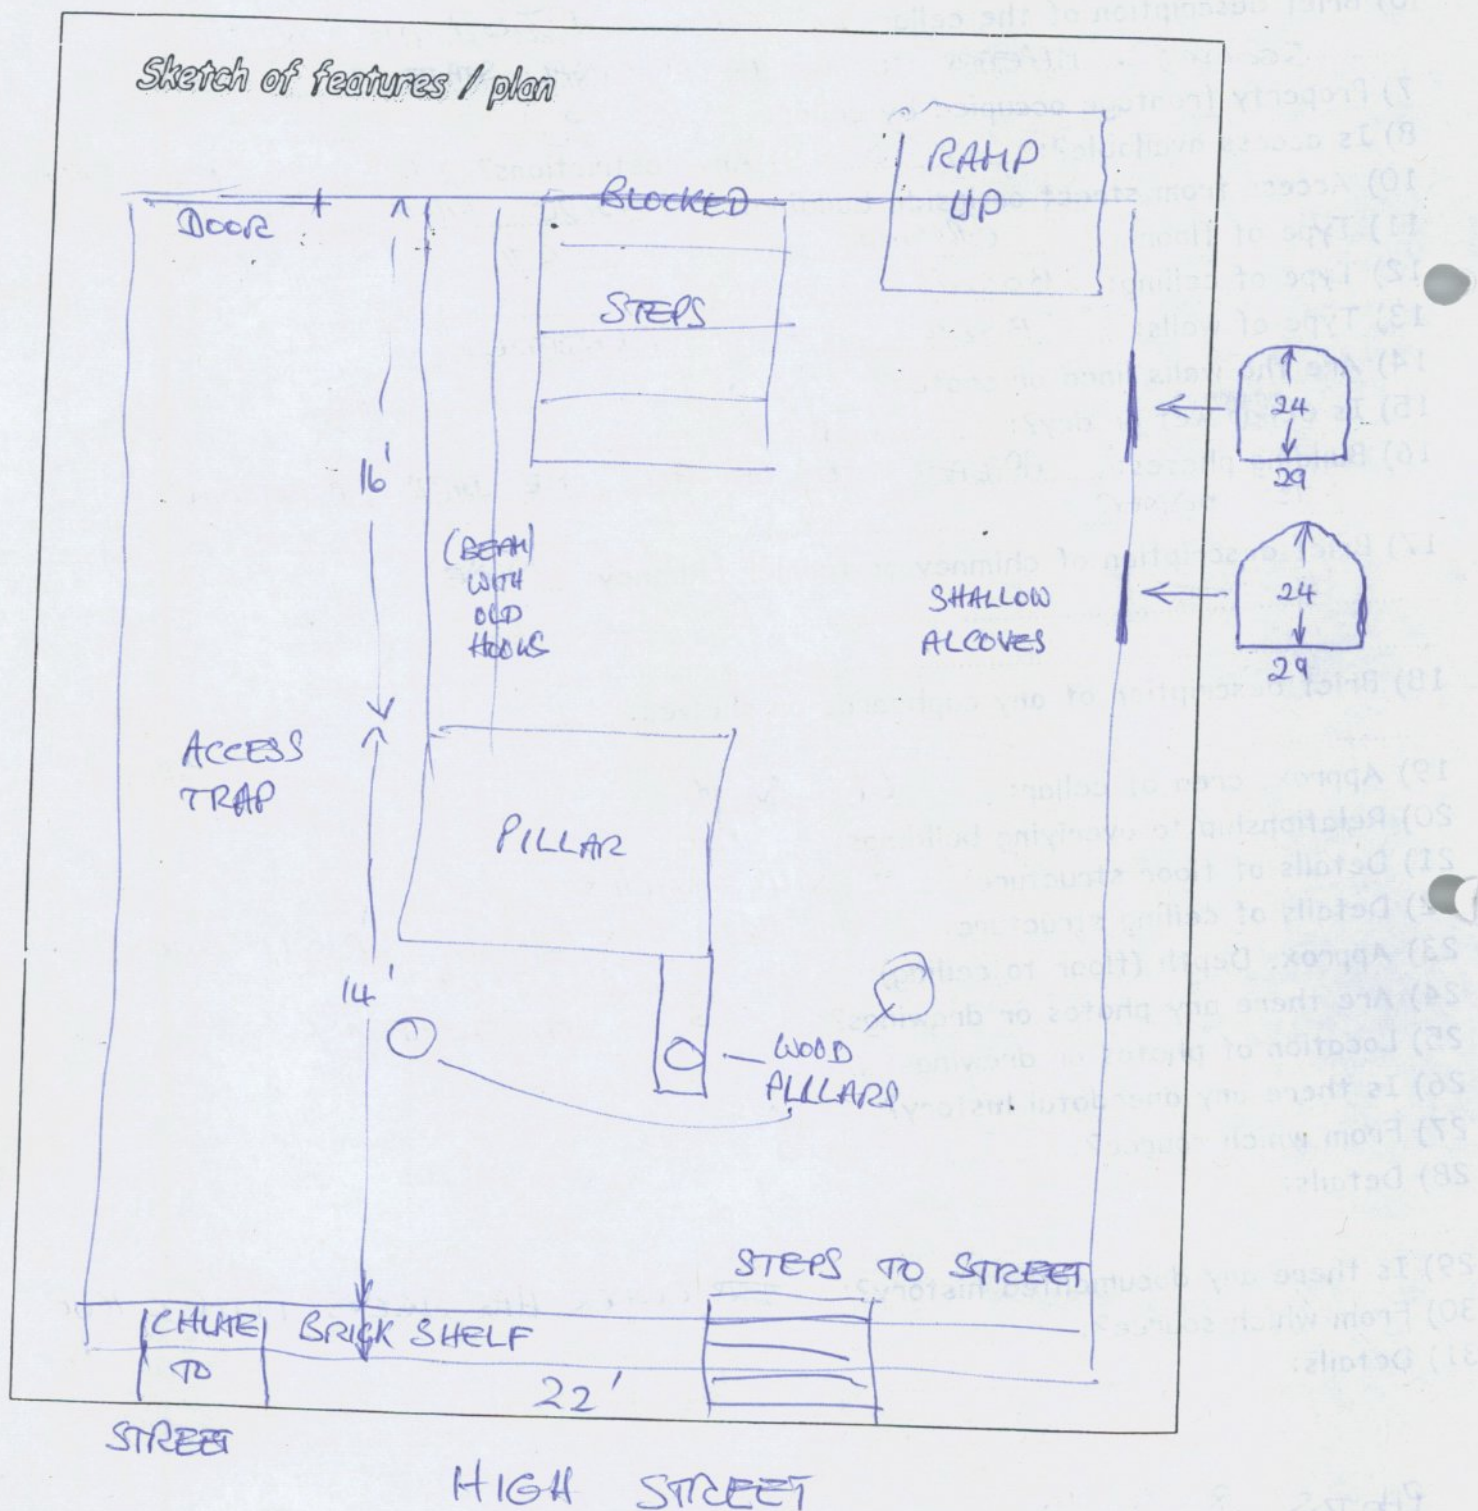
Sketch of features / plan

- 4) Address: 118 HIGH ST
- 5) Is it listed?: ☒ Yes || No || Listed Class Grade I || ☒ II || II\* ||
- 6) Brief description of the cellar: Lge Cellar divided into 2 sections. APPEARS TO BE IN ORIGINAL STATE

- 18) Brief description of any cupboards or shelves:
- 19) Approx. area of cellar: 660 Sq. ft.
- 20) Relationship to overlying buildings: 100%
- 21) Details of floor structure: 9" x 4" BRICKS

- 22) Details of ceiling structure: Older Beams 4" x 5 1/2" (6) UP to 11" BOARDS
- 23) Approx. Depth (floor to ceiling): 8' to EARTH 7' 6"
- 24) Are there any photos or drawings? YES - MR JEFFERY

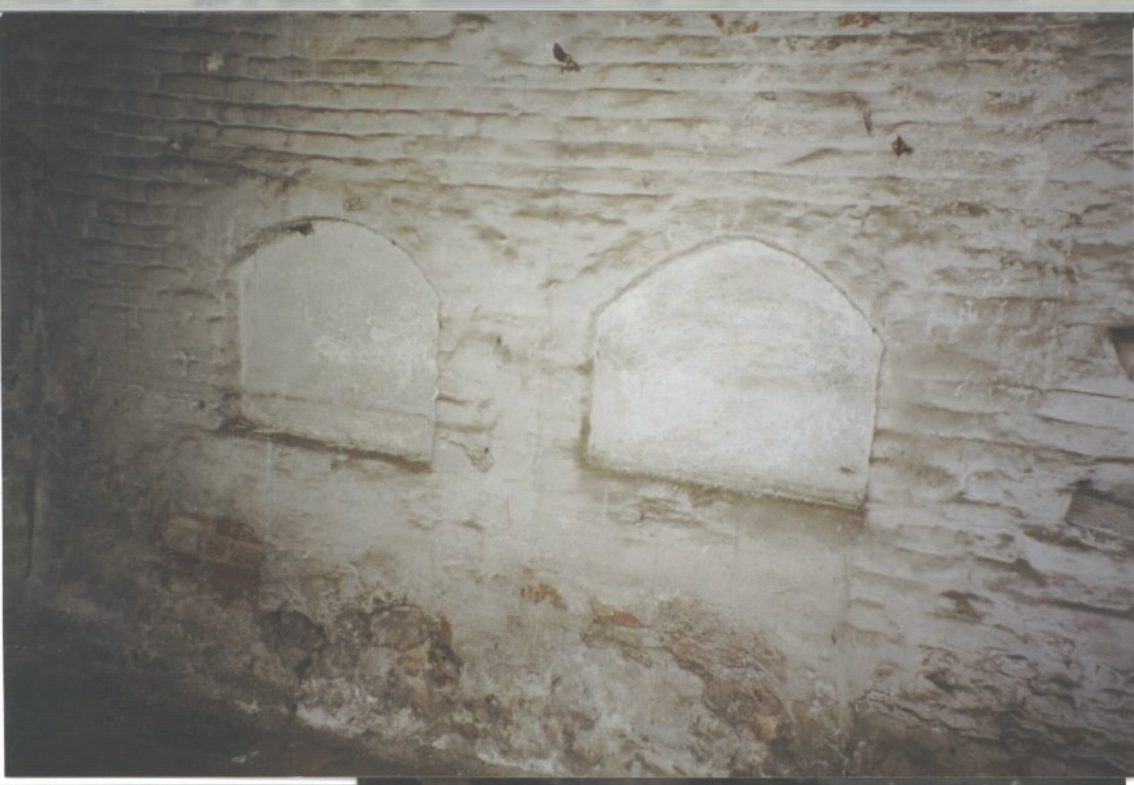
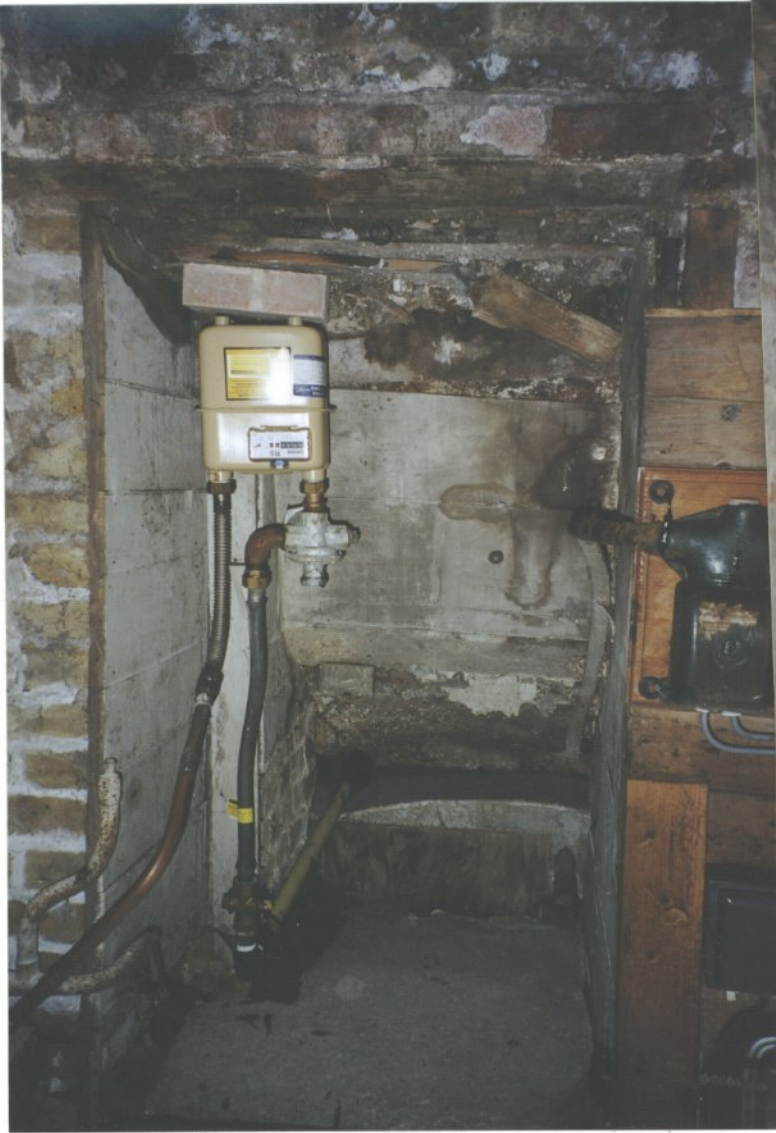
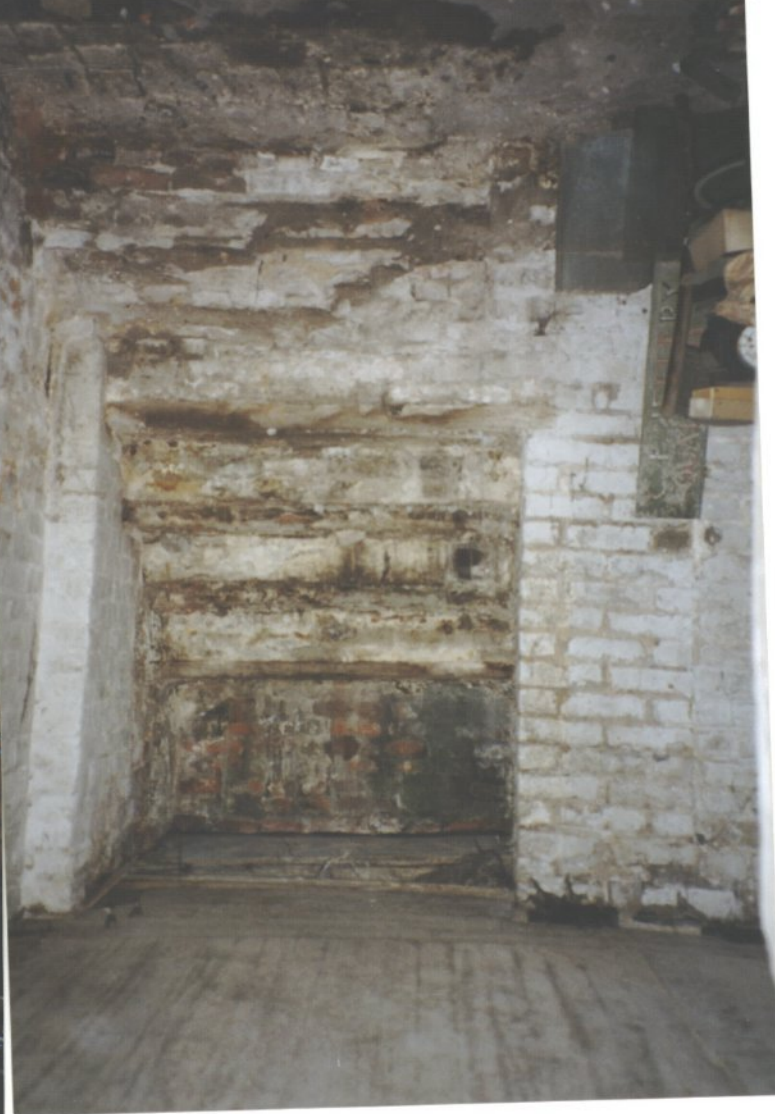
PHOTOS 8, 9, 10.

Additional notes: Old Iron Hooks attached to floor  
Joists, When road was taken up the  
old pavement lights were taken up  
Has original Deeds 1600'
